NASA CR-159424
PWA-5616

COMPRESSOR SEAL RUB ENERGETICS STUDY

FINAL REPORT

PRATT & WHITNEY AIRCRAFT GROUP
COMMERCIAL PRODUCTS DIVISION
UNITED TECHNOLOGIES CORPORATION

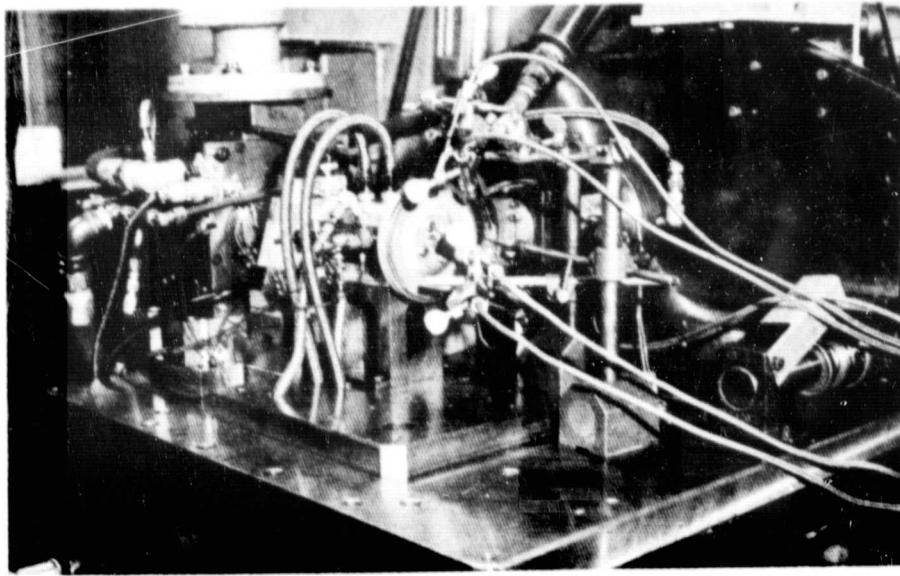
Figure 1. Test Rig Setup for Rub Energy Test

In establishing an experimental facility to investigate engine rub phenomena, it was desired to model as many of these factors as possible. Because of cost factors it was desirable to work in a small scale rig. Comparative testing in small scale rigs and full scale rigs and engines was used to substantiate that rig size does not have a significant effect on the controlling rub phenomena. Environmental conditions which are often costly to reproduce in a rig appear to be of secondary importance except for the effect of temperature on material properties. For compressor seal rubbing, however, rub energy is often the dominant effect in determining the temperature in the rub zone so that ambient testing is justified for initial studies of compressor seal rub energetics. The remaining variables of known importance can all be simulated in the P&WA small scale abrasibility test rig facilities. A photograph of the rig used in this program is shown in Figure 1 and a schematic of the rig is shown in Figure 2.

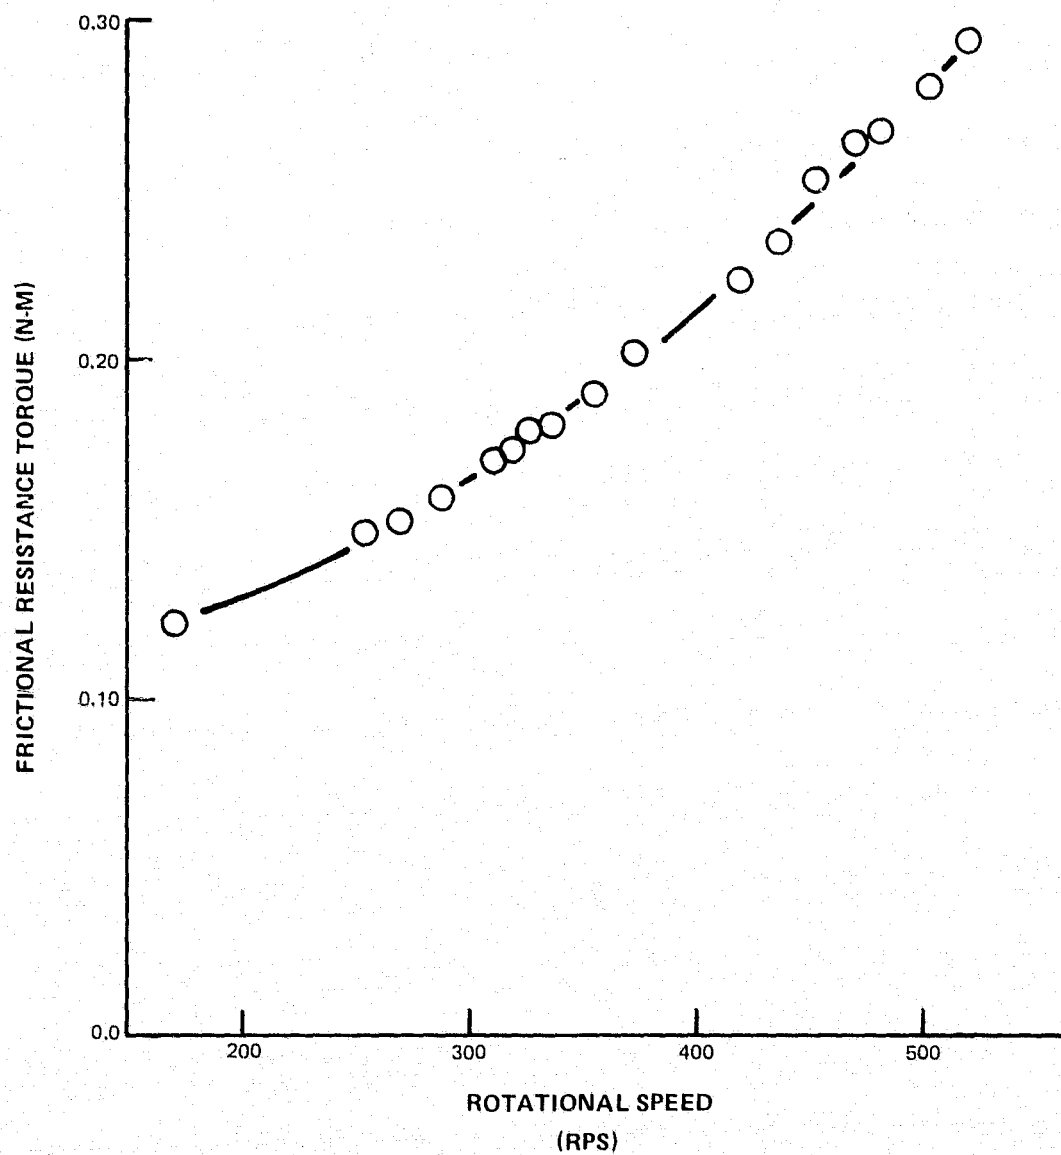
FRICTIONAL RESISTANCE TORQUE IS THE SUM OF
BEARING TORQUE AND WINDAGE TORQUE

Figure 8. Results of Testing to Determine Frictional Resistance Torque

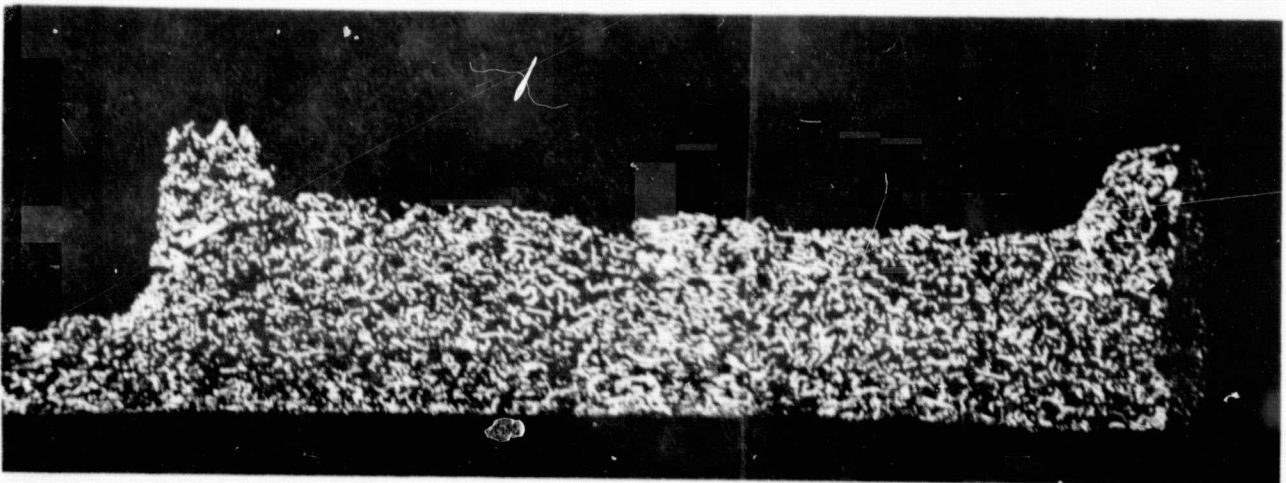
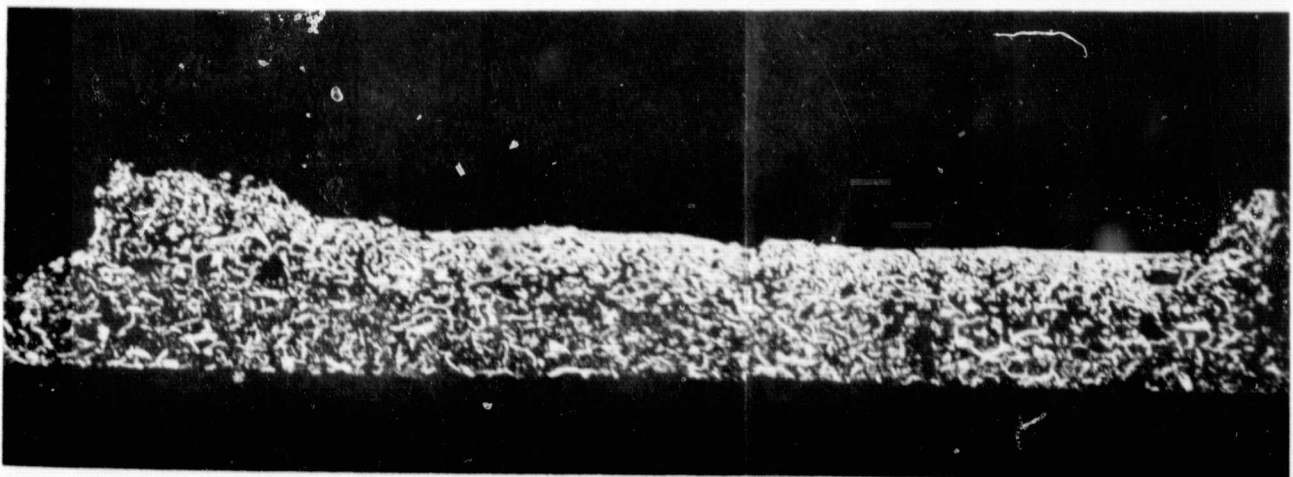
Figure 9. Post Test Cross-sections of Task I Test Seals (Mag: 25x)

Test 2 ($i = 0.0025$ mm/sec, $v = 213$ mps, $b = 0.53$ mm, $\delta = 0.5$ mm, $\rho = 19\%$)

Test 3 ($i = 0.25$ mm/sec, $v = 152$ mps, $b = 0.56$ mm, $\delta = 0.5$ mm, $\rho = 16\%$)

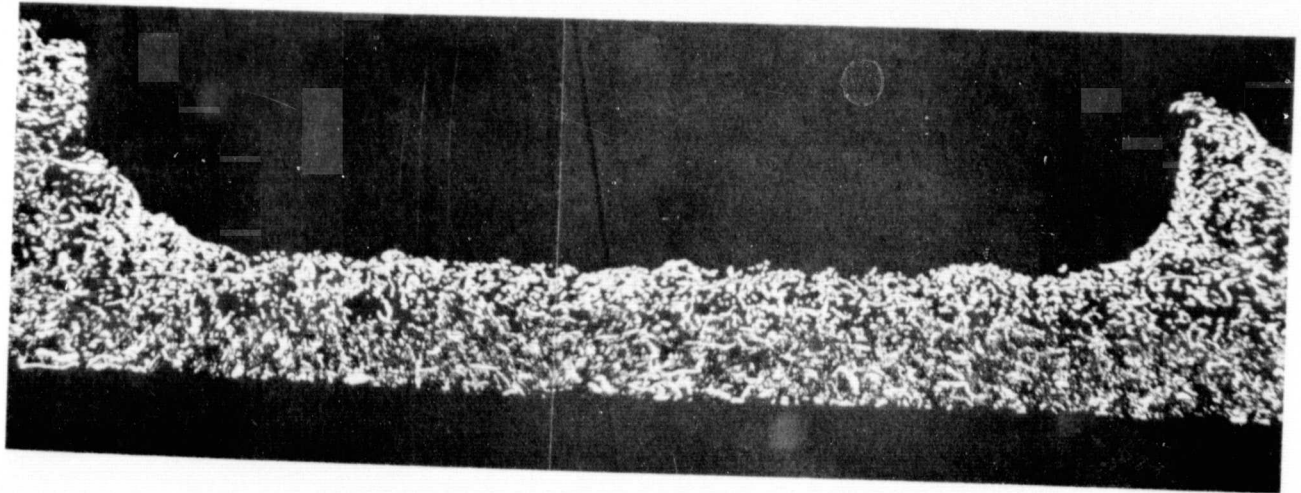
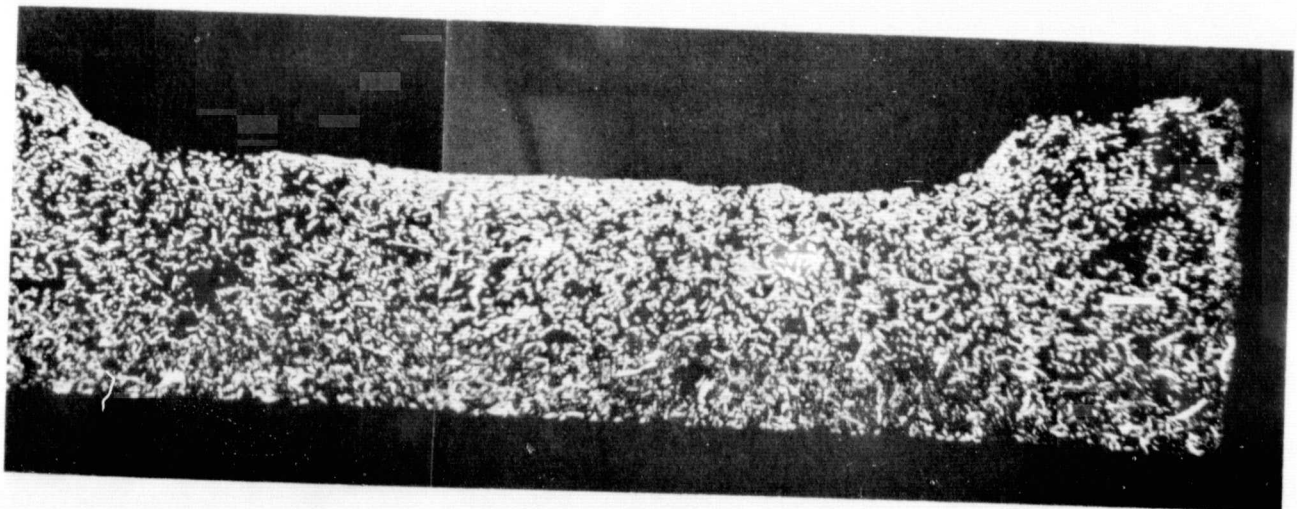
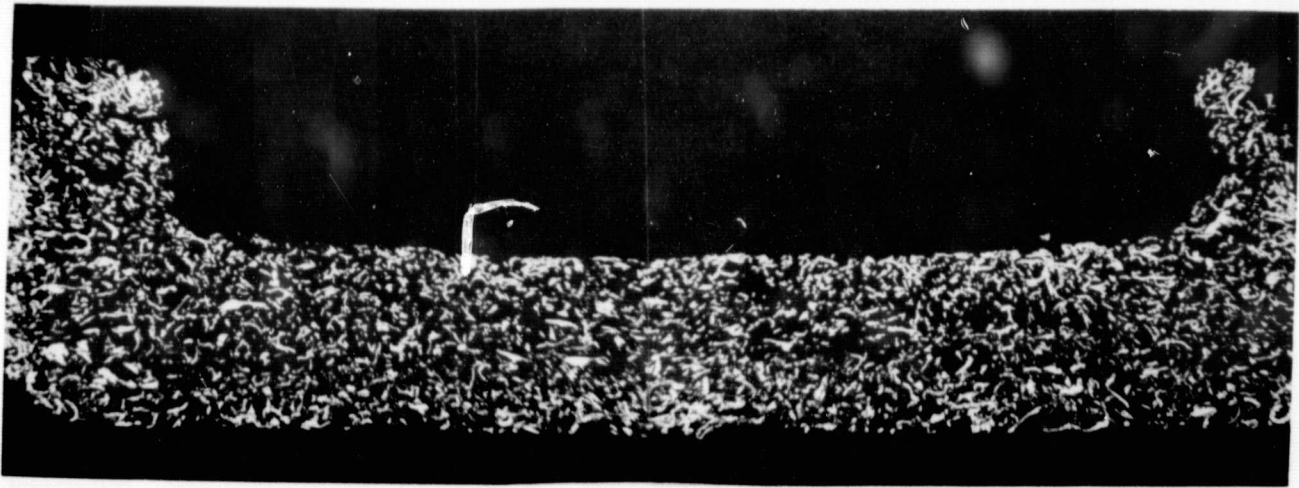
Figure 10. Post Test Cross-sections of Task I Test Seals (Mag: Top 50x, Center and Bottom 25x)

Test 5 ($i = 0.25$ mm/sec, $v = 213$ mps, $b = 1.74$ mm, $\delta = 1.0$ mm, $\rho = 19\%$)

Test 6 ($i = 0.025$ mm/sec, $v = 152$ mps, $b = 0.51$ mm, $\delta = 1.0$ mm, $\rho = 19\%$)

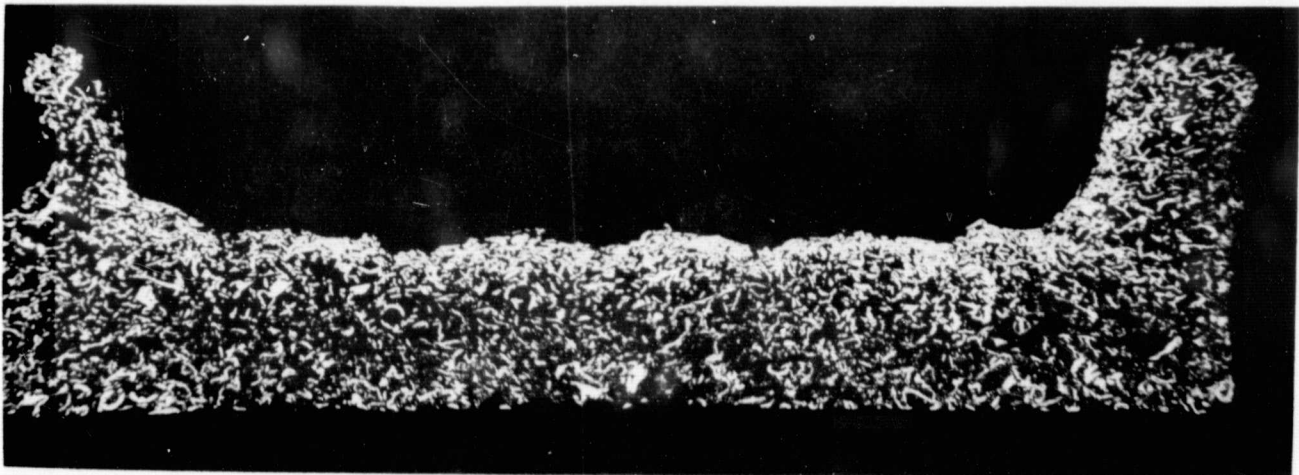
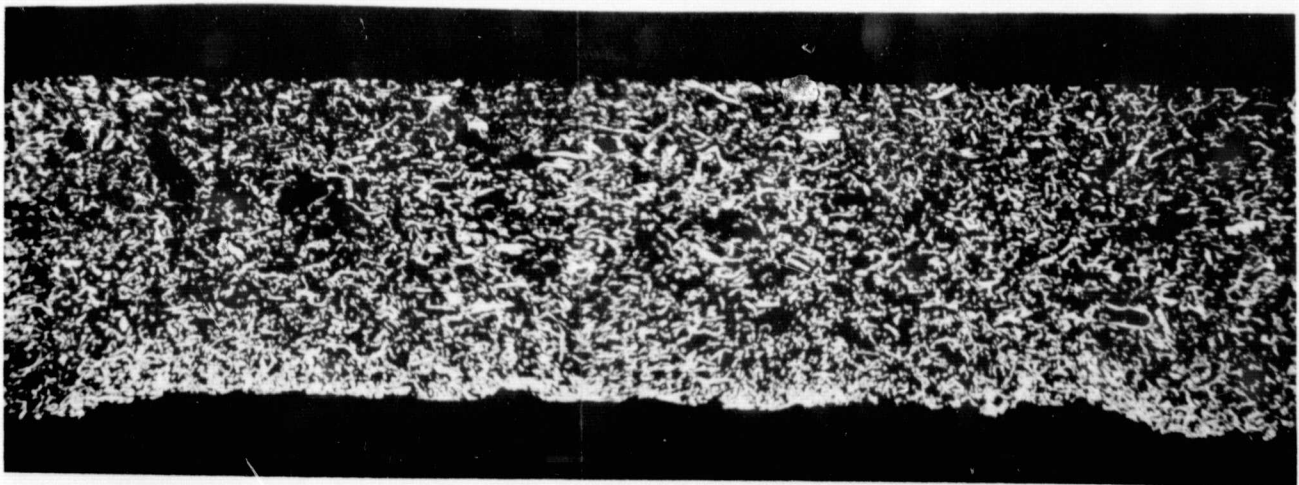
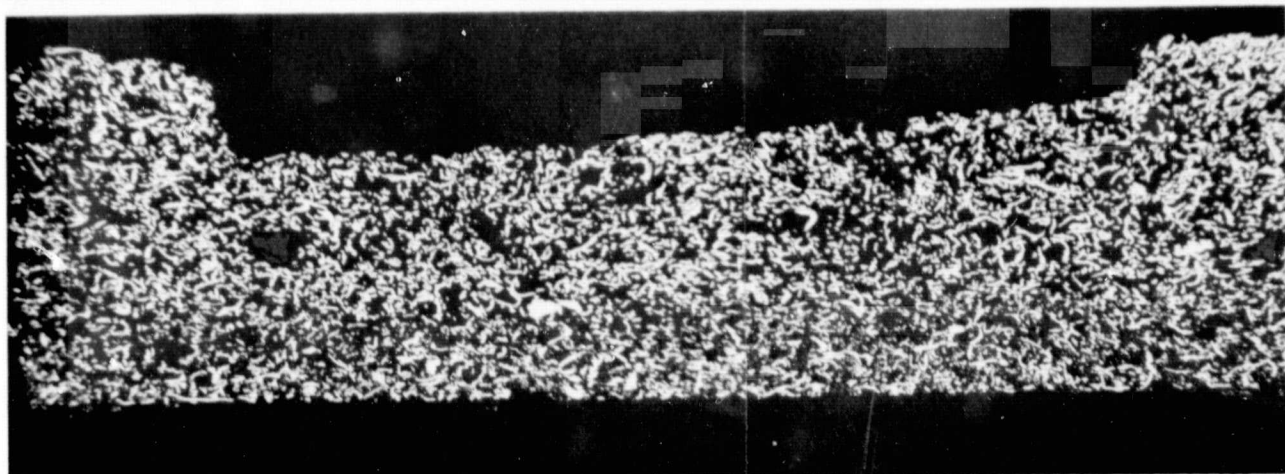
Figure 11. Post Test Cross-sections of Task I Test Seals (Mag: 25x)

Test 8 ($i = 0.25$ mm/sec, $v = 213$ mps, $b = 0.56$ mm, $\delta = 1.0$ mm, $\rho = 16\%$)

Test 9 ($i = 0.25$ mm/sec, $v = 152$ mps, $b = 1.75$ mm, $\delta = 0.5$ mm, $\rho = 19\%$)

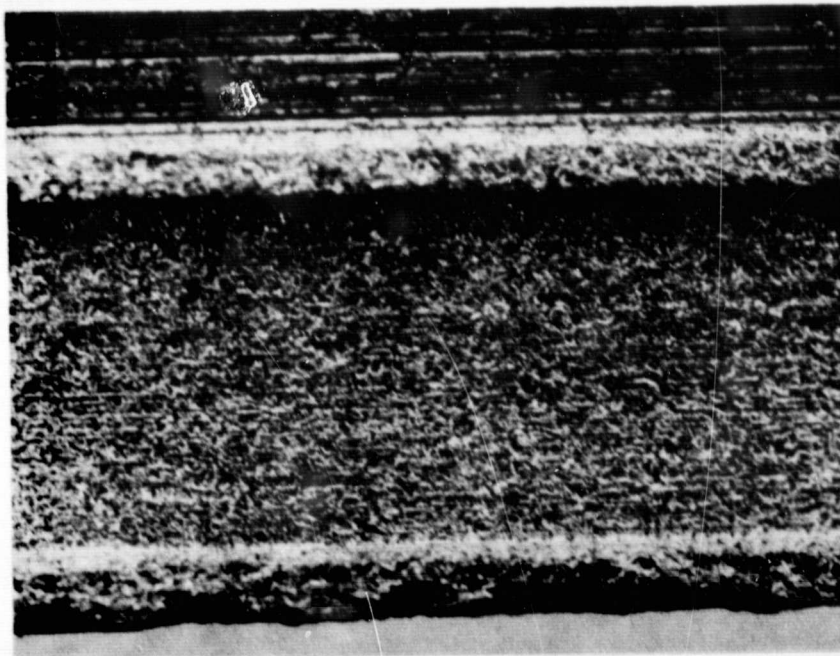
Test 10 ($i = 0.0025$ mm/sec, $v = 213$ mps, $b = 0.52$ mm, $\delta = 0.5$ mm, $\rho = 19\%$)

Figure 13. Photographs of Hastelloy X Fibermetal Abradable Seals Showing Typical Rub Surface Condition After Rub Interaction With PWA 1204 Blades. Note the smeared appearance and deep grooves on the seal from Test 9 (Mag: 10x)

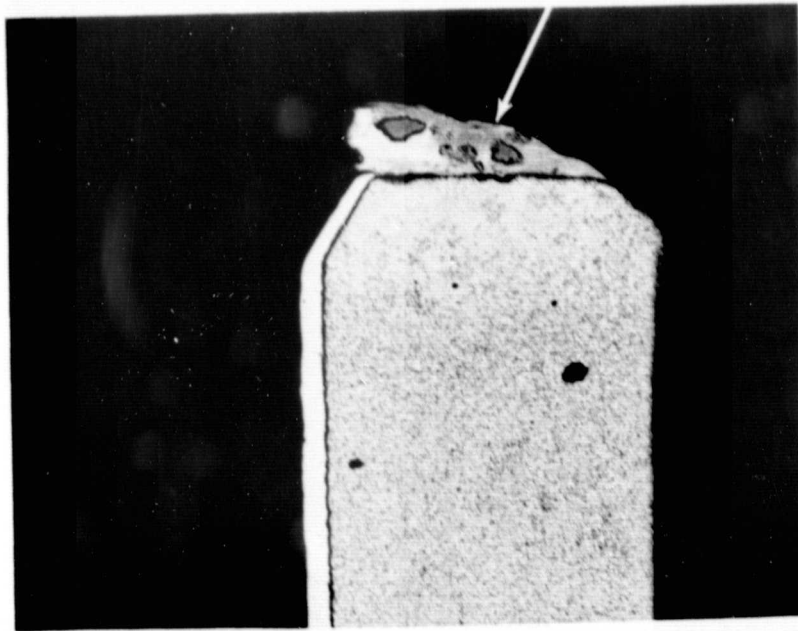
Test 11 ($i = 0.025$ mm/sec, $v = 152$ mps, $b = 0.56$ mm, $\delta = 1.0$ mm, $\rho = 19\%$)

Figure 14. Transverse Section Through Test Blade #11 Showing Transfer (Mag: 100x)

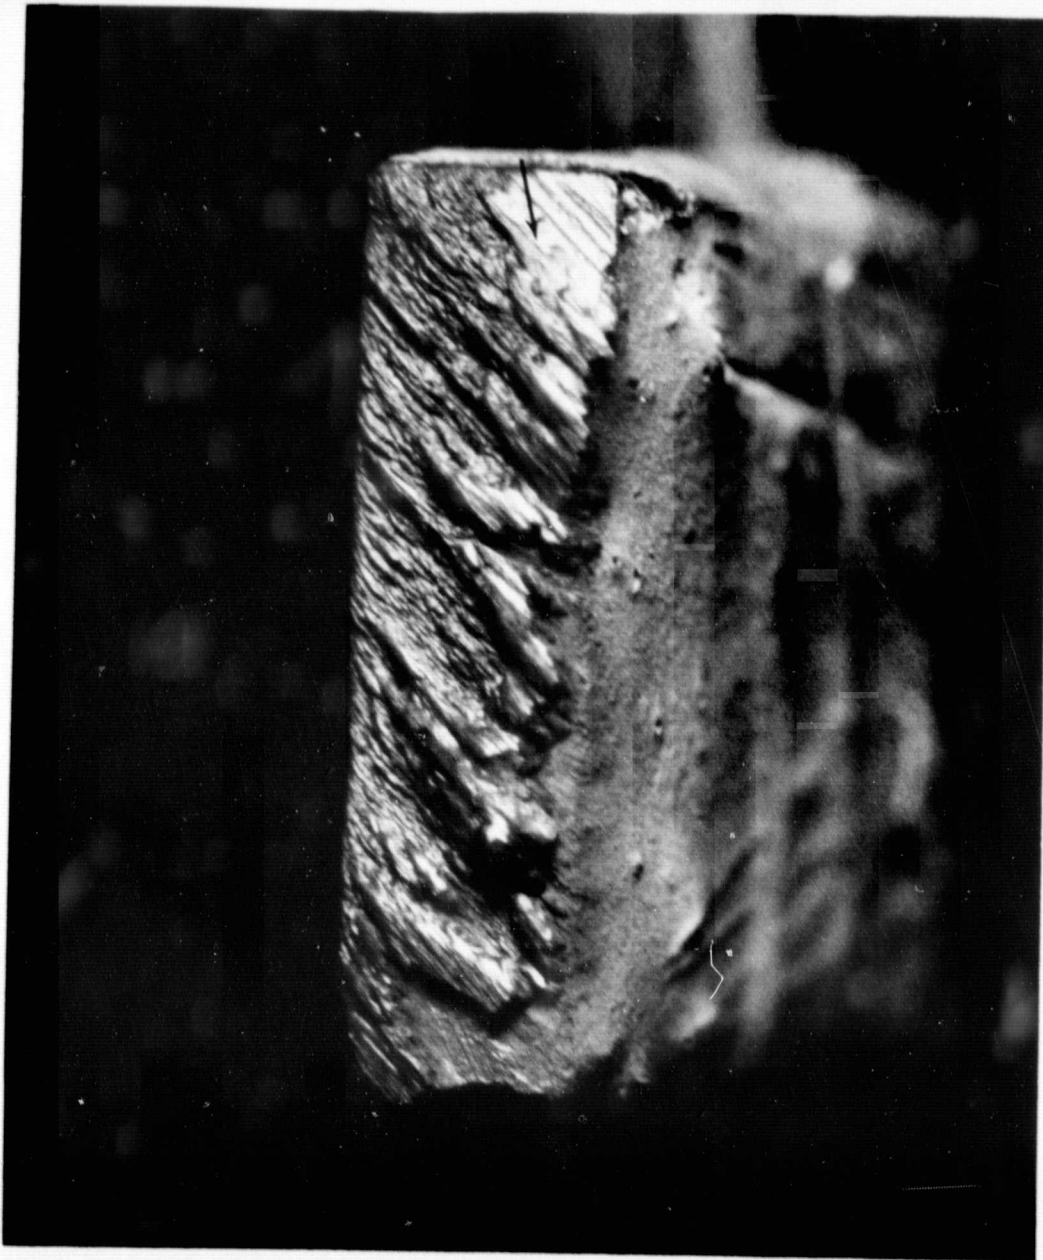
Test 1 ($i = 0.25$ mm/sec, $v = 213$ mps, $b = 1.78$ mm, $\delta = 1.0$ mm, $\rho = 19\%$)

Figure 15. Top View of Test Blade #1 Showing Transfer

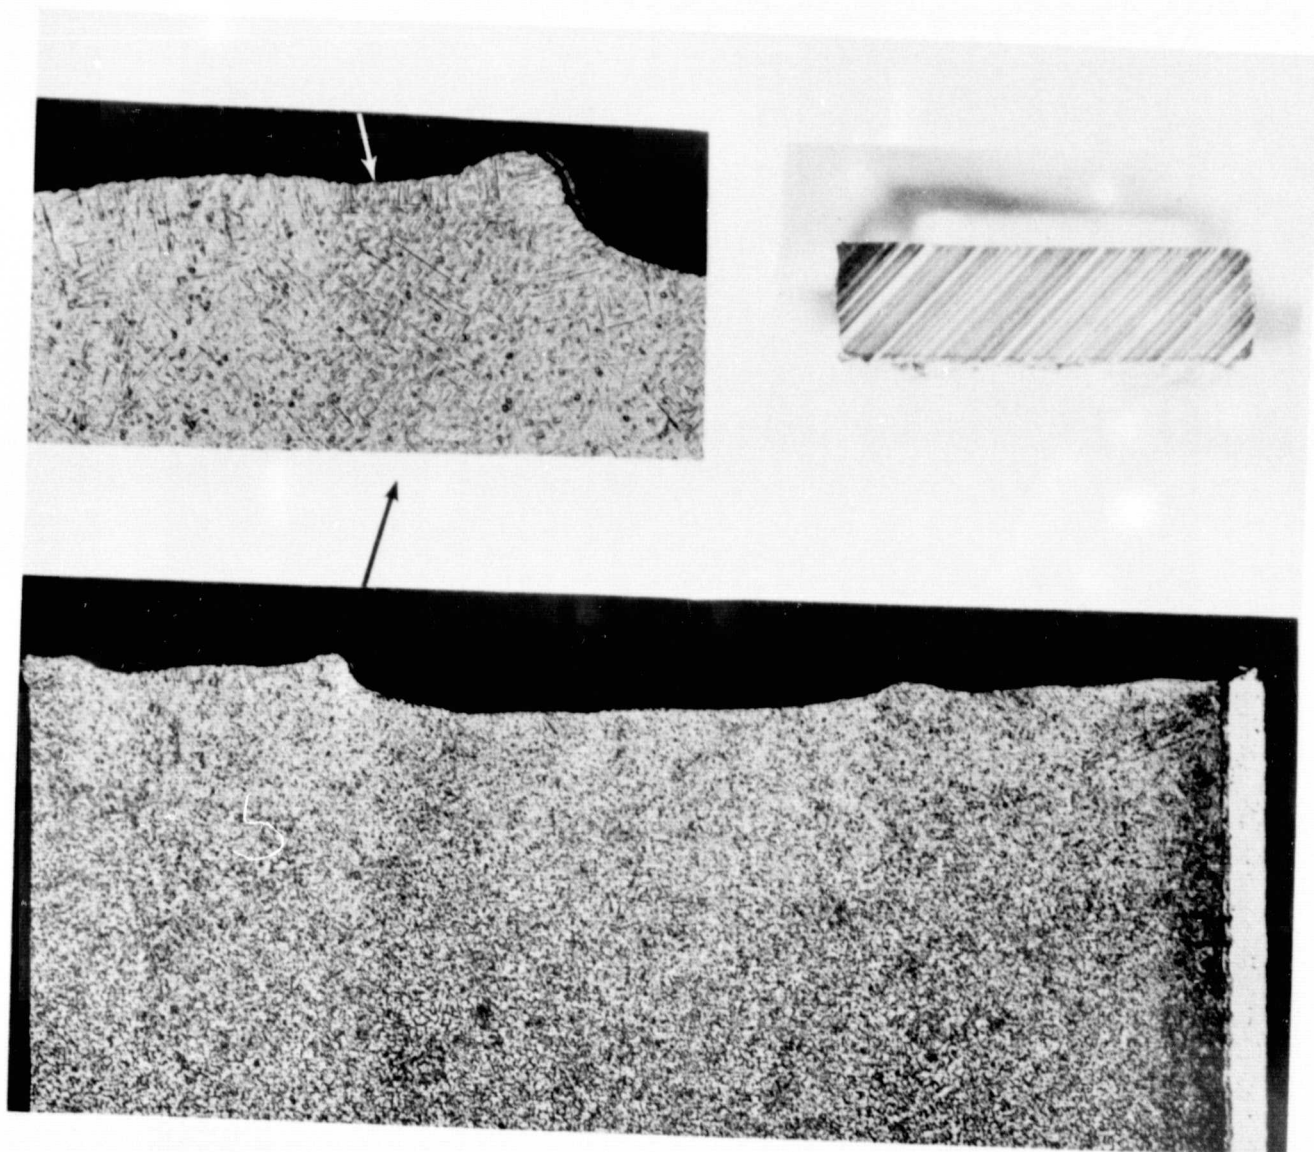
Test 9 ($i = 0.25$ mm/sec, $v = 152$ mps, $b = 1.75$ mm, $\delta = 0.5$ mm, $\rho = 19\%$)

Figure 16. Transverse Section Through Tip of PWA 1204 Blade from Test 9 (Mag: Top Left 250x, Top Right 10x, Bottom 100x)

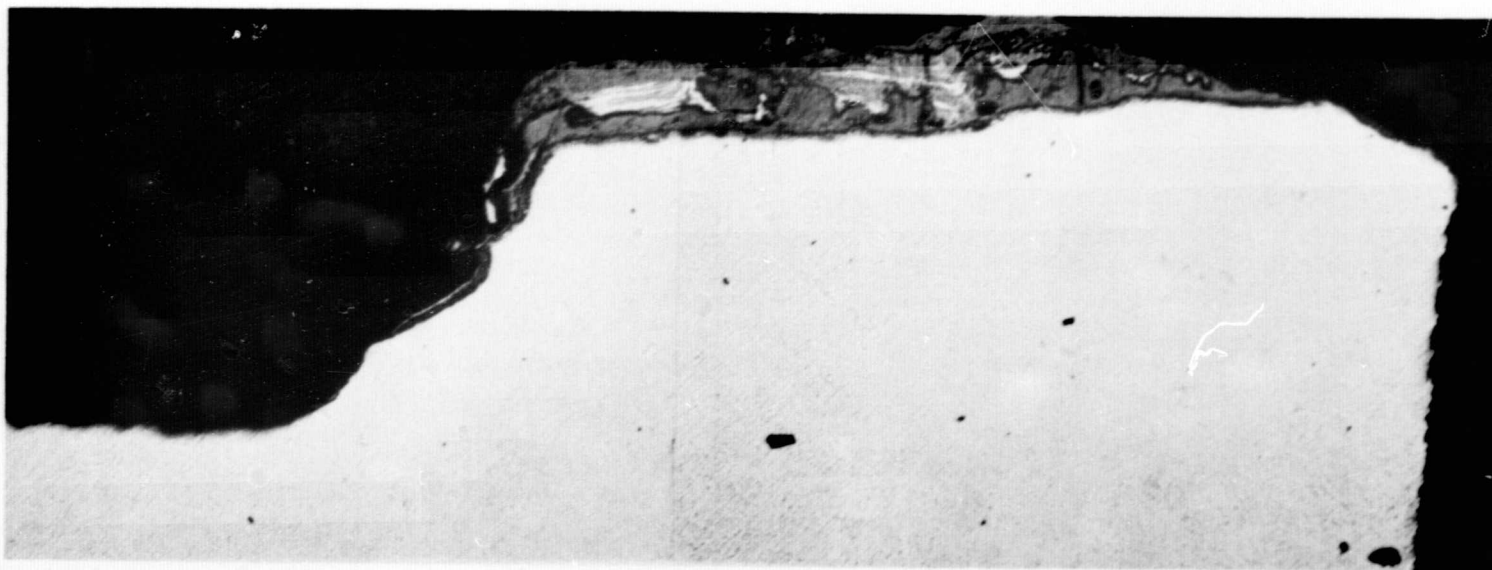
Test 12 ($i = 0.25$ mm/sec, $v = 152$ mps, $b = 0.61$ mm, $\delta = 1.0$ mm, $\rho = 19\%$)

Figure 17. Longitudinal Section Through Tip of PWA 1204 Blade from Test 12 (Mag: 100x)

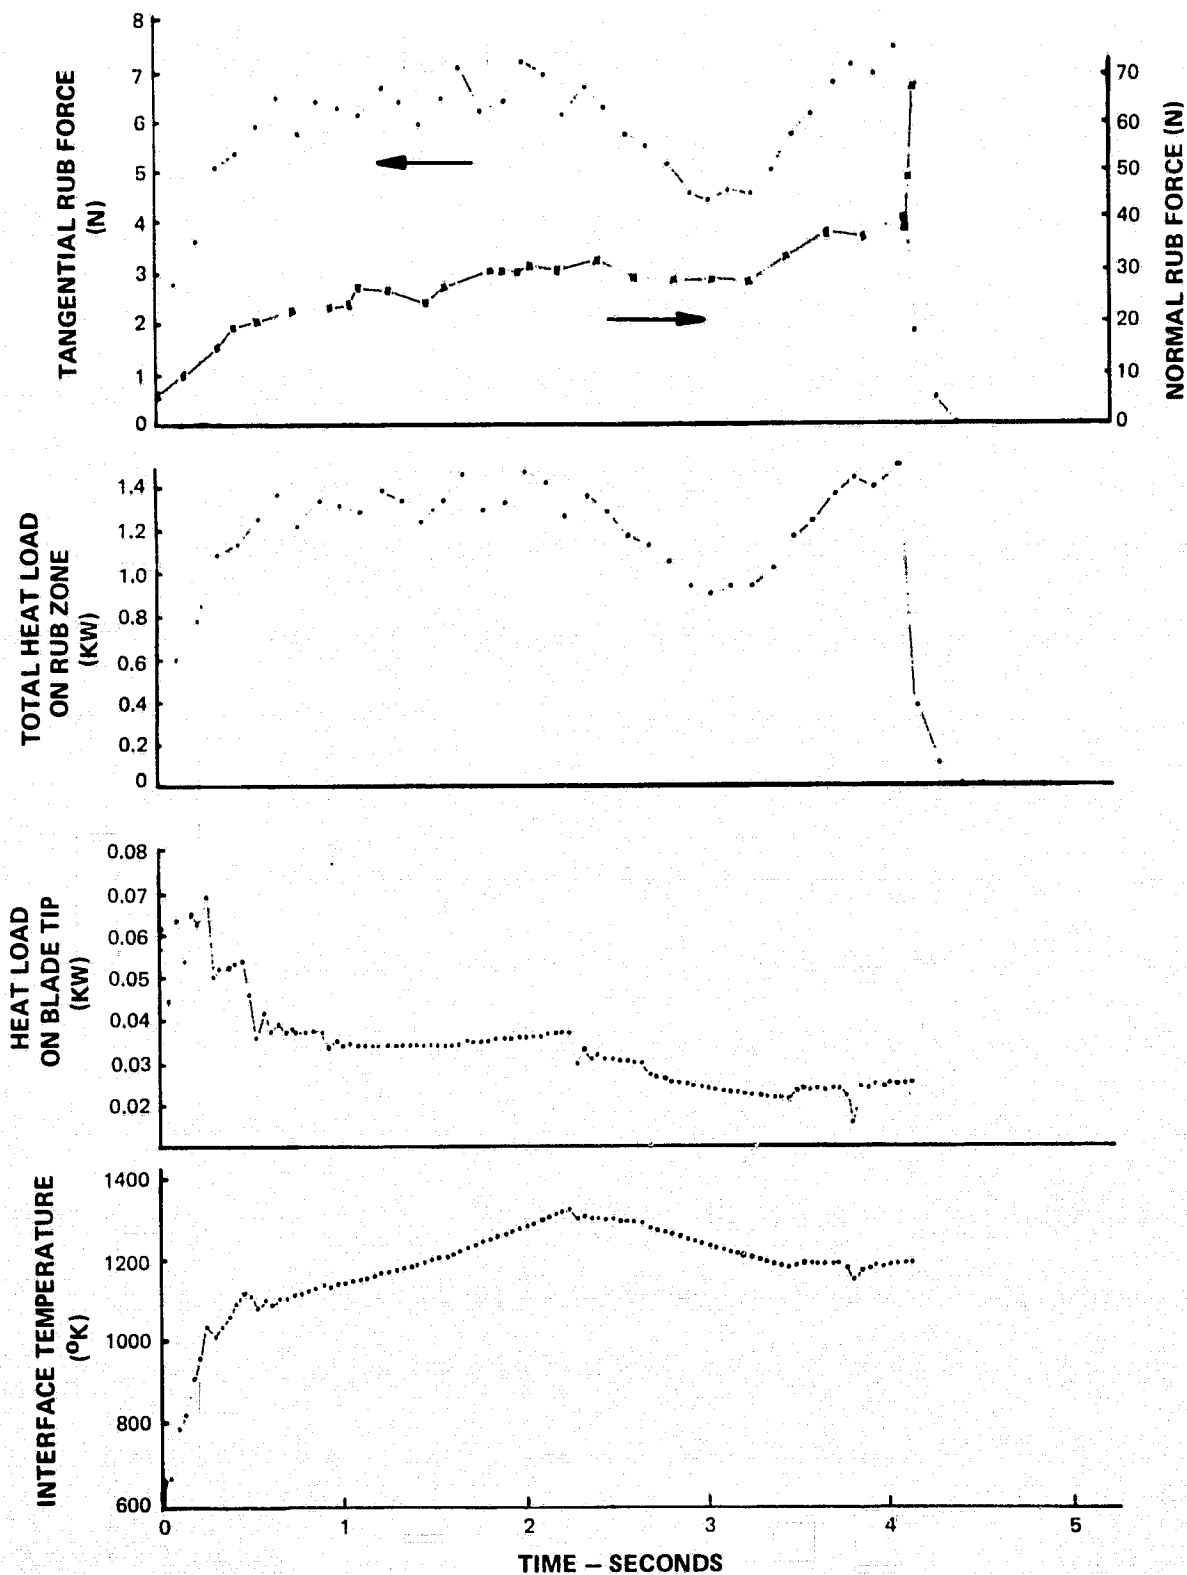
Figure 18. Task I Test 1 Data Reduction Results

Test 1 ($i = .25$ mm/sec, $v = 213$ mps, $b = 1.78$ mm, $\delta = 1.0$ mm, $\rho = 19\%$)

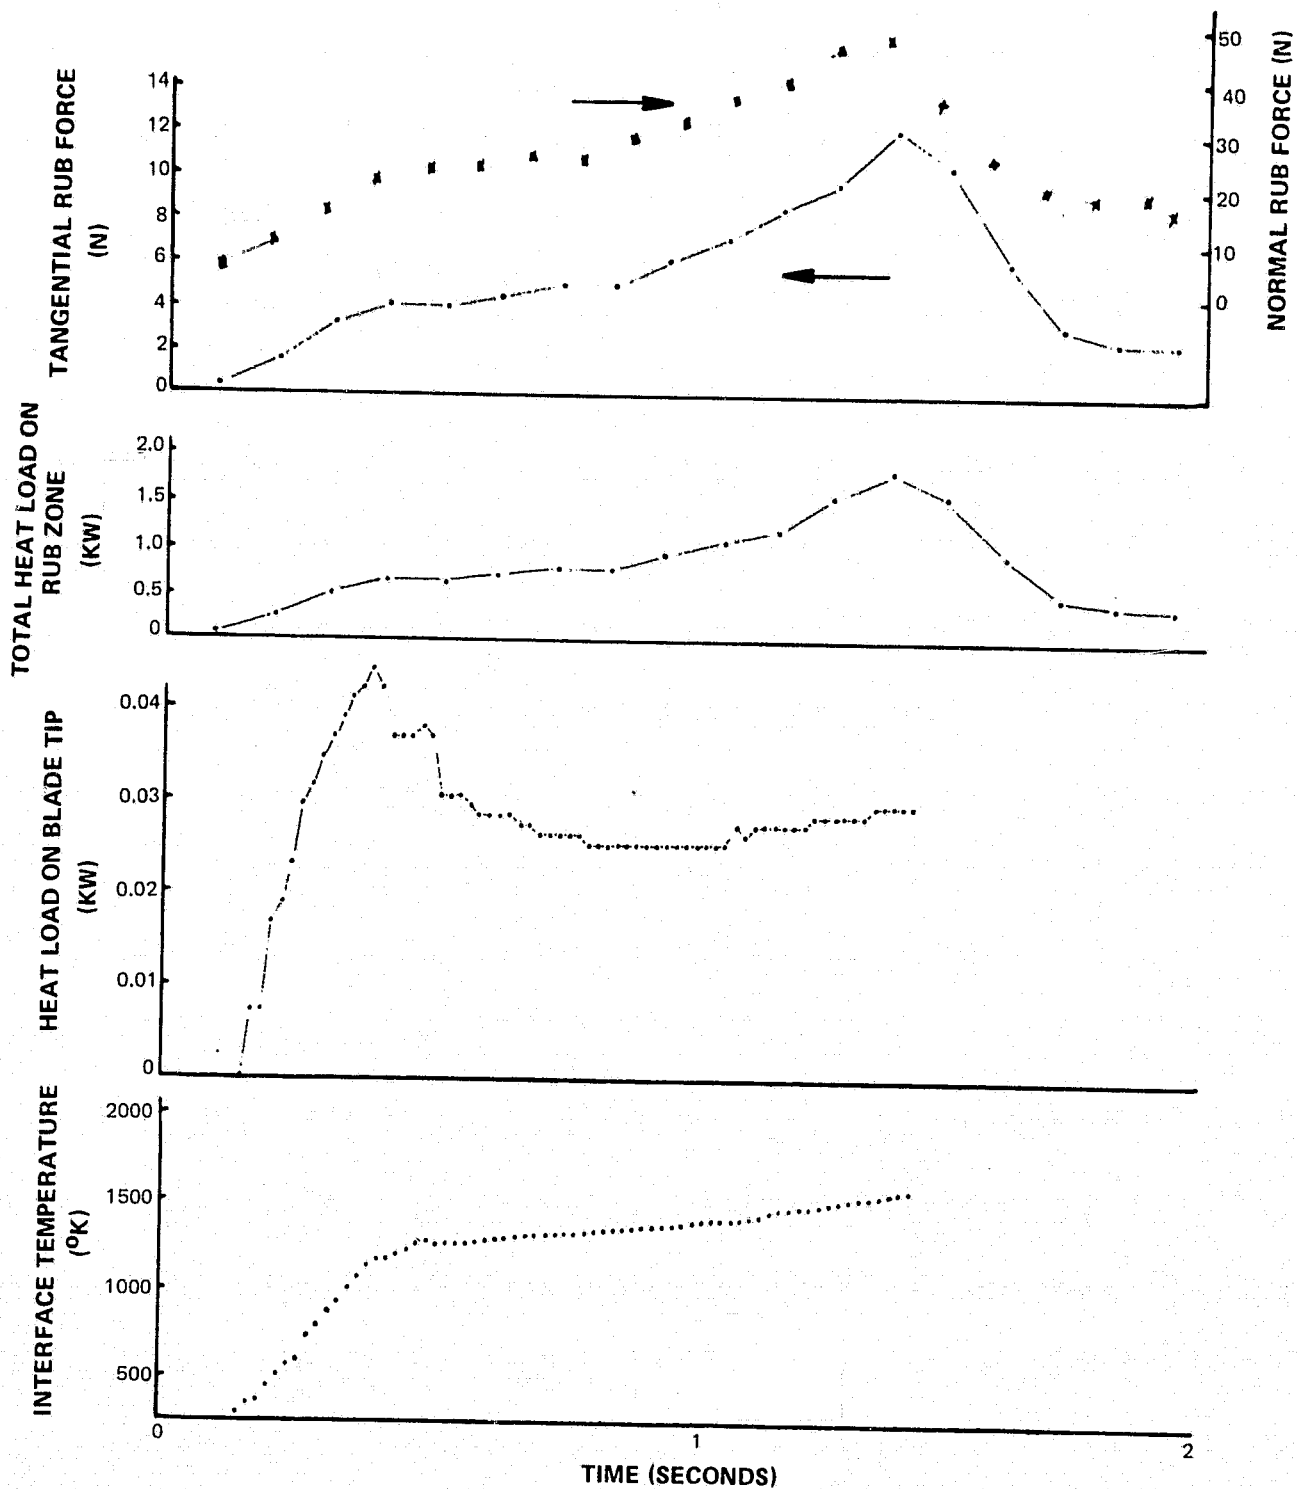
Figure 19. Task I Test 3 Data Reduction Results

Test 3 ($i = .25$ mm/sec, $v = 152$ mps, $b = .56$ mm, $\delta = 0.5$ mm, $\rho = 16\%$)

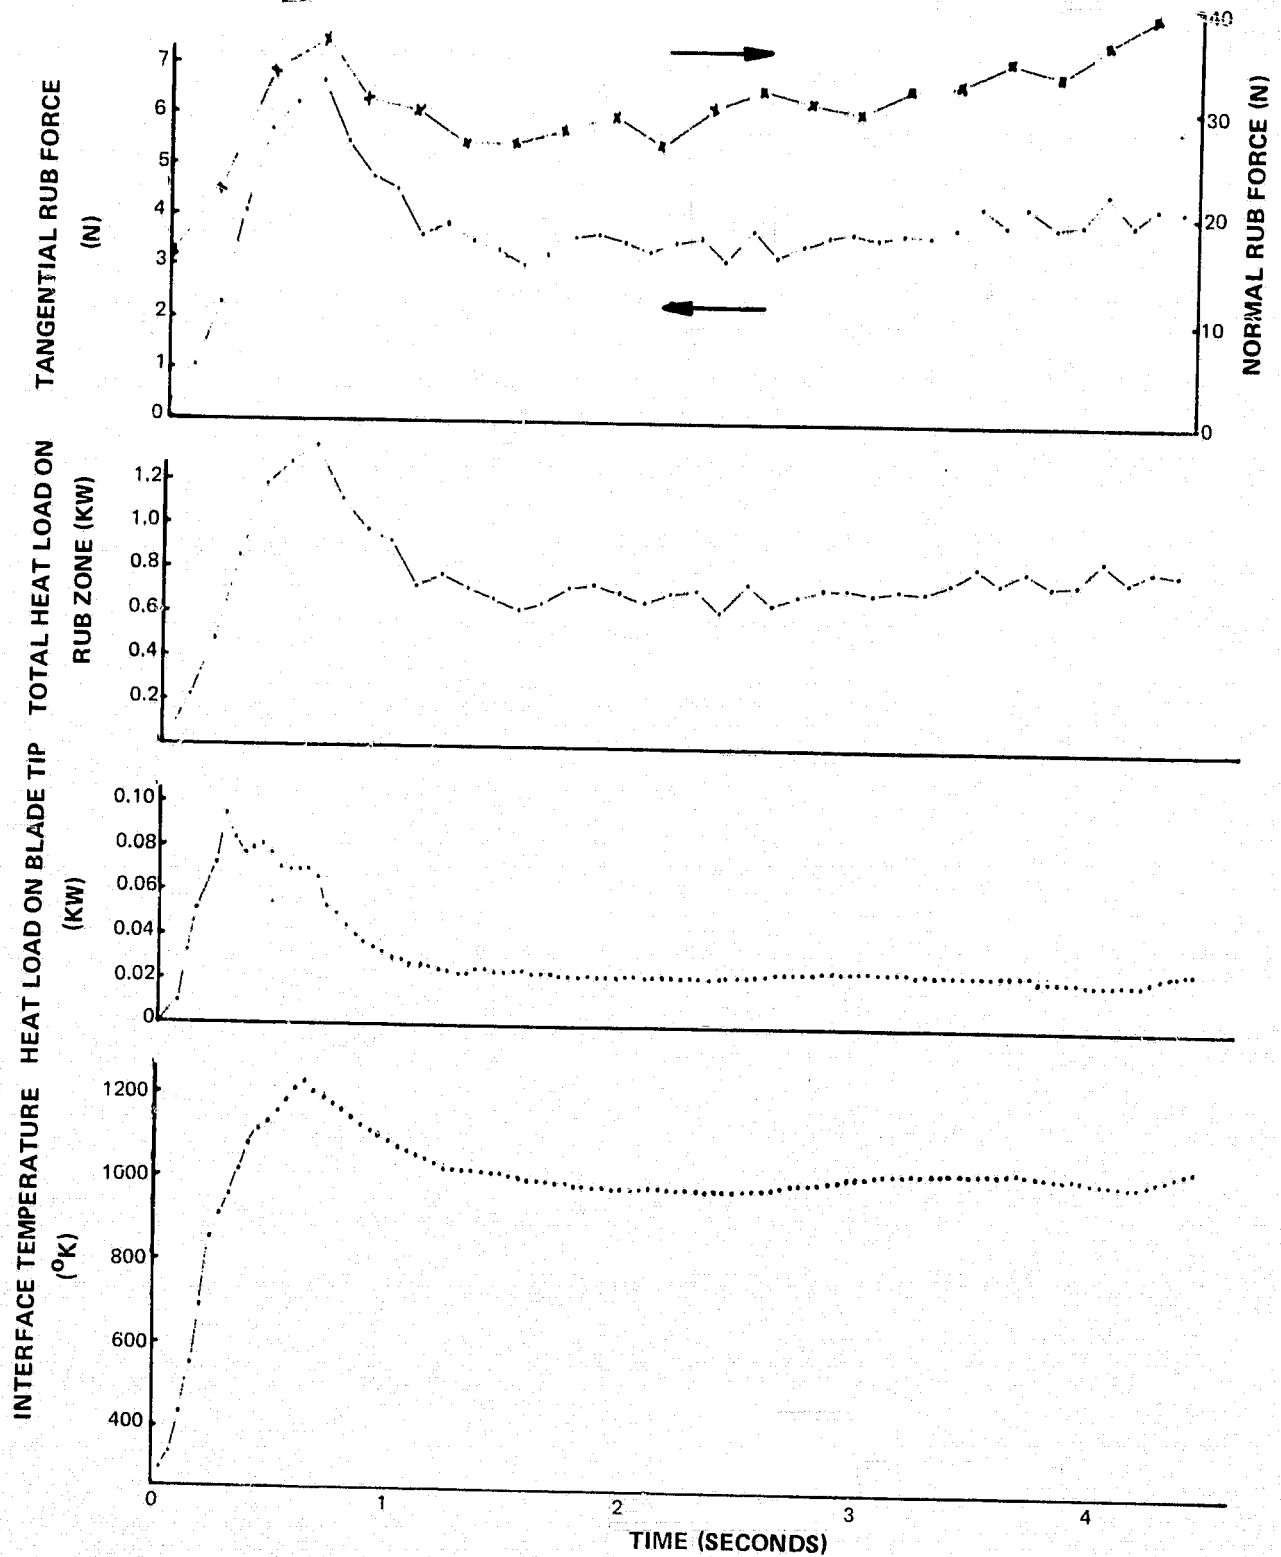
Figure 21. Task I Test 5 Data Reduction Results

Test 5 ($i = .25$ mm/sec, $v = 213$ mps, $h = 1.74$ mm, $\delta = 1.0$ mm, $\rho = 19\%$)

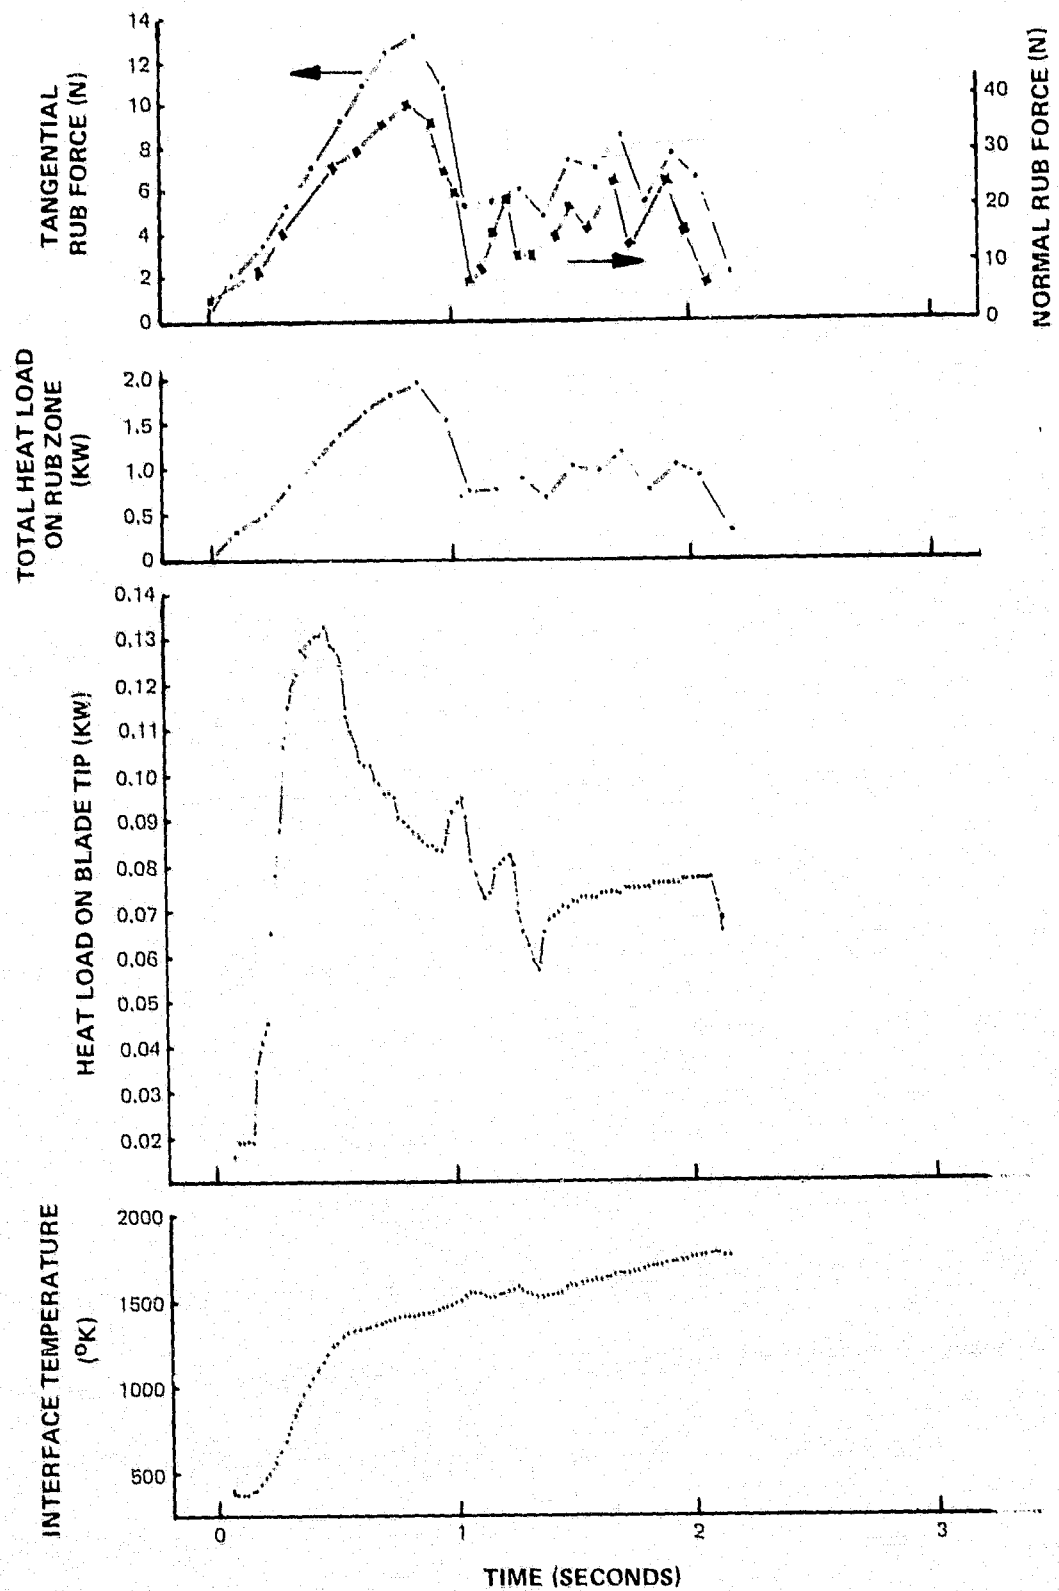
Figure 23. Task I Test 9 Data Reduction Results

Test 9 ($i = .25$ mm/sec, $v = 152$ mps, $b = 1.75$ mm, $\delta = .5$ mm, $\rho = 19\%$)

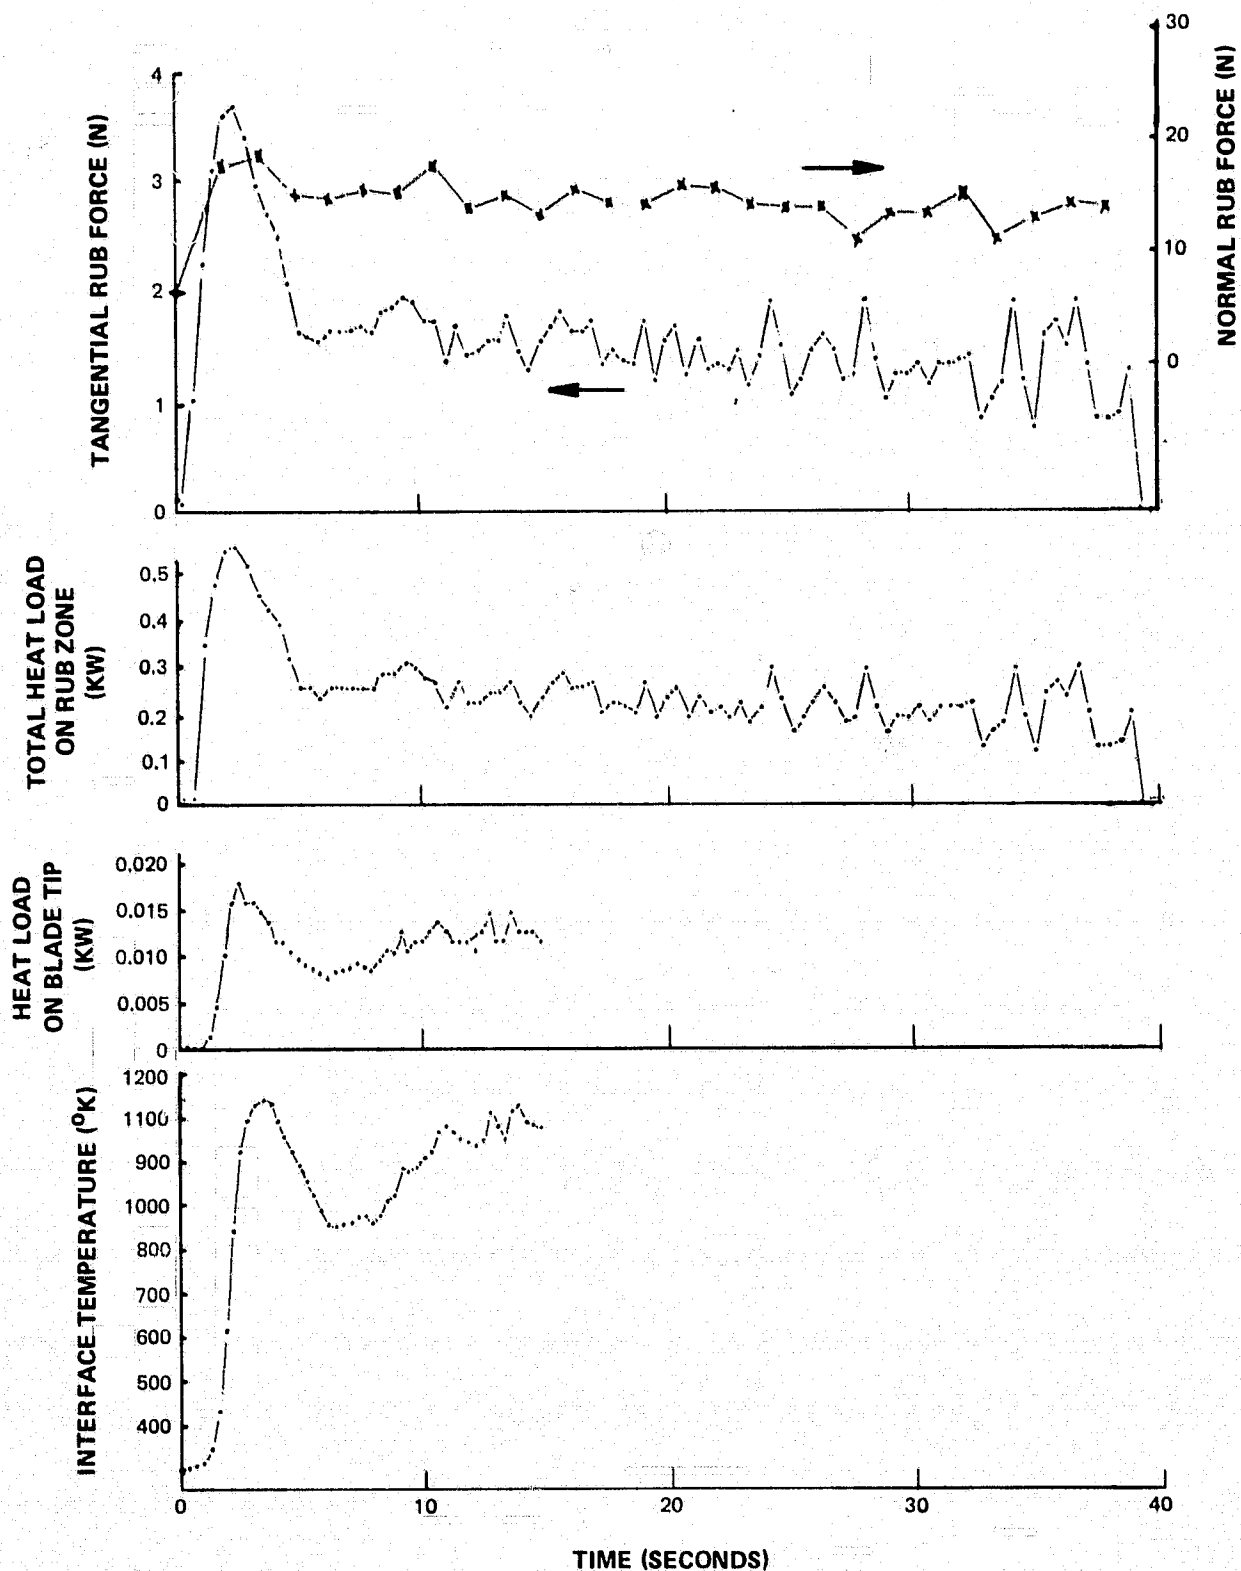
Figure 24. Task I Test 11 Data Reduction Results

Test 11 ($i = .025$ mm/sec, $v = 152$ mps, $b = 0.56$ mm, $\delta = 1.0$ mm, $\rho = 19\%$)

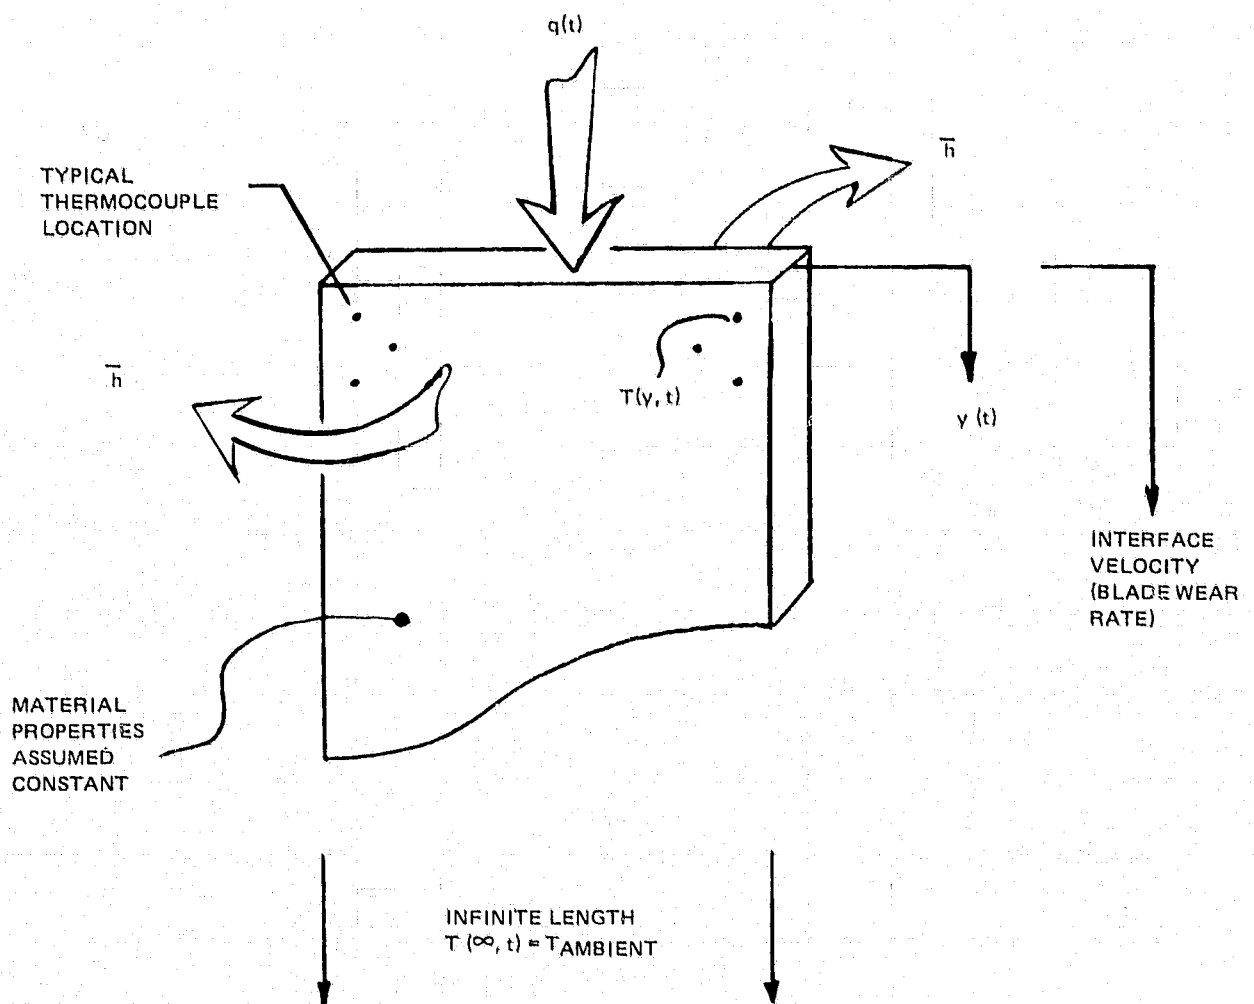
Figure 26. Model for Thermal Analysis of Blade
