NASA CR-159424
PWA-5616

COMPRESSOR SEAL RUB ENERGETICS STUDY

FINAL REPORT

PRATT & WHITNEY AIRCRAFT GROUP
COMMERCIAL PRODUCTS DIVISION
UNITED TECHNOLOGIES CORPORATION

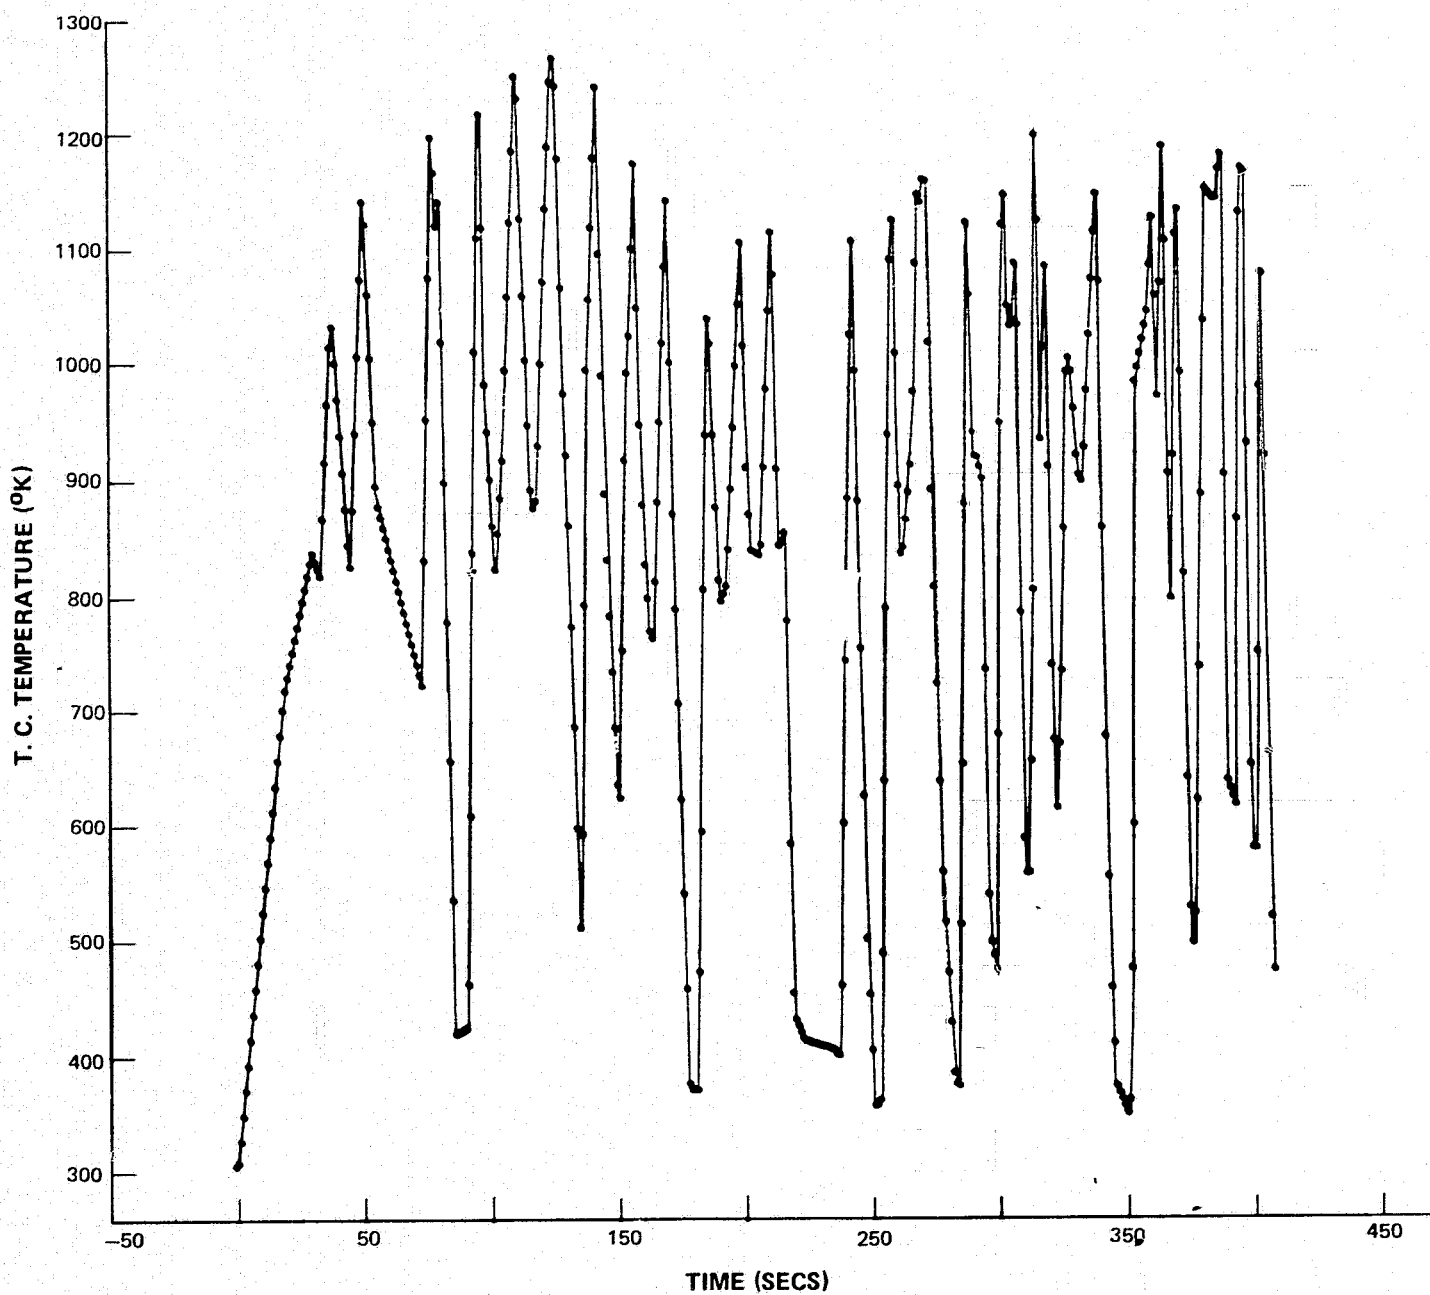
Figure 27. Test 7 – Thermocouple Trace During Test

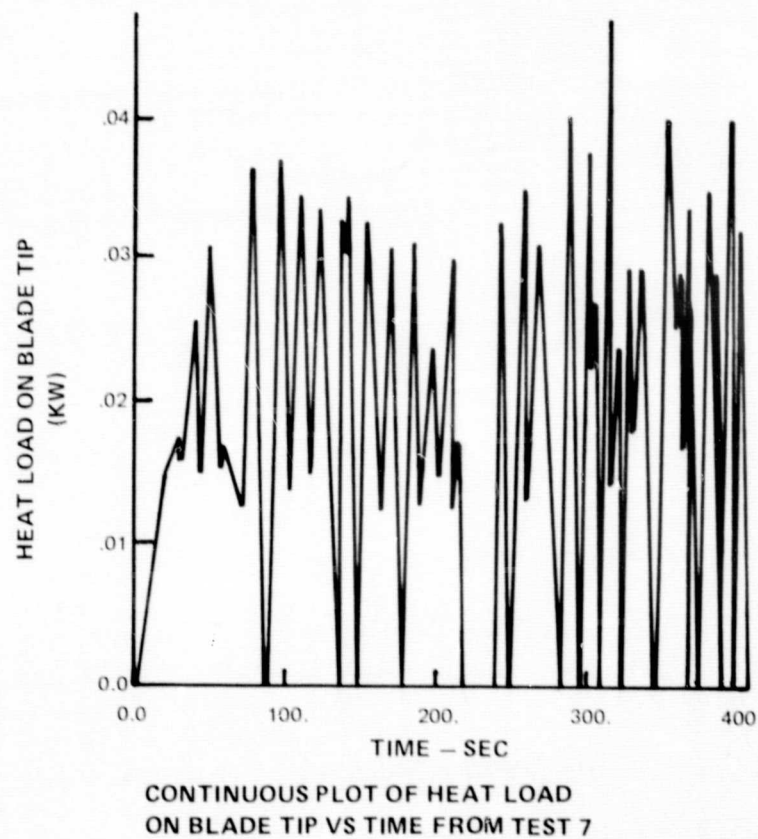
Figure 28. Test 7 - Blade Heating Data Reduction

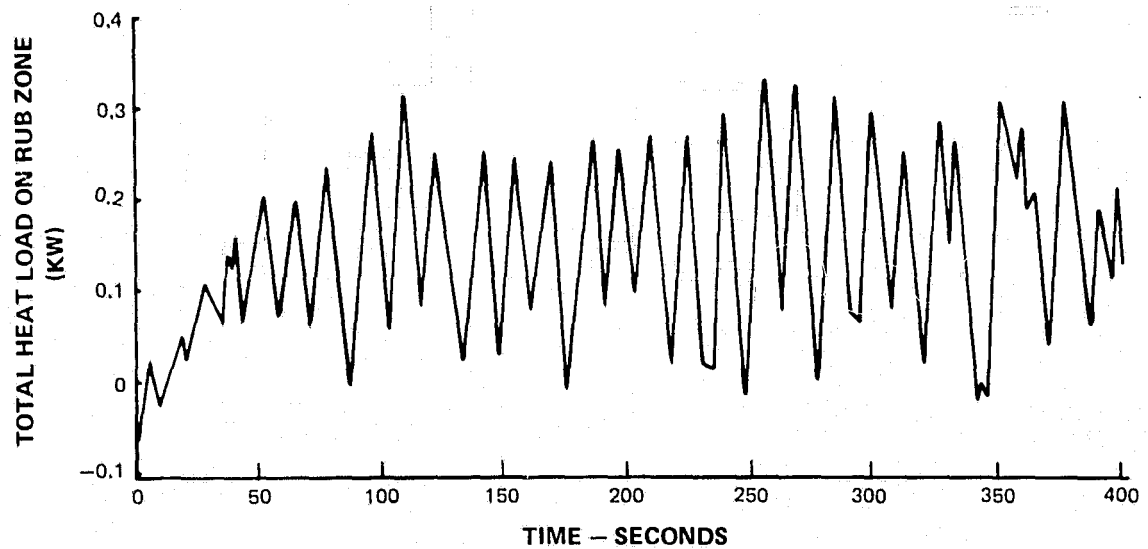
Figure 30. Task I Test 7 Data Reduction Results

Test 7 ($i = .0025$ mm/sec, $v = 152$ mps, $b = 1.75$ mm, $\delta = 1.0$ mm, $\rho = 16\%$)

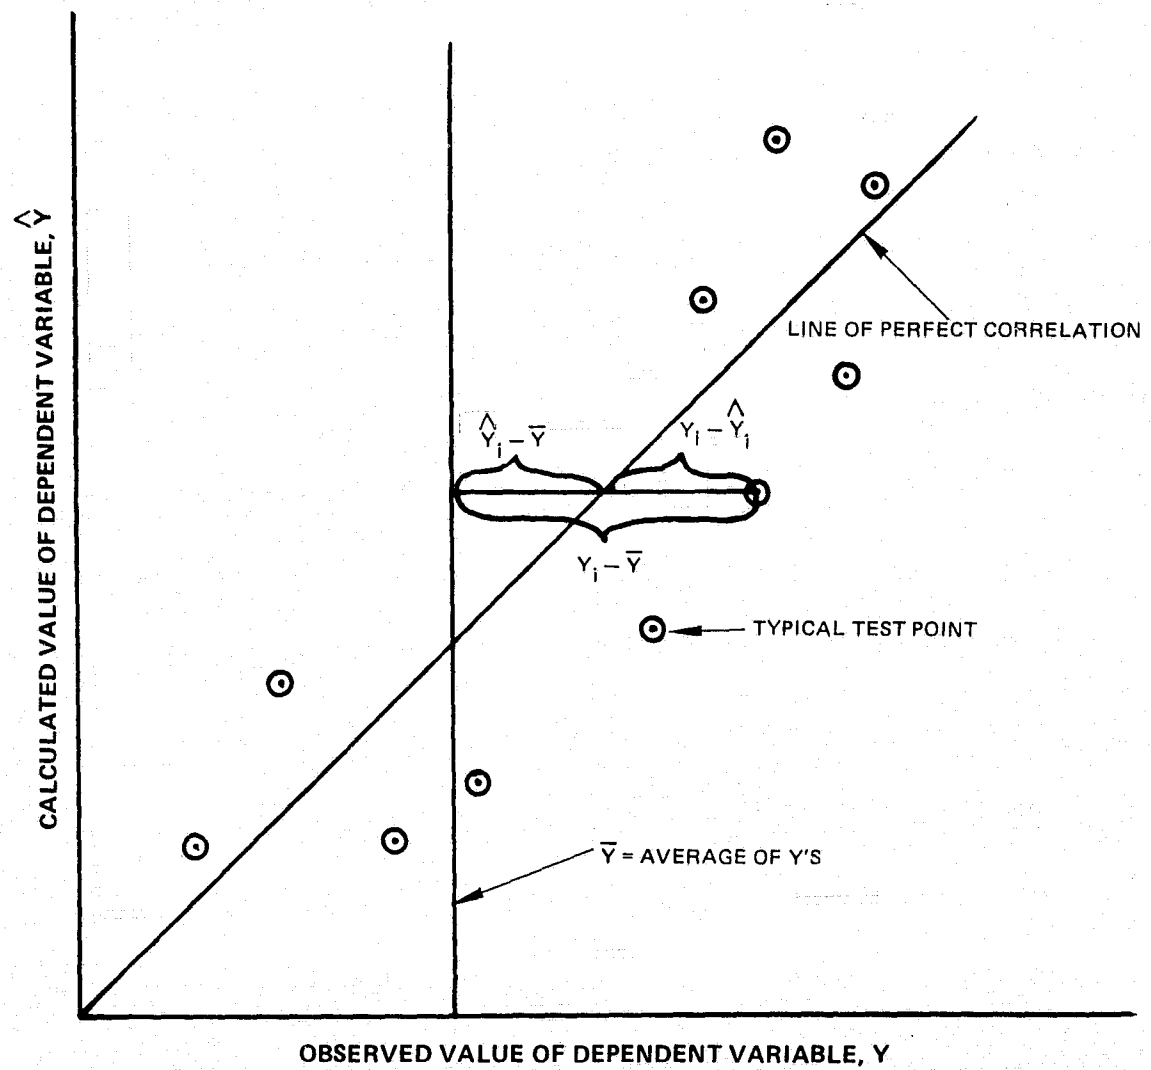
Figure 32. Data Fit to Model Using Least Squares Criterion

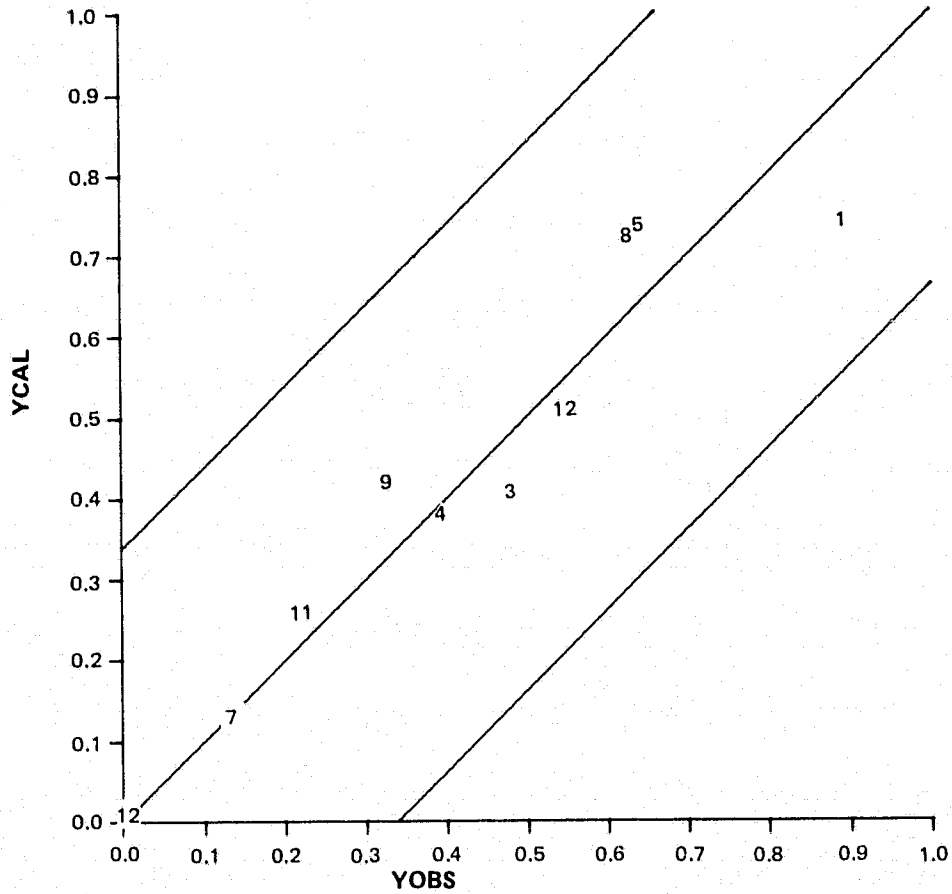
Figure 33. Regression Analysis for Task I Average Total Energy

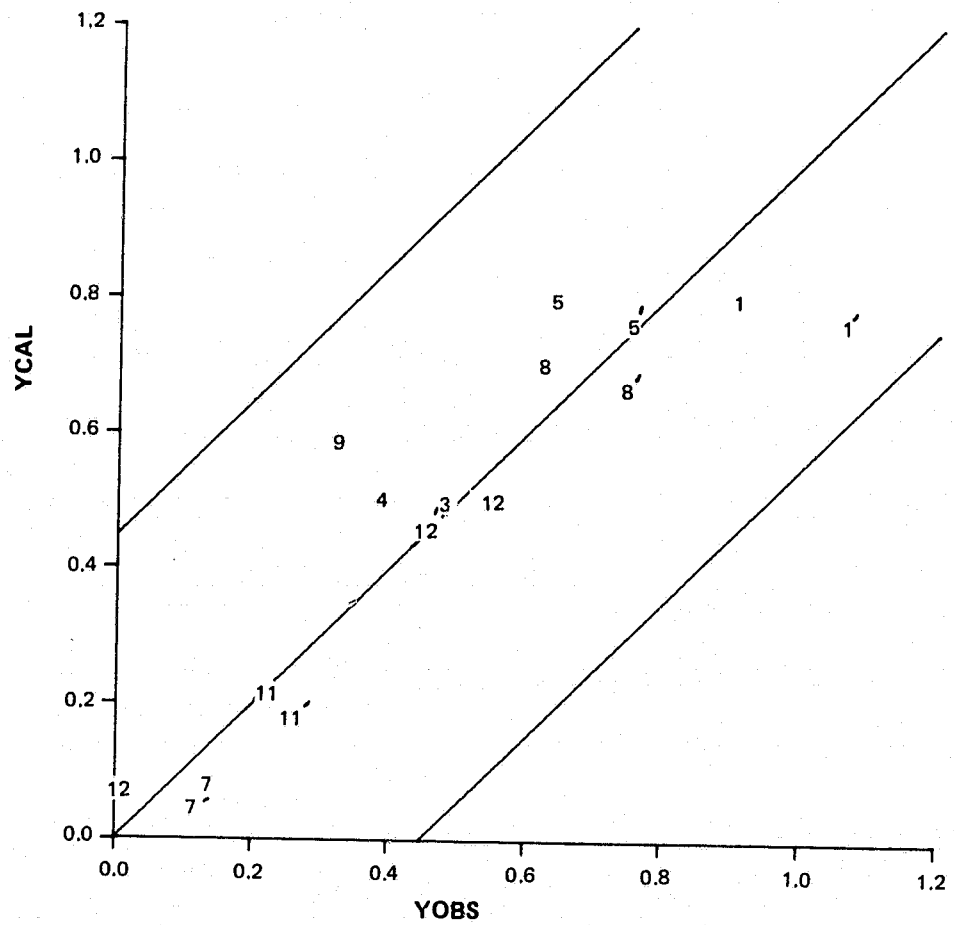
Figure 34. Regression Analysis for Task I Average Total Energy, Including Data from Expansion of 1.0 mm Tests

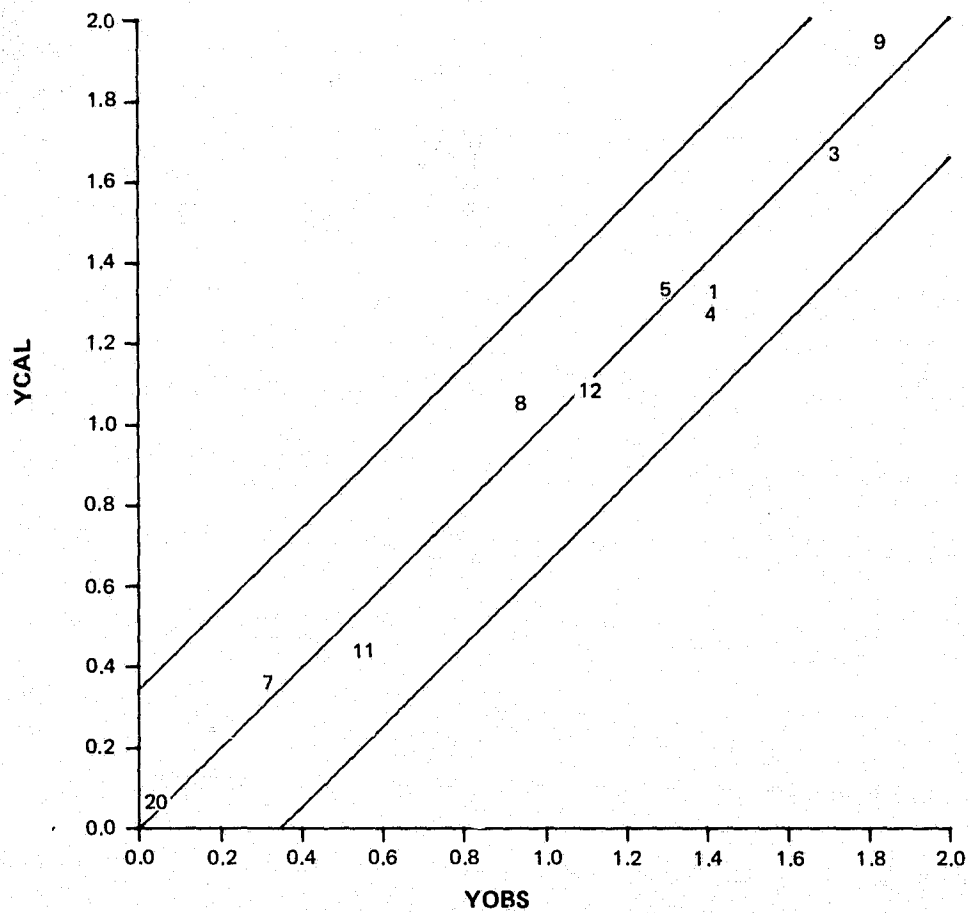
Figure 35. Regression Analysis for Task I Peak Total Energy

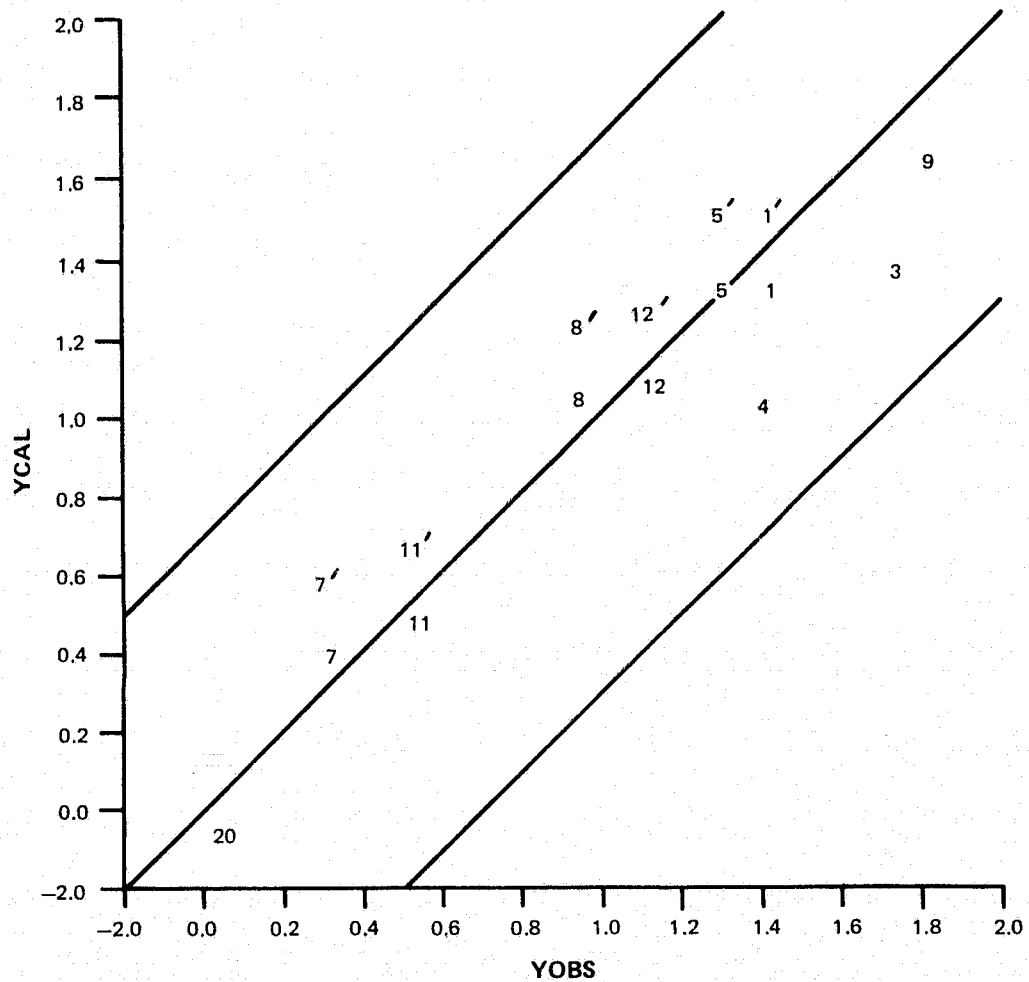
Figure 36. Regression Analysis for Task I Peak Total Energy, Including Data from Expansion of 1.0 mm Tests

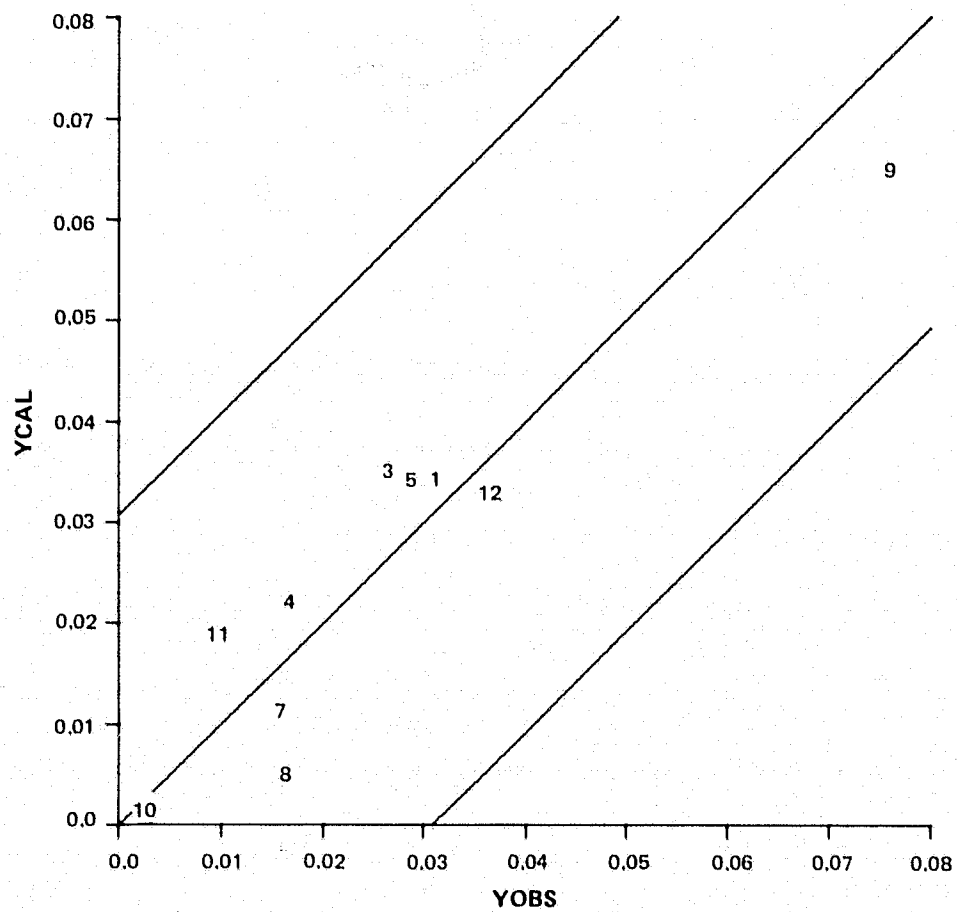
Figure 37. Regression Analysis for Task I Average Heat to Blade

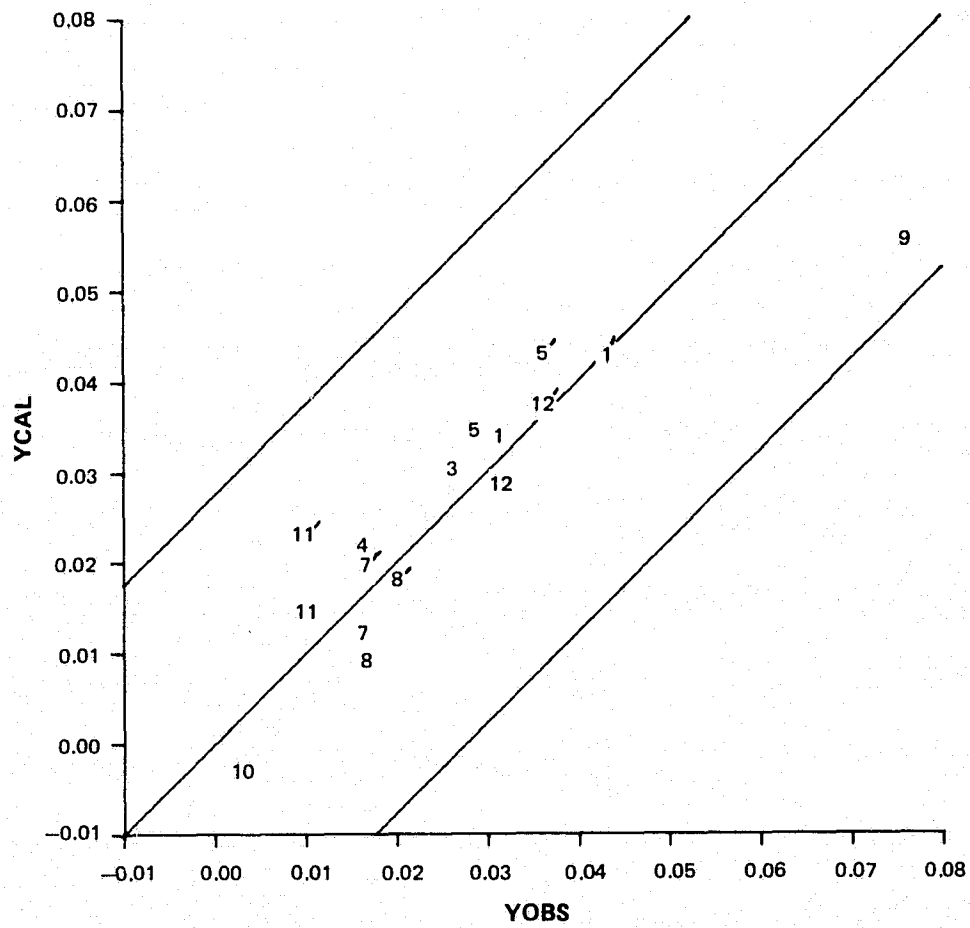
Figure 38. Regression Analysis for Task I Average Heat to Blade, Including Data from Expansion of 1.0 mm Tests

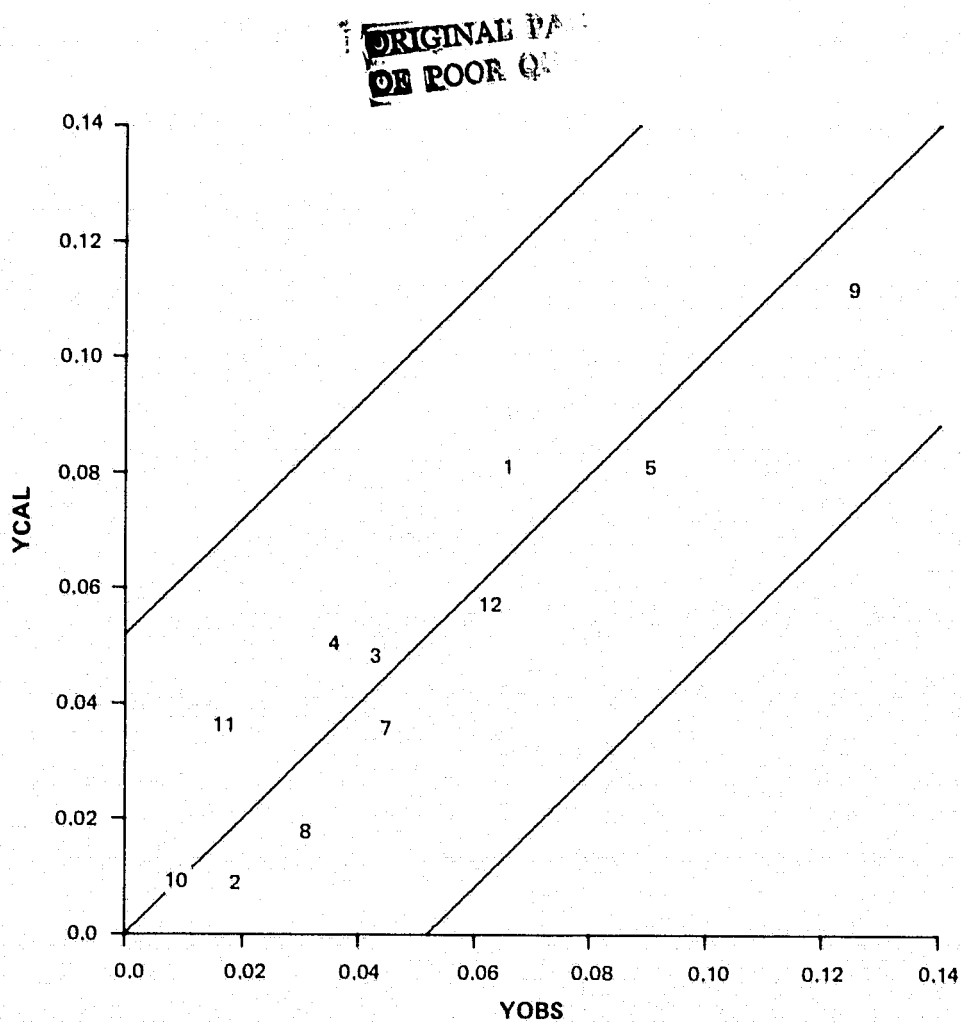
Figure 39. Regression Analysis for Task I Peak Heat to Blade

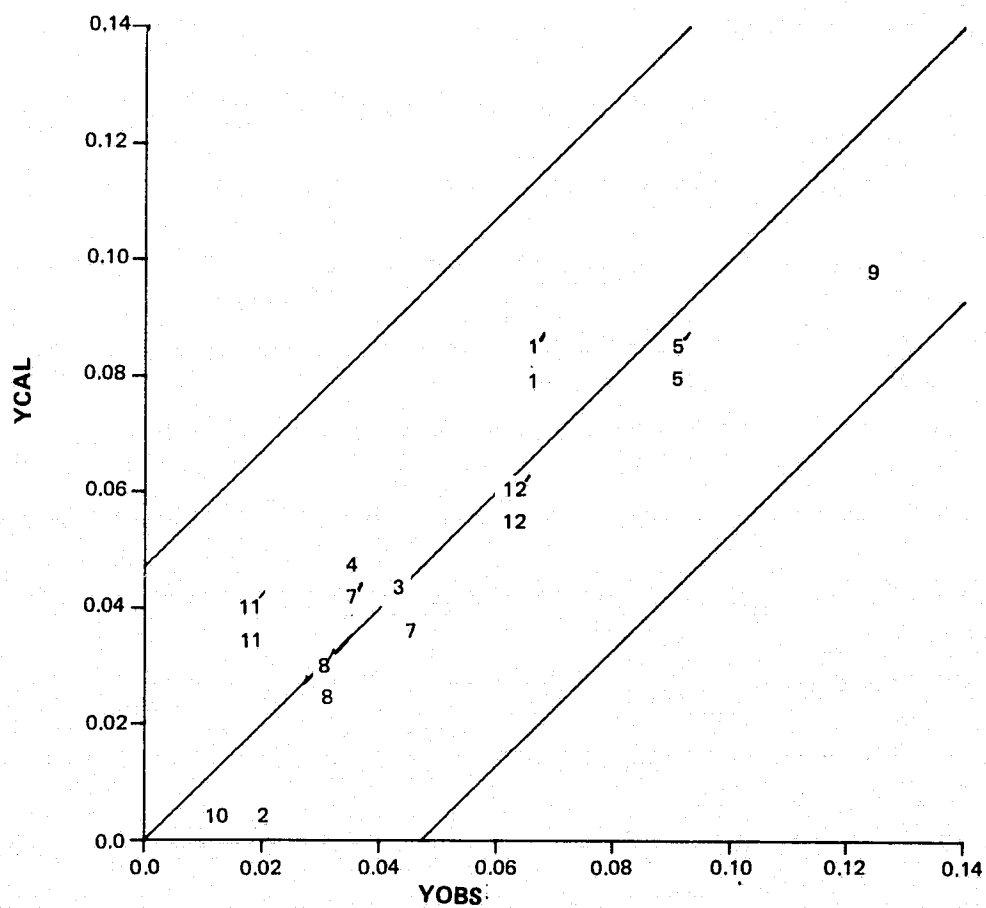
Figure 40. Regression Analysis for Task I Peak Heat to Blade, Including Data from Expansion of 1.0 mm Tests

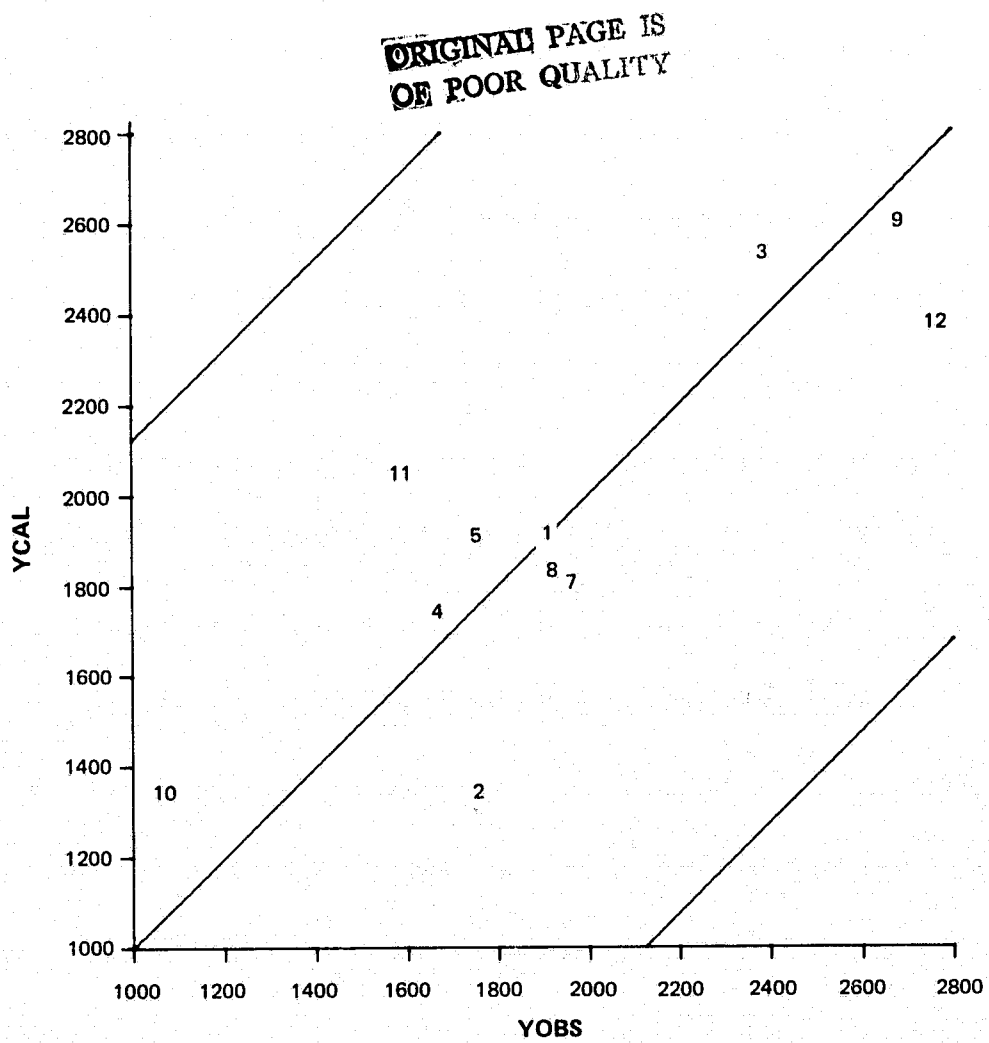
Figure 41. Regression Analysis for Task I Maximum Blade Temperature

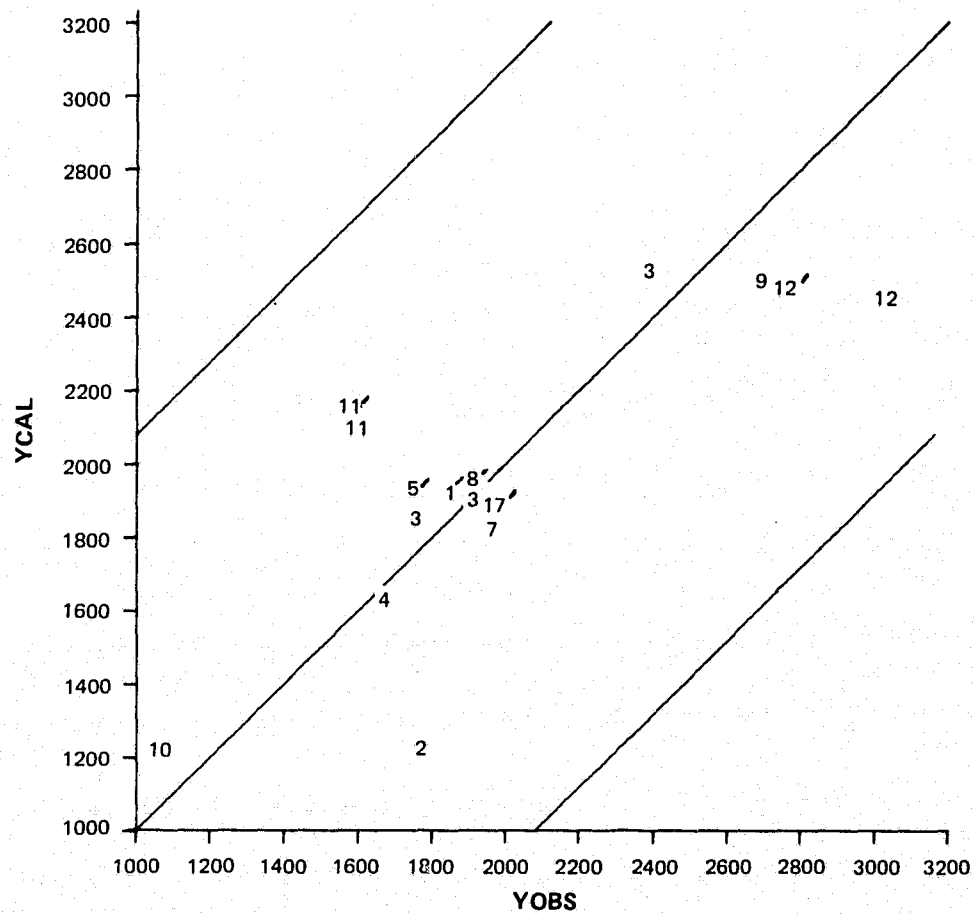
Figure 42. Regression Analysis for Task I Maximum Blade Temperature, Including Data from Expansion of 1.0 mm Tests

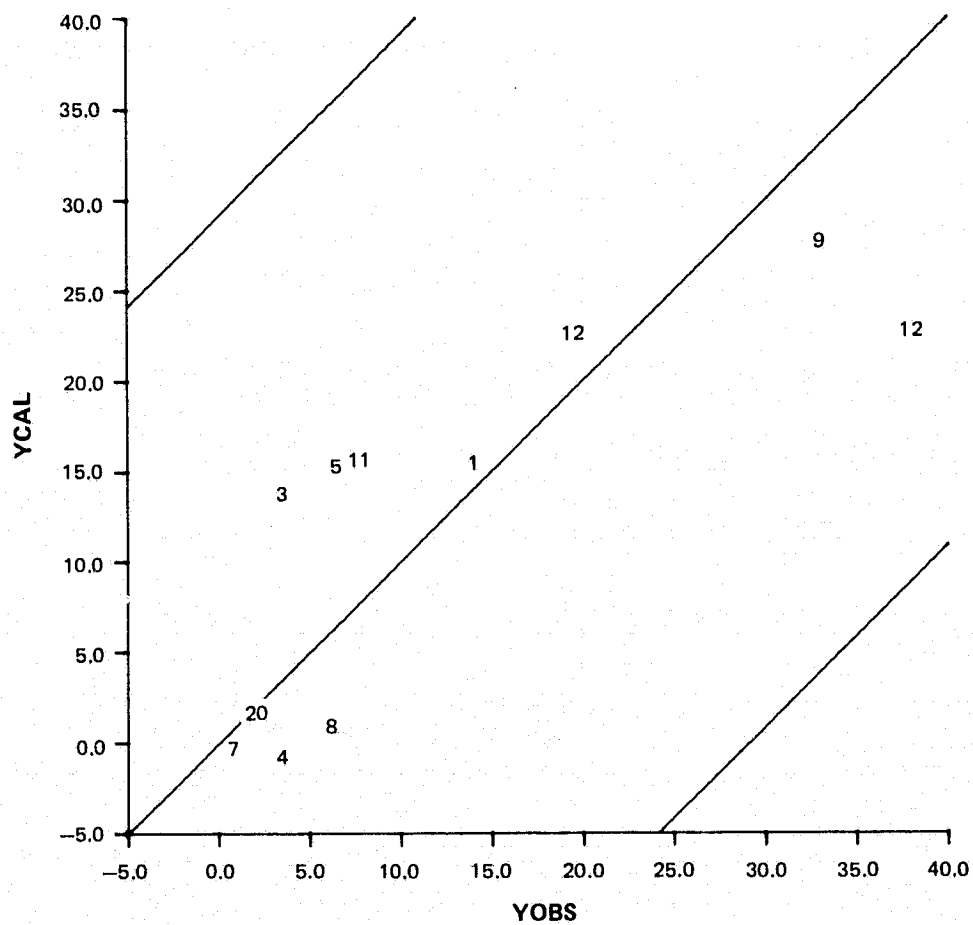
Figure 43. Regression Analysis for Task I Adjusted Blade Wear and Transfer

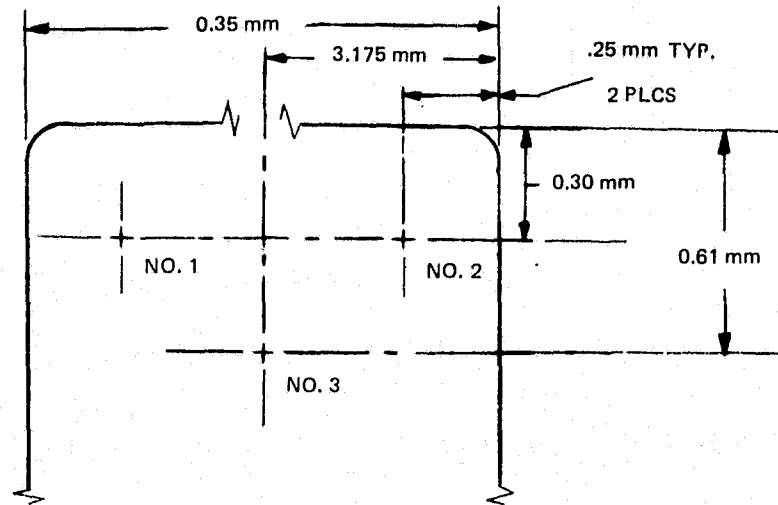
**TC CONFIGURATION FOR TEST 12 AND
SINGLE-BLADED TASK III TESTS**

**TC CONFIGURATION FOR EACH BLADE OF
MULTI-BLADED TASK III TESTS**

Figure 44. Task III Blade Thermocouple Installation

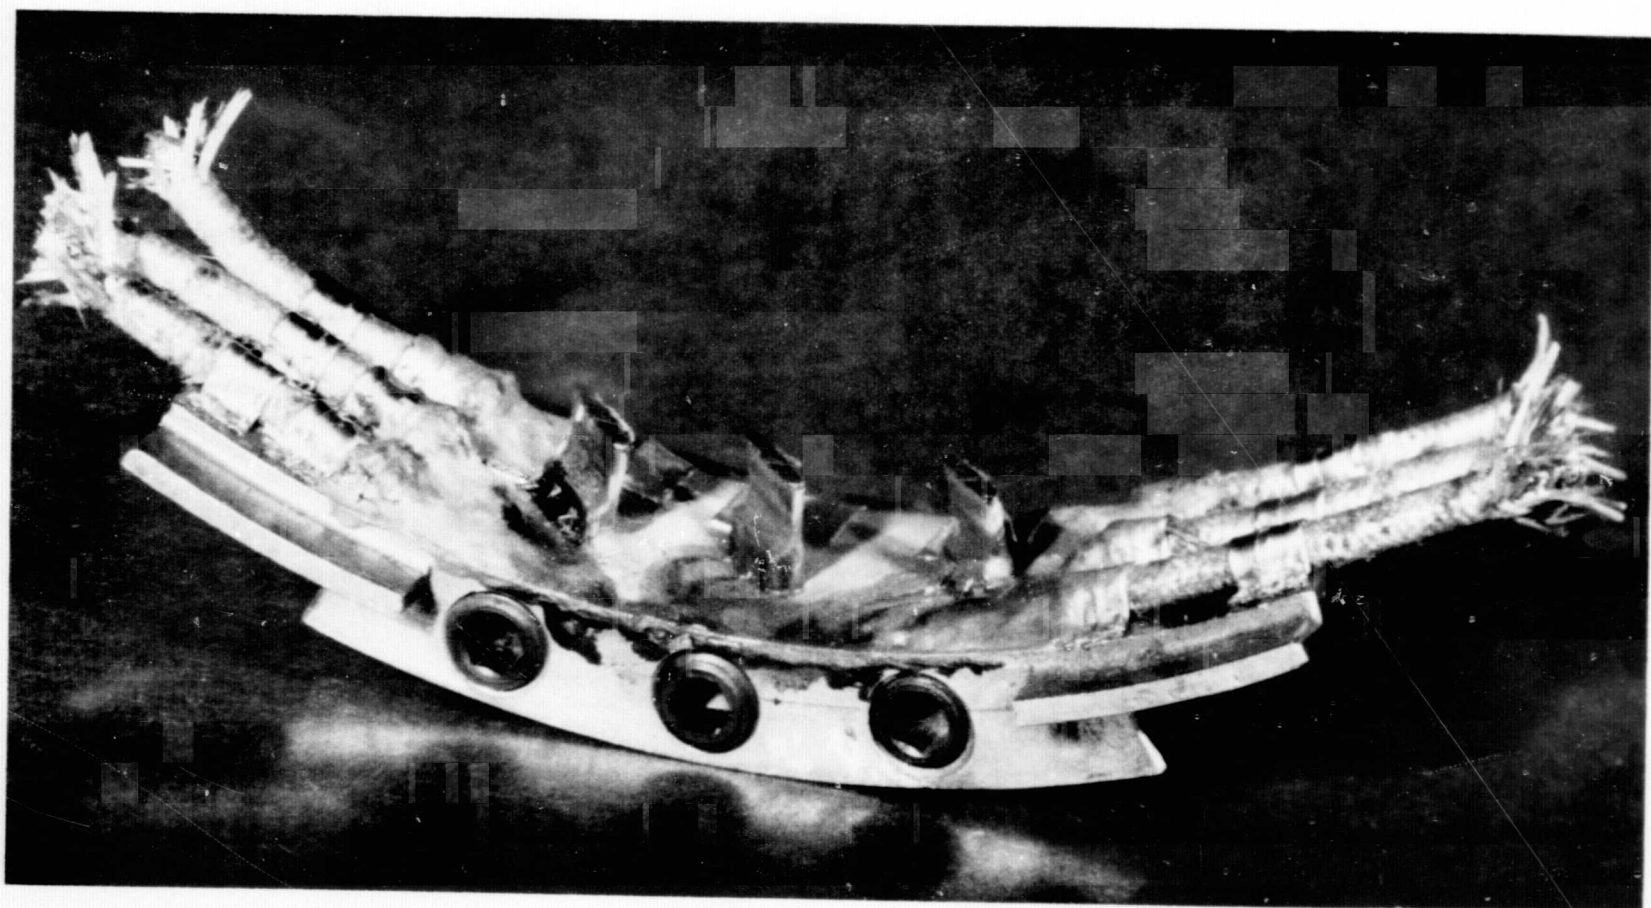
Figure 45. Test Setup for Task III, Multi-bladed Test

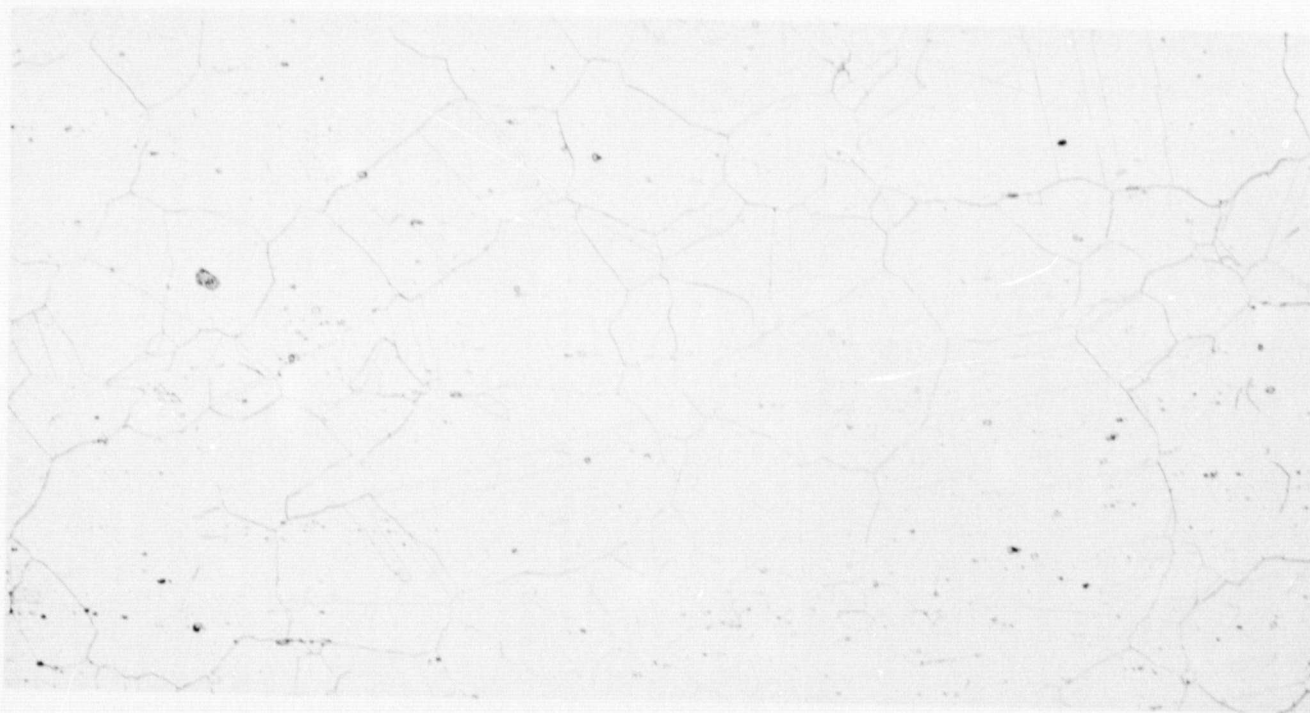
Test 15 (1, Ni, $i = 0.025$ mm/sec, $v = 213$ mps, $b = 1.70$ mm, $\delta = 1.0$ mm, $\rho = 16\%$)

Figure 50. Blade Rub Surface from Test 15 (Mag: 100 x)

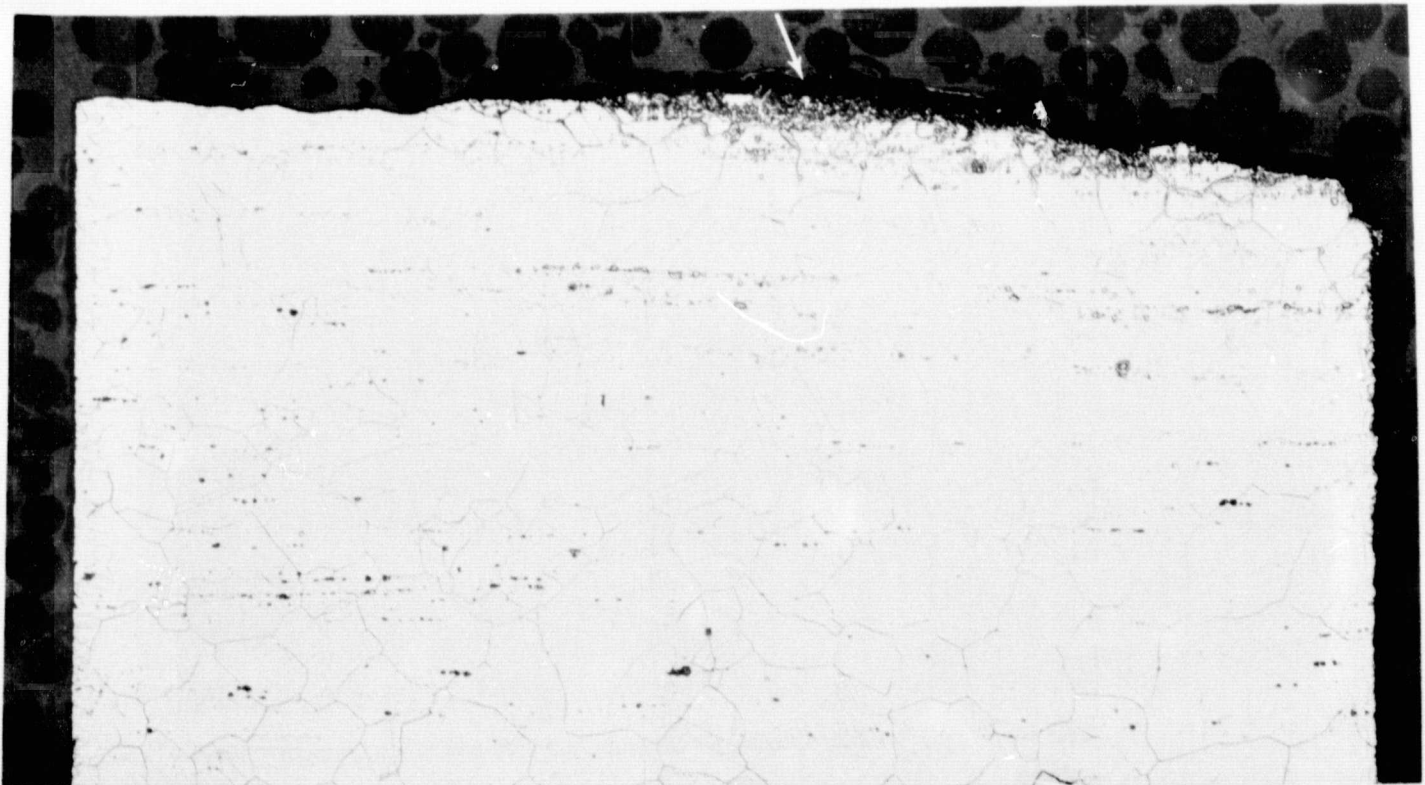
Test 17 (1, Ni, $i = 0.25$ mm/sec, $v = 152$ mps, $b = 1.68$ mm, $\delta = 1.0$ mm, $\rho = 19\%$)

Figure 52. Cross-section of Blade from Test 17 Showing Decomposition of the Grain Structure (Mag: 100x)

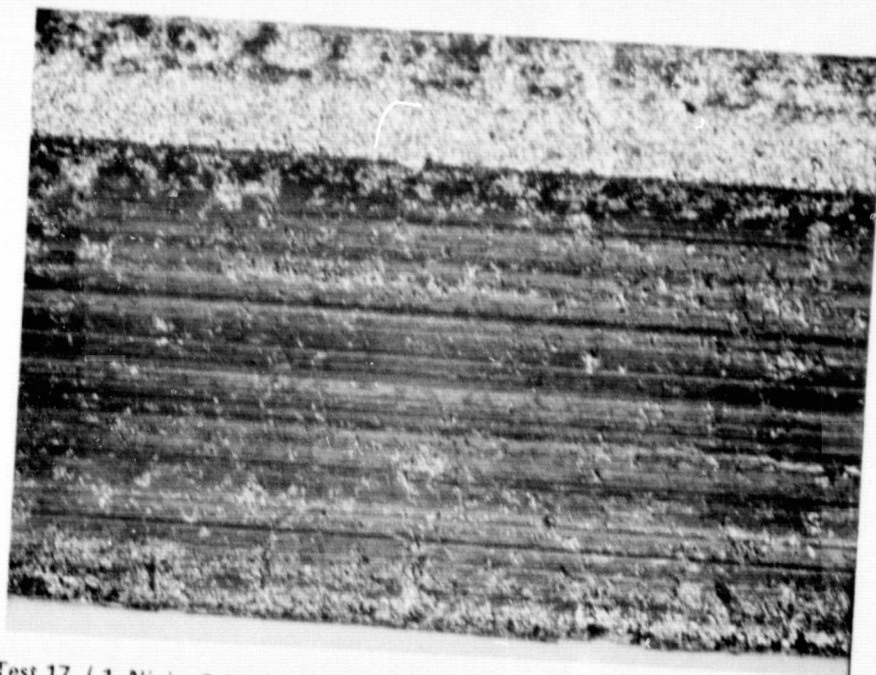
Test 17 (1, Ni, $i = 0.25$ mm/sec, $v = 152$ mps, $b = 1.68$ mm, $\delta = 1.0$ mm, $\rho = 19\%$)

Figure 53. Seal Surface from Test 17 Showing Heavy Surface Glazing (Mag: 10x)

Metallographic examination of the three nickel alloy Incoloy 901 blades was conducted. The condition of the surface material structure was representative of the amount of energy associated with the rub. The least severe rub, test 15, showed no heat affected area at the blade rub interface, Figure 50. The test of intermediate severity (#13) exhibited sections of recrystallization at the blade rub surface (Figure 51). These localized transition areas reached a temperature of approximately 1300°K. Test 17 experienced the most severe rub and a cross section (Figure 52) through its 1.68 mm thickness shows a large area near the surface indicating a decomposition of the original grain structure with surrounding grain boundaries that are broad, indicating that melting had taken place. Taking the short test duration into account (4 seconds), melting probably occurred in the 1560°K to 1590°K temperature range. The Feltmetal® seal in test 17 exhibited the heaviest surface glazing (Figure 53) of all tests. The smearing and glazing was continuous except for isolated locations of spallation. In addition the blades in tests 13 and 15 experienced seal material transfer. Figure 54 shows a cross section through blade 13's 0.48 mm thickness at approximately the point of maximum transfer (0.20 mm). The amount of transfer varied considerably along the blade width and averaged 0.122 mm high. As in Test 11 and Task I the bulk of the transfer was Hastelloy X seal material. The lighter gray areas mixed in with the Hastelloy X are SermeTel AP-1, the cement used to hold the thermocouple leads in place. The transfer on blade 15 was similar in structure and material constituents as that on blade 13.

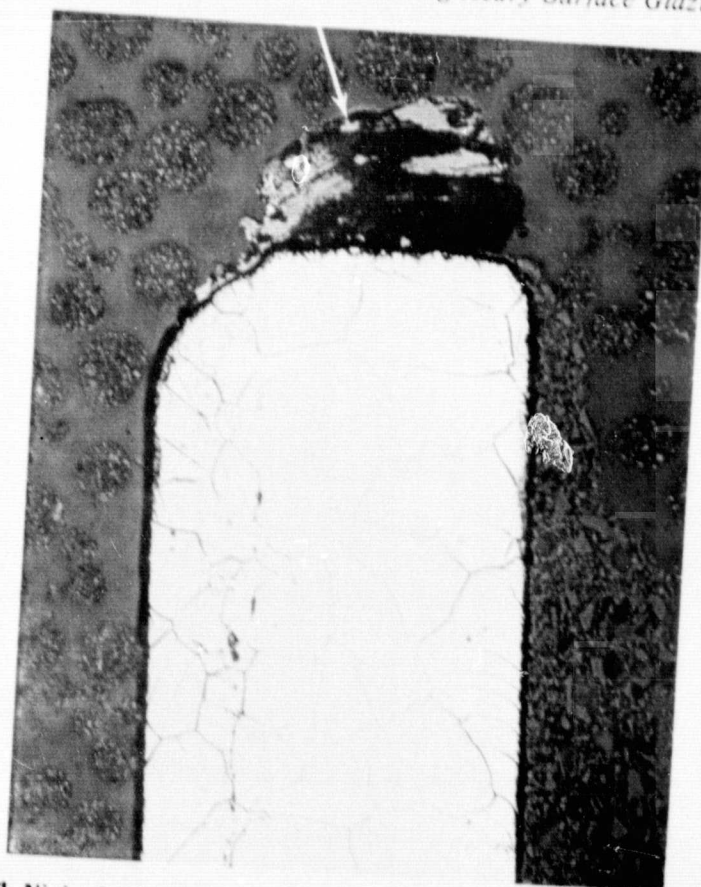
Test 13 (1, Ni, $i = 0.25$ mm/sec, $v = 213$ mps, $b = .48$ mm, $\delta = 1.0$ mm, $\rho = 16\%$)

Figure 54. Cross-section Through Blade from Test 13 Showing Region of Maximum Transfer (Mag: 100x)

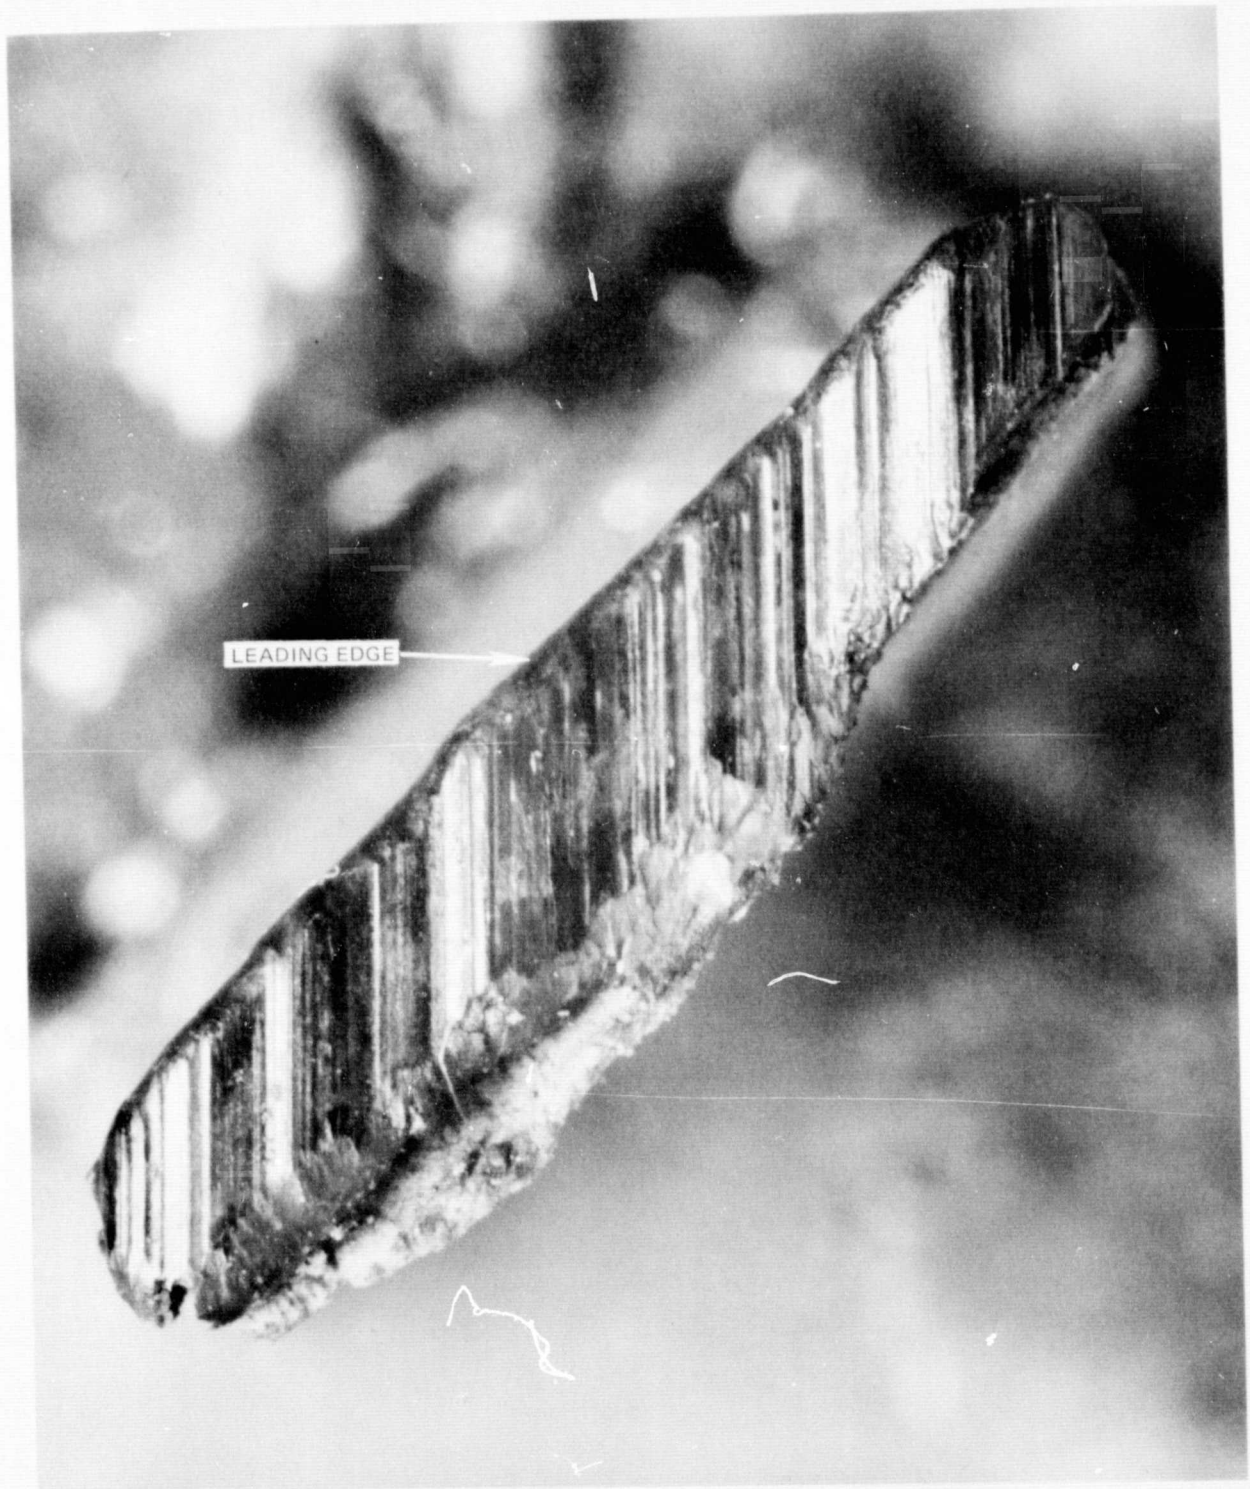
Test 14 (3, Ti, $i = 0.25$ mm/sec, $v = 152$ mps, $b = 0.55$ mm, $\delta = 1.0$ mm, $\rho = 19\%$)

Figure 55. Blade Tip #1 from Test 14 (Mag: 50x)
