NASA CR-159424
PWA-5616

COMPRESSOR SEAL RUB ENERGETICS STUDY

FINAL REPORT

PRATT & WHITNEY AIRCRAFT GROUP
COMMERCIAL PRODUCTS DIVISION
UNITED TECHNOLOGIES CORPORATION

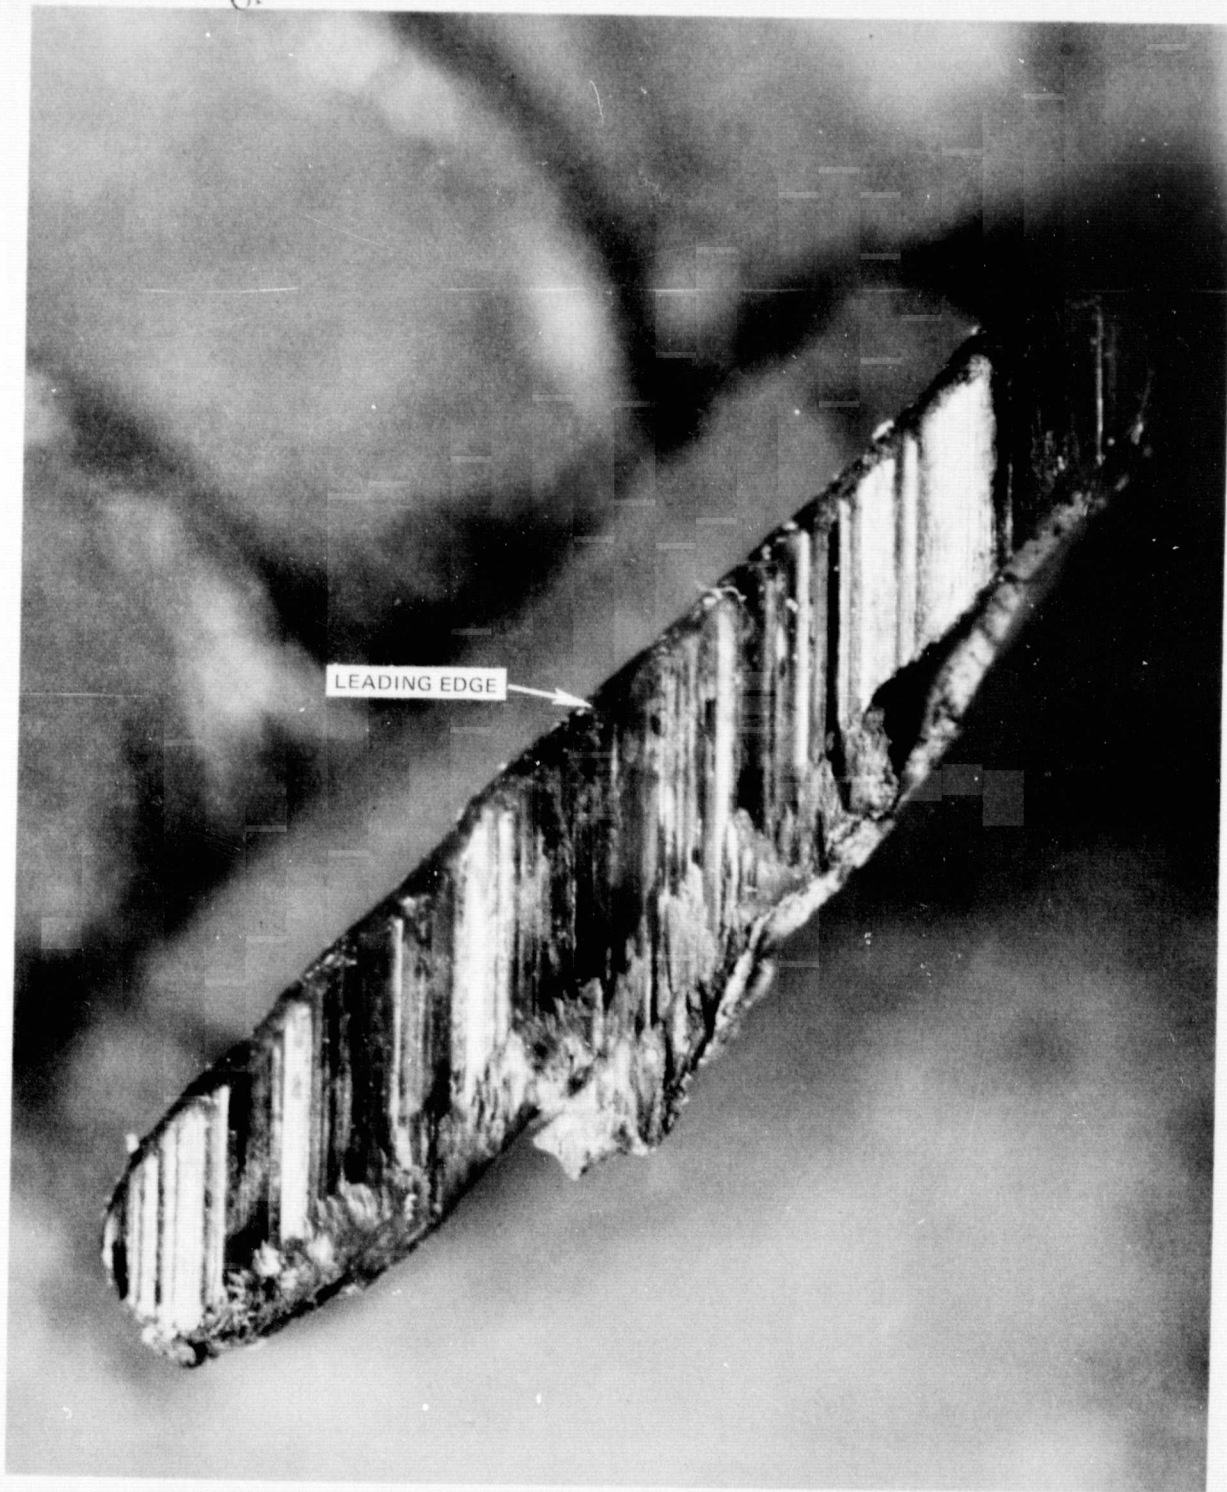
Test 14 (3, Ti, $v = 0.25$ mm/sec, $v = 152$ mps, $b = 0.55$ mm, $\delta = 1.0$ mm, $\rho = 19\%$)

Figure 56. Blade Tip #2 from Test 14 (Mag: 50x)

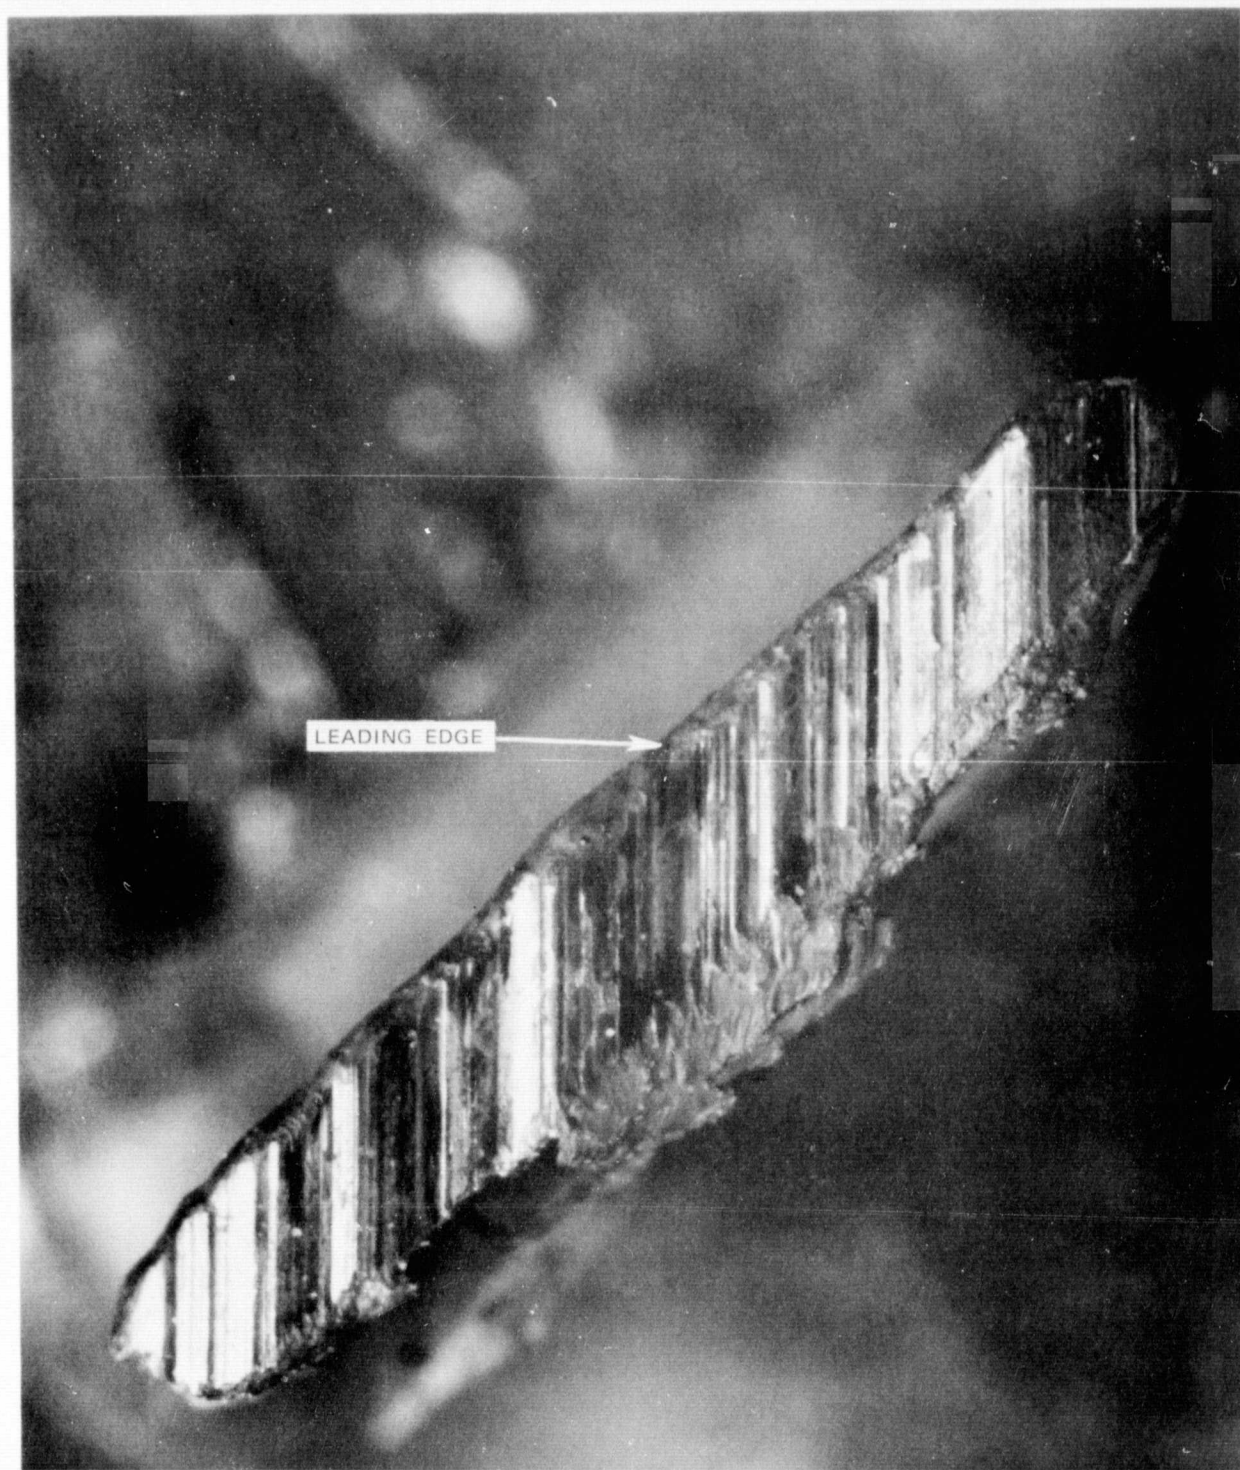
Test 14 (3, Ti, $i = 0.25$ mm/sec, $v = 152$ mps, $b = 0.55$ mm, $\delta = 1.0$ mm, $\rho = 19\%$)

Figure 57. Blade Tip #3 from Test 14 (Mag: 50x)

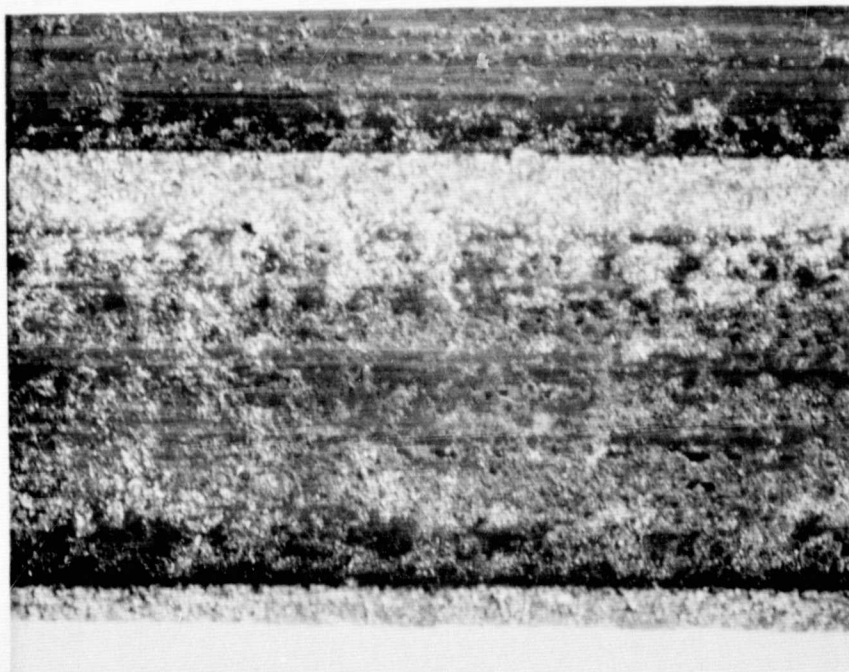
Test 14 (3, Ti, $i = 0.25$ mm/sec, $v = 152$ mps, $b = 0.55$ mm, $\delta = 1.0$ mm, $\rho = 19\%$)

Figure 61. Photomicrograph of the Rubstrip for Test 14 Showing Densification at the Rub Surface (Mag: 10x)

Although the photomicrograph of the Beltmetal® rubstrip for test 14 showed densification at the rub surface a plan view of the rubstrip indicated that the rub varied from fairly clean with no glazing to heavy glazing in some areas. The glazing generally appeared as both localized and discrete circumferential striations (Figure 61).

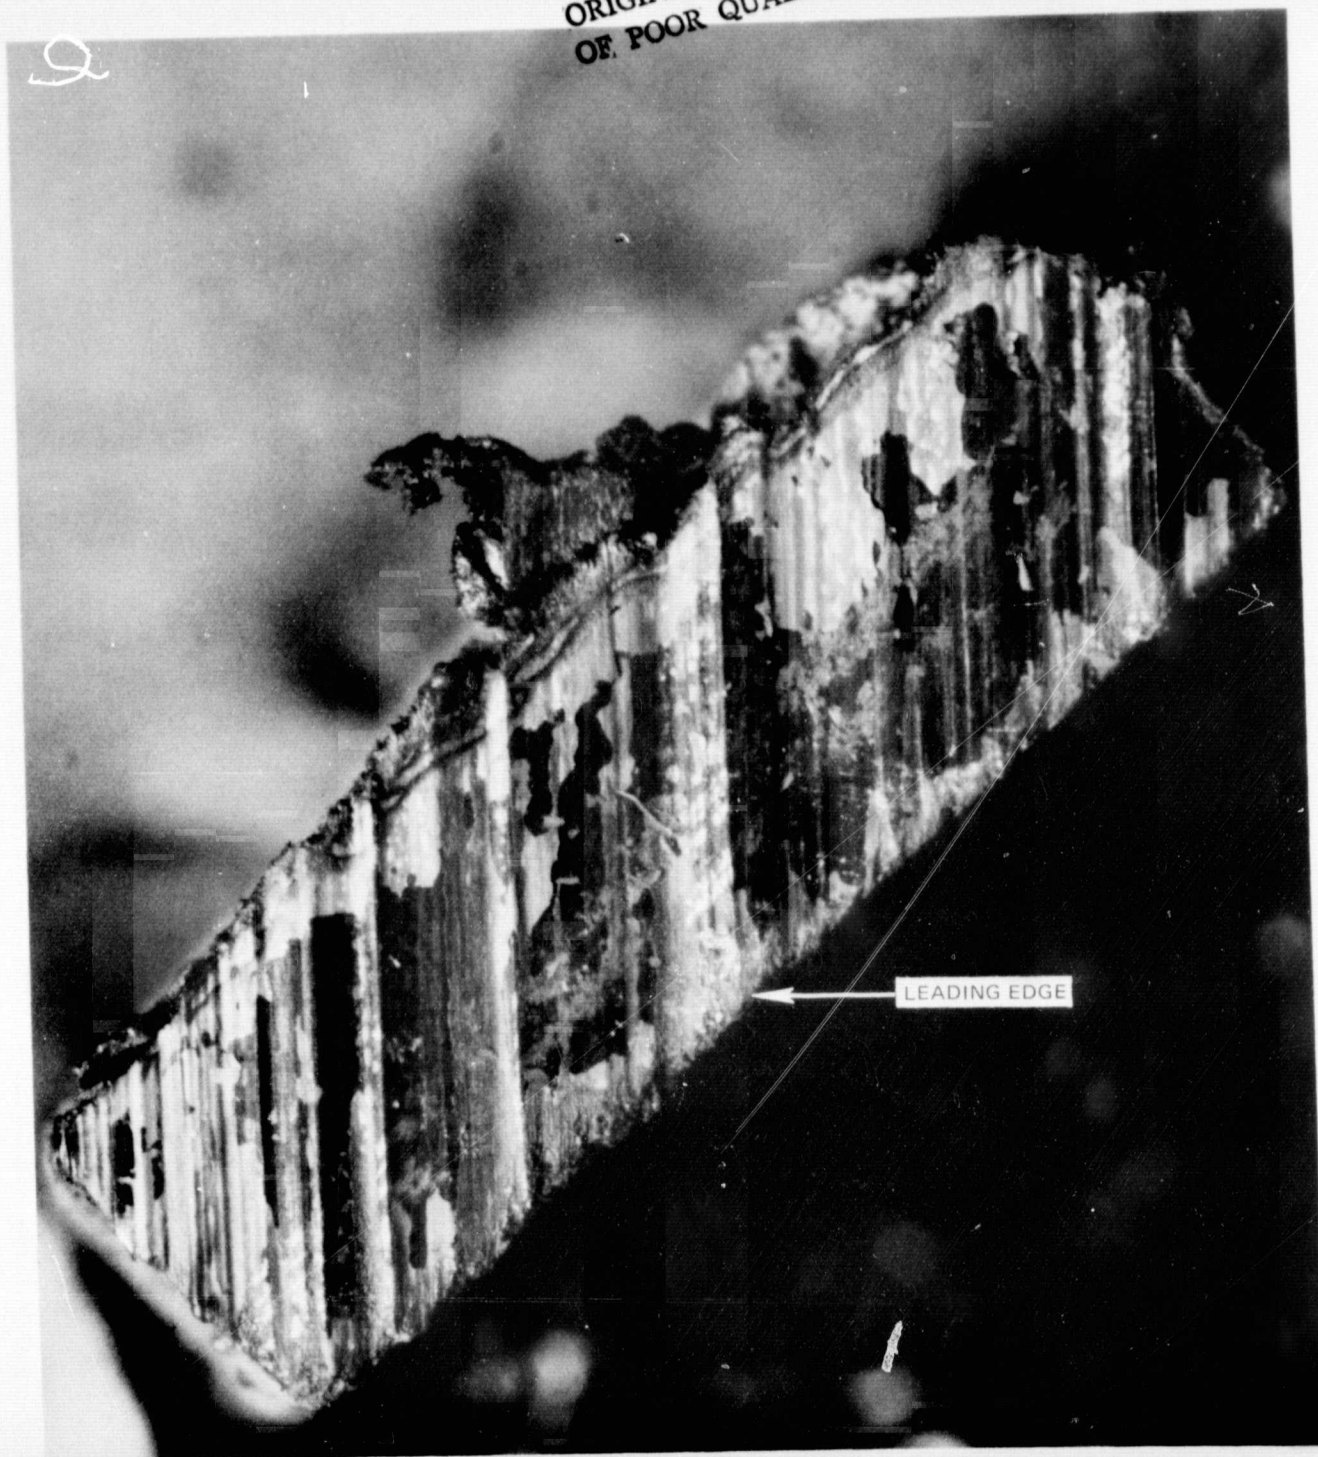
Test 16 (3, Ti, $i = 0.25$ mm/sec, $v = 152$ mps, $b = 1.71$ mm, $\delta = 1.0$ mm, $\rho = 19\%$)

Figure 62. Blade Tip #1 from Test 16 (Mag: 30x)

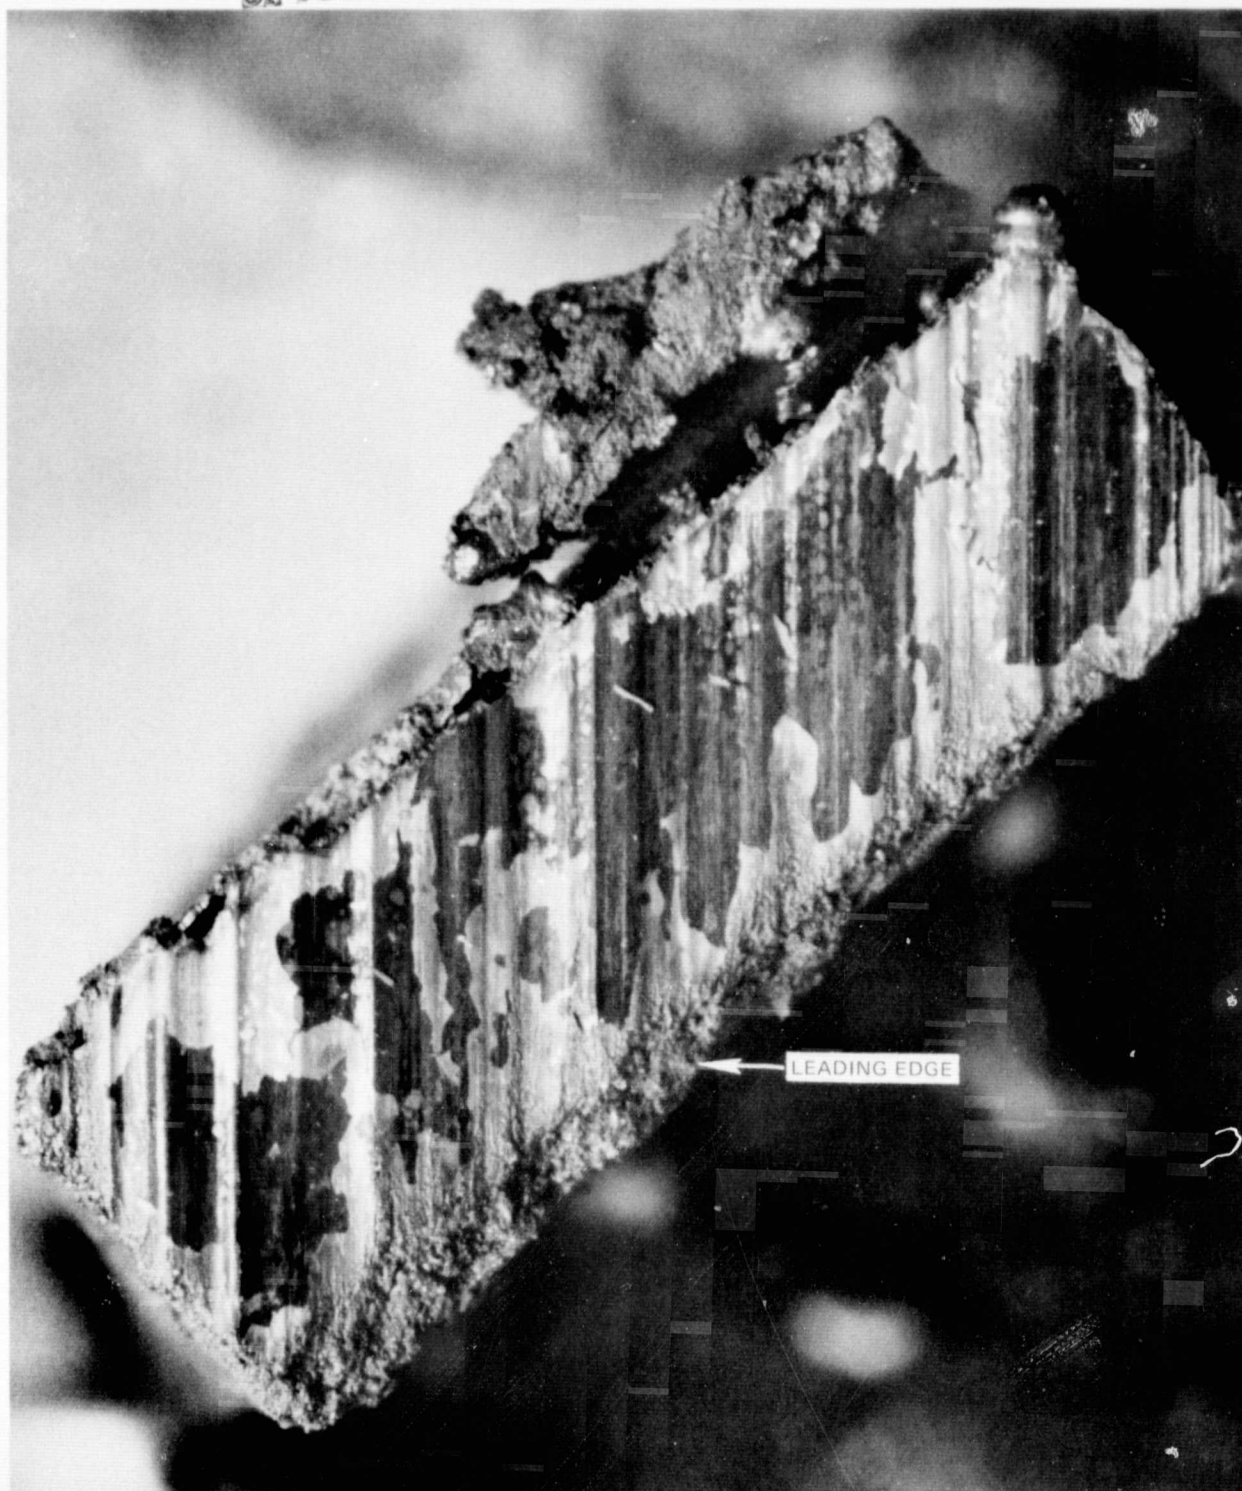
Test 16 (3, Ti, $i = 0.25$ mm/sec, $v = 152$ mps, $b = 1.71$ mm, $\delta = 1.0$ mm, $\rho = 19\%$)

Figure 63. Blade Tip #2 from Test 16 (Mag: 30x)

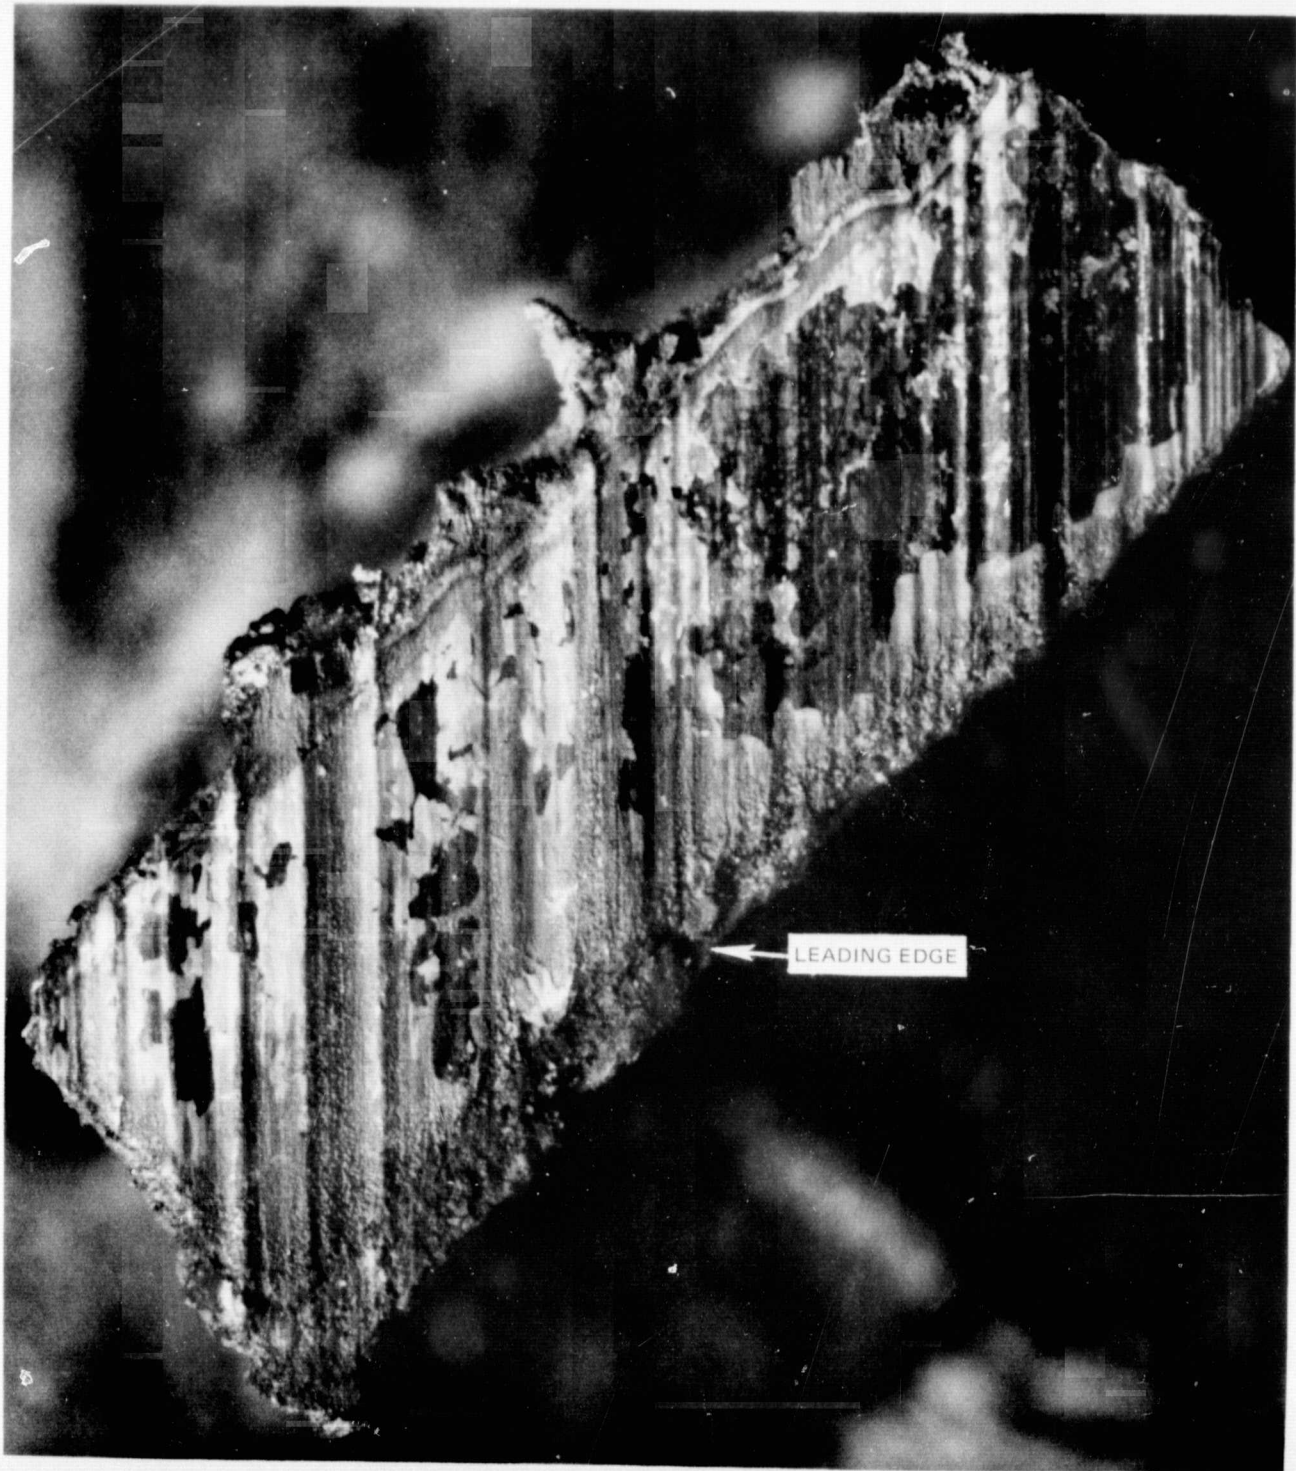
Test 16 (3, Ti, $i = 0.25$ mm/sec, $v = 152$ mps, $b = 1.71$ mm, $\delta = 1.0$ mm, $\rho = 19\%$)

Figure 64. Blade Tip #3 from Test 16 (Mag: 30x)

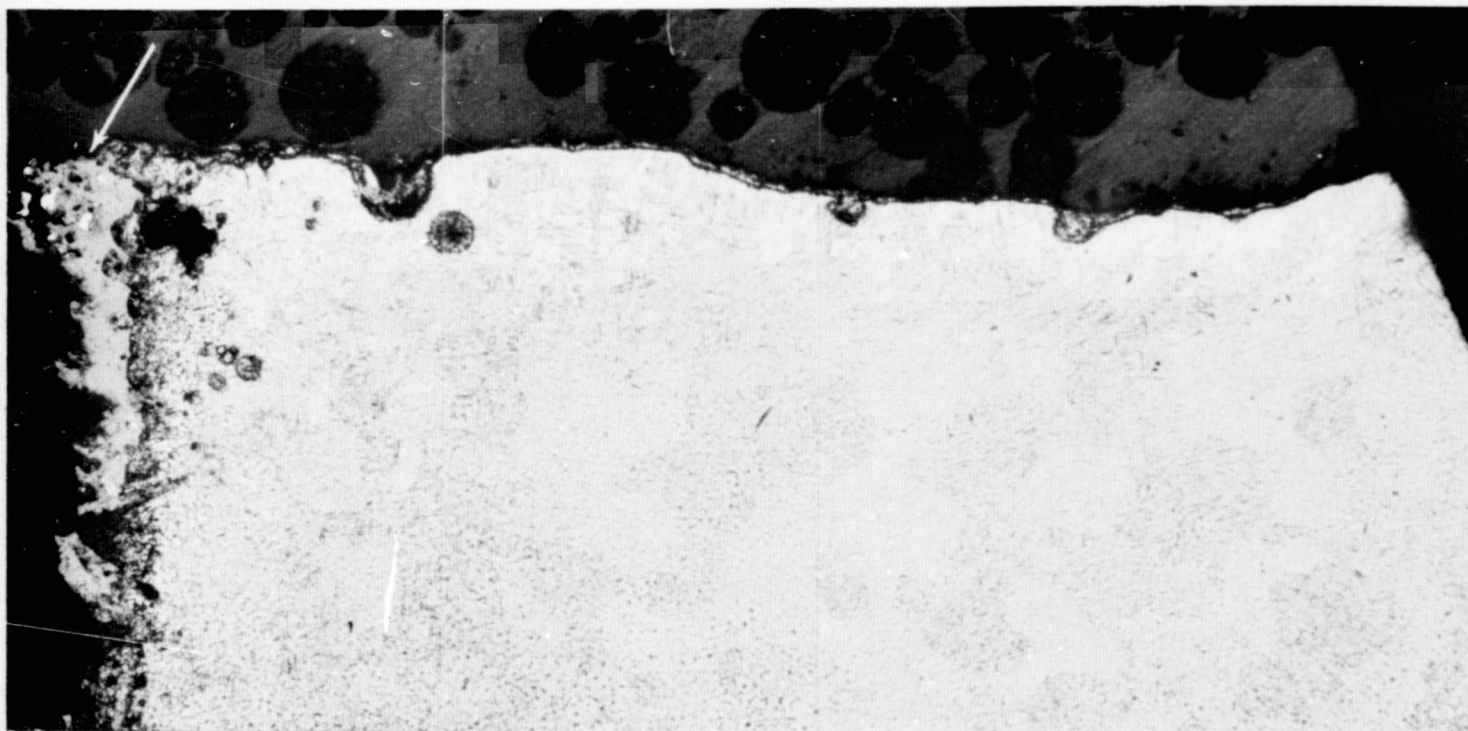
Test 16 (3, Ti, $i = 0.25$ mm/sec, $v = 152$ mps, $b = 1.71$ mm, $\delta = 1.0$ mm, $\rho = 19\%$)

Figure 65. Cross Section of Blade from Test 16 Showing Burr at Leading Edge (Mag: 100x)

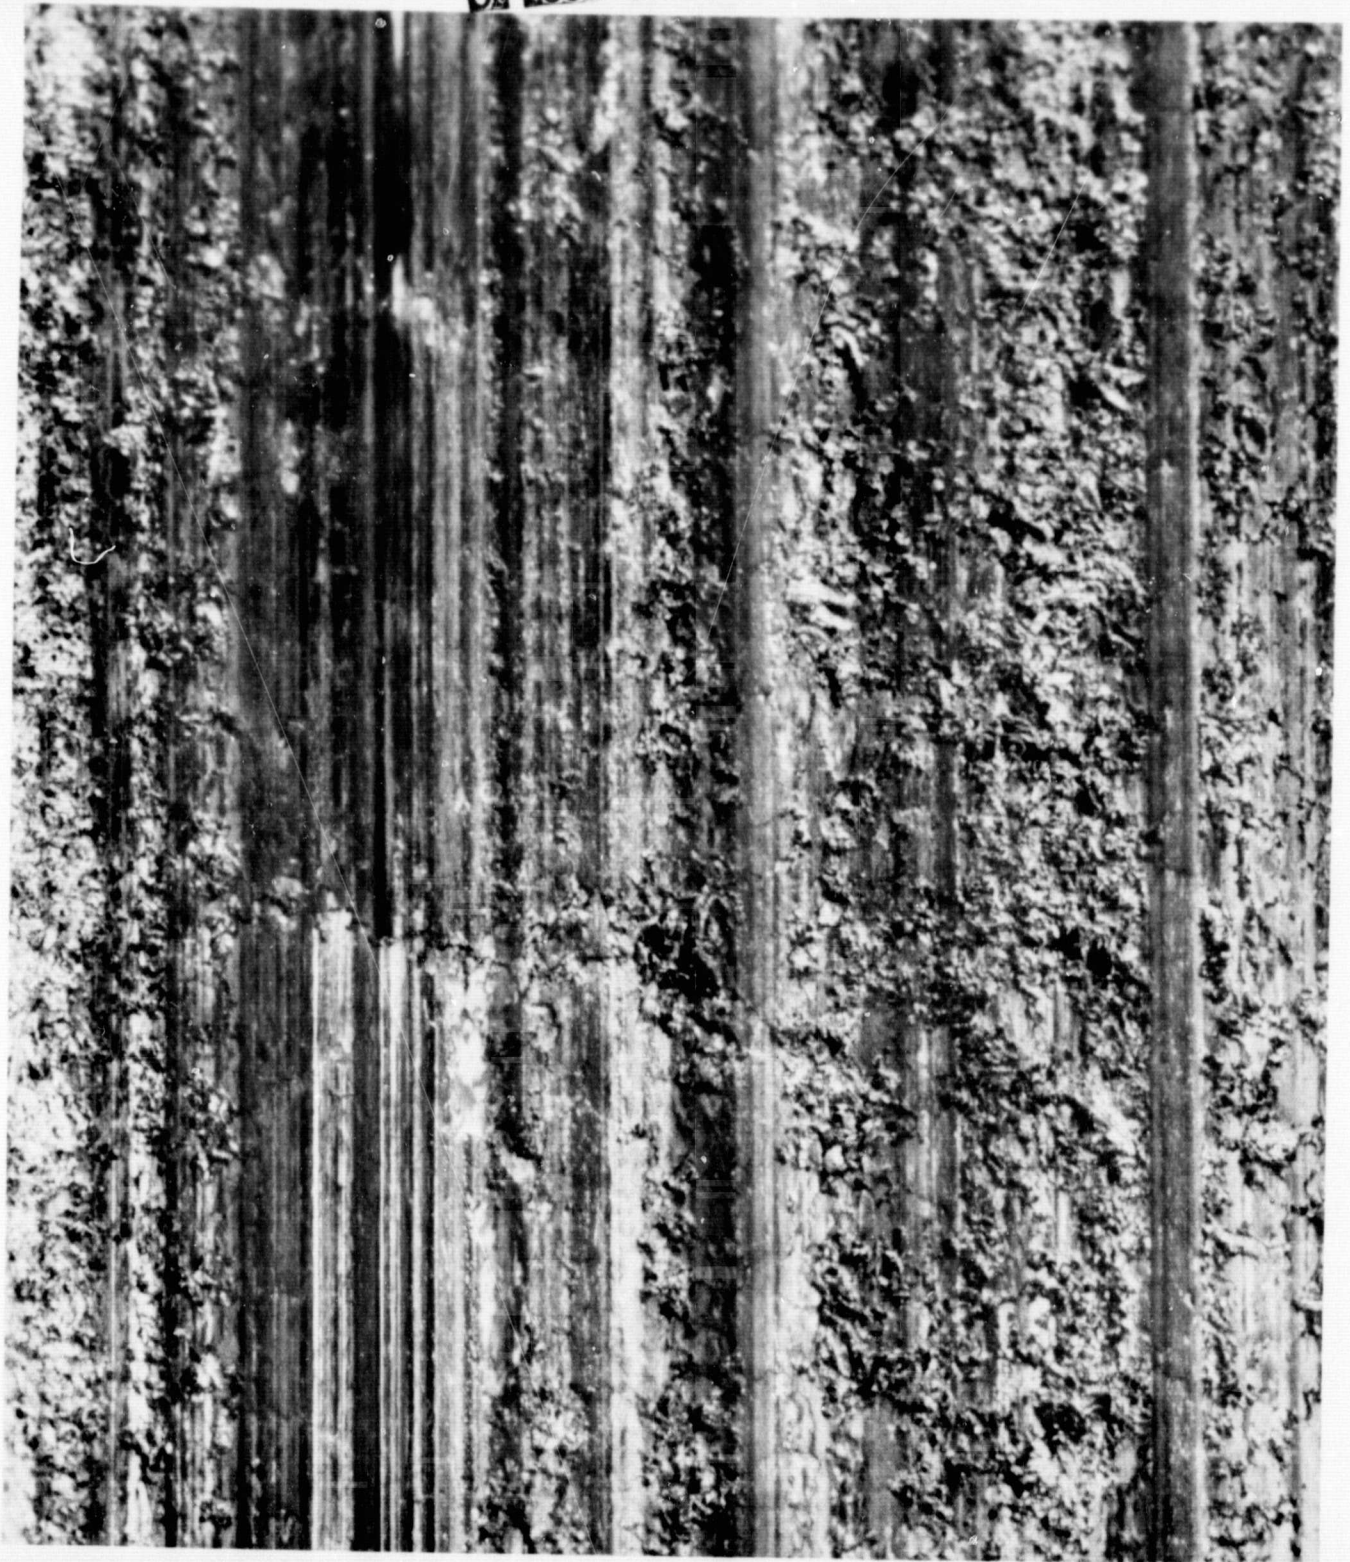
Test 16 (3, Ti, $i = 0.25$ mm/sec, $v = 152$ mps, $b = 1.71$ mm, $\delta = 1.0$ mm, $\rho = 19\%$)

Figure 66. Plan View of Rubstrip from Test 16 Showing Heavily Glazed Striations

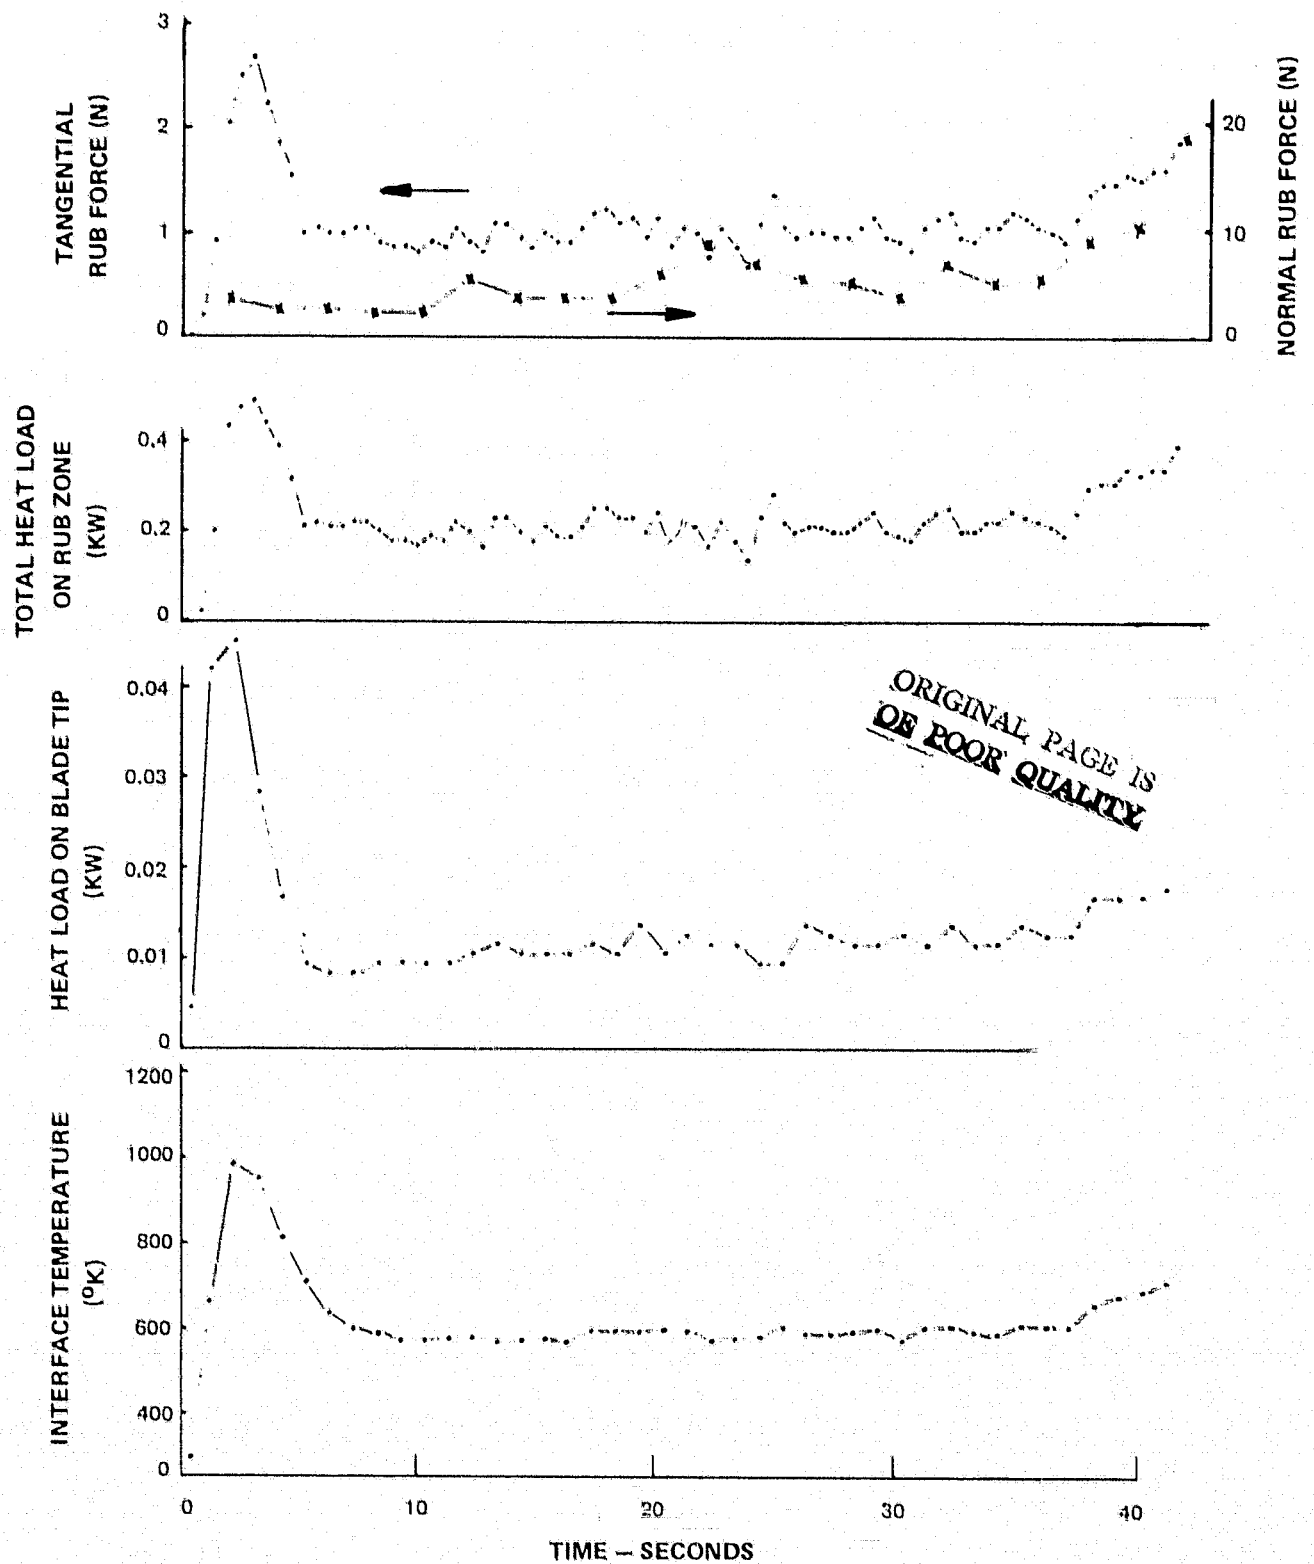
Figure 71. Task III Test 15 Data Reduction Results

Test 15 (i, Ni, i = .025 mm/sec, v = 213 mps, b = 1.70 mm, δ 1.0 mm, ρ = 16%)

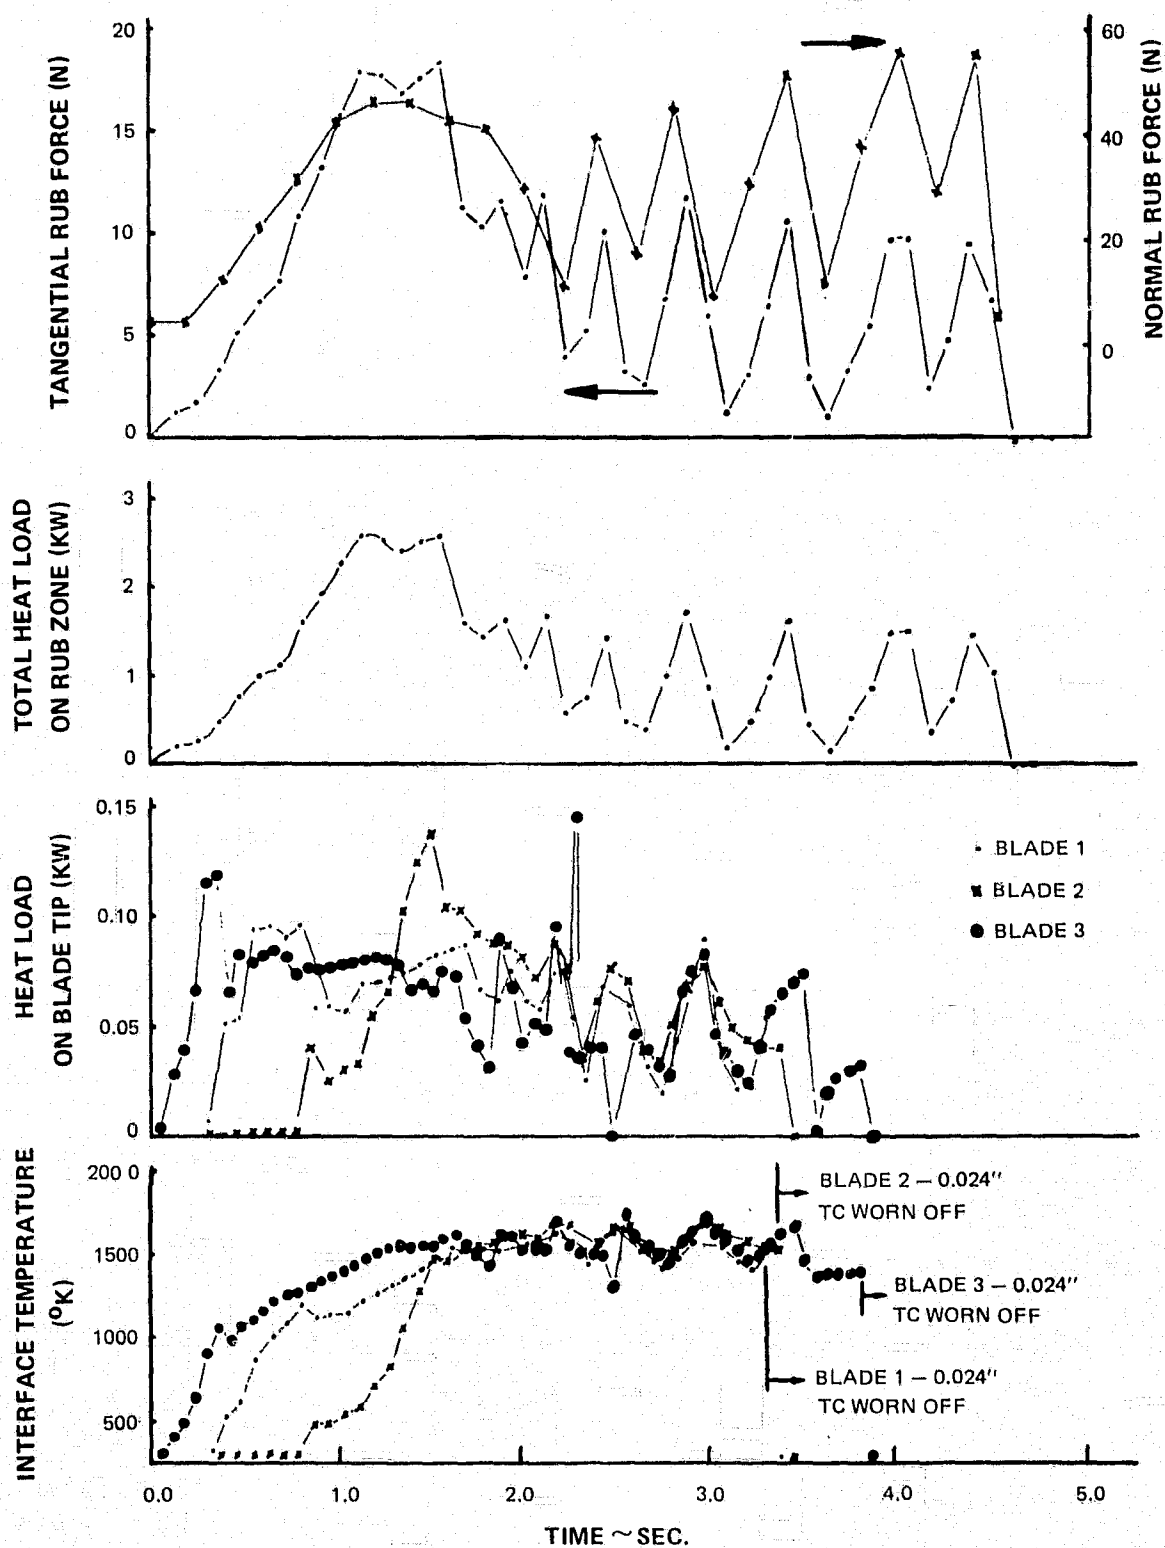
Figure 72. Task III Test 16 Data Reduction Results

Test 16 (3, Ti, i = .25 mm/sec, v = 152 mps, b = 1.71 mm, δ = 1.0 mm, ρ = 19%)

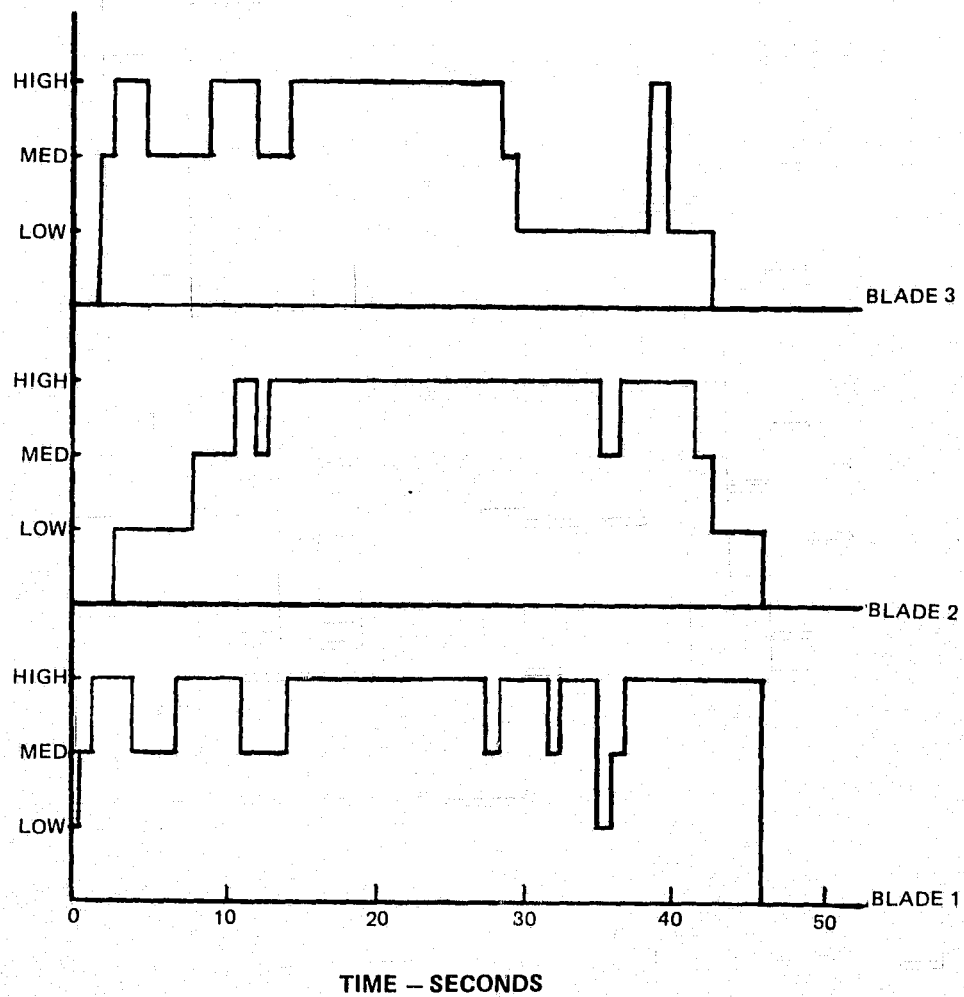
Figure 74. Task III Test 14 Strain Gauge Results

Test 14 (3, Ti, i = .25 mm/sec, v = 152 mps, b = .55 mm, δ = 1.0 mm, ρ = 19%)

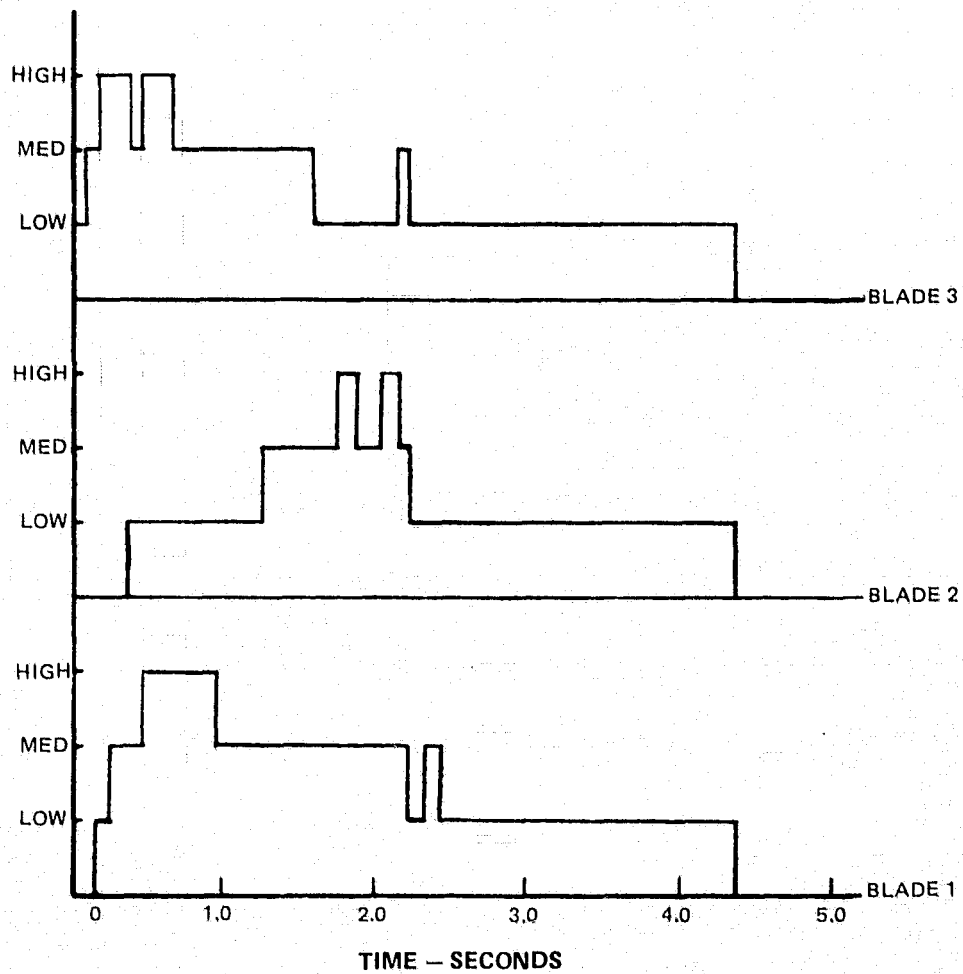
Figure 75. Task III Test 16 Strain Gauge Results

Test 16 (3, Ti, i = .25 mm/sec, v = 152 mps, b = 1.71 mm, δ = 1.0 mm, ρ = 19%)

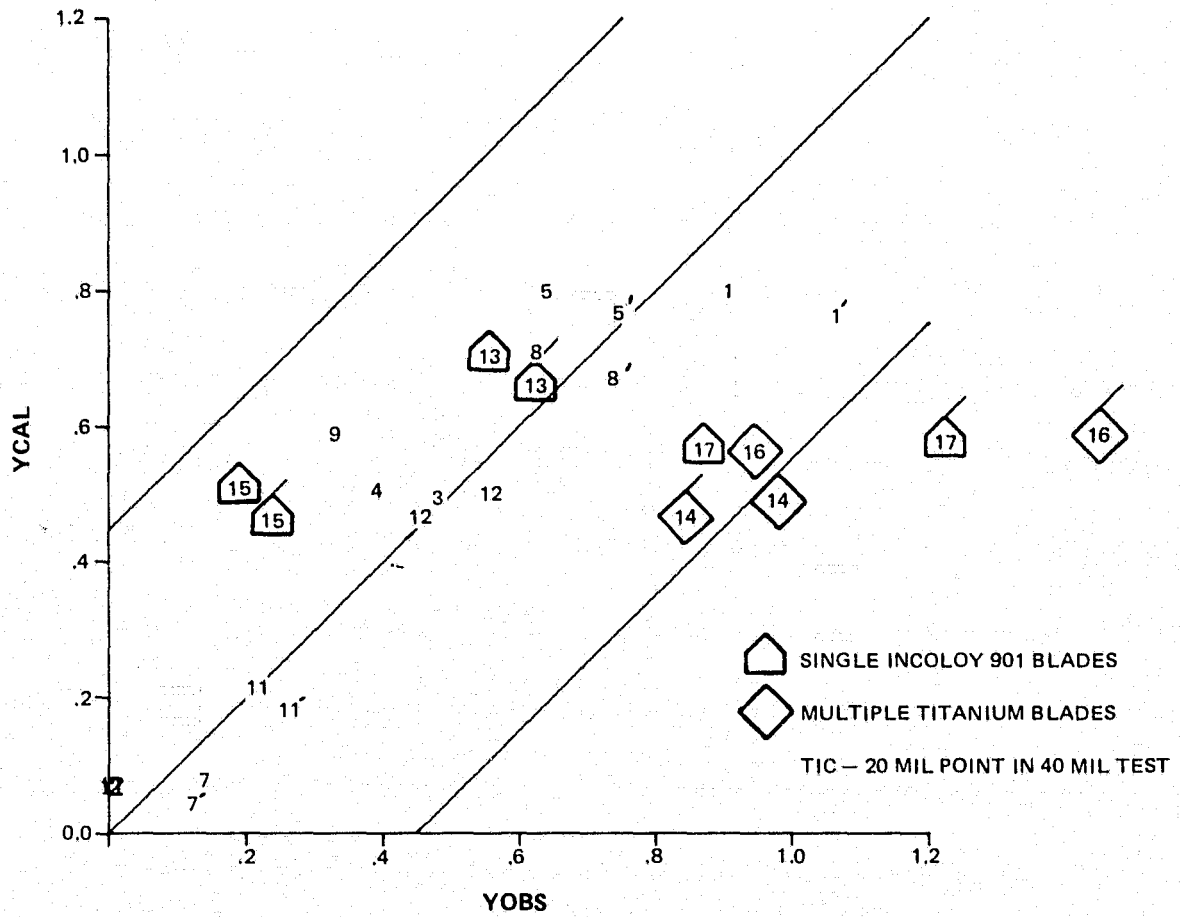
Figure 76. Comparison of Task III Data with Task I Model - Average Total Energy

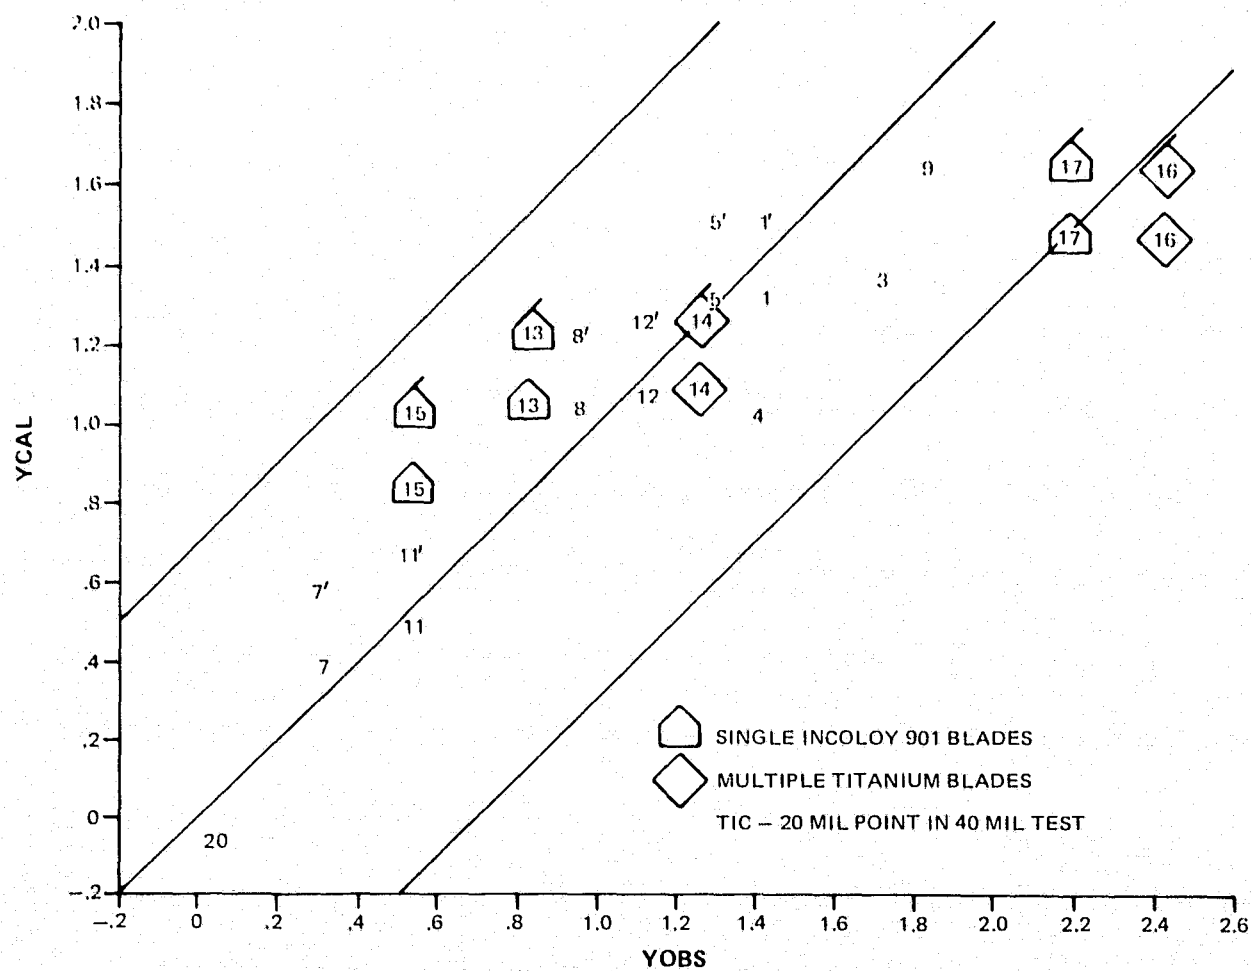
Figure 77. Comparison of Task III Data with Task I Model -- Peak Total Energy

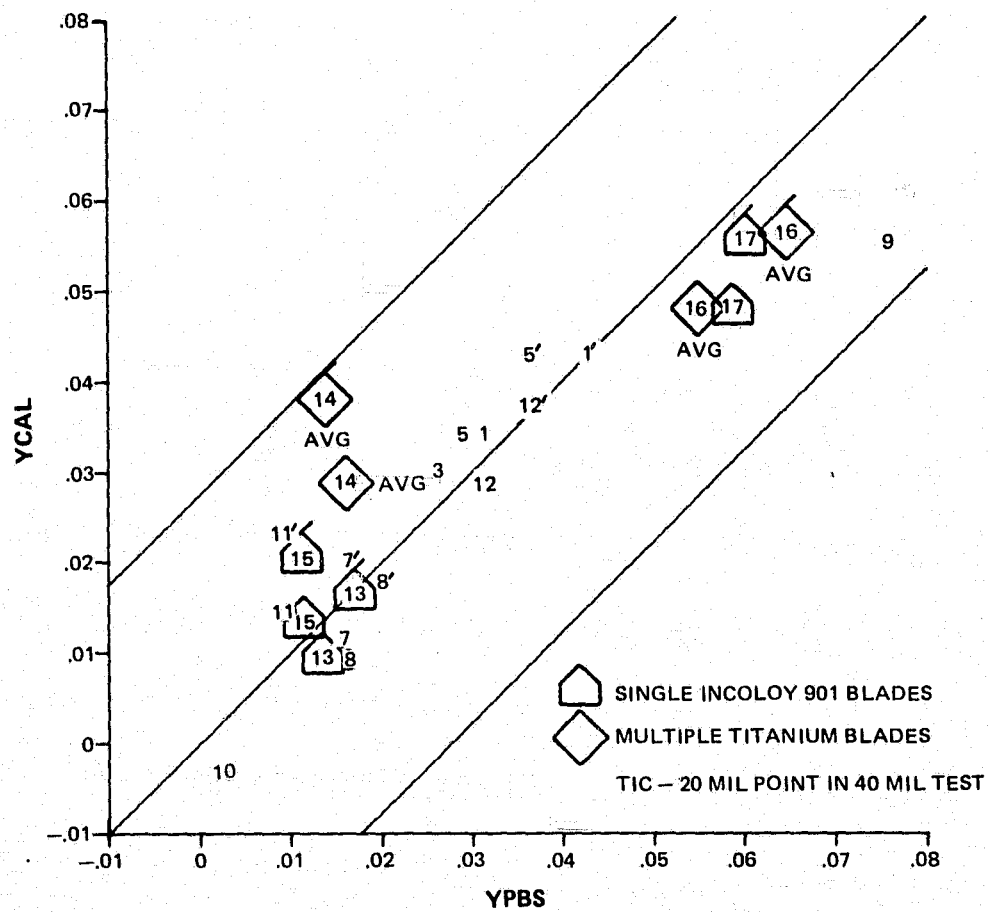
Figure 78. Comparison of Task III Data with Task I Model - Average Heat to Blade
