NASA CR-159424
PWA-5616

COMPRESSOR SEAL RUB ENERGETICS STUDY

FINAL REPORT

PRATT & WHITNEY AIRCRAFT GROUP
COMMERCIAL PRODUCTS DIVISION
UNITED TECHNOLOGIES CORPORATION

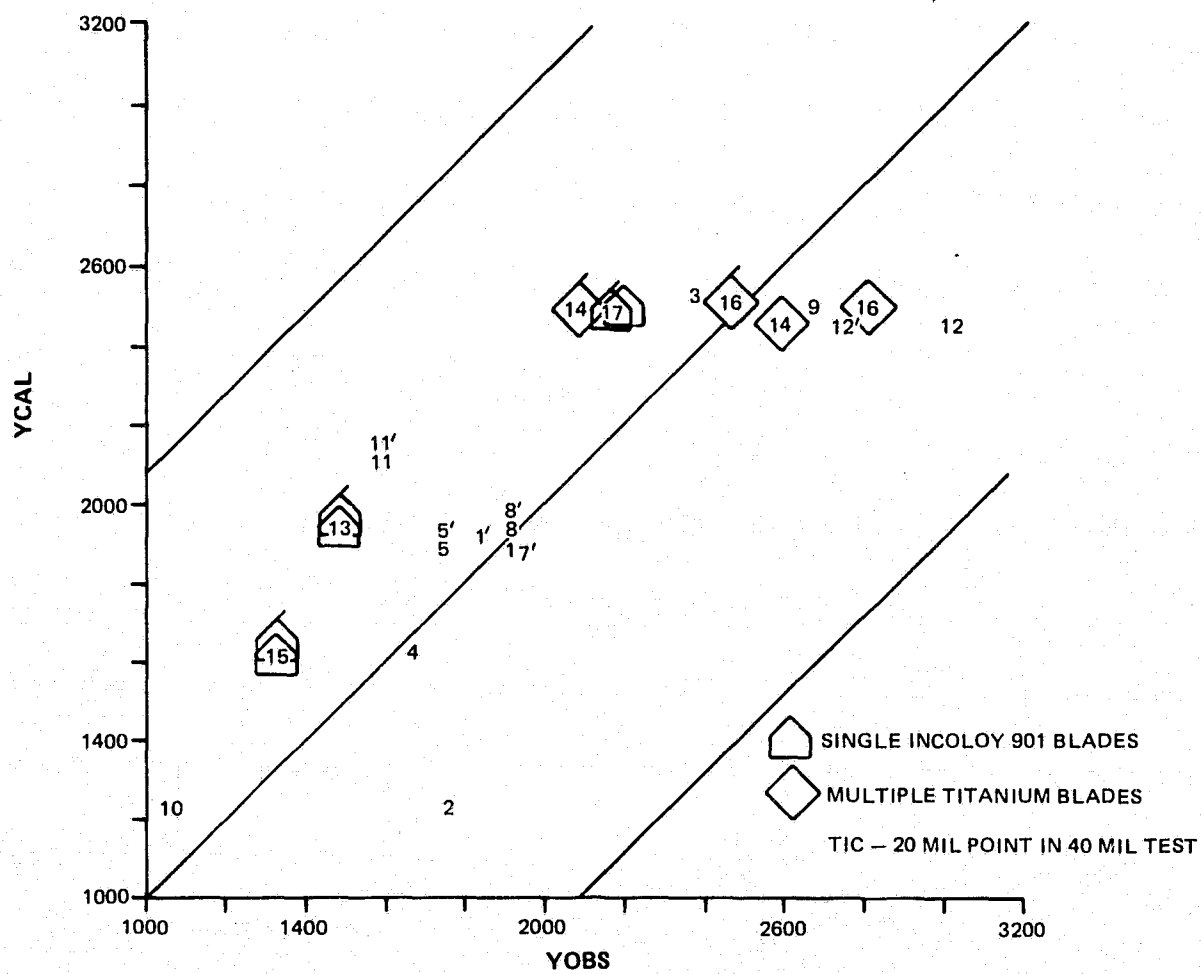
Figure 80. Comparison of Task III Data with Task I Model – Maximum Blade Temperature

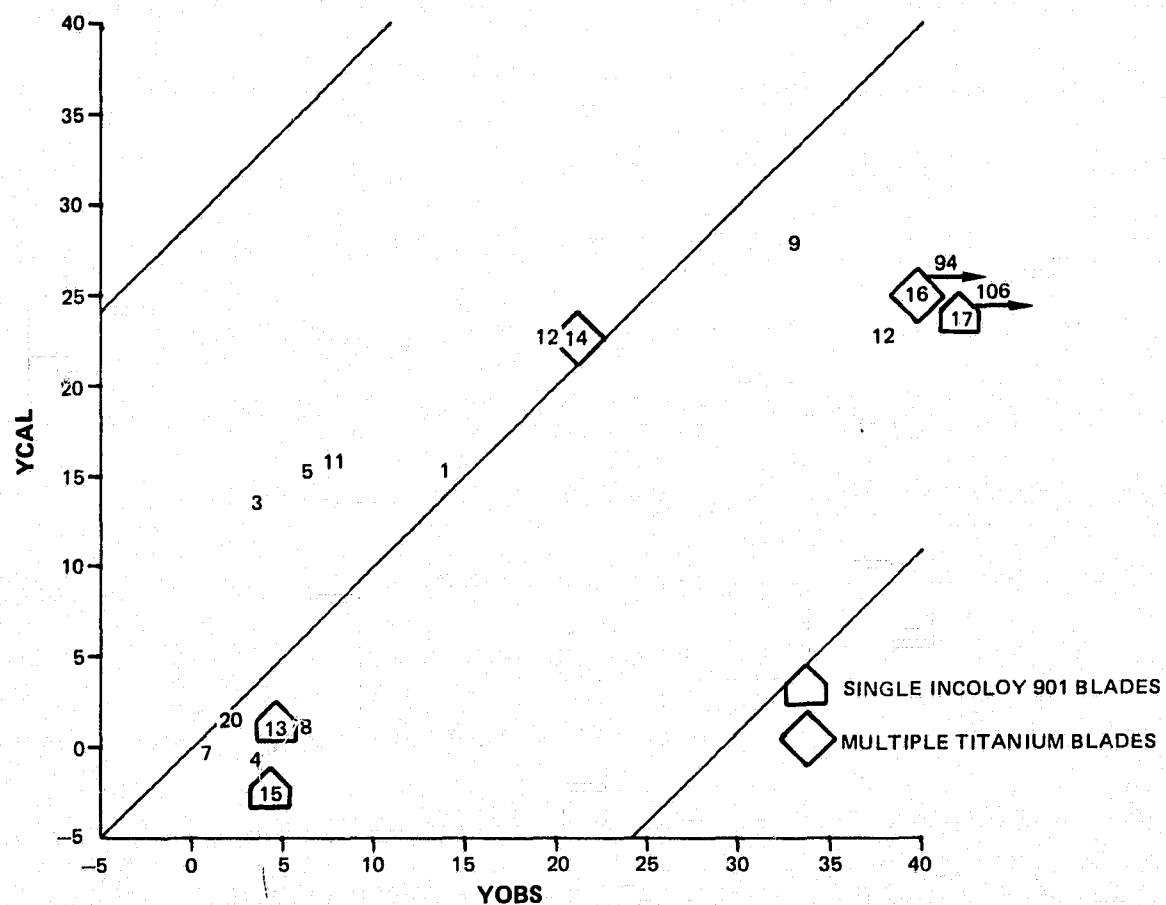
Figure 81. Comparison of Task III Data with Task I Model – Adjusted Blade Wear and Transfer
