NASA CR- 156827

KRYTOX LUBRICATION TAPE STUDY

CONTRACT NO. NAS5-22574

FRANK LEE  
RECORDING SYSTEMS  
RCA - GCSD  
CAMDEN, NEW JERSEY 08102

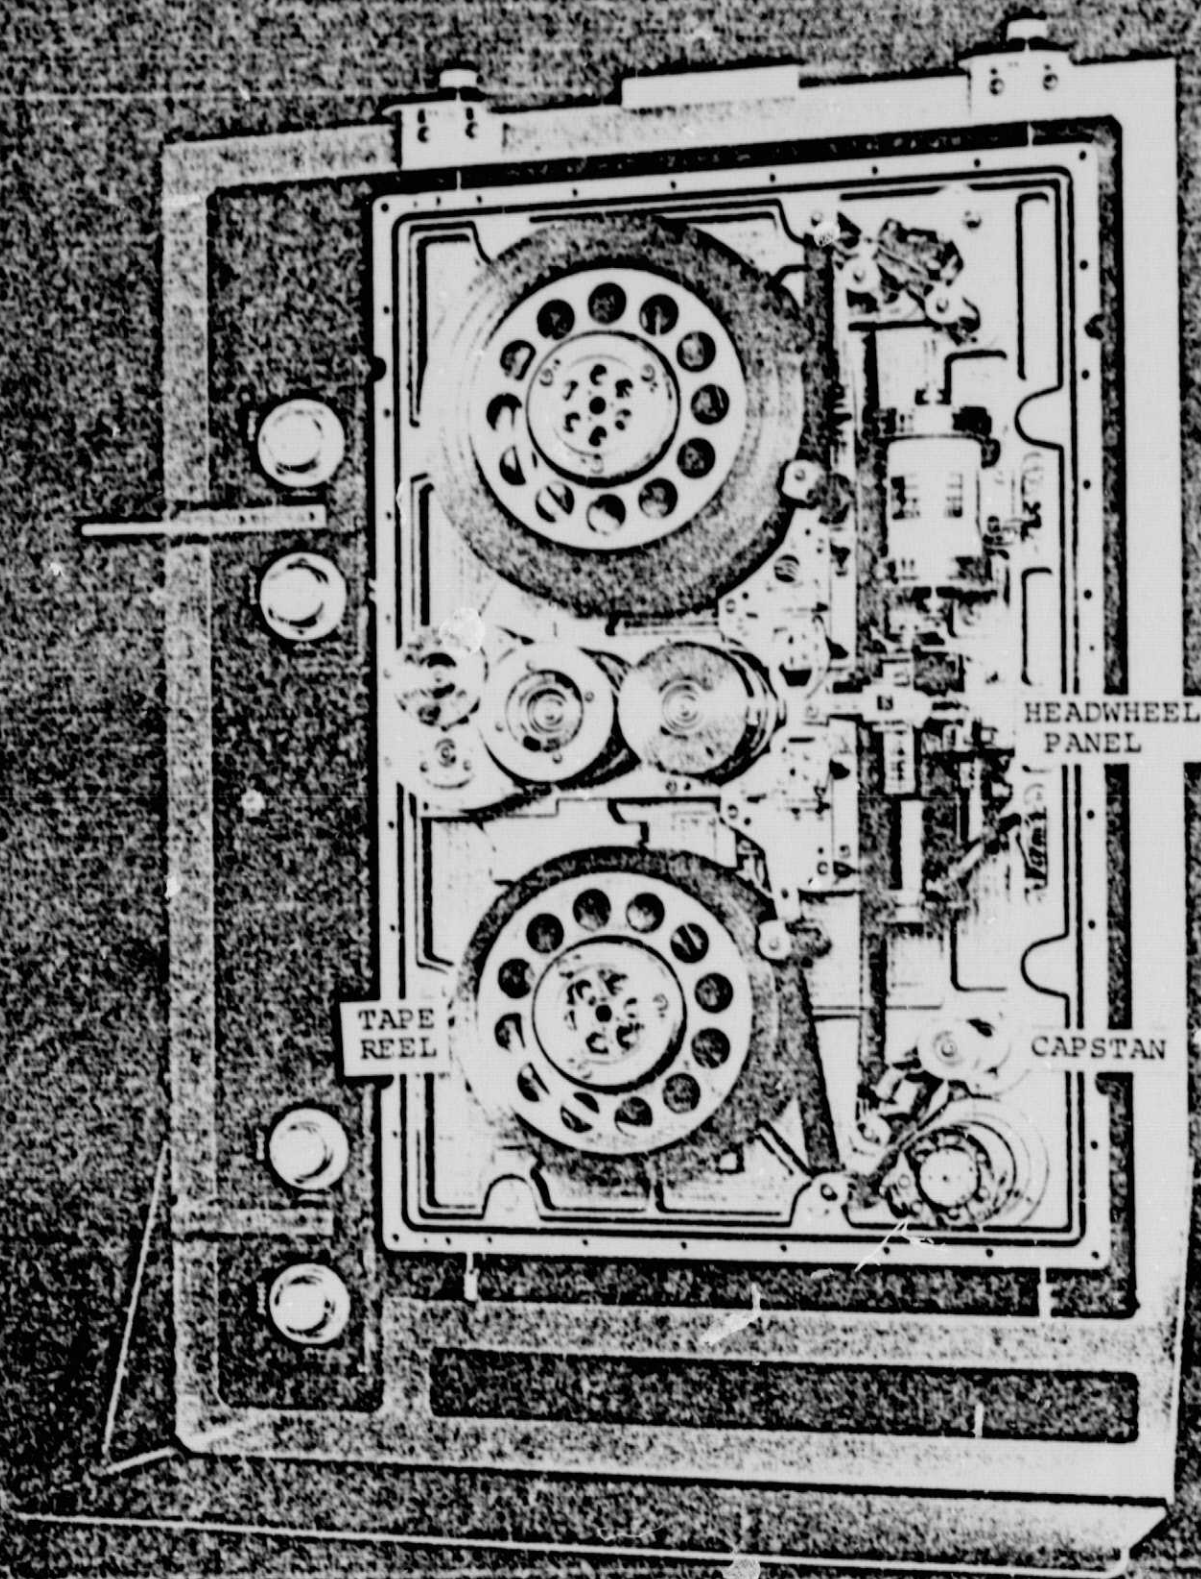
FIG. 1 LANDSAT WBVTR  
TRANSPORT UNIT

The WBVTR is a reel to reel transverse scan recorder with a capacity of 2000 feet of 2 inch tape or 30 minutes of recording time (Fig. 1). Flangeless reels used to store the tape are differentially coupled to a negator spring system to maintain tape tension. It has two modes of commandable operation, Analog with 3.5 MHz BW or 15 Mb/s Digital data. With an operating temperature range from 0° to 45°C, the performance of the WBVTR is critically dependent on many properties of the tape. The use of a surface lubricant should not materially change any of the critical tape parameters. RCA will test effects of the surface lubricant on:

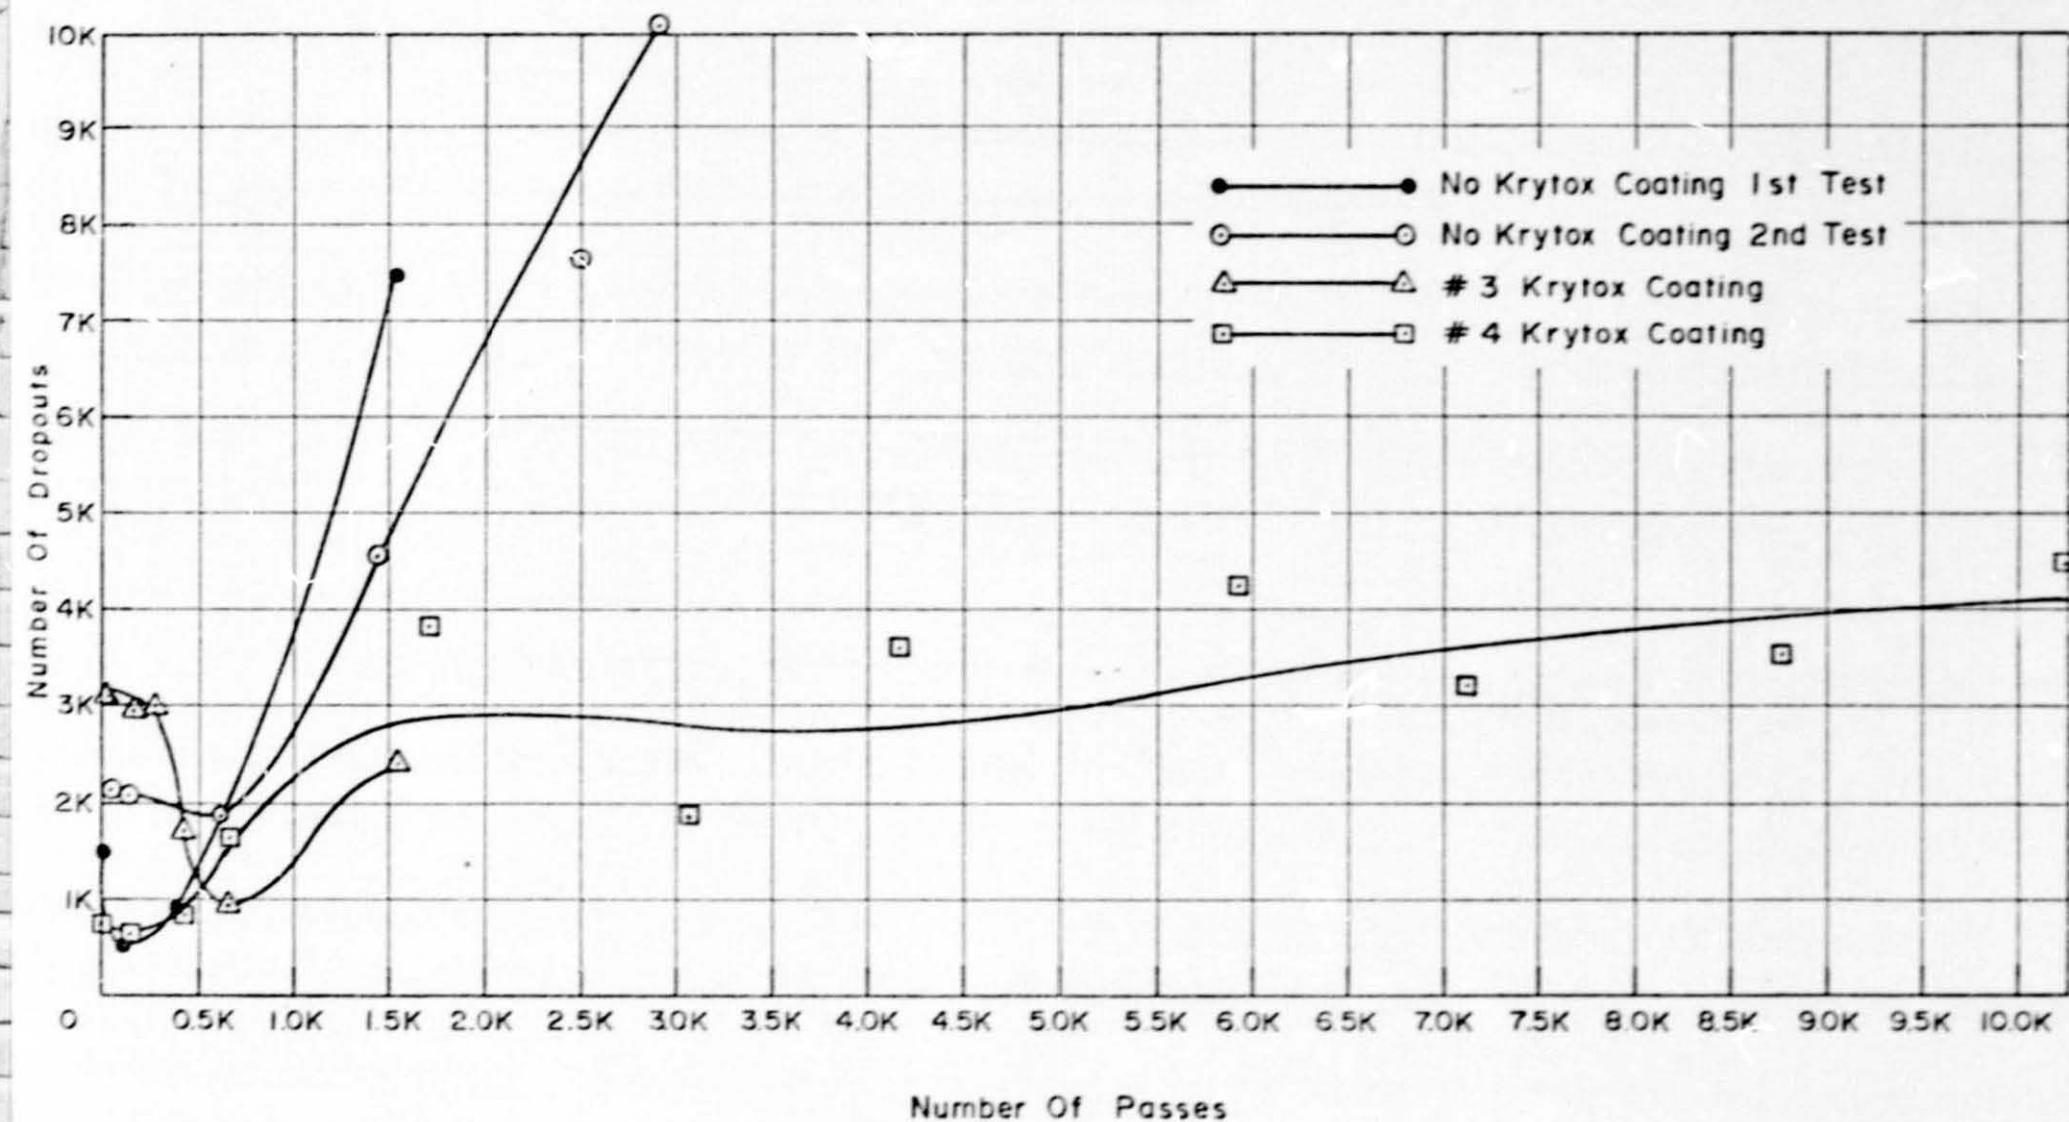
FIGURE 2 NUMBER OF DROPOUTS VS. NUMBER OF PASSES  
TAPE TYPE MTA - 20237

IITRI tested untreated and Levels 3 and 4 coated samples of the MTA 20237 on the TR22. The testing was begun on the untreated tape. The tape was run for 1500 passes with dropout measurements conducted at various intervals during the test. The total number of dropouts and their average duration were recorded (Figures 2 and 3). The data was averaged over 10 runs for an interval measurement. After 1500

passes, the dropout count increased to 15 times the minimum. The next sample tested was coated to Level 3. After 1500 passes the dropout count had only increased 2.5 times. The tests were repeated with a new headwheel panel because of problems of scability with the old headwheel panel. This time it was decided to extend the testing beyond 1500 passes and increase the lubricant coating to Level 4. For the second run, the untreated tape had a 5.5 time dropout growth after approximately 3000 passes. The Level 4 sample showed a somewhat flat dropout growth even out to 10,000 passes. With a 5000 count taken as an indication of end of life, the treated tape showed at least a six times improvement in life.

Based on this performance, the surface lubricant thickness of Level 4 was selected for final testing.

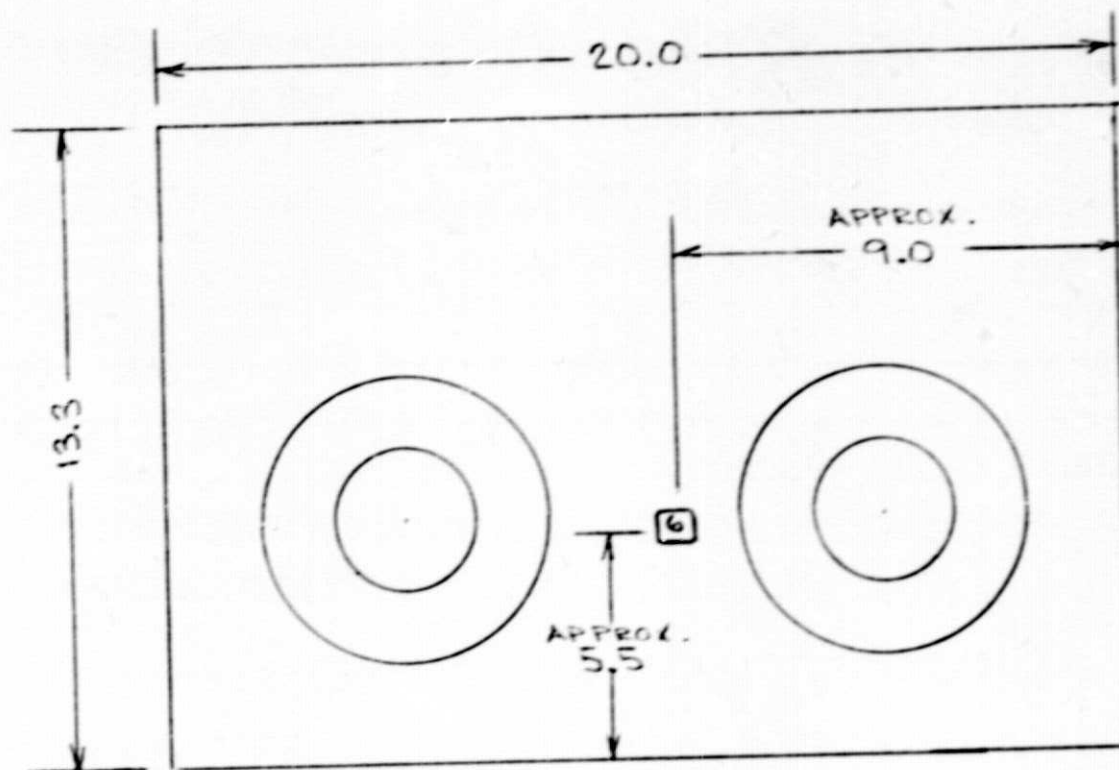
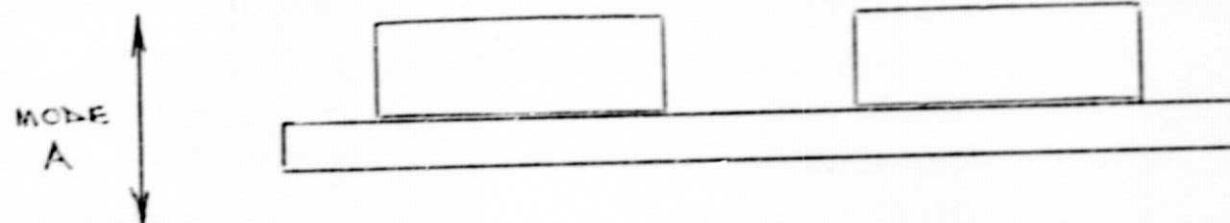
FIGURE 4

[6] ACCELEROMETER LOCATION

ERTS VIBRATION TEST  
ACCELEROMETER LOCATION

A separate test was conducted to assess the effect of the surface lubricant on the tape pack stability. Another MTA 20237 87784 tape was coated to the same #4 level as the final qualification test tape. When received, the tape was allowed a 24 hour period to adjust to the temperature and humidity conditions of the laboratory. The tape was then wound through twice on a tape winder before being loaded onto the WBVTR. Three reel throughs were then performed to develop the proper tension pattern and then the tape packs were equalized. The tape was cut and the ends secured to the tape packs. The two rolls of tape with their respective reel hubs were transferred to a vibration fixture (Fig. 4) and subjected to a 2-axes sine and random vibration of Qualification level. Since the fixture has a transmissibility of one, the output frequency/G levels were adjusted to reflect the transmissibility of the actual Landsat tape deck (Fig. 5, 6, 7, 8). The "A" mode of vibration was parallel to the reel axes and is the worse case for tape shift.

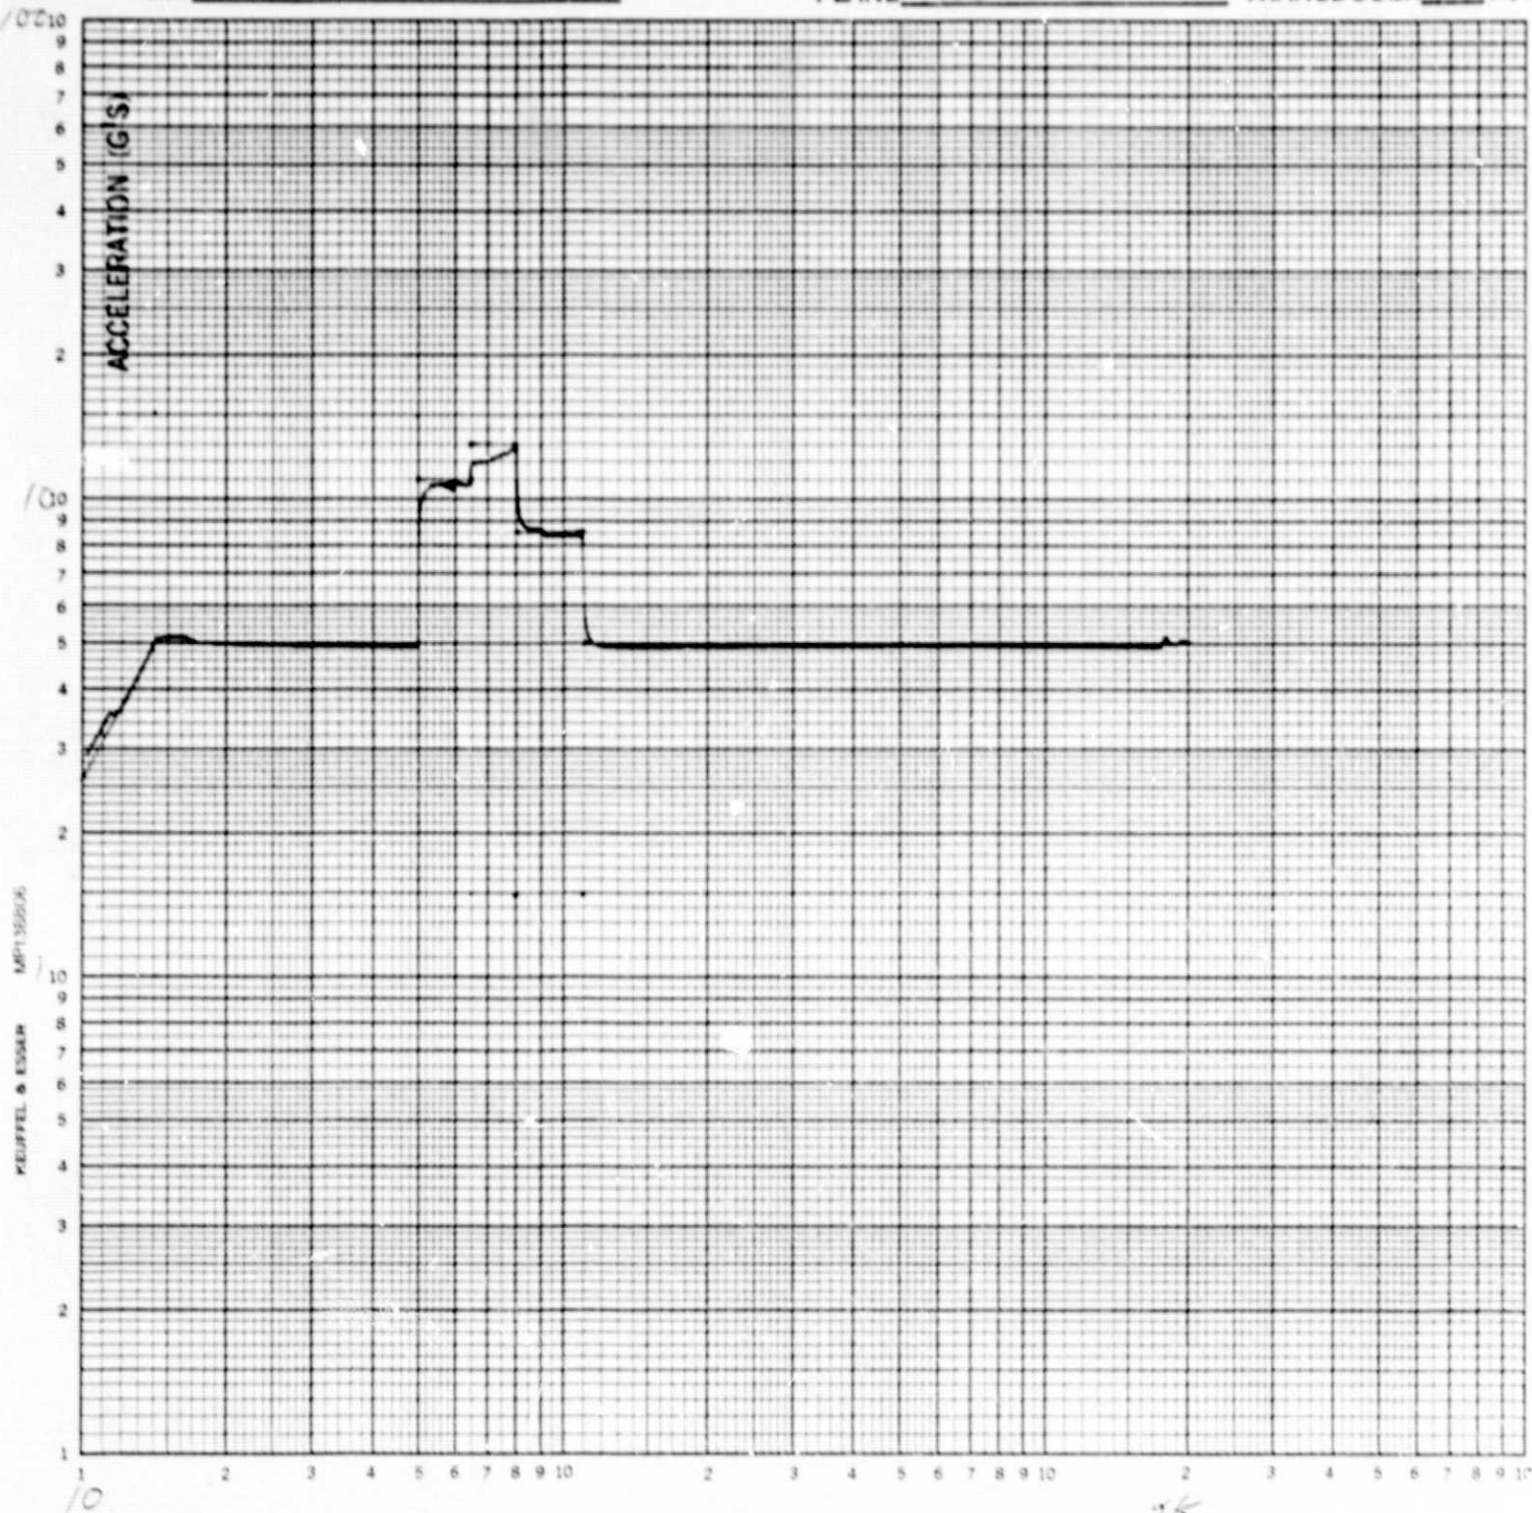
FIGURE 5

TEST SINE VIBRATION

PLANE MODE A TRANSDUCER CENTRAL

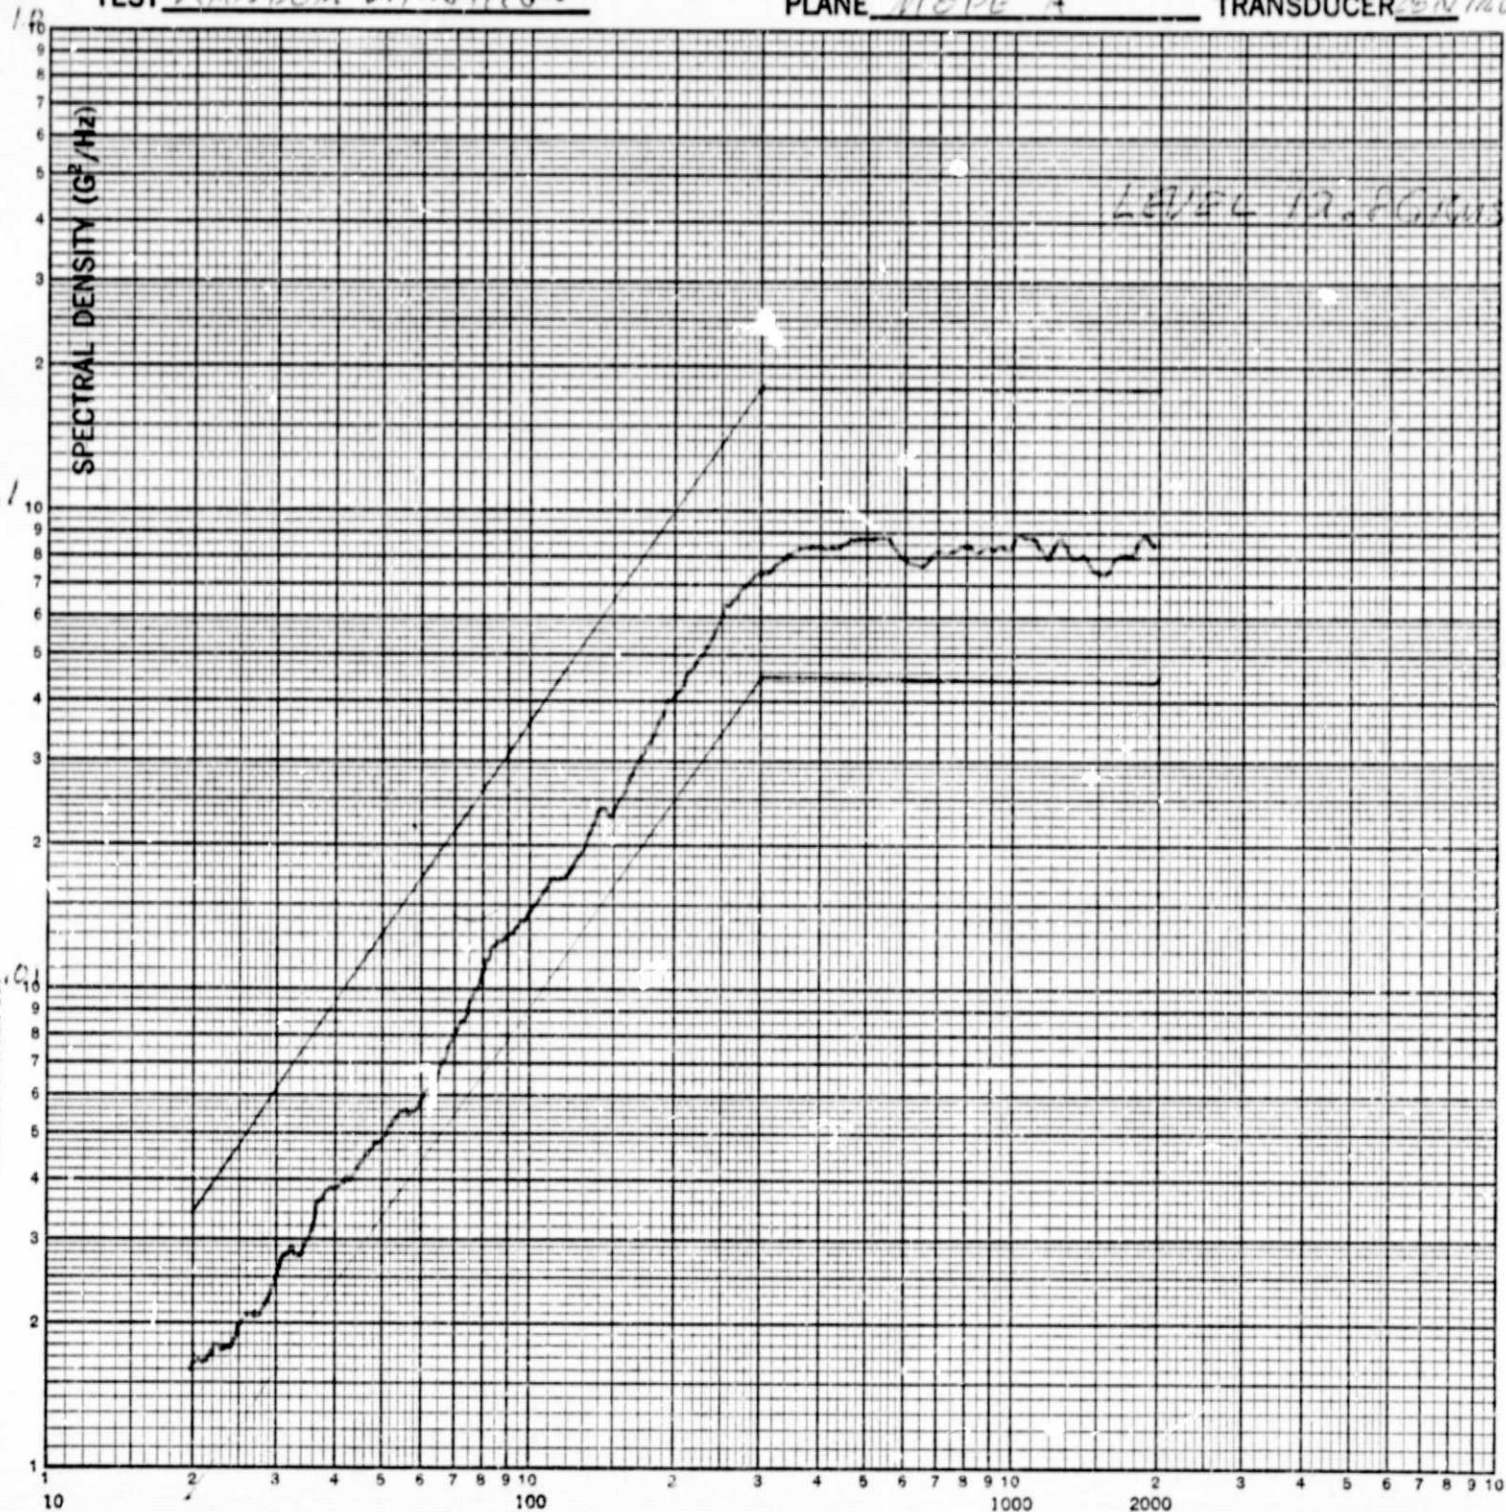
FIGURE 6

TEST RANDOM VIBRATION

PLANE NOPE A TRANSDUCER CONTACT

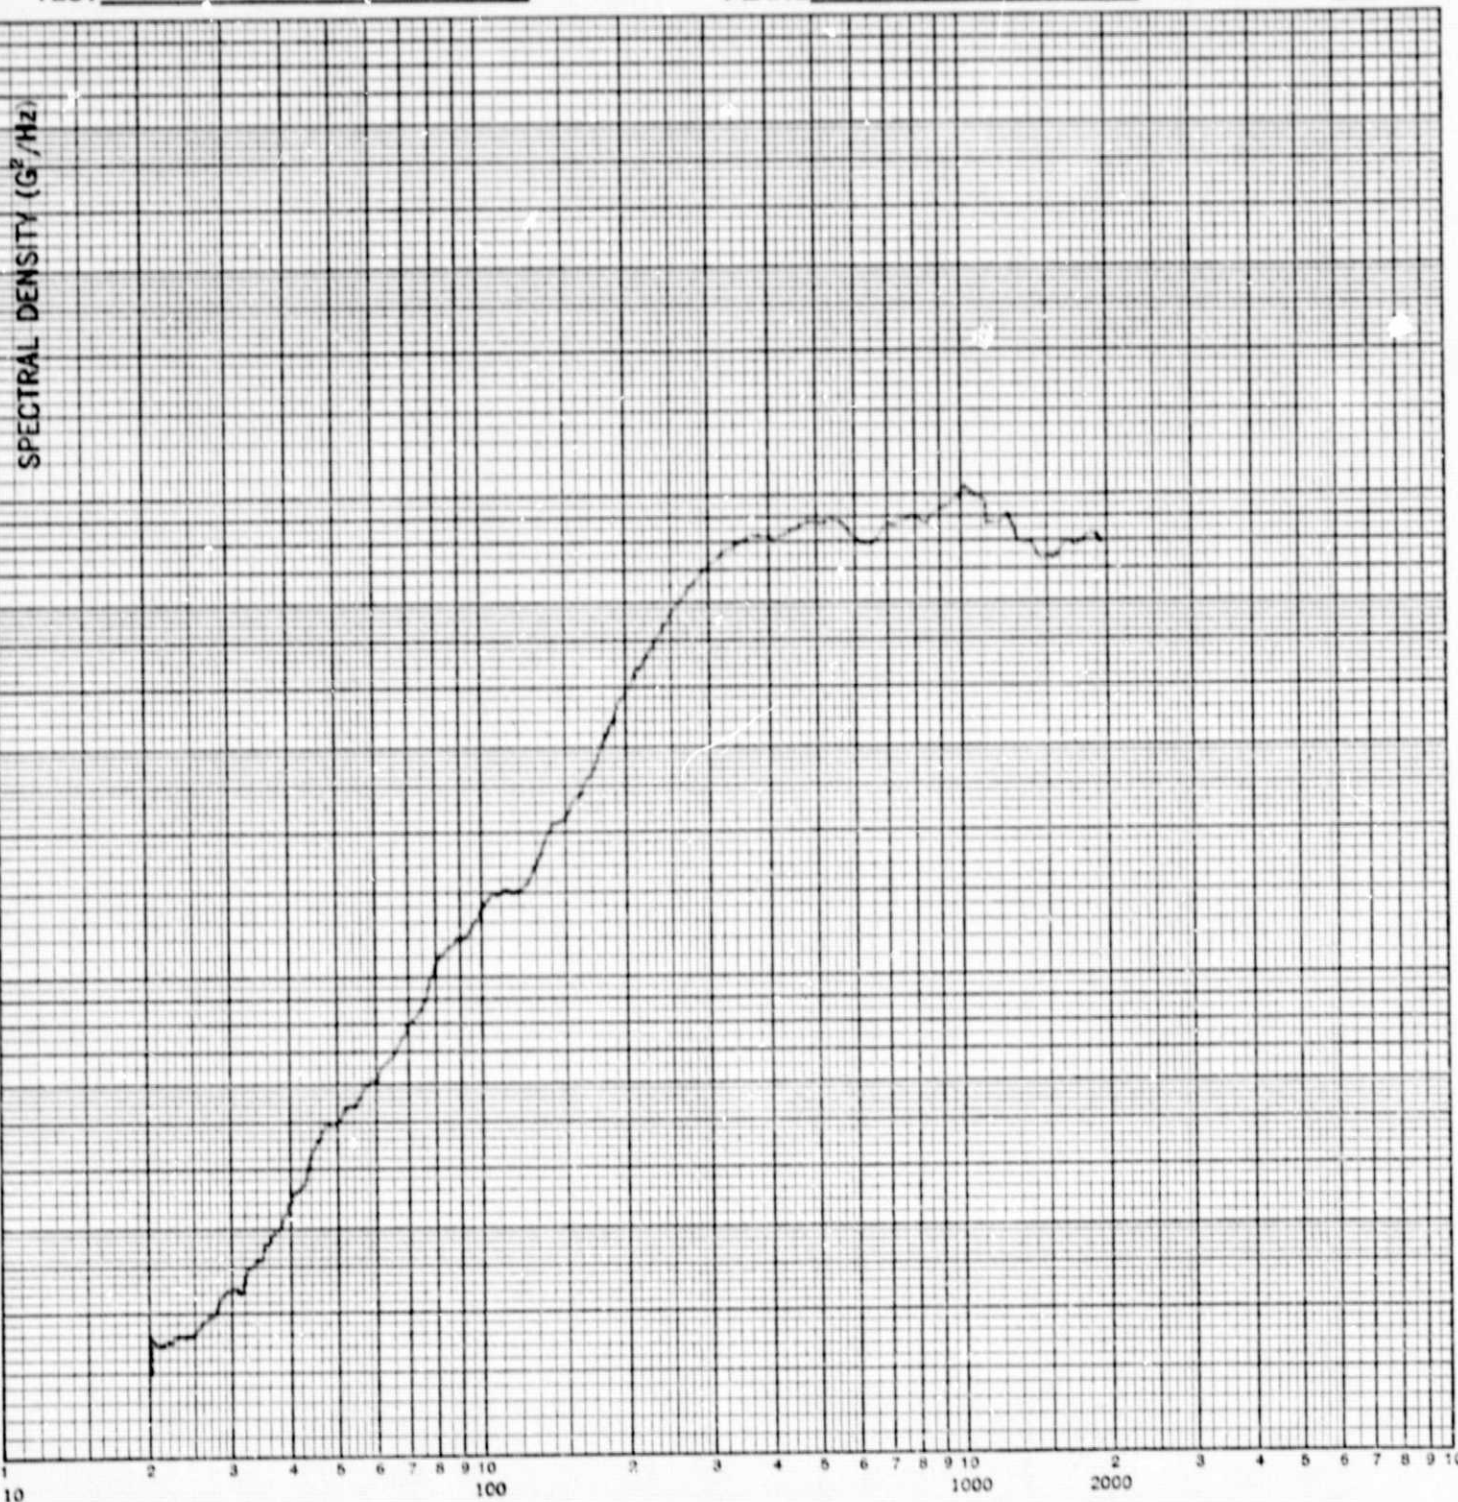
FIGURE 8

TEST RANDOM VIB

PLANE MODE B TRANSDUCER CONTROL

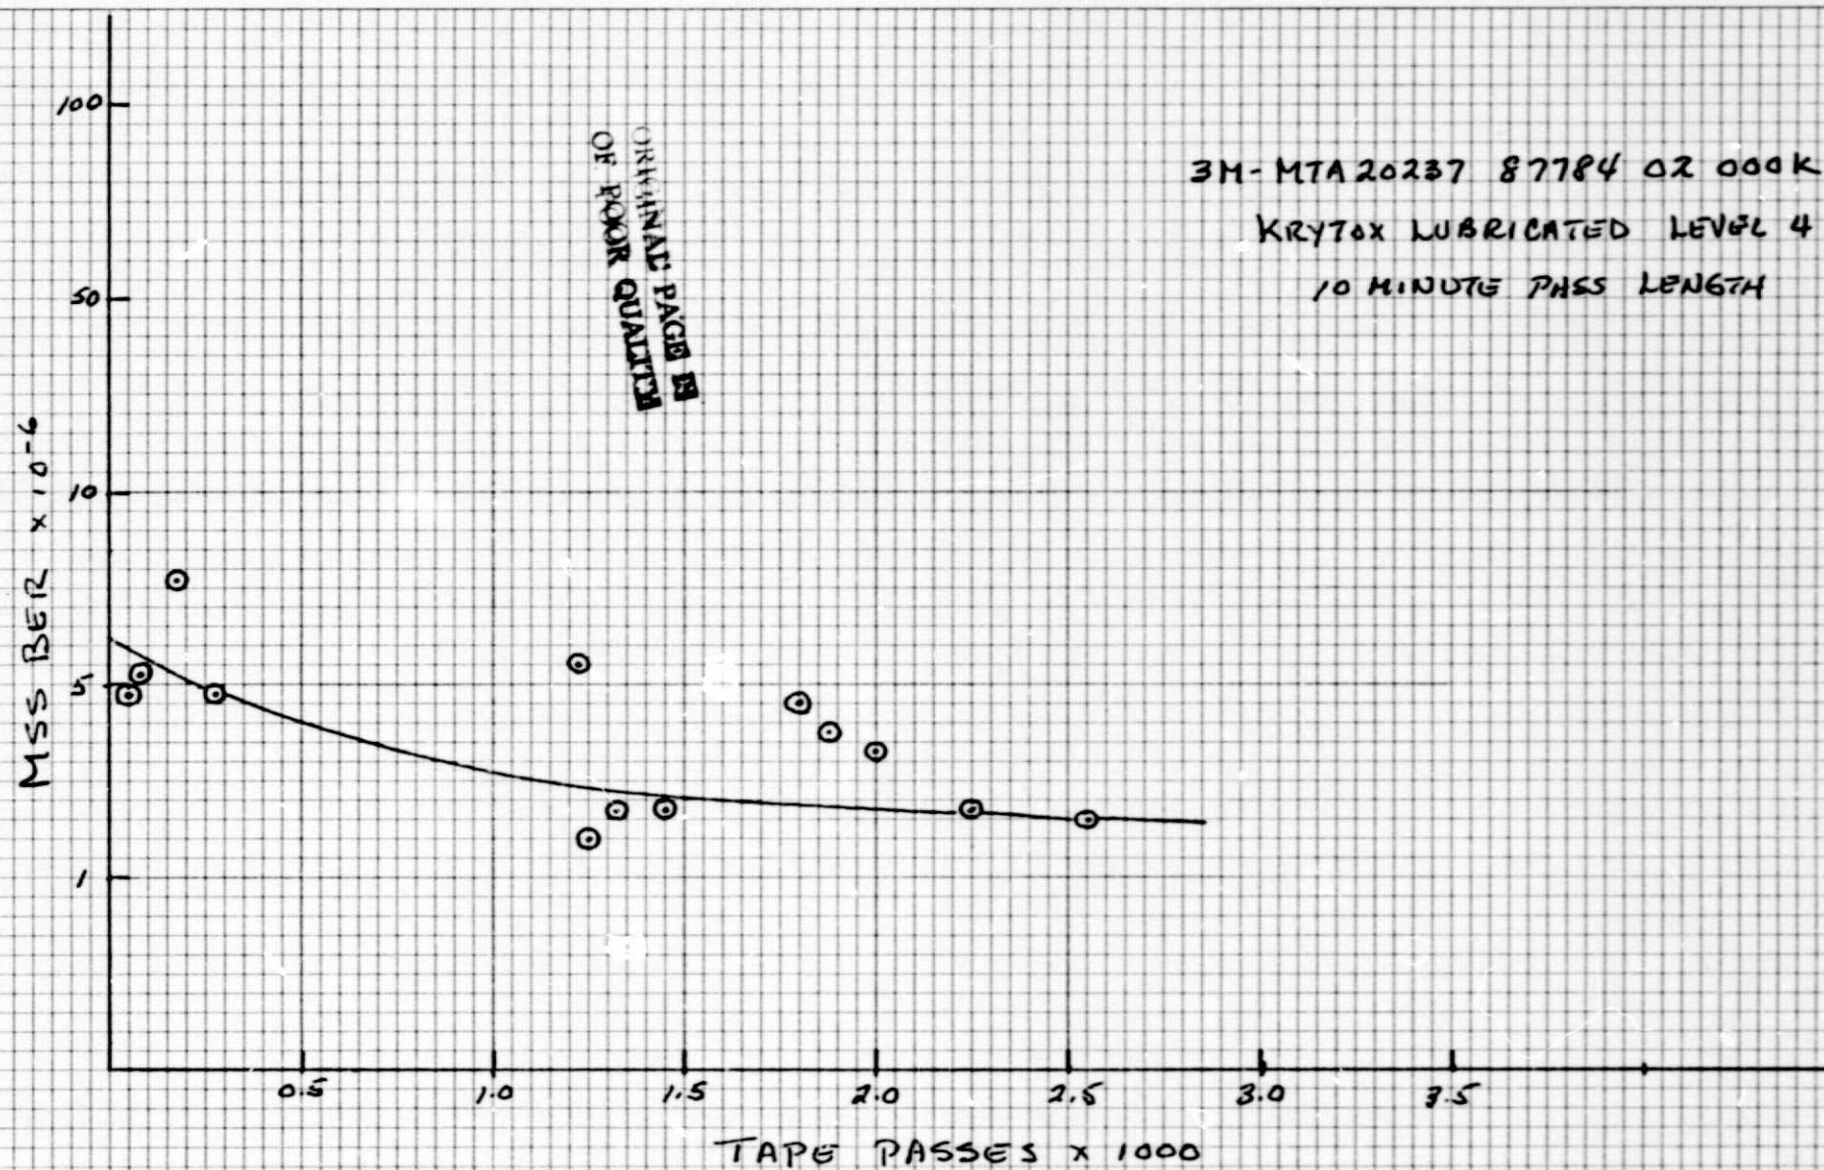
Figure 9 BER PERFORMANCE, LIFETEST

An initial 10 minute cycle was selected to allow pass accumulation to occur at a faster rate than cycling the full 30 minutes. The remaining 20 minutes would be cycled tested in a second phase of the life test. BER runs and visual observations of the headwheel were periodically performed to monitor the progress of the life test. The BER runs were reduced to average values for the full 10 minute run and the results are shown in Figure 9. After 2500 passes, the headwheel panel was removed to make a scheduled head

protrusion measurement for wear rate determination. The pole tip protrusion was found to be 1.48 mils, representing a loss of 0.60 mils since the start of the test. Since 428 hours had elapsed for the 2500 passes, this equaled to a wear rate of 140u in/100 hr. This wear rate projected meant the heads would barely last 1000 hours. Qualifying tape tests for Landsat A & B had indicated long term wear rates on the order of 30u in/100 hrs. The high wear explains why a record current adjustment was needed after 1200 passes to optimize BER performance.
