# Lubrication and Failure Mechanisms of Molybdenum Disulfide Films

## I - Effect of Atmosphere

Robert L. Fusaro

DECEMBER 1978

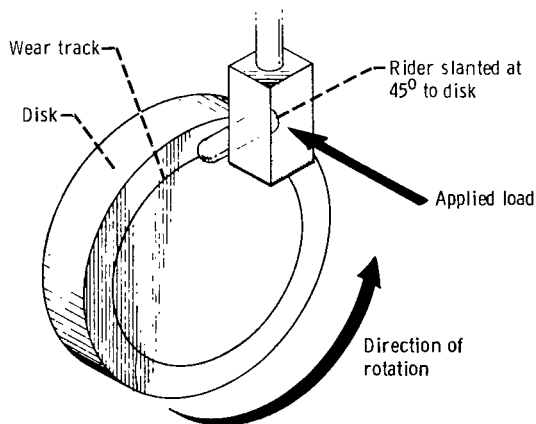
Figure 1. - Schematic diagram of friction specimens.

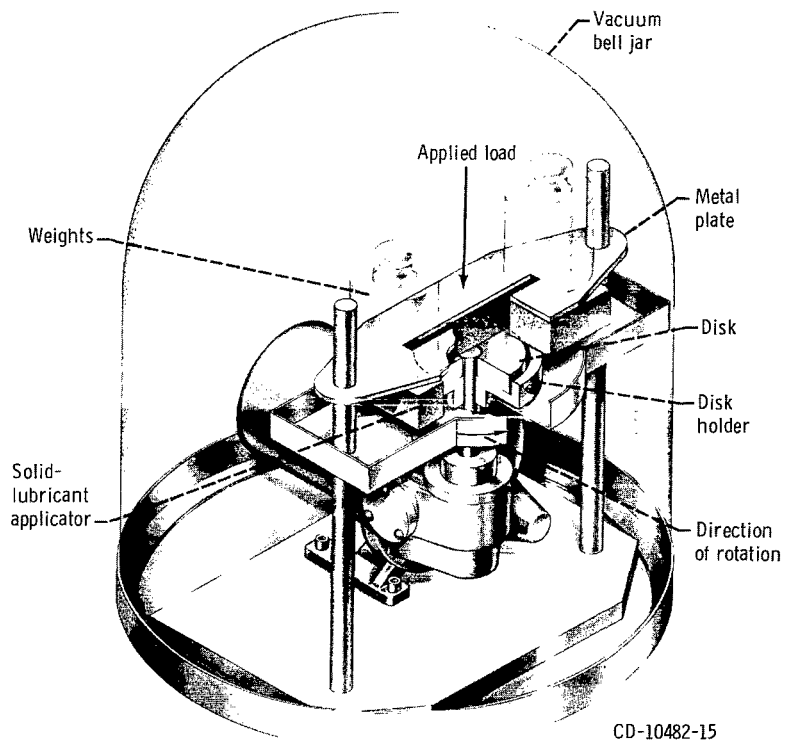
Figure 2. - Apparatus used for applying molybdenum disulfide films.

The rubbing apparatus was designed to fit within the bell jar of a vacuum system so that the atmosphere in which the films were applied could be controlled. This was done by evacuating the bell jar to 1000 pascals and then backfilling to atmospheric pressure with the desired atmosphere. Previous results (ref. 14) have shown that films applied in moist air are thicker and denser than films applied under dryer conditions. Therefore the films in these experiments were applied in moist air (10 000-ppm  $\text{H}_2\text{O}$ ).

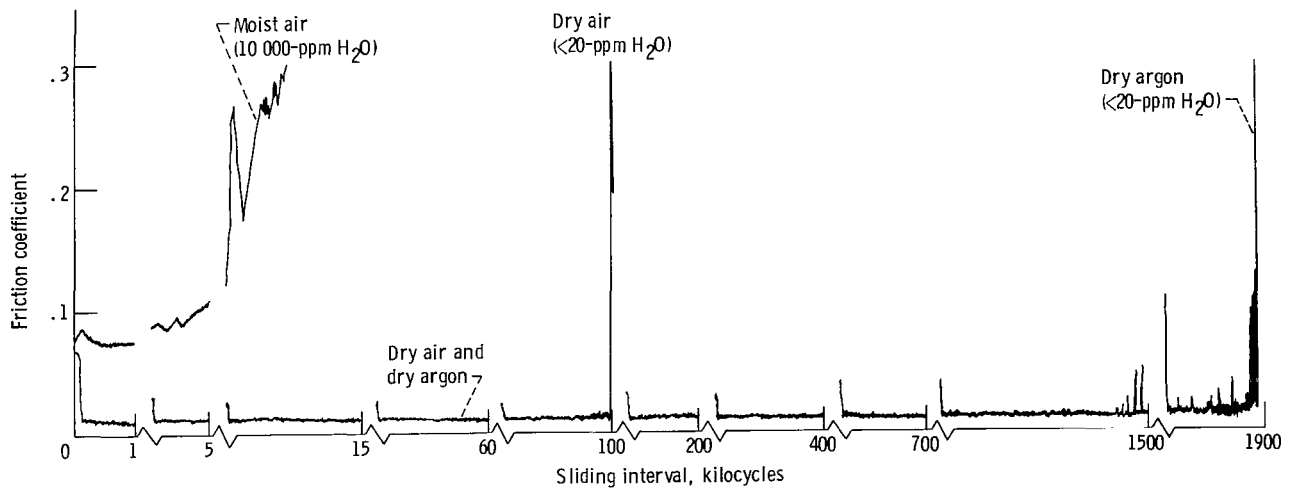
Figure 3. - Friction coefficient as a function of sliding interval for rubbed  $\text{MoS}_2$  films applied to sanded 440C HT steel disks and evaluated in three atmospheres. Rider material, 440C HT steel; sliding speed, 2.6 meters per second (1000 rpm); load, 1 kilogram; temperature,  $25^\circ\text{C}$ .

Figure 3 gives typical friction traces for hemispherically tipped 440C HT steel riders sliding on  $\text{MoS}_2$  rubbed films that were applied to sanded 440C HT steel disks. Testing was done in atmospheres of moist air (10 000-ppm  $\text{H}_2\text{O}$ ), dry air ( $<20$ -ppm  $\text{H}_2\text{O}$ ),

and dry argon (<20-ppm H<sub>2</sub>O). The gaps in the traces represent the intervals when the tests were stopped so that wear measurements could be made. As the figure illustrates, the friction coefficient and wear life of the MoS<sub>2</sub> rubbed films were highly dependent on atmosphere. The lowest friction coefficient was obtained in both dry air and dry argon (0.01 to 0.02). The lowest friction coefficient in the moist air was 0.08. At startup in dry air and dry argon, the friction coefficient always was higher than its resultant average value. This "run-in" phenomenon did not occur in moist air, where the friction coefficient started out higher (0.08) and either remained at this value or increased with sliding. Since there was higher friction and no run-in in moist air, the run-in phenomenon in the dry atmospheres may have been caused by water adsorbed when the tests were stopped and the MoS<sub>2</sub> films were exposed to laboratory air.

The amount of  $\text{MoS}_2$  transferred to the rider did not affect the friction coefficient. Figures 8 and 12 show varying degrees of  $\text{MoS}_2$  transfer to the rider scar, but figure 3 shows that this did not affect the friction coefficient. Only when the transfer became powdery (transformed  $\text{MoS}_2$  and or powdery metallic debris), was the friction observed to increase (figs. 8(d), 9(d), 12(d), and 13(d)).

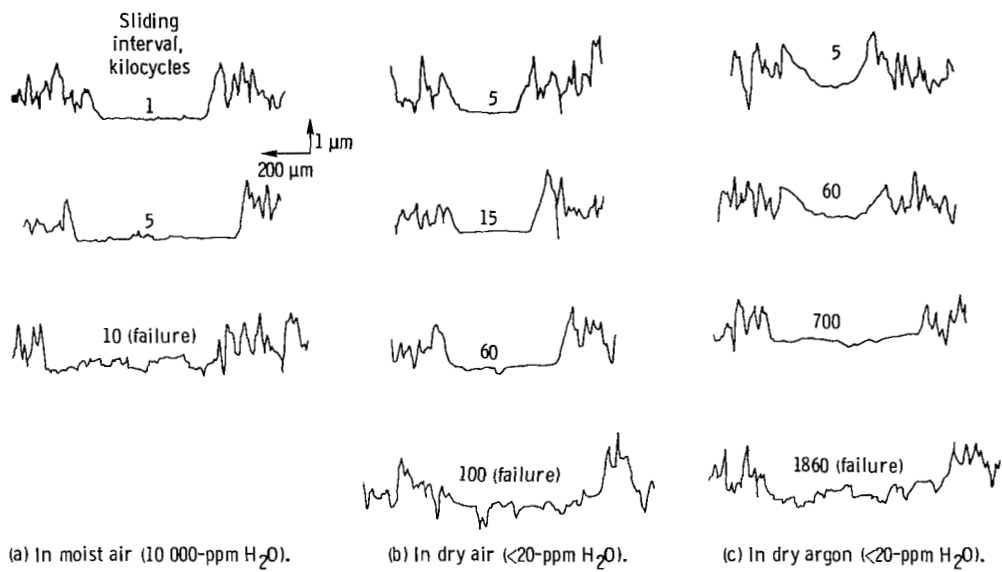
Figure 4. - Surface profiles of wear tracks on rubbed MoS<sub>2</sub> films applied to sanded 440C HT steel disks and evaluated in three atmospheres.

The wear of the disk surfaces to which the MoS<sub>2</sub> was applied was also studied. Figure 4 gives typical surface profiles of the wear tracks that were taken after various sliding intervals. The vertical magnification of the surface profiles is about 170 times the horizontal magnification; thus a distorted view of the true surface was obtained. The surface profiles show that the sliding surface of a wear track was very smooth, at least until failure occurred. At failure the wear track was somewhat rough because powdery metallic debris and powdery transformed MoS<sub>2</sub> had built up. This is discussed in the following section. From the surface profiles, metallic wear could not be distinguished from film wear. The MoS<sub>2</sub> rubbed films were about 1 to 2 micrometers thick, and the wear tracks were of the same depth. Thus, in general, very little wear occurred to the metallic disks.

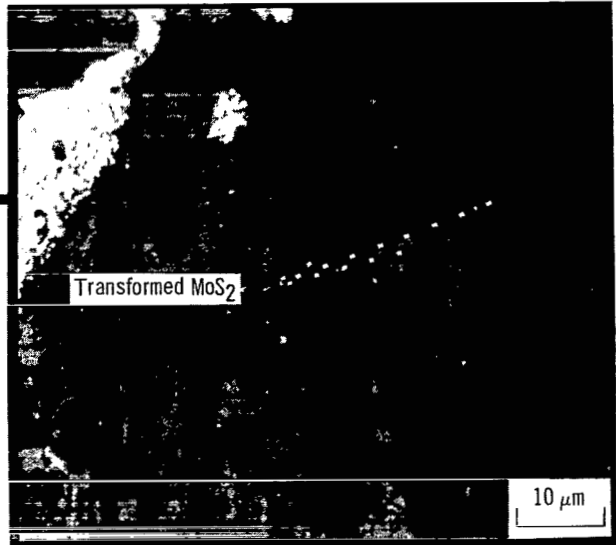
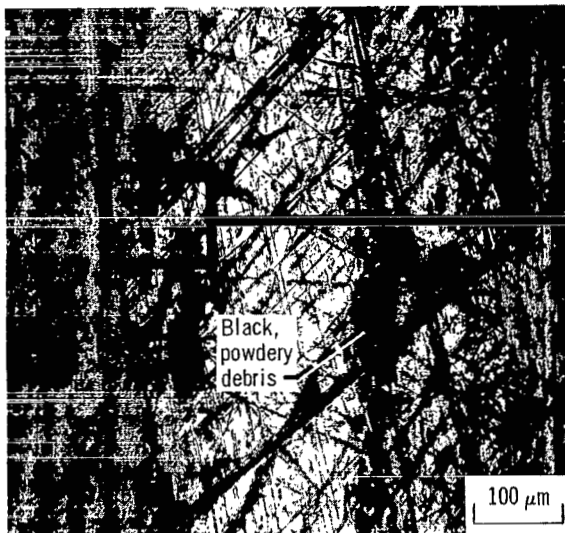
(a) Rider wear scar.

(b) MoS<sub>2</sub> film wear track.

Figure 6. - Photomicrographs of rider wear scar and MoS<sub>2</sub> film wear track after 5 kilocycles of sliding in moist air (10 000-ppm H<sub>2</sub>O) at 25° C.

The moist-air atmosphere might be considered a typical condition; that is, an atmosphere of 50-percent-relative-humidity air at 25° C (~10 000-ppm H<sub>2</sub>O). Figures 5 to 7 show the sliding surfaces after 1, 5, and 10 kilocycles of sliding.

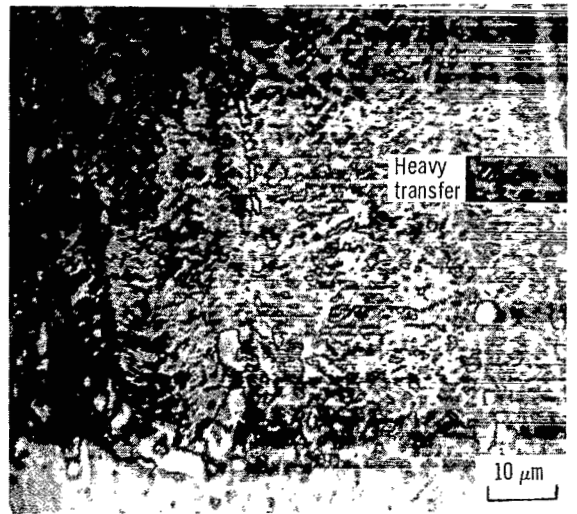
Figure 9. - Higher magnification photomicrographs of rider transfer films shown in figure 8.

After 1 kilocycle of sliding, transfer to the rider was like that in moist air; that is, the transfer film was fairly heavy. After continued sliding in dry air, the transfer film became considerably thinner (figs. 8(a) and 9(a)). After 15 kilocycles of sliding (figs. 8(b) and 9(b)) the heavy transfer film of  $\text{MoS}_2$  had disappeared and layer-like flow of  $\text{MoS}_2$  through the contact was occurring. After 60 kilocycles of sliding (figs. 8(c) and 9(c)), no layer-like flow was visible in the center of the rider scar. As the  $\text{MoS}_2$  moved into the contact zone (flat area), it was sheared thinner and thinner. Interference fringes are visible in this region, but in the actual contact region the  $\text{MoS}_2$  was sheared too thin for interference fringes to occur and the transfer was milky colored (figs. 8(c) and 9(c)).

At failure (figs. 8(d) and 9(d)), the transfer film resembled that in moist air; that is, it was heavy, rippled, and coarse. This film still possesses flow properties (fig. 9(d)).

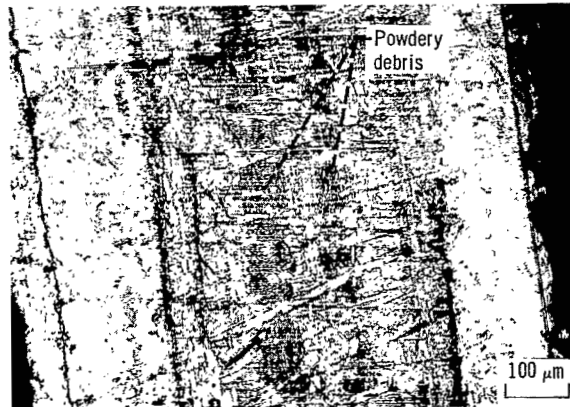
Figure 14. - Photomicrographs of MoS<sub>2</sub> film wear progression in dry argon (<20-ppm H<sub>2</sub>O).

Little evidence of  $\text{MoS}_2$  transformation in dry argon was found on the rider or in the film wear track. The films were very smooth and had a bright metallic luster. Figures 14 and 15 show photomicrographs of the wear tracks at intervals that correspond to the intervals used for the riders. After 1 kilocycle of sliding (fig. 14(a)), the film on the wear track was smooth and continuous and the metallic substrate was not visible. There were a few bubble-like protrusions at the outer edge of the wear track after 1 kilocycle of sliding (figs. 14(a) and 15(a)). These bubbles could also be found in the center of the wear track at longer sliding intervals (fig. 14(b)). Figure 15(b) shows one of these bubble areas in which the bubbles had cracked and spalled from the surface. These areas of bubbling, cracking, and spalling were localized and most of the track remained smooth and continuous. Since there was no change in color (i. e., the areas remained metallic colored and did not turn black), it is surmised that no transformation of  $\text{MoS}_2$  was occurring.

After continued sliding, the spalled areas tended to be self-healing; nevertheless, after long sliding the films started to thin in the center (figs. 14(c) and 15(c)). After 1500 kilocycles of sliding, the friction started to get "rough." At the sides of the wear track the film still had a metallic luster (fig. 14(d)); however, in the middle of the wear track the film looked disrupted. This disrupted area was a buildup of powdery material (fig. 15(d)).

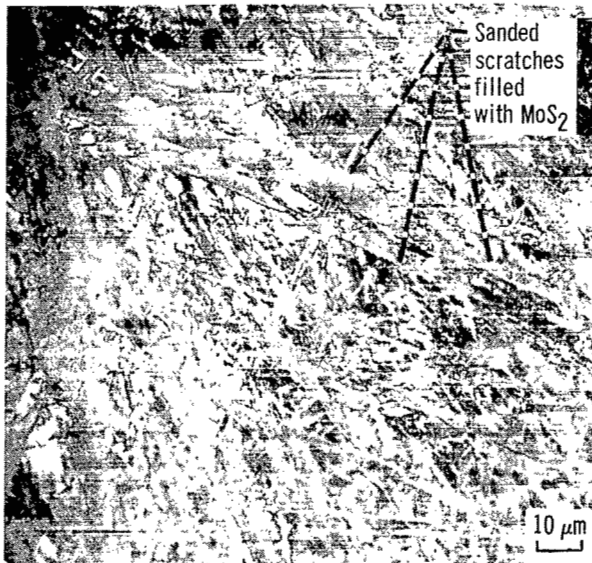
Figure 15. - Higher magnification photomicrographs of MoS<sub>2</sub> film wear tracks shown in figure 14.
