NASA Technical Memorandum 79214

ELASTOHYDRODYNAMIC FILM THICKNESS
MEASUREMENTS OF ARTIFICIALLY
PRODUCED NONSMOOTH SURFACES

Prepared for the
Joint Lubrication Conference
cosponsored by the American Society of Lubrication Engineers
and the American Society of Mechanical Engineers
Dayton, Ohio, October 16-18, 1979

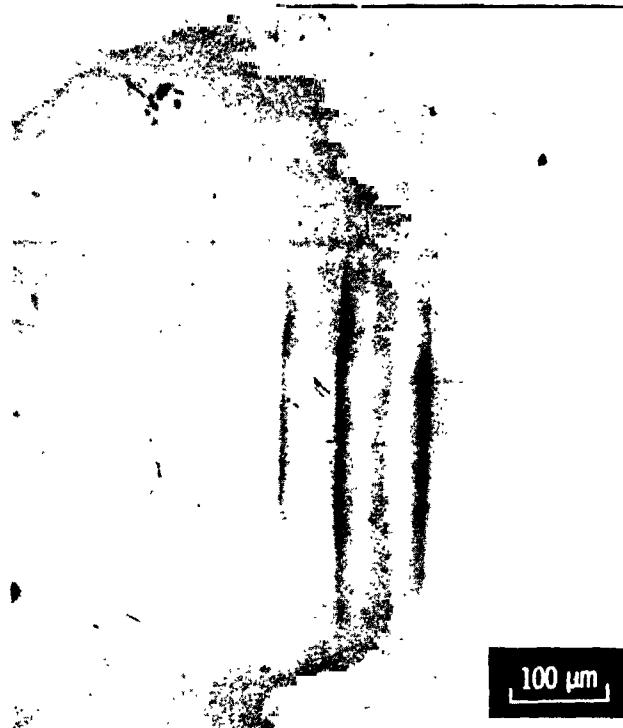
Figure 15. - Grooves made with wedge-shaped tool - perpendicular to direction of flow.

Figure 15 shows three closely-spaced grooves formed on a highly-polished ball with a wedge-shaped tungsten carbide tool. The depressions are deepest at their centers and the depth gradually decreases on both sides of the centers along the length of the depressions. Figure 16 shows the stylus trace through the deepest portion of these grooves. The width of each groove is approximately $40\text{ }\mu\text{m}$ and their peak-to-peak height is approximately $0.65\text{ }\mu\text{m}$. The minimum "asperity" summit is approximately $0.2\text{ }\mu\text{m}$ for the left "asperity" and $0.18\text{ }\mu\text{m}$ for the right "asperity."
