**NASA Contractor Report 159101**

COMPARATIVE EVALUATION OF WOVEN GRAPHITE-EPOXY  
COMPOSITES

GEORGIA INSTITUTE OF TECHNOLOGY  
Atlanta, Georgia 30332

Final Report  
E-16-604

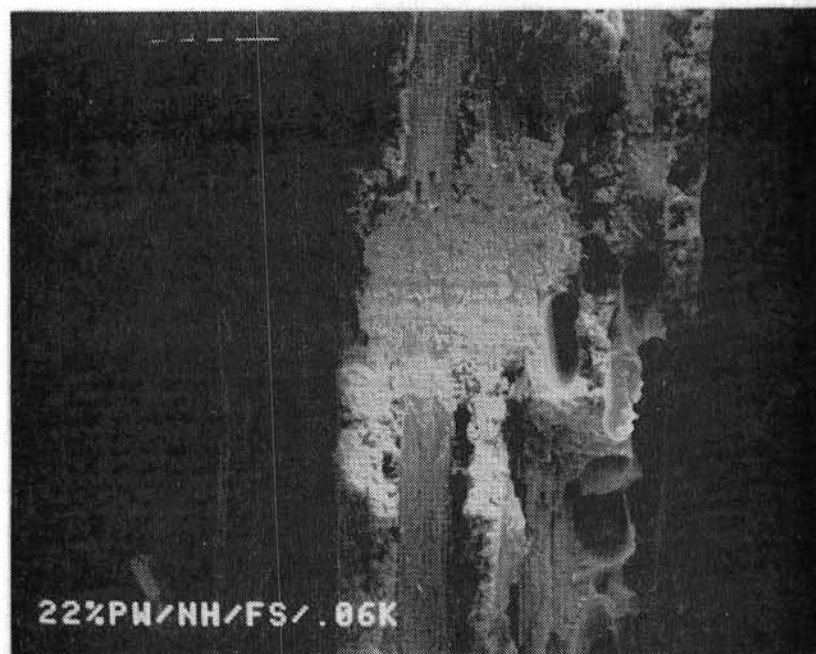
Fig. 15 Fractograph at 60 X

Fig. 16 Fractograph at 60 X

The figures 15 and 16 show the voids. In particular, the figure 16 shows the oval shaped smoothly contoured areas. The figure 15 shows areas where there were pre-existing fiber breaks before the composite

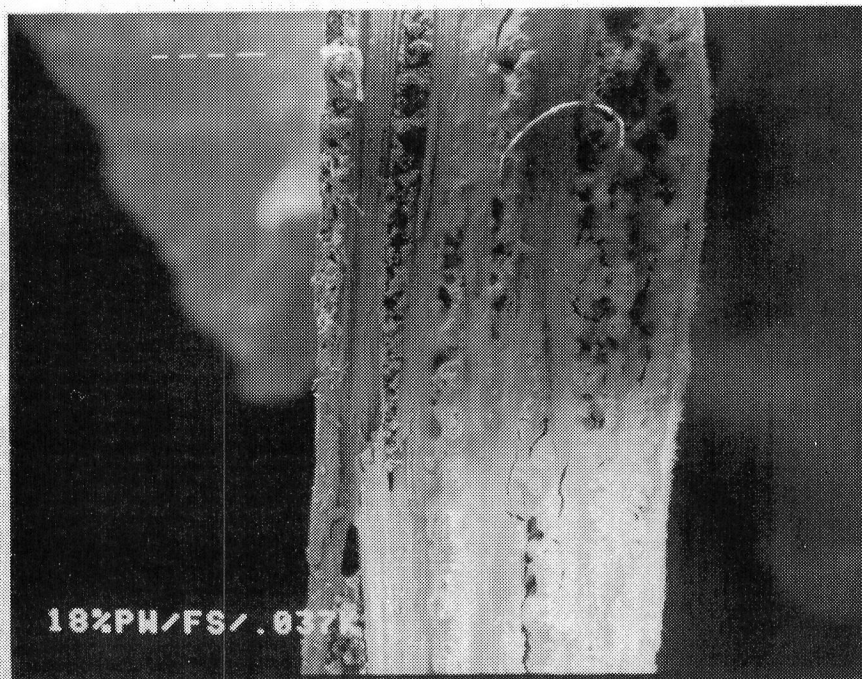
Fig. 22 Fractograph at 37 X

Fig. 23 Fractograph at 37 X

The figures 22 and 23 are from a plain weave specimen which showed very poor failure load. The reason for this can be observed in the pictures. The specimen shows extreme fabrication damage. In figure 22 and 23 well over half of the available  $0^\circ$  bundles were broken and covered with matrix. These are the bumps on the surface. The figure 24 shows how the cross-section should normally look. The figure 24a is for 37%

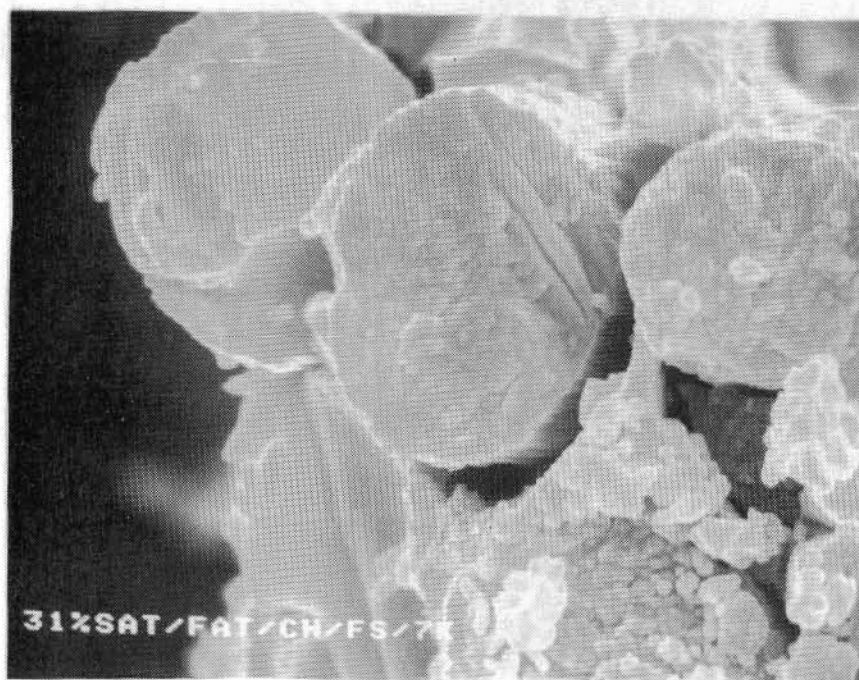
Fig. 37 Fatigue Fractograph at 7000 X

Fig. 38 Fatigue Fractograph at 7000 X

Fig. 39 Fatigue Fractograph at 11000 X

Fig. 40 Fatigue Fractograph at 2400 X

Fig. 41 Fatigue Fractograph at 15000 X

Fig. 42 Fatigue Fractograph at 2500 X

The inspection under S.E.M. is restricted to the area near the fatigue crack origin which was near the hole. The figures 37 to 44 show the fracture pattern of single fibers under magnifications varying from 2.0K to 15K. The fracture patterns of these fibers are very distinct from the fracture patterns of the fiber under static tensile loading as can be seen in figures 18 and 19. The fracture patterns of these fibers are characterized by a smooth area over substantial part of the fiber. Also no stress concentration such as a hole is seen at the crack origin. They appear to be cracks originated by fatigue. However, more tests are needed to confirm the hypothesis. Away from the crack origin standard tensile fracture patterns were observed. The figure 40 shows a number of such unusual fracture patterns. Similar observations on plain weave composites can be seen in figures 41 to 44.
