NASA CR-159669
PWA-5633-11

DEVELOPMENT OF A PLASMA SPRAYED
CERAMIC GAS PATH SEAL FOR
HIGH PRESSURE TURBINE APPLICATIONS

By: L. T. Shiembob and J. F. Hyland

Pratt & Whitney Aircraft Group
Commercial Products Division
United Technologies Corporation

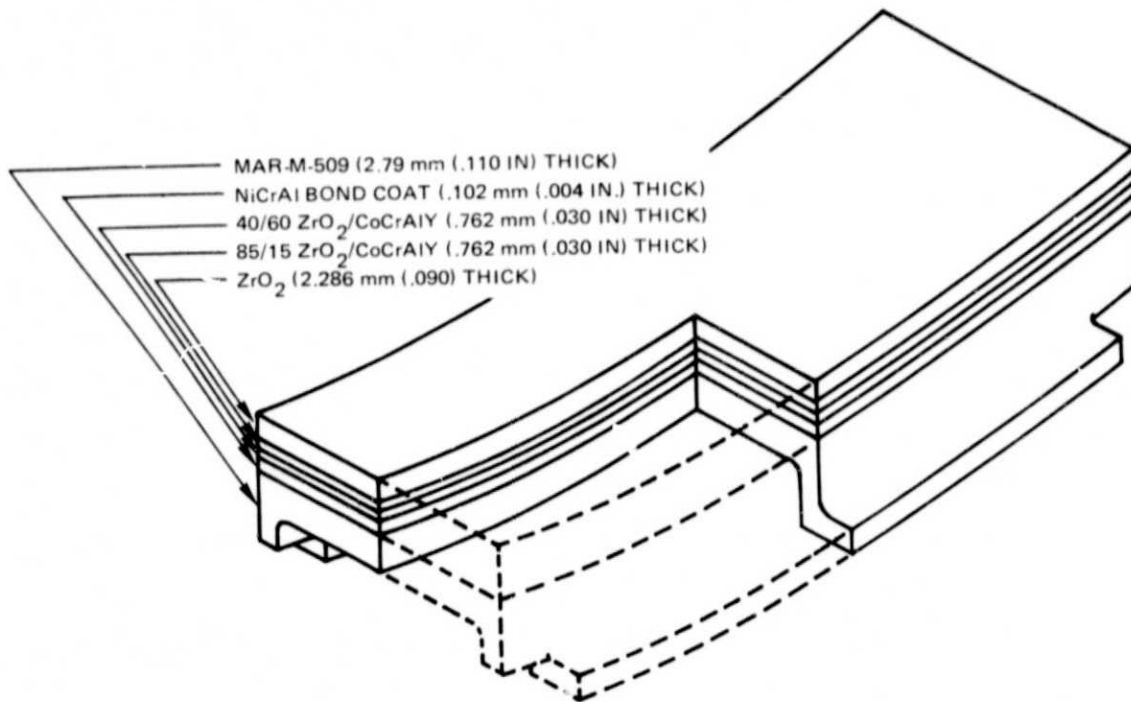
Figure 1 Typical Abradability Specimen

Baseline configuration parts, shown schematically in Figure 1, fabricated without supplemental heating of substrate and with substrates at 922°K (1200°F) during spray deposition were exposed to a typical engine thermal cycle in the cyclic thermal shock rig, Figure 2, and the results reported in NASA CR-135387. An analysis was conducted on both parts to estimate the thermal stresses generated during the rig test. This analysis utilized latest available physical properties and residual stress data to investigate the correlation between both stress-to-strength ratio and strain to strain to failure ratio and crack initiation during rig test. The analyses focused on the circumferential configuration which historically has been limiting with respect to thermal stresses. Acceleration, sea level take off (SLTO) and deceleration operating cycles were investigated. The results of this evaluation are presented in Figures 3 through 6.

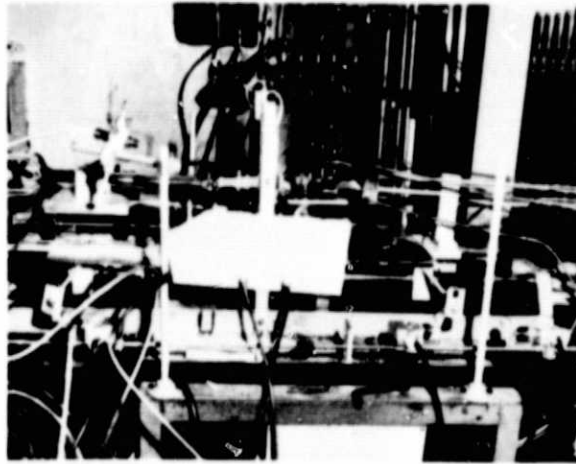
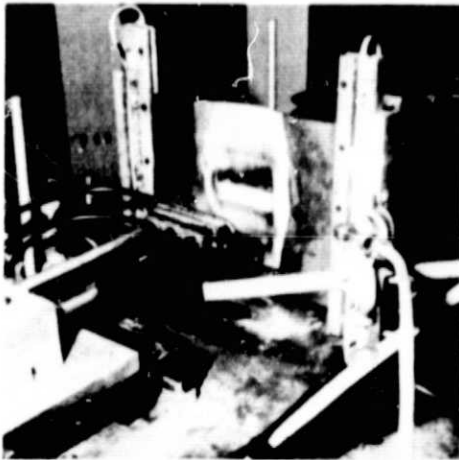
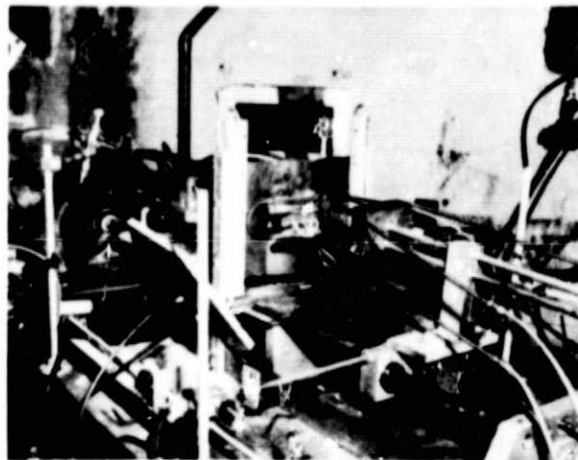
Figure 2 Cyclic Thermal Shock Test Rig

The specimen was mounted in the cyclic thermal shock test rig, shown in Figure 2, by a fire brick holding fixture held by a water cooled copper fixture. A combination of oxygen-propane torches and cooling air jets was used to achieve the desired thermal cycles on the ZrO₂ and metal substrate surfaces. The torches were mechanically moved toward or away from the specimen at controlled rates to provide the required thermal cycle. Fixed cooling air jets were turned on or off or the flow was changed at predetermined intervals to meet the cycle requirements. The ZrO₂ and metal substrate surface temperatures were monitored continuously with an optical pyrometer and thermocouples, respectively, and recorded on a strip chart.

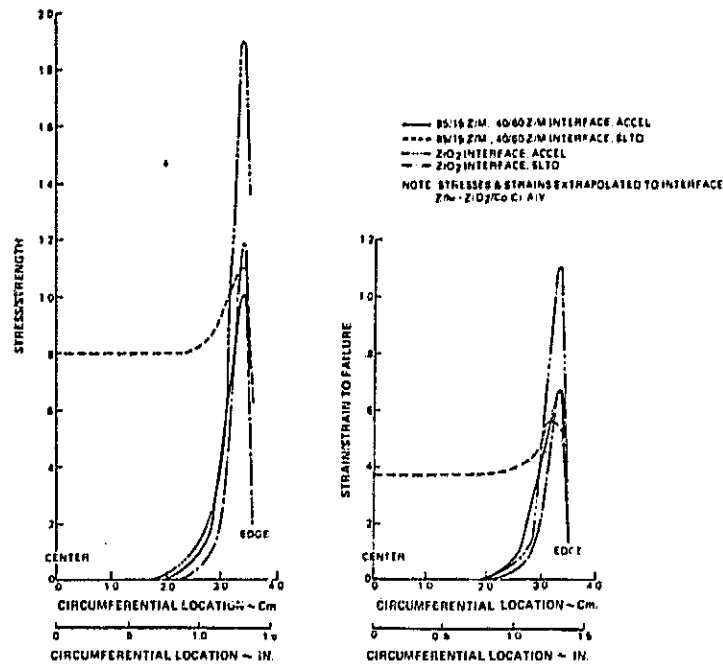
Figure 3 Stress/Strength and Strain/Strain to Failure Ratios for the 922°K (1200°F) System Predicts Failure at the ZrO₂ Interface, near the Edge during Acceleration

The results of the analysis of the parts employing the 922^oK (1200^oF) preheated substrate during spray deposition correlated favorably with the actual test results. Stress-to-strength and strain to strain to failure ratios shown in Figure 3 are maximum and of sufficient magnitude, greater than 1.0, to indicate crack initiation at the edge of the part at the ZrO₂-85/15 ZrO₂/CoCrAlY interface during the acceleration portion of cycle. Crack initiation actually occurred during test at this location during the acceleration transient. The crack location is shown as well as the location of maximum stress-to-strength and strain-to-failure ratios in Figure 4.

The thermal stresses during deceleration and the 40/60 ZrO₂/CoCrAlY layer acceleration and SLTO stresses were not shown in Figures 3 and 4 because they were insignificant in magnitude.

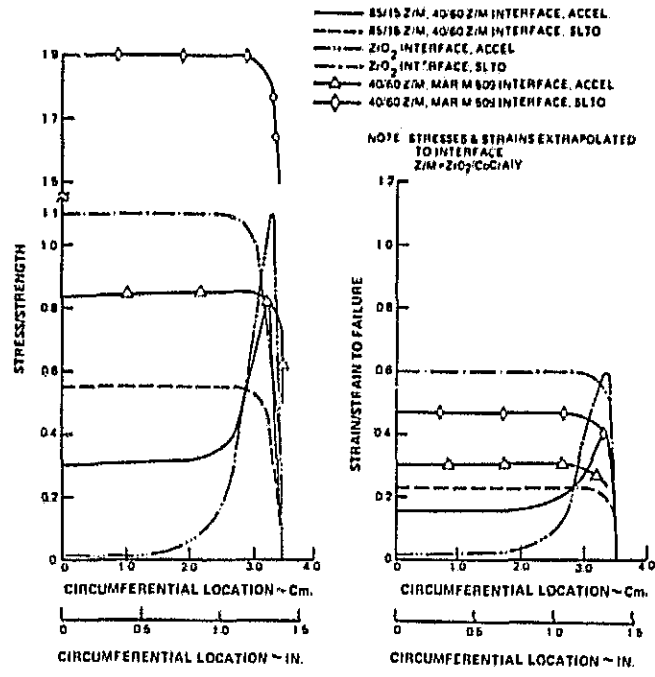
Figure 5 Stress/Strength Ratios for the Baseline System Predict Failure at the ZrO₂ Interface Near the Edge During Acceleration

The results of the baseline system analyses did not produce the same correlation with the actual test results. The maximum estimated stress-to-strength ratio (1.9) shown in Figure 5 was calculated to occur during deceleration at the 40/60 ZrO₂/CoCrAlY substrate interface and the maximum strain to strain-to-failure ratio (.6) was not sufficient to indicate crack initiation. The result of the thermal shock test of the baseline system is shown in Figure 6 with the more important analytically predicted stress-to-strength and strain to strain to failure values. Crack initiation occurred at the ZrO₂ - 85/15 ZrO₂/CoCrAlY interface after 100 cycles.

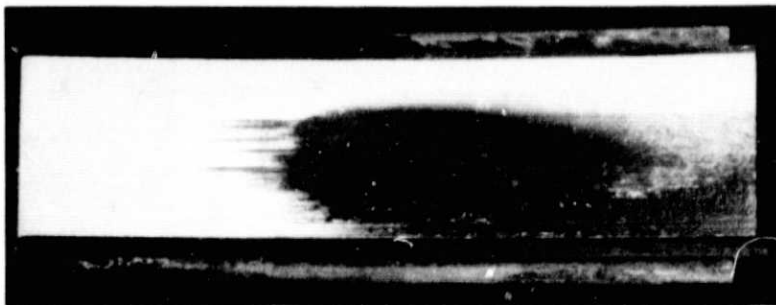
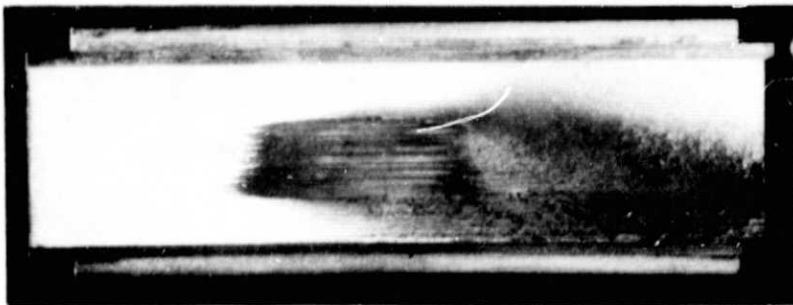
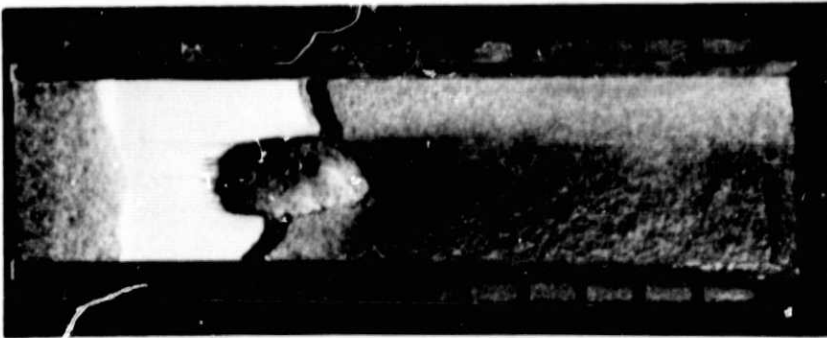
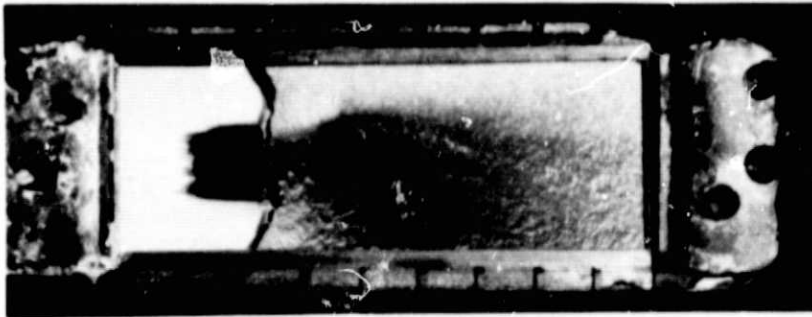
Four abrasability tests were conducted and results are summarized in Table 3 with results of similar testing under previous contracts. The post test conditions of the four parts is shown in Figure 8.

The first test was of a baseline specimen, rubbed at 1589°K (2400°F) surface temperature and 304.8 m/sec (1000 ft/sec) with twelve PWA 1455 blades at an incursion rate of 0.0254 mm/sec (0.001 in/sec). The blades did not groove the seal and the average blade tip wear was 0.909 mm (0.0358 in). Thus a volume wear ratio could not be calculated. A thin layer of blade tip material transfer was evident at the blade contact area.

The second specimen (baseline) was rubbed at the same test conditions except that the incursion rate was 0.254 mm/sec (0.01 in/sec). The blades wore a groove 0.0508 mm (0.002 in) deep in the seal with an average blade tip wear of .5004 mm (0.0197 in), yielding a volume wear ratio of 64.69. This result is consistent with earlier testing. The third and fourth tests were conducted on specimens of the improved geometry. The rig parts developed laminar cracks and spalled severely after approximately 60 percent of the rub interaction.

Spalling that resulted during testing of these specimens is attributed to laminar cracks located at the ends of the part that developed during machining.

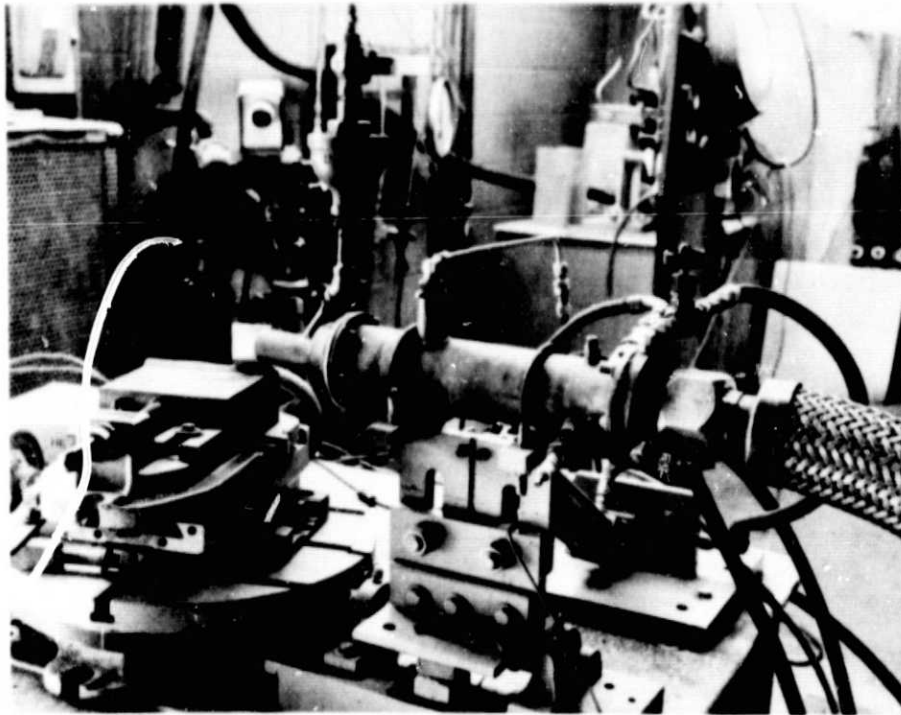
Figure 9 Hot Particulate Erosion Rig

Erosion tests were performed in the hot particulate erosion rig shown in Figure 9. The specimens were positioned at a distance of 3.81 cm (1.5 in) and 0.262 rad (15°) relative to the end of the combustor exit nozzle by a compound vise. The specimen was heated by impinging JP-5 fuel and air combustion products on the ZrO_2 surface of the specimen through a 1.905 cm (0.75 in) diameter exit nozzle. Specimen temperature and exit gas velocity were controlled by varying fuel and air flows.

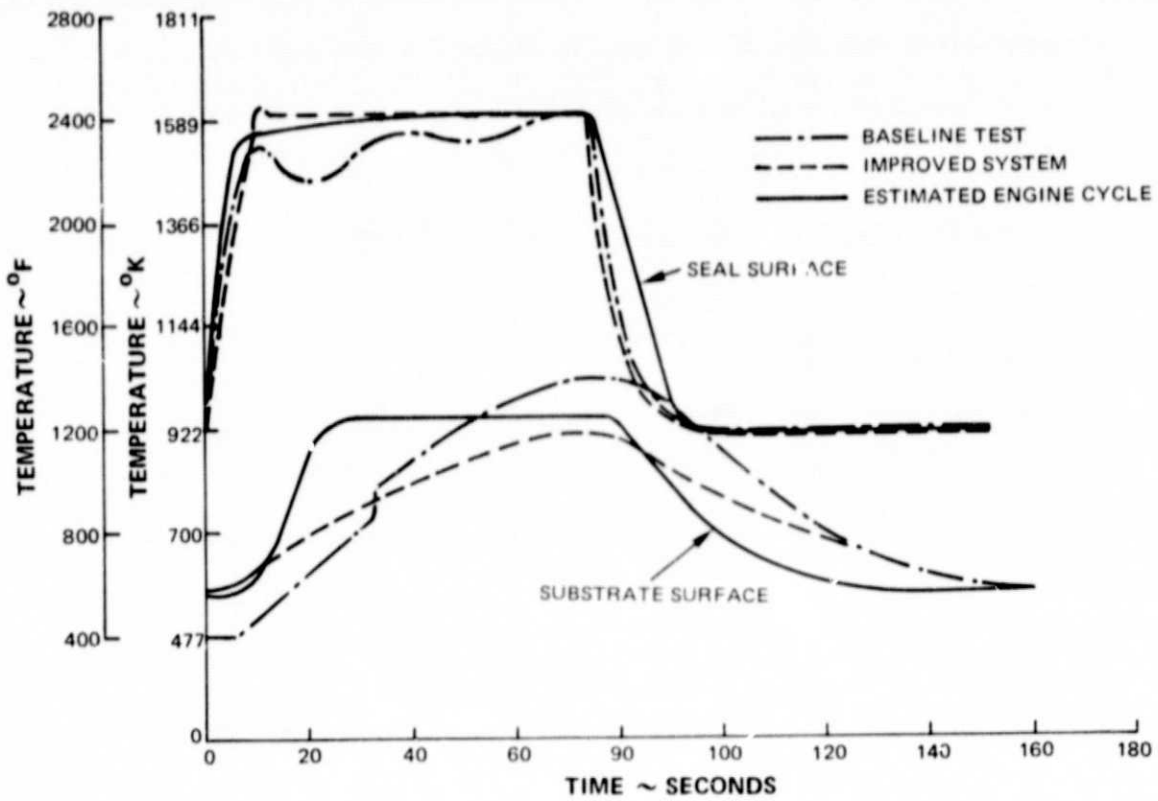
Figure 11 Thermal Test Cycle

Cyclic thermal shock characteristics were evaluated by rig tests which subjected the seal specimens to a thermal cycle simulating the gas turbine engine cycle from idle to SLTO and back to idle, shown in Figure 11. A typical rig test cycle is also shown in Figure 11 and illustrates the close simulation produced by this rig.

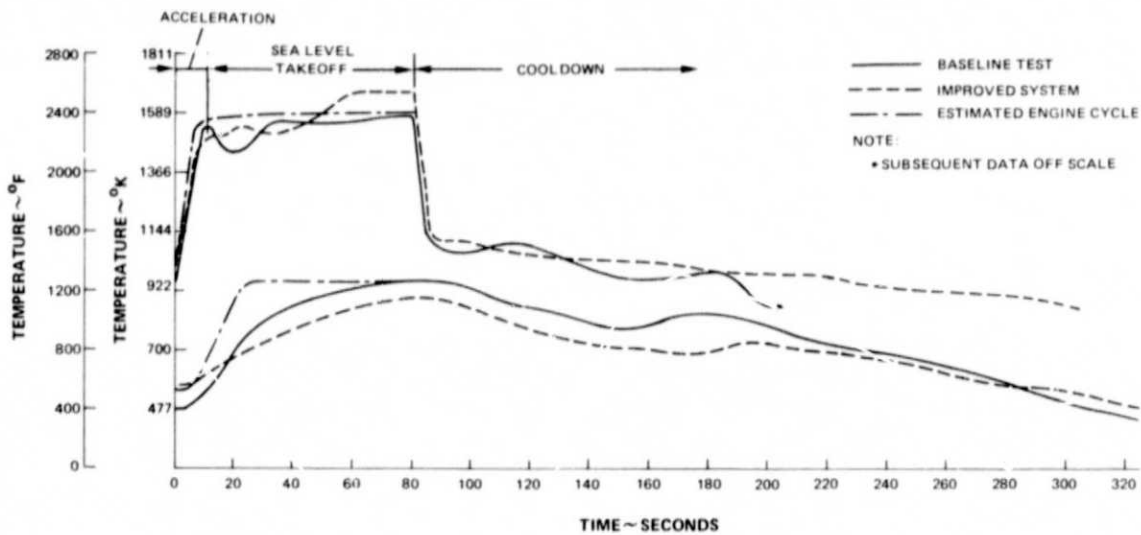
Figure 12 Initial Acceleration Transient

Earlier thermal shock test results reported in NASA CR-135183 indicated thermal stress cracking initiated very early during the test. Analysis indicated cracking could occur in the first thermal cycle during acceleration to SLTO. Therefore, an attempt was made to better define when and where cracking was initiating by subjecting the seal specimens to an initial acceleration heatup cycle shown in Figure 12.

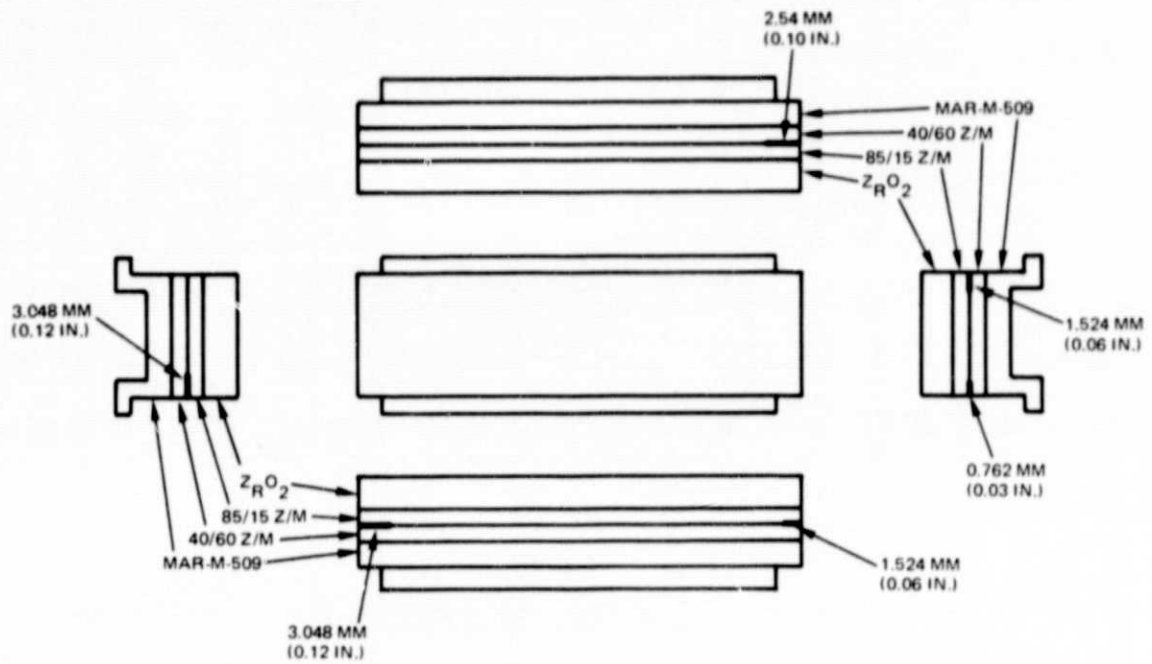
Figure 13 Baseline Specimen Initial Acceleration Transient Crack Map

The baseline specimen exhibited tight laminar cracks at the 85/15 ZrO₂/CoCrAlY - 40/60 ZrO₂/CoCrAlY interface at three of the four corners (see Figure 13) as a result of exposure to the initial acceleration transient. No radial cracks were detected during this inspection. The first full simulated engine cycle resulted in additional laminar cracks at the ZrO₂ - 85/15 ZrO₂/CoCrAlY interface as well as radial cracks and the spalling of approximately a 1.27 cm (.5 in) long piece of ZrO₂ (see Figure 14).

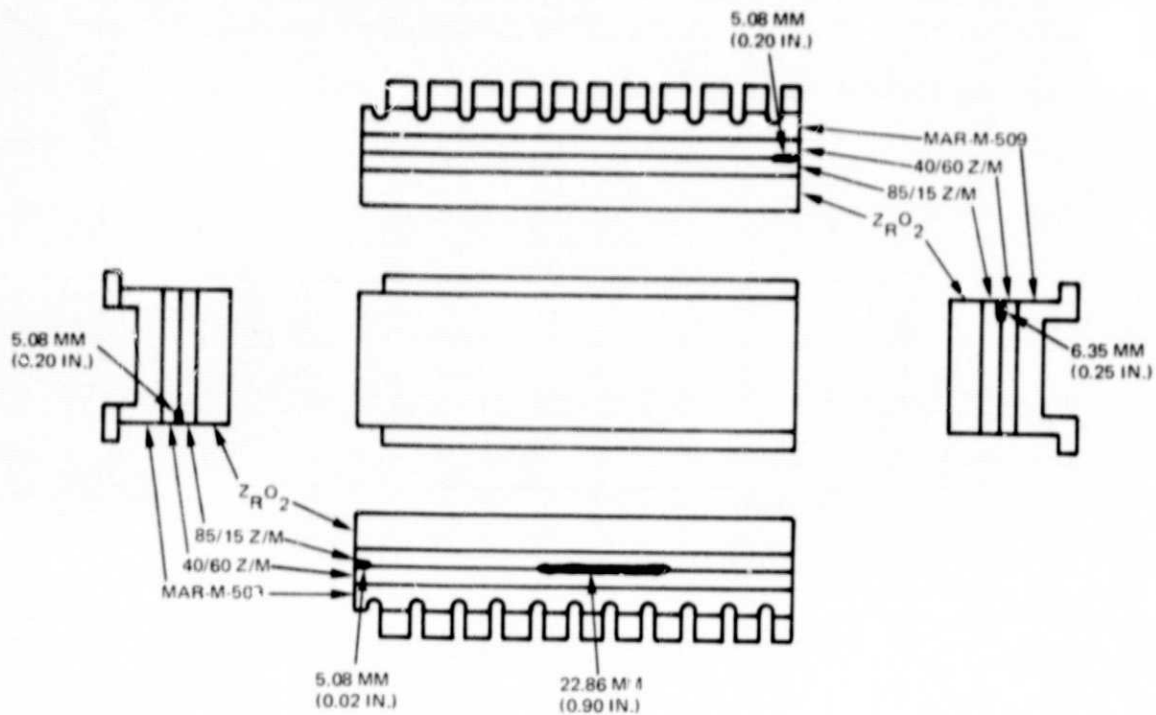
Figure 15 Improved Geometry System Specimen Initial Acceleration Transient Crack Map

The improved geometry specimen exhibited tight laminar cracks at the 85/15 ZrO₂/CoCrAlY - 40/60 ZrO₂/CoCrAlY interface at several locations (see Figure 15) as a result of exposure to the initial acceleration transient. No radial cracks were detected during this inspection. After the first full simulated engine cycle the laminar cracking propagated slightly and radial cracks were observed (see Figure 16). Inspection after twenty-five cycles revealed extensive laminar cracking at the 85/15 ZrO₂/CoCrAlY - 40/60 ZrO₂/CoCrAlY interface (see Figure 17). As a result of the 59th cycle approximately a 1.27 cm (.5 in) long section of ZrO₂ - 85/15 ZrO₂/CoCrAlY material spalled off causing the test to be terminated (see Figure 18).

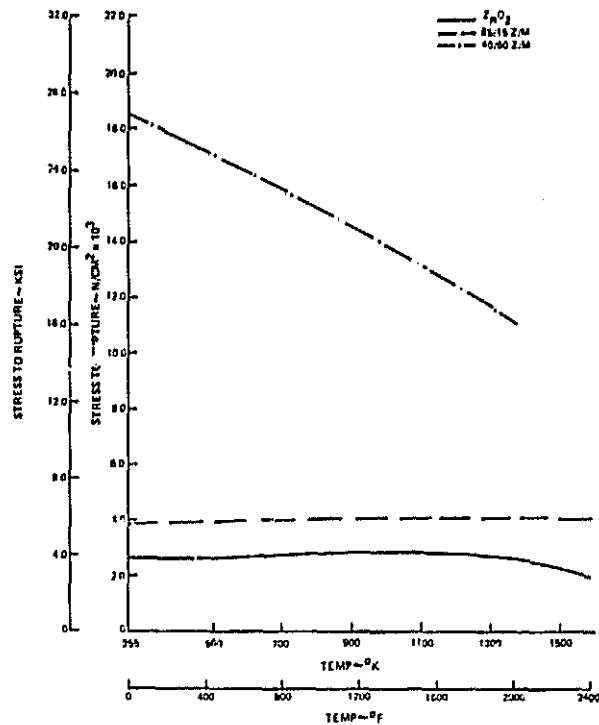
Figure 19 Average Modulus of Rupture

1. The modulus of rupture of the ZrO_2 is essentially constant at 2.7×10^3 N/cm² (4.0 ksi) to $1400^{\circ}K$ and decreases thereafter.
2. The rupture modulus for the 85/15 $ZrO_2/CoCrAlY$ material is essentially constant at 4×10^3 N/cm² (5.8 ksi).

3. The rupture modulus for the 40/60 ZrO₂/CoCrAlY material decreases with increasing temperature.
4. The modulus of elasticity of the ZrO₂ material decreases with increasing temperature.
5. The modulus of elasticity of the 85/15 ZrO₂/CoCrAlY and 40/60 ZrO₂/CoCrAlY materials decreases with increasing temperature until approximately 700°K after which the modulus increases.

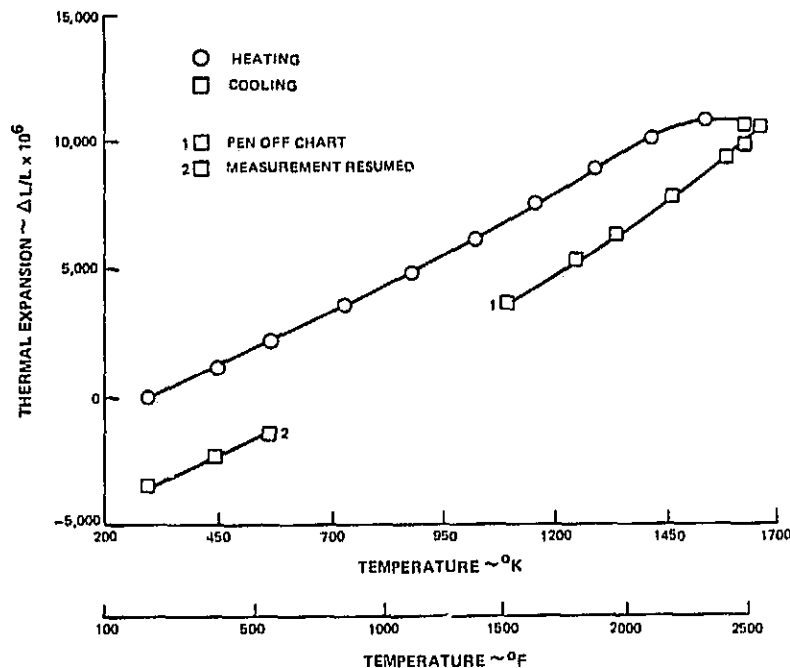
Figure 21 Thermal Expansion Plasma Sprayed ZrO_2 First Cycle

The ZrO_2 material demonstrated a very definite shrinkage above 1473^oK (2192^oF) during the first thermal cycle, as shown in Figure 21. Total shrinkage of 0.36 percent was measured. Subsequent cycles did not exhibit this shrinkage and were very repeatable. Figure 22 shows data typical of these subsequent cycles.

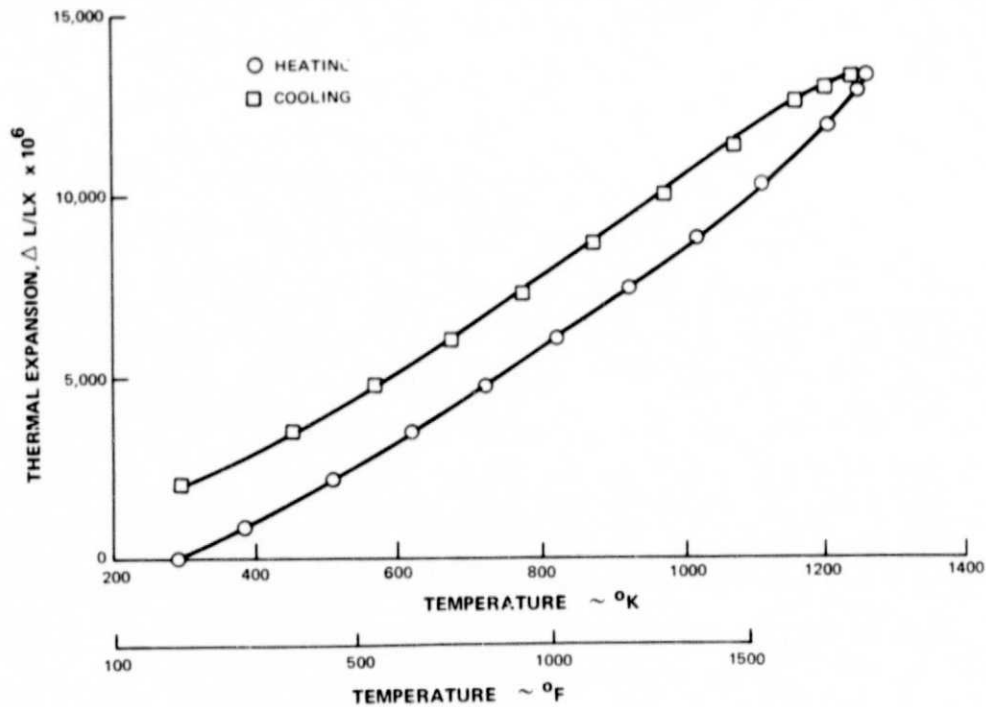
Figure 23 Thermal Expansion of Plasma Sprayed 85/15 ZrO₂/CoCrAlY

The 40/60 and 85/15 $ZrO_2/CoCrAlY$ materials demonstrated fairly repeatable thermal growths both during heating and cooling and from cycle to cycle although some tendency to grow was seen. Data for these layers is shown in Figures 23 and 24, respectively.

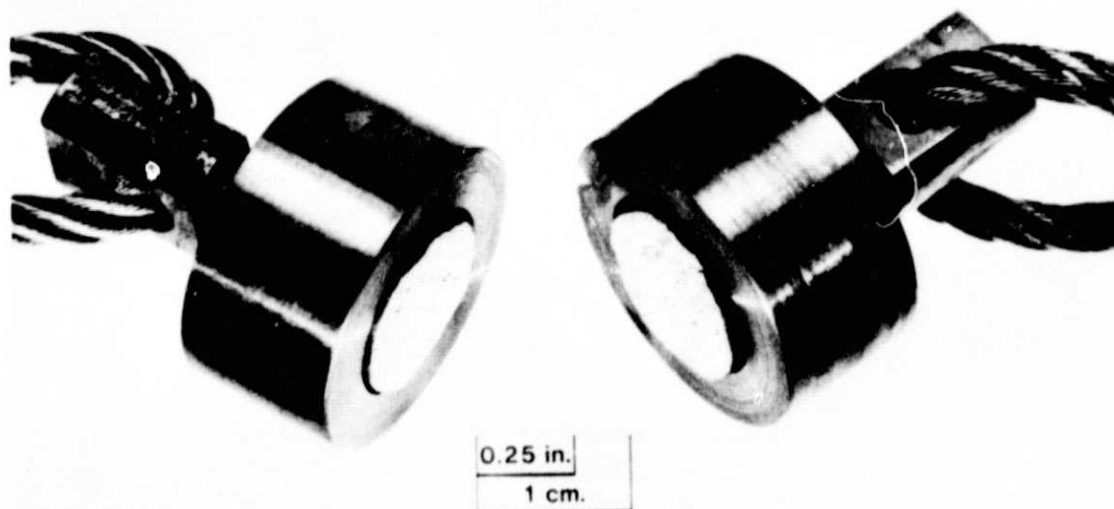
Figure 25 Results of Radial Strength Measurement of ZrO₂
Illustrating Typical Fracture

Figure 25 illustrates the separation in approximately the middle of the specimen which was typical of the results of measurements of each the ZrO₂ and 85/15 ZrO₂/CoCrAlY materials.

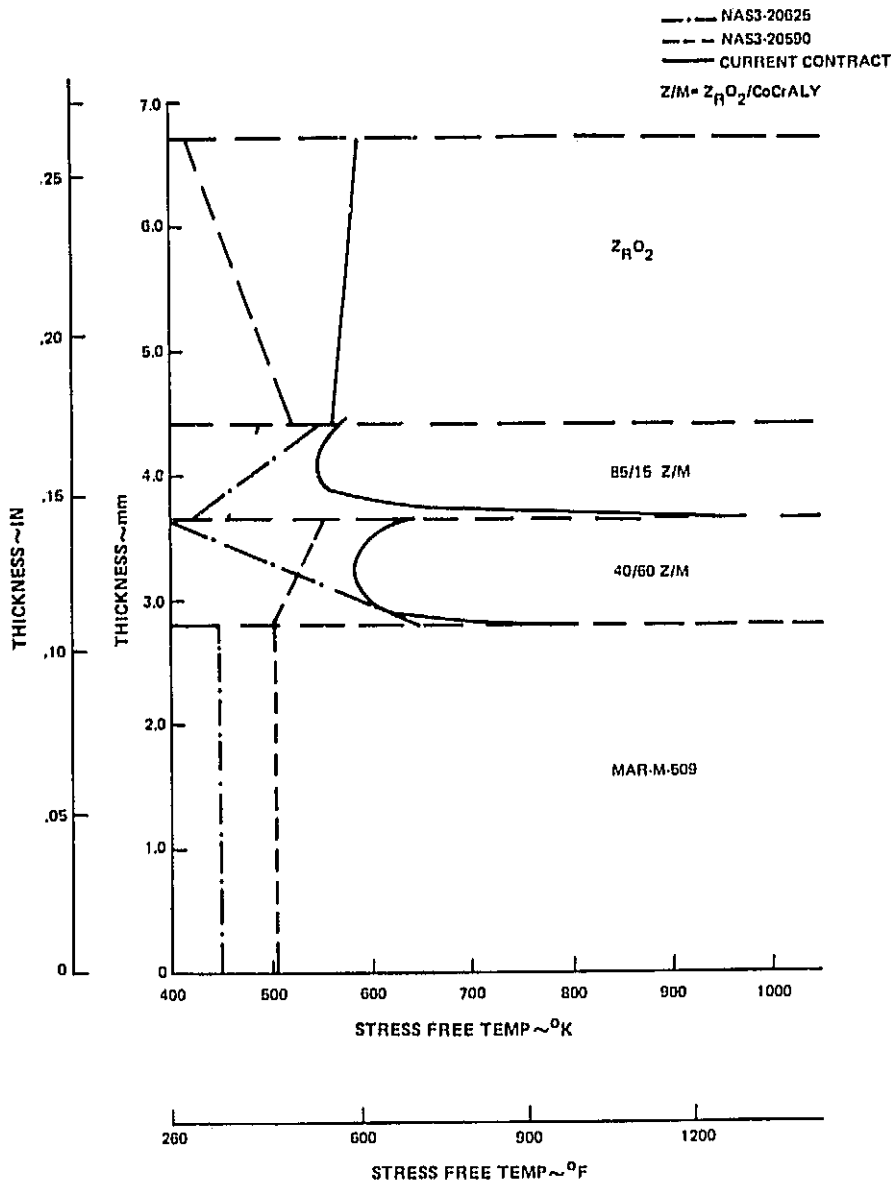
Figure 26 Stress Free Temperature Comparison Curve

A comparison of these results to those previously determined (NAS3-19759 and NAS3-20623) is provided in Figure 26. Larger discontinuities in the SFT at the 85/15 ZrO₂/CoCrAlY - 40/60 ZrO₂/CoCrAlY and the 40/60 ZrO₂/CoCrAlY - substrate interfaces were identified. This increase in SFT discontinuity causes an increase in resultant operating stresses. Crack initiation during thermal shock testing occurred at the 85/15 ZrO₂/CoCrAlY - 40/60 ZrO₂/CoCrAlY interface, the location of the larger discontinuity in the SFT.

The stress free temperature distribution calculated for the two systems were virtually identical verifying the previous assumption that substrate configuration for residual stress determination does not significantly affect the stress free temperature distribution.

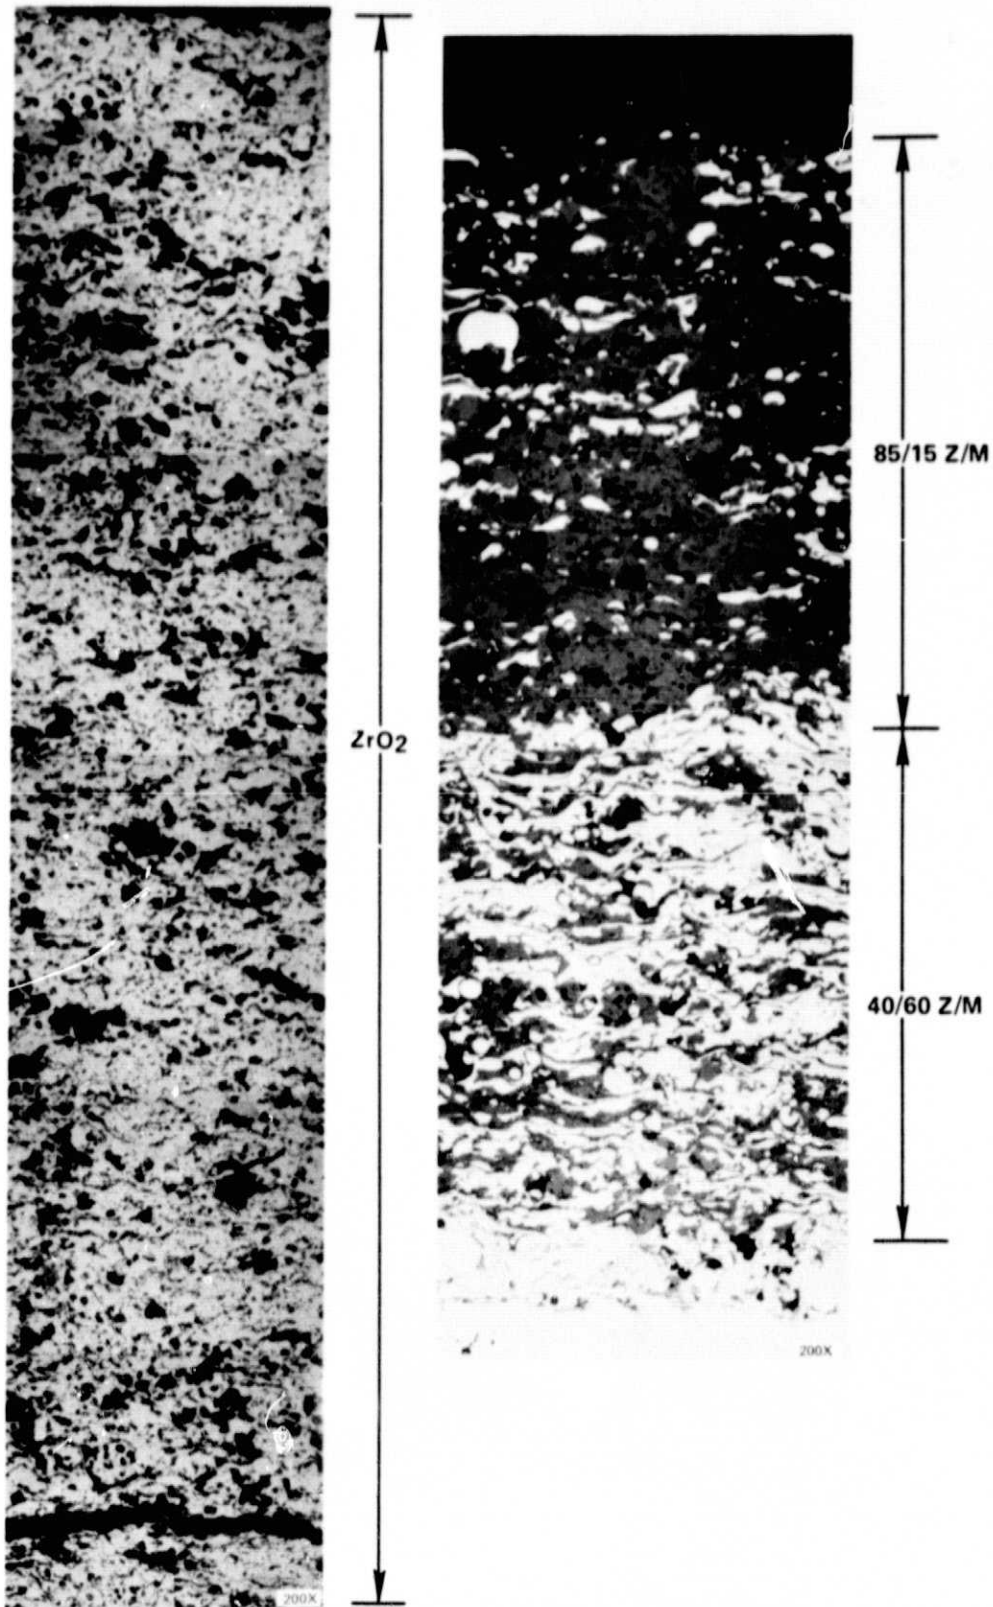
Both of the cyclic thermal shock specimens were microsectioned after testing to identify any structural changes due to thermal exposure and to indicate location of cracks. Typical microsections of the baseline and improved geometry specimens are shown in Figures 27 and 28 respectively.

A comparison of Figures 27 and 28 indicates the similarity of the structures and is an indication of the repeatability of the spray fabrication procedure.

Microstructure of Baseline System

The crack location shown for the baseline system in Figure 27 is directly at the ZrO_2 - 85/15 $ZrO_2/CoCrAlY$ interface and extends along the entire axial and a majority of the circumferential plane. This crack occurred during the SLTO condition. Not shown in the metallography is another crack at the 85/15 $ZrO_2/CoCrAlY$ - 40/60 $ZrO_2/CoCrAlY$ interface. This crack occurred during acceleration and extended approximately .254 cm (.1 in) both axially and circumferential at three of the four corners. The two cracks were joined by radial crack after the first full simulated engine cycle.
