# NASA Technical Memorandum 58222

## Preliminary Results of Penetrator Field Test Program—Tonopah, Nevada, April 16-28, 1979

Maxwell B. Blanchard, Uel Clanton, Mischelle Dalbey, Victor Rhoder, and James P. Murphy

October 1979

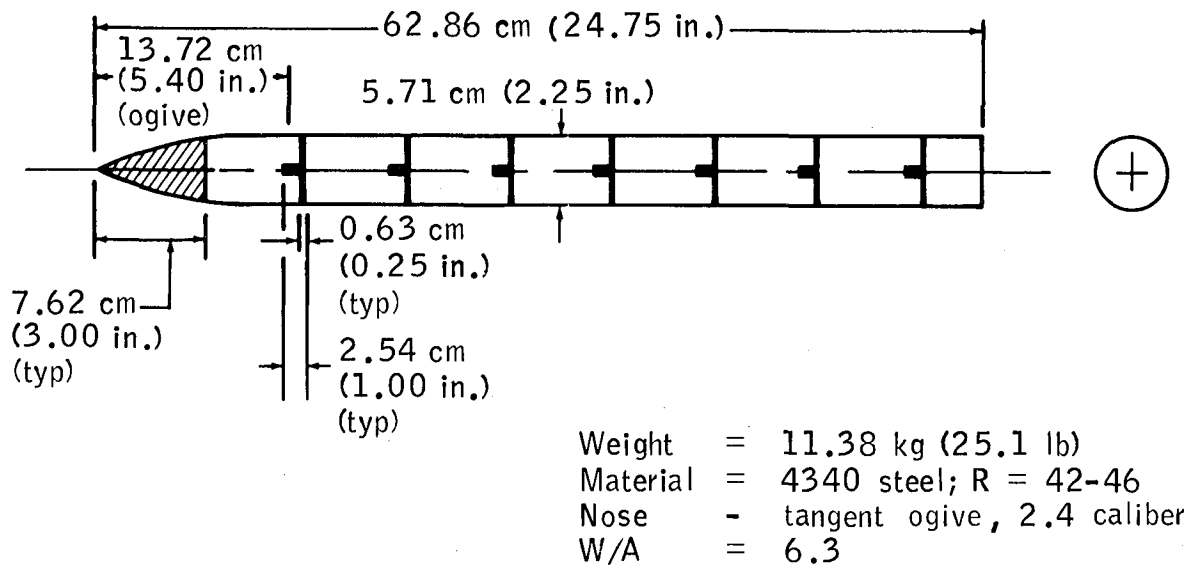
Figure 1.- Mars penetrator (0.63 scale) configuration fired in tests at Tonopah, Nevada, in April 1979.

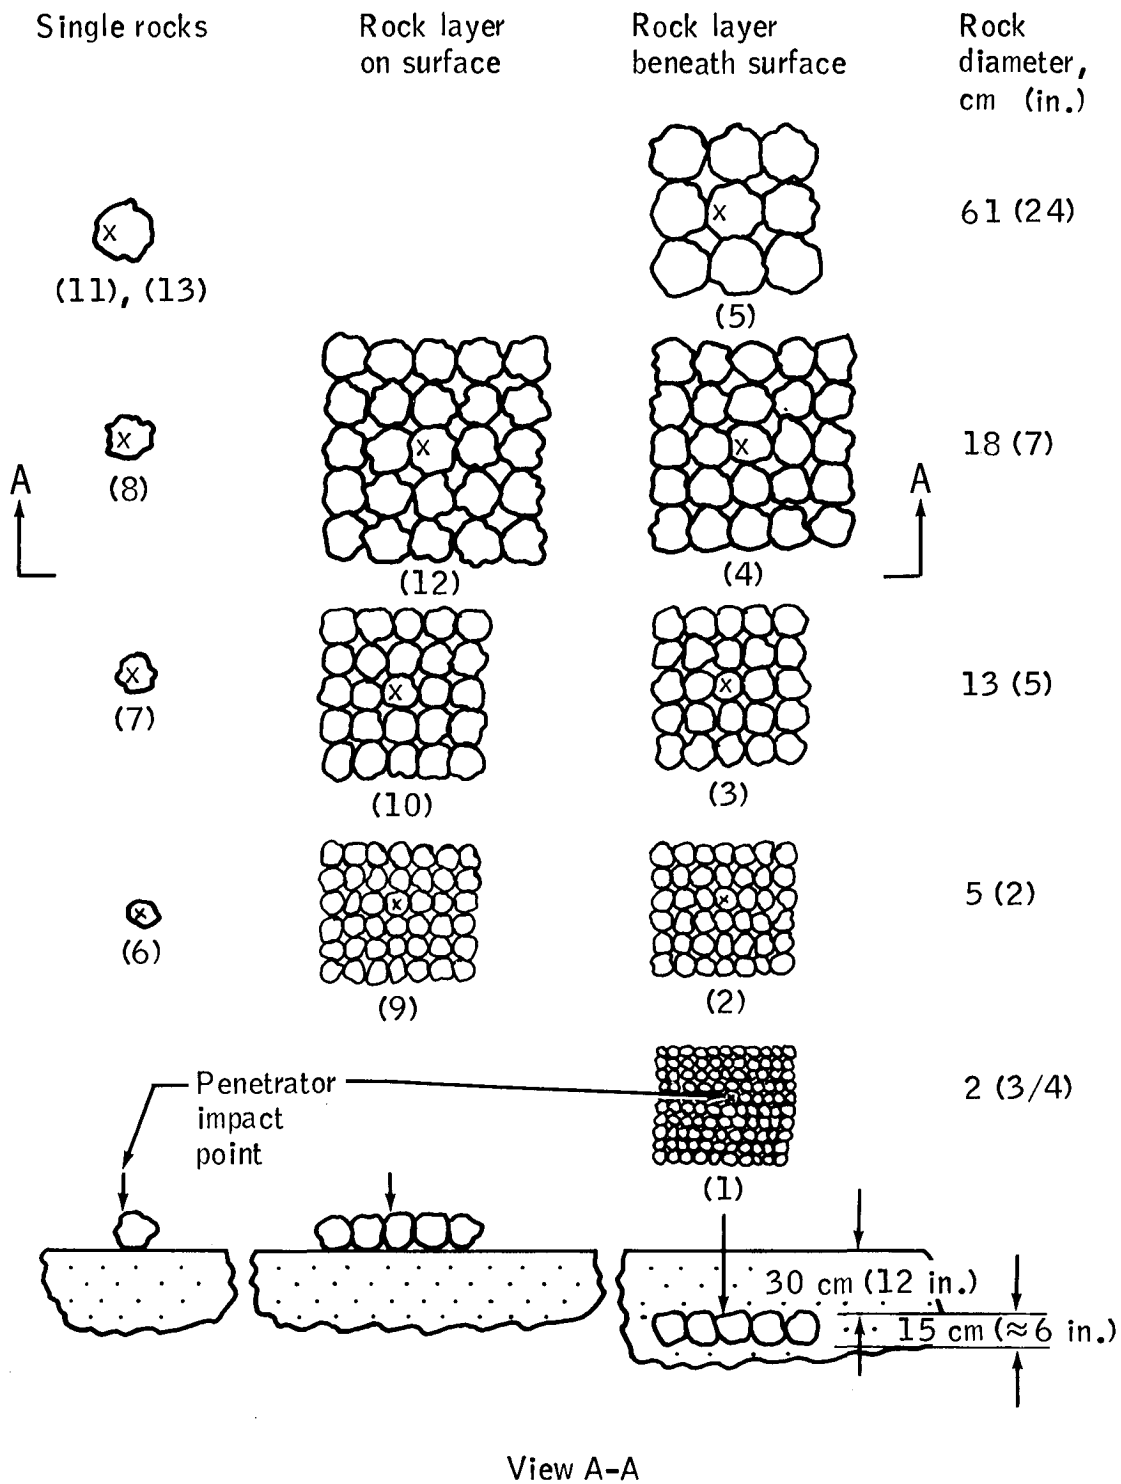
Figure 2.- Layout of test site. The penetrator impact points are located at one-half the radius of the rock. Test numbers are shown beneath each target arrangement.

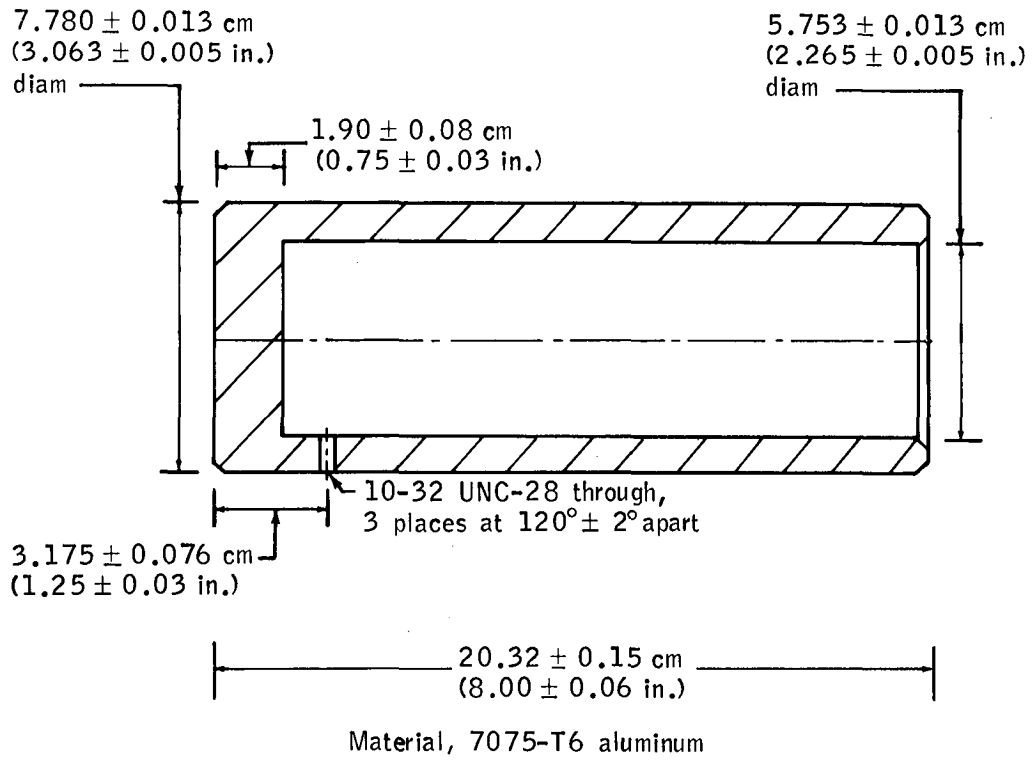
Figure 3.- Sabot used to adapt penetrator to 7.6-centimeter (3 inch) air gun.

inside diameter (7.818 centimeters (3.078 inches)) of this air gun was too large for the 0.63-scale penetrator (5.71 centimeters (2.25 inches) diameter), an aluminum sabot was used to guide the projectile down the gun barrel (fig. 3). The aft end of the penetrator was mounted in the sabot and held with three setscrews. The sabot and the penetrator were mounted in the breech (fig. 4), where another setscrew was used to hold the sabot-penetrator assembly and prevent it from falling out when the gun was erected to the vertical position. However, on one test, the penetrator fell as the gun was erected and broke the target rock. The target was rebuilt using another rock before firing the shot (test 4). Although the sabot was stripped from the penetrator by a wood block, on six tests, the sabot went through the block and impacted the ground about 150 milliseconds after the penetrator disappeared from the field of view.

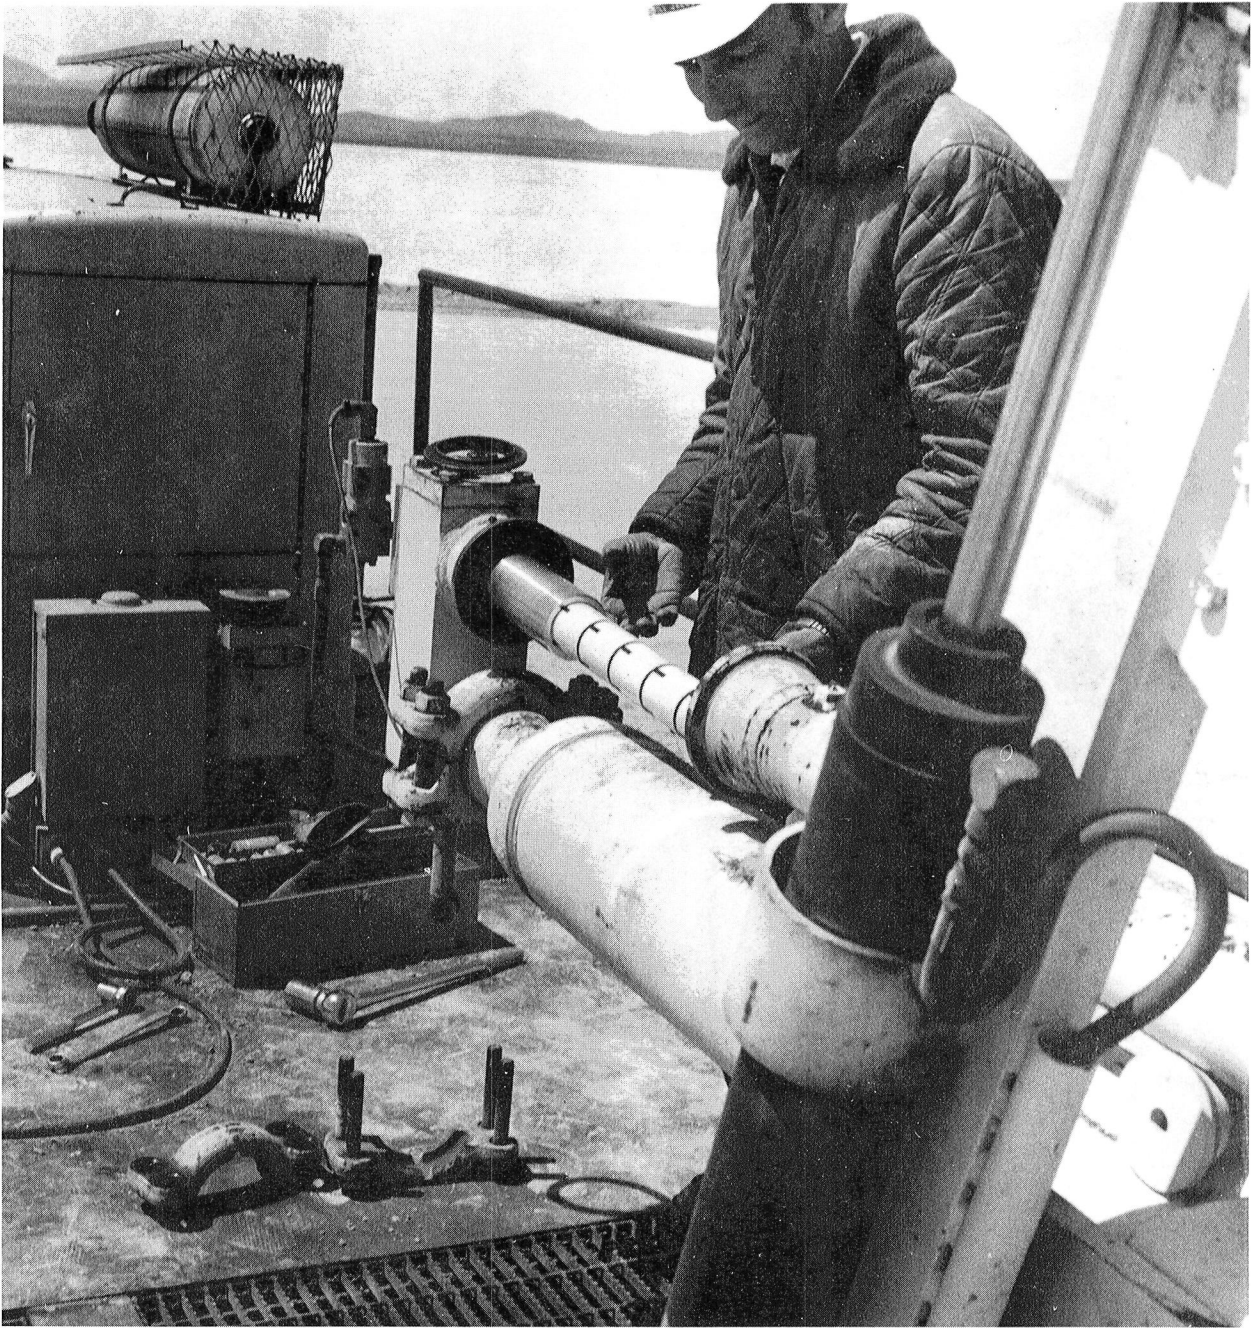
Figure 4.- Penetrator and sabot assembled and mounted in breech of air gun.

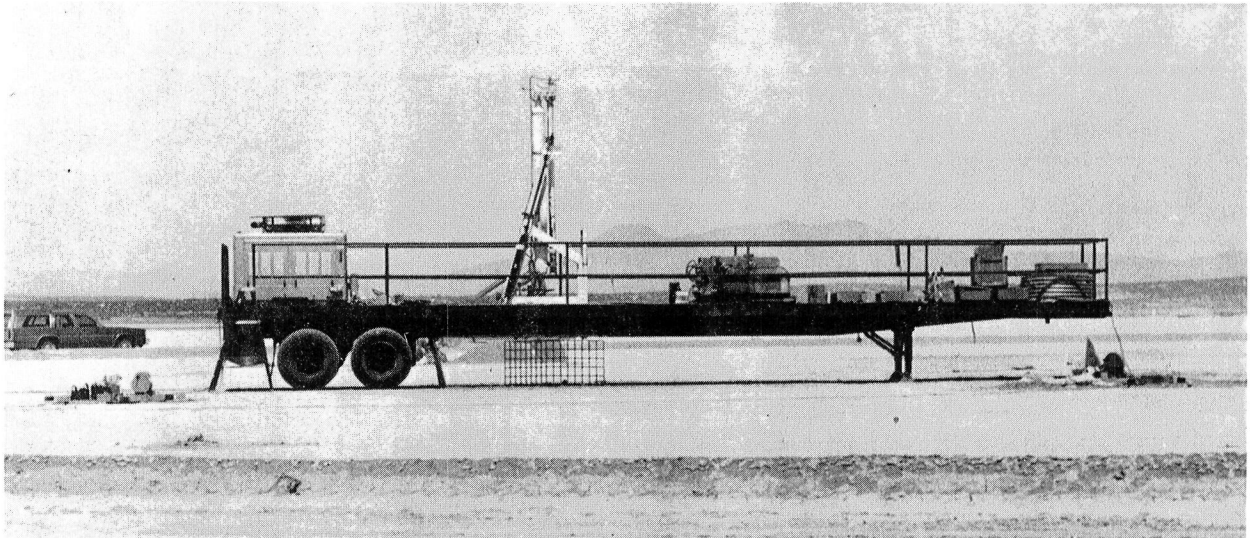
Figure 5.- Air gun shown in vertical position (orientation from which measurements were made) and grid frame located beneath trailer before test 6. Camera pallets are located on the ground near the front and rear of the trailer.

The orientation of the air-gun barrel after being erected (fig. 5) was measured in two directions along the same axis as the grid frame staked to the ground as a basis of reference for photography. The orientation of the air gun was within  $\pm 0^{\circ}40'$  of vertical for all tests (table I). The air-gun tank pressure at firing was  $10\,997\text{ kN/m}^2$  ( $1595\text{ lb/in}^2$ ), which produced an impact velocity of  $150\text{ m/sec}$  ( $492\text{ ft/sec}$ ) for the penetrator (fig. 6).

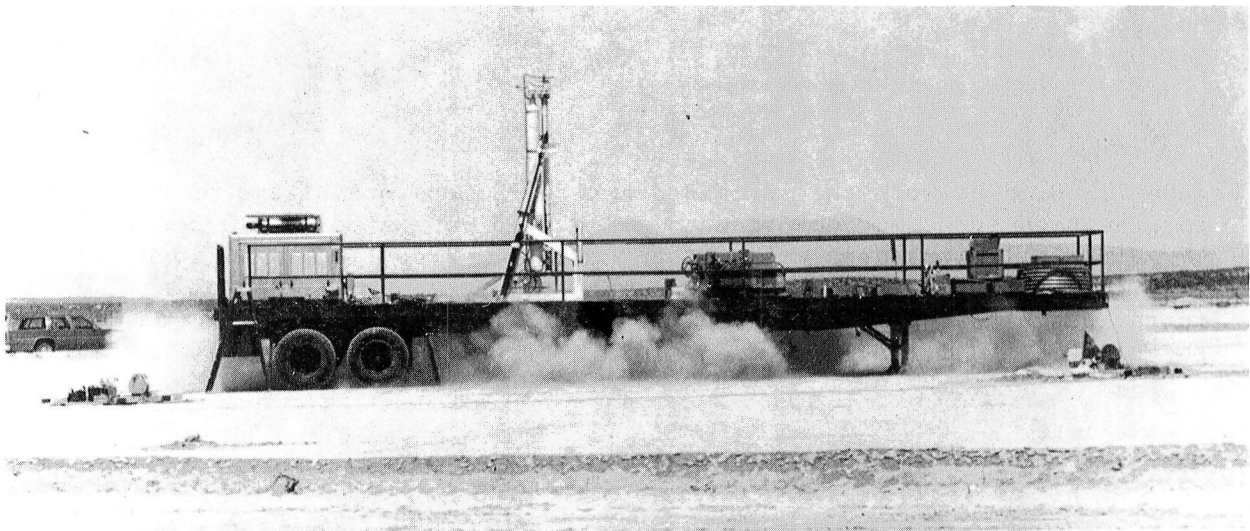
Figure 6.- Penetrator being fired by air gun (test 6). The blast of air which replaces the penetrator produces the cloud of dust obscuring the grid and the target.

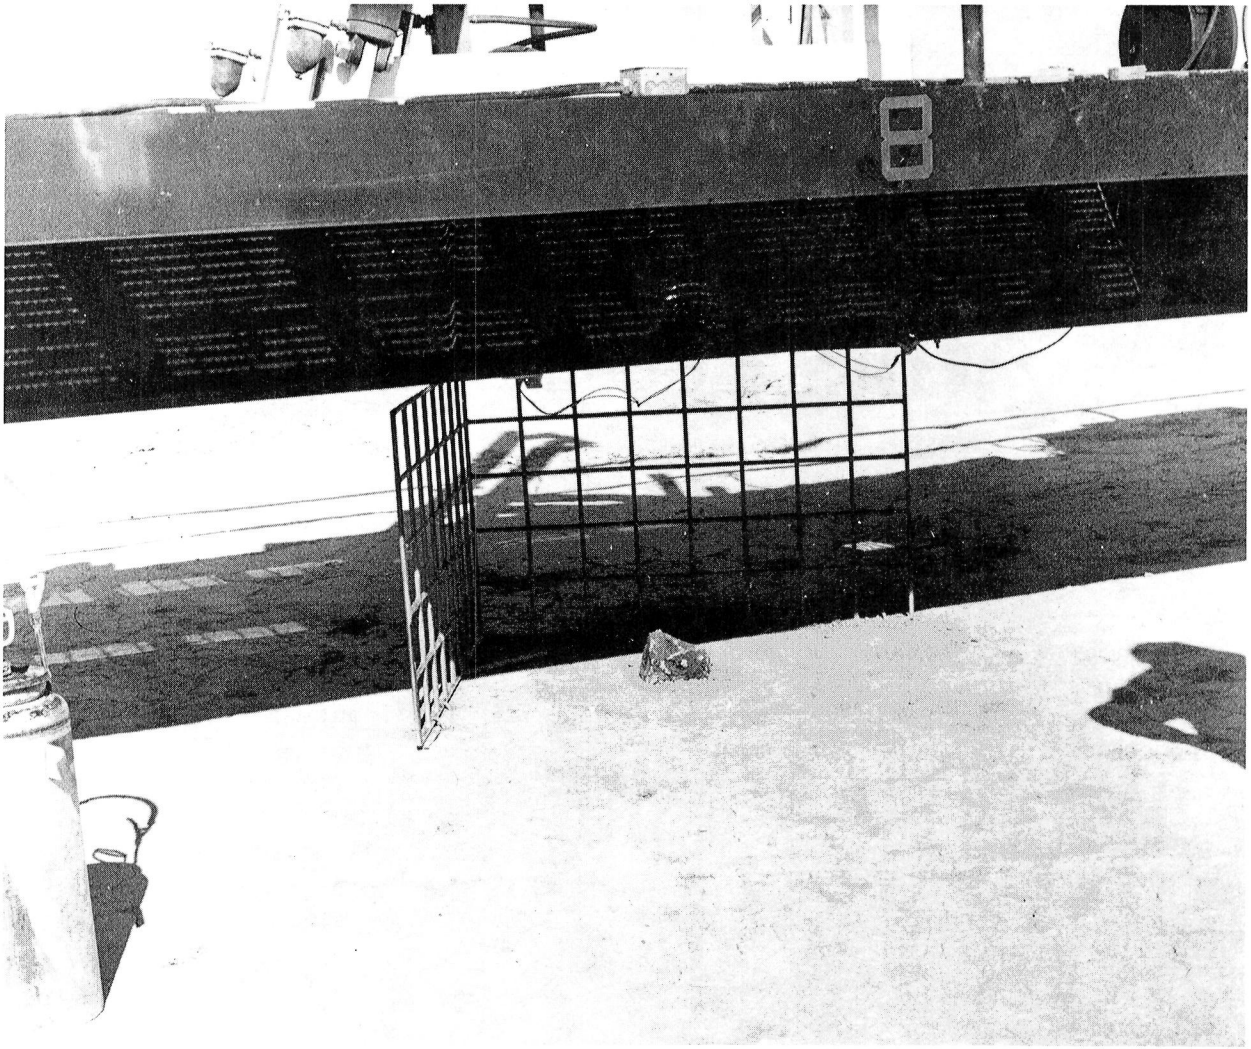
Figure 7.- Grid network that provided a three-dimensional frame of reference for the high-speed motion pictures. The grid consisted of 1.3-centimeter (0.5 inch) aluminum bars welded together at 15.2-centimeter (6 inch) intervals. The grid was staked to the ground to prevent movement during the tests, but airblast-produced vibration occasionally blurred the image of the grid in the films.

An L-shaped metal frame painted orange, having 1.3-centimeter (0.5 inch) bars welded in a grid pattern on 15.2-centimeter (6 inch) intervals (fig. 7), was used as a reference for tracking penetrator movement. This grid was leveled using a Brunton compass for tests 4 to 13; the orientation of the grid is not precisely known for tests 1 to 3.

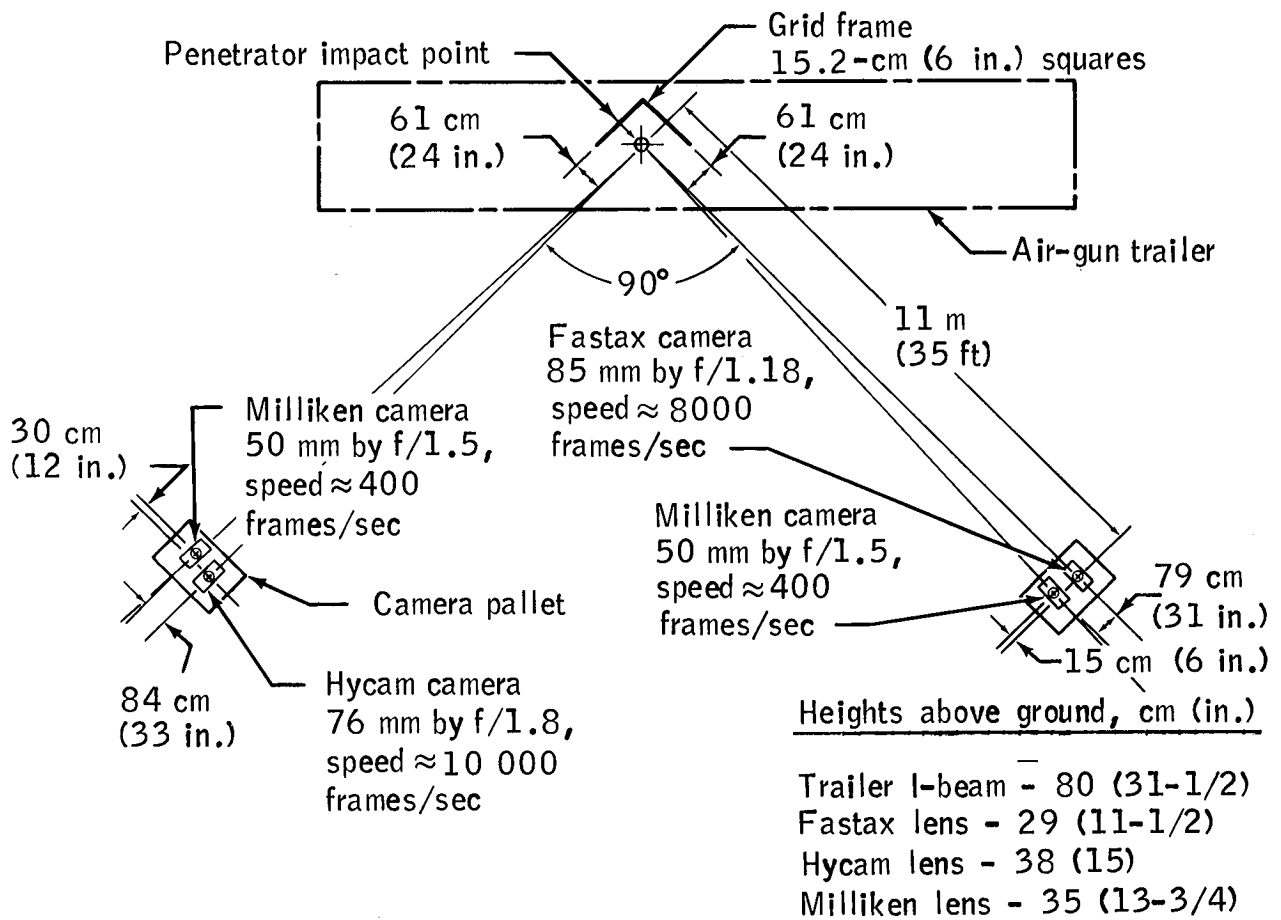
Figure 8.- Layout of motion picture cameras, grid frame, and penetrator impact point.

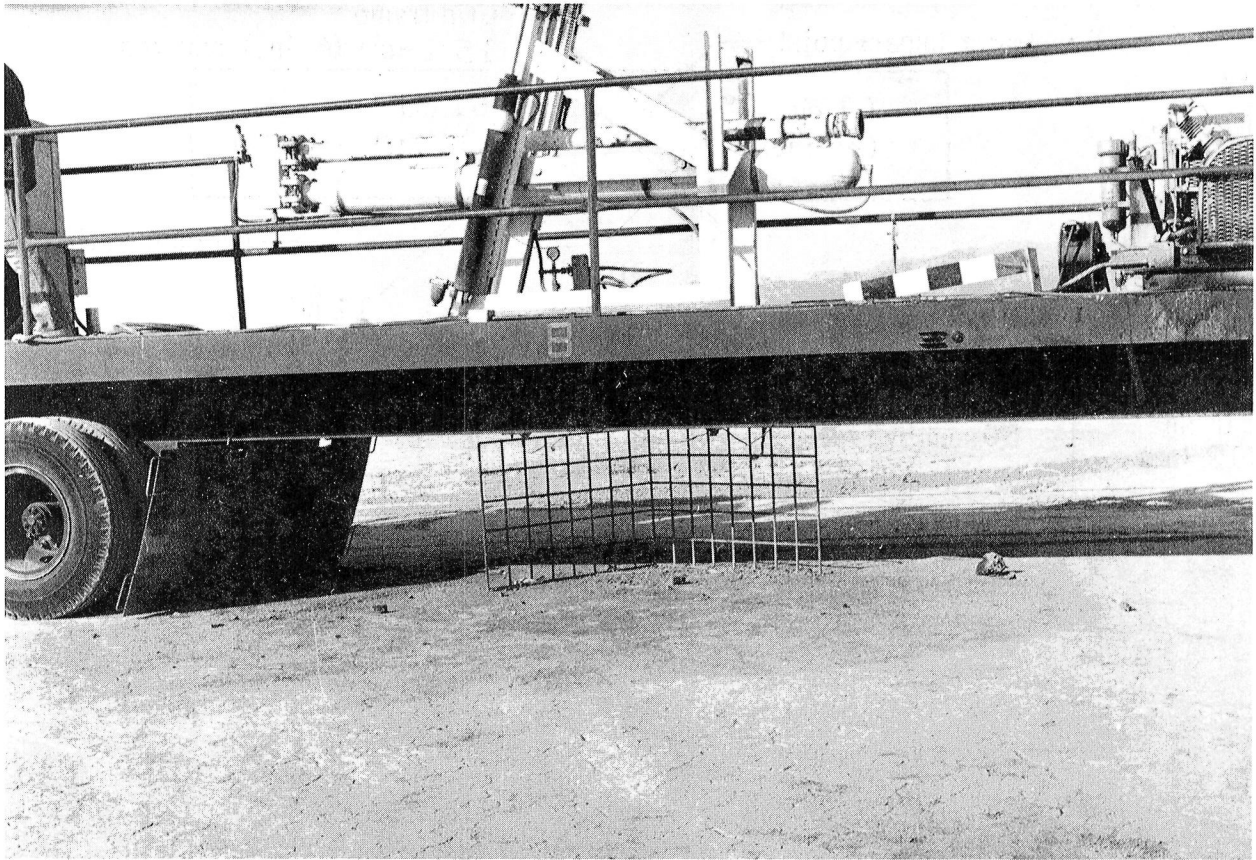
Figure 9.- Cratered area after penetrator passed through the 13-centimeter (5 inch) diameter rock shown in figure 7. The penetrator stopped approximately 4 meters (12 feet) beneath the surface after impact. Several broken fragments of the original rock are near the grid.

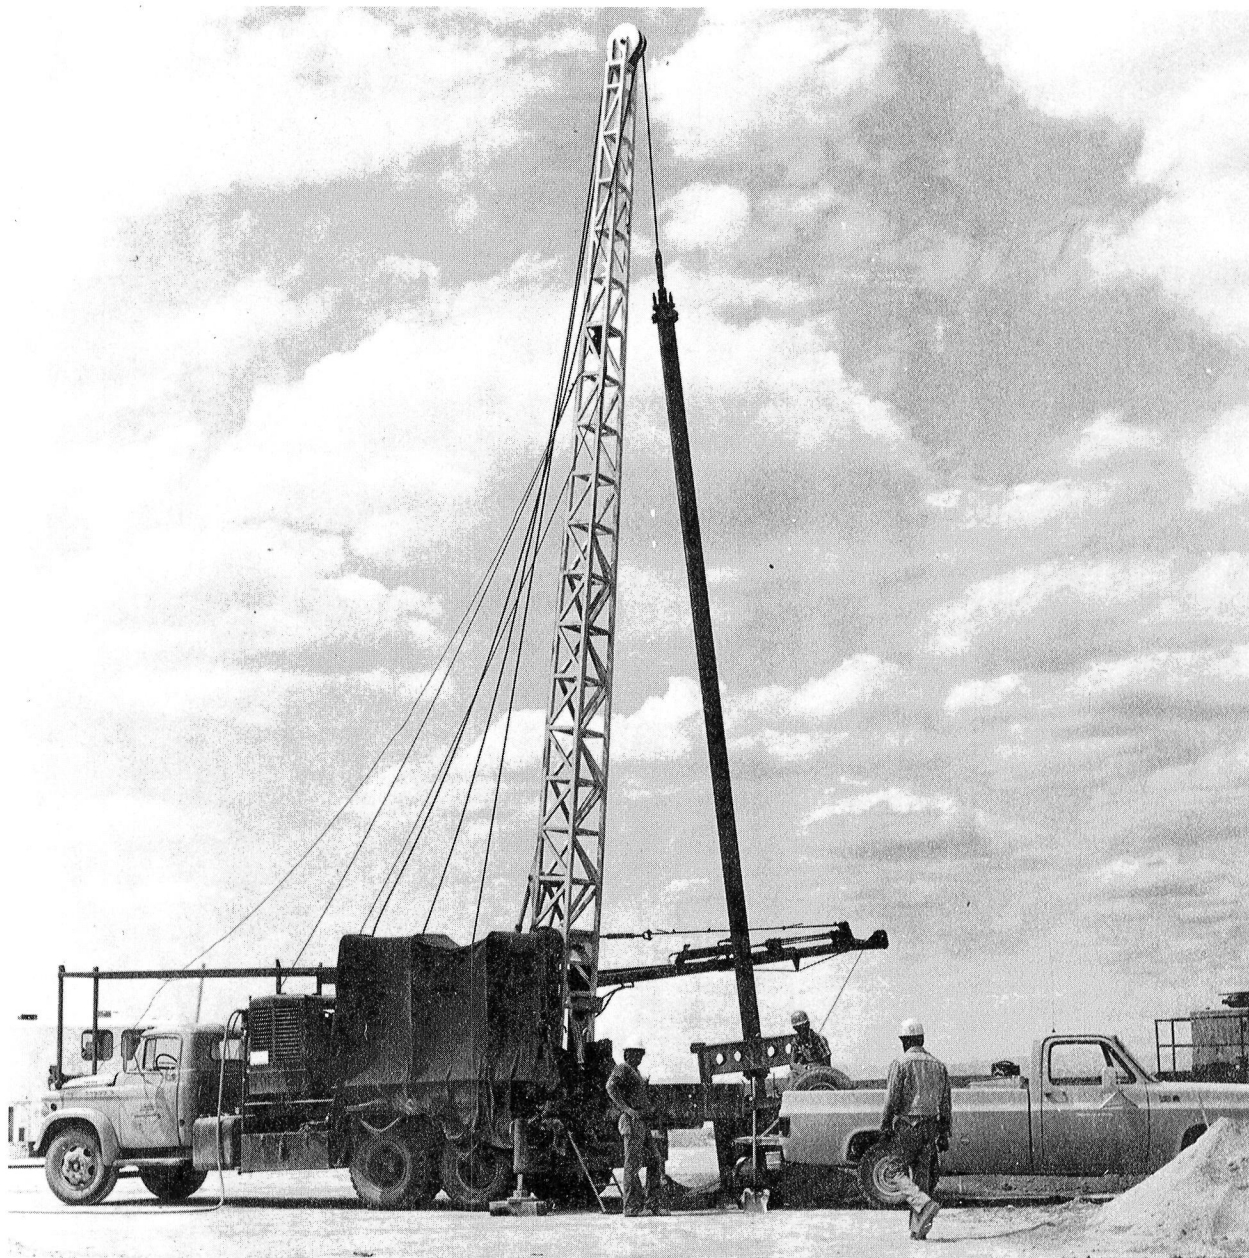
Figure 10.- A 1.2-meter (4 foot) diameter hole was drilled with a bucket auger adjacent to the hole made by the penetrator.

A drill rig with a large bucket auger (fig. 10) was used to drill a 1.2-meter (4 foot) diameter hole adjacent to the point of impact (fig. 11); by this means, a cross section could be made of the entire length of the hole (fig. 12). The final orientation of all penetrators was measured in situ.

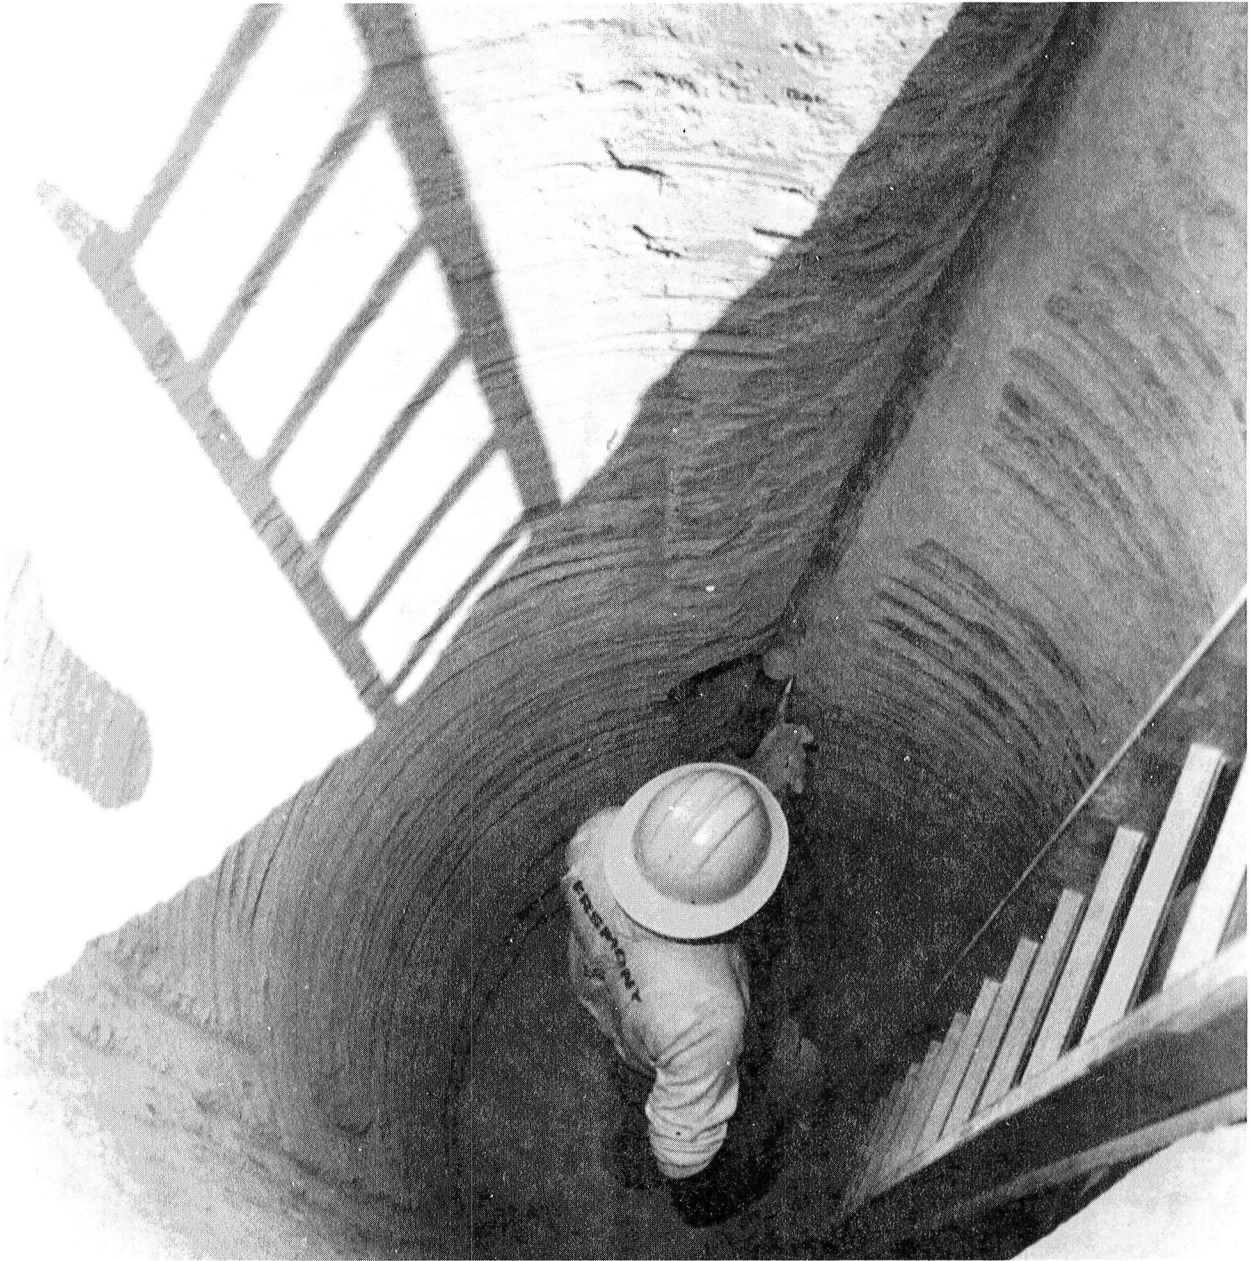
Figure 11.- One side of the hole was removed to expose a complete cross section of the hole made by the penetrator.

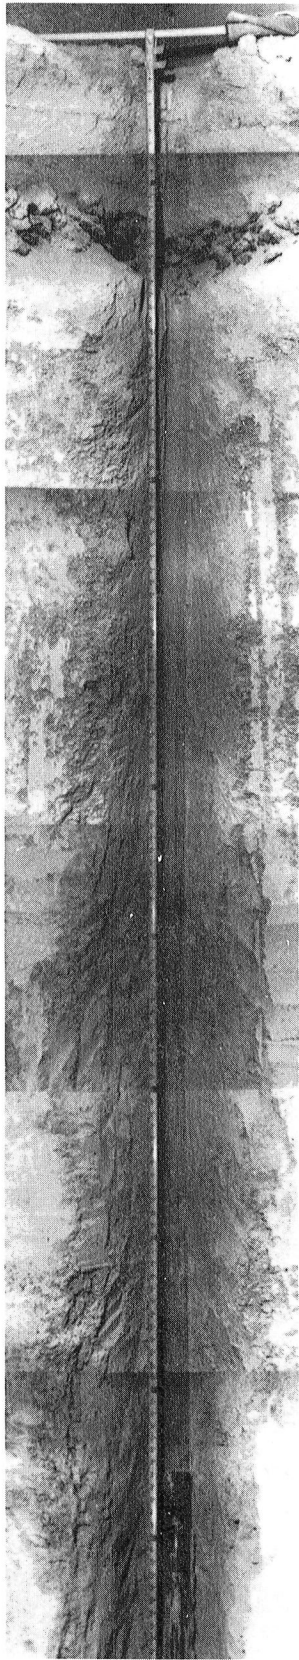
Figure 12.- Cross section of the hole made by the penetrator in test 2. The distance from the surface of the ground to the nose of the penetrator is 323 centimeters (127 inches). The penetrator had a final orientation of  $89^{\circ}20'$  from the horizontal along a bearing of  $60^{\circ}$ . A change in direction occurred just after the penetrator passed through the 5-centimeter (2 inch) diameter rocks.

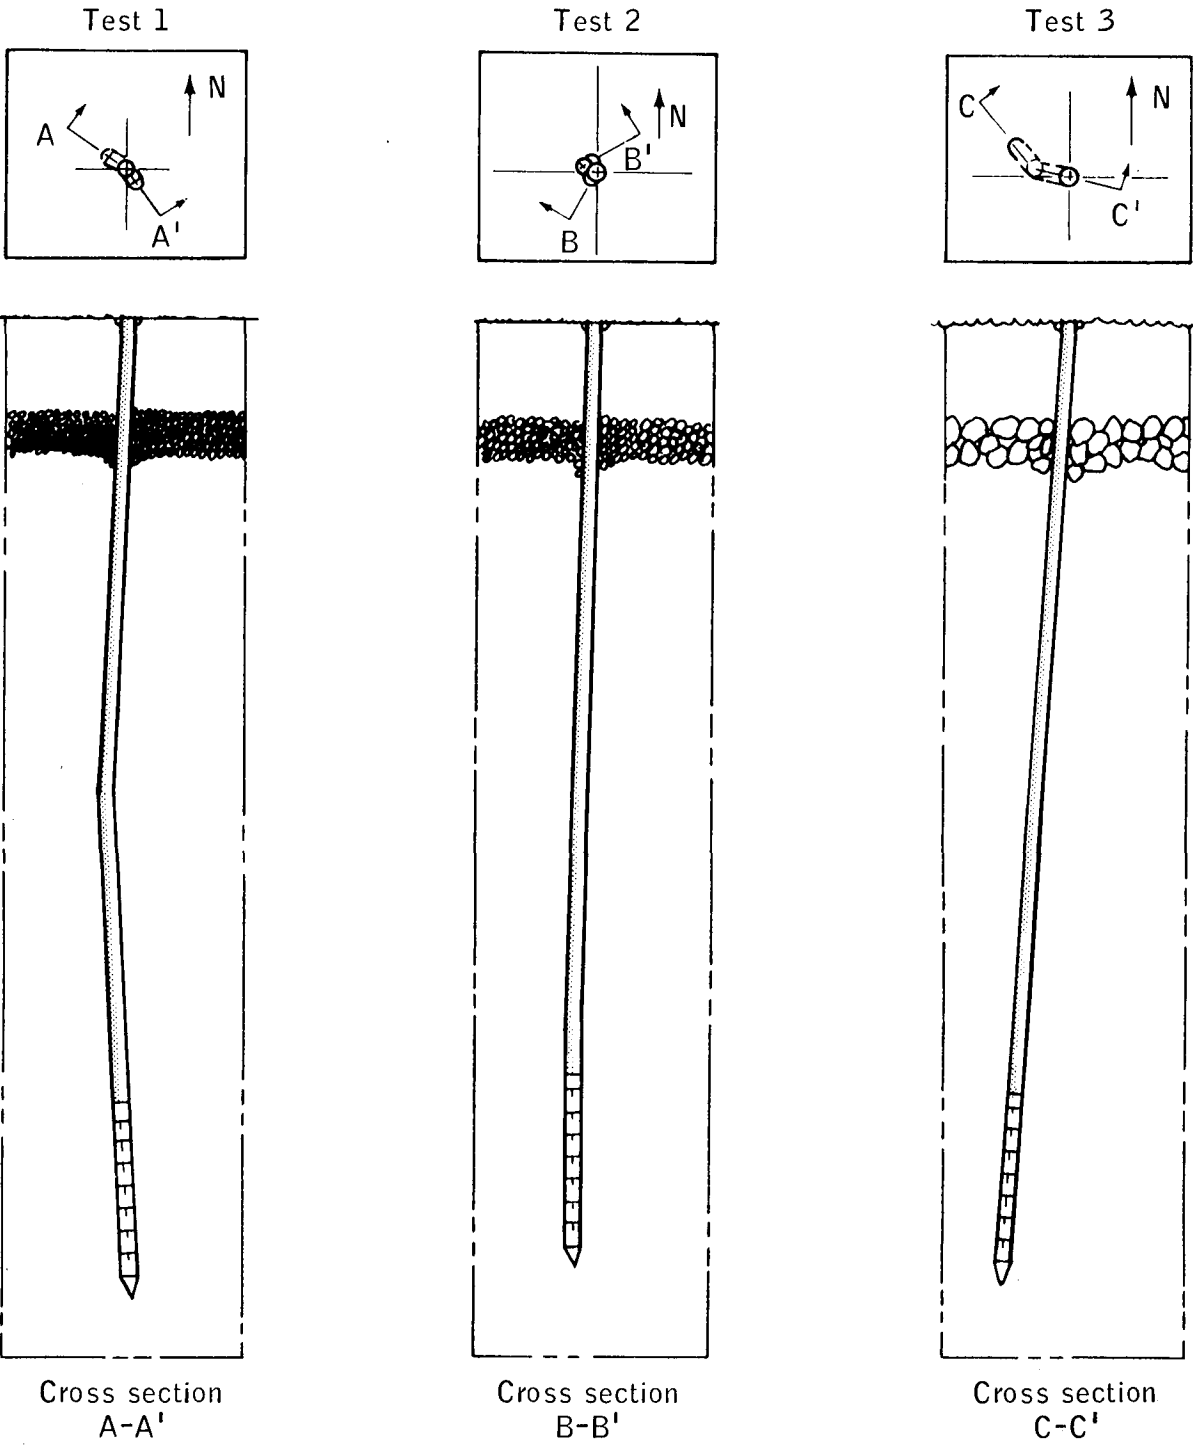
(a) Tests 1 to 3.

Figure 13.- Cross sections of the hole after each penetrator test.

A cross section of the path of each penetrator through the ground is shown in figure 13. To compare the orientation of the penetrator in the air

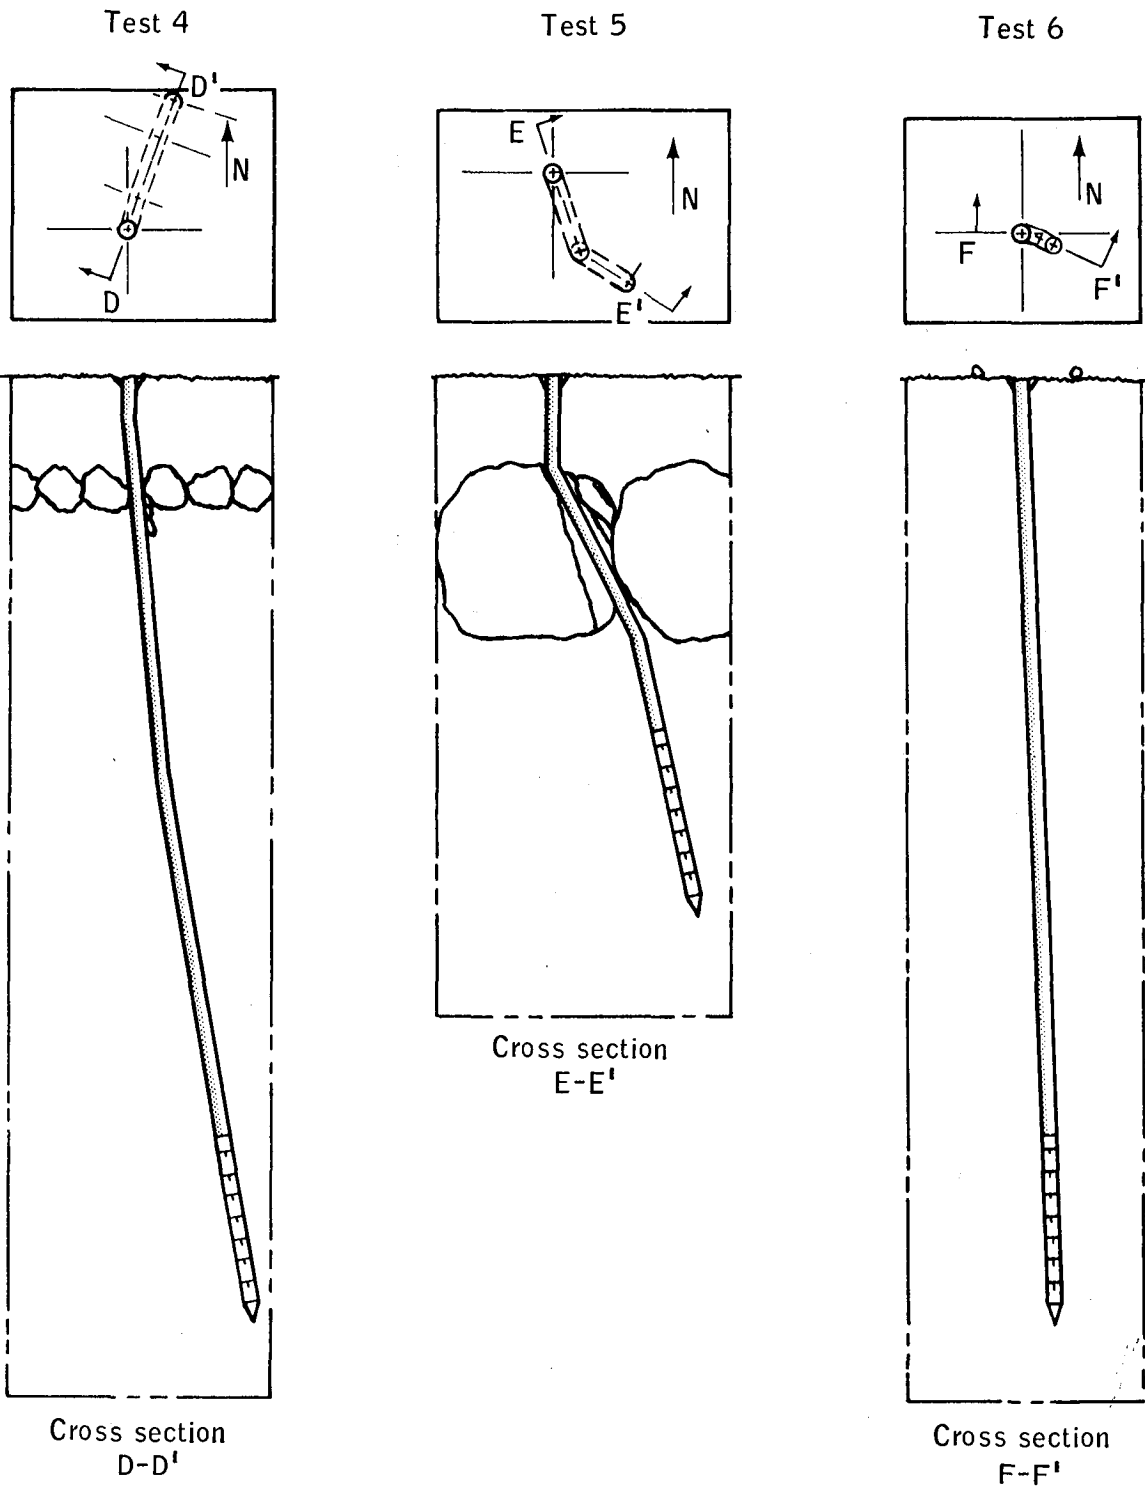
(b) Tests 4 to 6.

Figure 13.- Continued.

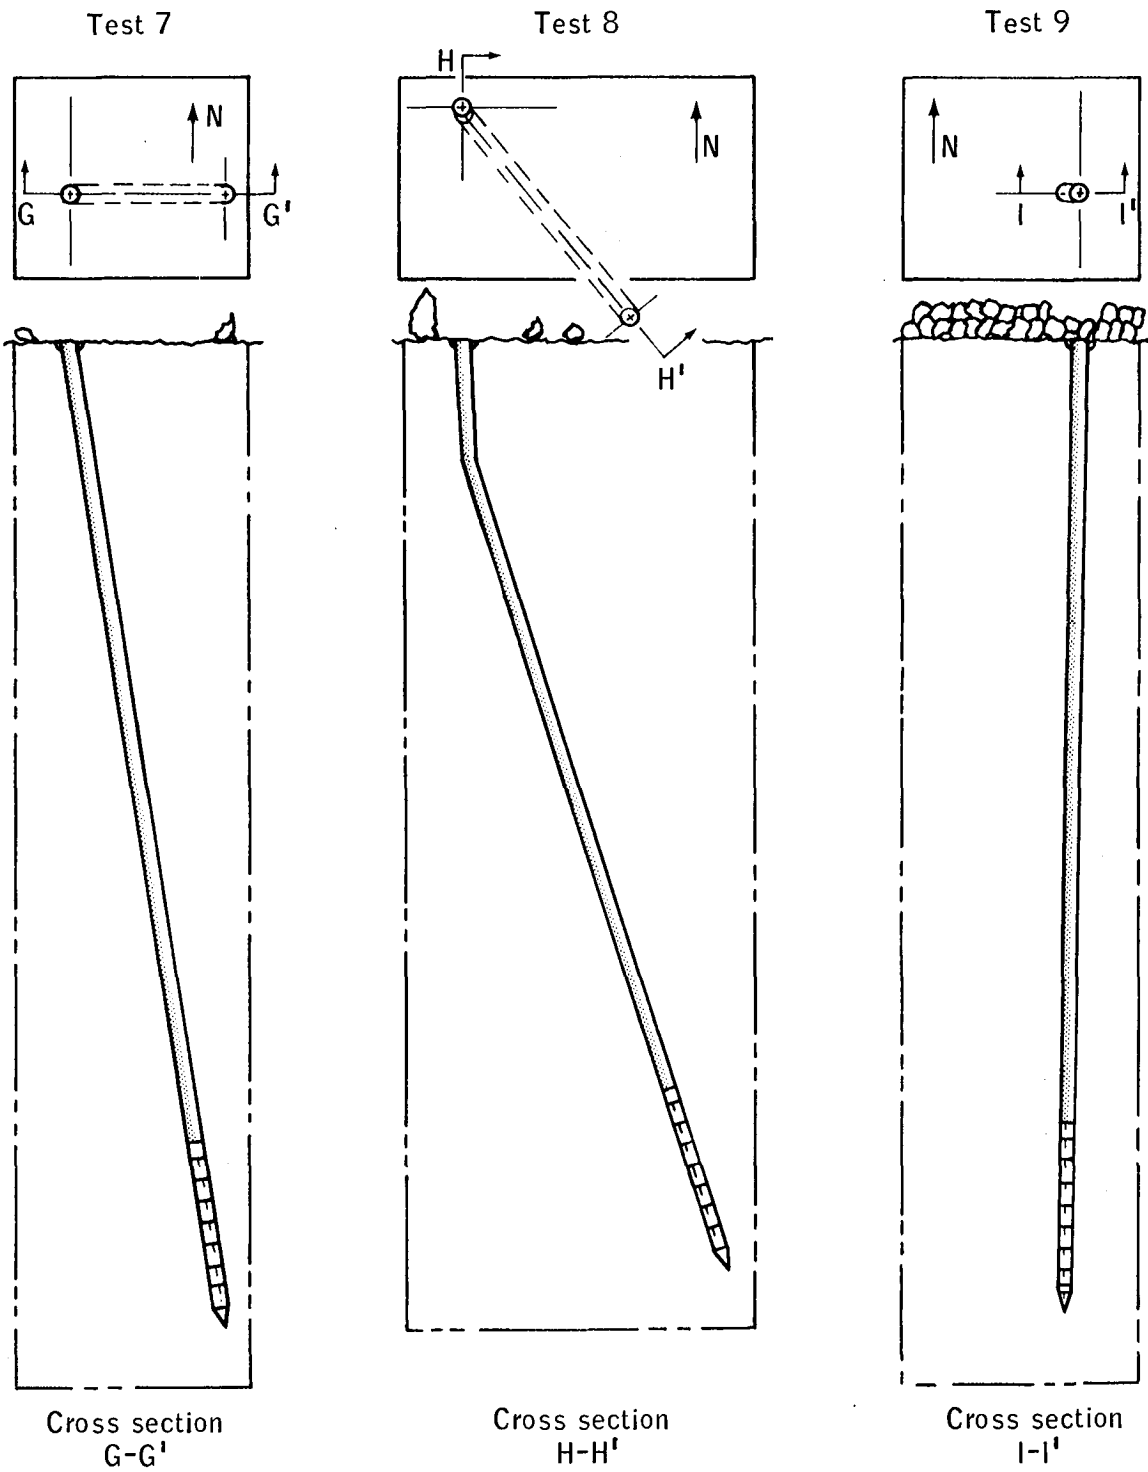
(c) Tests 7 to 9.

Figure 13.- Continued.

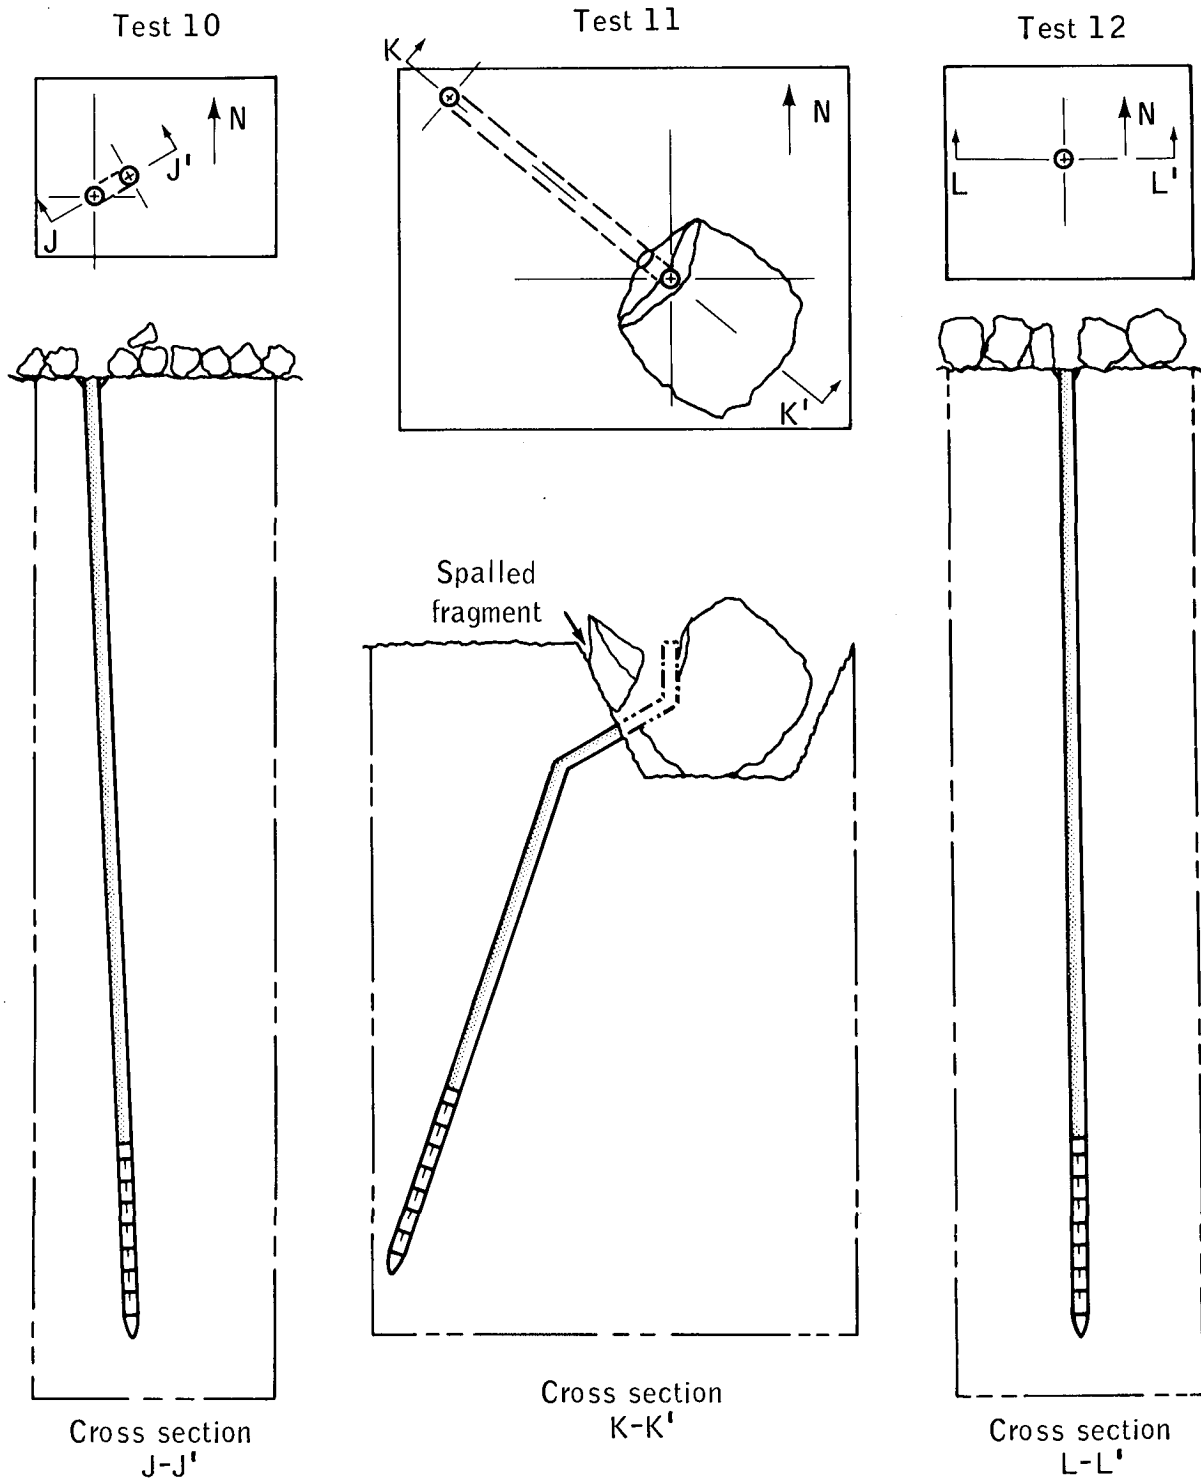
(d) Tests 10 to 12.

Figure 13.- Continued.

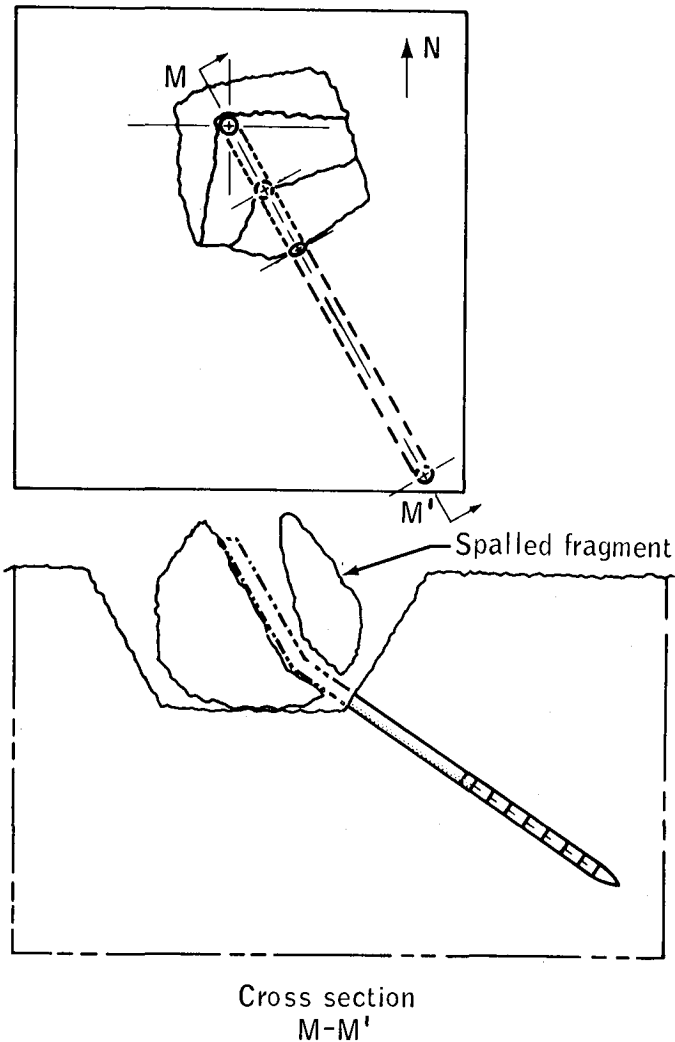
(e) Test 13.

1. These diagrams have been reconstructed from field measurements and are intended to show only major changes in penetrator direction. The diagrams only approximate the actual penetrator movement.
2. The diagrams only approximate the location and shape of the rocks the penetrator encountered. Rock boundaries have been omitted for clarity in plan views of tests 1 to 10 and 12.

Figure 13.- Concluded.
