# NASA Technical Memorandum 58222

## Preliminary Results of Penetrator Field Test Program—Tonopah, Nevada, April 16-28, 1979

Maxwell B. Blanchard, Uel Clanton, Mischelle Dalbey, Victor Rhoder, and James P. Murphy

October 1979

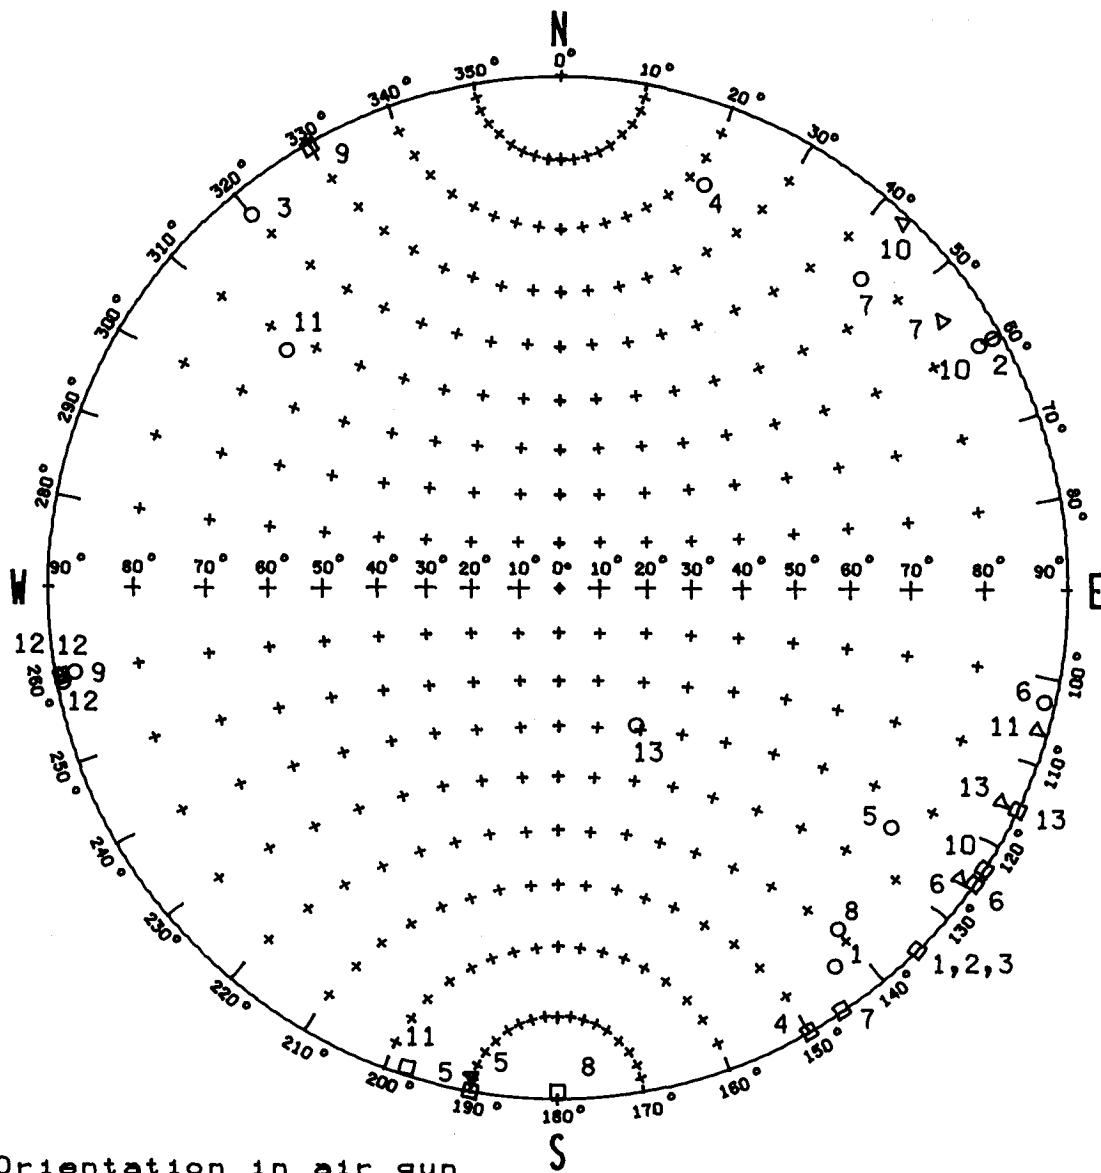
- Orientation in air gun
- △ Free-flight orientation
- Final orientation

Figure 14.- A cyclographic projection showing penetrator orientations for each test. Three points were plotted for tests 5, 6, 7, 10, 11, 12, and 13: orientation in the air gun (data from table I), orientation during free flight (data from high-speed motion pictures), and final orientation (data from table II). Two points were plotted for all other tests: orientation in the air gun and final orientation. The bearing for each point is read on the outside perimeter as a compass direction. The dip angle is read along a radius from the origin to either E or W using the graduated 10° increments from 0° to 90°. The procedure used to locate these points is described in reference 6.

gun before firing with its orientation during free flight and in the ground after the test, the data from tables I and II and from the high-speed motion pictures have been plotted on a cyclographic projection (fig. 14). The orientation of the penetrators in the gun and in the ground has been plotted on the figure for all tests. However, free-flight orientation of the penetrators is shown for only 7 (tests 5, 6, 7, 10, 11, 12, and 13) of the 13 tests. Data were not plotted for tests 1, 2, 3, and 4 because of poor image quality and for tests 8 and 9 because only a single film was obtained. Films from both cameras (Fastax and Hycam) are required to plot the true orientation of the penetrator during free flight. A single film provides only an apparent orientation.

If the orientations of the penetrator in the air gun, during free flight, and in the ground were identical, then the various symbols from a single test would plot in the same location (e.g., test 12). An evaluation of the orientations indicates that the gun and free-flight penetrator azimuths are within  $1^\circ$  for 4 (tests 5, 6, 12, and 13) of the 7 tests that can be evaluated. When the free-flight and in-ground penetrator orientations are compared, the azimuths are within  $45^\circ$  for 5 (tests 6, 7, 10, 12, and 13) of the 7 tests, and the dips are within  $10^\circ$  for 11 of the 13 tests.
