NASA Technical Memorandum 81396

MECHANISMS OF LUBRICATION
AND WEAR OF A BONDED
SOLID LUBRICANT FILM

Robert L. Fusaro
Lewis Research Center
Cleveland, Ohio

Prepared for the
Thirty-fifth Annual Meeting of the
American Society of Lubrication Engineers
Anaheim, California, May 5-8, 1980

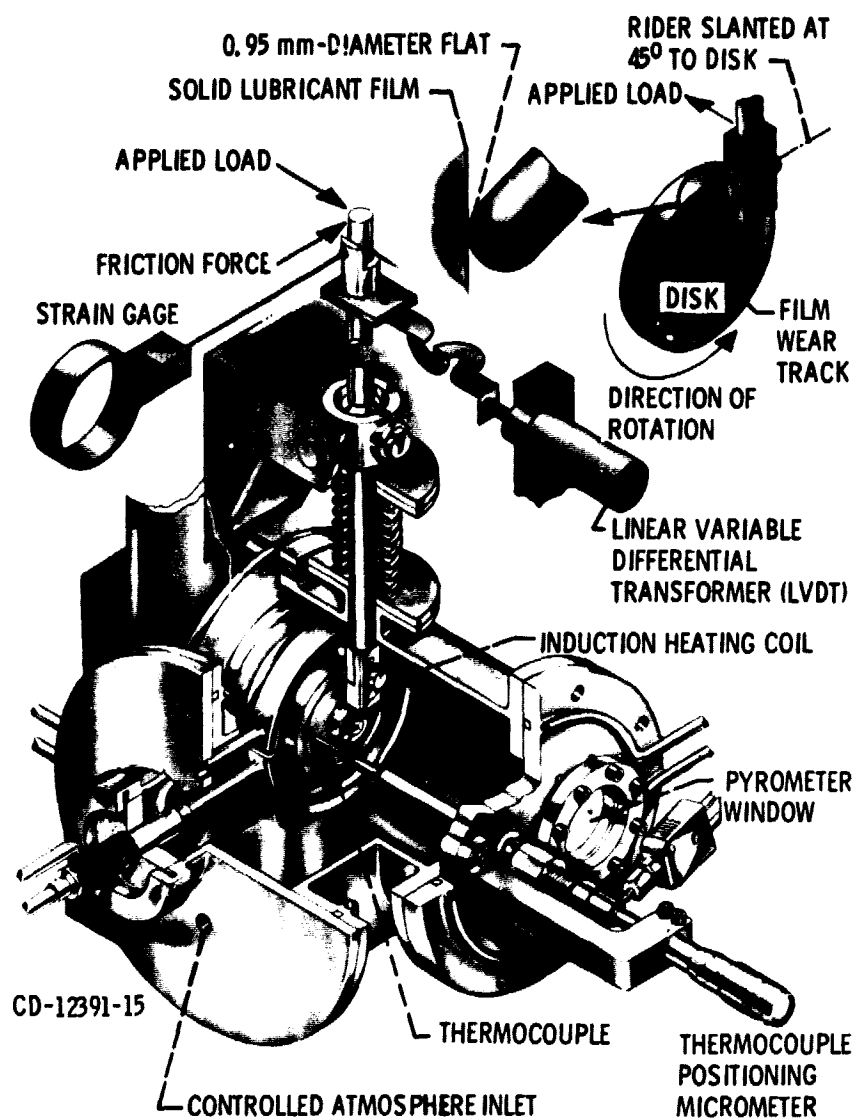
Figure 1. - Friction and wear apparatus.

A conventional type of pin-on-disk friction and wear apparatus was used in this study (fig. 1). The riders were either hemispherically tipped pins with a radius of 0.476 cm or the same hemispherically tipped pins with a 0.95 mm-diameter flat worn on the hemisphere (see insert fig. 1). They were loaded with a 1-kilogram deadweight against the film which was applied to a flat, 6.3-cm-diameter disk. The disk was rotated at 1000 rpm, and the rider slid on the disk

The flat on the 0.476 cm-radius hemispherically tipped rider (pin) was generated prior to conducting the friction and wear experiments by sliding it against a rubbed graphite fluoride film which was applied to a sandblasted AISI 440C HT stainless steel sandblasted disk. The rider was not removed from the holder after the flat was generated or while it was cleaned; and it and the disk (with applied polyimide-bonded graphite fluoride film) were positioned and indexed in the apparatus by using a linear variable differential transformer (LVDT) so that a flat-on-flat configuration occurred with minimal misalignment being introduced (fig. 1).

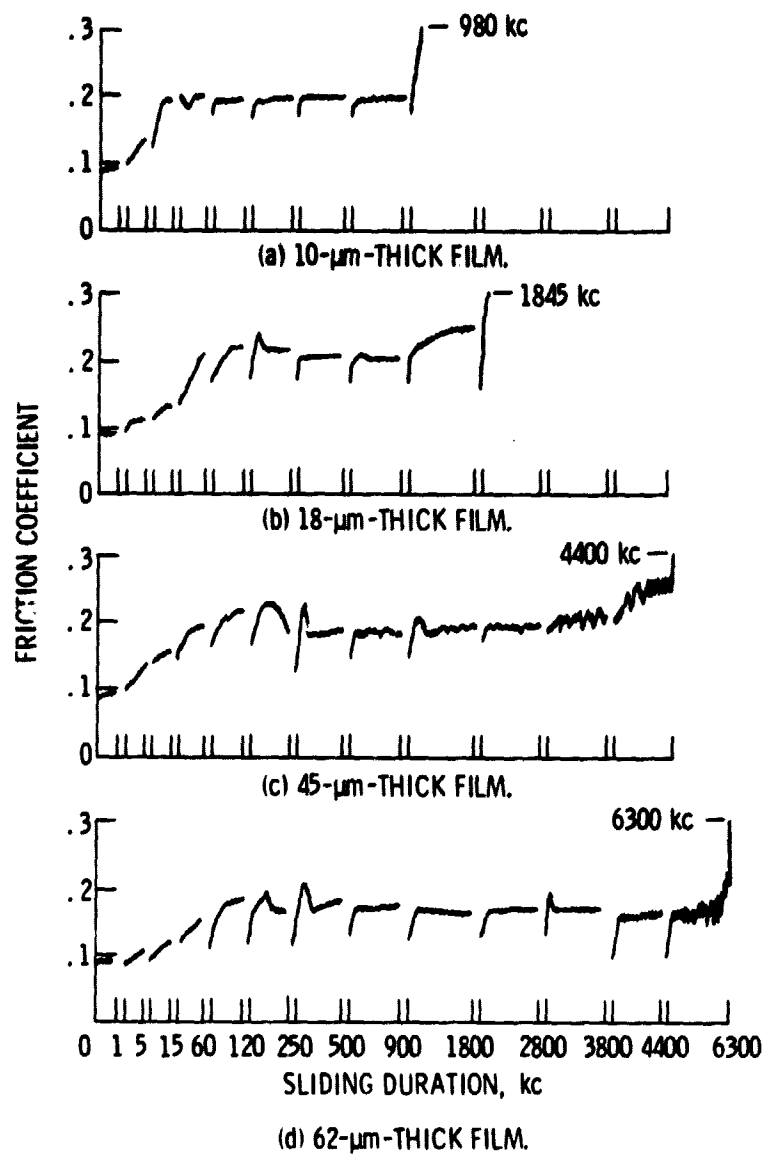
Figure 2. - Friction traces for 440C HT stainless-steel hemispherically tipped riders sliding on polyimide-bonded graphite fluoride films 10, 18, 45, and 62 μ m thick.

Friction traces for hemispherically tipped 440C HT stainless-steel riders (0.476 cm radius) sliding on polyimide-bonded graphite fluoride films of four thicknesses (10 , 18 , 45 , and $62\text{ }\mu\text{m}$) are shown in figure 2. The friction traces are discontinuous because the tests were stopped at various intervals to make wear measurements and to observe the sliding surfaces with an optical microscope. The experiments were terminated when the friction coefficient reached

0.30, and wear life was defined as the number of sliding revolutions to reach this friction coefficient. For all four film thicknesses evaluated, the friction coefficient started out at 0.08 to 0.09 and then rose gradually with sliding duration. Eventually the friction coefficient leveled off at a steady-state value of 0.20 ± 0.02 . On restart, after the tests had been stopped to measure wear, the friction coefficient was usually lower than it had been at the end of the previous interval. A continuous increase in friction coefficient (from the steady-state value) signified that the films were approaching failure (fig. 2).

Figure 2 shows that as film thickness increased, so did wear life. The 10-micrometer-thick film gave a wear life of 980 kilocycles, the 18-micrometer-thick film gave a wear life of 1845 kilocycles, the 45-micrometer-thick film gave a wear life of 4400 kilocycles, and the 62-micrometer-thick film gave a wear life of 6300 kilocycles. Wear life is shown to be directly proportional to film thickness in figure 3. This result agreed with results of previous experiments conducted on polyimide-bonded molybdenum disulfide films (ref. 6). The wear life of the polyimide-bonded graphite fluoride film was found to be about 100 kilocycles per micrometer of film thickness.

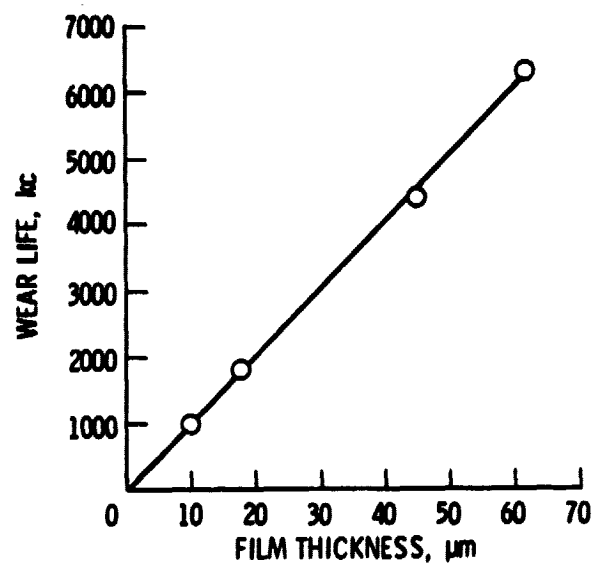
Figure 3. - Wear life as a function of polyimide-bonded graphite fluoride film thickness.

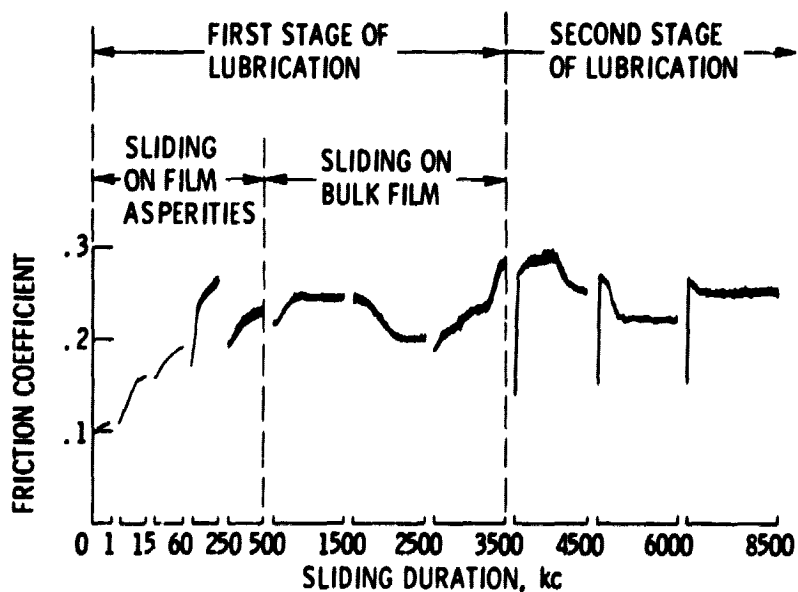
Figure 4. - Friction trace for a 440C HT stainless-steel hemispherically tipped rider (with a 0.95 mm diameter flat on it) sliding on polyimide-bonded graphite fluoride film.

A friction trace for a 0.95-mm-diameter flat sliding against the 45 μm -thick polyimide-bonded graphite fluoride film is shown in figure 4. As found for the hemispherically tipped rider sliding on the same film (fig. 2), the friction coefficient started at a low value of 0.08 to 0.09, then rose gradually with sliding distance, and eventually leveled off at 0.24 ± 0.02 . This was slightly higher than the friction coefficient found for the hemisphere on film experiments (0.20 ± 0.02). For the 0.95-mm-diameter flat sliding on the 45 μm -thick film, failure did not occur after 8500 kilocycles of sliding (which was arbitrarily chosen as the time duration of this test).

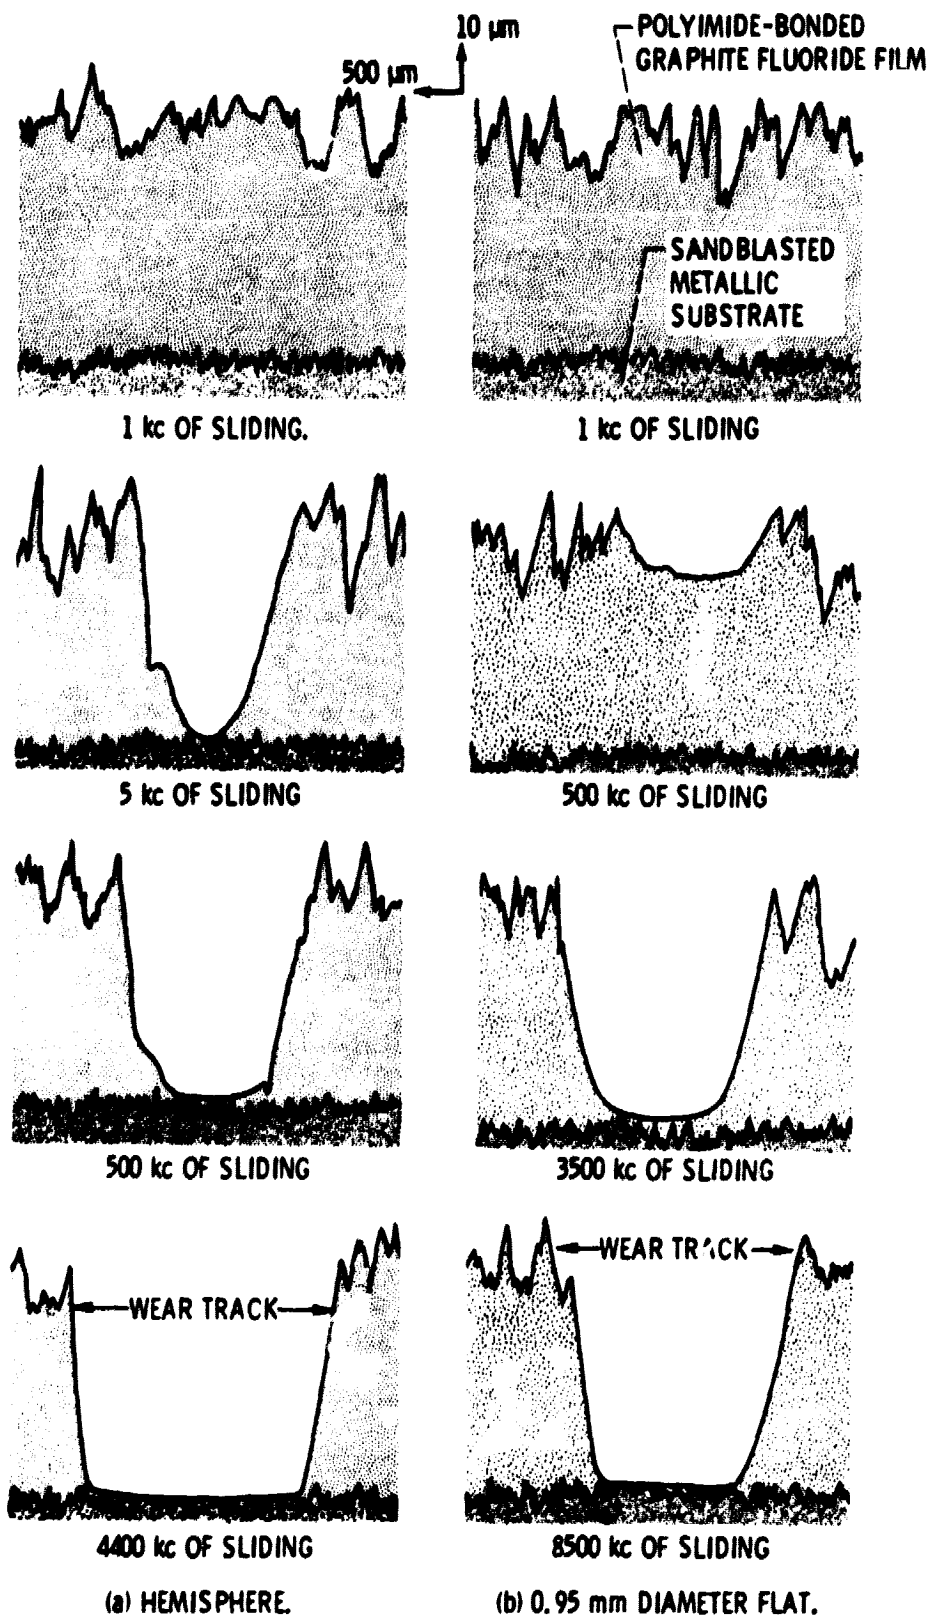
Figure 5. - Comparison of surface profiles of the wear tracks on polyimide-bonded graphite fluoride films for a hemisphere and for a 0.95 mm diameter flat after various intervals of sliding on the film.

Film wear was studied by taking surface profiles of the film wear track after each sliding interval. Figure 5 compares surface profiles of the wear traces on 45 μm -thick polyimide-bonded graphite fluoride films for (a) a hemisphere and for (b) a 0.95-mm-diameter flat after various intervals of sliding. Superimposed on each trace in figure 5 is a surface profile of the 440C HT stainless-steel substrate to show the topography and the location of the coating-substrate interface.

Because the vertical magnification of the surface profiles is about 50 times the horizontal magnification, the view of the surface is distorted. The surface profiles show that after 1 kilocycle of sliding very little wear had occurred on the film surfaces. But after only 5 kilocycles of sliding, the hemisphere had worn through the film and contact with the sandblasted metallic substrate had occurred. A similar result occurred with the three other film thicknesses. Thus, regardless of film thickness, the hemisphere had worn through the film to the metal after 5 kilocycles of sliding. From this point onward, wear was characterized by the gradual increase in wear track width.

The surface profiles of figure 5(b) indicate that the wear process for the flat sliding on the film was one of gradual wear through the film. It took approximately 3500 kilocycles of sliding for the rider to wear through the 45 μm -thick film and make contact with the metallic substrate. Once the metallic substrate was reached, the wear track gradually increased in width as was found for the hemisphere.

The surface profiles of figure 5(a) show that on initial contact of the hemisphere on the film very little wear of the film occurred. However, figure 7 shows that the contact stress and the stresses induced by sliding caused cracking of the film to occur. At first, the cracks were very small (fig. 7(a)); but as sliding progressed, they propagated and enlarged (fig. 7(b)) and eventually led to crumbling and the complete breakup of the film on the wear track.

After 500 kilocycles of sliding, the film asperities were worn away. As figure 5 shows, the rider continued to wear gradually through the film until the metallic asperities on the substrate were reached at approximately 3500 kilocycles of sliding. The film wear mechanism (after the film asperities had been worn away), was very similar to the mechanism when sliding was only on the film asperity plateaus. Figure 11 shows an area of the film wear track after 1500 kilocycles of sliding. In general, the track was smooth and lustrous, but there were blistered areas and areas where a very thin layer of the film had spalled from the surface (fig. 11) and exposed unrubbed polyimide-bonded graphite fluoride. The area exposed after the film fragment had spalled (fig. 11) was not lustrous and appeared rough. The thickness of layers that spalled varied somewhat; usually they were less than 1 to 2 μm thick but occasionally they were as thick as 6 μm .

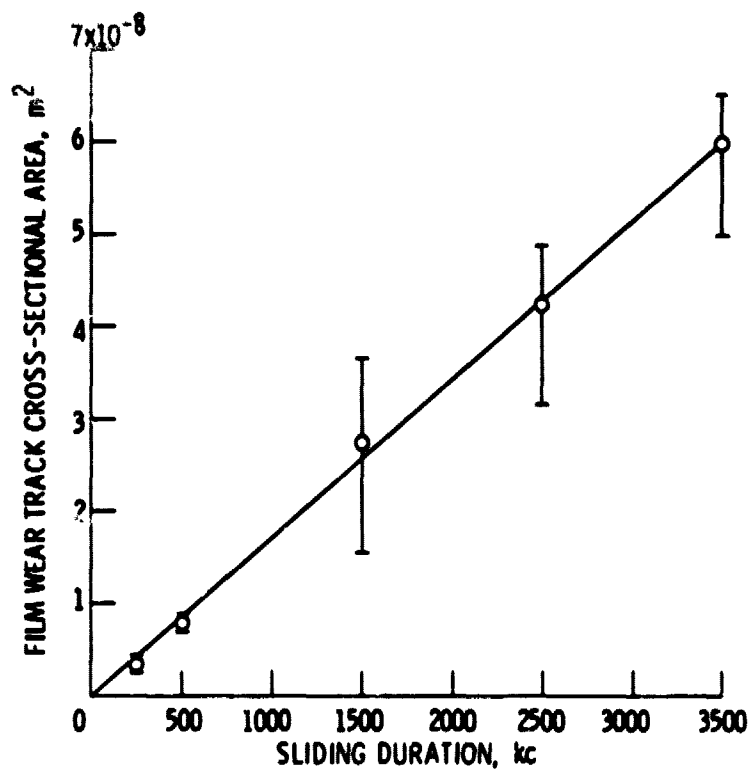
Figure 6. - Wear of polyimide-bonded graphite fluoride film as a function of sliding duration for a 0.95 mm diameter flat sliding on the film.

To quantify the wear process for the flat sliding on the film under a 1-kilogram load, film wear (for the first 3500 kilocycles of sliding) was calculated by measuring the cross-sectional area of the film wear tracks (from the surface profiles) after each sliding interval. At least four traces were taken at each interval. Figure 6 plots the average and the range of these values as a function of the number of sliding revolutions (expressed in kilocycles). The general

trend was that the film wear increased linearly (from zero) as a function of sliding revolutions. A linear regression fit (least squares) of the points gave an average film wear rate of $1.7 \pm 0.3 \times 10^{-7} \text{ cm}^2/\text{kc}$, or in terms of wear volume per unit sliding distance the wear rate was $1.7 \pm 0.3 \times 10^{-10} \text{ cm}^3/\text{cm}$. The wear rate for the hemisphere sliding on the film was $1.2 \pm 0.4 \times 10^{-7} \text{ cm}^3/\text{cm}$. Thus, wear was reduced about 700 times at the lower contact stress with a flat rider.

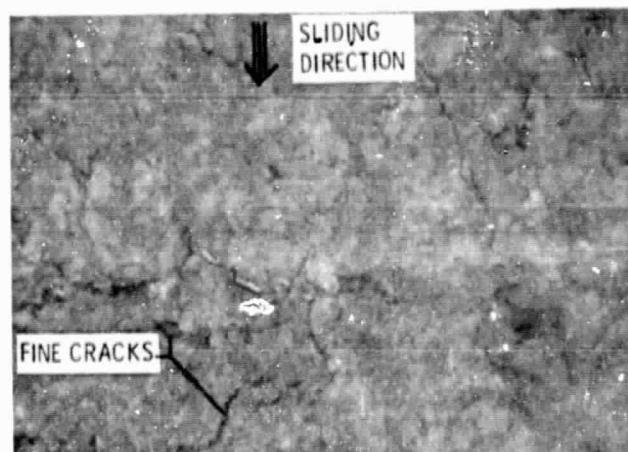
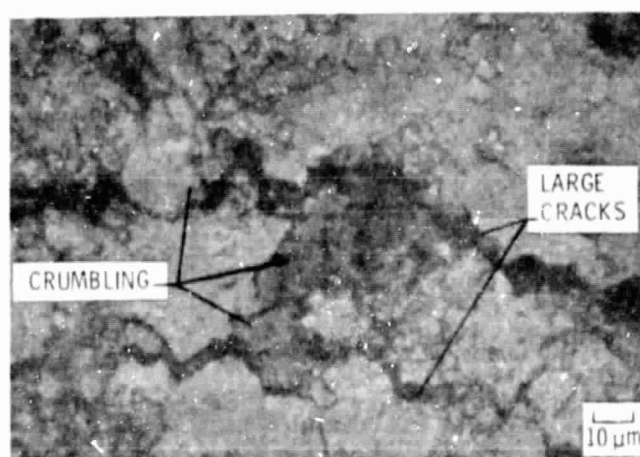
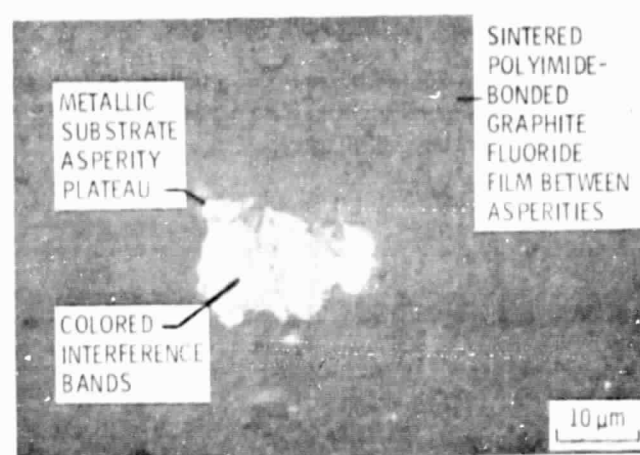
Figure 7. - High magnification photomicrographs of the central area of the wear track (for the hemisphere sliding of the 45-micrometer-thick polyimide-bonded graphite fluoride film) after sliding intervals of 1/4, 5, and 15 kilocycles.

Once the original film was worn away, however, asperities on the 440C HT stainless-steel substrate interacted with the rider and helped support the load (fig. 7(d)). The polyimide-bonded graphite fluoride material tended to compact and sinter into a very smooth, continuous film in the regions between the asperities, and flat plateaus were worn on the tips of the metallic asperities (fig. 7(c)).

The second stage occurred after the film had been worn through to the metal surface. The rider interacted with the asperities on the sandblasted metallic substrate and caused flats to be worn on the tips of those asperities (fig. 7(c)). The lubricating mechanism then became the shear of very thin lubricant films ($<0.8 \mu\text{m}$) between the rider flat and flat plateaus on the metallic asperities. The polyimide-bonded graphite fluoride could be discerned on the plateaus by color changes and interference fringes.

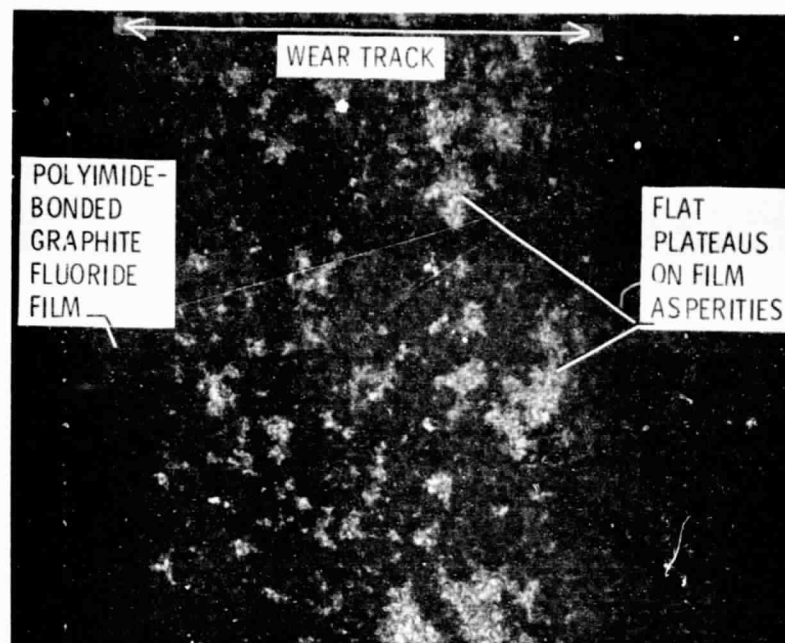
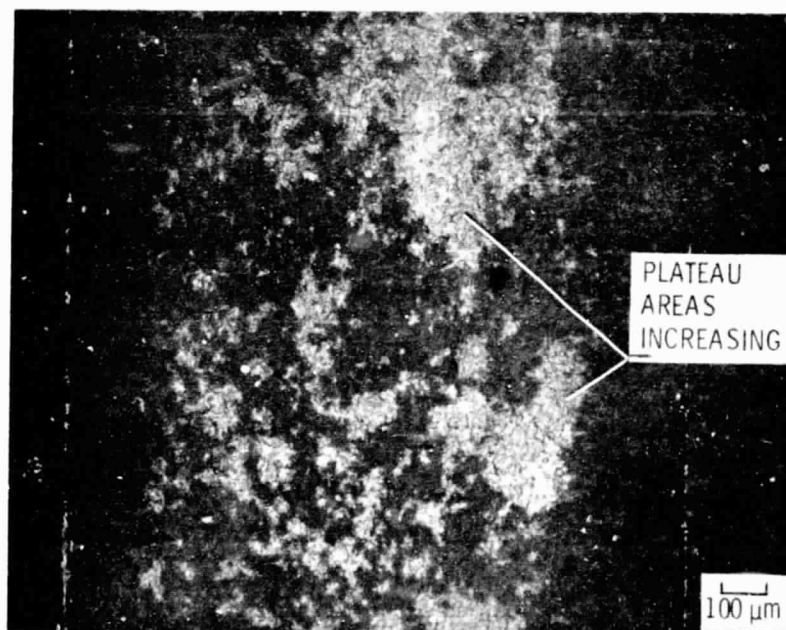
Figure 8. - Photomicrographs of the same area of the wear track after 1 and 60 kc of sliding for a 0.95 mm diameter flat sliding on a polyimide-bonded graphite fluoride film.

Figure 8 gives photomicrographs of the same area on the film wear track (for the flat sliding on the film) after sliding intervals of 1 and 60 kilocycles. The bright areas seen in the photomicrographs are flat plateaus worn on the film asperities. With repeated passes over the wear track, the ratio of bright areas to dark areas increased, indicating the gradual wear and truncation of the asperities. It took approximately 500 kilocycles of sliding to wear the film asperities down to the bulk film.

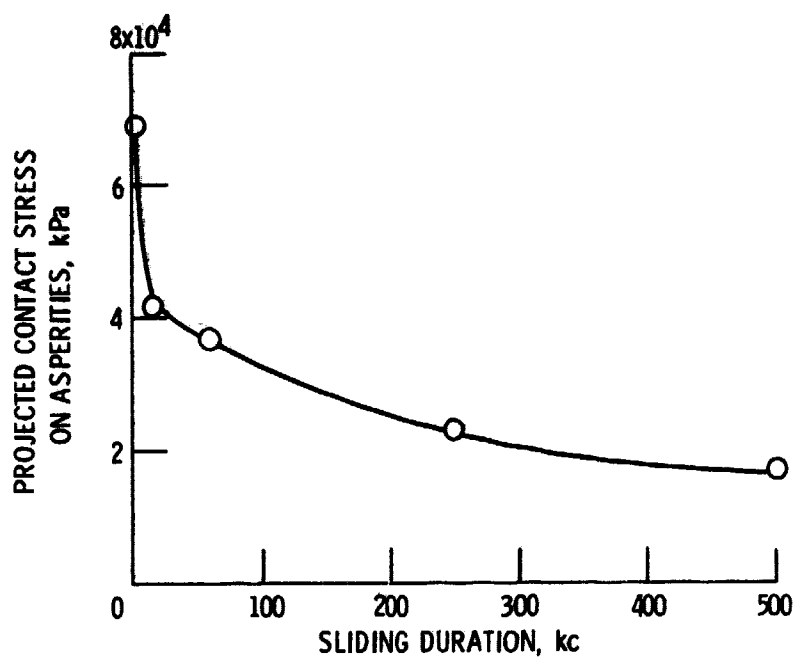
Figure 9. - Projected contact stress on the asperities of a polyimide-bonded graphite fluoride film as a function of sliding duration for a 0.95 mm diameter flat sliding on the film.

In order to quantify the contact stresses involved, the wear track was observed using an image analysis system. Table I shows how the estimated area of contact increased (in percent) as a function of sliding duration and the corresponding calculated values of stress. Figure 9 gives the estimated contact stress on the film asperities as a function of sliding duration. The stress was calculated by assuming that all bright areas were contacting the rider at any particular interval. However, this may not have been the case, and these values of contact stress may be low. Nevertheless, the data give an estimate of the contact stresses involved.

Assuming full contact on the film asperity tips, the rider contact after 1 kilocycle of sliding was estimated to be approximately 20%. Thus, the contact stress supported by the film asperities was at least 69 000 kPa (10 000 psi). Because of film asperity wear, the contact stress decreased very rapidly during the first 15 kilocycles of sliding (fig. 9) to a value of 42 000 kPa (6100 psi). After 15 kilocycles of sliding, the rate of decrease slowed and it took approximately 500 kilocycles of sliding to reach a "steady" value of approximately 17 000 kPa (2500 psi). This represents a contact area of ap-

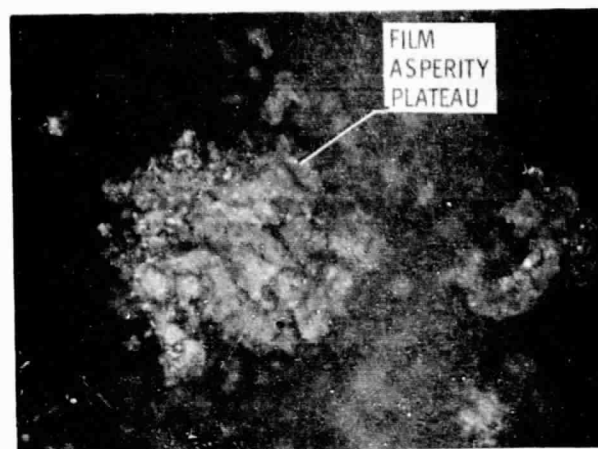
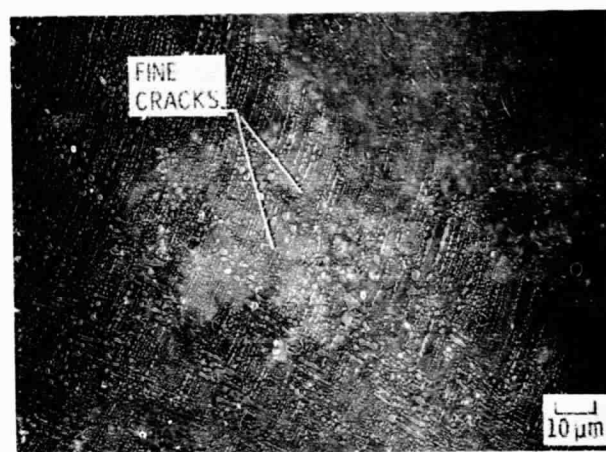
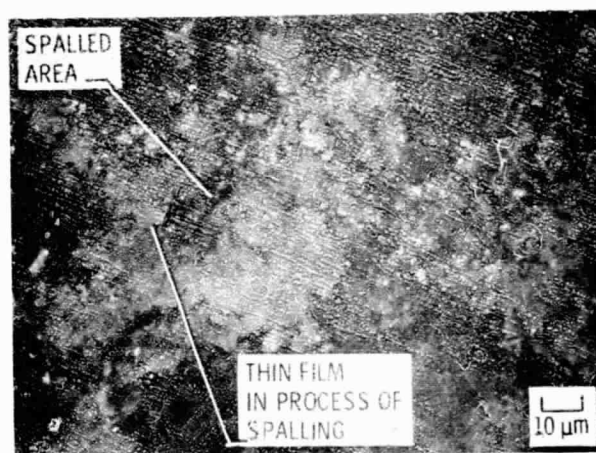
Figure 10. - High magnification photomicrographs of the same polyimide-bonded graphite fluoride film asperity, showing the wear progression which occurred when a 0.95 mm-diam flat slid against the film.

The wear progression of an individual film asperity is shown in figure 10 after intervals of 1, 5, and 60 kilocycles of sliding. The high-magnification photomicrographs show the truncation of a film asperity and its merging together with other asperities as wear occurred. The plateau on the film asperity was very smooth and reflective; however, there were some very fine cracks present and areas where a film fragment has spalled from the plateau. High magnification optical observation of the film wear track suggested that spalling of very thin layers on the plateaus was the primary wear mechanism while sliding was on the film asperities.

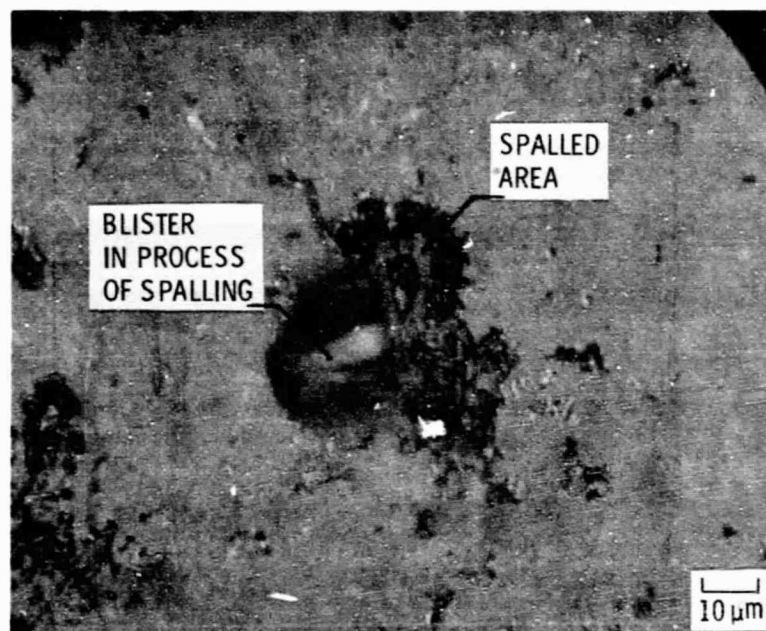
Figure 11. - High magnification photomicrograph of the wear track which was taken after the 0.95 mm diameter flat had slid for 1500 kc on the polyimide-bonded graphite fluoride film, showing blistering and spalling of a thin layer of the film.

One mechanism by which spalling occurred, appeared to be due to texturing of the wear track. Texturing means that the individual constituents (polyimide and graphite fluoride) plastically flowed and coalesced on the wear track

into a very thin smooth layer at the surface of the film. After repeated passes were made over this layer, it tended to disengage from the bulk film by blistering and spalling. Another wear mechanism (not shown in the figures) appeared to originate in the bulk of the film, since the textured layers were up to 1 to 2 μm thick and some spalled areas were as much as 6 μm thick. These spalled areas were most likely caused by crack propagation due to defects in the bulk, while the thinner spalled layers were caused by scaling of the textured layer.

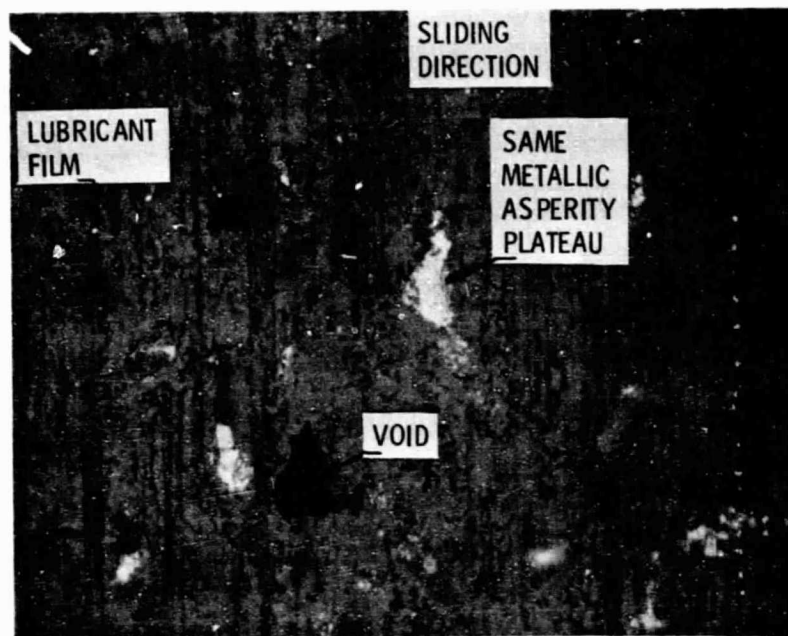
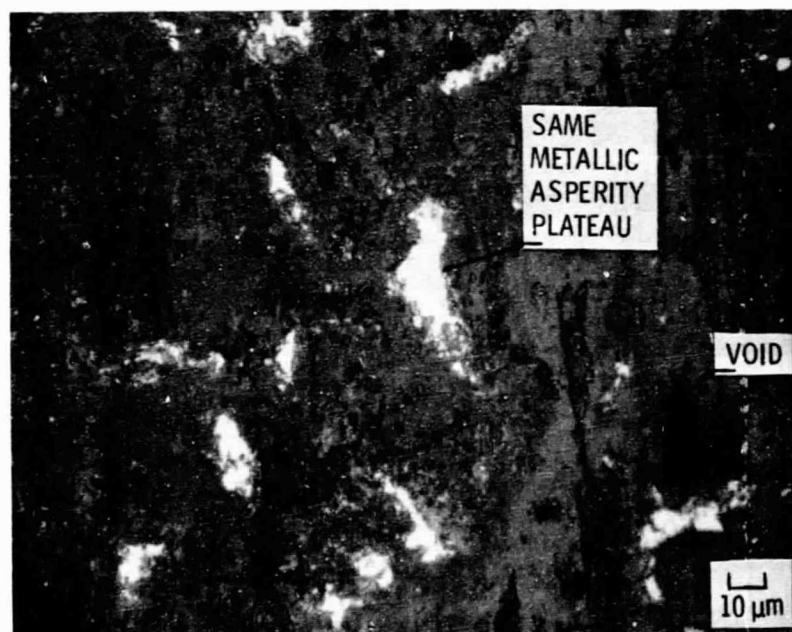
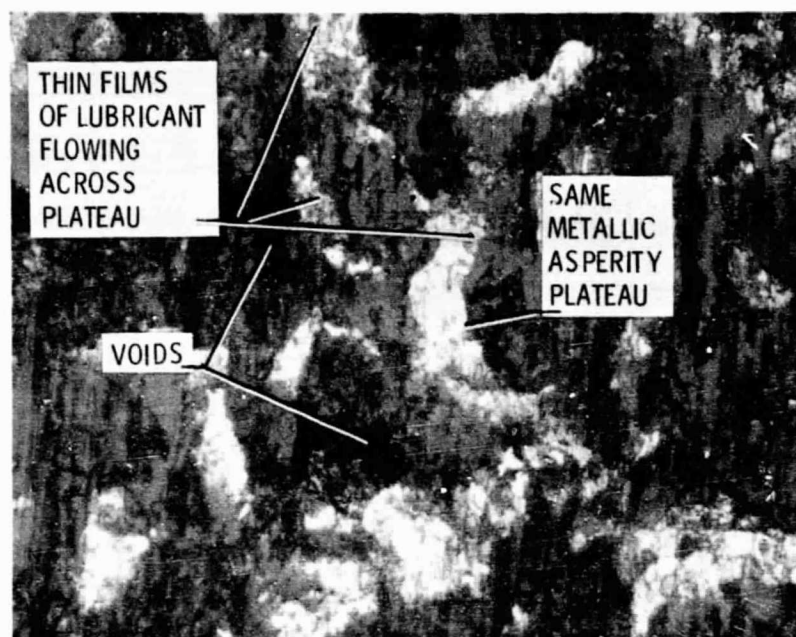
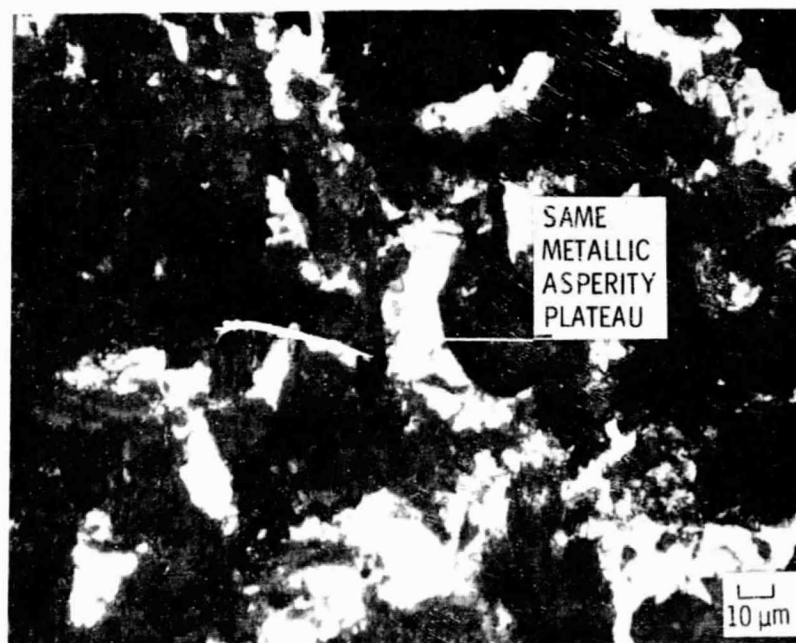
Figure 12. - High magnification photomicrographs of the same area on the polyimide-bonded graphite fluoride film wear track (for the hemisphere sliding on the 45 μ m thick film) after sliding intervals of 120, 500, 1800, and 2800 kc.

Figure 12 gives high magnification photomicrographs of the same area of the film wear track (for the hemisphere sliding on the 45 μm thick film) after sliding intervals of 120, 500, 1800, and 2800 kilocycles. The bright areas of figure 12 are flat metallic plateaus. The figure illustrates that the interaction of the rider with the sandblasted asperities was a gradual process. As sliding duration increased, the number of and the area of the individual asperity plateaus increased. Figure 12 also shows a number of voids (or depleted areas) in

the wear track. The dynamic nature of the lubrication process is evidenced by observing the movement of voids with sliding duration. Figure 13 gives an idealized schematic drawing of the sliding surfaces, illustrating this lubricating mechanism. The lubricant was supplied to the plateaus from the valleys between the asperities, and thin films of the lubricant essentially flowed across the plateaus and were deposited in a following valley.

It is believed this band resulted from depletion of the lubricant. Figure 12(d) shows valleys in the wear track becoming depleted of lubricant. When too many of these valleys became depleted, an excessive quantity of metallic wear particles was produced (from both the rider and disk substrate). These particles mixed with the lubricant and a powdery mixture of the two constituents resulted. It is interesting to note that the surfaces underneath this powdery buildup were still very smooth and no galling wear had taken place

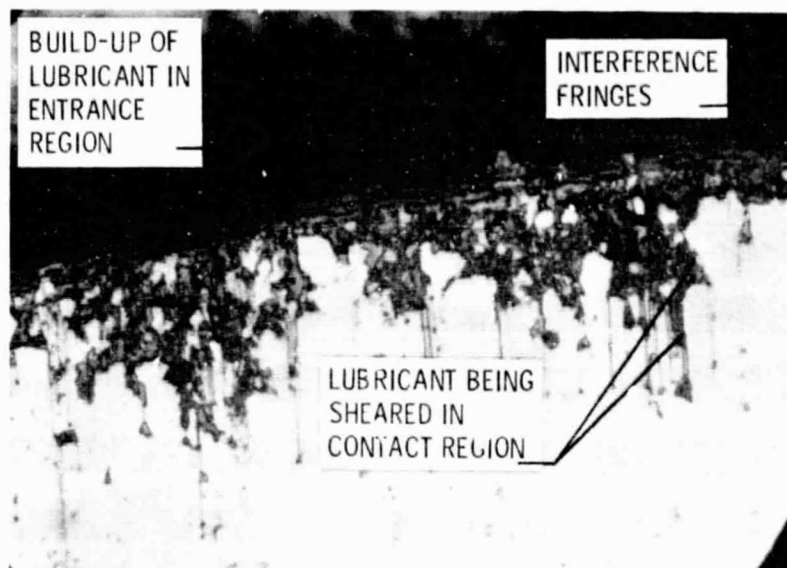
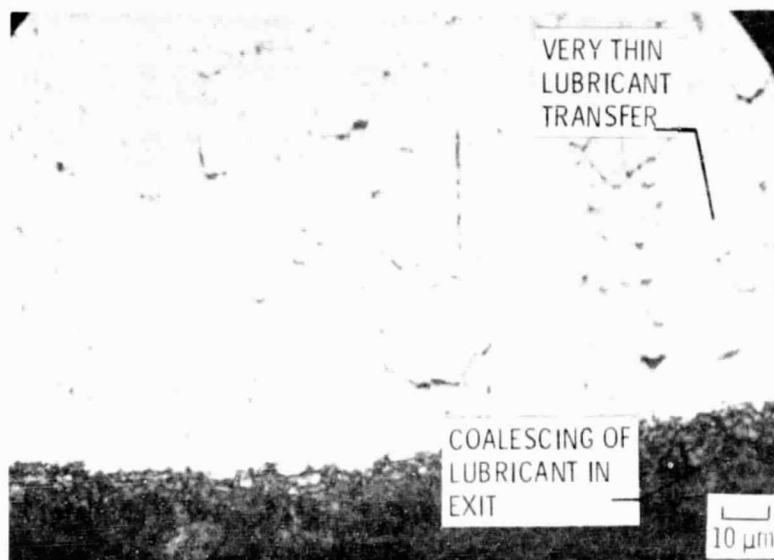
Figure 14. - High magnification photomicrographs of the rider wear scar inlet and exit areas of the 0.476 cm radius hemispherically-tipped rider after 2800 kc of sliding on the 45 μ m thick film.

The polyimide-bonded graphite fluoride tended to build up in the entrance region and was sheared thinner as it entered the contact zone. Interference fringes were observed in the entrance region and suggested that the polyimide-bonded graphite fluoride wear debris had coalesced into a very smooth, continuous film in the inlet area.

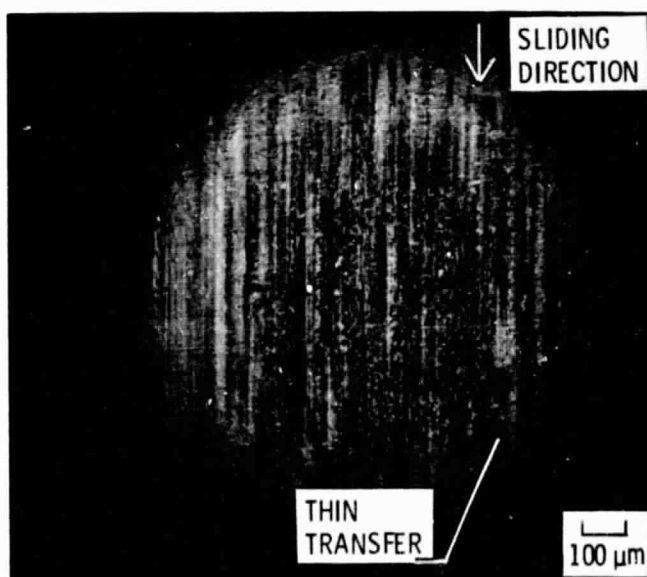
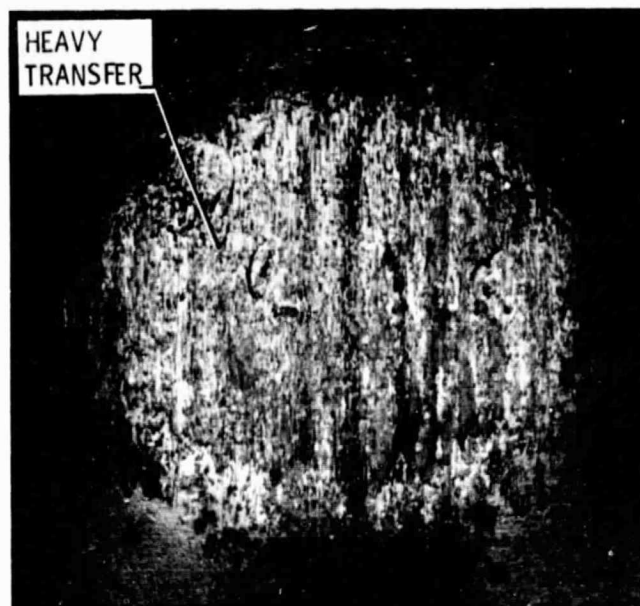
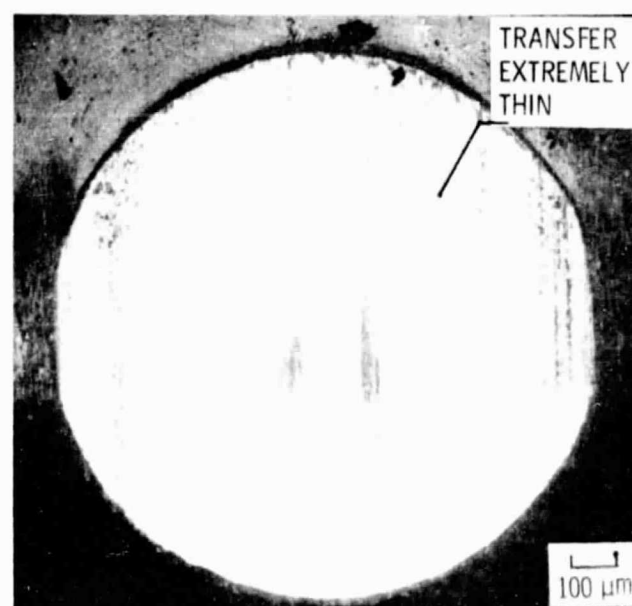
Figure 15. - Photomicrographs of the 440C HT stainless steel rider (with the 0.95 mm diam flat) after various sliding intervals.

Figure 15(d) shows the wear scar after 8500 kilocycles of sliding. The transfer and the wear results were found to be identical to those experiments in which the hemisphere slid on the film.

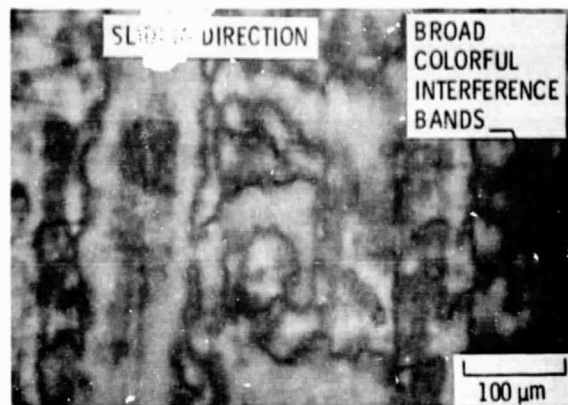
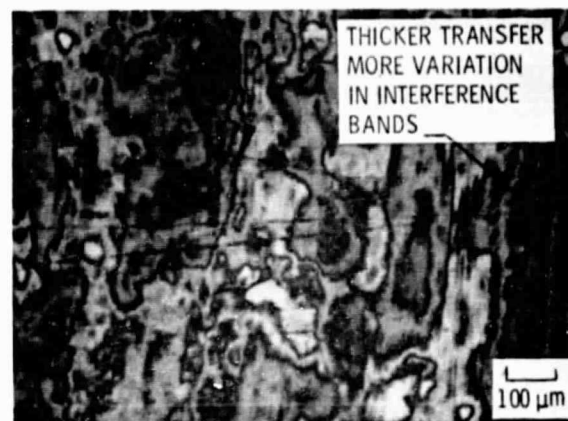
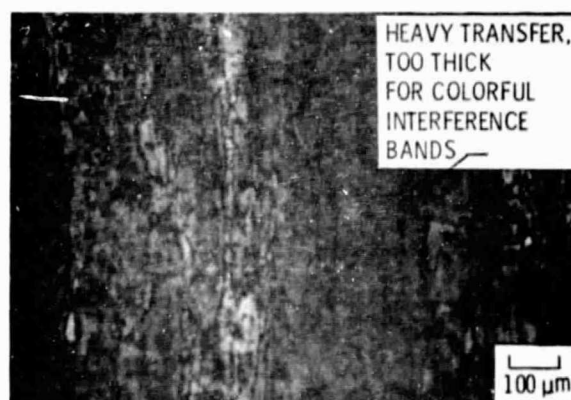
Figure 16. - High magnification photomicrographs of typical transfer to the 0.95 mm diameter flat on the rider after various sliding intervals.

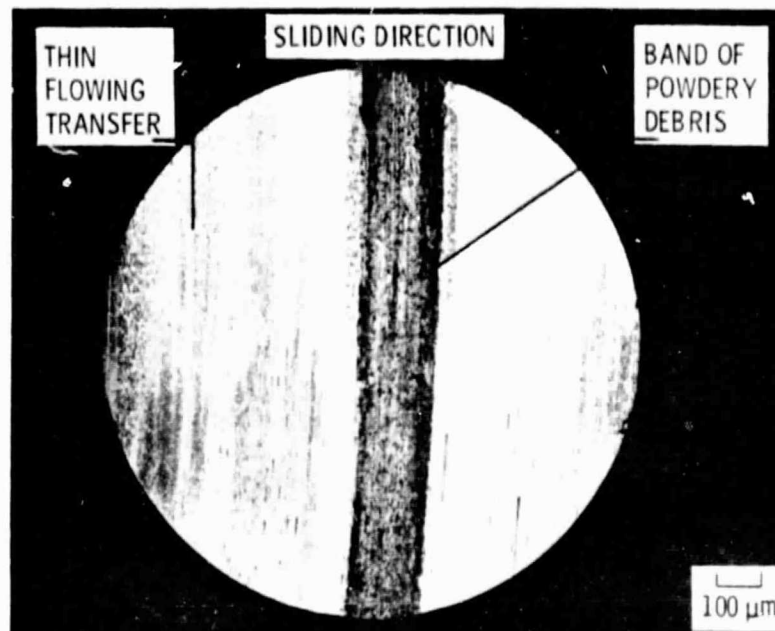
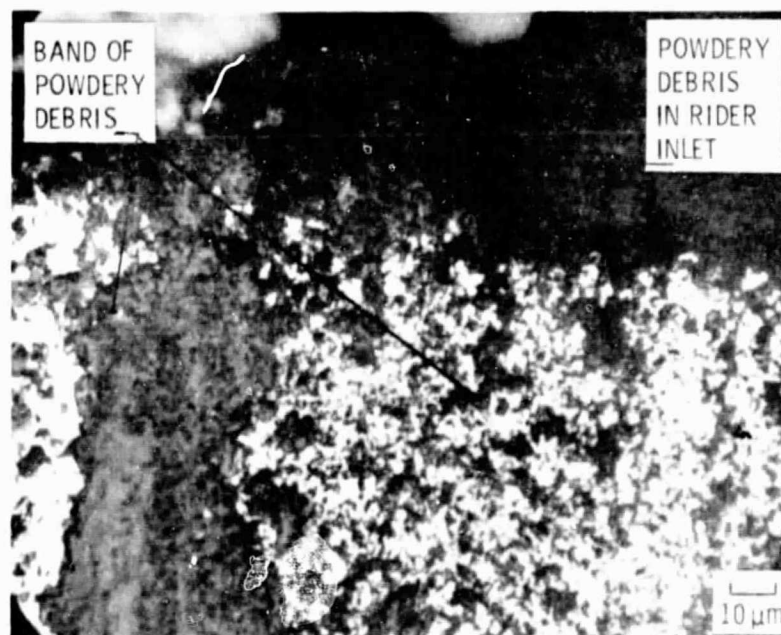
Figure 17. - Photomicrographs of a typical rider contact area after failure had occurred.

Figure 17 shows photomicrographs of the rider contact area from the test on the 45 μm thick film after failure occurred. The photomicrographs typify what happened with the films of other thicknesses. A powdery band was found to extend from the rider inlet region to the exit region (fig. 17(a)). A similar band was found on the disk wear track.
