NASA Technical Memorandum 81399

**CHEMICAL PROCESSES INVOLVED IN  
THE INITIATION OF HOT CORROSION  
OF B-1900 AND NASA-TRW VIA**

George C. Fryburg, Fred J. Kohl,  
and Carl A. Stearns  
Lewis Research Center  
Cleveland, Ohio

Prepared for the  
One hundred fifty-sixth Meeting of the  
Electrochemical Society  
Los Angeles, California, October 14-19, 1979

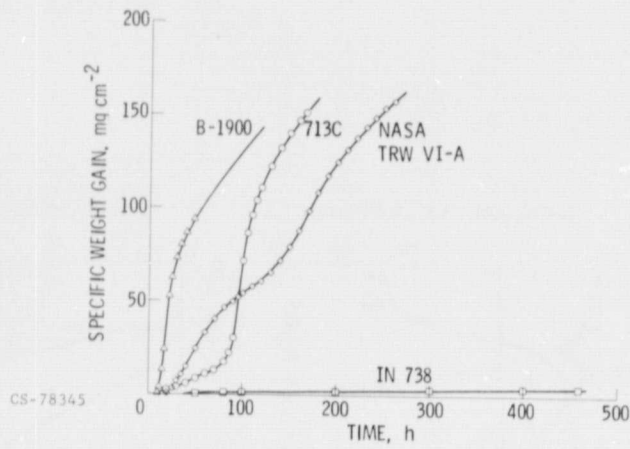
Figure 1. - Comparison of sodium sulfate-induced hot corrosion behavior of four nickel-base superalloys tested at 900° C. All specimens were preoxidized at 900° C for 100 hours in flowing oxygen and coated with 3 mg cm<sup>-2</sup> Na<sub>2</sub>SO<sub>4</sub> (Ref. 4) prior to hot corrosion test.

Thermogravimetric. - Both B-1900 and NASA-TRW VIA are alloys that are classified as "alumina formers"; that is, their oxidation resistance results from the formation of a thin dense protective oxide composed largely of  $\alpha$ -Al<sub>2</sub>O<sub>3</sub> (Ref. 9). Generally, alumina formers are more susceptible to hot corrosion than "chromia formers," i.e., alloys that derive their oxidation resistance from a protective oxide layer composed largely of Cr<sub>2</sub>O<sub>3</sub>. The comparative hot corrosion behavior of four nickel-base superalloys (B-1900, 713C, NASA-TRW VIA, and IN738) is shown in Figure 1 where we have plotted the specific weight gain against exposure time (Ref. 4). The samples were preoxidized for 100 hours at 900° C and corroded at the same temperature after application of 3 mg cm<sup>-2</sup> Na<sub>2</sub>SO<sub>4</sub>. The two alumina formers and 713C<sup>1</sup> corroded catastrophically while the chromia former, IN738, was hardly affected.

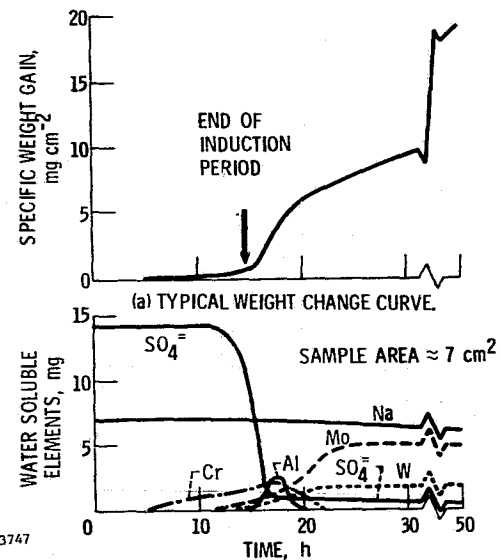
Figure 4 - Preoxidized NASA-TRW VJA with  $3 \text{ mg cm}^{-2} \text{ Na}_2\text{SO}_4$  tested at  $900^\circ \text{ C}$ .

The corrosion curve for VIA, shown in Figure 4a, is somewhat different from that for B-1900. The induction period is much longer, being about 15 hours, and the "abrupt change" in the slope is less pronounced. For VIA, the whole corrosion process is more protracted.

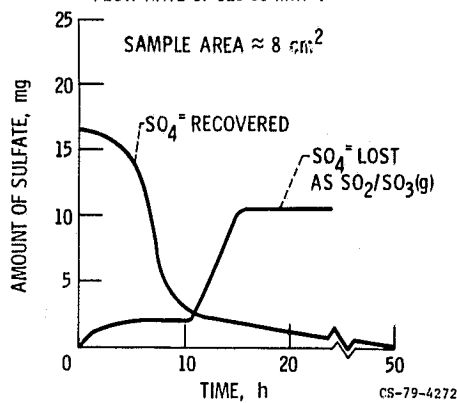
(c) COMPARISON OF THE AMOUNT OF WATER SOLUBLE SO<sub>4</sub><sup>2-</sup> RECOVERED WITH EQUIVALENT SO<sub>4</sub><sup>2-</sup> FROM SO<sub>2</sub>/SO<sub>3</sub>(g) EVOLVED.

It is instructive to relate the instantaneous concentrations of  $\text{SO}_2$  observed to the total amount of  $\text{SO}_2$  evolved during the corrosion process; that is, to integrate the concentrations over the time. These results are presented in Figure 5c where the amount of  $\text{SO}_2$  evolved after a given corrosion time is expressed in terms of the equivalent milligrams of  $\text{SO}_4^{=}$  required. The equivalent sulfate was calculated on the basis that the sulfur evolved as  $3/4 \text{SO}_2$  and  $1/4 \text{SO}_3$ .<sup>2</sup> For comparison, we also present in Figure 5c the amount of water soluble  $\text{SO}_4^{=}$  recovered (from Fig. 3b). It can be seen from Figure 5c that about 11 mg of the originally applied 17 mg was evolved as  $\text{SO}_2$ - $\text{SO}_3$  gases during the course of the hot corrosion. Roughly, 2 mg came off during the first  $2/3$  of the

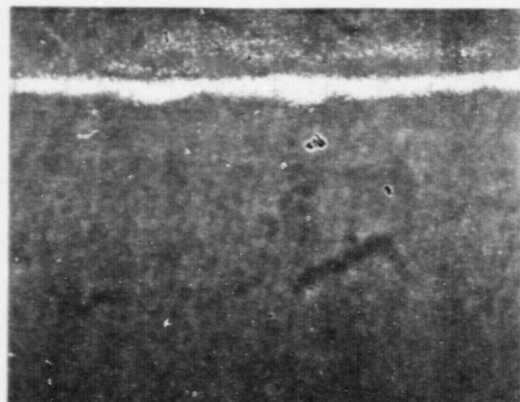
Figure 6. - Secondary electron micrograph and X-ray micrographs of preoxidized B-1900 sample corroded at 900° C with 3 mg cm<sup>-2</sup> Na<sub>2</sub>SO<sub>4</sub> for 15 minutes.

Microprobe Analysis. - Samples were mounted and cross-sectioned for microprobe examination by using dry techniques so that water soluble compounds, especially sodium compounds, were not removed. Most of this work was done with B-1900 samples. As a test of the efficacy of the techniques, a sample was prepared that had been corroded for only 15 minutes. This sample also served as a point of reference for the other B-1900 samples corroded for longer times. The secondary electron and elemental X-ray micrographs are displayed in Figure 6. The micrographs show that the sample is covered with a thin continuous protective oxide composed largely of  $\text{Al}_2\text{O}_3$  which, in turn, is covered with a layer of  $\text{Na}_2\text{SO}_4$ .

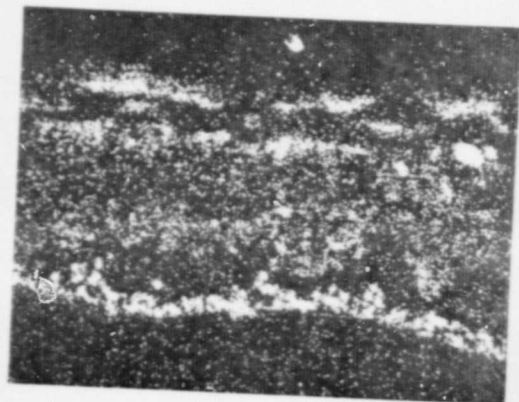
Figure 10. - Secondary electron micrograph and X-ray micrographs of preoxidized B-1900 sample corroded at 900° C with  $3 \text{ mg cm}^{-2} \text{ Na}_2\text{SO}_4$  for 6.25 hours. Arrow points out nickel sulfide particle in oxide scale.

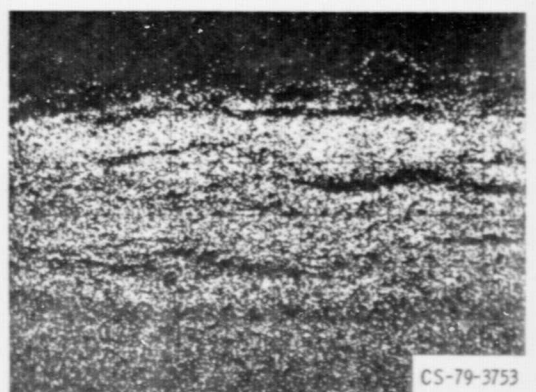
Figure 15. - Backscattered electron micrograph and X-ray micrographs of preoxidized B-1900 sample corroded at 900° C with 3 mg cm<sup>-2</sup> Na<sub>2</sub>SO<sub>4</sub> for 10 hours.

After 10 hours of corrosion exposure, the scale has increased markedly in thickness (Fig. 15). Residual nickel sulfides are still present but are much reduced in size while chromium sulfides are situated down in the alloy. The  $\text{Na}_2\text{MoO}_4$ - $\text{MoO}_3$  layer is prominent underneath the scale. Even at this stage in the corrosion, areas are present where attack is characteristic of much earlier times (Fig. 16), emphasizing the localized nature of the processes.

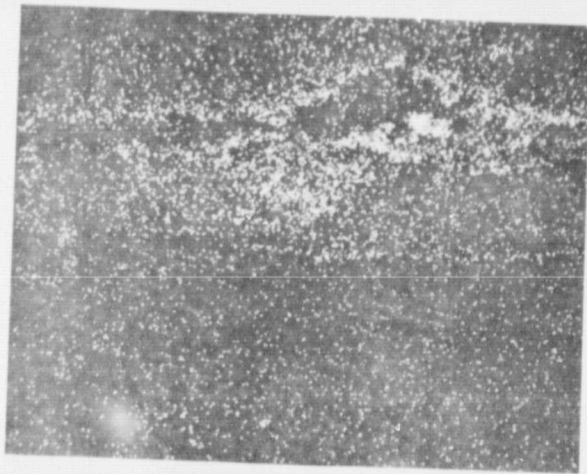
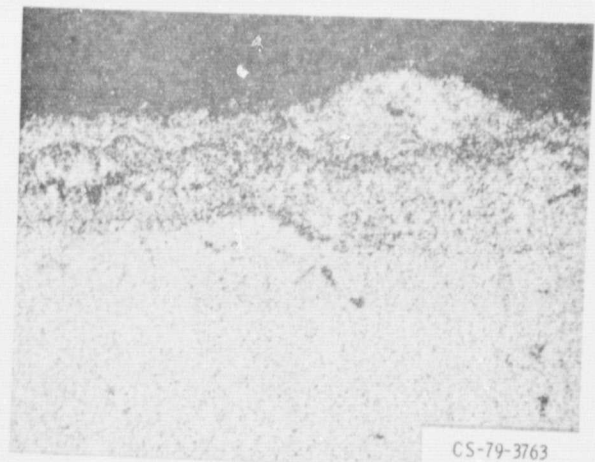
Figure 18. - Backscattered electron micrograph and X-ray micrographs of preoxidized NASA-TRW VIA sample corroded at 900° C with 3 mg cm<sup>-2</sup> Na<sub>2</sub>SO<sub>4</sub> for 17.5 hours.

While less extensive work has been done with the VIA alloy, it appears that the hot corrosion attack results in morphological features similar to those found with B-1900. Figure 18 shows the X-ray micrographs for a VIA sample corroded for 17.5 hours, a time just after the end of the induction period. The  $\text{Na}_2\text{MoO}_4$ - $\text{MoO}_3$  layer is prominent and

is progressing under the oxide scale from right to left. This sample was cut and polished by using standard wet techniques so that no sodium X-ray micrographs were obtainable. Nevertheless, the morphology is very similar to that of B-1900 samples at the same stage of corrosion.
