ENDURANCE AND FAILURE  
CHARACTERISTICS OF MODIFIED  
VASCO X-2, CBS 600 AND  
AISI 9310 SPUR GEARS

Dennis P. Townsend and E. V. Zaretsky  
Lewis Research Center  
Cleveland, Ohio

Prepared for the  
Third International Power Transmission and Gearing Conference  
sponsored by the American Society of Mechanical Engineers  
San Francisco, California, August 18-22, 1980

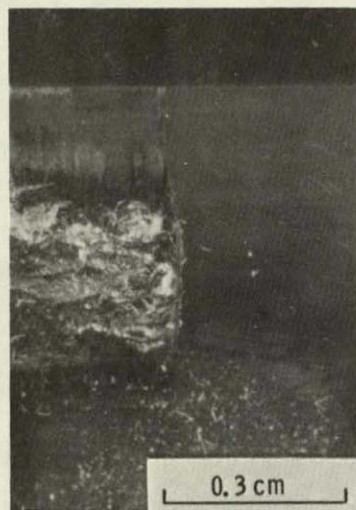
(a) FATIGUE SPALL.

(b) CROSS SECTION OF SPALL.

Figure 7. - Typical pitch-line fatigue spall of CBS 600 test gear. Speed, 10 000 rpm; lubricant, synthetic paraffinic oil with additive package.

One of the fatigue spalls on the CBS 600 gears is shown in Fig. 7(a). A cross section of this fatigue spall is shown in Fig. 7(b). The two gears with pitting failures were run for 6 hours after spalling had occurred. A single tooth bending fracture occurred on each of the gears as a result of the overrun. A fractured tooth is shown in Fig. 8. AISI 9310 gears that were overrun did not fracture.

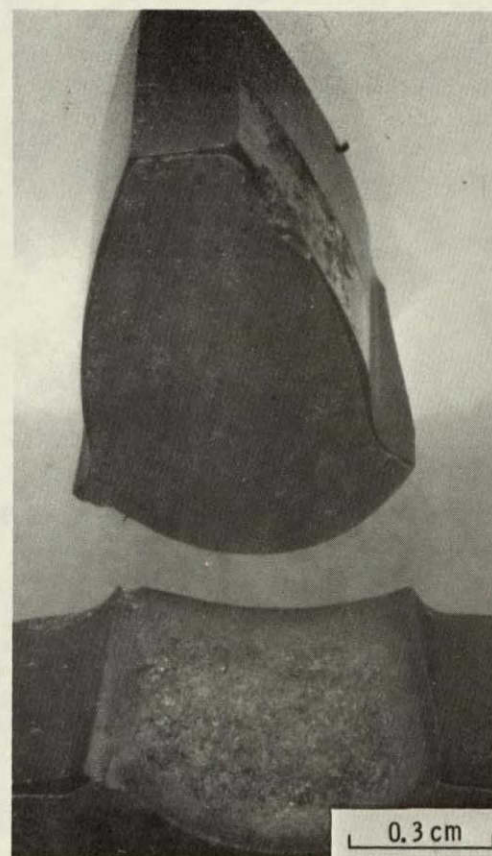
Figure 8. - Typical tooth bending fracture on CBS 600 after running with a fatigue spall; speed, 10 000 rpm; lubricant, synthetic paraffinic oil with additive package.

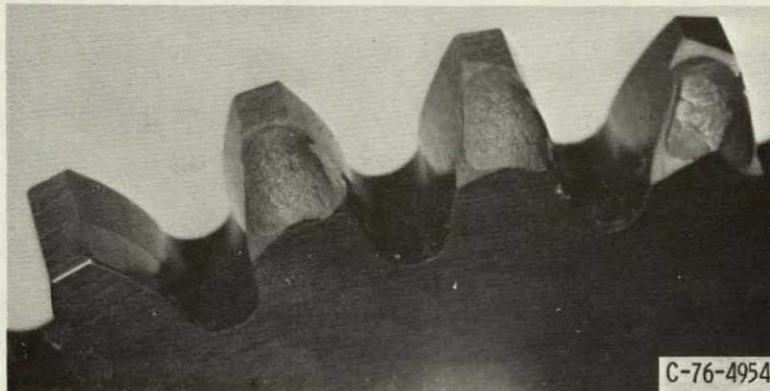
Figure 9. - Typical fracture of modified Vasco X-2 gear teeth with NASA specified heat treatment carburized on all sides.

Four pairs of modified Vasco X-2 gears having the NASA heat treat specification which were carburized on all sides were tested. Several fracture failures occurred, in a short time on each pair of gears tested. Failure was by tooth fracture at the tips of the teeth as shown in Fig. 9.

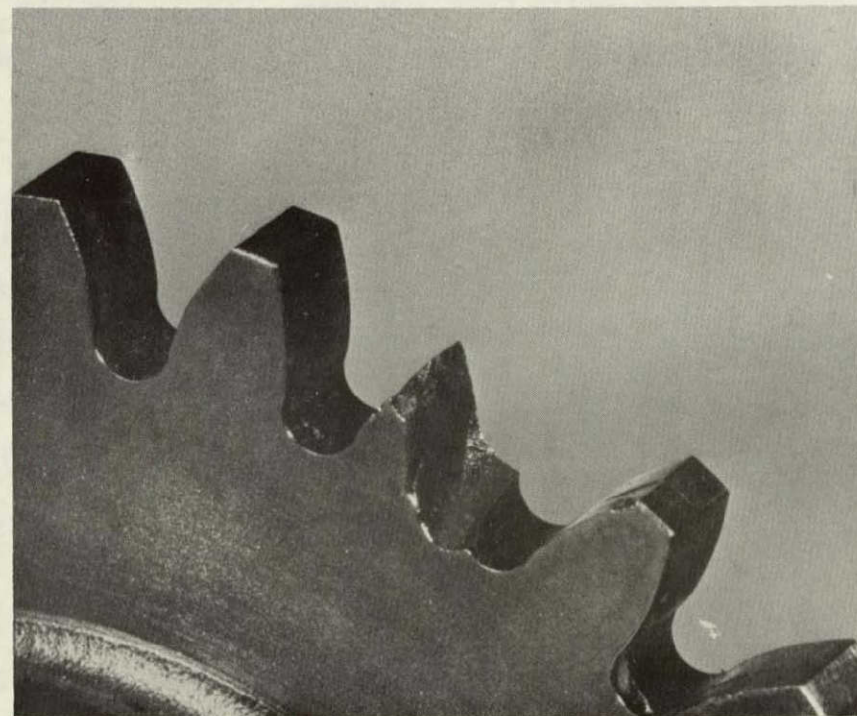
Figure 12. - Gear tooth fracture through a fatigue spall of NASA heat treated modified Vasco X-2, maximum Hertz stress,  $1.71 \times 10^9$  N/m<sup>2</sup> (248 000 psi) speed, 10 000 rpm.

The pitting fatigue life results for the three lots of gears made from the modified Vasco X-2 are shown in Fig. 11. A statistical comparison was made between the gear tooth pitting fatigue life of the three lots of modified Vasco X-2 gears and the CVM AISI 9310 and is summarized in Table 6. The difference between the pitting fatigue life of the AISI 9310 gears and modified Vasco X-2 lot D having the Boeing Vertol heat treatment gears is statistically insignificant with a confidence number of 80 percent. Lots B and C having the NASA and Curtis-Wright heat treatments, respectively, had statistically lower lives than the AISI 9310 gears. In addition, lot B had fracture failures of several of the gears concurrent with the pitting fatigue failure. A representative fracture failure is shown in Fig. 12.
