UPDATE OF THE IUE BATTERY IN-FLIGHT PERFORMANCE

S. Tiller
NASA/GSFC

RECONDITIONING OF VIKING LANDER BATTERY

A. Britting
Martin Marietta

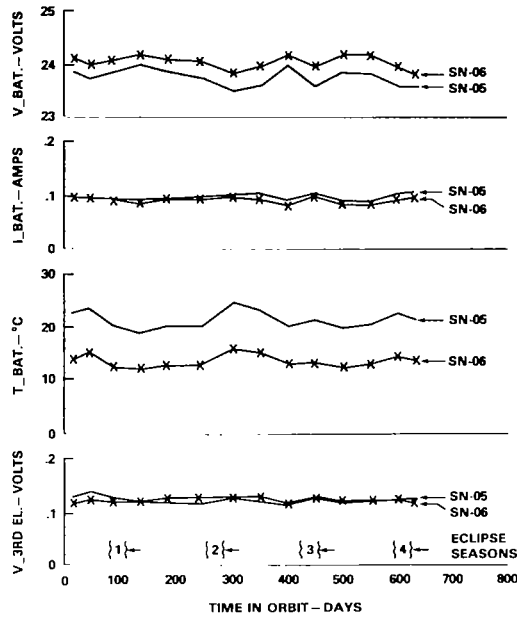
Figure 3-22

These curves are plotted from the spacecraft telemetry data with a point selected at random over approximately 625 days of operation. The battery current curves, charge current curves, and the third electrode curves indicate that they are being well maintained in the trickle charge mode of operation.

The fluctuations noted in the battery voltage and the battery temperature are caused by the spacecraft being moved throughout a beta range of 0 to 130 degrees. At 0 and 130 degrees, the solar panels start becoming efficient, and at that time the batteries will start producing power, sending power to the spacecraft.

**IUE SPACECRAFT
BATTERY TRICKLE CHARGE CHARACTERISTICS
DURING THE SOLAR SOLSTICE SEASONS
(BATTERIES SN-05, -06)**

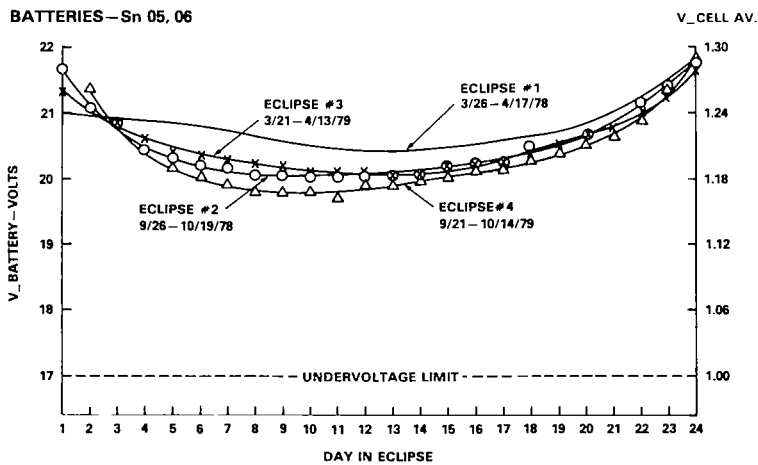
Figure 3-23

This data represents the battery discharge voltage during the peak eclipse seasons, one through four. One thing I would like to point out is that during eclipse seasons three and four, the spacecraft power requirements reduced slightly in order to maintain the batteries above an 80-percent DOD and above a 4.5-ampere discharge current. You can notice this on the third and fourth eclipse seasons, as compared to eclipse season number two.

**END OF DISCHARGE VOLTAGE VS DAY IN ECLIPSE
(IUE SPACECRAFT)**

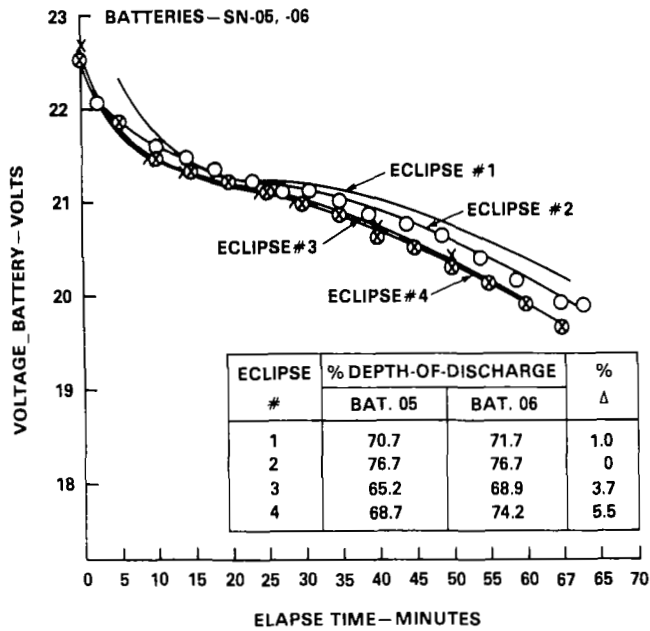
Figure 3-24

Here you see the battery voltage observed at the end of the discharge during the daily seasons or daily eclipse periods over the four eclipse seasons.

Here again you can notice the eclipse season number two and number three, that number two actually has a lower voltage than number three, due to the reduction in spacecraft power during the eclipse season three and four.

IUE SPACECRAFT BATTERY DISCHARGE VOLTAGE AT THE PEAK ECLIPSE PERIOD OF SOLAR ECLIPSE SEASONS 1-4

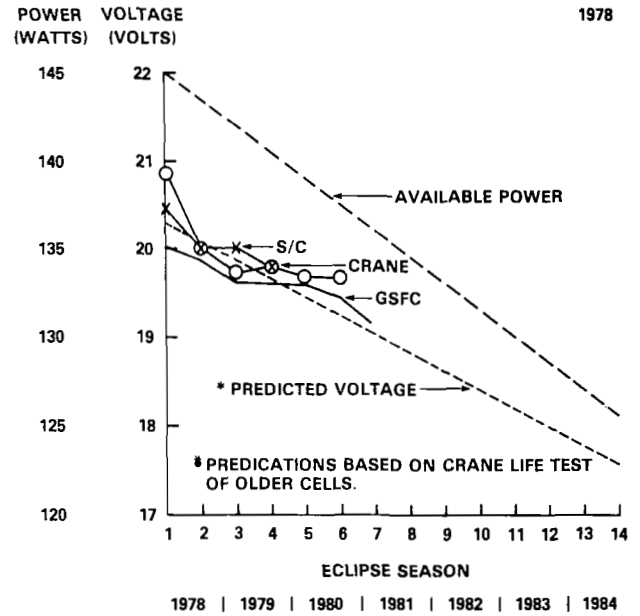
Figure 3-25

The two dashed lines in this graph represent the rate of battery voltage degradation relative to the available power to the spacecraft, over 14 solar eclipse seasons.

The X's represent the spacecraft batteries, the circles represent data performed on a 6-ampere-hour test pack at Crane, and the lower curve represents data acquired from a test flight tested here at the Goddard Space Flight Center.

The pack that was tested at Goddard had been in operation for approximately 1 year prior to the first solar eclipse season at about a 50-percent DOD. After we made some calculations, we believe the battery voltage is approximately 1/4 volt high for this particular data.

The trends being established from these three sources indicate that the spacecraft battery will follow the trend that was predicted on the curve. Future data points from the spacecraft battery and from the tests at Crane will be plotted on the future curves to maintain trends through the future eclipse seasons.

IUE SPACECRAFT BATTERY AVAILABLE POWER AND VOLTAGE VS ECLIPSE SEASONS PREDICTED PERFORMANCE AT 80% D.O.D.

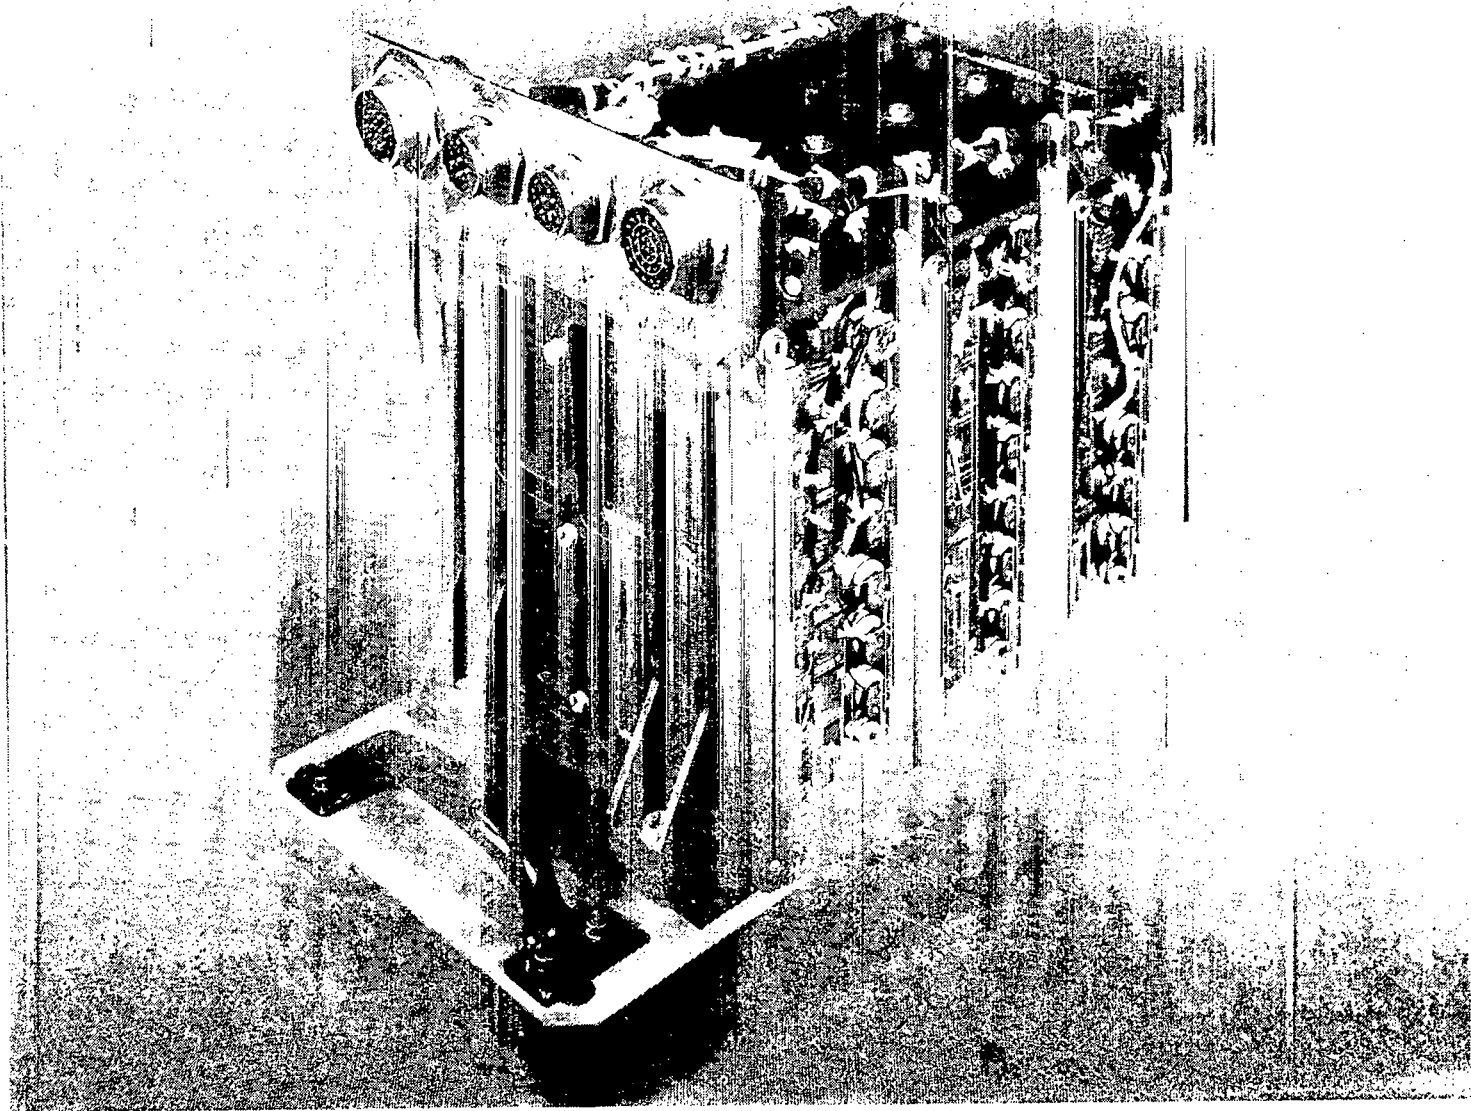
Figure 3-28

As I said, the batteries are 24-cell, 8-ampere hour NiCads. We have two batteries for assembly. In the picture on the right you have one battery in the front, second battery in the back. We have two battery assemblies per spacecraft. Each battery weighs 50 1/2 pounds.

Heat sterilization requirement was the item for which we had no data base to draw from so we chose to use Pellon FT 2140 nonwoven polypropylene separator material.

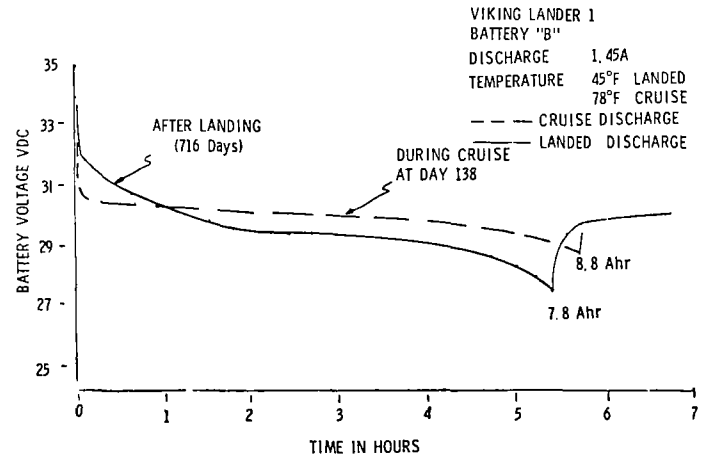
Figure 3-32

We did condition the batteries during cruise. Now that conditioning was done by charging them, discharging them through a 19.3-ohm fix load, and then recharging them, measuring the ampere-hour capacity and recording it.

This is one of the batteries on Viking Lander 1, battery B. During cruise we measured a capacity of 8.8 ampere-hours. We didn't intend to do subsequent tests after landing because we did plan on a 90-day mission. But there was some opportunity here to get some information as far as degradation on the battery is concerned. So we went ahead and reactivated the discharge sequence after 716 days on the surface. We discharged and compared each one of the batteries. This one is representative of the Lander 1 batteries, having roughly a 10-percent degradation after almost 2 years.

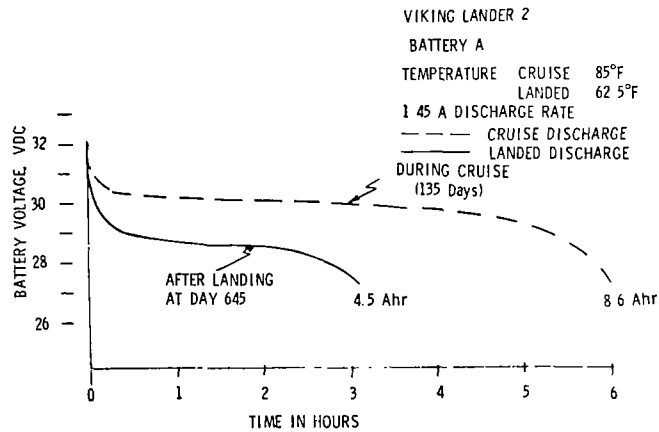
Figure 3-33

Lander 2 had some interesting differences. This lander tended to operate at a higher temperature than the other lander. We had some spacecraft hardware anomalies that caused it—part of the contribution to the high temperature was a busier sequence, which tended to heat up the equipment bus.

The second curve here was taken just a little bit less than 2 years after touchdown.

What happened here is that during the Martian winter, this particular vehicle happened to sit right on the edge of the northern polar cap on Mars, and therefore we were afraid that frost was going to build up on the landers. As a result, we shut down much of the external operating hardware, such as soil samplers, etc. As a result, the lander was essentially asleep. With it being asleep, we didn't terminate the charge-discharge sequence. We went ahead on a 1-hour charge cycle, but with no discharging, constantly putting power in for 1-hour cycles for roughly the Martian winter, about 6 months.

I think this was partly contributing to the 4.5-ampere hour, or 50-percent loss in capacity that we see here.

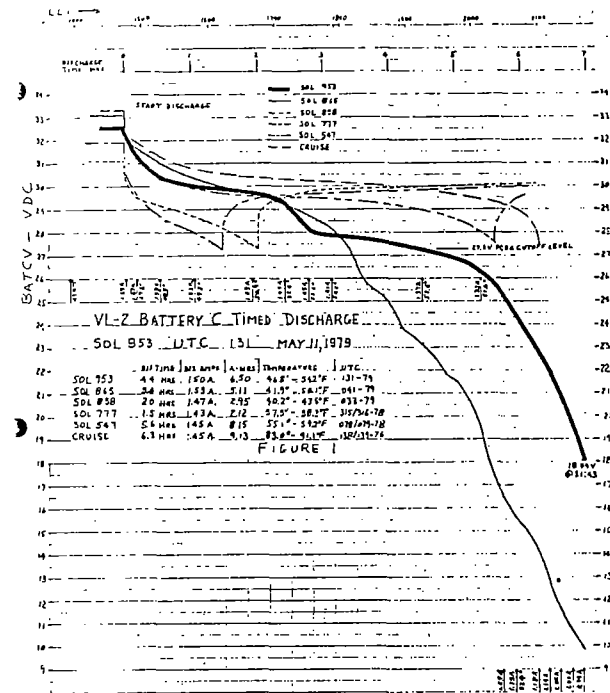
Figure 3-34

Slightly after the workshop, we got additional data, which showed us the hardware anomaly that caused us to operate in excess of 80°F for the 137-day period. Coupled with low-discharge rates, low-recharge rates, and because of the high temperatures, there was lower battery terminal voltage.

When we came out of this period, we found that we had lost roughly as much as 75-percent original capacity of the batteries. At this time we decided to embark on a program on Lander 2, to do more than just to discharge to the predetermined 27.3-volt cutoff that we had been normally doing earlier along the curve here, and do a time discharge instead.

We arbitrarily chose a 7-hour time discharge through the 19.3-ohm resistive load bank because it fit nicely into the sequence. We followed that by a 21-hour recharge, C/8, and the 19.3 ohms give us a value of C/5 discharge rate. Some of the gains can be seen in the next chart.
