NASA Technical Memorandum 81512

DEVELOPMENT OF IMPROVED-DURABILITY
PLASMA SPRAYED CERAMIC COATINGS
FOR GAS TURBINE ENGINES

Prepared for the
Sixteenth Joint Propulsion Conference
cosponsored by the AIAA, ASME, and SAE
Hartford, Connecticut, June 30-July 2, 1980

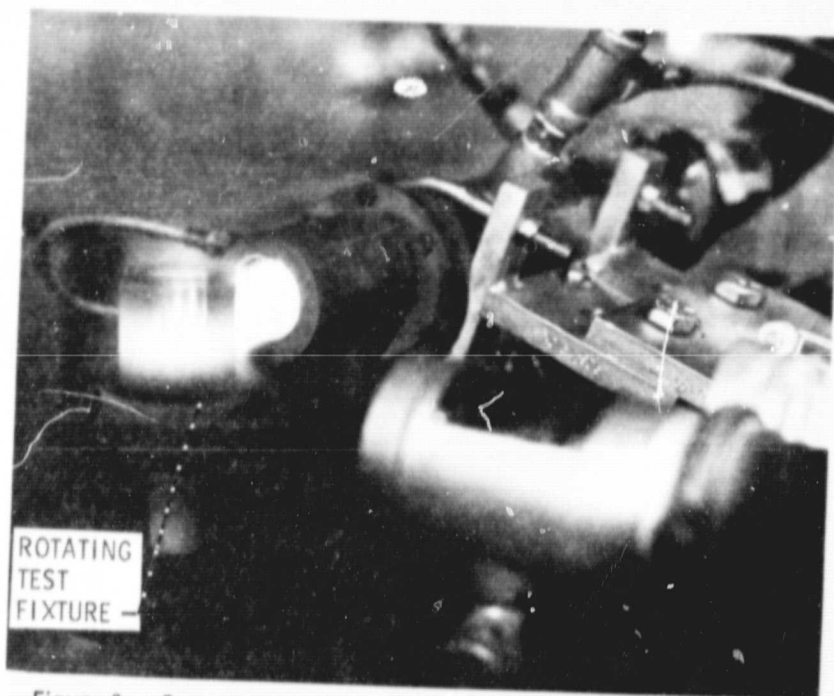
Figure 3. - Burner rig in operation during hot portion of the thermal cycle.

Burner rig tests were performed to determine the relative durability of the various TBC systems in a cyclic thermal environment. Twelve of the TBC test specimens mounted in a test fixture and ready for burner rig testing are shown in Fig. 2. The thermal cycle consisted of a 4 minute period of heating to a maximum temperature of 1010° C (1850° F) followed by a 2 minute period of cooling to approximately 260° C (500° F) or less. The test fixture was rotated at 1725 rpm in the exhaust gas stream of a Jet A fueled burner to provide a relatively uniform hot temperature environment for all test specimens (Fig. 3). The gas velocity at the specimen location was Mach 0.3. The specimen temperature was monitored and controlled using an optical pyrometer and an automatic feedback controller to vary the fuel flow to the burner. The emittance of the test specimens was measured periodically, and corrections were applied to maintain accurate test temperatures. During the cooling period of the cycle, the burner was automatically moved away from the test fixture and forced air cooling was directed at the test specimens.

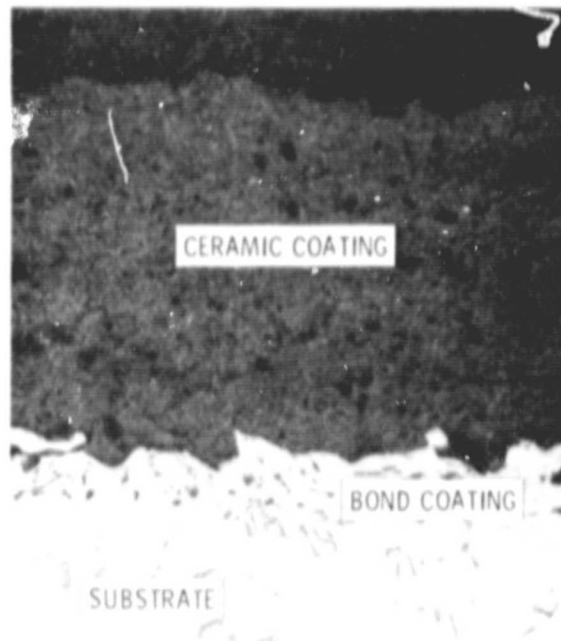
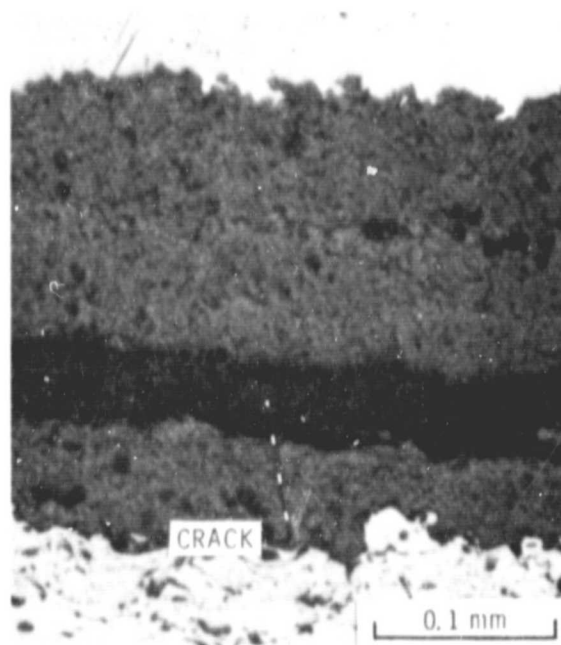
(a) PRE-TEST.

(b) POST-TEST.

Figure 5. - Dense microstructure of baseline 20 w/o YSZ TBC.

The baseline 20 w/o YSZ PS coating applied using the -325 mesh fine powder was a relatively dense coating having a porosity of approximately 10 percent. The coating had a fully stabilized cubic structure with only a very small amount of the monoclinic phase as determined by X-ray diffraction analyses. This was typical of all of the 20 w/o YSZ coating systems. A comparison of the microstructures representative of the pre-test and post-test condition of the coating is shown in Fig. 5. The very dense structure of the ceramic coating most likely resulted in relatively high stresses within the coating. It was observed that the coatings normally failed by exhibiting buckling of the ceramic during the cold portion of the thermal cycle. This appeared to be caused by compressive stresses in the plane of the coating and the resultant tensile stress normal to the plane of the coating. These stresses would tend to create cracks in the plane of the coating such as shown in Fig. 5(b).

A typical burner rig bar coating failure is shown in Fig. 7. The ceramic coating spalled adjacent to the ceramic/bond coating interface leaving a thin irregular layer of ceramic still attached to the bond coating. This failure is consistent with the cracks seen in the microstructure (Figs. 5 and 6) and also with previous findings which indicated that the region of the coating immediately adjacent to the bond coating was the weakest link in the structure.⁵

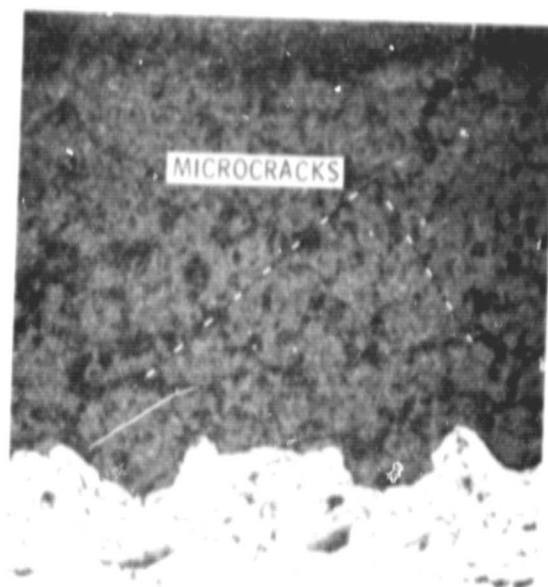
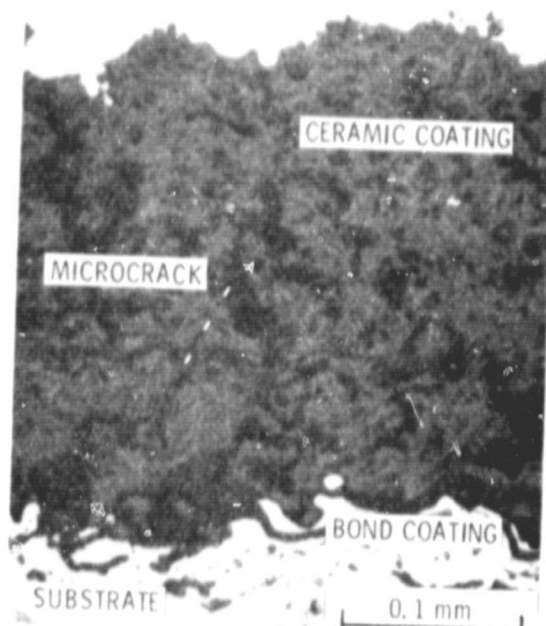
(a) PRE-TEST.

(b) POST-TEST.

Figure 6. - Porous microstructure of 20 w/o YSZ TBC using coarse (-170 mesh) powder.

This 20 w/o YSZ TBC was applied using a coarser -170 mesh powder. The resulting coating was less dense than the baseline, having a porosity of approximately 15-20 percent. A comparison of the microstructures of the coating representative of the pre-test and post-test conditions is shown in Fig. 6. The durability of this coating (6000 cycles) was due to the strain tolerance provided by the porous microstructure which effec-

tively reduced the modulus of elasticity from that of a more dense structure. Some limited microcracking of the ceramic microstructure can also be seen, both before and after testing. The microcracks lying in the plane of the coating (parallel to the ceramic/bond coat interface) might be expected to propagate and eventually lead to spallation of the coating.

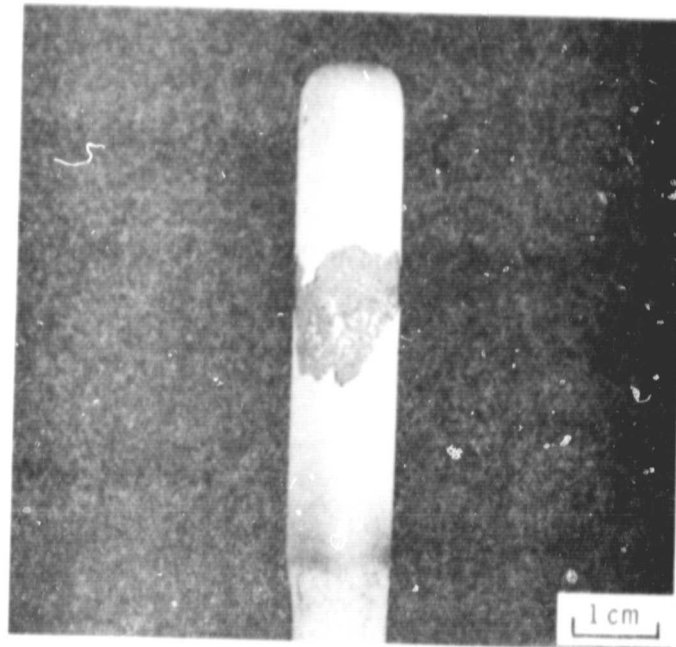
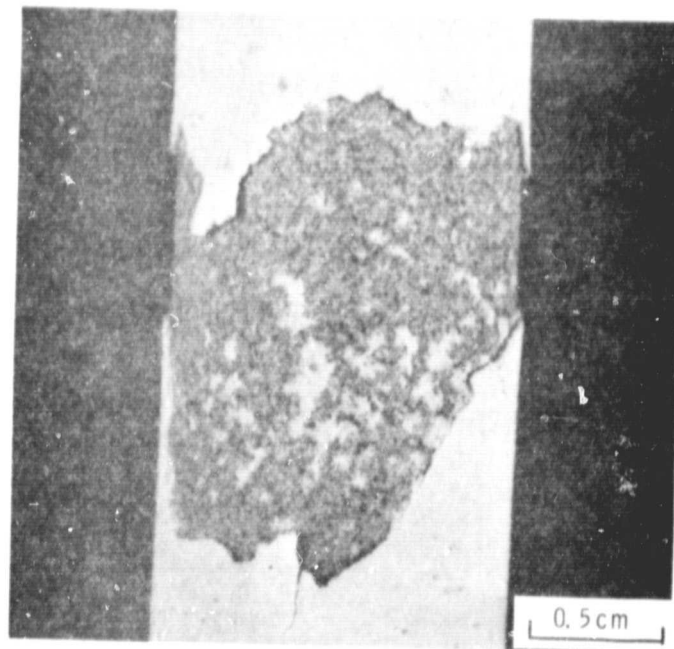
Figure 7. - Typical spallation failure of porous 20 w/o YSZ TBC after thermal cycling in burner rig test.

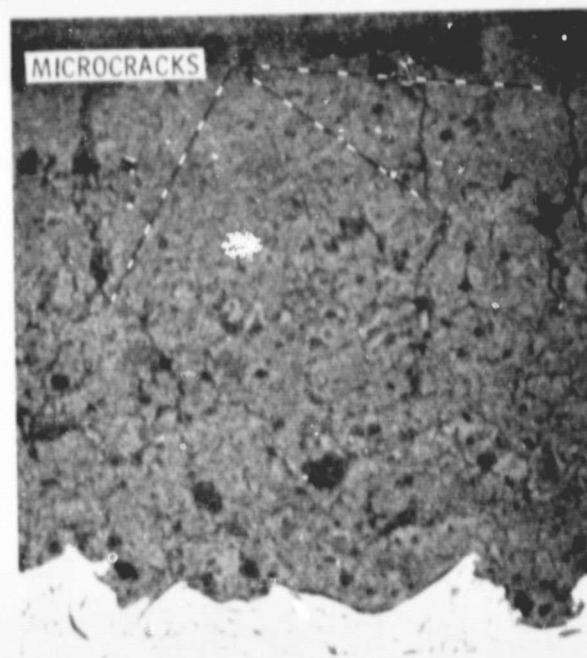
(a) PRE-TEST.

(b) POST-TEST.

Figure 8. - Microcracked microstructures of 21 w/o MSZ TBC.

An increased level of microcracking in the ceramic structure was obtained by varying the baseline chemistry from 20 w/o YSZ to 21 w/o MSZ. All other plasma spray parameters remained the same. The microstructure for this coating is shown in Fig. 8. The 21 w/o MSZ coating has a partially stabilized cubic structure which may undergo a phase transformation to a tetragonal structure with a considerable fraction of the monoclinic phase. Some free magnesium oxide (MgO) particles may also be found. Both the monoclinic ZrO₂ and the free MgO contribute to the extensive microcracking in the coating. The microcracking was essentially discontinuous and random in direction. These microcracks, in general, did not tend to propagate, although the start of two larger cracks, one normal to and one in the plane of the coating, could be noted after testing (Fig. 8(b)). The crack in the plane of the coating could ultimately lead to a failure of the coating. For this coating system, the microcracking apparently acted as an effective strain relief mechanism as evidenced by the 5230 cycle durability determined in the burner rig test.

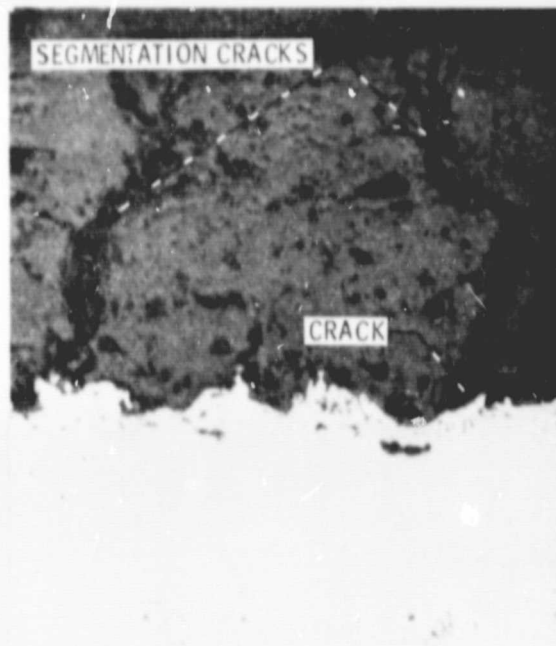
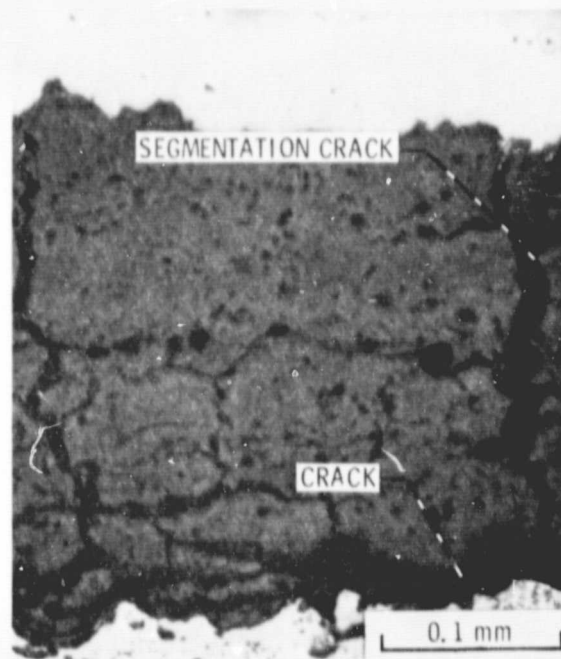
(a) PRE-TEST.

(b) POST-TEST.

Figure 9. - Segmented microstructures of 20 w/o YSZ TBC with 2.5 cm gun to specimen distance.

One technique of creating a segmented ceramic coating was to reduce the baseline gun to specimen distance from 7.6 to 2.5 cm (3 to 1 in.). The microstructure of the porous 20 w/o YSZ PS coating using the reduced gun distance is shown in Fig. 9. For this case, the coating exhibited an increased density due to melting which resulted from the extreme heat. Upon cooling, segmentation cracks were created normal to the plane of the coating. Some cracking (or increased porosity) also occurred parallel to the plane of the coating (Fig. 9(a)) which would have an adverse effect on

coating durability. These cracks tended to propagate into larger cracks, such as can be noted in Fig. 9(b), during the burner rig testing. The durability of this coating (5490 cycles) indicated that the segmented structure did relieve the strain mismatches. However, additional investigation and careful control of the PS application parameters would be required to optimize this system by eliminating the flaws in the plane of the coating while still maintaining the desired segmentation characteristics.

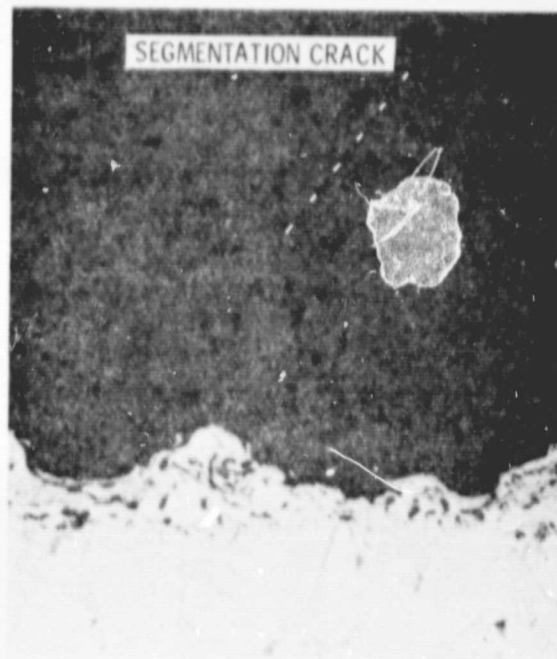
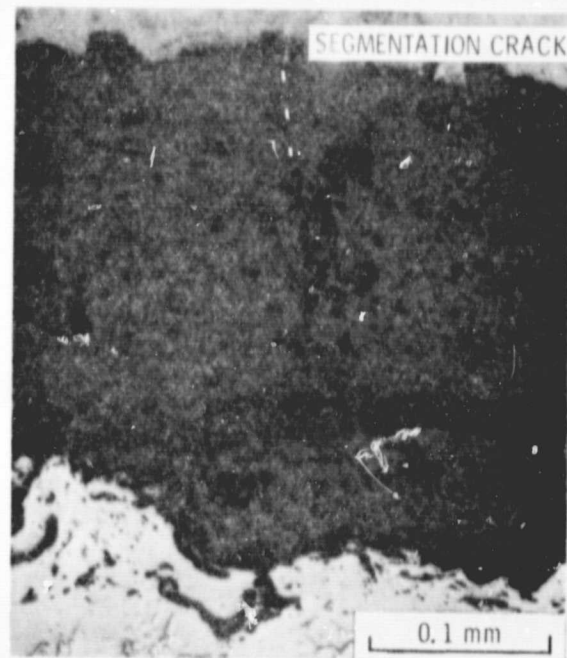
(a) PRE-TEST.

(b) POST-TEST.

Figure 10. - Segmented microstructures of 6 w/o YSZ TBC with fine powder.

A second technique of creating a PS segmented ceramic structure was the 6 w/o YSZ coating where a fine particle size powder (~325 mesh) had been used (Fig. 10). The 6 w/o YSZ was only partially stabilized and underwent a partial transformation from a cubic to a tetragonal phase upon cooling. The segmentation was believed to be due to a volume reduction associated with the phase transformation, thereby creating tensile stresses which resulted in cracking of the coating normal to the interface. Two of the test specimens exhibited a relatively long life (4410 and 5040 cycles) while the third specimen failed at 1570 cycles. However, the 6 w/o YSZ was considered to be one of the more promising systems tested. For this particular segmented coating, the characteristic size of a typical segmented column was about 1 mm (40 mil). The remnant segmentation pattern remaining on the burner rig bar after testing was completed is shown in Fig. 11. Further investigation is required, particularly to develop a more porous microstructure using a coarser particle size powder as used in some previous investigations.⁶

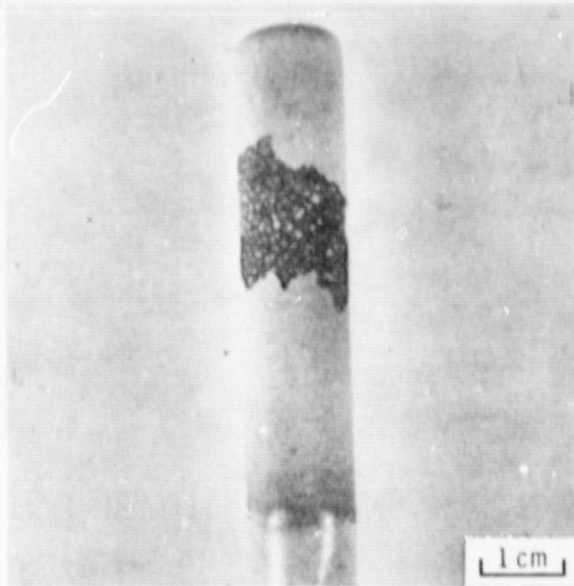
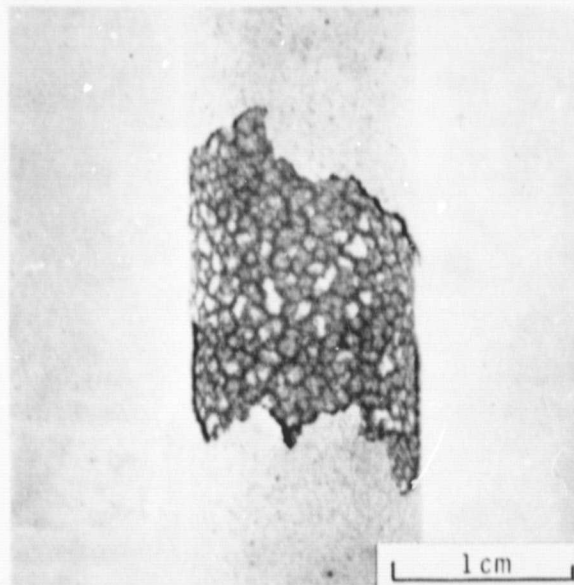
Figure 11. - Failure of 6 w/o YSZ TBC showing remnants of segmentation pattern in spalled region.

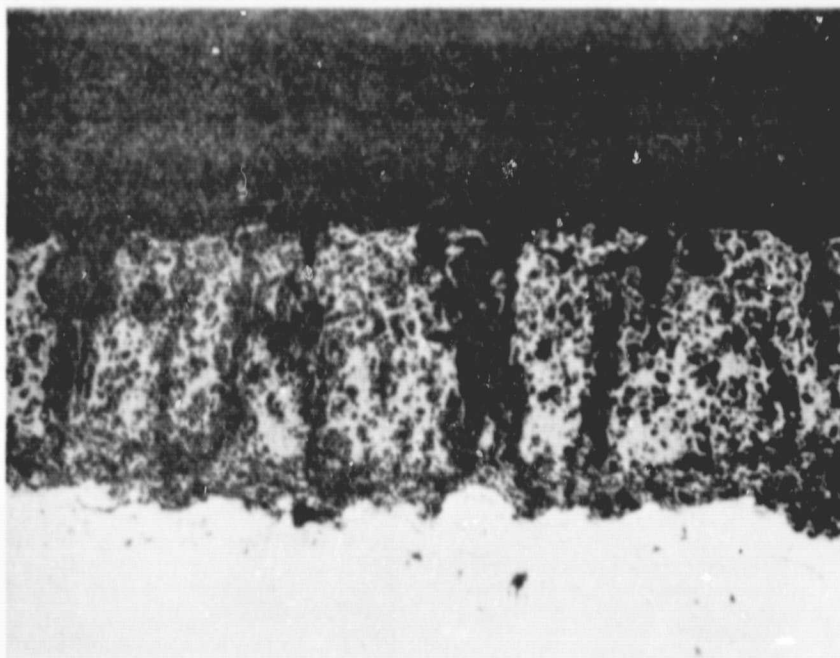
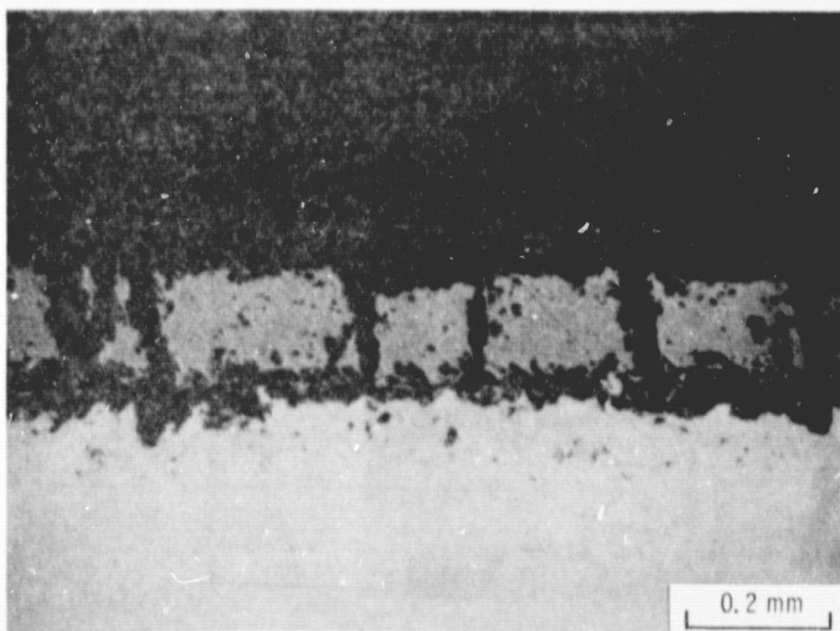
(a) 0.6 cm DIAMETER LASER BEAM PATTERN; 2 kW POWER INPUT; 4.2 cm/sec SCANNING SPEED.

(b) 6.1 cm ELLIPTICAL LASER BEAM PATTERN; 5 kW POWER INPUT; 2.1 cm/sec SCANNING SPEED.

Figure 12. - Segmented microstructures of 20 YSZ TBC using laser scanning.

The third technique of providing a segmented PS coating was to scan the surface of the baseline 20 w/o YSZ coating with a laser beam. The intense heat produced by the laser beam melted and densified the ceramic coating. Upon cooling, residual segmentation cracks normal to the plane of the coating were produced. The laser scanning was performed using a CO₂ laser with a wavelength of 10.6 microns. The laser beam was focused to produce either a circular or an elliptical "donut" shaped beam. Two examples of the microstructures produced during preliminary tests on flat 5 cm (2 in.) square test coupons for varying laser beam conditions are shown in Fig. 12. In each case, cracking of the ceramic coating normal to the interface and extending just to the bond coat was achieved.

Laser scanning of round burner rig bar specimens was accomplished with a 8.8 cm (3.45 in.) elliptical beam, a power input of 5 kW and a scanning speed of approximately 1.27 cm/sec (30 in./min). However, it was necessary to use the porous 20 w/o YSZ coating system and to preheat the coated round bar specimens to 845° C (1550° F) prior to the laser scanning process to avoid premature spallation of the coating upon cooling after laser scanning was completed. The preheating apparently allowed accommodation of thermal strains induced in the coating by the intense laser heating. Looking back to the preliminary tests using the flat coupons, these same thermal strains had apparently been accommodated by actual bending of the thin metal substrate.

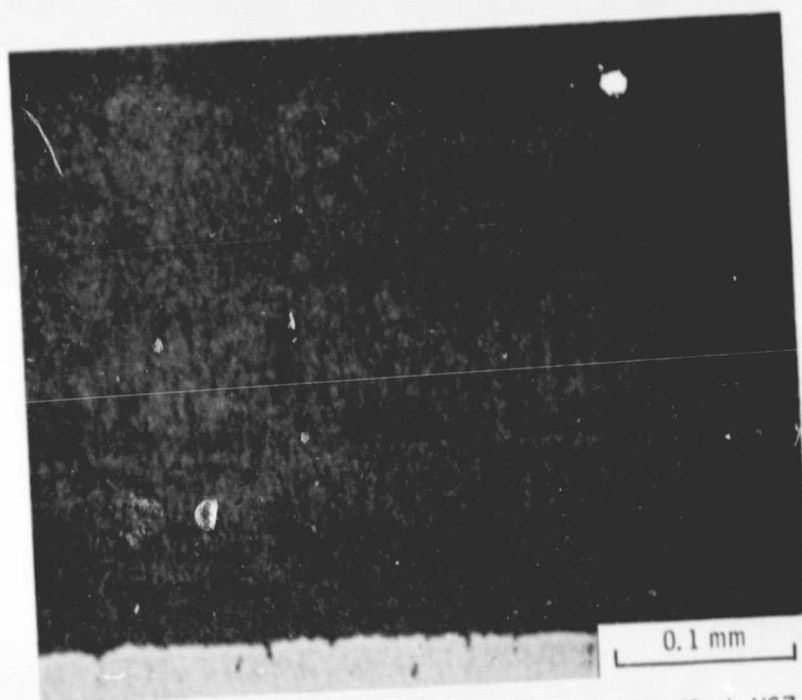
Figure 13. - Finely segmented microstructure of EB/PVD 20 w/o YSZ TBC.

The last technique employed to achieve a segmented coating was to apply a 20 w/o YSZ coating with an electron beam/physical vapor deposition (EB/PVD) process. This technique required the use of a vacuum chamber and was relatively complex compared to the PS technique. However, the EB/PVD process produced a coating with a finely segmented structure consisting of long, thin columns (Fig. 13). This columnar structure probably represented a near optimum size and spacing for a segmented coating. The durability of the EB/PVD coating (10 420 cycles) in the burner rig tests confirmed that the EB/PVD coating was very strain tolerant. The post-test examination of the failed coating (Fig. 14) revealed that internal oxidation of the bond coating had occurred. This led to debonding of the bond coating from the Mar-M 509 substrate. Therefore, the performance of the bond coating precluded an evaluation of the full potential durability of the EB/PVD coating.

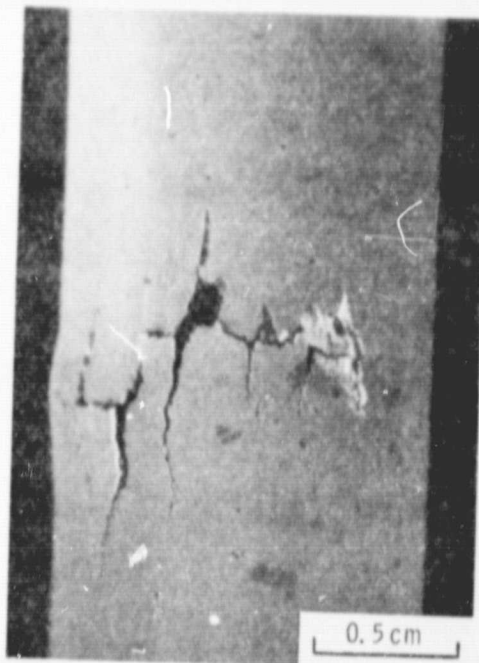
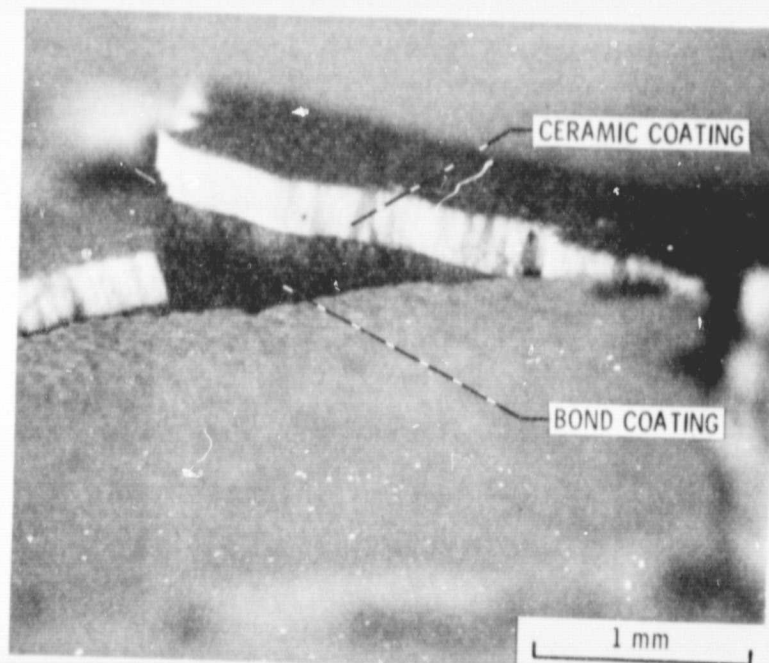
(a) FAILED REGION ON BURNER RIG BAR.

(b) CROSS-SECTION OF COATING SYSTEM FAILURE.

Figure 14. - Failure of MCrAlY bond coating for EB/PVD 20 w/o YSZ TBC specimen.

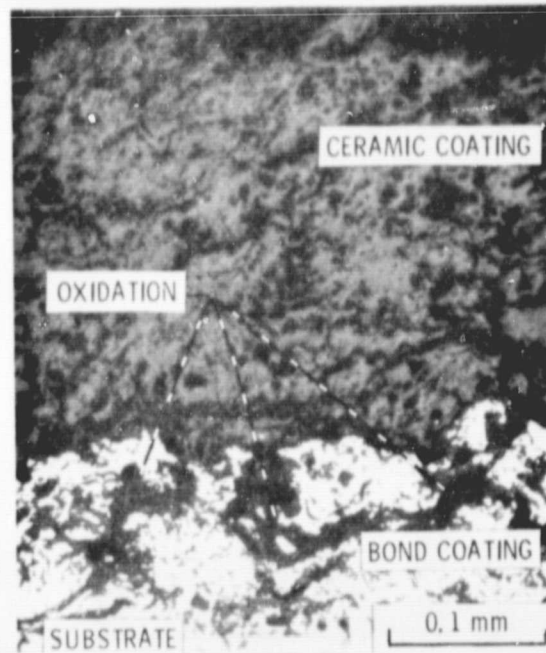
(a) SPALLED REGION OF BURNER RIG BAR.

(b) MICROSTRUCTURE OF COATING SHOWING OXIDATION OF BOND COATING.

Figure 15. - Coating failure of 20 w/o YSZ TBC specimen with controlled 20⁰ C temperature substrate due to oxidation of bond coating.

contributing to spalling of the ceramic coating. Two other factors were: (1) oxidation of the bond coating, and (2) bending of the burner rig bars during the testing. Oxidation of the bond coating (Fig. 15) resulted in a volume expansion, which effectively forced spallation of the ceramic coating. The bending of the burner rig bars (Fig. 16) was caused by oxidation of the Mar-M 509 substrate in the internal cooling passage which weakened the bar. The centrifugal force from the rotation of the test fixture caused the bar to bend, thereby applying additional stresses to the ceramic material. For these reasons, the full potential durability of these coatings also was not achieved.

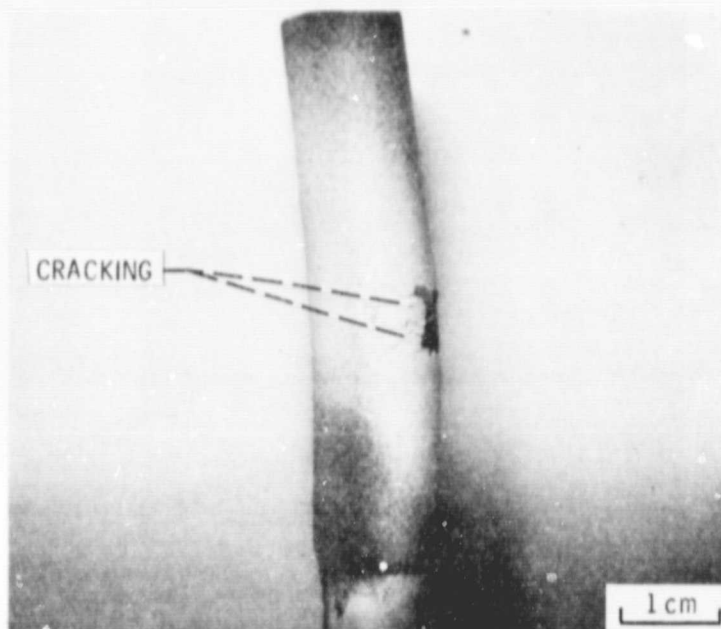
(a) INTERNAL OXIDATION.

(b) BENDING OF BURNER RIG BAR AND RESULTANT CRACKING OF CERAMIC COATING.

Figure 16. - Coating failure of 20 w/o YSZ TBC specimens with controlled 20⁰ C temperature substrate due to internal oxidation and bending of burner rig bar.

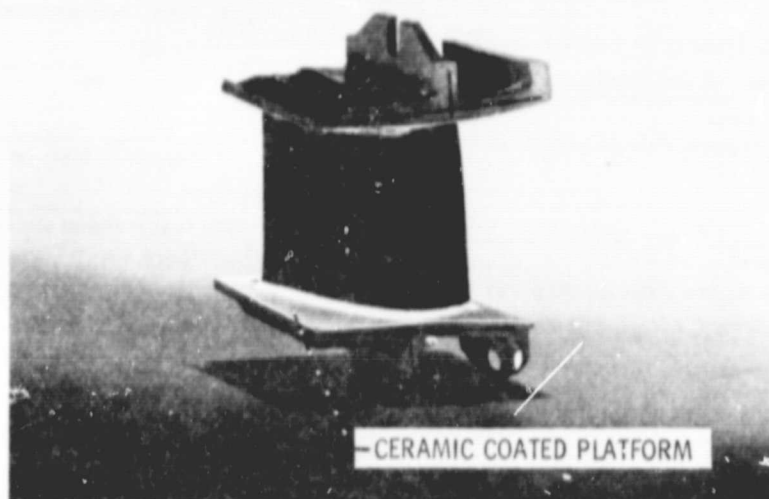
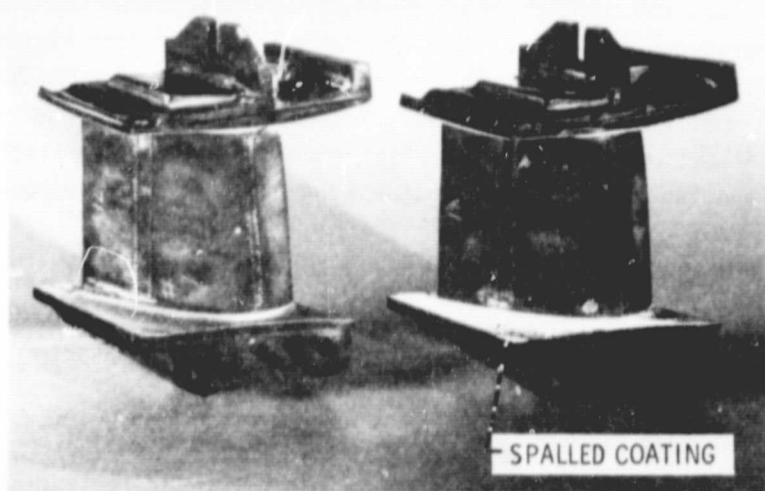
(a) PRE-TEST CONDITION.

(b) POST-TEST CONDITION SHOWING COATING THAT SURVIVED INTACT (ON LEFT) AND COATING THAT SPALLED (ON RIGHT).

Figure 17. - First stage vanes with thermal barrier ceramic coatings used in engine test.

Preliminary inspection of the test vanes after removal from the engine indicated that they had been subjected to a severe 1000 cycle endurance test in terms of the turbine inlet temperature. Of the 36 platforms coated with a ceramic TBC, nine platforms exhibited some slight to moderate spallation of the coating, as can be noted in Fig. 17. However, most of these vanes had been clustered together in a very hot region of the circumferential temperature profile of the combustor. The remaining 27 platform coatings survived the engine test with no apparent damage.
