DOE/NASA CONTRACTOR
REPORT

DOE/NASA CR-161434

SOLAR HOT WATER SYSTEM INSTALLED AT QUALITY INN,
KEY WEST, FLORIDA -- FINAL REPORT

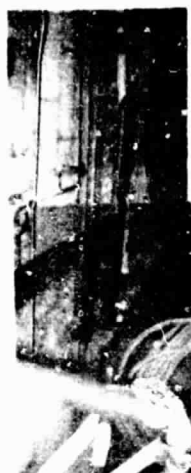
RETURN FROM COLLECTORS

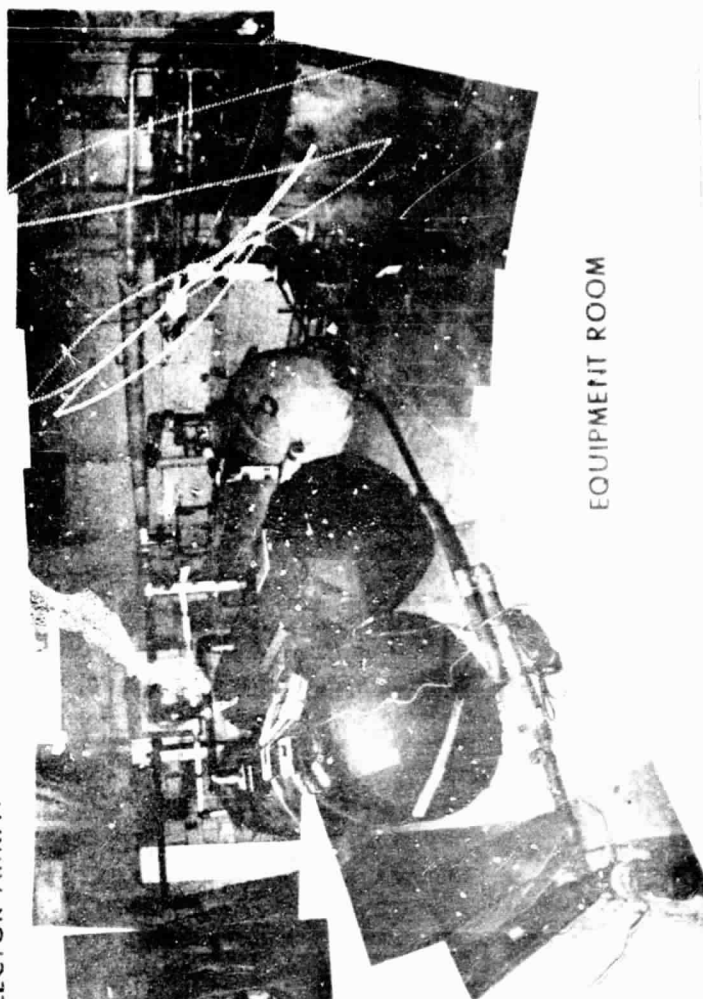
EQUIPMENT ROOM

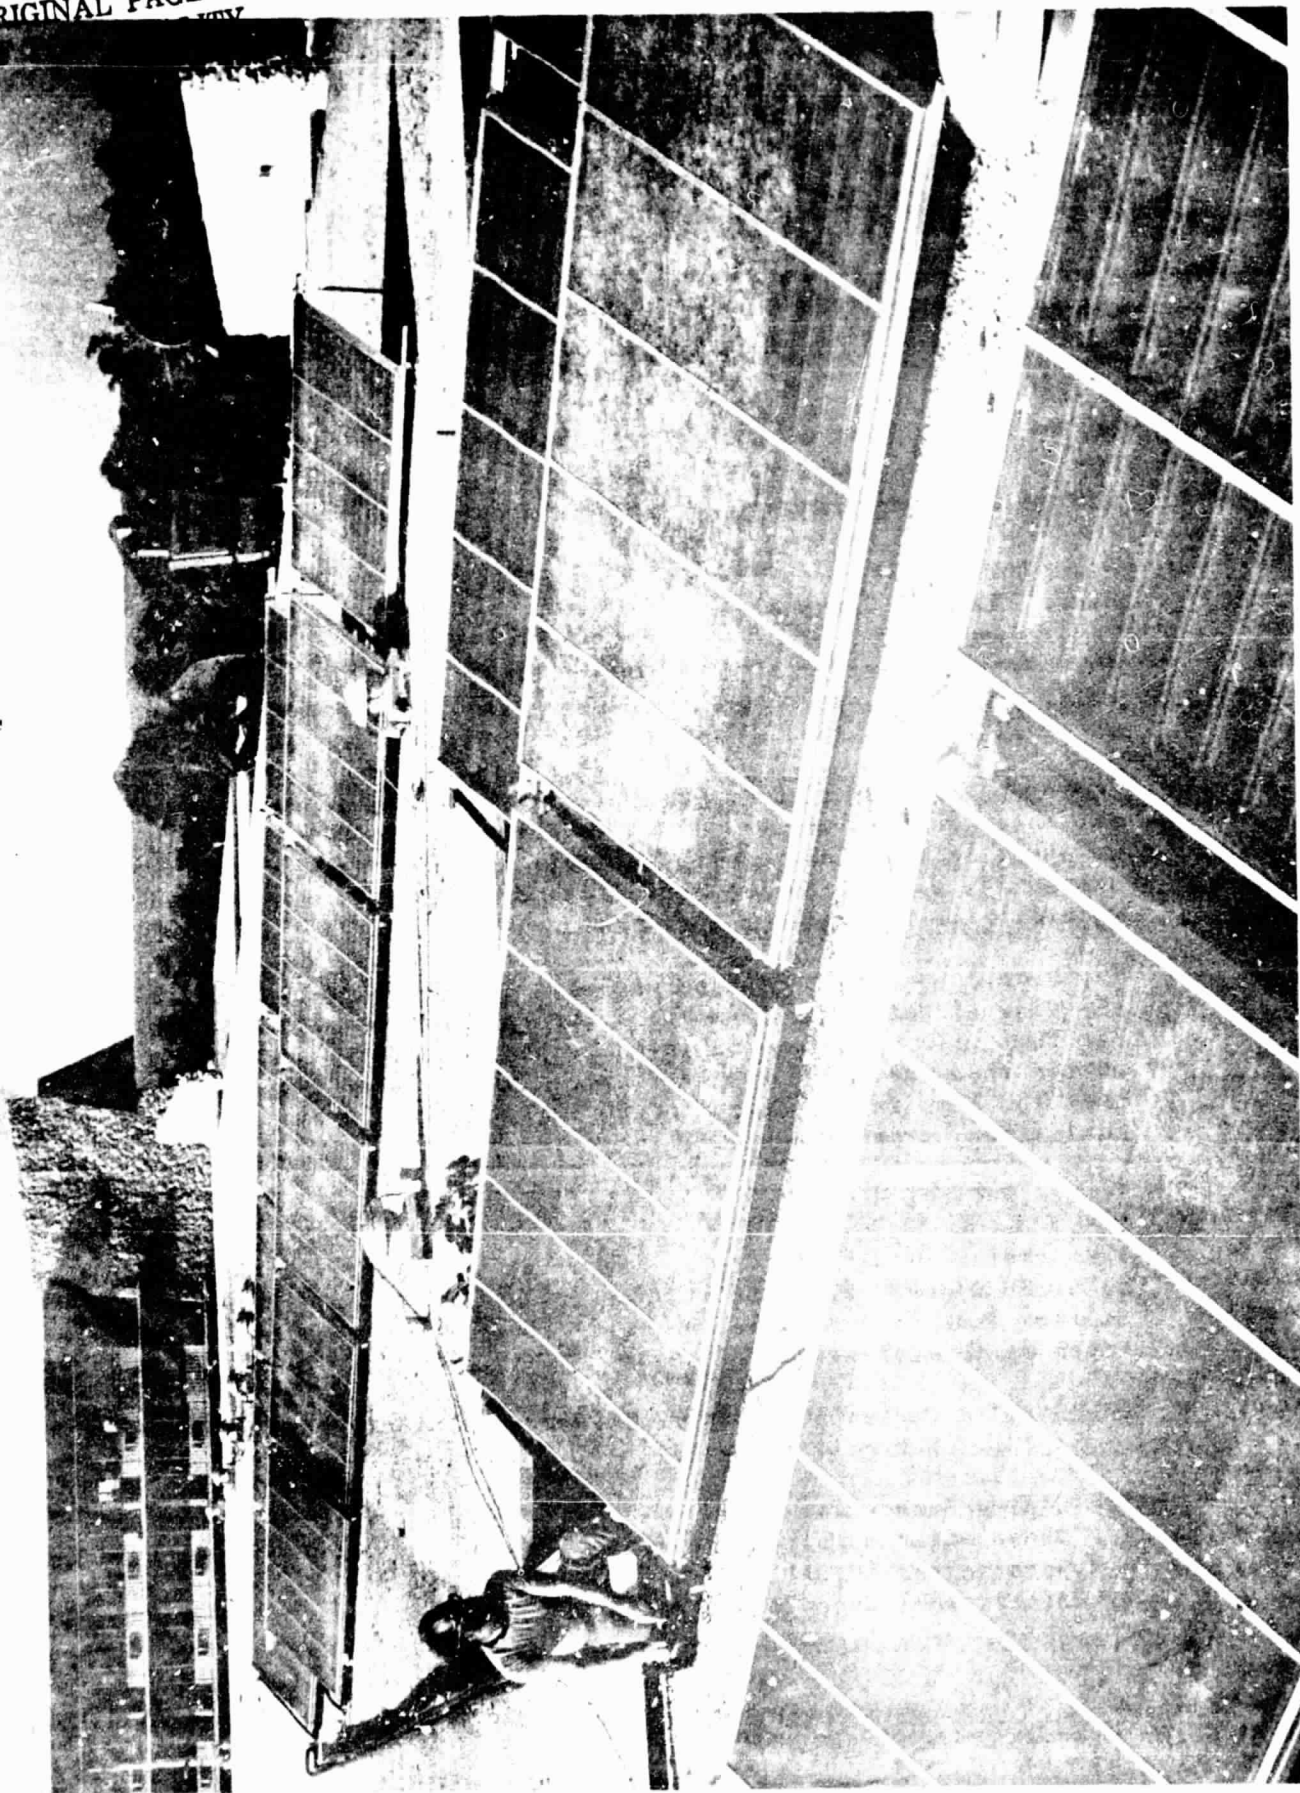
FAILED PUMP

In May, 1979, and again in June, 1979, the system failed to maintain continuous flow through the collectors. Investigation by a team from the Marshall Space Flight Center, headed by Lary Lawson, determined that the magnetically coupled circulation pump impeller thrust bearing had failed. Replacement of the pump by a direct-drive pump solved the problem. Reports on the problem are attached in Appendix B. The reports also suggest some piping modifications for greater efficiency.

System fails to maintain continuous flow thru collectors since (1) new pump was installed or (2) pressurization system was installed. Air has been vented from collectors; two different plumbers called to investigate, no positive results.

During the first year of operation, the only problem encountered was a solar pump failure. The pump was replaced under the warranty, and the system was back in operation within two days.

Solar pump failed once and was warranty replaced. New H₂O pressurization system installed Fall of 78 to boost city pressure from 15-30 psig to 30-65 psig required by new four story model addition.
