NASA Technical Memorandum 81505

COMPARISON OF SEVERAL INFLOW
CONTROL DEVICES FOR FLIGHT
SIMULATION OF FAN TONE NOISE
USING A JT15D-1 ENGINE

Prepared for the
Sixth Aeroacoustics Conference
sponsored by the American Institute of Aeronautics and Astronautics
Hartford, Connecticut, June 4-6, 1980

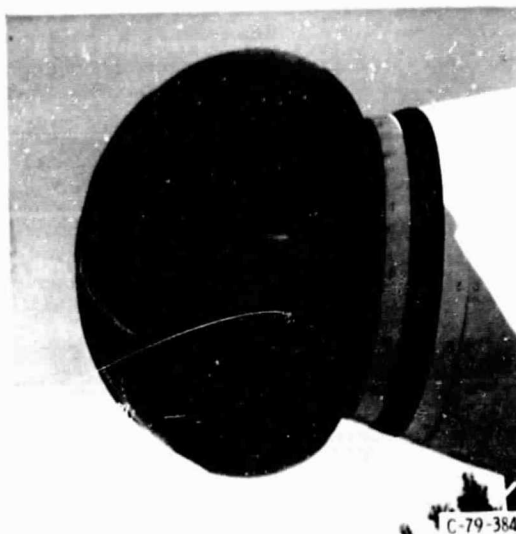
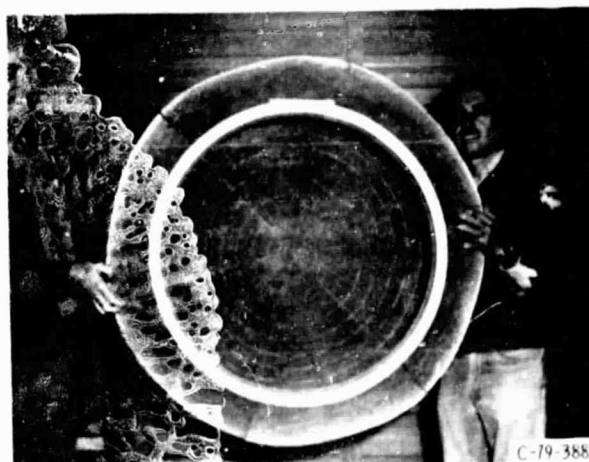
Figure 6 ICB no. 5.

(a) INSTALLED ON ENGINE, SHOWING RIBS JOINING HONEY-COMB SECTIONS, AND CONICAL COWLING.

(b) VIEW LOOKING DOWN STREAM, SHOWING WIRE GRID SUPPORTING HONEYCOMB SECTIONS.

ICD number 5 (figs. 3(d) and 6) was made of six sections of 5-centimeter (2-in.) thick flexible honeycomb (cell $\ell/d \sim 8$). It was fabricated with thin ribs between the sections, similar to ICD number 4. In addition, a grid of 1.6 millimeter (0.063 in.) wires on approximately 5-centimeter (2-in.) centers was used for more support beneath the honeycomb (see fig. 6(b)). The inlet duct for this ICD was a conical diffuser duct rather than a cylinder as used with the other ICD's. The lip (taken from ref. 8) was elliptical in cross-section up to the highlight, then faired into a conical skin, which in turn faired into the cowl. The ICD was mounted on a machined ring in the conical section. The ICD contour was designed so the honeycomb cells were aligned with flow streamlines calculated by a potential flow analysis. A similar analysis showed that this inlet would be suitable for low-speed flight.

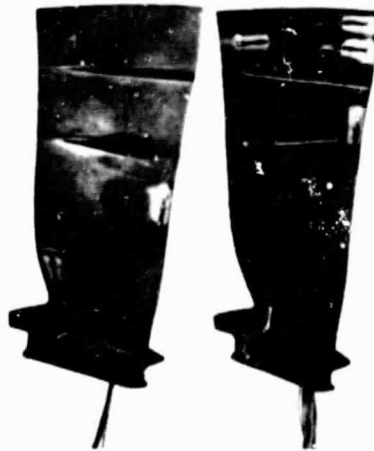
Figure 7. - Blade mounted pressure transducers.

(a) INSTRUMENTED BLADES.

(b) TRANSDUCER LOCATIONS.

For some of the tests, dynamic pressure data were obtained with eight miniature transducers mounted on two of the fan rotor blades. A photograph of the instrumented blades is given in figure 7(a), and the transducer locations on the blades are shown in figure 7(b). Six transducers were mounted approximately 4 millimeters (0.16 in.) from the leading edge, and two were mounted approximately 9 millimeters (0.35 in.) from the trailing edge. All measured dynamic pressures on the "pressure" surface of the blade, except transducer B-4. For some of the tests (not reported herein) transducers were mounted on fan stator and core stator vanes.
