NASA CR-159525
PWA-5512-35

PERFORMANCE DETERIORATION
BASED ON IN-SERVICE ENGINE DATA
JT9D JET ENGINE DIAGNOSTICS PROGRAM

G. P. Sallee

UNITED TECHNOLOGIES CORPORATION
Pratt & Whitney Aircraft Group
Commercial Products Division

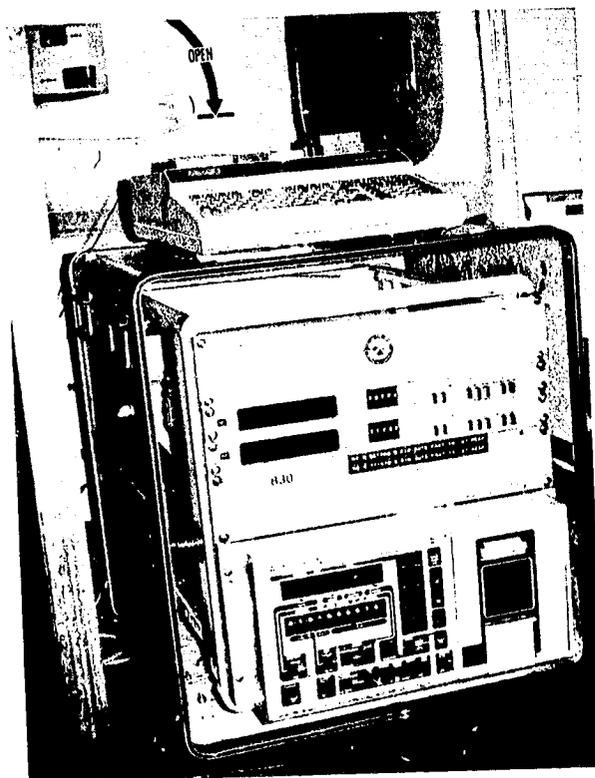
Figure 5 PIC System Data Acquisition Unit - The recording equipment and the HP9825 minicomputer are shown.

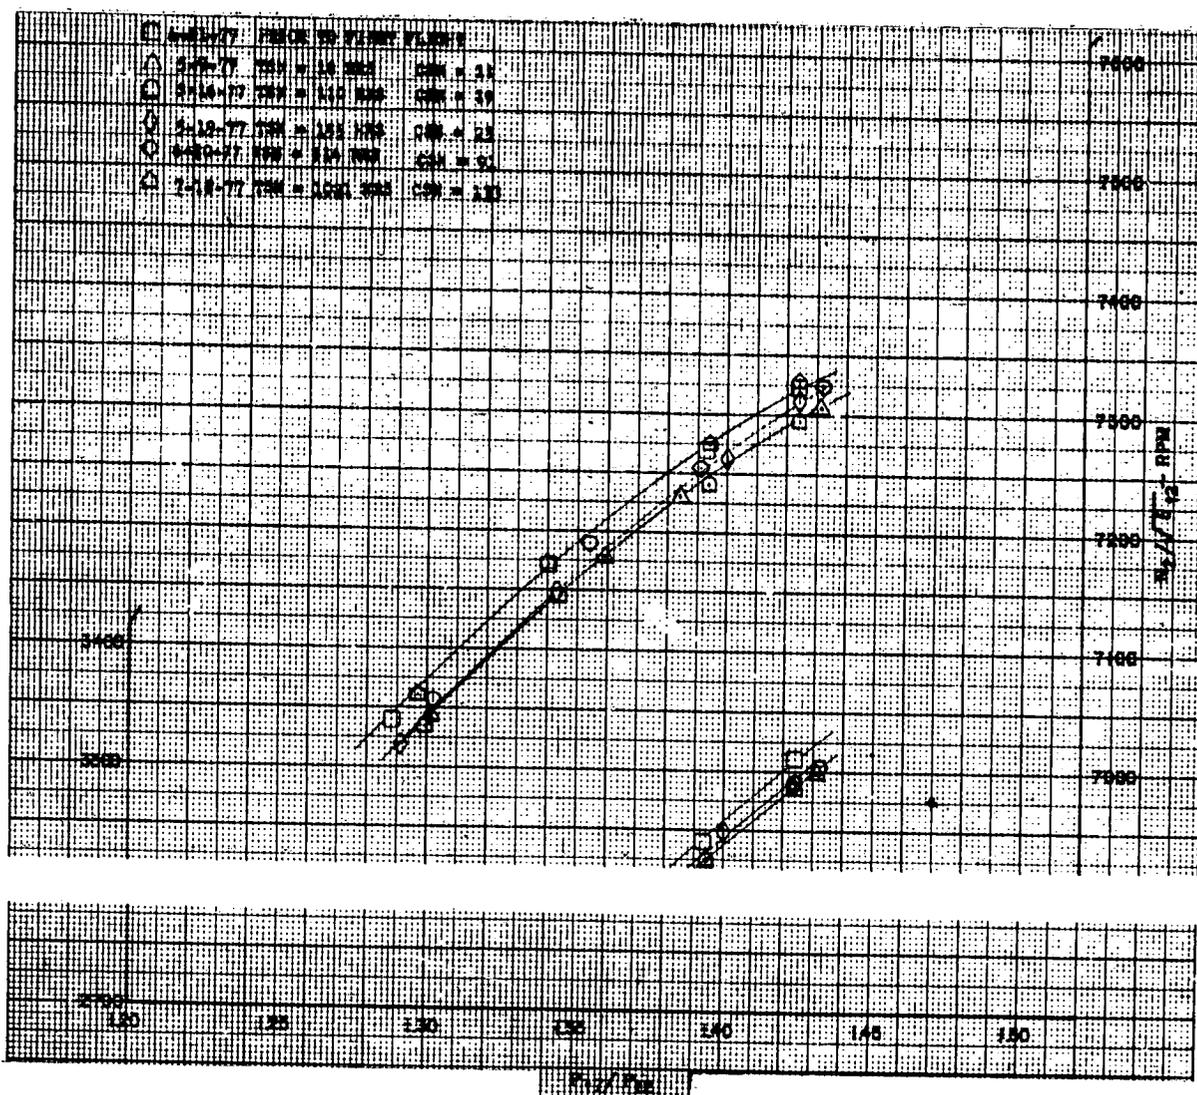
Figure 7 Typical Plot of On-Wing PIC Calibration of JT9D-7(SP) Engine P-695745 - Plots of the data were made to permit comparison with previous calibrations and to check on data quality. (J18859-8)

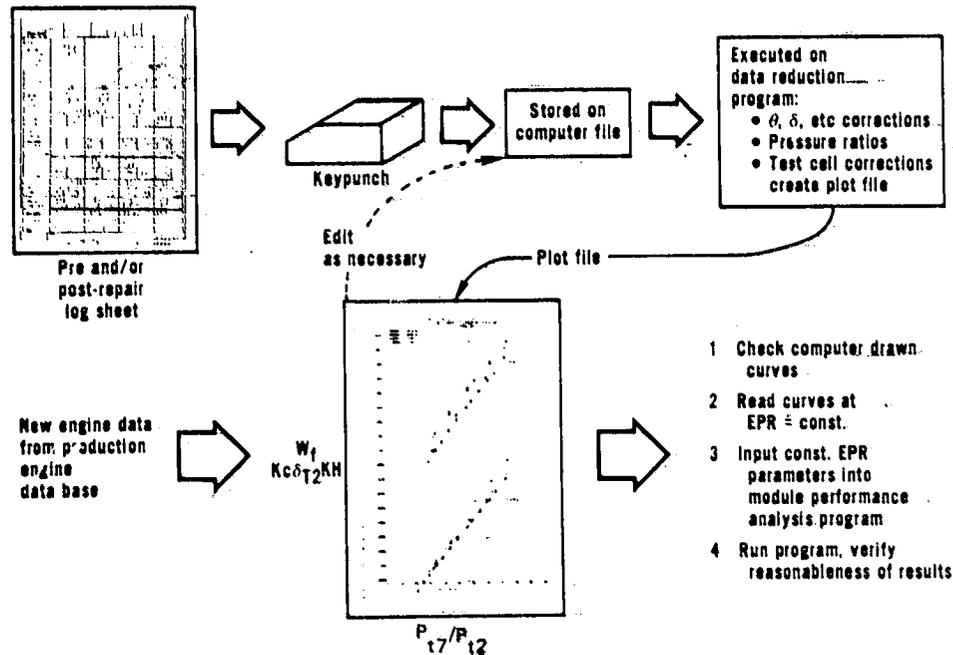
Figure 8 Data Processing Flow for Prerepair and Postrepair Test Stand Testing - The steps in processing test cell data from test log sheets through preliminary module analysis are shown schematically.

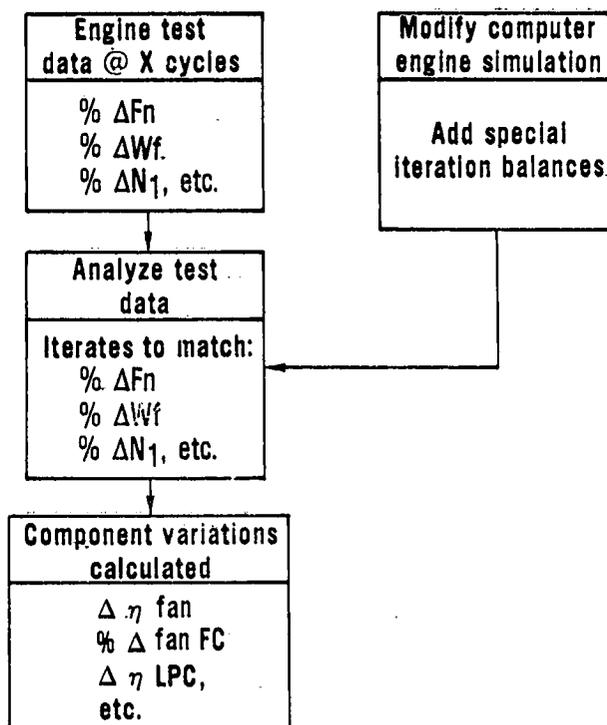
Figure 9 Flow Diagram for "Top Down" Analysis - Top down analysis begins with measured engine performance parameter changes and utilizes the JT9D engine simulation to analyze the module performance losses required to match the performance data.

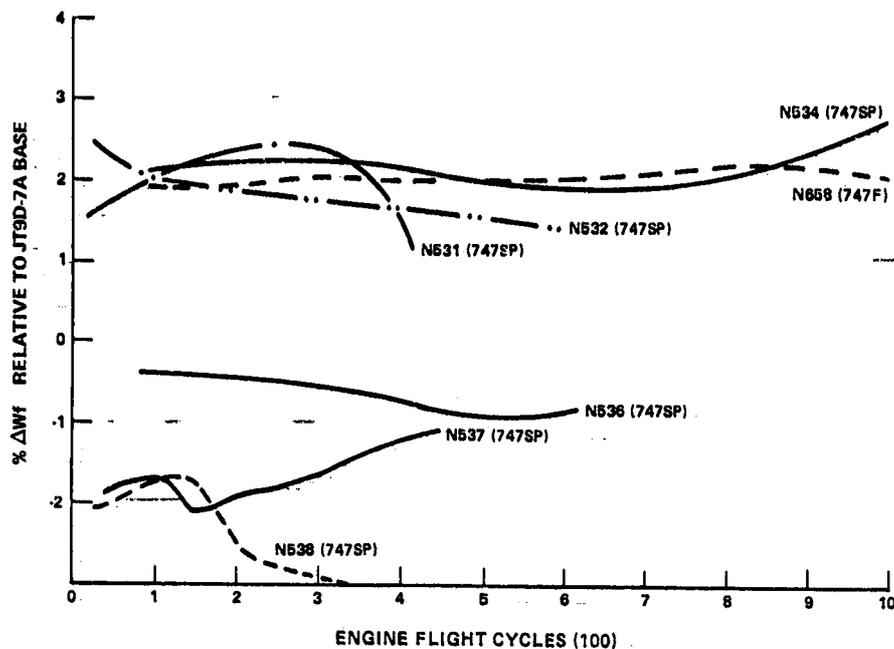
Figure 12 747SP Airplane Average Wf Performance Deterioration Trends. Based on ECM Data - The four-engine average change in fuel flow as a function of usage shows little change at constant EPR between 100 and 1000 flights; the later configuration engines in airplanes N536PA and N537PA show better performance.

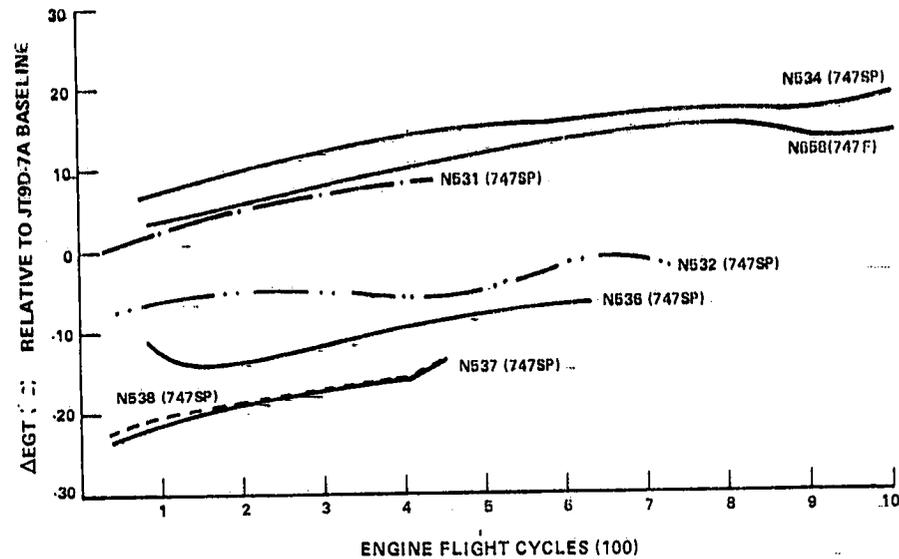
Figure 13 747SP Airplane Average EGT Performance Deterioration Trends Based on ECM Data -- The four-engine average change in EGT as a function of usage shows similar trends for the airplanes used in the study.

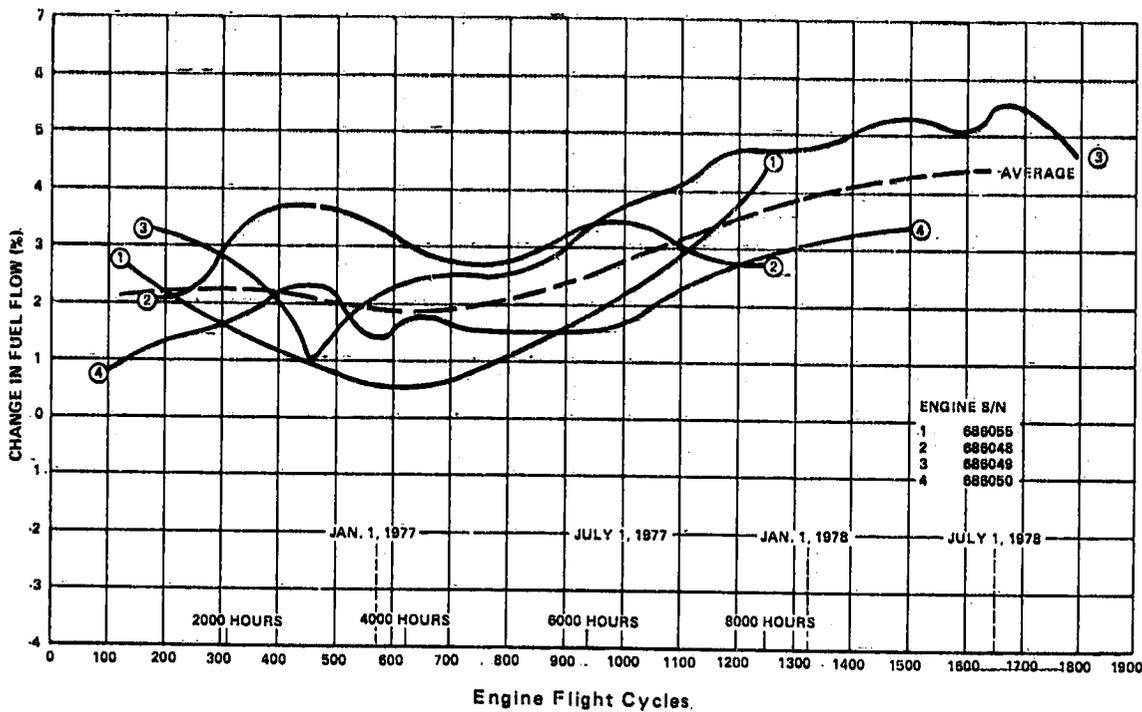
Figure 14 ECM Data from Pan American Airplane N534PA on Change in Fuel Flow with Usage - Early variations in individual trends are believed to be caused by airplane-induced effects; airplane average closely follows the fleet trend.

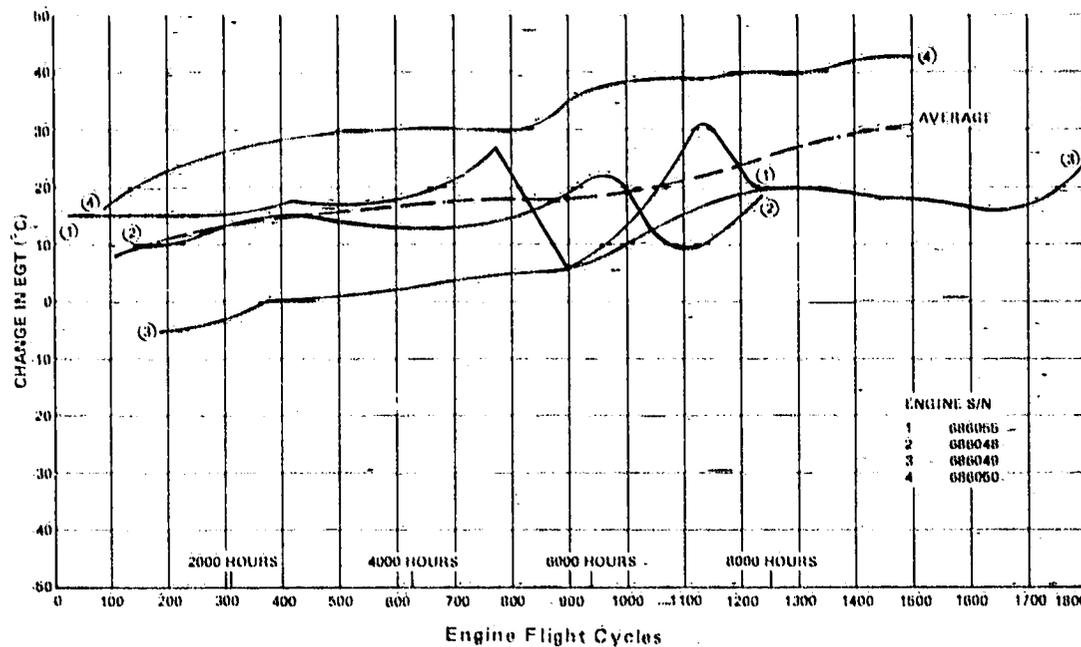
Figure 15 ECM Data from Pan American Airplane N534PA on Change in EGT with Usage - The shift in the EGT trends of engines 1 and 2 coincides with changes in the fuel flow slopes (Figure 14).

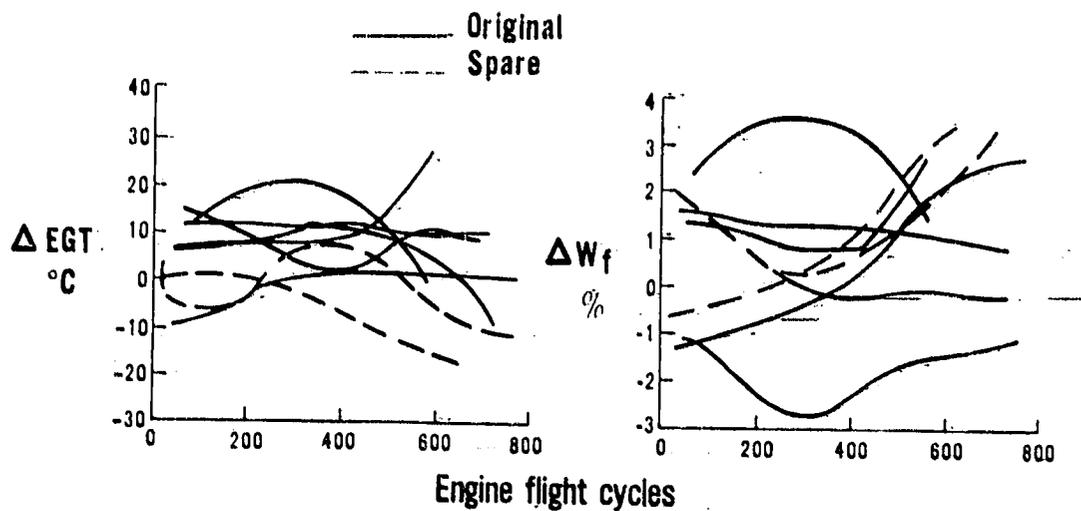
Figure 16 Aircraft-Delivered versus Spare Engine Performance Deterioration for South African Airways JT9D-7F Engines --Based on these data, it would appear that the EGT for the two spare engines improved with usage relative to the six airplane-delivered engines while the fuel flow for the spares increased with usage relative to the airplane-delivered engines; these apparent trends conflict.

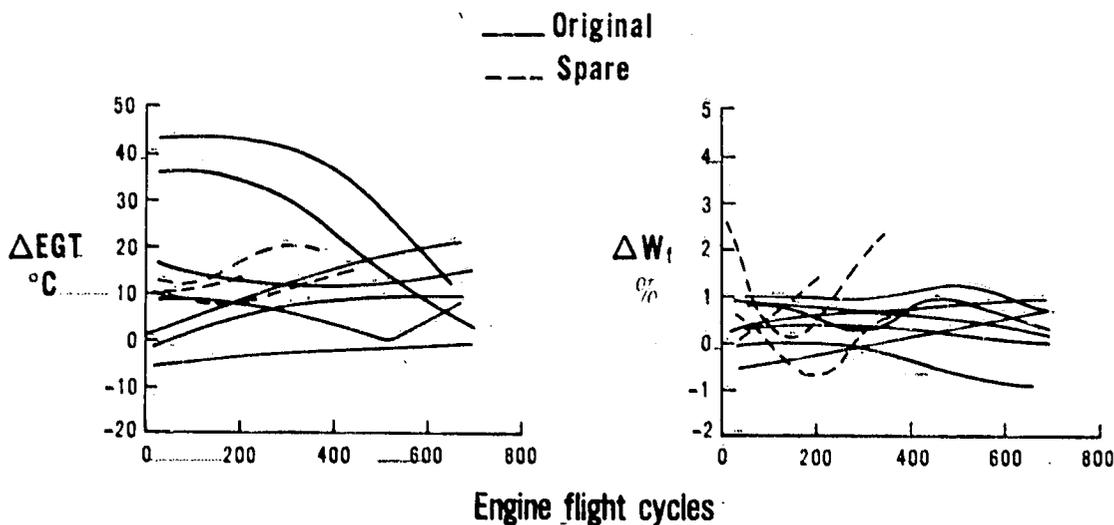
Figure 17 Aircraft-Delivered versus Spare Engine Performance Deterioration for Iraqi Airlines JT9D-7F Engines - The spare engine performance trends generally fall within the trends defined by the airplane-delivered engines; the performance for these spare engines appears to deteriorate slightly more after 150 cycles.

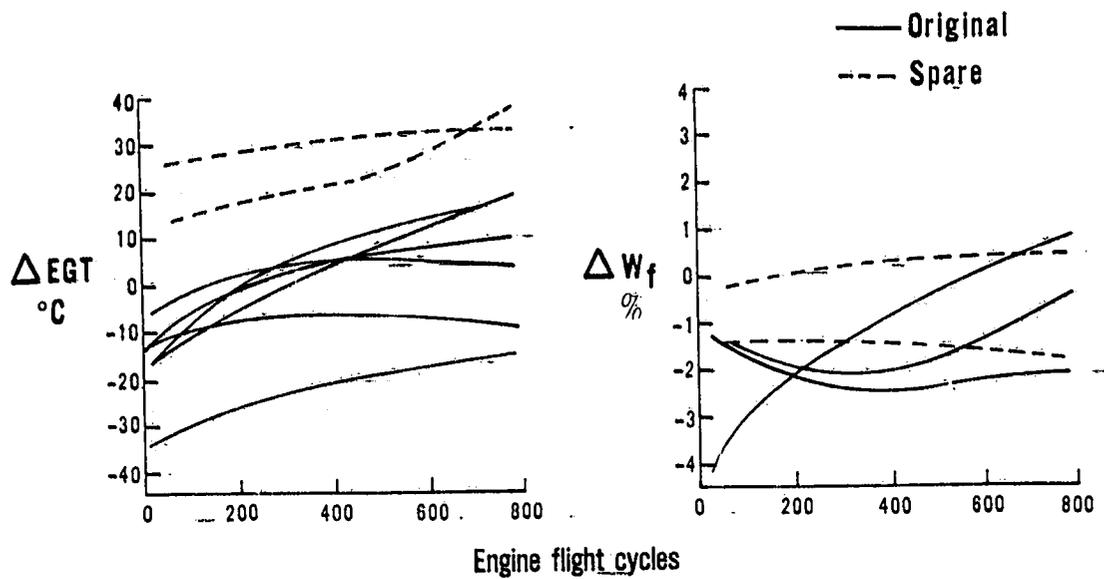
Figure 18. Aircraft-Delivered versus Spare Engine Performance Deterioration for Northwest Orient Airlines JT9D-20 Engines - The spare engines exhibit poorer initial performance compared to the airplane-delivered engines, but the subsequent fuel flow trends are similar.

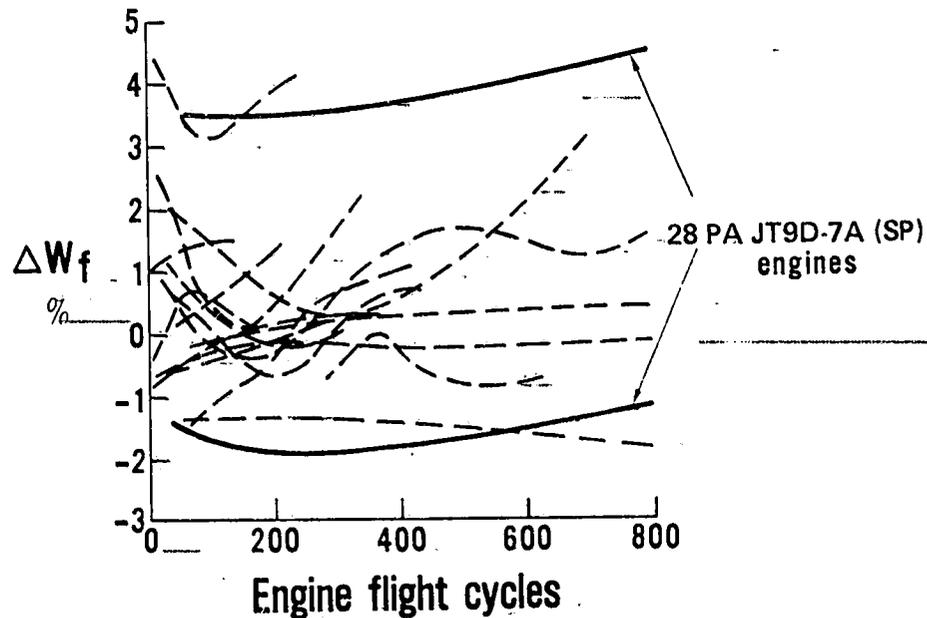
Figure 19 Performance Deterioration for 28 Pan American Airplane-Delivered JT9D-7A(SP) Engines versus 16 Spare Engines from Eight Airlines - The spare engines, operating over different routes and cycles, exhibit a similar band of fuel flow change to that defined by the airplane-delivered engines.

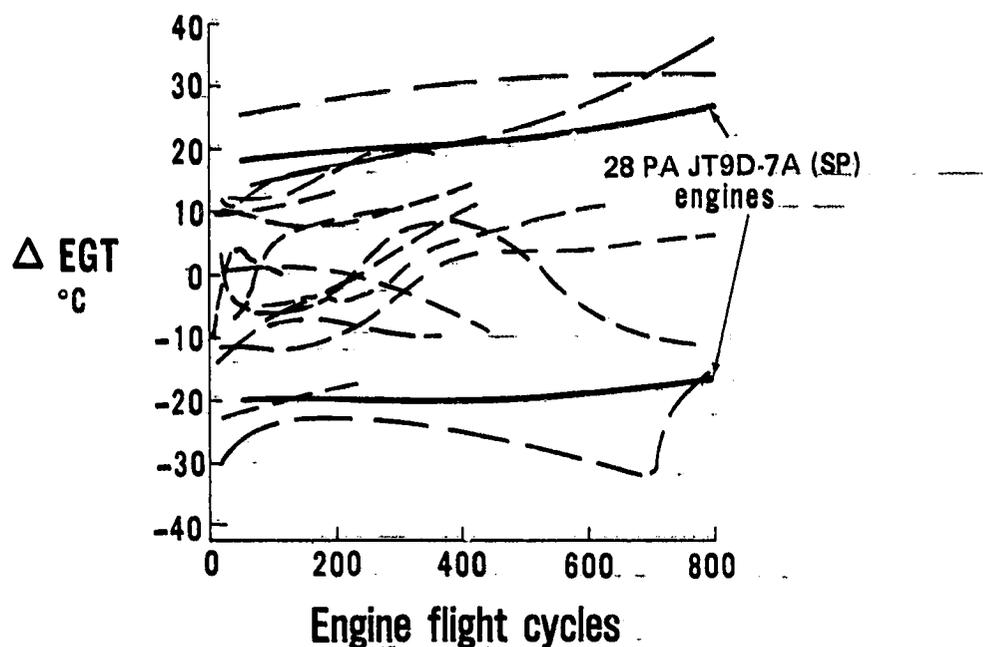
Figure 20. Performance Deterioration for 28 Pan American Airplane-Delivered JT9D-7A(SP) Engines versus 16 Spare Engines from Eight Airlines - The spare engines, operating over different routes and cycles, exhibit a similar band of EGT change to that defined by the airplane-delivered engines.

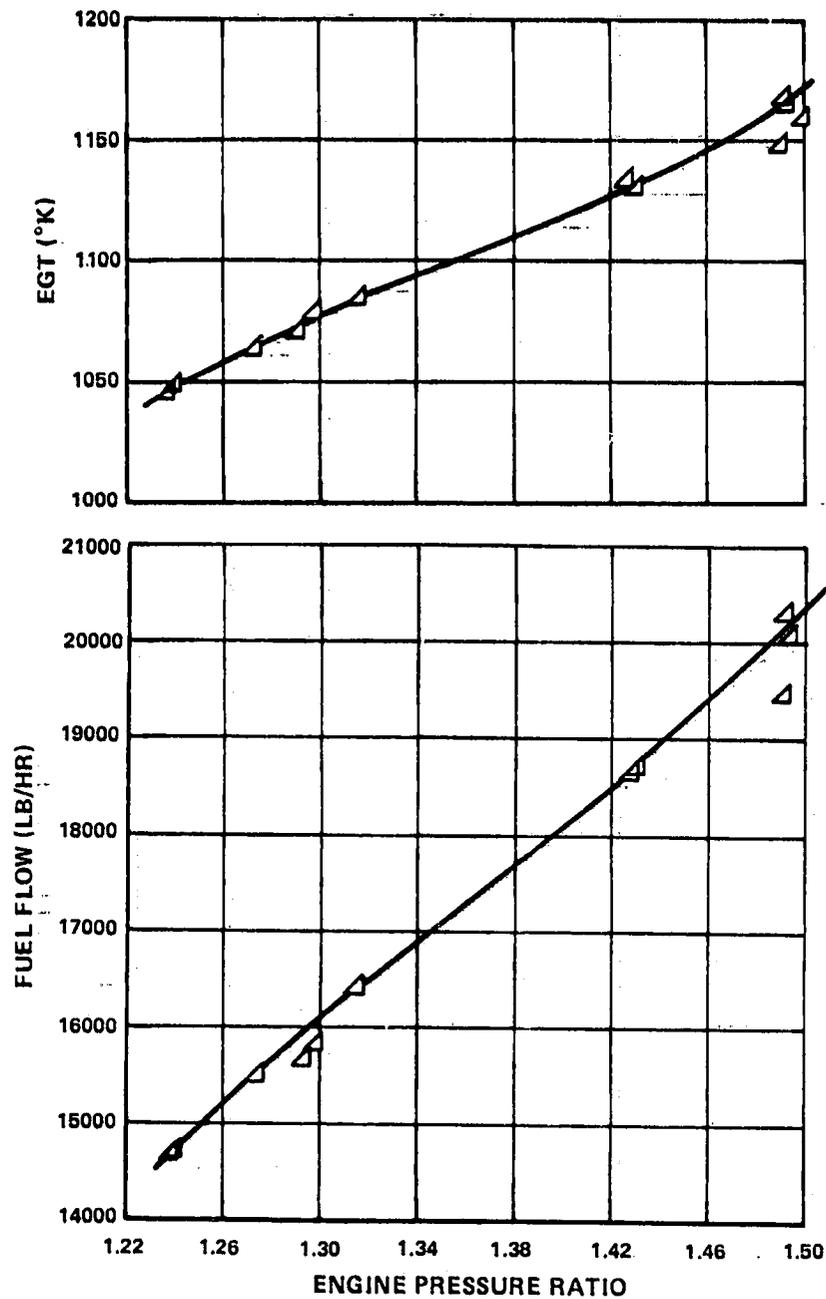
Figure 21 In-Flight Calibration Fuel Flow and Exhaust Gas Temperature Data as Functions of Engine Pressure Ratio for Engine P-695738 on Airplane N536PA Taken on May 21, 1977 at 155 Hours/23 Cycles - The data show very little scatter over the range of power at which data were recorded.

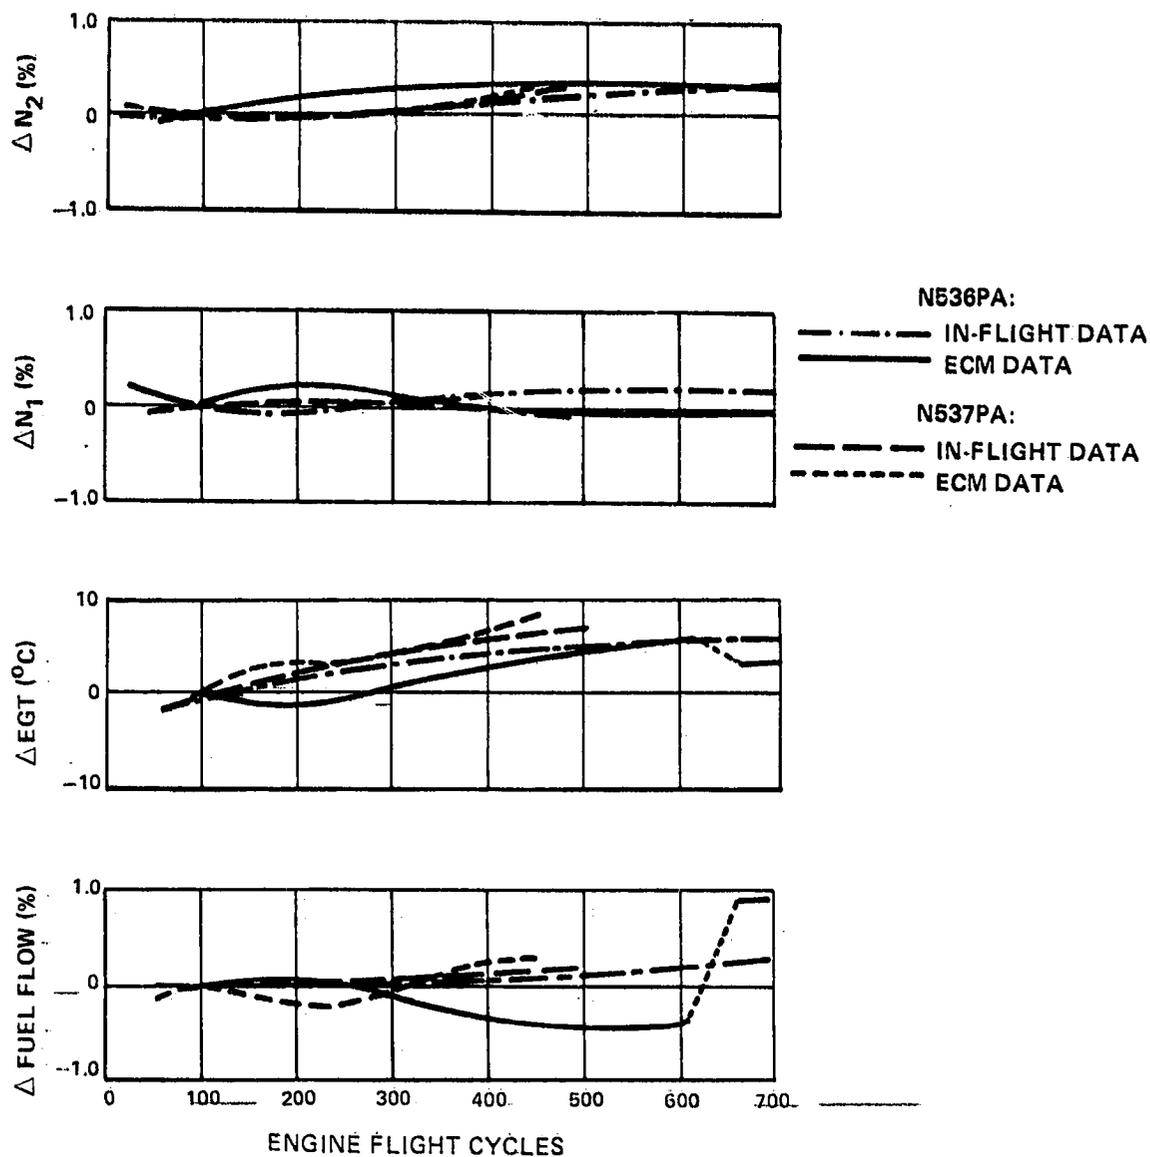
Figure 25 Comparison of Four-Engine Averages of Gas Generator Parameters as Functions of Cycles as Determined by In-Flight Calibrations and Engine Condition Monitoring of Engines on Airplanes N536PA and N537PA. - The four-engine averages reduce the data scatter and improve the agreement between the two data sources.

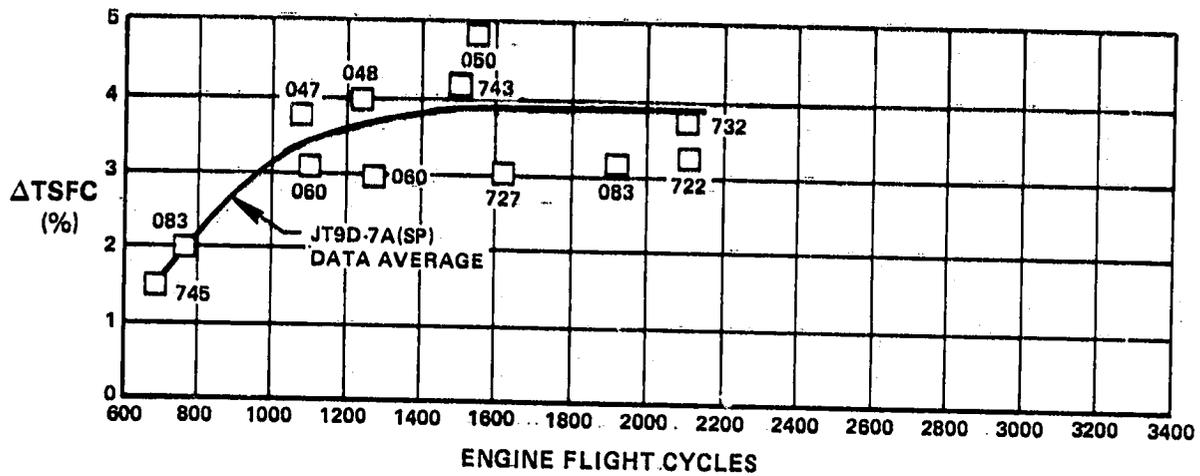
Figure 26 Long-Term Prerepair TSFC Deterioration, Measured at Constant Thrust, as a Function of Flight Cycles - The prerepair data are similar in trend and level to the average of the historical data.

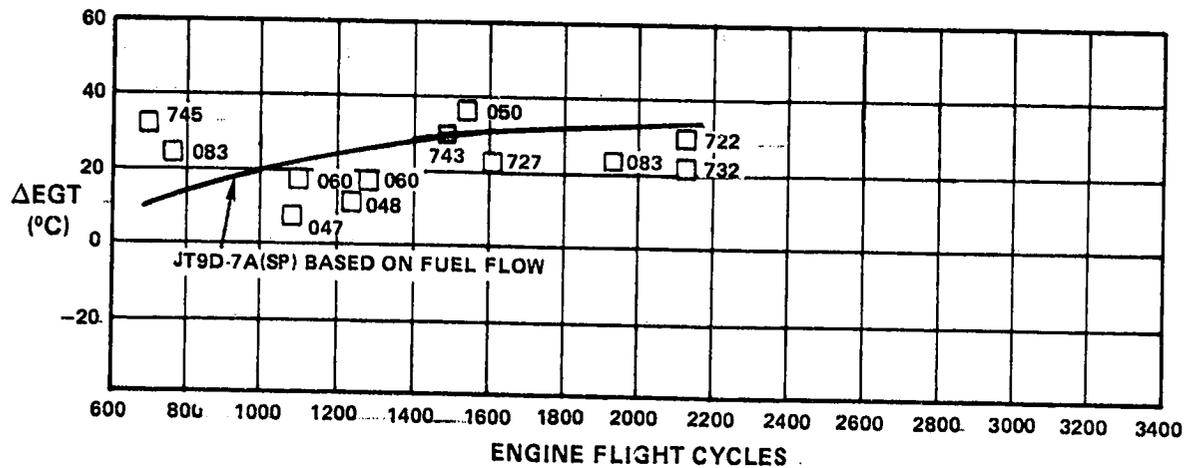
Figure 27 Long-Term Prerepair EGT Deterioration, Measured at Take-Off EPR, as a Function of Flight Cycles - After temperature profile adjustments were made, the prerepair data agrees well with the average of the historical data.

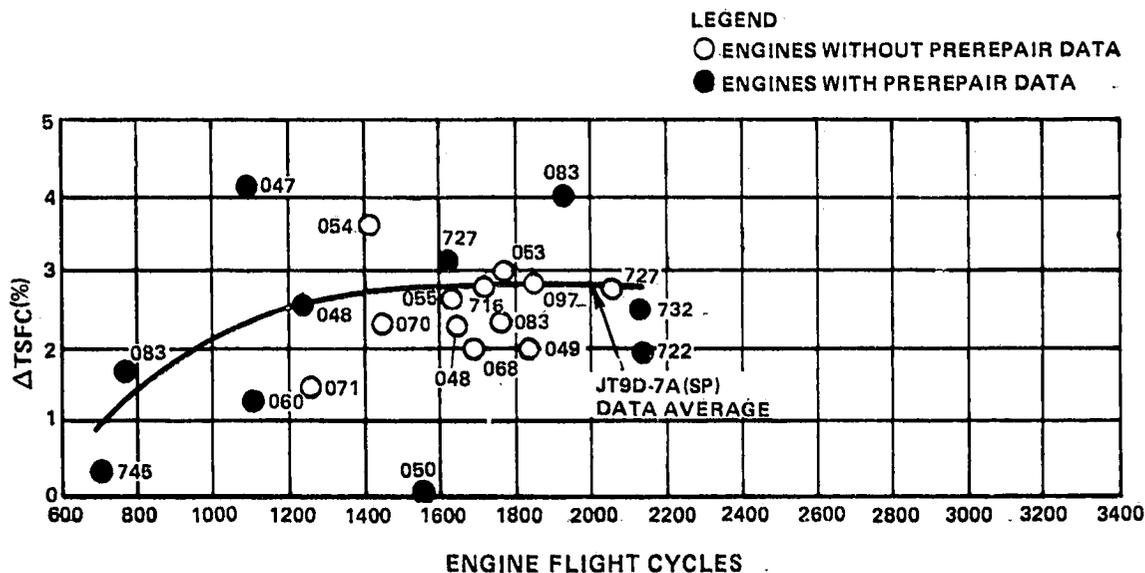
Figure 28 Long-Term Postrepair TSFC Deterioration, Measured at Constant Thrust, as a Function of Flight Cycles. - The postrepair data scatter shows results of a wide-range of repairs and broader repair build clearances.

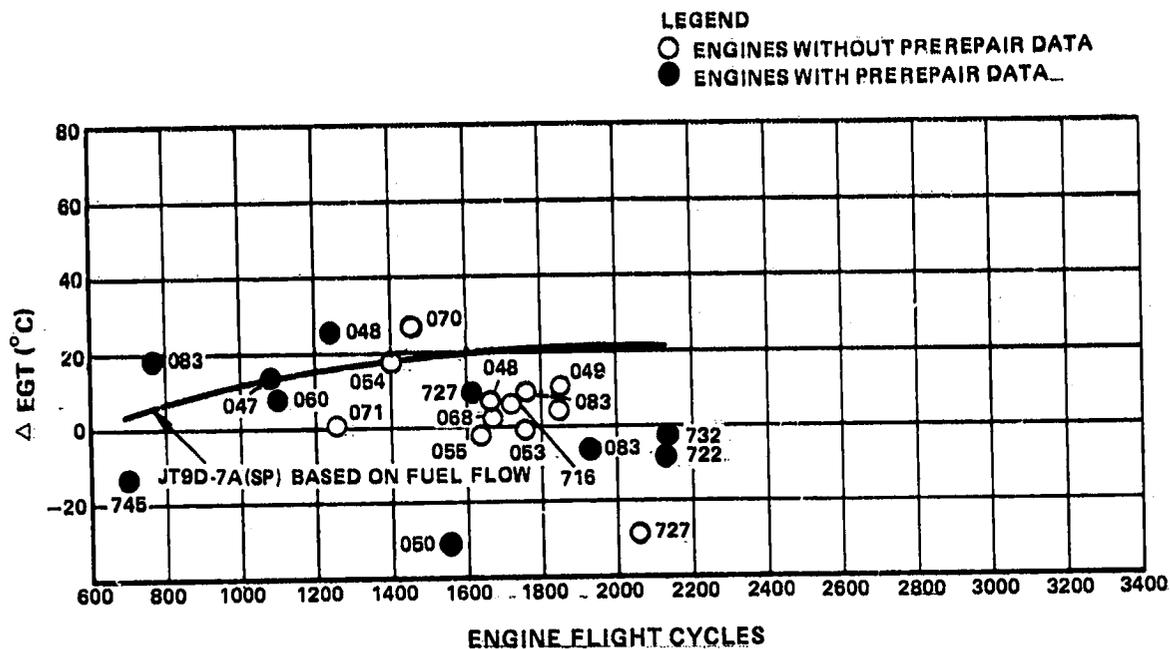
Figure 29 Long-Term Postrepair EGT Deterioration, Measured at Take-Off EPR, as a Function of Flight Cycles - The postrepair data agrees well, except for a degree of data scatter, with the average of the historical data.

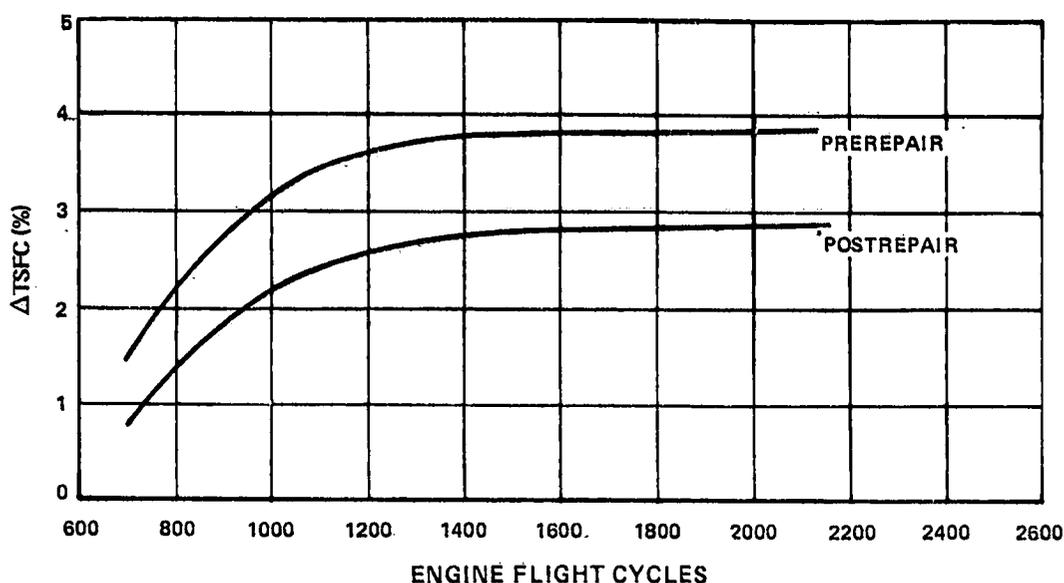
Figure 30 Long-Term TSFC Deterioration, Measured at Constant Thrust, as a Function of Flight Cycles; Comparison of Average Prerepair to Average Postrepair Performance - The repair process did not attempt to maximize performance restoration.

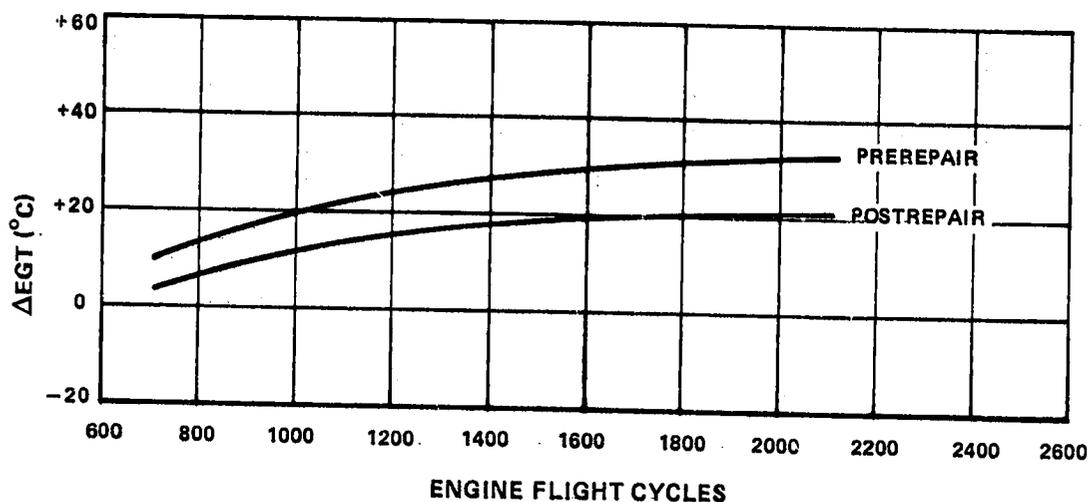
Figure 31 Long-Term EGT Deterioration, Measured at Take-Off EPR, as a Function of Flight Cycles; Comparison of Average Prerepair to Average Postrepair Performance -- An average of about 10°C in EGT is recovered as a result of repair.

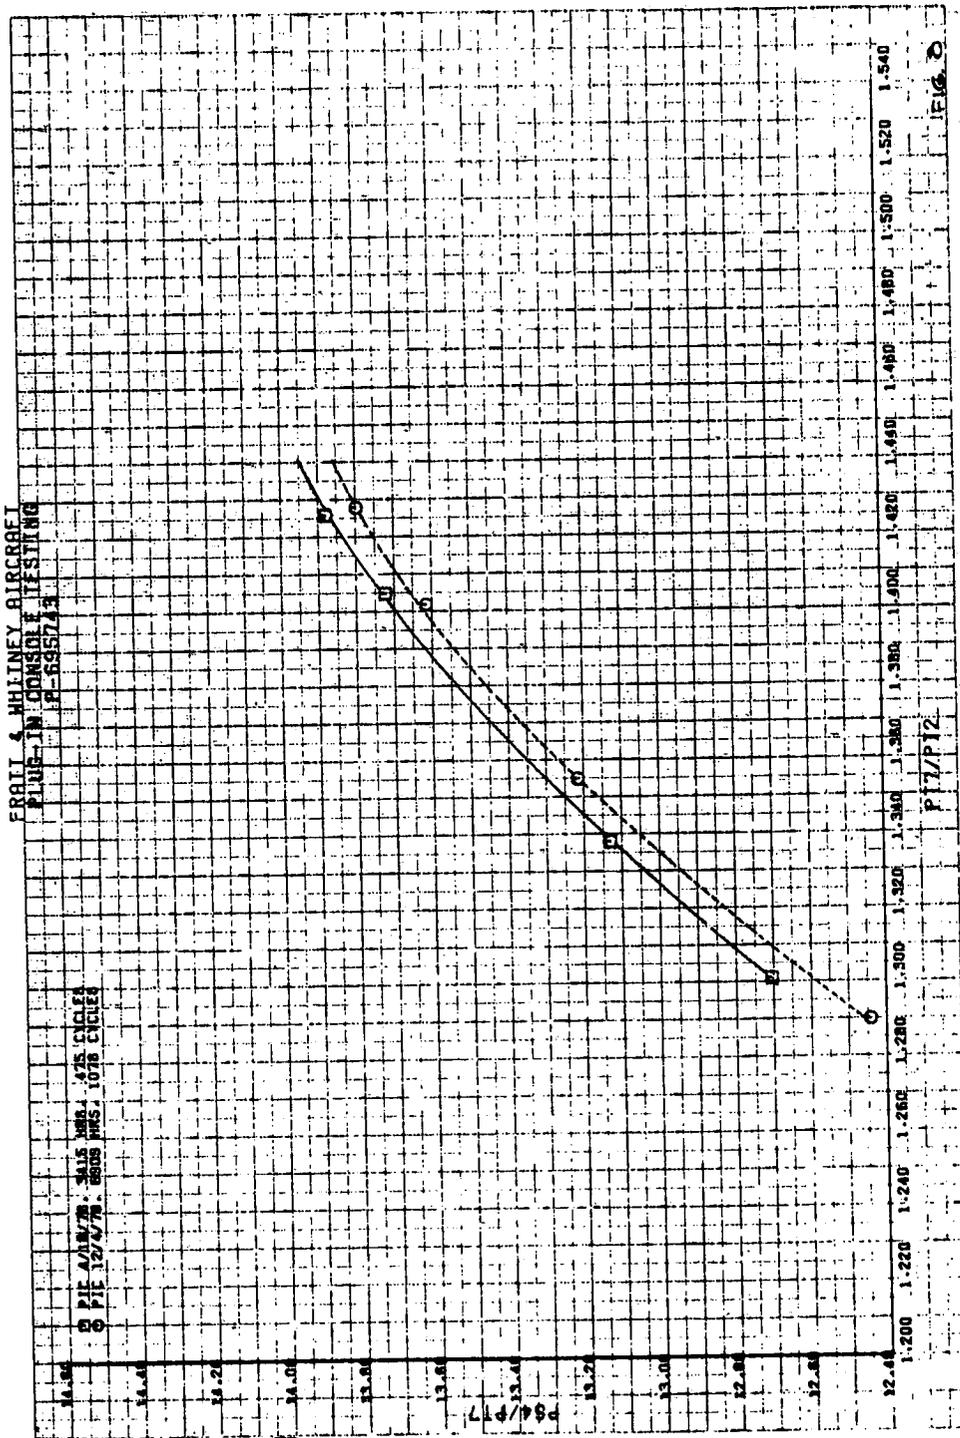
Figure 32 Typical Gas Generator Plot - Expansion ratio is plotted as a function of EPR for two PIC calibrations of engine P-695743 and used in the data analysis.

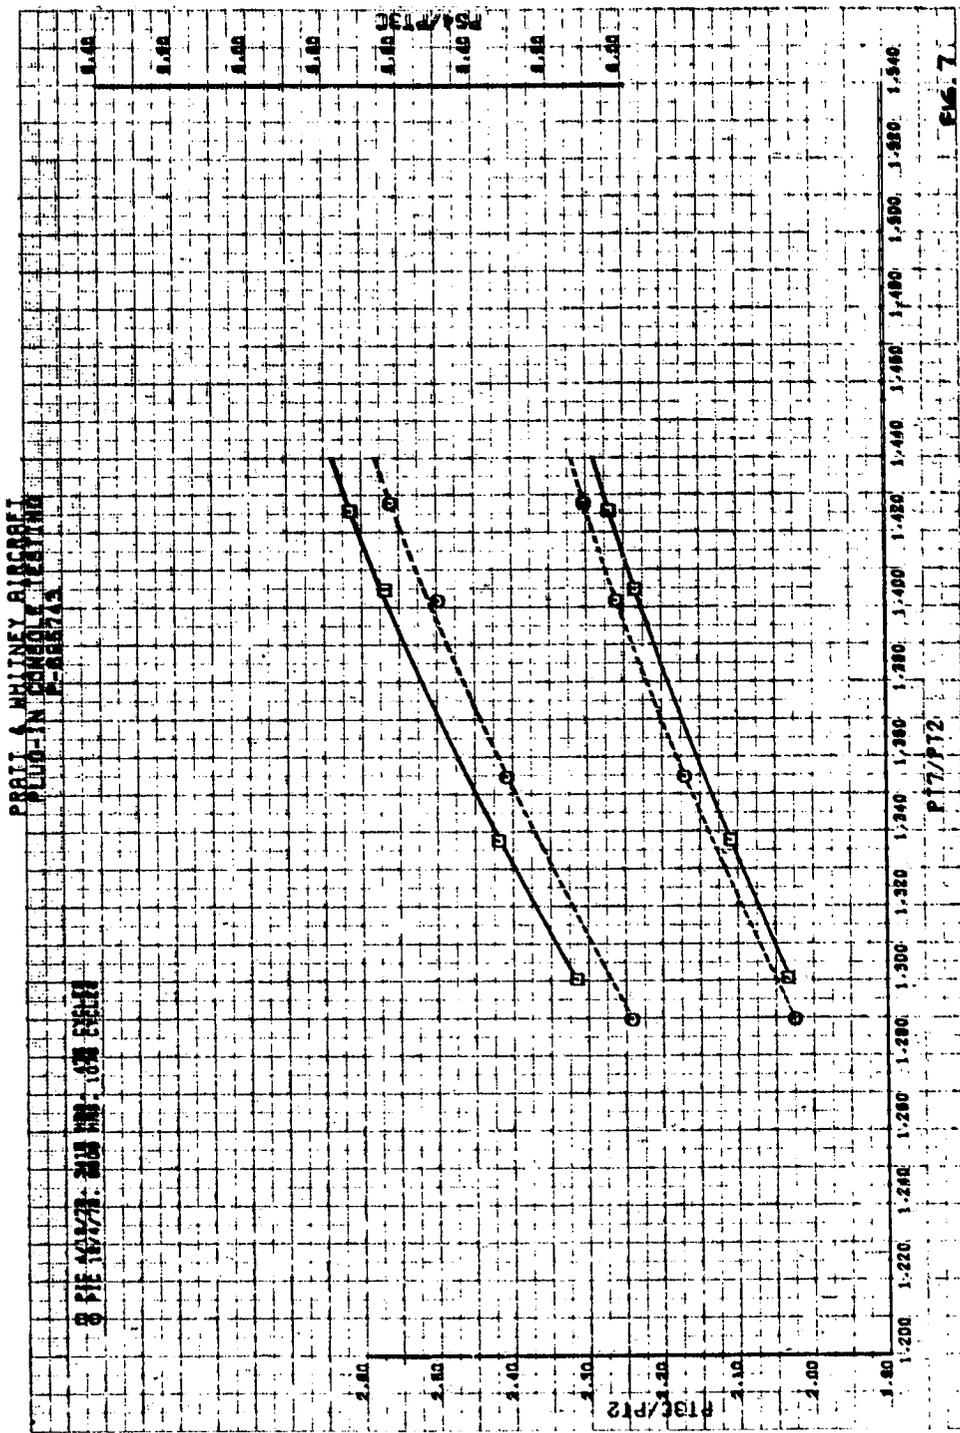
Figure 33 Typical Gas Generator Plot - Corrected low-pressure and high-pressure compressor compression ratios are plotted as functions of EPR for two PIC calibrations of engine P-695743 and used in the data analysis.

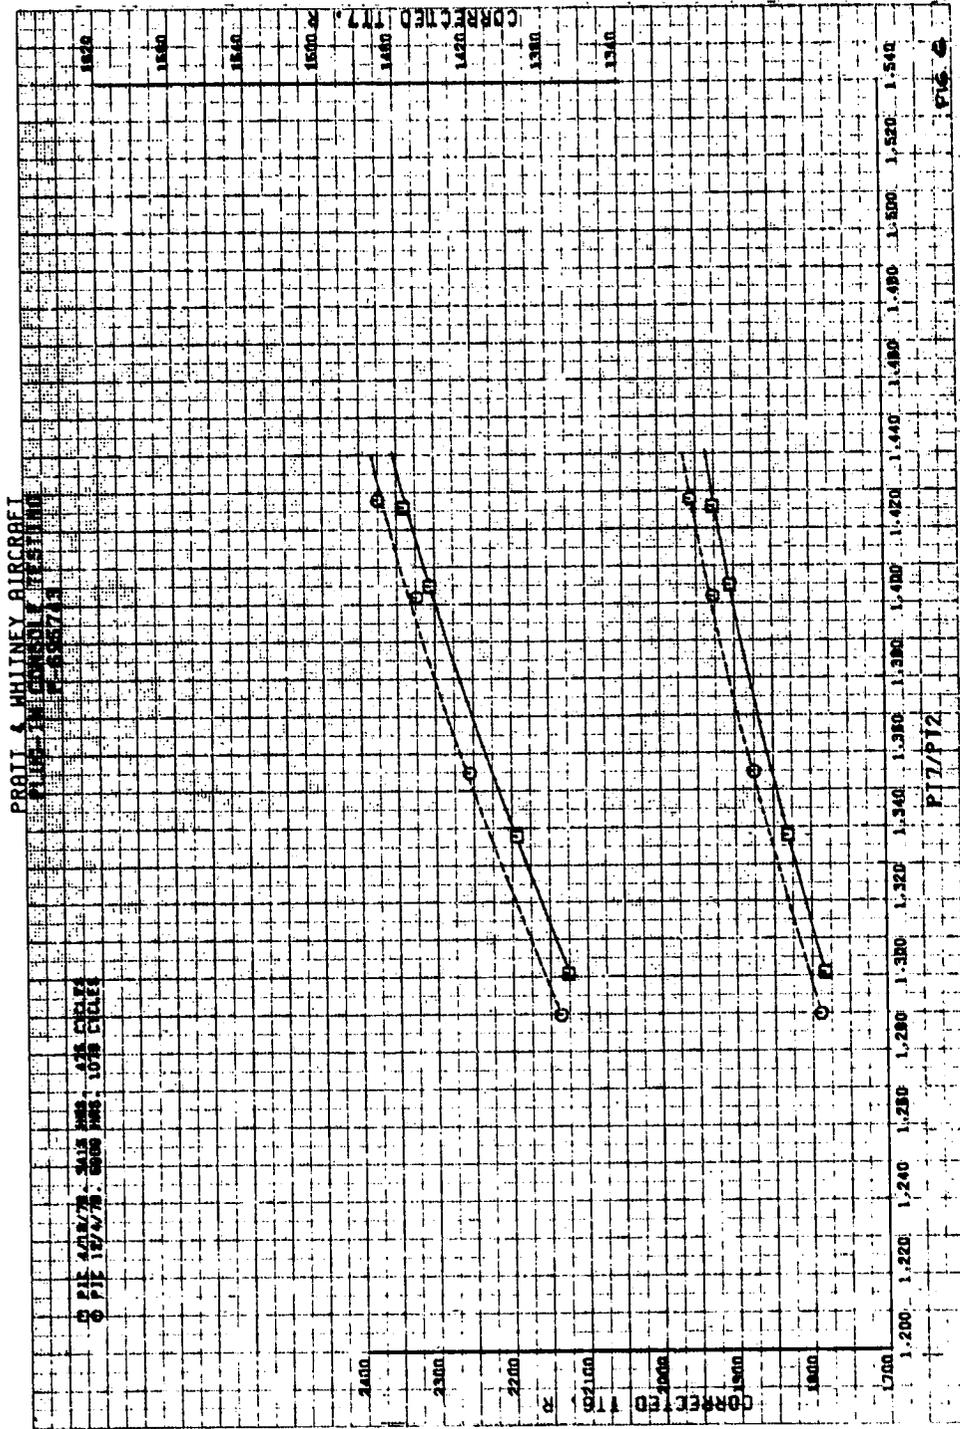
Figure 34 Typical Gas Generator Plot - Corrected high-pressure and low-pressure turbine discharge total temperatures are plotted as functions of EPR for two PIC calibrations of engine P-695743 and used in the data analysis.

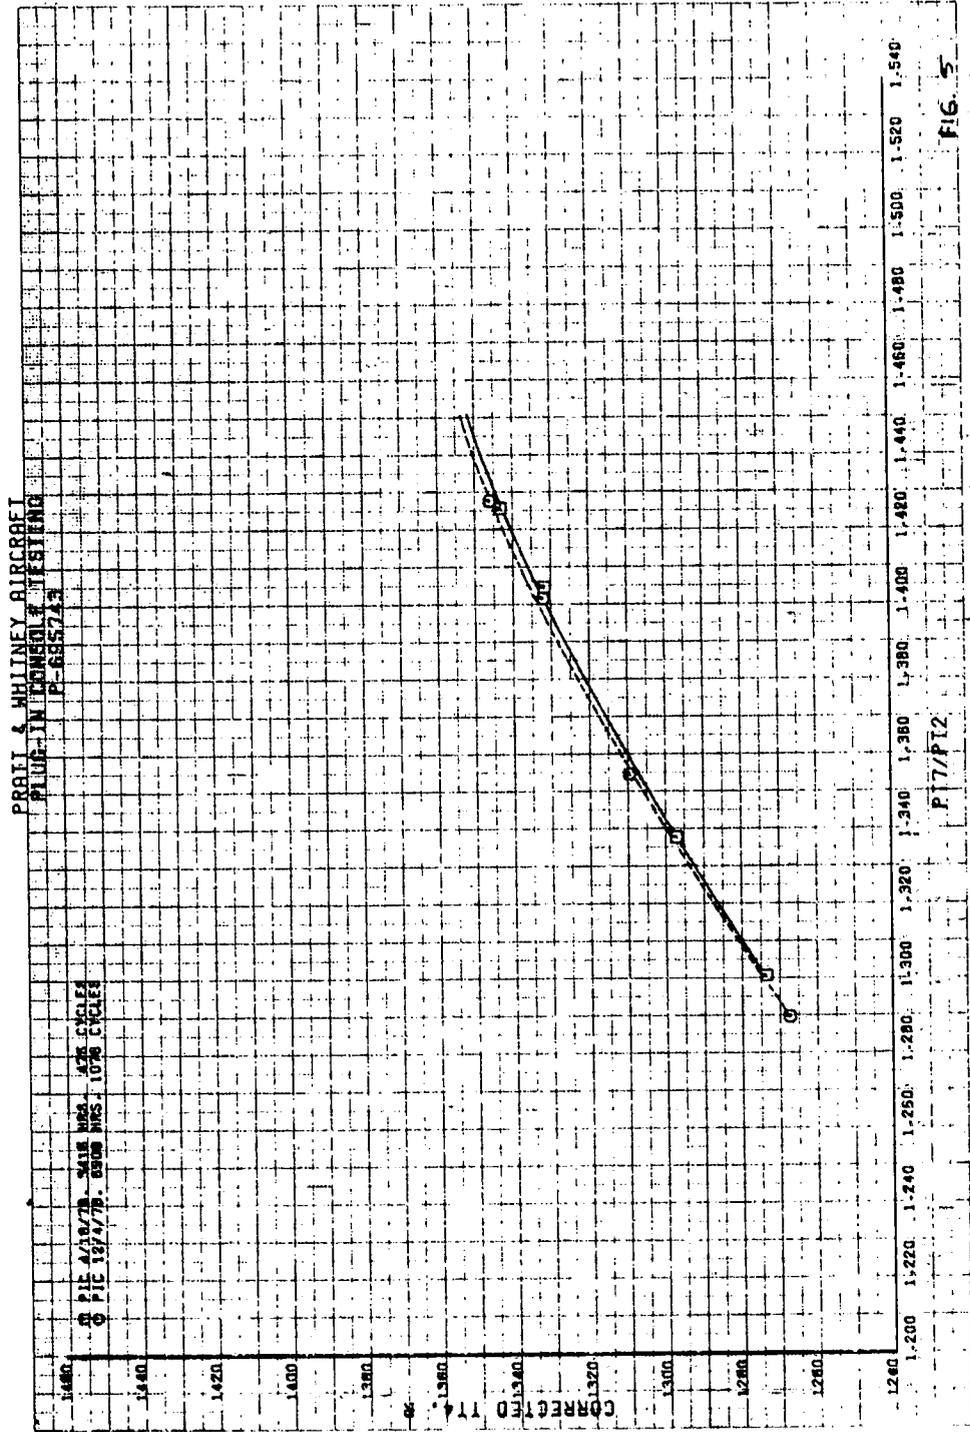
Figure 35. Typical Gas Generator Plot - Corrected high-pressure compressor discharge total temperature is plotted as a function of EPR for two PIC calibrations of engine P-695743 and used in the data analysis.

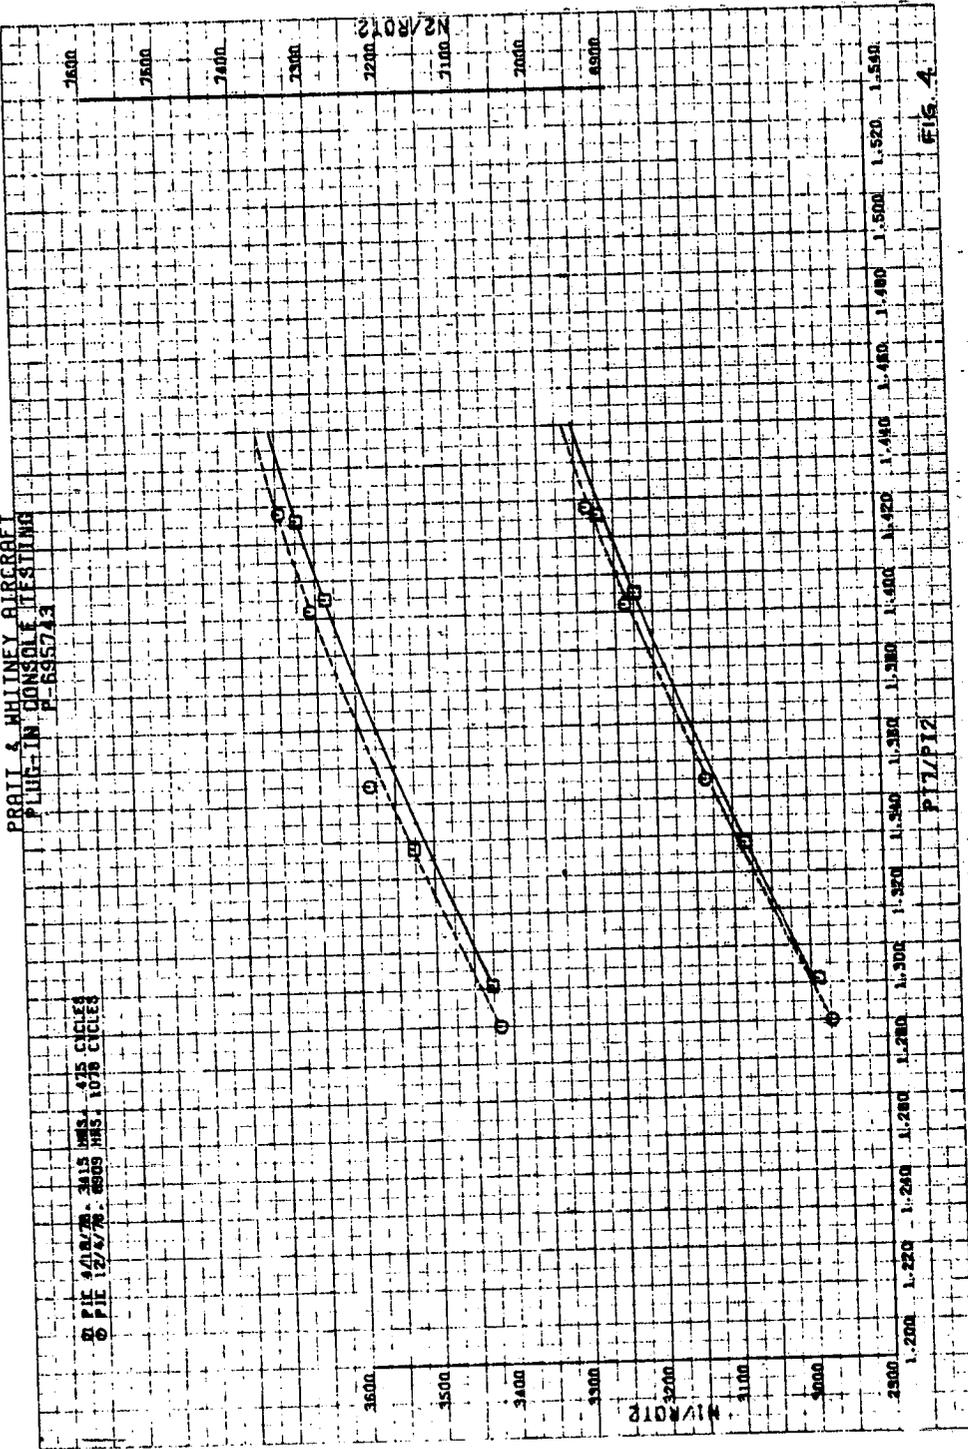
Figure 36 Typical Gas Generator Plot - Low-pressure and high-pressure rotor speeds are plotted as functions of EPR for two PIC calibrations of engine P-695743 and used in the data analysis.
