NASA CR-159525
PWA-5512-35

PERFORMANCE DETERIORATION
BASED ON IN-SERVICE ENGINE DATA
JT9D JET ENGINE DIAGNOSTICS PROGRAM

G. P. Sallee

UNITED TECHNOLOGIES CORPORATION
Pratt & Whitney Aircraft Group
Commercial Products Division

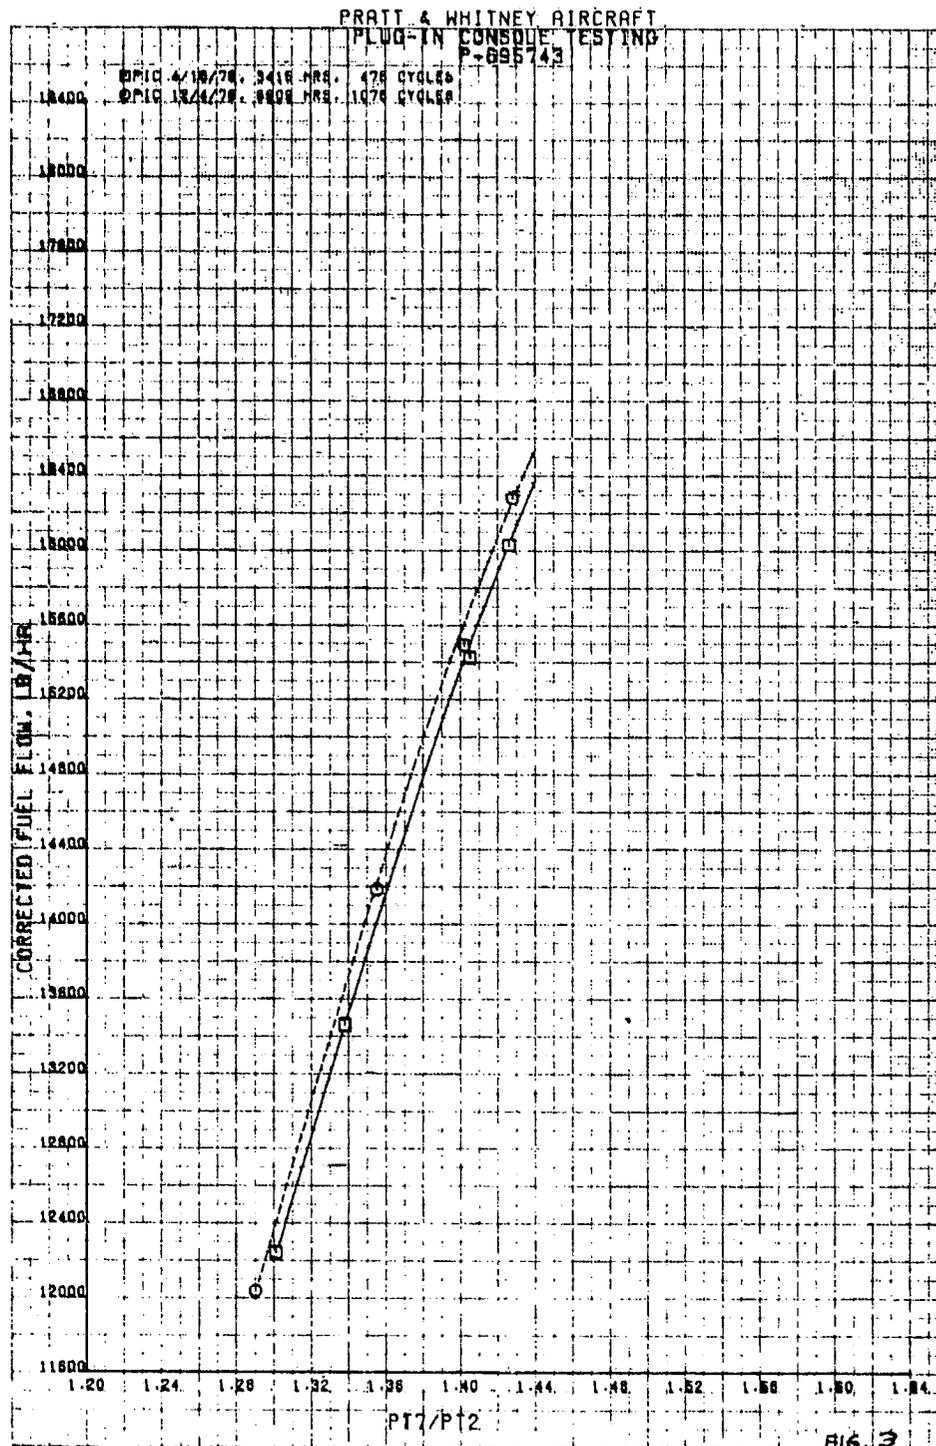
Figure 37 Typical Gas Generator Plot - Corrected fuel flow is plotted as a function of EPR for two PIC calibrations of engine P-695743 and used in the data analysis.

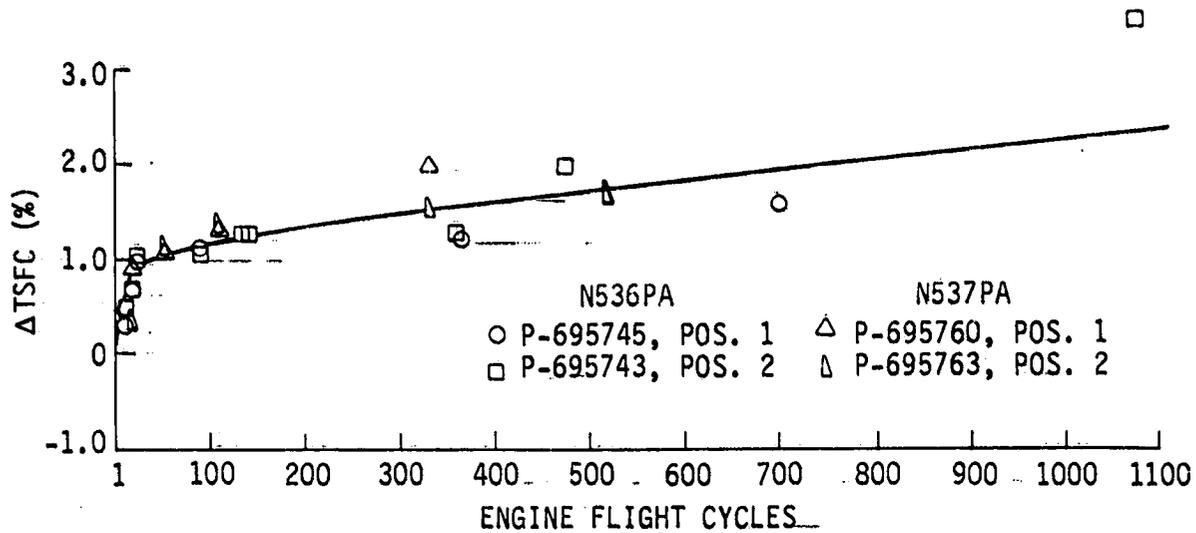
Figure 38 Estimated Sea Level Static TSFC Deterioration - Overall TSFC. Prerepair deterioration, based on module deterioration and influence coefficients, shows a rapid deterioration of 1 percent in the first 50 cycles followed by long-term deterioration at a much slower rate to 2.2 percent at 1000 cycles.

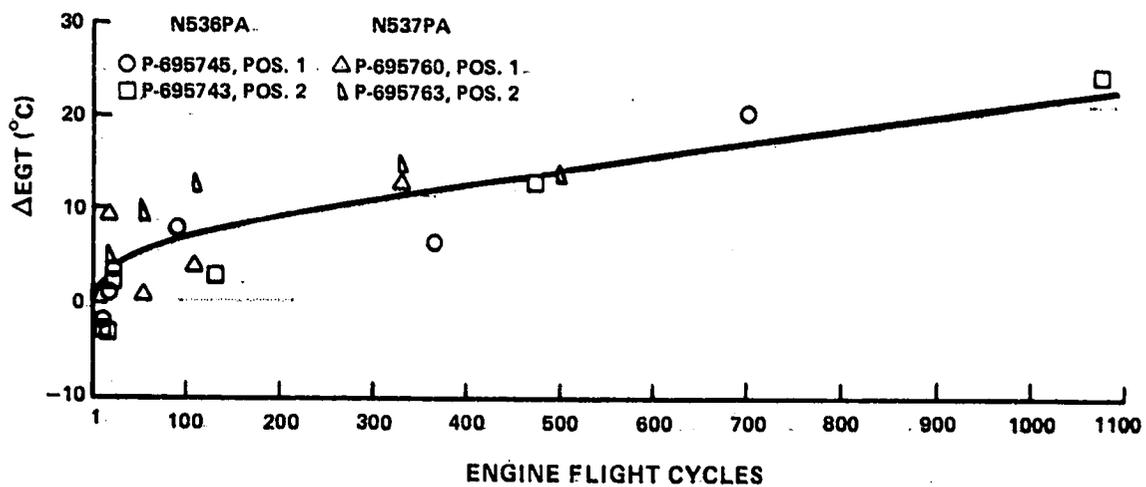
Figure 39 Estimated Sea Level Static Prerepair EGT Deterioration. - Overall EGT deterioration, based on module deterioration and influence coefficients, shows a rapid deterioration of 6°C in the first 50 cycles followed by a long-term deterioration at a slower rate to 22°C at 1000 cycles.

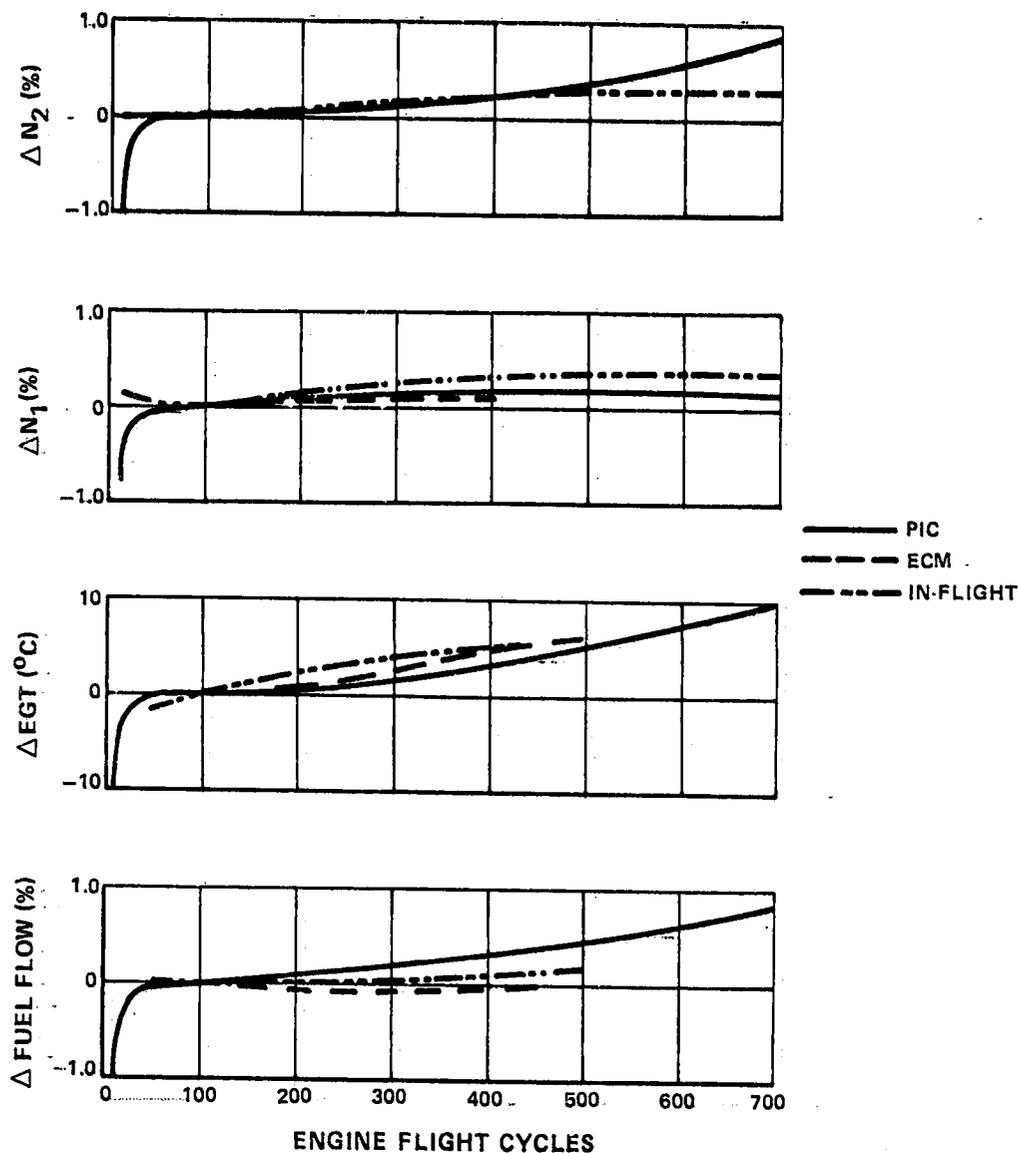
Figure 40 Comparison of Prerepair Gas Generator Parameters as Functions of Cycles as Determined by PIC Data Corrected For Altitude, In-Flight Calibration Data, and ECM Data. Agreement among the three trends is fairly good although wide variations in fuel flow occurred in in-flight calibration data and ECM data for engine P-695745 and thus influenced the average values.

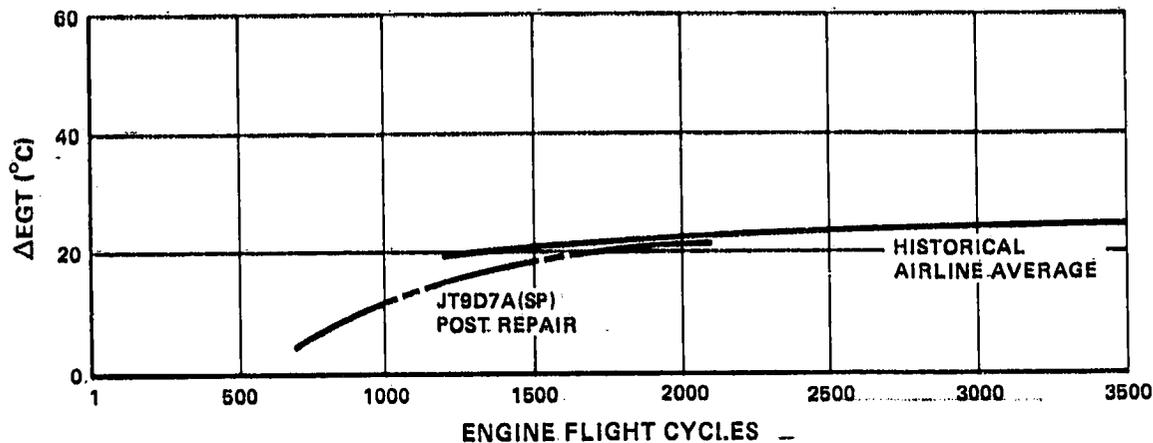
Figure 44 Postrepair Sea Level Static EGT Performance for JT9D Engines at Constant EPR - JT9D-7A(SP) test stand data and historical airline data are very similar in both trend and level.

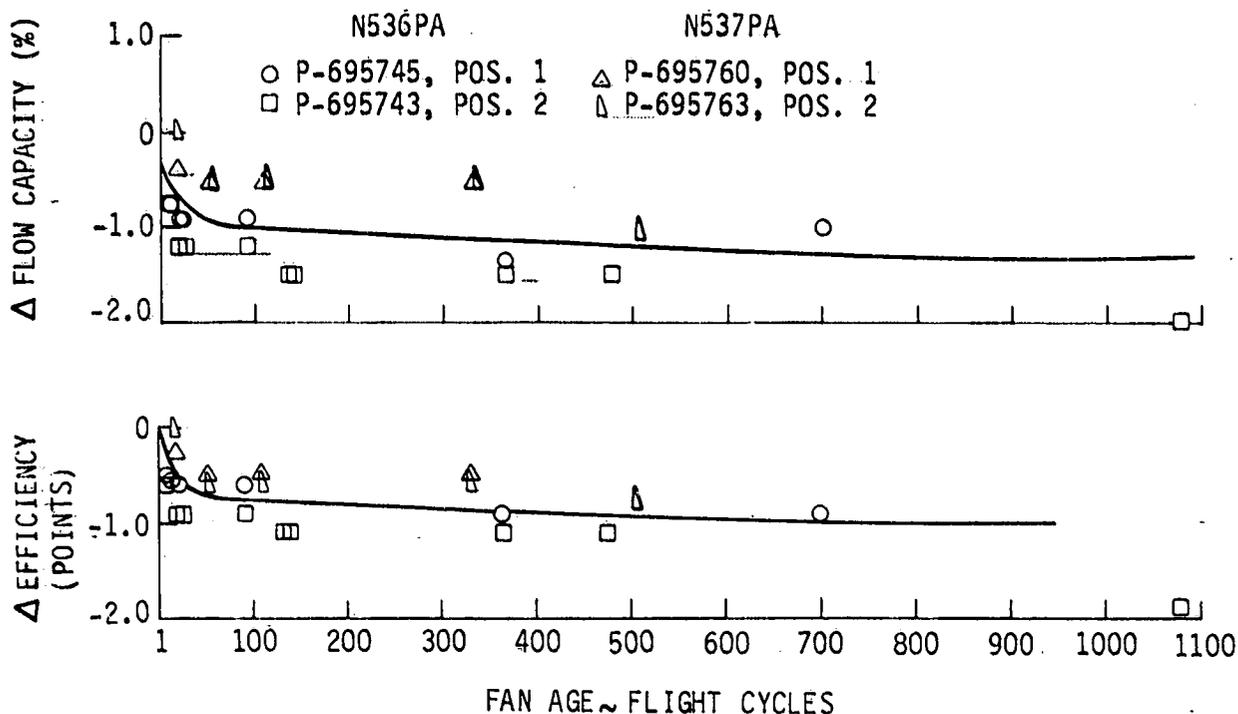
Figure 45 Fan Module Performance Deterioration - PIC calibrations from four engines, on two airplanes, show very rapid initial deterioration followed by long-term deterioration at a much slower rate.

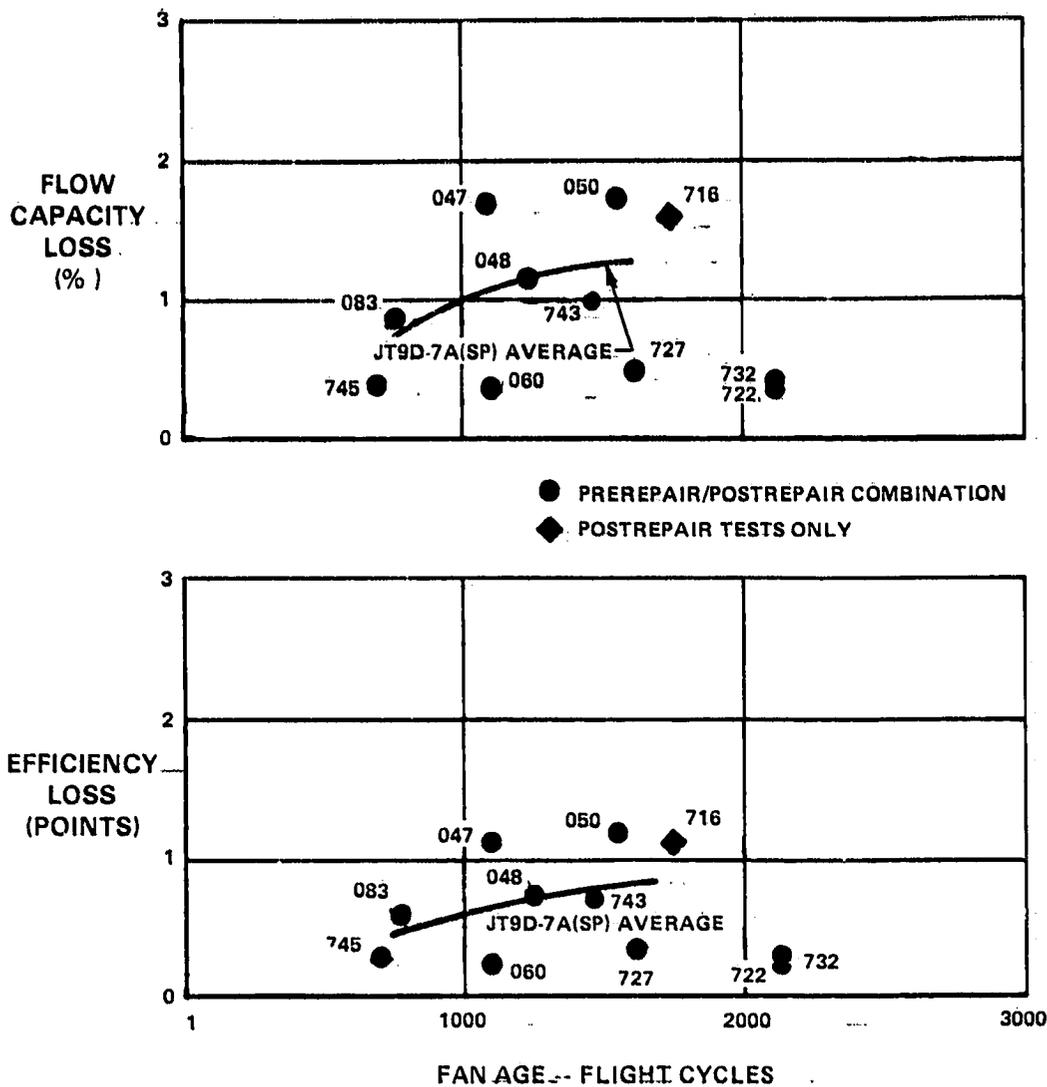
Figure 46 Estimated Fan Module Deterioration with Usage - The average estimated losses in fan efficiency and flow capacity are shown.

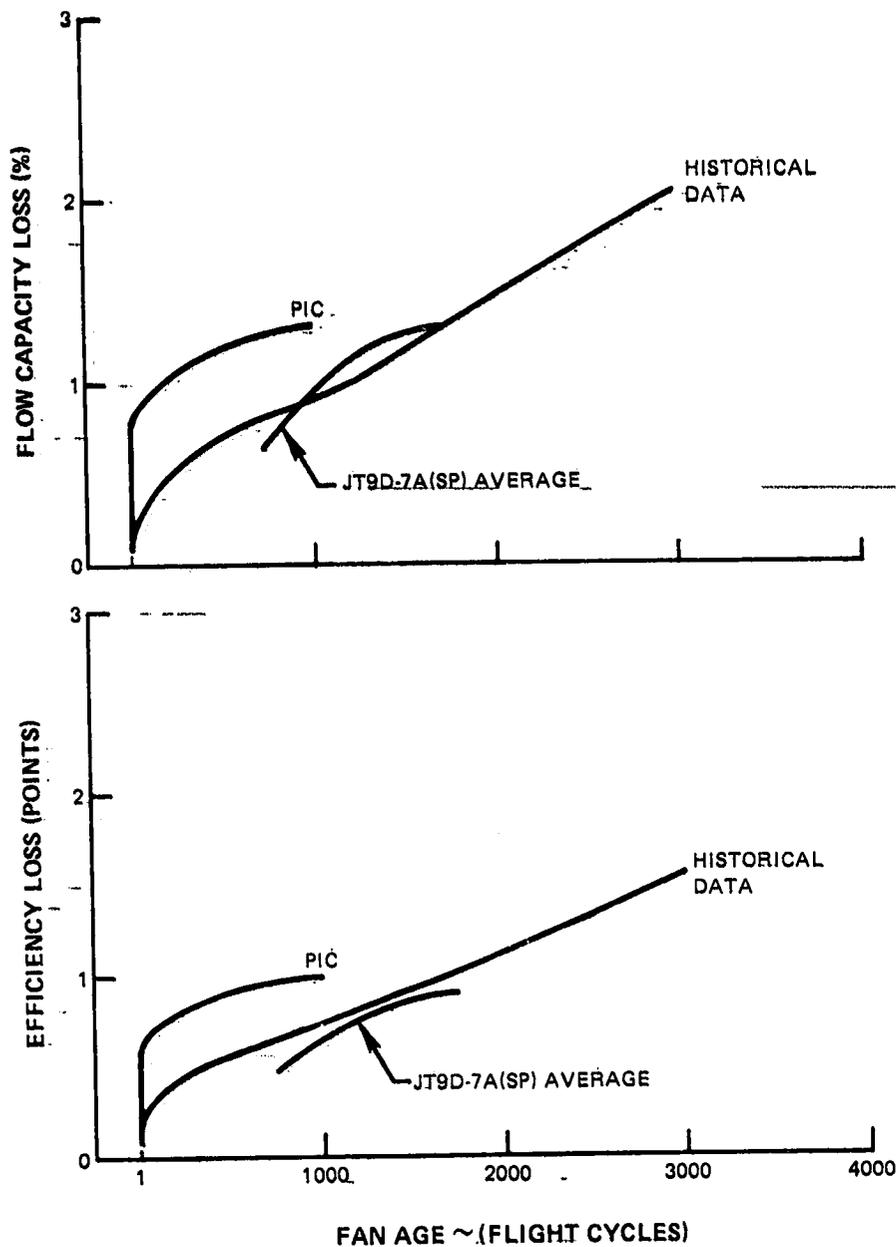
Figure 47 Comparison of PIC, JT9D-7A(SP) Prerepair, and Historical Fan Performance Deterioration Data - The prerepair test stand data shows good agreement while the PIC data shows a higher level of loss.

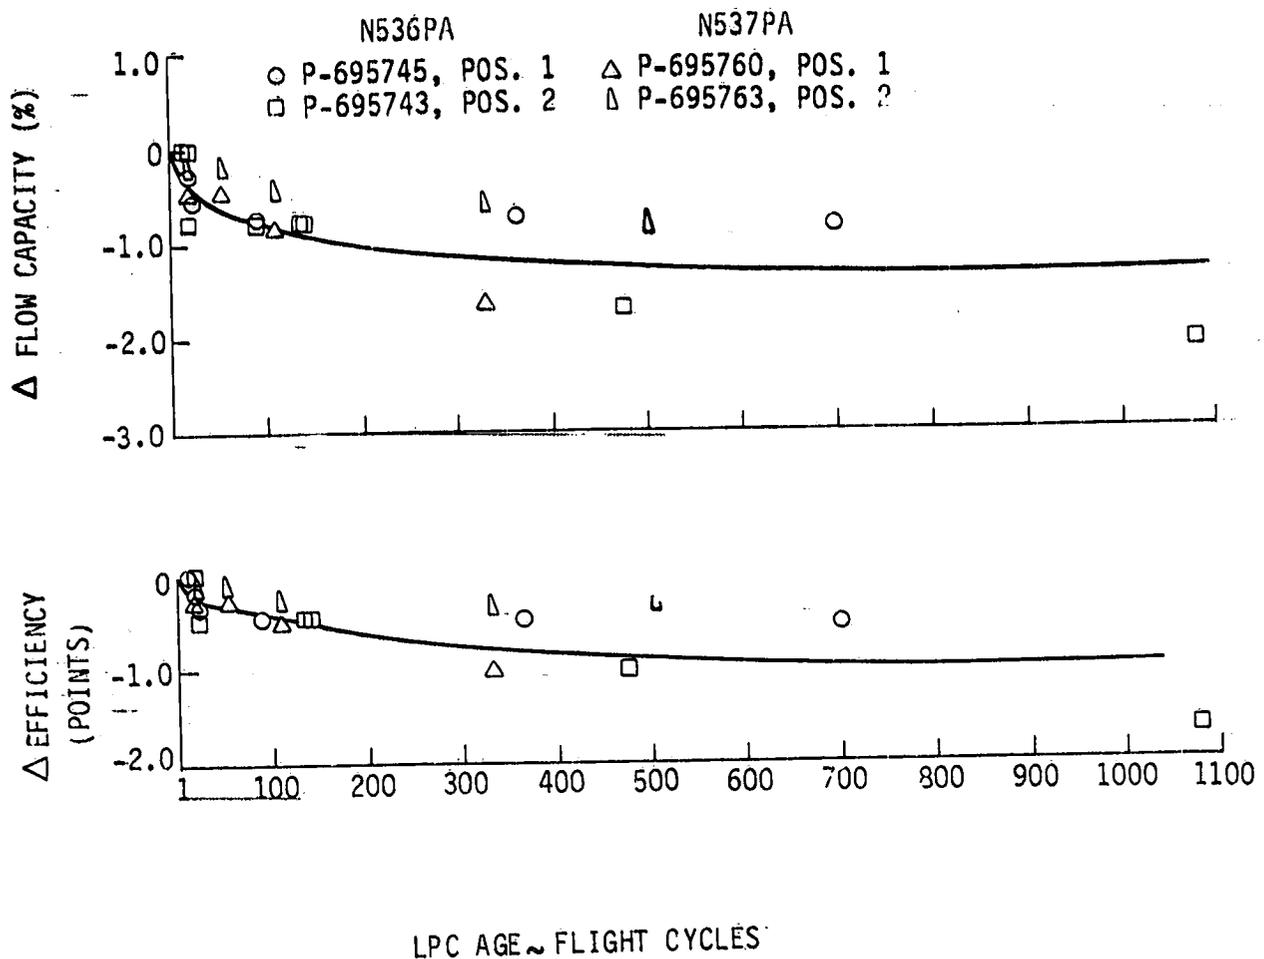
Figure-48 Low-Pressure Compressor Module Performance Deterioration -- PIC calibrations from four engines, on two airplanes, show rapid initial deterioration (less than that for the fan) followed by long-term deterioration at a much slower rate.

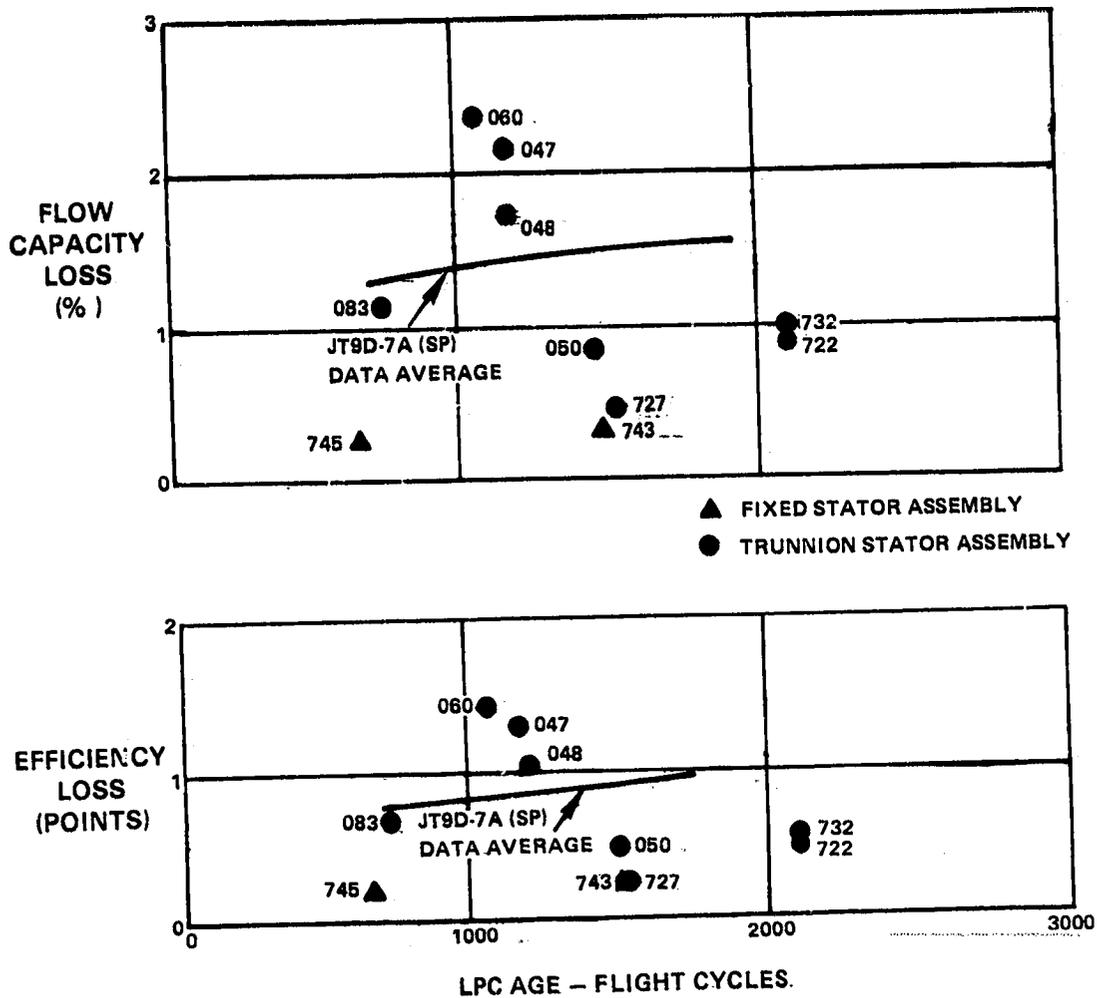
Figure 49 Estimated Low-Pressure Compressor Module Deterioration with Usage - The magnitude of low-pressure compressor deterioration appears related to the magnitude of fan deterioration for individual engines. It is believed that the data scatter is aggravated by the greater potential for leakage in the case of the trunnion stator.

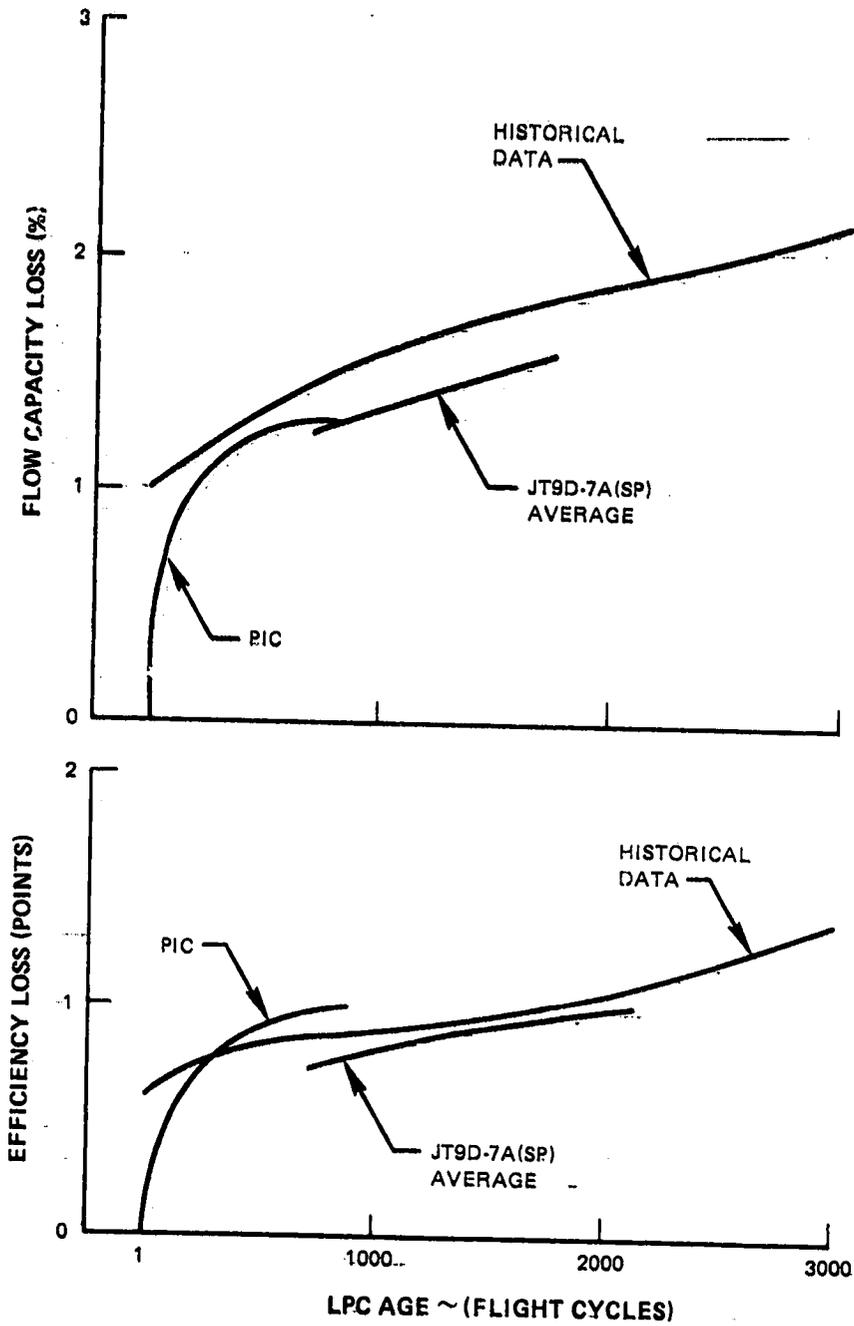
Figure 50 Comparison of PIC, JT9D-7A(SP) Prerepair and Postrepair, and Historical Low-Pressure Compressor Performance Deterioration Data - The loss in efficiency is comparable for all data sources.

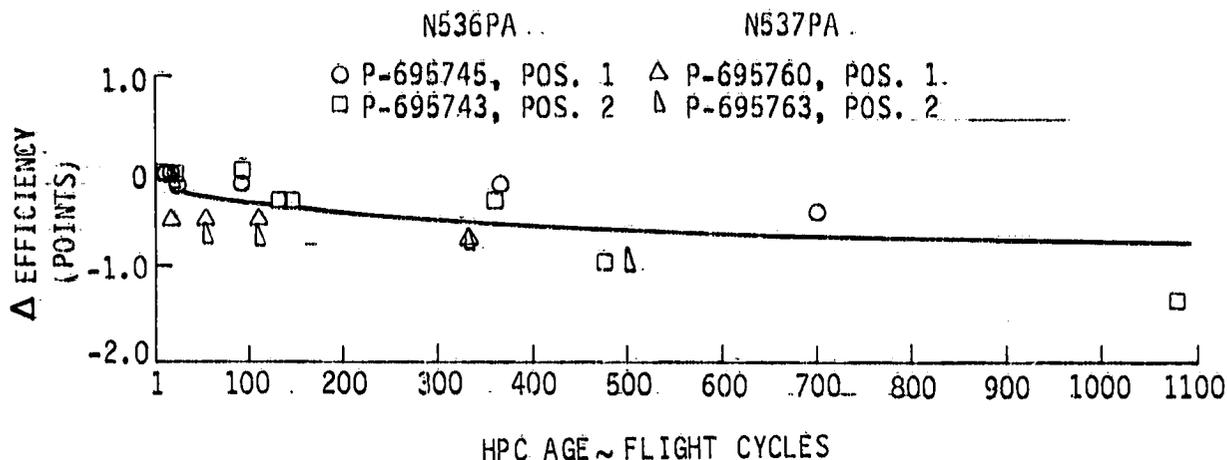
Figure 51 High-Pressure Compressor Module Performance Deterioration - PIC calibrations from four engines, on two airplanes, show characteristic initial deterioration for engines on one of the airplanes but a reduced initial deterioration for engines on the other airplane, followed by long-term deterioration at a much slower rate.

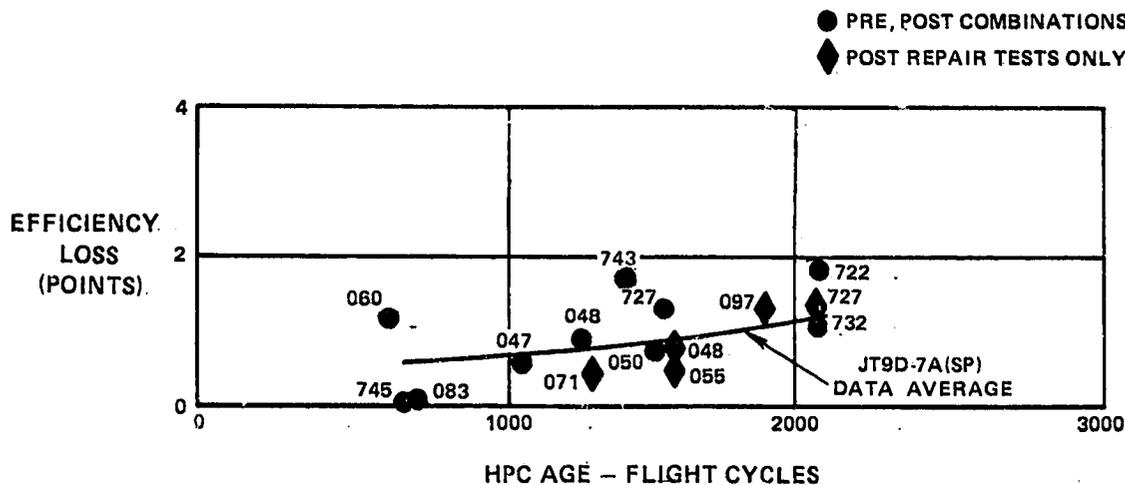
Figure 52 Estimated High-Pressure Compressor Module Deterioration with Usage - Results are shown for only efficiency loss since analytical flow capacity loss results include the effect of variable vane trim in addition to deterioration.

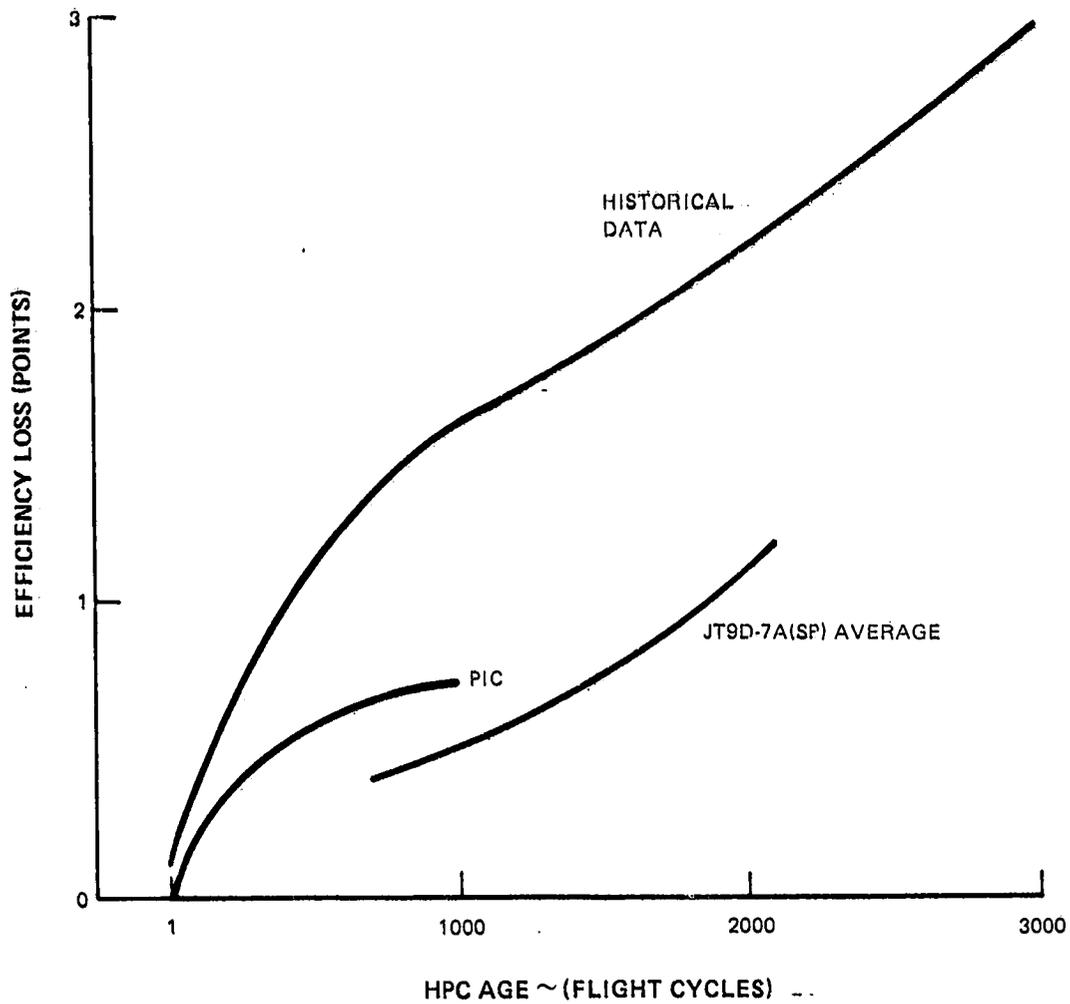
Figure 53 Comparison of PIC, JT9D-7A(SP) Prerepair and Postrepair, and Historical High-Pressure Compressor Performance Deterioration Data - The PIC and test stand data indicate less high-pressure compressor loss than does the historical data.

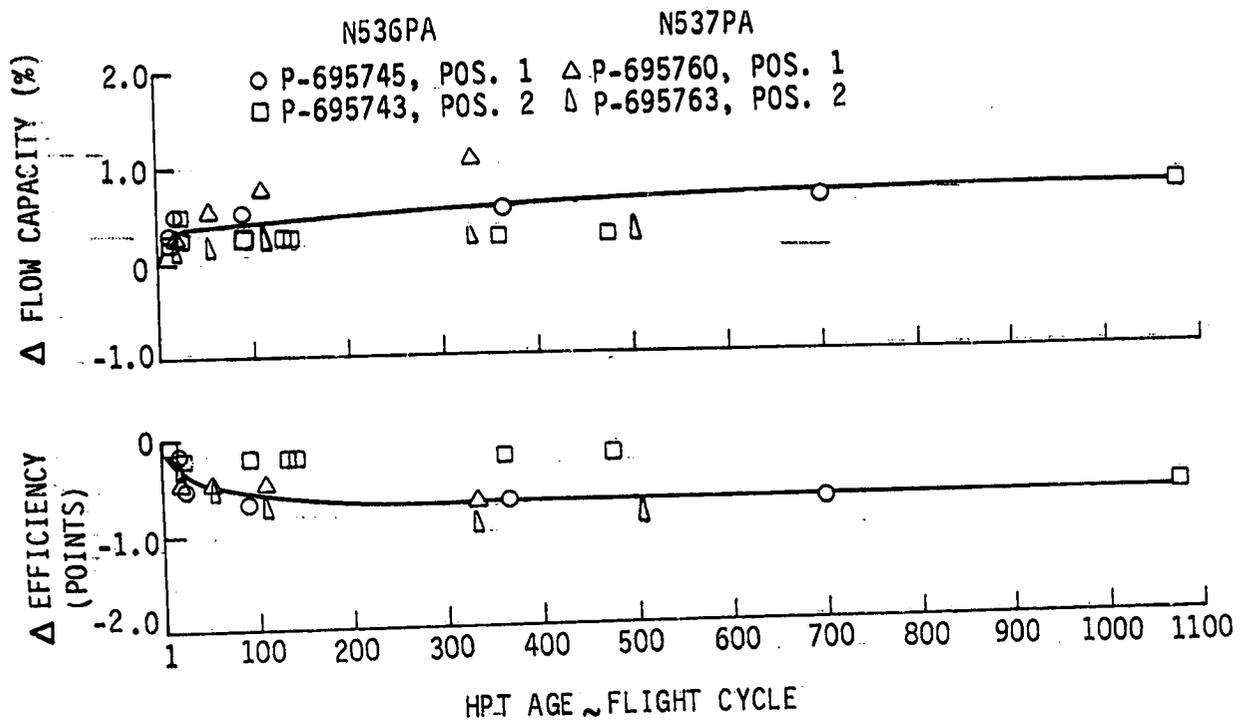
Figure 54 High-Pressure Turbine Module Performance Deterioration - PIC calibrations from four engines, on two airplanes, show characteristic initial deterioration followed by long-term deterioration at a much slower rate.

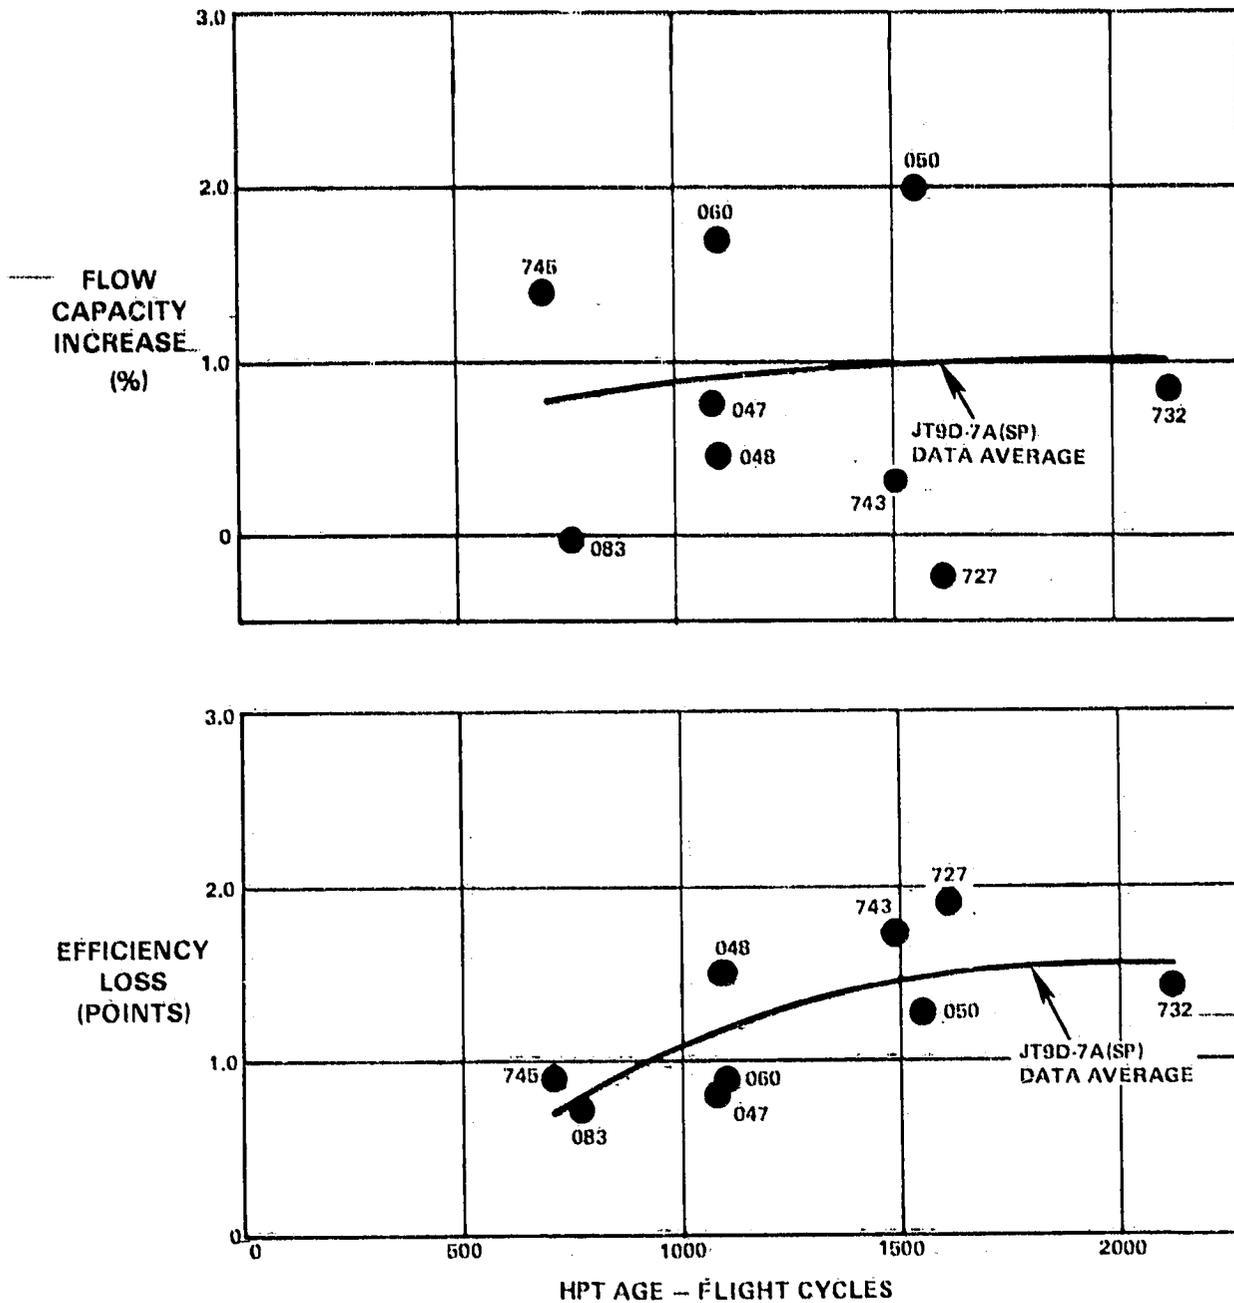
Figure 55 Estimated High-Pressure Turbine Module Deterioration with Usage -- The greater data scatter in the case of flow capacity increase is attributed to the strong dependency of predicted flow capacity on measured Ps4/Pt7 and the associated influence of compressor condition on exit profile and measured Ps4.

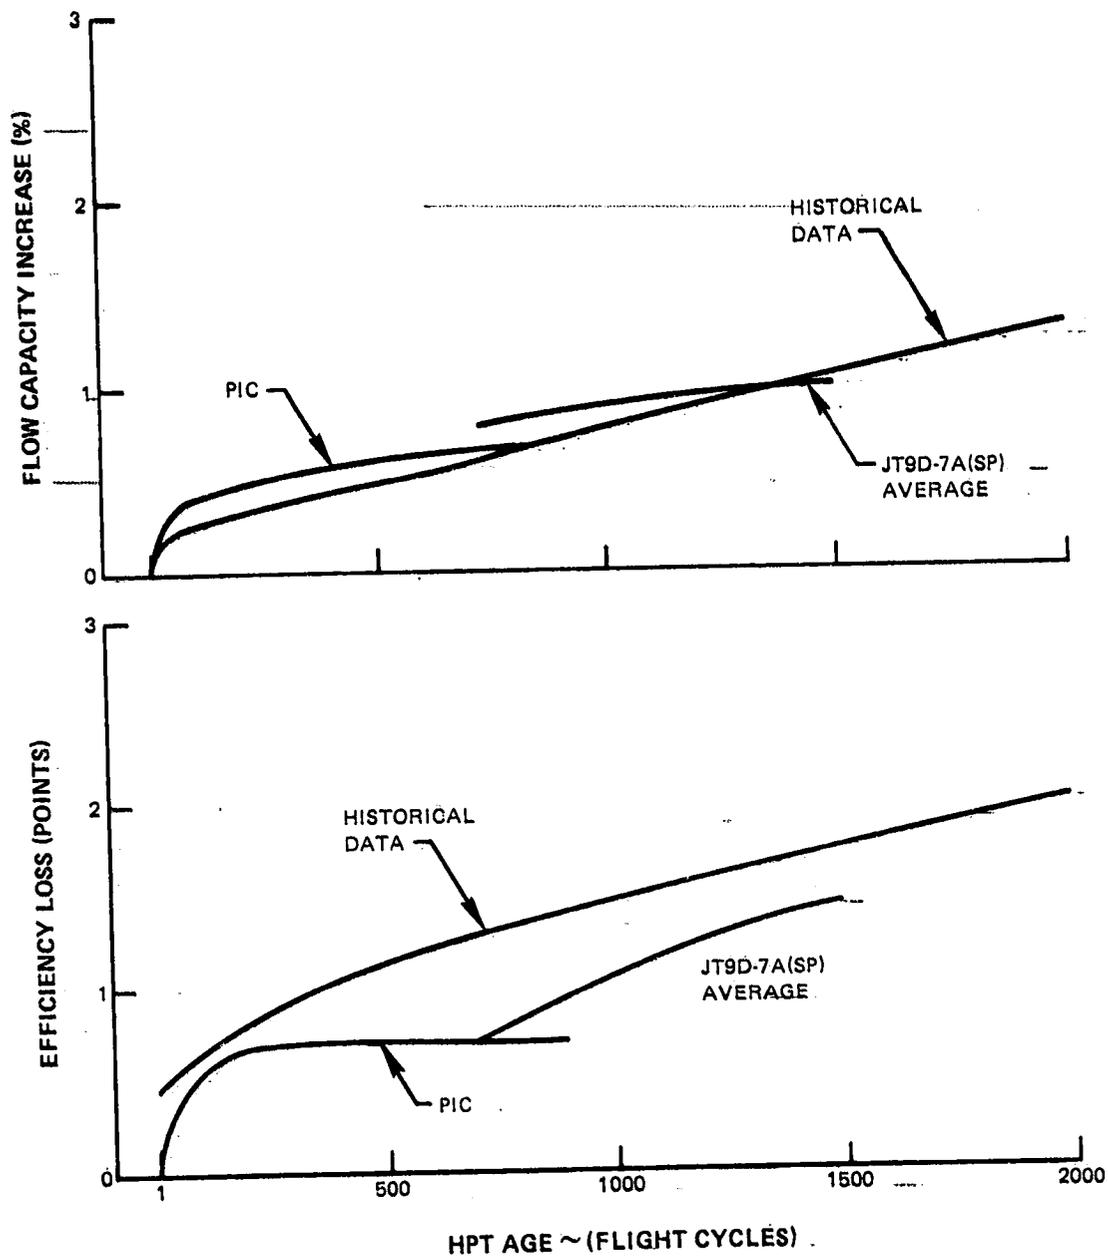
Figure 56 Comparison of PIC, JT9D-7A(SP) Prerepair and Postrepair, and Historical High-Pressure Turbine Performance Deterioration Data - The PIC and test stand data indicate lower high-pressure turbine losses than does the historical data.

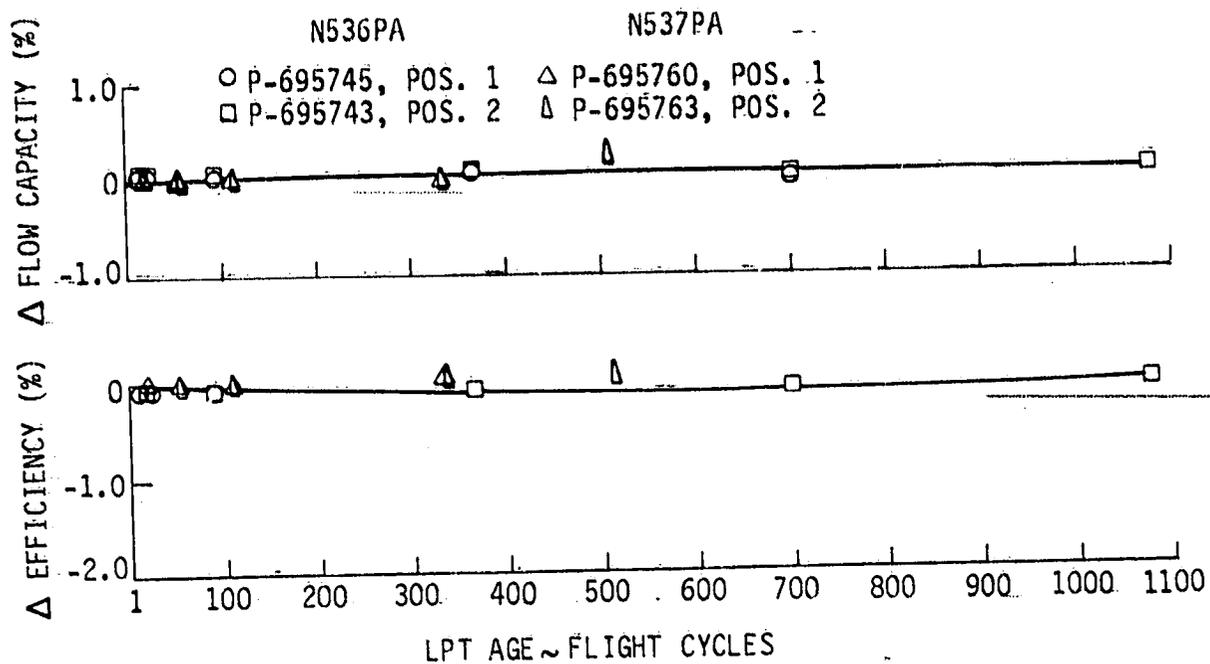
Figure 57 Low-Pressure Turbine Module Performance Deterioration - PIC calibrations from four engines, on two airplanes, show that both initial and long-term deterioration is practically negligible.

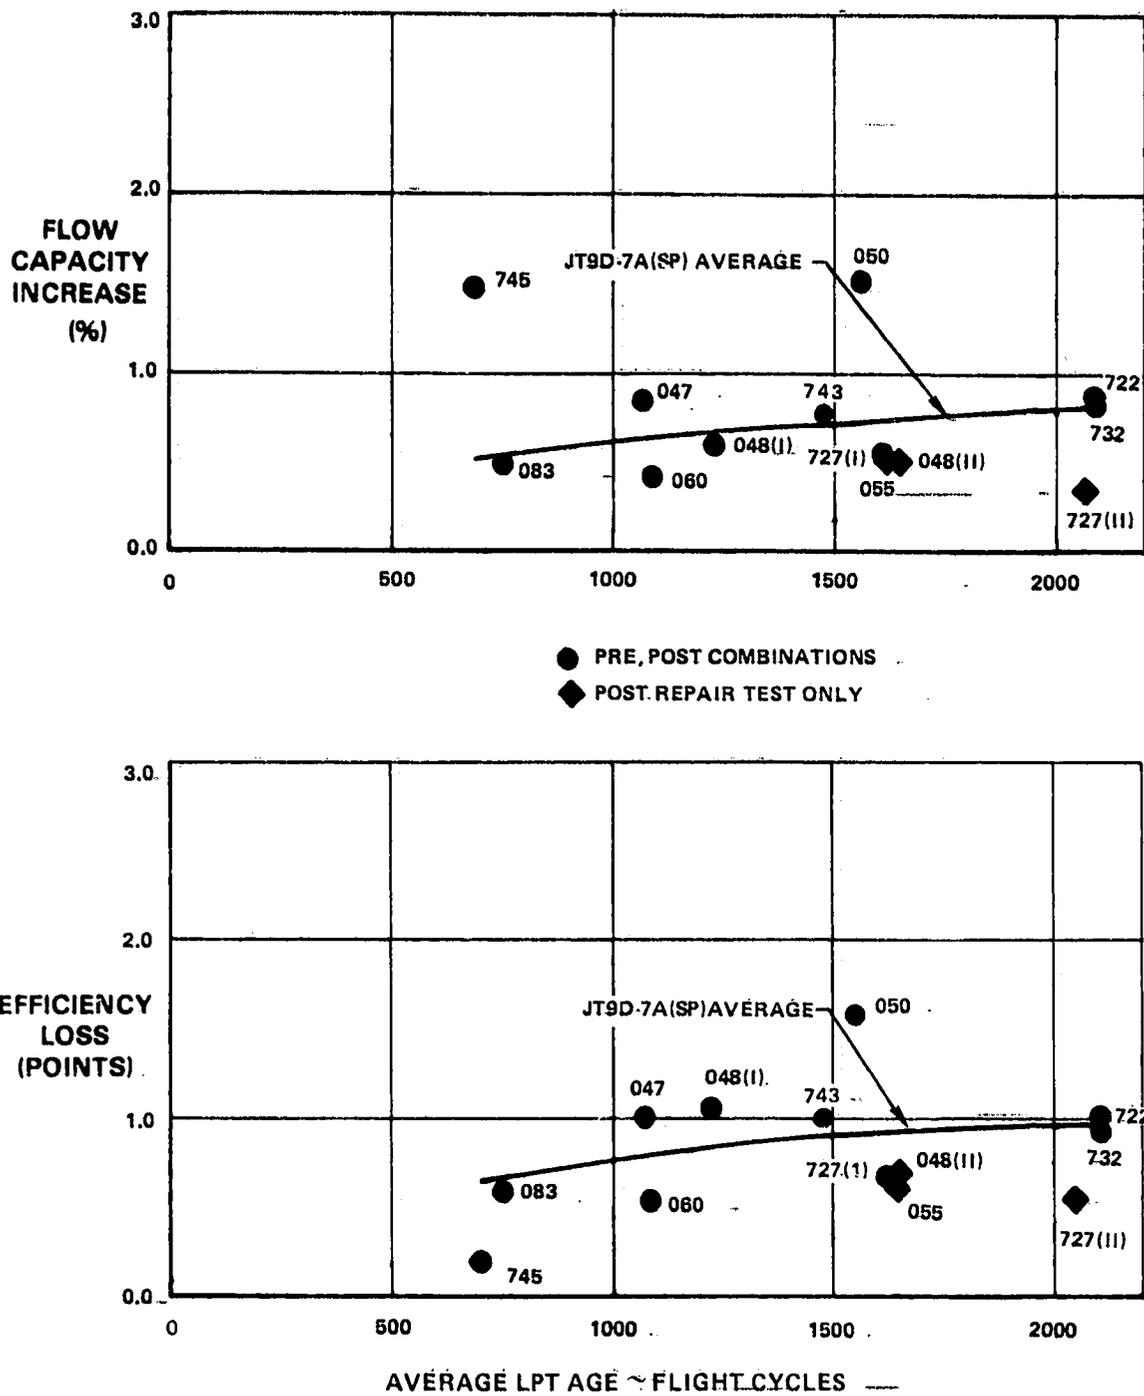
Figure 58: Low-Pressure Turbine Module Deterioration with Usage - The rate of low-pressure turbine deterioration appears to be related to the rate of fan/low-pressure compressor deterioration; engines that are high in fan and low-pressure compressor losses also tend to be high in low-pressure turbine loss and vice versa.

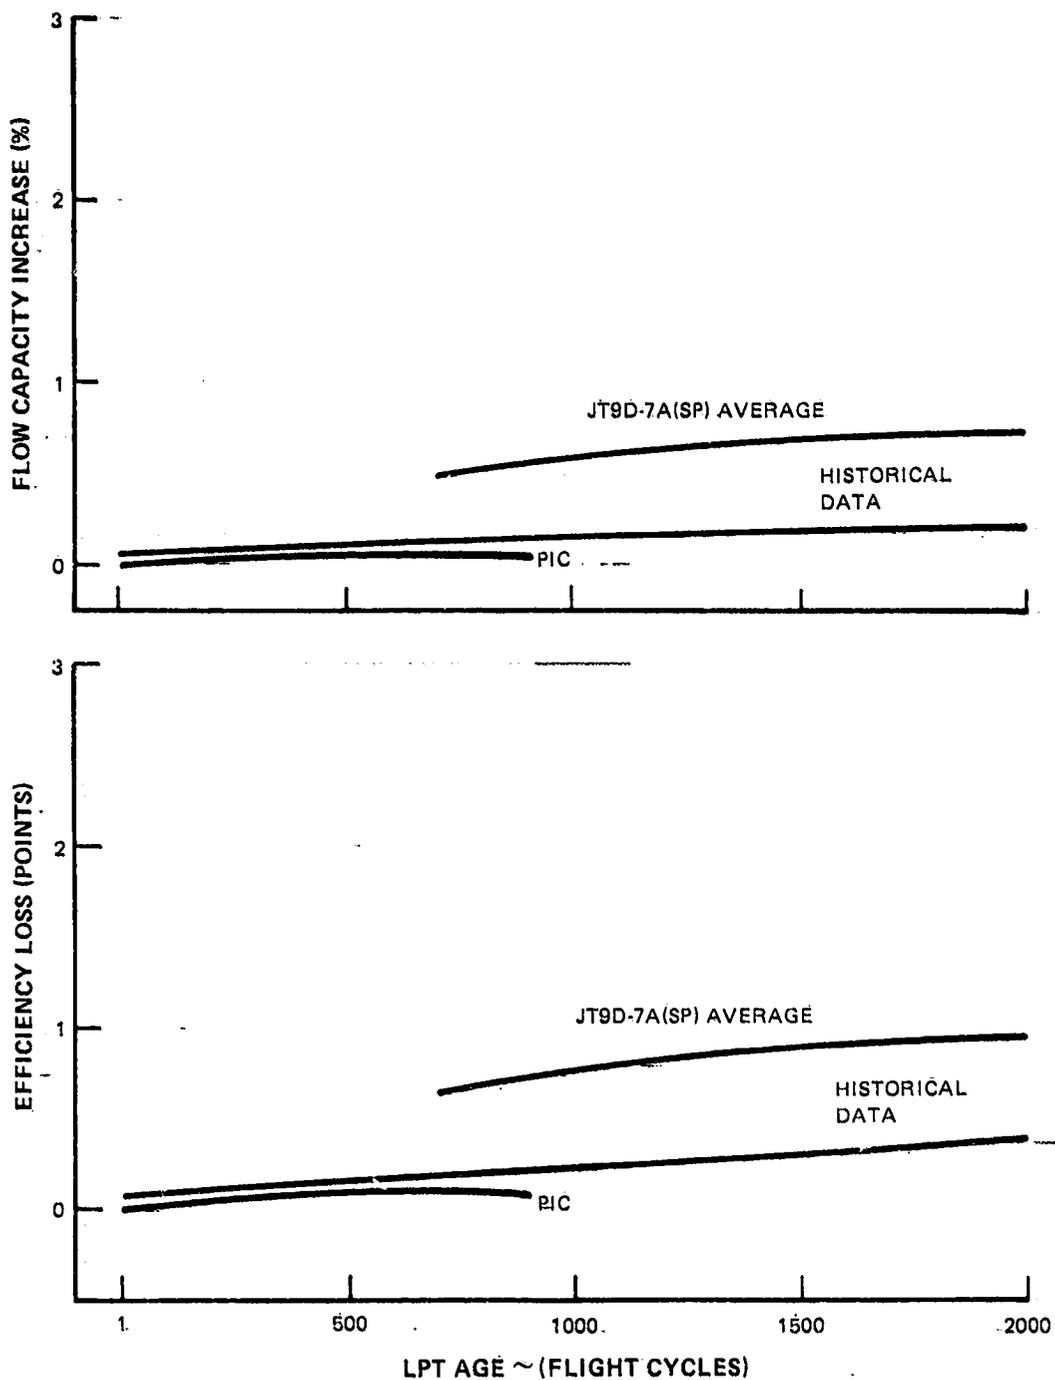
Figure 59 Comparison of PIC, JT9D-7A(SP) Prerepair and Postrepair, and Historical Low-Pressure Turbine Performance Deterioration Data - The test stand data shows greater low-pressure turbine losses than does either the PIC or historical data.

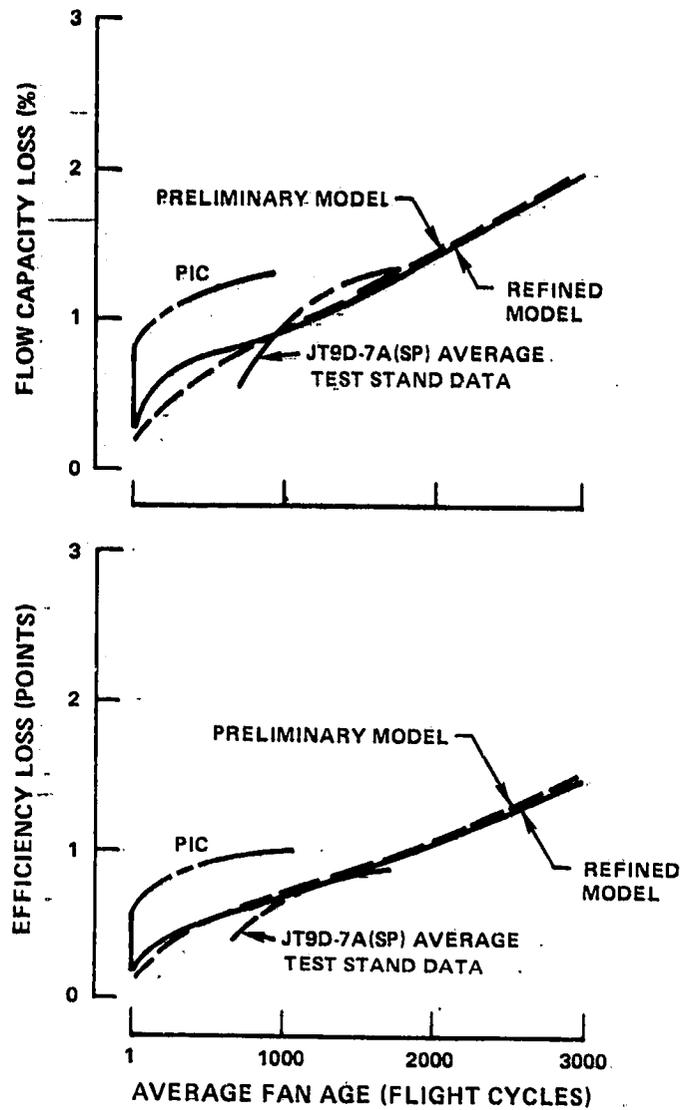
Figure 60 Development of Fan Performance Deterioration Refined Model
 - The refined model is based predominately on the JT9D-7A(S) test stand data and the preliminary model.
