NASA CR-159525
PWA-5512-35

PERFORMANCE DETERIORATION
BASED ON IN-SERVICE ENGINE DATA
JT9D JET ENGINE DIAGNOSTICS PROGRAM

G. P. Sallee

UNITED TECHNOLOGIES CORPORATION
Pratt & Whitney Aircraft Group
Commercial Products Division

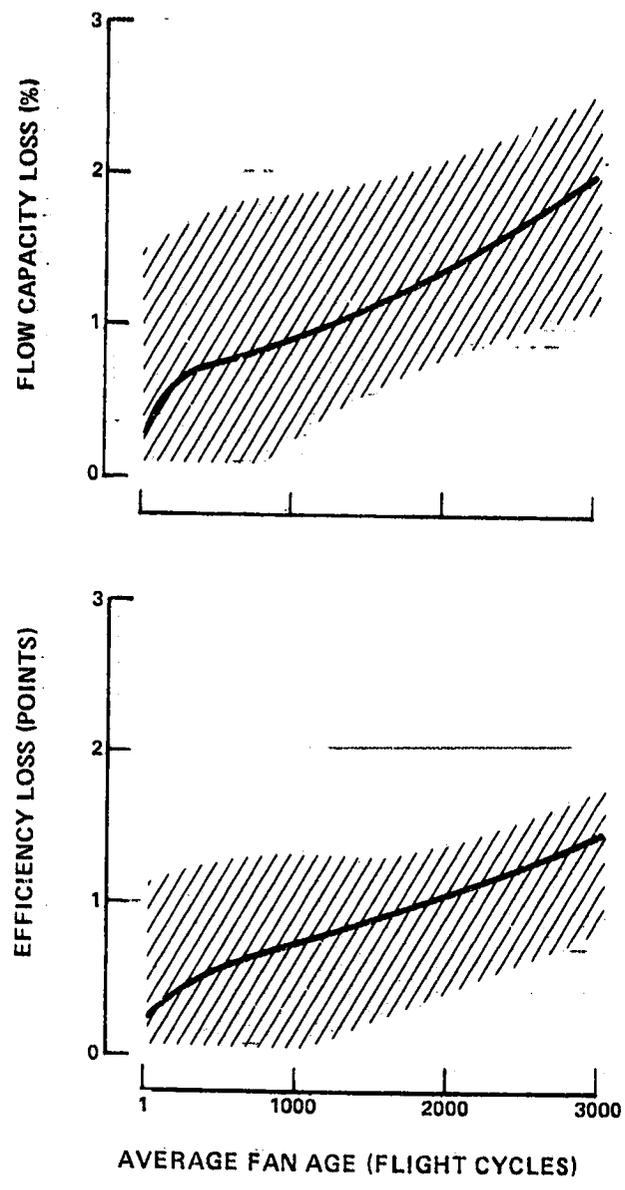
Figure 61 Fan Performance Deterioration Refined Model and Variation Band - The variation band represents data scatter among individual JT9D-7A(SP) engines.

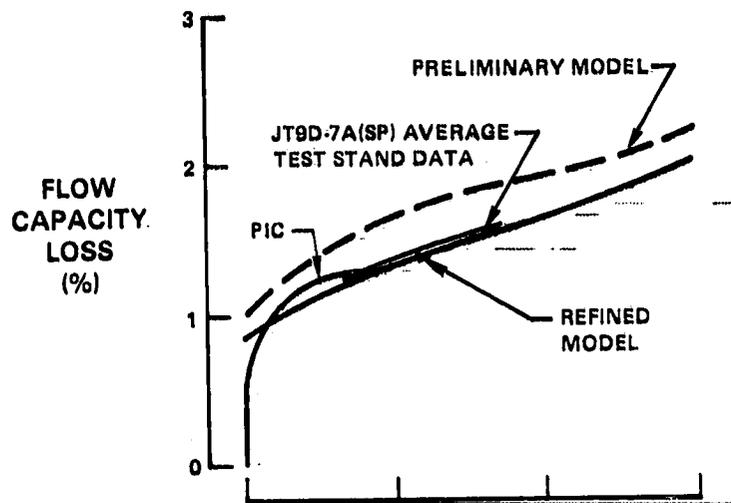
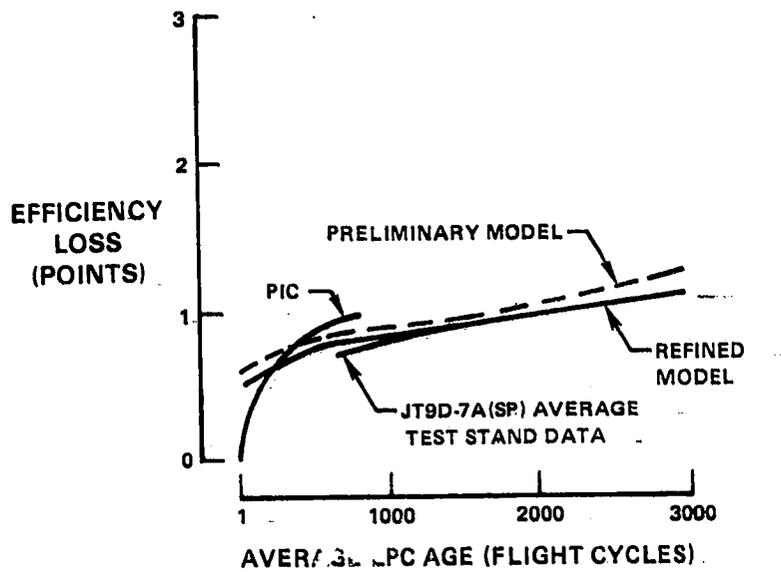
Figure 62 Development of Low-Pressure Compressor Performance - Deterioration Refined Model - The refined model shows less flow capacity loss than the preliminary model.

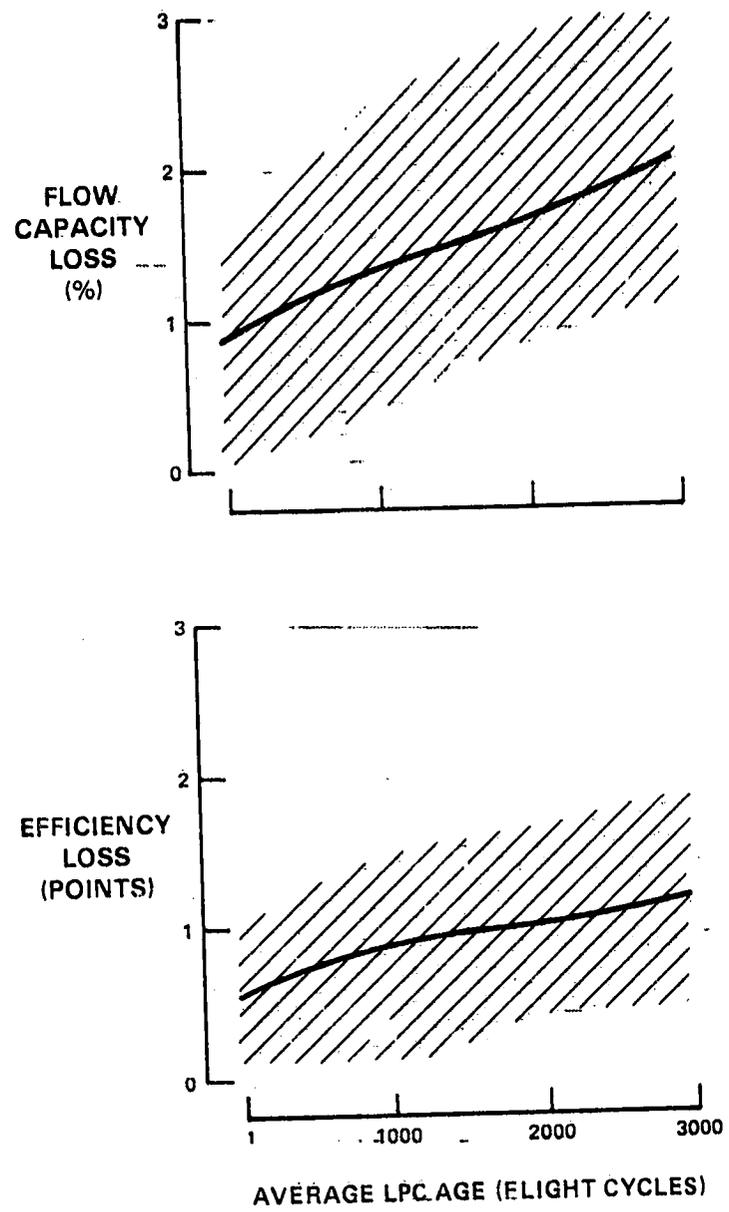
Figure 63 Low-Pressure Compressor Performance Deterioration Refined Model and Variation Band - The variation band represents scatter among individual JT9D-7A(SP) engines.

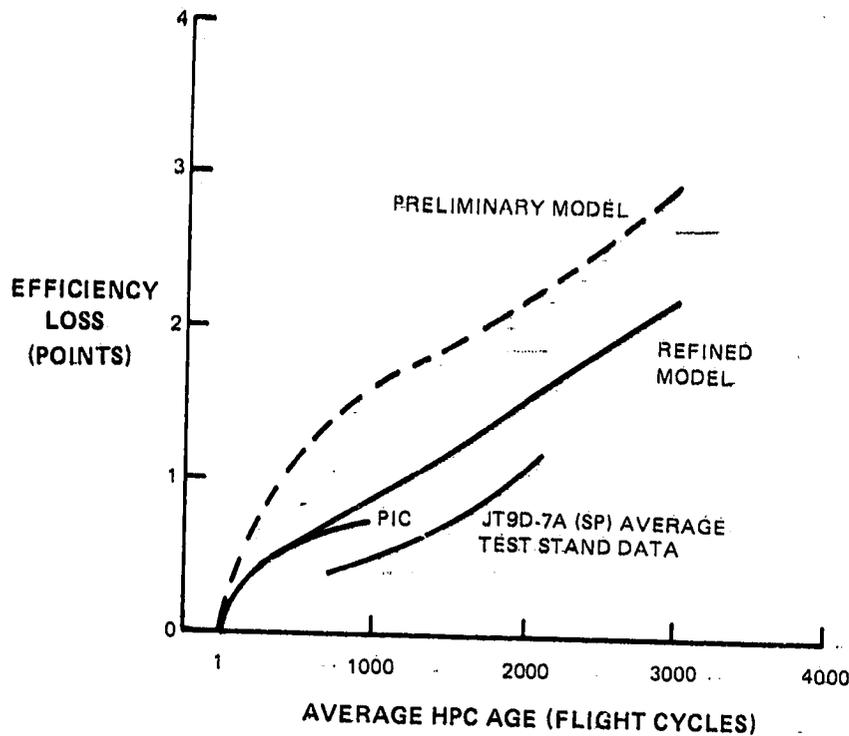
Figure 64 Development of High-Pressure Compressor Performance Deterioration Refined Model - The refined model lies between the historical data and JT9D-7A(SP) data which indicate lower deterioration with respect to usage.

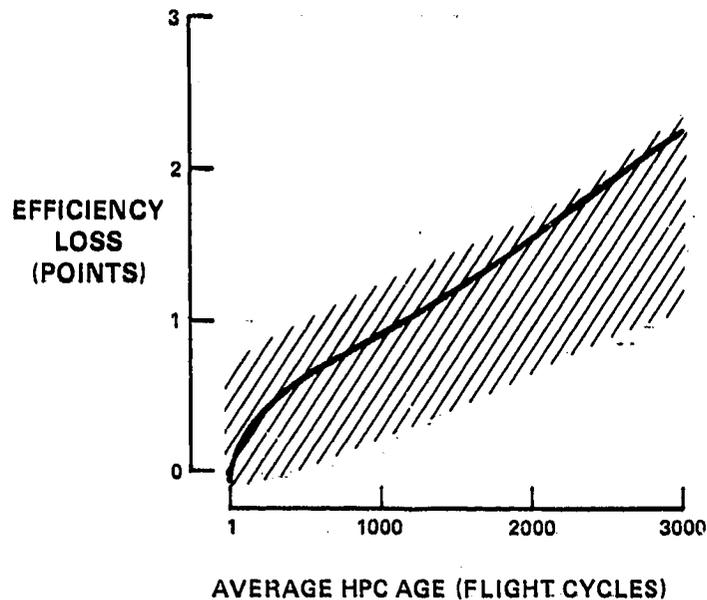
Figure 65 High-Pressure Compressor Performance Deterioration Refined Model and Variation Band - The variation band represents data scatter among individual JT9D-7A(SP) engines.

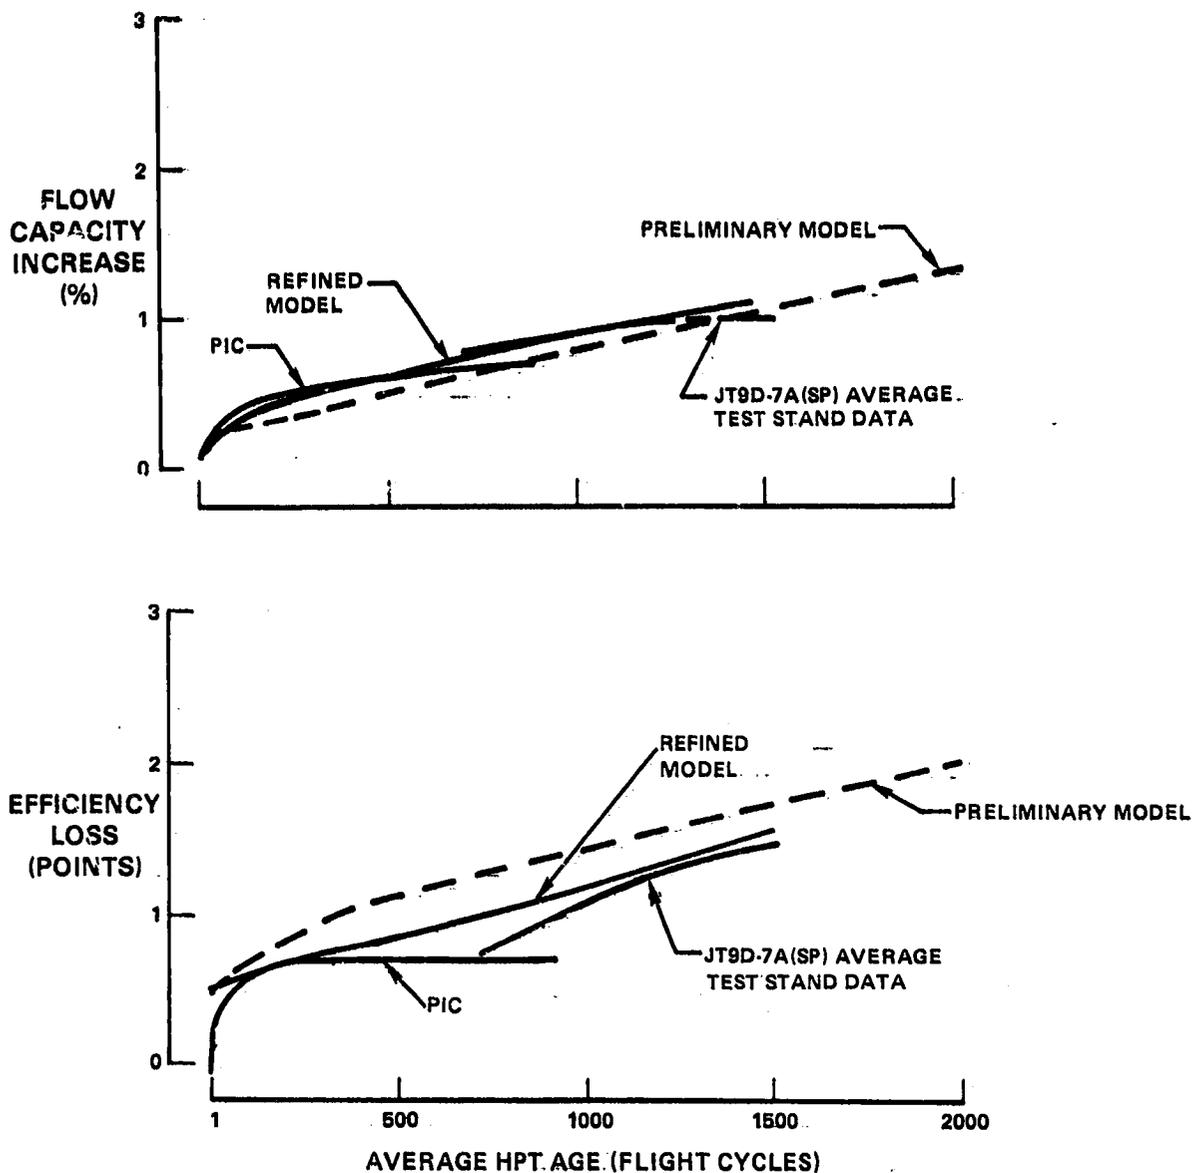
Figure 66 Development of High-Pressure Turbine Performance Deterioration Refined Model - JT9D-7A(SP) engine data showed lower efficiency deterioration and slightly higher flow capacity increase than that for the historical data.

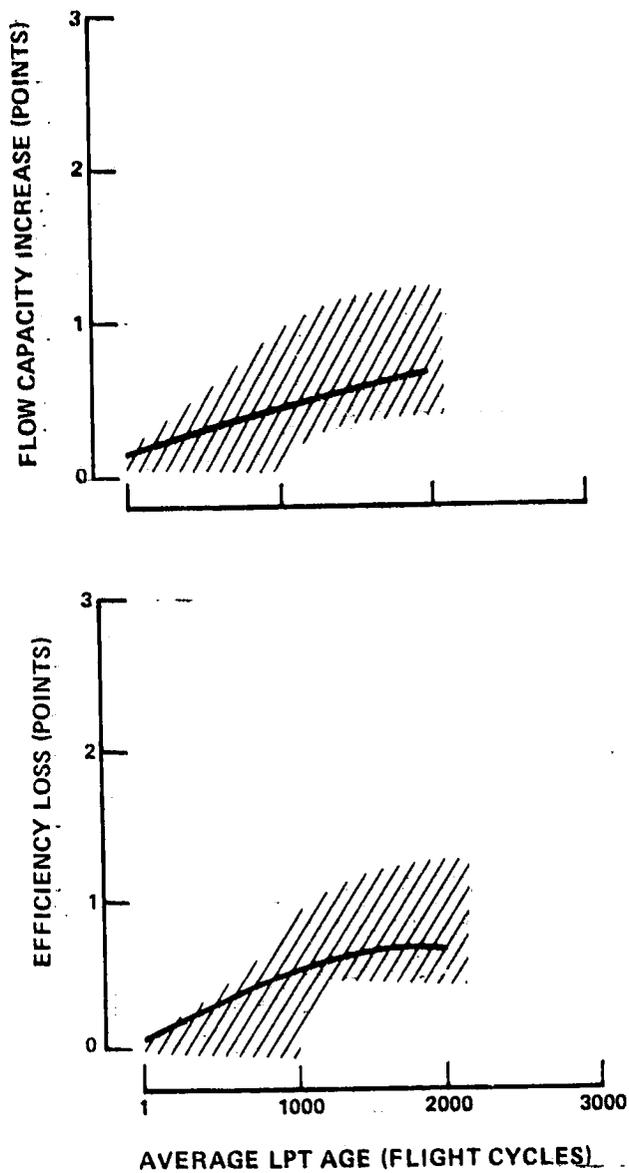
Figure 69 Low-Pressure Turbine Performance Deterioration Refined Model - The variation band includes all data collected to date.
