DOE/JPL 954852-80/5
Distribution Category UC-63
Report #5

DEFECT STRUCTURE OF WEB SILICON RIBBON

B. Cunningham, H. Strunk and D. Ast

Materials Science and Engineering
Bard Hall, Cornell University
Ithaca, New York 14853

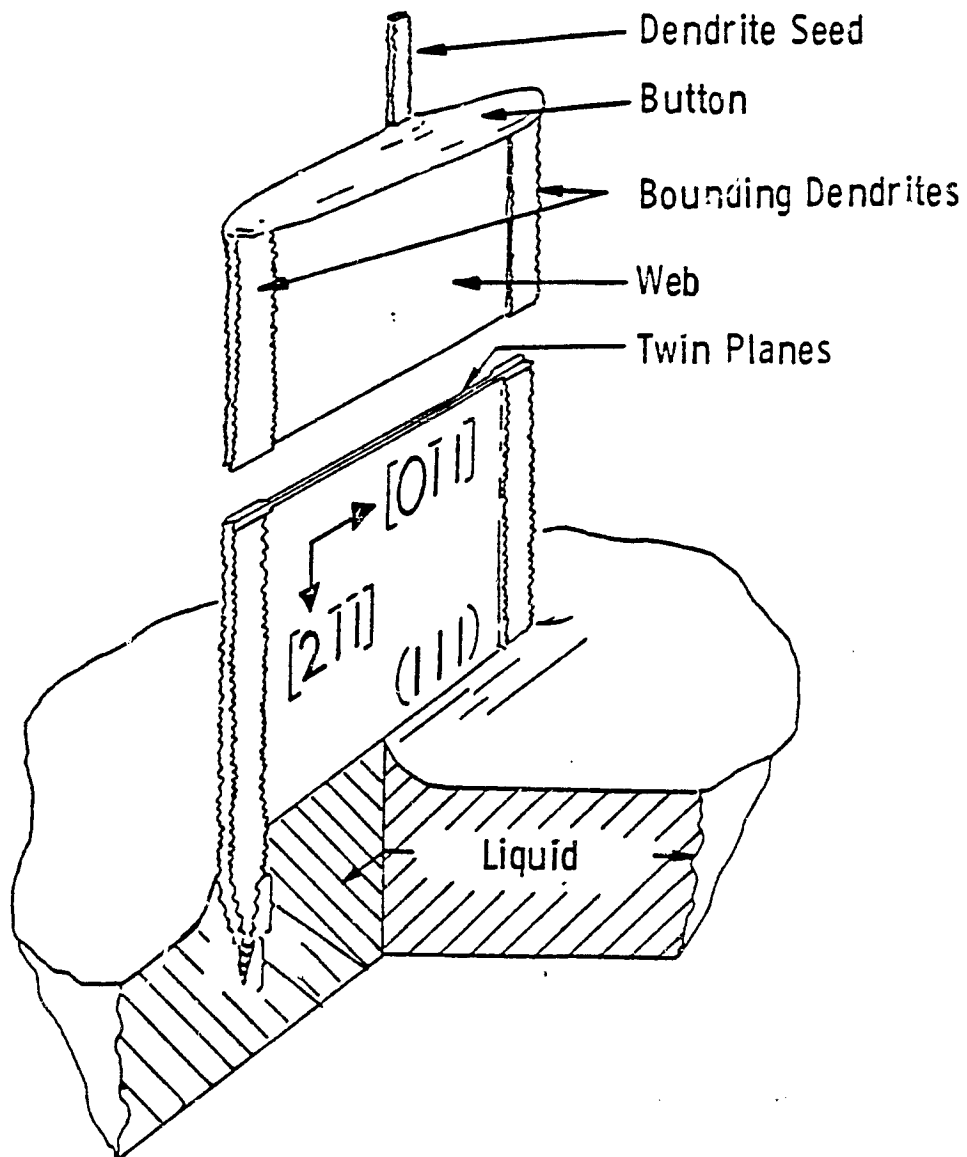
Figure 1 Schematic Section of Web Growth

The crystallographic orientation of the web and dendrites is shown schematically in Figure 1. The dendrites must contain at least two planes before dendritic growth of a diamond lattice structure can occur(3) and, although it is not necessary, it is common to find some of these twin planes extending into the web. Both the W180-3.4C and J135-3.6 webs were Laue x-rayed to determine the orientation relationship between opposite growth faces. Figure 2 shows an x-ray pattern taken with the beam striking the W180-3.4C web end-on. The (111) twin relationship between opposite faces is evident showing that the web contains an odd number of twin planes. X-ray patterns from the J135-3.6 web determined that this sample contained an even number of twin planes.

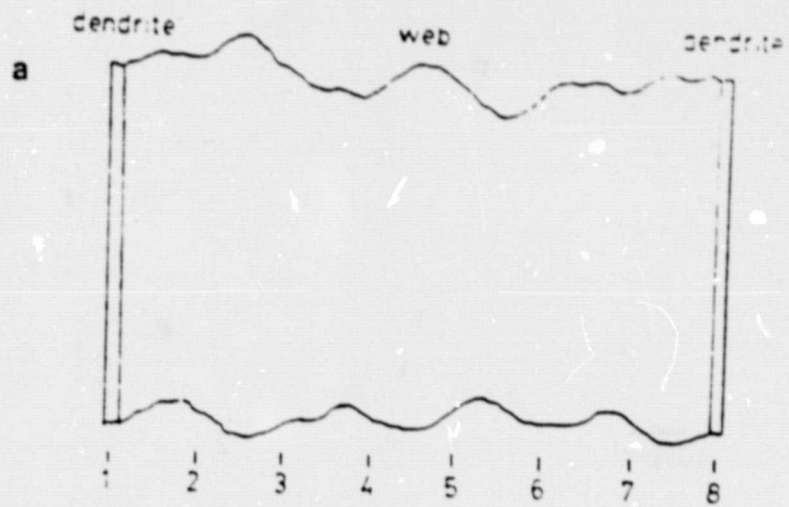
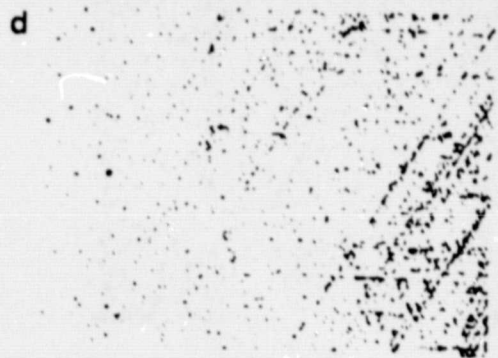
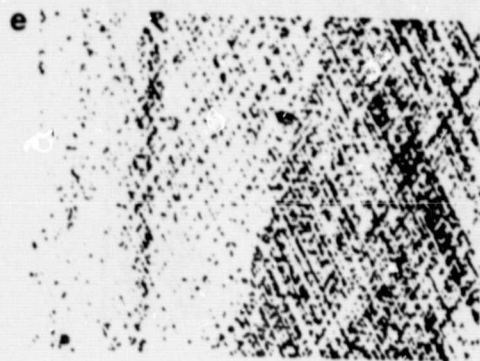
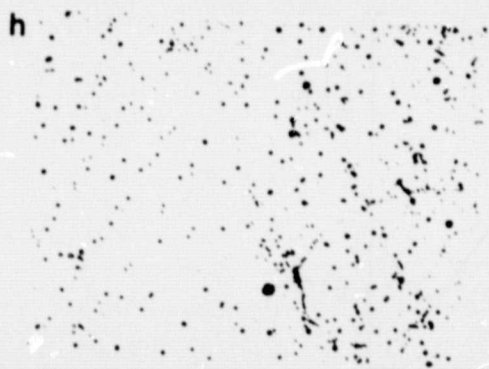
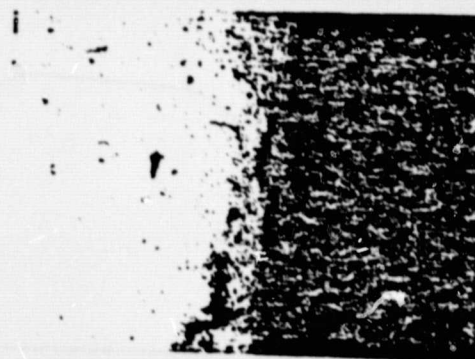
Fig. 3

Silicon web J135-3.c was etched and optical micrographs taken at various positions across the surface. These are shown in Figure 2 together with a sketch of the web surface indicating the areas corresponding to the micrographs. Figure 3 (j) shows the relationship between position and etch-pit density. The density is $45 \cdot 10^5$ in the center of the web dropping to $45 \cdot 10^4$ at the edges. It is generally accepted(5,c) that most of the dislocations in silicon webs originate from highly strained regions in the dendrites, caused by liquid entrapment during growth. Such a region is shown in Figure 4, with the slip plane traces clearly visible. The maximum of about $5 \cdot 10^5$ dislocations per cm^2 observed in Figure 3(j) is due to thermal stresses generated during growth causing most of the dislocations to slip into the center of the web. If the stresses generated at a dislocation source are insufficient to promote slip, then these dislocations will remain at regions close to the dendrites. This explains the secondary maxima observed in Figure 3(j).

Dislocation etch pits in web-dendritic silicon

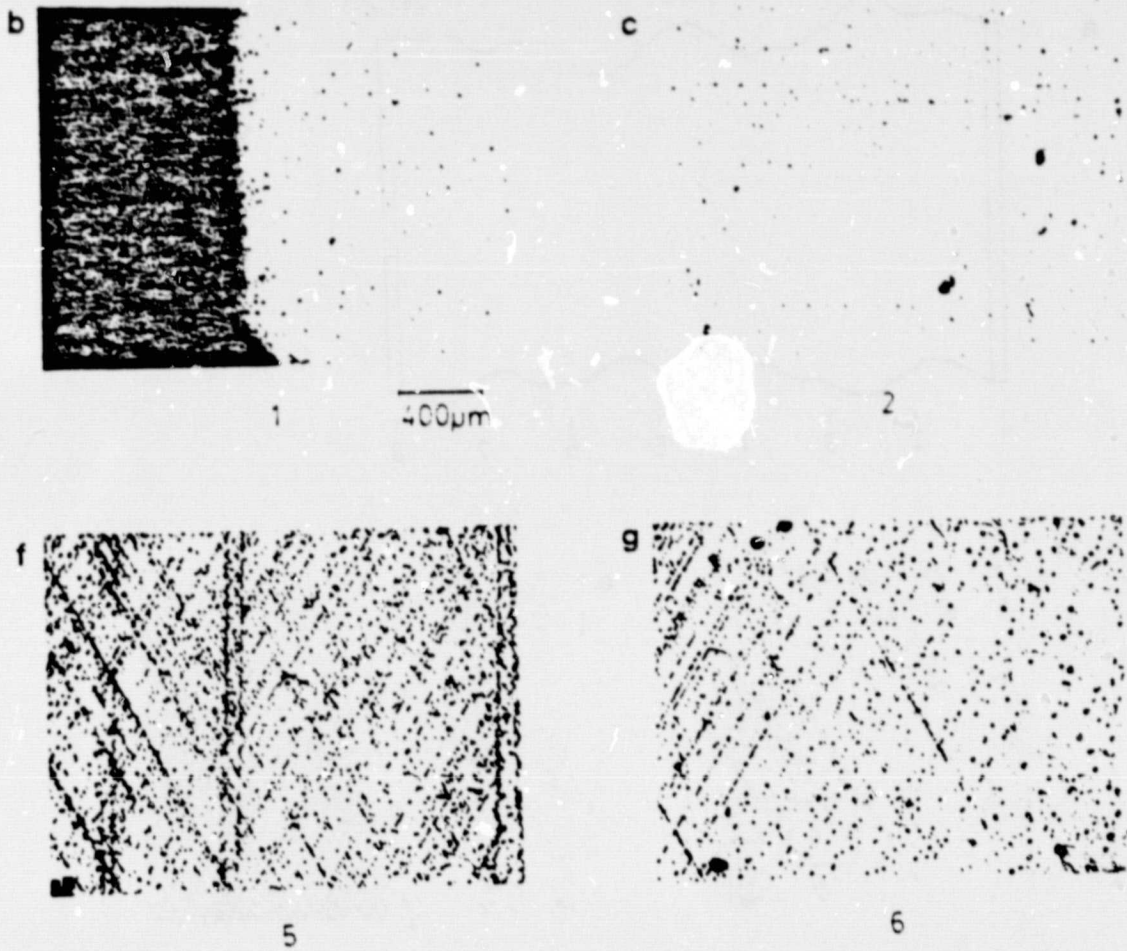
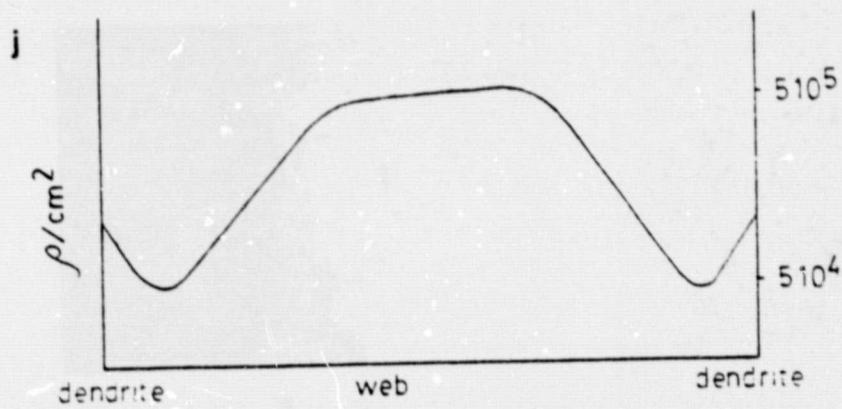
Fig.3

Dislocation etch pits in web-dendritic silicon

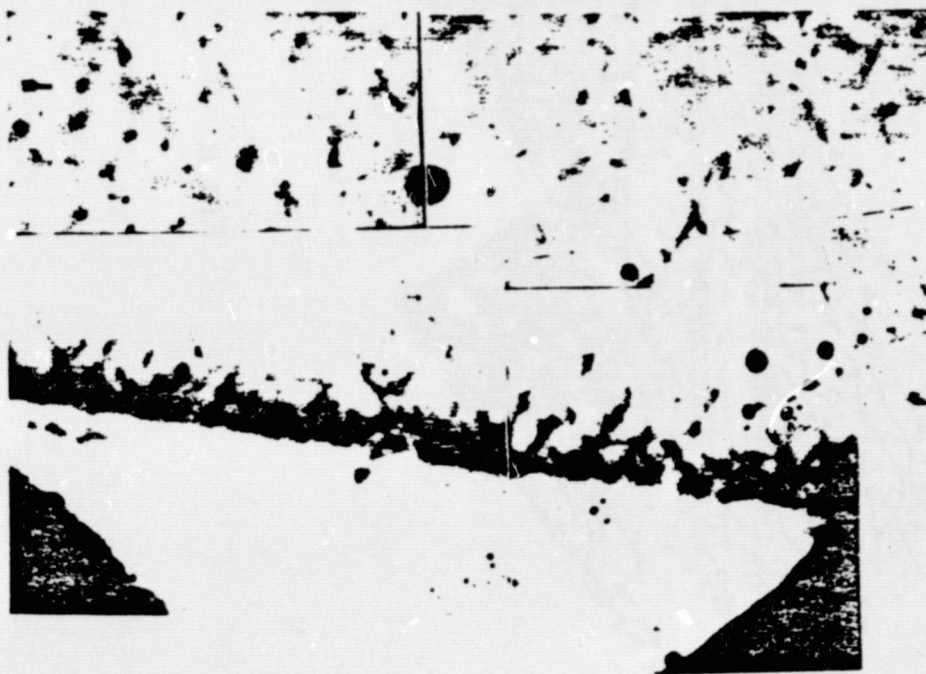
Fig. 6

The electrical activity of the twin boundaries was studied by beveling and polishing a specimen (JISF-3.0) at a shallow angle, $1-2^\circ$, to the growth surface. EBIC, see Figure 6, shows that a high density of dislocations is concentrated at the twin boundaries and that in this region strong minority carrier recombination processes occur. It is thought that the thermal stresses generated during growth also cause dislocations to slip to the interior of the web, where the twin planes act as obstacles to further slip processes. Figure 7 is an optical micrograph of the same area as the EBIC image after the specimen had been etched to remove the Schottky diode and delineate the defect. As in the case of dislocations at the web surface, there is a close agreement between the density of dark EBIC features in Figure 6 and the optical etch pit density in Figure 7. A direct correspondence between Figures 6 and 7 is not possible since the etching process removes several μm of material from the surface. Both EBIC and optical micrographs show that two twin boundaries exist in the web, i.e., a microtwin, and that the dislocation density on one side of the microtwin is higher than on the other.

The fine line marked A in Figure 6 is thought to be a small angle grain boundary; however, this has not yet been confirmed. The width and contrast features are not typical of surface scratches normally visible in EBIC micrographs and the contrast is probably due to the surface topology rather than to an associated electrical activity. Laue x-ray diffraction patterns from either side of the line failed to reveal any difference in orientation, indicating that, if the observed feature is indeed a low-angle boundary, the mismatch is $<1^\circ$. Similar features have been observed by the authors in other web specimens where they are visible on the surface faces.

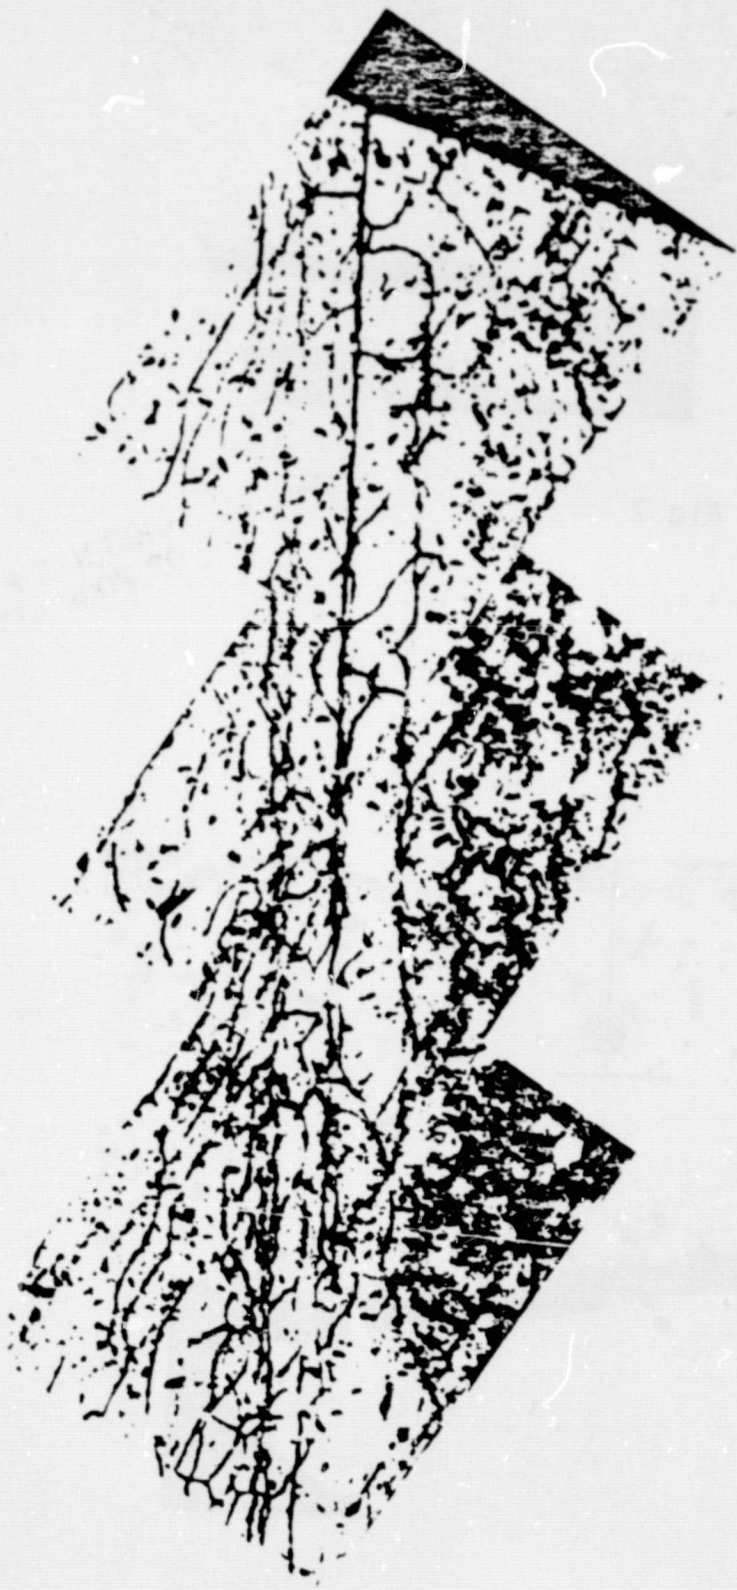
Fig. 8

Figure 8 shows an EBIC micrograph taken from silicon web material W30-3-3, where the dislocations are almost surface parallel. The dislocations are centered around the active boundary shown in the middle of the micrograph. This is probably a twin boundary which has been forced out of the web during growth. The dislocations associated with it are also strongly electrically active.

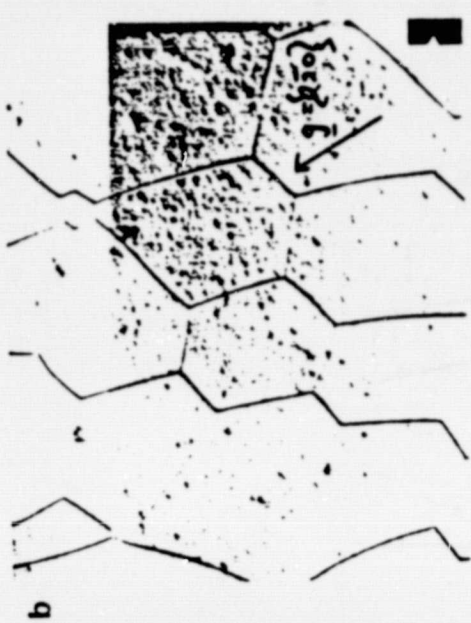
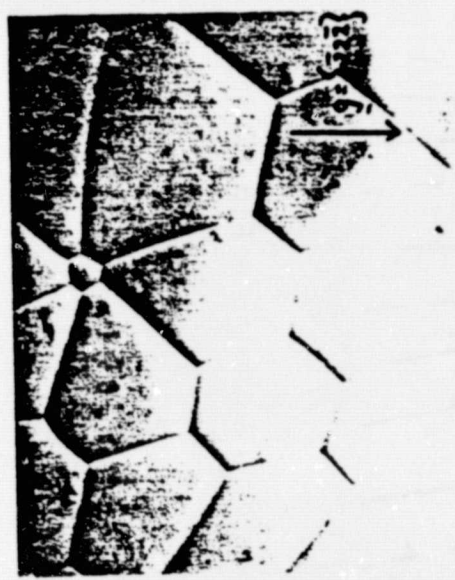
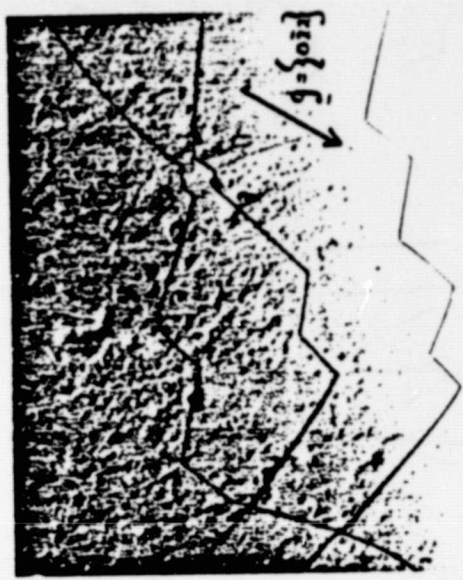
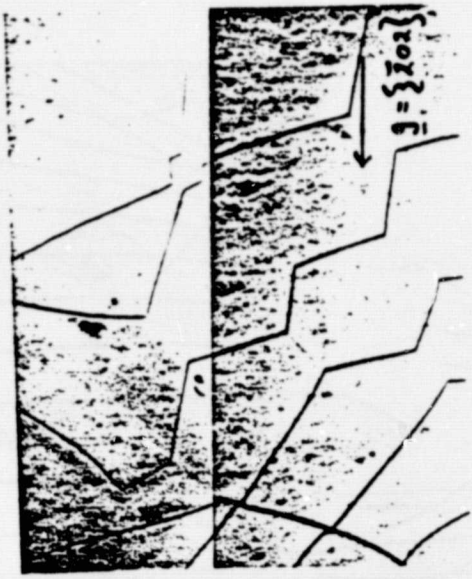
Fig. 9

Previous investigators(8) identified the defect structure of twin boundaries in silicon web as complicated arrays of dislocations displaying $\langle 110 \rangle$ Burgers vectors, with the dislocation lines primarily directed along $[2\bar{1}\bar{1}]$ and $\langle 110 \rangle$ directions. The present study has confirmed the existence of these dislocations and in addition has identified two sets of misfit dislocations. Figures 9(a) - 9(d) are HVEM micrographs of web J135-3.6 showing an hexagonal array of twin boundary dislocations imaged with different diffraction conditions. From contrast analysis the Burgers vectors of these dislocations were determined as being of the $\langle 211 \rangle$ type. Each set can be extinguished by using the appropriate $\{220\}$ reflection. The observed Burgers vectors are in agreement with the prediction of the Bollman theory(9), that intrinsic dislocations in coherent twin boundaries are Shockley partials, $b = 1/6 \langle 211 \rangle$. These dislocations take up a small twist component in the (111) twinning plane. The twin relationship could be easily verified from selected area diffraction. The twist component estimated from $\theta = \frac{|b|}{a}$ is in the order of 0.01° and is therefore too small to be detected by electron diffraction. The second set of misfit dislocations, Figure 10, consists of slightly curved dislocations running in the $[2\bar{1}\bar{1}]$ direction. They are also contained in a (111) twin plane and take up a small tilt component. Most of these dislocations are 60° partials having Burgers vectors $= 1/6[\bar{1}2\bar{1}]$, all of the same sign of b as revealed by $+g$, $-g$, while others are perfect dislocations with Burgers vectors of $\frac{1}{2}[0\bar{1}\bar{1}]$, 90°

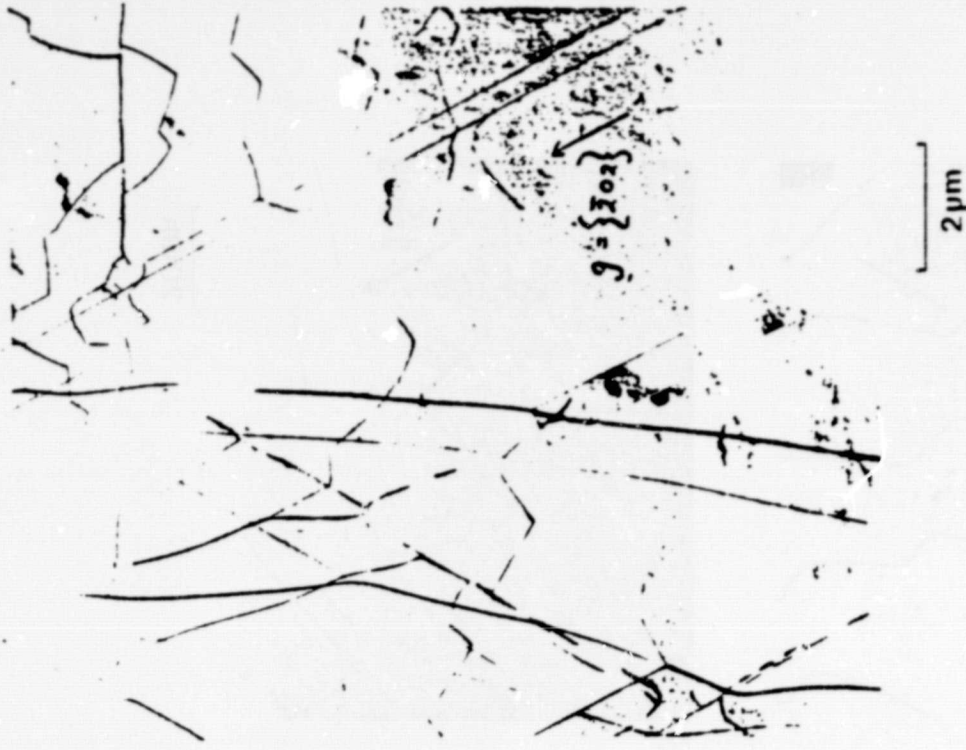
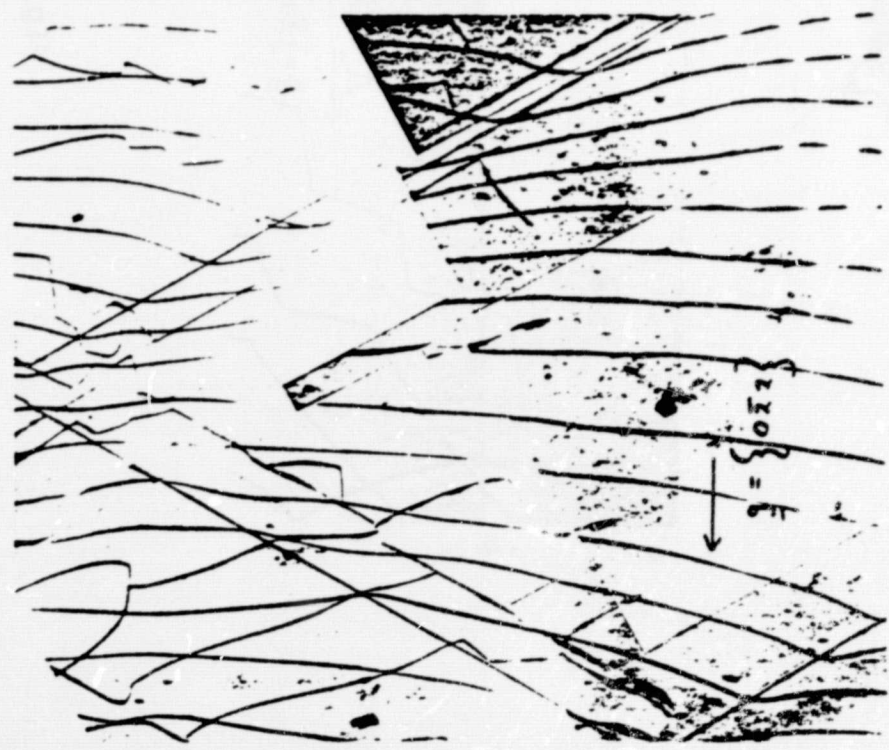
Fig.10

and $\frac{1}{2}[1\bar{1}0]$, 30° . The diffraction vector in Figure 10.6' was chosen such that the partials were out of contrast. O'Hara and Schwuttke, using a large area scanning oscillator technique (SOT) identified the edge and 30° perfect dislocations but did not resolve the 60° partials. They also reported dislocations with Burgers vectors $[101]$ and $[110]$ type lying in the $[c\bar{c}\bar{c}]$ direction, although they also noted that such dislocations should not slip readily, as opposed to the ones reported above.

Figure 10 also shows straight dislocations running in the $\langle 110 \rangle$ directions, and part of an hexagonal network similar to that shown in Figure 9. Stereomicrographs show that these dislocations are not contained in the same (111) plane as the curved dislocations and must therefore belong to another twin plane, i.e., the other side of a microtwin. A strong interaction occurs between the dislocations running in the $\langle 110 \rangle$ directions and the network of partials. The straight dislocations have $\langle 110 \rangle$ type Burgers vectors and are edge sessile. They form when dislocations slipping on either $(1\bar{1}1)$, $(11\bar{1})$ or $(\bar{1}11)$ planes intersect dislocations in the twin planes and form Lomer sessile dislocations. O'Hara and Schwuttke proposed that the reaction for dislocations slipping on the $(\bar{1}11)$ plane would be

The $\frac{1}{2} a [110]$ Lomer dislocations, shown in Figure 10, lying along the $[1\bar{1}0]$ direction, can then dissociate into a Cottrell-Lomer lock by the following reaction.
