NASA CR-165201
PWA-5604-31

TURBINE BLADE TEMPERATURE MEASUREMENTS
USING THIN FILM TEMPERATURE SENSORS

UNITED TECHNOLOGIES CORPORATION
Pratt & Whitney Aircraft Group
Commercial Products Division

Contract NAS3-20831

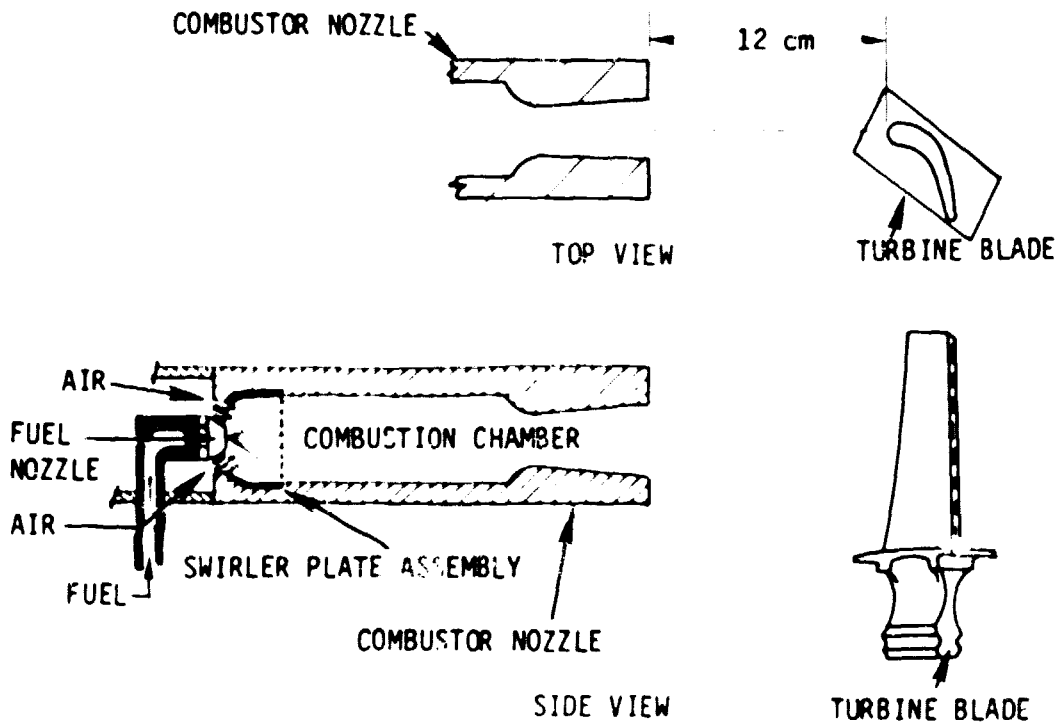
Figure 5 Simulated Combustor Exhaust Gas-Stream Test Arrangement

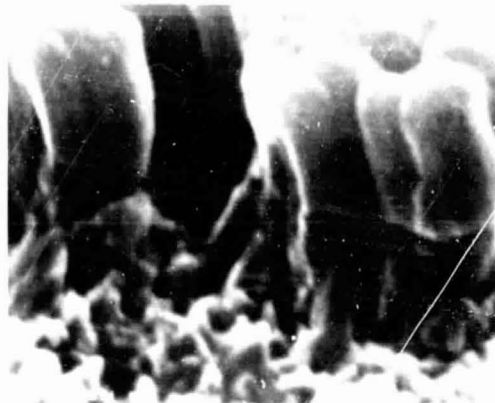
Figure 11 Scanning Electron Microscope Views of the Aluminum Oxide Structure on Blade C, Resulting in Poorly Adherent Platinum and Platinum-10% Rhodium Films - The "corn-cob" outer structure of the oxide is clearly visible at the higher magnifications. The fine-grained structure underlying the corn-cob (at a depth of 11,000 Angstroms) is also aluminum oxide. This is the same blade as that shown in Figure 10.

Further SEM examination of the Blade C oxide structure (Figure 11) reveals a corncob appearance with a demarcation plane within the corncob structure at the 6000-Angstrom depth. The corncob extends below this level to a depth of 11,000 Angstroms. Below this is a close-grained Al_2O_3 surface. It appears that the initial growth of Al_2O_3 was normal during heat treatment in hydrogen, and perhaps during part of the furnace oxidation in air. By the end of the oxidation process, the coarse nodular corncob structure had developed and was preserved during subsequent sputtering of Al_2O_3 and heat treatment in air. The literature reveals that various nodular, cellular, or columnar Al_2O_3 structures can be produced by growth on aluminum surfaces containing asperities or on aluminum surfaces pretreated with phosphoric or chromic acid in preparation for epoxy adhesive bonding of aluminum panels (Reference 9). The corncob structure is reminiscent of these structures but not exactly like any previously reported structure. Surface finish and oxidation were the same on all blades. In fact, Blade A and Blade C were oxidized in the same furnace at the same time. Therefore, it appears that the difference in structure may have stemmed from some difference in initial coating surface chemical composition.
