NASA Technical Paper 1834

Some Effects of Thermal-Cycle-Induced Deformation in Rocket Thrust Chambers

Ned P. Hannum and Harold G. Price, Jr.

APRIL 1981

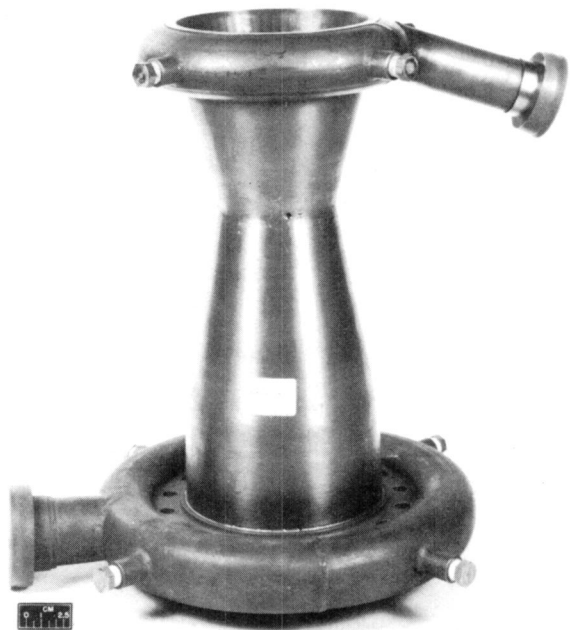
Figure 3. - Fatigue chambers.

The details of the thrust chambers used in the low-cycle fatigue life investigation are shown in figure 3. The chamber contour is shown in figure 3(a). The chambers, which had a contraction ratio of 3.70, were 38.1 centimeters (15 in.) long overall, with the throat located 25.4 centimeters (10 in.) from the injector face. The throat was 6.60 centimeters (2.6 in.) in diameter, and the nozzle exit was 13.2 centimeters (5.2 in.) in diameter. The chamber liners were made of copper or copper alloys and had coolant passages machined into the outer surface (fig. 3(b)). After machining, the coolant passages were temporarily filled with a wax, and a layer of nickel was electrodeposited onto the outer surface to close out the coolant channels and form the outer structural jacket. The coolant passage cross section thus formed is shown in figure 3(c), which is a section through the throat plane of the chamber. The coolant passage dimensions were selected to provide a hot-gas-side wall temperature of 811 K (1460° R) in the throat for the operating conditions of 4.14-MN/m² (600-psia) chamber pressure and 0.91-kg/sec (2.0-lb/sec) coolant flow rate. Much lower temperatures were selected for other areas of the chamber to ensure that the throat would be the region of highest strain. All chambers used in the testing were designed with the same coolant passage height at the throat section. After electroforming of the closeout the wax was melted out of the coolant

(b) Thrust chamber liner showing milled coolant channels before addition of electroformed closeout.

(d) Completed fatigue chamber.

A sectional view showing a typical rib thermocouple hole is presented in figure 3(c). Inspection of the precision-machined holes indicated that the distance from the bottom of the hole to the hot-gas-side surface was 1.27 ± 0.05 millimeters (0.05 ± 0.002 in.). Analysis has shown that the temperature profile across the rib at this radial station is essentially flat, and precision in circumferential location of the thermocouple hole is necessary only to keep from breaking into a coolant passage. To make sure that the thermocouple holes did not break into the coolant passages, each was leak tested with helium.

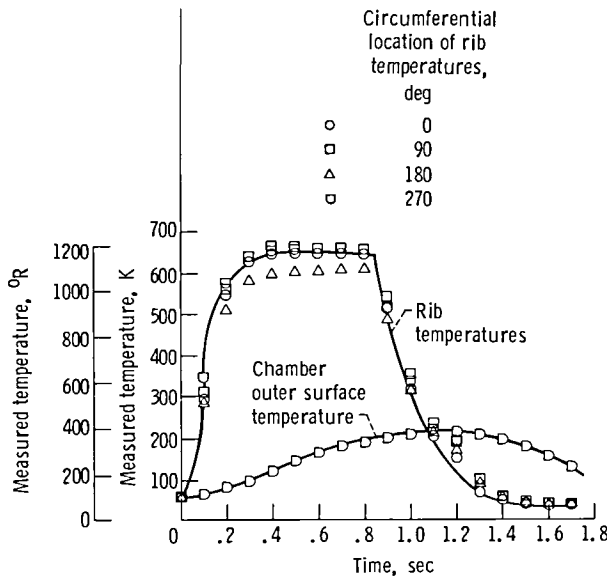
Figure 5. - Measured throat-plane rib temperature and chamber outer surface temperature as a function of time for one firing cycle.

The test cycle selected for this program is shown in figures 4 and 5. In this cycle the maximum temperature difference between the hot-gas-side wall

and the chamber outside surface occurred during the fast start transient. The combustion chamber reached full chamber pressure in 0.05 to 0.06 second. The maximum temperature difference across the wall was achieved 0.3 second after start and was equal to approximately 130 percent of the steady-state value. Once the test firing was well beyond the time when the maximum temperature difference had occurred, the chamber was shut down. This gave a rated thrust duration of about 0.85 second. The liquid-hydrogen coolant flow was continued during a 1.4 second shutdown period, which was enough time to cool all parts of the chamber to original temperature conditions. Then the chamber was recycled. This gave a total cycle duration of 2.3 seconds. The propellant storage capability of the facility permitted as many as 125 cycles in a single firing series.

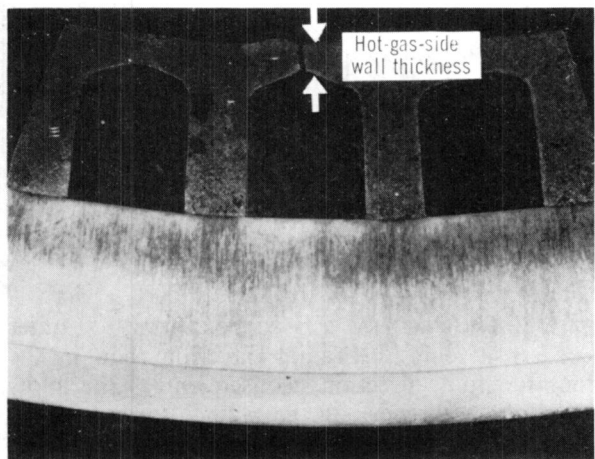
Figure 7. - Cross-sectional view of failure sites.

(a) OFHC copper thrust chamber 75.

(b) Narloy-Z thrust chamber 150.

Cross-sectional views of the failure sites for two different materials are shown in figure 7. The failed

coolant channel is characterized by a “doghouse” shape and a bulge of the hot-gas-side wall toward the centerline of the thrust chamber. Conservation of the wall material was assumed since no hot-gas-side surface melt or erosion was observed. The hot-gas-side wall must thin therefore to accommodate the bulge. Because of the progressive thinning a valley tends to form at the center of each bulge to form two bumps per cooling channel. It can be seen in figure 7(a) that much greater bulging and thinning occurred with the OFHC copper material than with Narloy-Z (fig. 7(b)). The failure sites for the other thrust chambers (not shown) also had the doghouse shape. Although all materials deformed similarly, an important difference is evident between the two failure sites shown in figure 7. In addition to the thinning of the hot-gas-side wall, a necking of the material in a small region on each side of the failure site occurred with the OFHC copper. This is the typical appearance of a tensile failure with a ductile material. Tensile failures were observed in reference 4 for OFHC copper, heat-treated Amzirc, and Narloy-Z. The failure mechanism was described as stress rupture. In the present work the failure site

shown for Narloy-Z in figure 7(b) does not show necking of the material adjacent to the crack. Therefore the visual evidence in the present work supports the reference 4 contention of a tensile stress failure mechanism only with OFHC copper. The failure sites of the Narloy-Z and heat-treated Amzirc in the present work are different than those observed in reference 4 because there is no evidence of necking adjacent to the crack with these materials. The failure mechanism for Narloy-Z and heat-treated Amzirc appears therefore to be more fatigue related.

Some metallographic observations were made of the material at the failure sites. It appears that some recrystallization has occurred in the hot-gas-side wall of OFHC copper chamber 75 (fig. 7(a)). No recrystallization was observed for the other materials. When hardness surveys were taken across sections similar to those shown in figure 7, it was found that the hardness adjacent to the failure site was different from the hardness away from the failure site (near the electroformed closeout). If it is assumed that the liner material away from the failure site remained in the pretest condition, then a change in hardness must have occurred at the failure site for all the liner materials during cyclic testing. Hardness measurements for each chamber are given in table I. The as-fabricated hardness with OFHC copper was R_B 12 to 15. At the failure sites there was softening

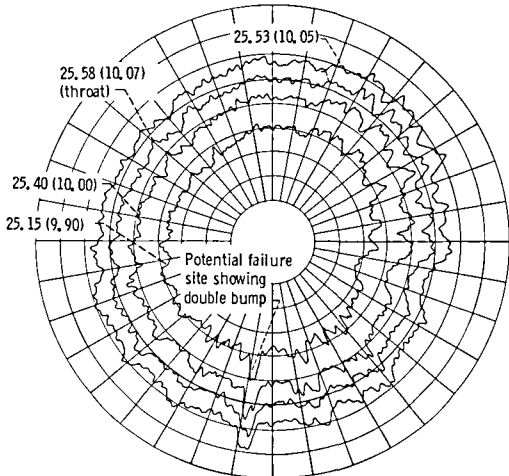
Figure 8. - Polar plots showing hot-gas-side wall deformation.

(a) Postfailure data for OFHC copper thrust chamber 74 after 193 cycles.

(c) Postfailure data for Narloy-Z thrust chamber 140 after 301 cycles.

(b) Intermediate-life data for OFHC copper thrust chamber 74 after 124 cycles.

(d) Postfailure data for heat-treated Amzirc thrust chamber 82 after 250 cycles.

(e) Intermediate-life data for heat-treated Amzirc chamber 82 after 99 cycles.

figure 8. The calibration is approximately 20 times more sensitive in the radial direction than in the circumferential direction; consequently, the plots give a distorted view of the wall deformation. In most cases plots were made at several axial locations at or near the failure site. Reference plots were made for each chamber before hot testing, and no deformation was observed.

Polar plots were made for each of the thrust chambers to document the post-test hot-gas-side wall deformation. The hot-gas-side wall deformation for OFHC copper chamber 74 is presented in figure 8(a). The failure site and one or two other channels exhibit the double-bump characteristic. (Each cooling channel covers a 6° arc.) The deformation at the failure site is much greater than that at other locations in the thrust chamber. This was true for all materials, as shown in figure 8(c) for Narloy-Z chamber 140 and in figure 8(d) for heat-treated Amzirc chamber 82. The deformation data from these polar plots are tabulated in table I. Deformation at the failure site was defined as the distance from the valley (at approximately the rib centerline) to the largest peak. The data tabulated were for the largest observed hot-gas-side wall deformation measured from plots such as figure 8(a).

As noted in reference 4 and as can be seen in figure 8(a) of the present work the visual evidence supports the contention of tensile stress failure with OFHC copper. For a tensile stress failure to occur the ultimate stress for the material must be exceeded at some point in the cycle. The exact point in the cycle when failure occurred is not known since both the stress in the wall and the ultimate stress of the material are changing with time. The stress is nominally the same for all three materials for the same wall thickness and would increase as the wall thickness decreases. Therefore it is assumed that a wall thickness of approximately 0.475 millimeter (0.0187 in.) corresponds to a stress in the wall equal to the ultimate stress value of OFHC copper. The result is a tensile stress failure. However, since the published data for heat-treated Amzirc and Narloy-Z indicate that the ultimate stress is greater than that for OFHC copper at similar temperature conditions, the level of stress in a wall 0.475 millimeter (0.0187 in.) thick would not produce a tensile stress failure in these stronger materials. Figure 10 shows that these stronger materials possibly failed at even lower stress levels than did the OFHC copper since the final wall thickness was greater than with OFHC copper. The implication is that the failure mechanism for the heat-treated Amzirc and Narloy-Z thrust chambers in the present work is more complicated than simple tensile stress failure and probably includes a crack-producing mechanism such as fatigue.

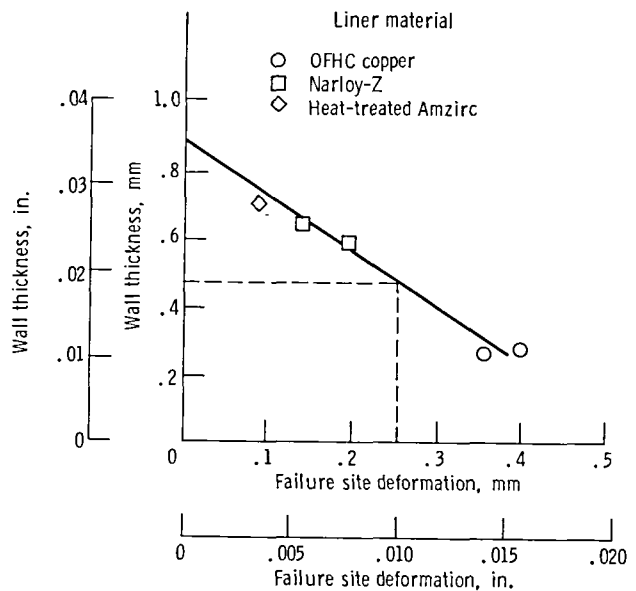
Figure 10. - Failure site deformation as a function of coolant channel wall thickness for three different thrust chamber liner materials.

The final failure site deformation as a function of the final failure site hot-gas-side wall thickness is shown in figure 10 for three different thrust chamber materials. The data were obtained by measuring cross-sectional photographs. The definition of deformation was the same as that used with the polar plots (fig. 8). The wall thickness was measured as indicated in figure 7. As shown in figure 10 the wall-thickness-versus-deformation data are correlated by a straight line that extrapolates to the original wall thickness of 0.899 millimeter (0.035 in.) for zero deformation. Although this correlation was made from postfailure data, it is assumed that the correlation is also valid at intermediate life. Use of this correlation provides a means for determining wall thickness at intermediate-life points from measurements of hot-gas-side wall deformation.

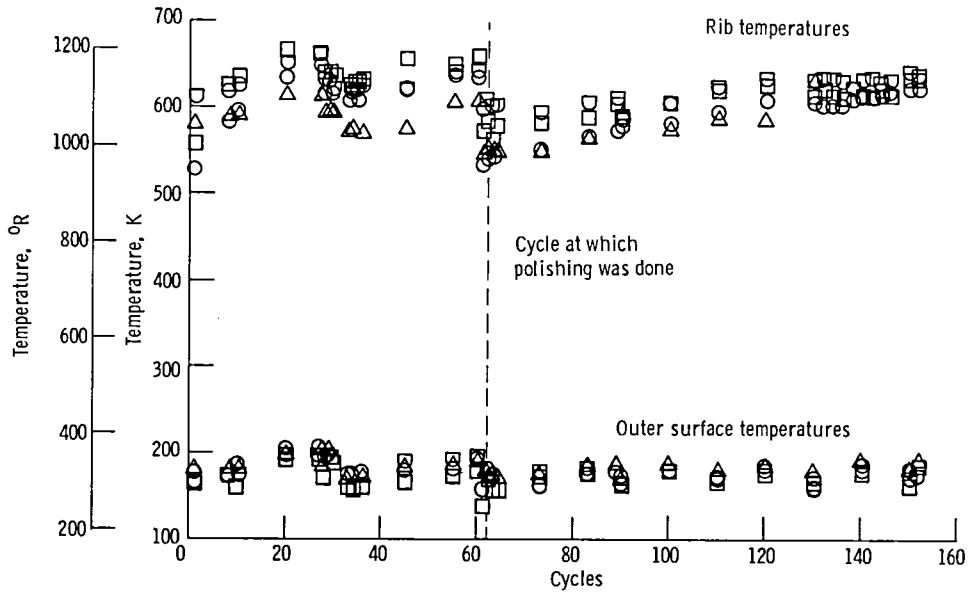
Figure 11. - Effect of polishing hot-gas-side wall surface on wall temperatures - OFHC thrust chamber 70.

Previously unpublished data obtained during the life testing with an OFHC copper chamber in reference 5 are presented in figures 11 and 12 to further illustrate the effect of surface roughness on

the hot-gas-side wall temperature. Increases in the measured rib temperature (fig. 11), the coolant pressure drop, and the coolant temperature rise (fig. 12) were reported for an OFHC copper chamber with a thick electroformed nickel closeout similar to the Narloy-Z chambers in the present work. The roughening progressed and the temperatures increased as 60 cycles were accumulated. In an attempt to link the surface roughening effect to the increasing temperature effect the hot-gas-side wall was polished with a fine-grit emery paper by rubbing only in the axial direction. The effect of this

polishing can also be seen in figures 11 and 12. The average rib temperature for the sixty-first cycle was approximately 83 K (150 deg R) less than that for the sixtieth cycle. Similar changes can be seen in other parameters. The polishing did not remove the deformation (bulging of the coolant channel) but instead restored the surface finish to approximately the original condition. The resumption of cyclic testing again caused the temperatures to steadily increase. After the chamber had been tested for a total of 153 cycles the hot-gas-side surface roughness (in the axial direction) was measured. The roughness was 230×10^{-6} to 760×10^{-6} centimeter rms (90×10^{-6} to 300×10^{-6} in. rms).

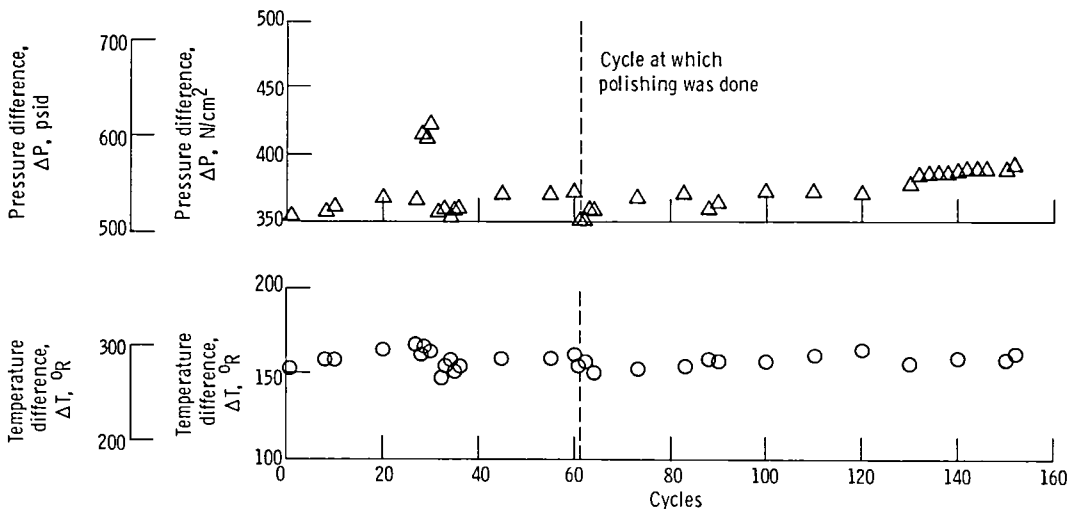
Figure 12. - Effect of polishing hot-gas-side wall surface on coolant temperature and pressure differences - OFHC thrust chamber 70.

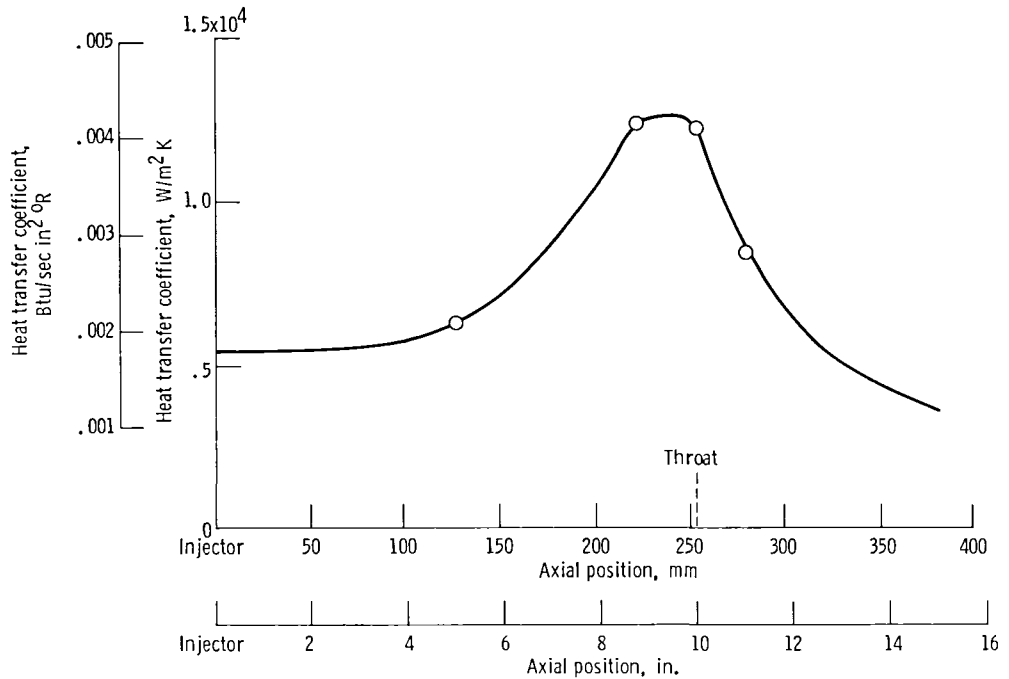
Figure 16. - Heat transfer coefficients as a function of axial position.

These differences were also due to the difference in transport properties as a function of temperature. Figure 16 shows the axial distribution at steady-state conditions of h_g for the thrust chamber at the four instrumented stations.
