NASA Technical Memorandum 81740

The Fracture Morphology of Nickel-Base Superalloys Tested in Fatigue and Creep-Fatigue at 650° C

John Gayda and Robert V. Miner
Lewis Research Center
Cleveland, Ohio

April 1981

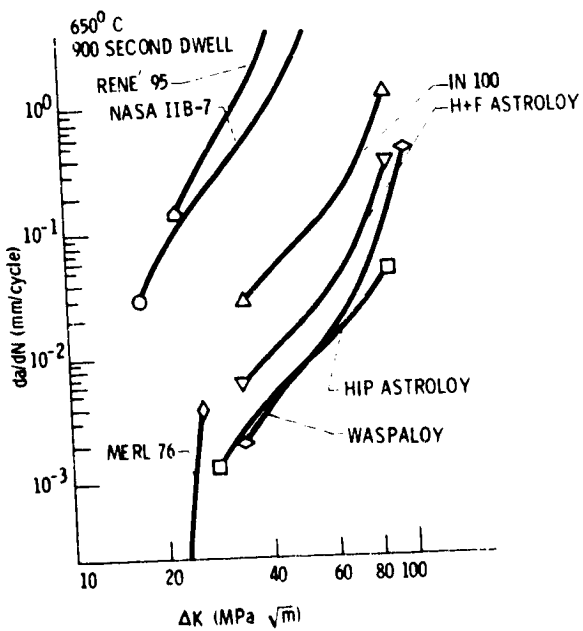
Figure 4. - The crack growth rates of the seven nickel-base superalloys tested in creep-fatigue. 4-6

Results of the crack propagation tests,³⁻⁵ in which growth rates are plotted as a function of the stress intensity range, are reproduced in figure 3 for fatigue tests and in figure 4 for the creep-fatigue tests. Each of these curves are an average of at least three trials although not all of the individual tests cover the range shown.

In all instances, the crack growth rates for the creep-fatigue conditions increased at least one order of magnitude over the fatigue tests, with the stronger alloys exhibiting a much more pronounced increase. In comparison to the fatigue crack propagation data, the crack growth rates for the creep-fatigue test exhibit a greater spread between alloys. Once again, the lower strength alloys tend to have lower crack propagation rates; however, an exact ranking between crack propagation and strength is lacking. The order of NASA IIB-7 and René 95 is again inverted relative to yield strength with Rene 95 having the highest crack growth rate over the range of the data.

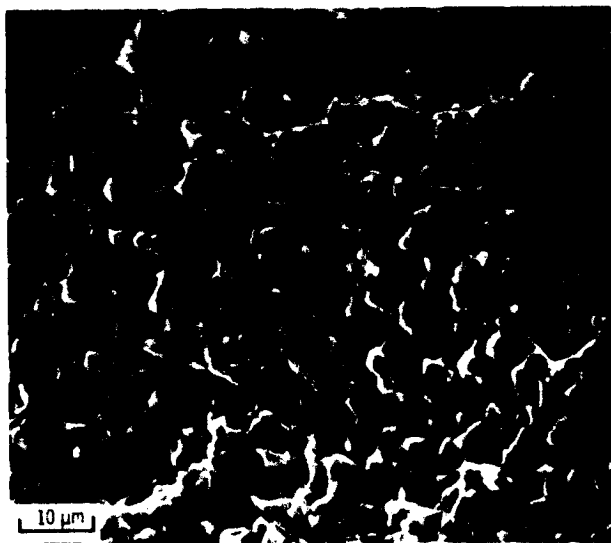
Figure 7. - Intergranular fracture morphology of IN 100 (a) and NASA 11B-7 (b) tested in fatigue. The stress intensity range is about $20 \text{ MPa} \sqrt{\text{m}}$. The direction of crack propagation is top to bottom in the semiphotos on the left.

Fatigue. - Under fatigue conditions, the fracture mode associated with stable crack growth varied from alloy to alloy. Waspaloy and HIP Astroloy, with grain sizes greater than 40 μm , exhibited a transgranular fracture mode as seen in figure 6. These two alloys also displayed the lowest crack growth rates. The two fine grain alloys, IN 100 and NASA IIB-7, exhibited an intergranular fracture mode as seen in figure 7. Their crack growth rates were greater than those of Waspaloy or HIP Astroloy.

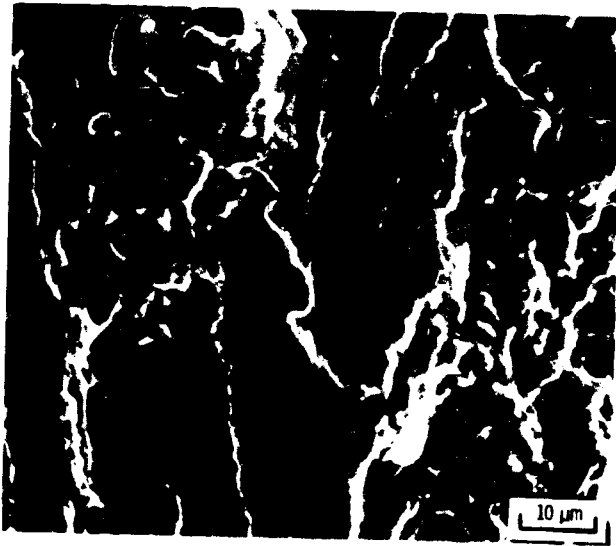
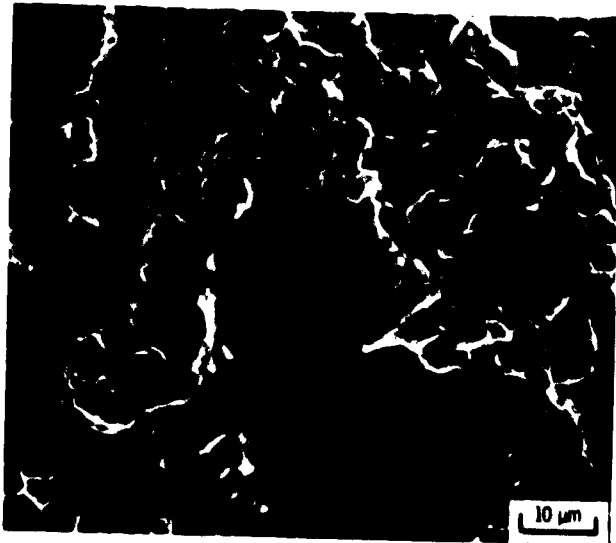
Figure 8. - Mixed fracture modes in H + F Astroloy (a) and Rene 95 (b) tested in fatigue. The stress intensity range is approximately $20 \text{ MPa} \sqrt{\text{m}}$. Trans-granular fracture was prevalent in large grains, while the fine necklace grains cracked along grain boundaries. Crack growth direction is top to bottom in the sem photos on the left.

Alloys which possessed the necklace structure, H+F Astroloy and René 95, exhibited a mixed fracture mode when tested in fatigue at 0.33 Hz. The fine recrystallized grains failed along grain boundaries, while the larger grains showed a transgranular failure mode as seen in figure 8. H+F Astroloy was more resistant to crack propagation than the high strength, fine grain alloys, but not as resistant as the low strength, coarse grain material. René 95, as previously stated, exhibited the highest crack growth rate, but it was neither the strongest alloy nor did it possess the finest grain size. Ranking crack growth rate with grain size is somewhat ambiguous for these alloys since cracking was both transgranular in the coarse grains and intergranular in the fine, recrystallized necklace grains. Therefore, a ranking of crack growth rate with either grain size in these alloys could be misleading.

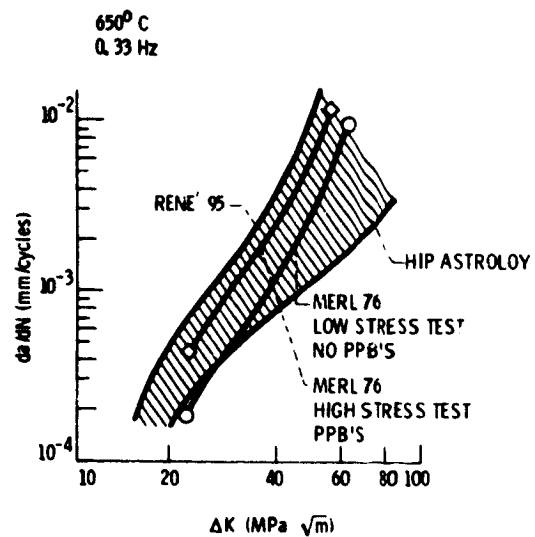
Figure 10. - The effect of prior particle boundaries (PPB) on crack growth rate of MERL 76 tested in fatigue is illustrated above. At lower stress levels, but similar stress intensity ranges, the presence of PPB'S and the crack growth rate for MERL 76 are dramatically reduced, approaching that of HIP Astroloy.

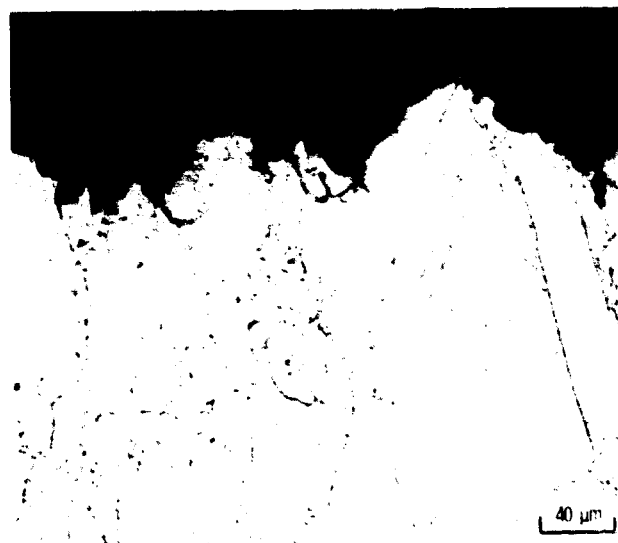
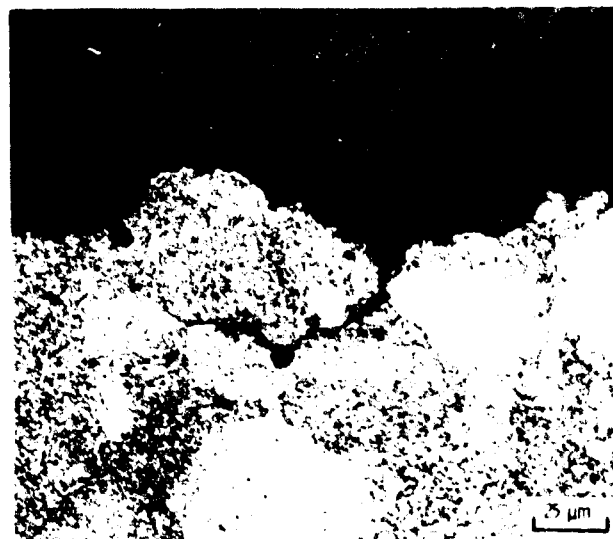
Figure 12. - Intergranular fracture morphology of Waspaloy (a) and HIP Astroloy (b) under creep-fatigue test conditions. The stress intensity range is approximately $35 \text{ MPa}\sqrt{\text{m}}$. Crack growth direction is top to bottom for the sem photos on the left.

Creep-fatigue. - Under creep-fatigue conditions, the fracture morphology of all alloys was predominantly intergranular, as seen in figures 12 to 16. MERL 76 also exhibited fracture sites associated with prior particle boundaries (fig. 15) while Waspaloy was found to crack along twin boundaries on occasion (fig. 16). In both cases fracture was predominantly intergranular as previously stated. Intergranular secondary cracking was present in all alloys and very little cleavage or slip band cracking was observed. Further, there was little change in fracture morphology at higher values of the stress intensity range. Fracture remained predominantly intergranular. The gross ridges shown earlier in figure 5 become more severe as the crack grows. A more detailed view of these ridges (fig. 17) reveals an erratic fracture path with many deep secondary cracks. This behavior differs sharply from the fatigue tests in which the fracture surface is relatively flat and secondary cracks are shallow. While the ridges on the creep-fatigue specimens were associated with cracking along grain boundaries, spacing between adjacent ridges was much larger than the grain size and could not be linked with any other structural feature.

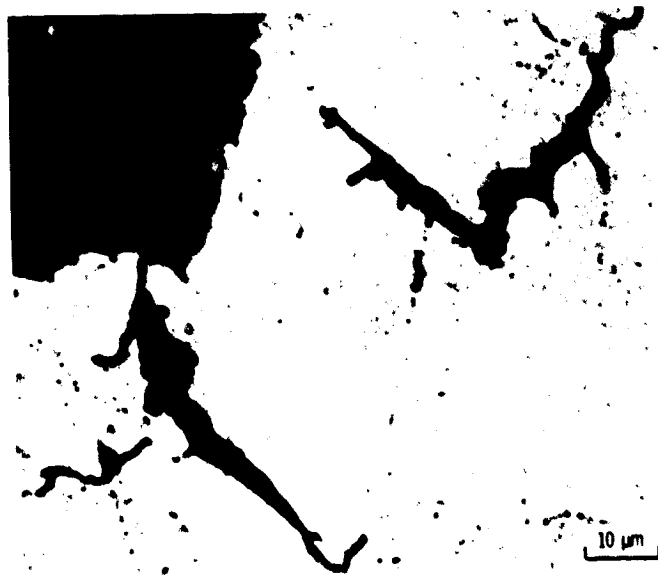
Figure 16 - Secondary cracking in Waspaloy under creep-fatigue test conditions. Fracture occurs along grain boundaries and twin boundaries (a). Subsurface cracks (b) were also observed to a lesser degree.

Examination of sections cut perpendicular to the fracture surface did not reveal grain boundary cavities at magnifications up to 3000X. In several instances, oxidized subsurface cracks were observed, as seen in figure 16. However, a majority of the cracks were linked with and appear to have originated at the primary fracture surface. These observations suggest an environmental interaction has accelerated crack growth along grain boundaries.
