# NASA TECHNICAL MEMORANDUM

NASA TM-82421

## PASSIVE OPTICAL SAMPLE ASSEMBLY (POSA) FOR STS-1-- QUICK LOOK POST-MISSION REPORT

By Roger C. Linton and Edgar R. Miller  
Space Sciences Laboratory

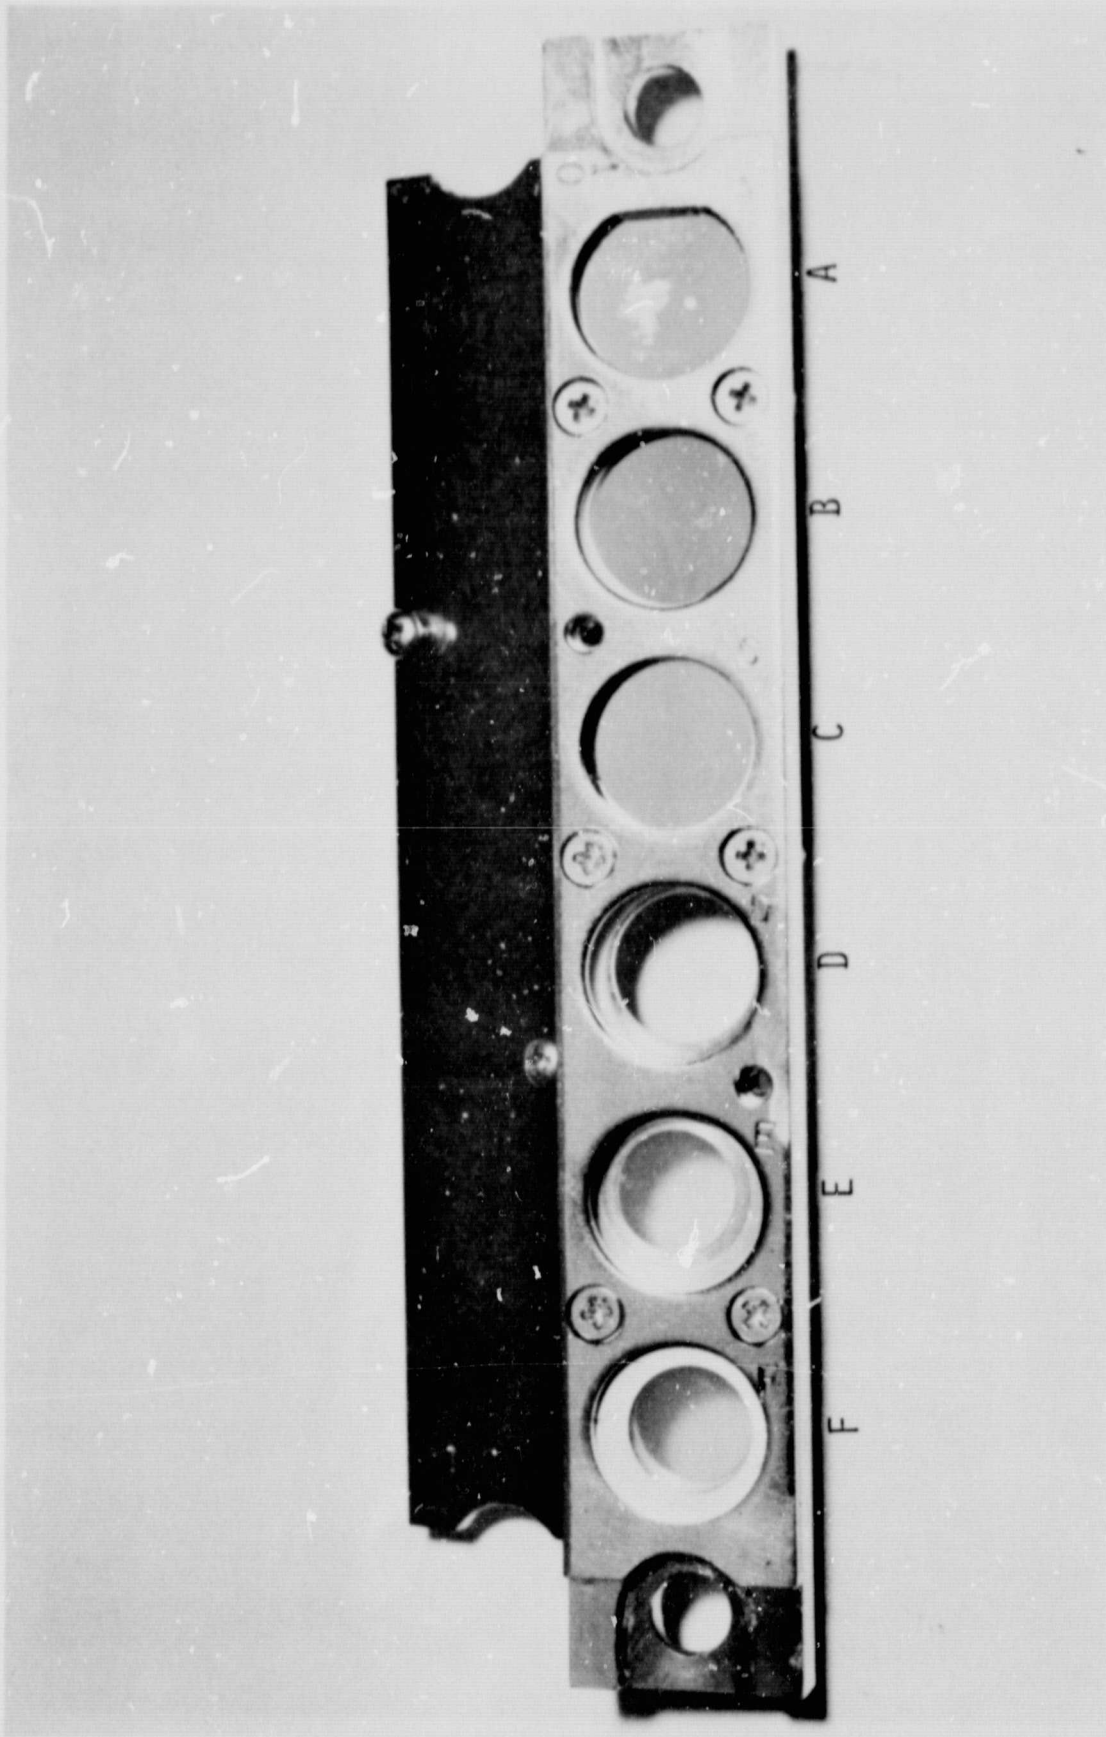
Figure 1. POSA/DFI postflight.

The POSA units were received at MSFC on May 7, 1981. They were photographed, as received, on May 8, and the postmission measurements were begun soon thereafter (Figs. 1 and 2). From inspection of Figures 1 and 2, the larger particulates (and/or fibers) can be readily observed on the reflective samples of both units; considerably greater amounts of particulates of smaller size can be seen on closer inspection and in magnified photographs. Visual inspection of the samples from both POSA units reveals no direct evidence of a contaminant film, with the single exception of the magnesium fluoride overcoated aluminum ( $MgF_2/Al$ ) mirror of the POSA/DFI unit (sample position "A" in Figure 1). The smudge and droplet on this sample remain of as yet undetermined origin, in both chemical nature and point of time.

With the single exception of the smudged  $\text{MgF}_2/\text{Al}$  mirror from the POSA/DFI unit, none of the samples measured in the Gier-Dunkle facility (0.25 to 2.5  $\mu\text{m}$ ) indicate any significant degradation through that spectral range.

The smudged  $\text{MgF}_2/\text{Al}$  mirror from the POSA/DFI unit indicated, by diffuse reflectance measurements from 0.25 to 2.5  $\mu\text{m}$ , a 10 percent relative increase in mirror absorptance. Backscatter measurements on this sample, in this range, indicated an increase more than double the original level, although the levels (0.02 preflight, 0.07 postflight) are, in magnitude, subject to large uncertainty.

In the range 120 to 290 nm, the measurements of specular, spectral reflectance of the smudged  $\text{MgF}_2/\text{Al}$  mirror indicate a generally uniform 9 to 10 percent relative decrease in reflectance. Measurements on the other samples of both POSA units basically indicate minimal (if any, significant) degradation at wavelengths longer than 200 nm, with patterns of apparent increased degradation at shorter wavelengths. A summary of the optical changes at selected, representative wavelengths is given in Table 4, where the parameter  $\% \Delta$  refers to the percent change in reflectance or transmittance at a given wavelength, computed as the difference of the prelaunch values and the postlaunch value, divided by the original value and expressed as a percentage.
