A REMOTE SENSING EVALUATION of the POTENTIAL FOR SINKHOLE OCCURRENCE

January 1981

Remote Sensing Applications Laboratory
Department of Civil Engineering
University of Florida, Gainesville, Florida

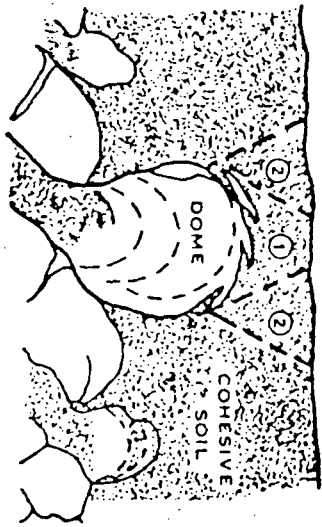
a. Dome formation by raveling and spalling into openings

b. Dome dropout (1) followed by rim collapse (2)

c. Hourglass erosion

Figure 3 - Raveling sinkhole development.
(From Sowers, 1976)

material. A thin pipe may work its way to the surface with a cone shaped surface depression appearing, as cohesionless soil falls into the pipe (27).

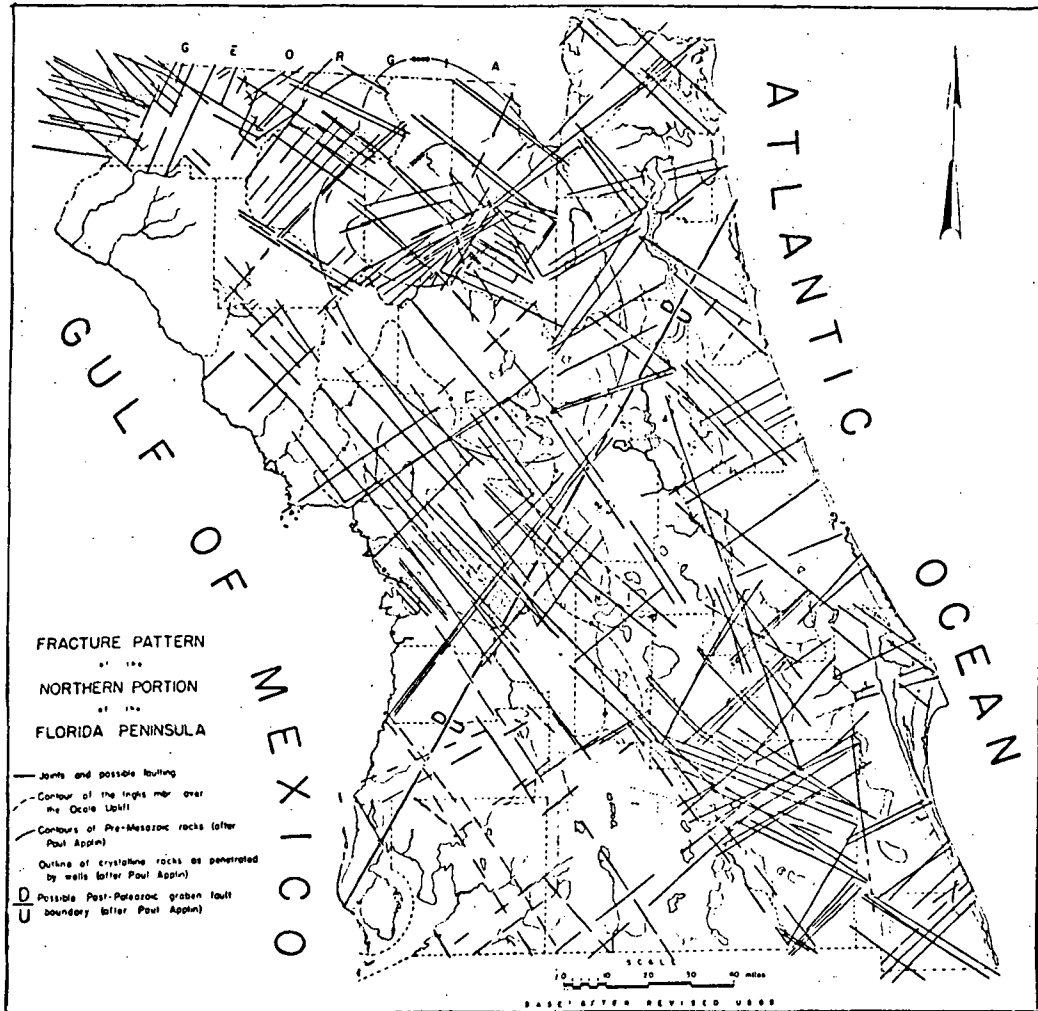
Figure 8 - Fracture patterns of northern peninsular Florida. (from Vernon)

In 1951, Vernon (33) presented a map of the fracture pattern for the northern portion of peninsular Florida (Figure 8). In general, two dominant fracture trends are apparent: a north/northwest pattern and a northeast trending pattern. The patterns are probably controlled by structural features such as the Ocala uplift and the Peninsular arch.

These lineaments approximately follow the northeast and northwest trends mapped by Vernon in 1951 (Figure 8). Many of the new sinkholes

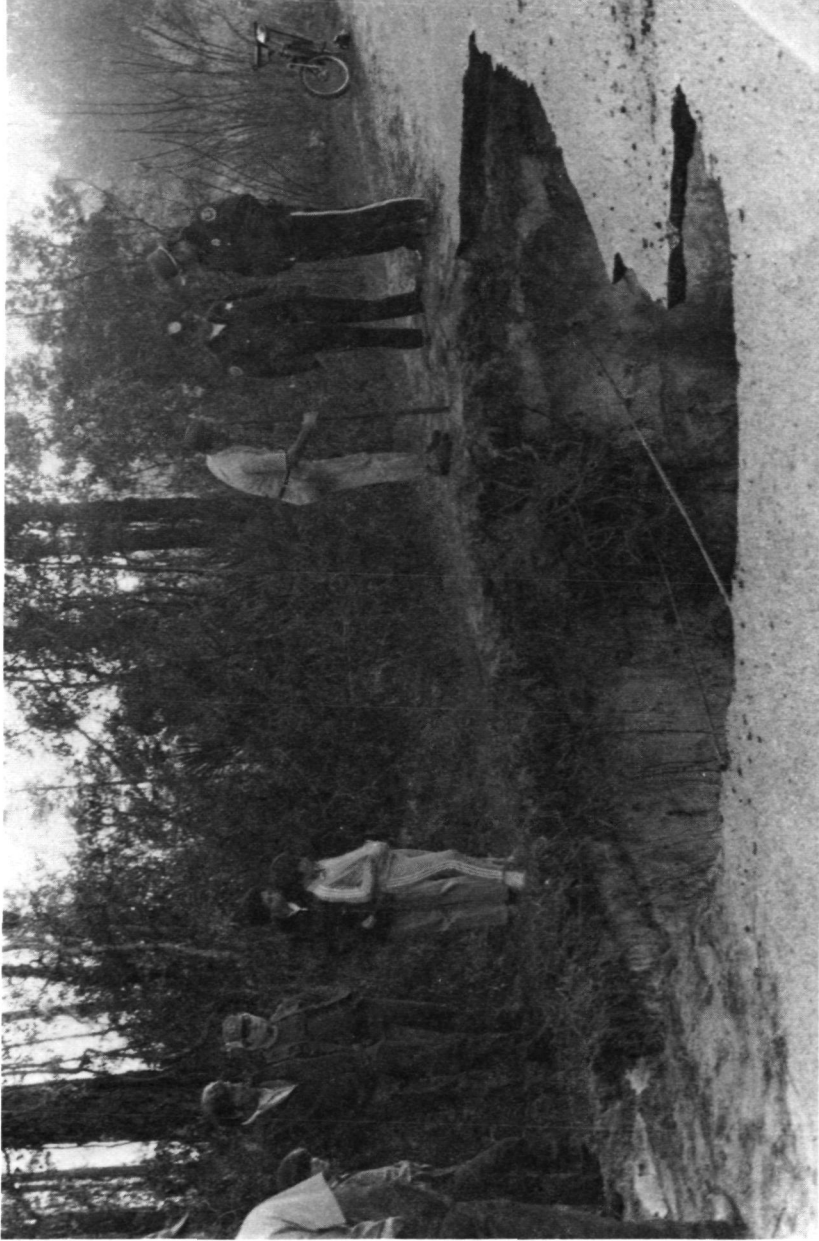
Figure 19 - Sinkhole at Pierson, Florida on January 9, 1979.
(DeLand Sun News)

On January 9, 1979, another sinkhole occurred on Washington Street, just past a neck of land separating two lakes (Figure 19). This also occurred during a period of freezing temperatures.*

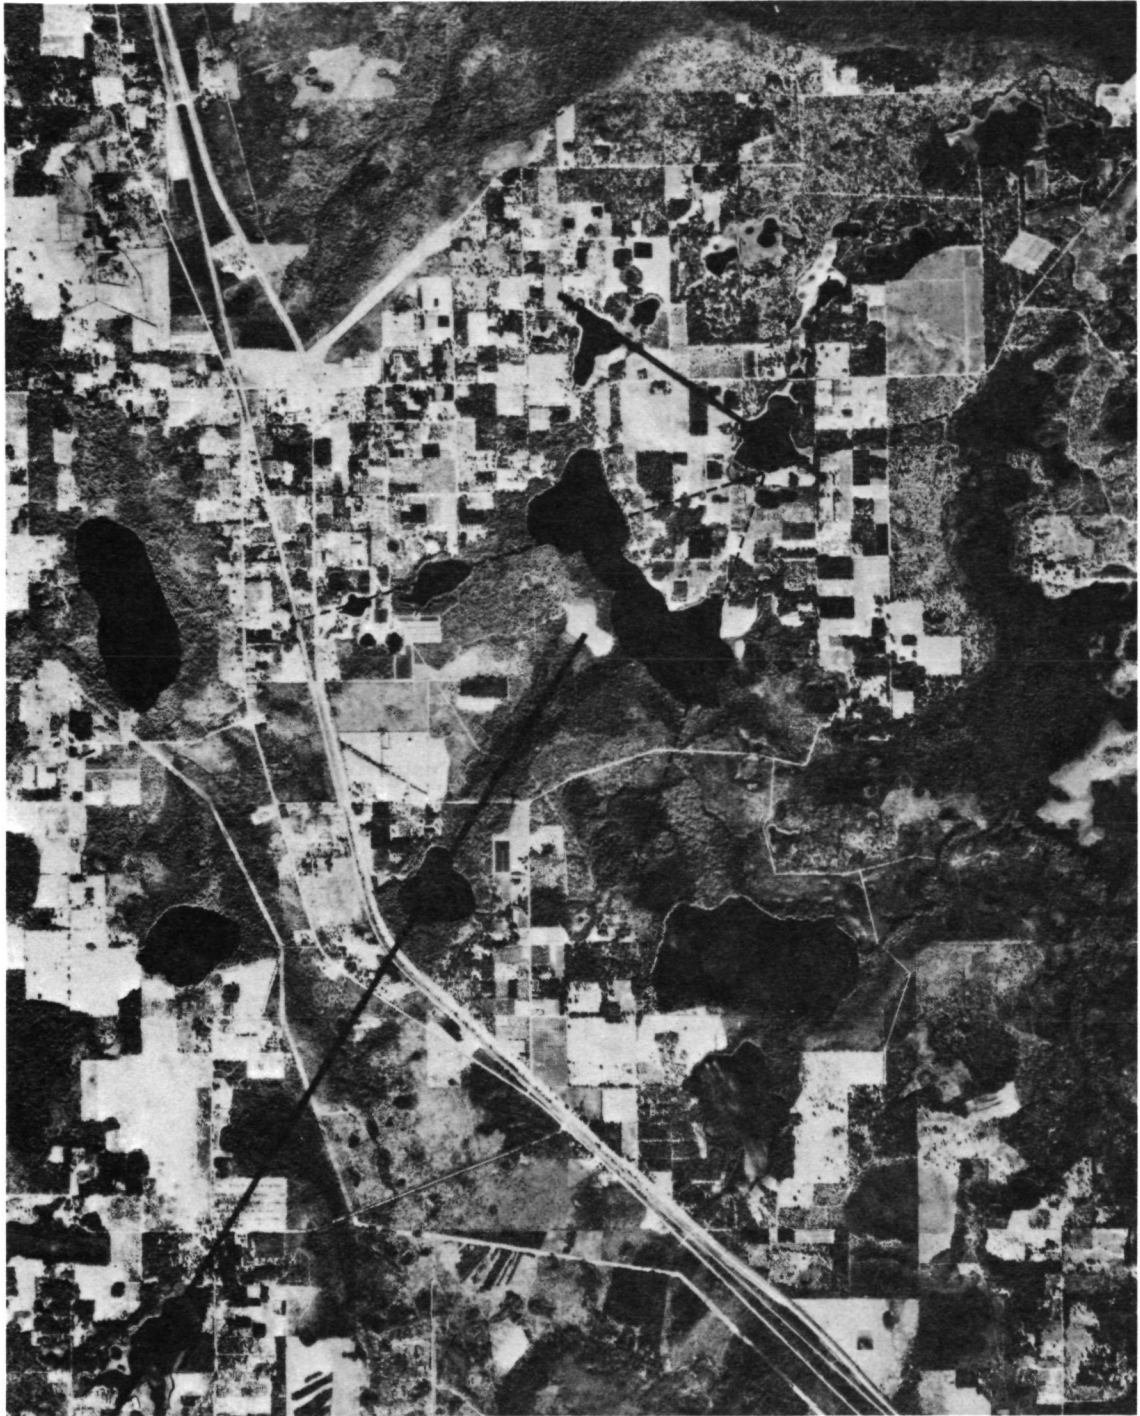
Figure 22 - ASCS aerial photograph of the Pierson, Florida area and example of lineament mapping.

The dashed line represents a lineament trending east/northeast (Figure 22) and was first noticed on the CIR imagery by alignment of

lakes. Final location for this lineament was determined with the aid of the black and white photographs. The black and white photographs showed some sinkholes east of Shaw Lake (Figure 20), and the lineament was mapped through these sinkholes and the lakes.

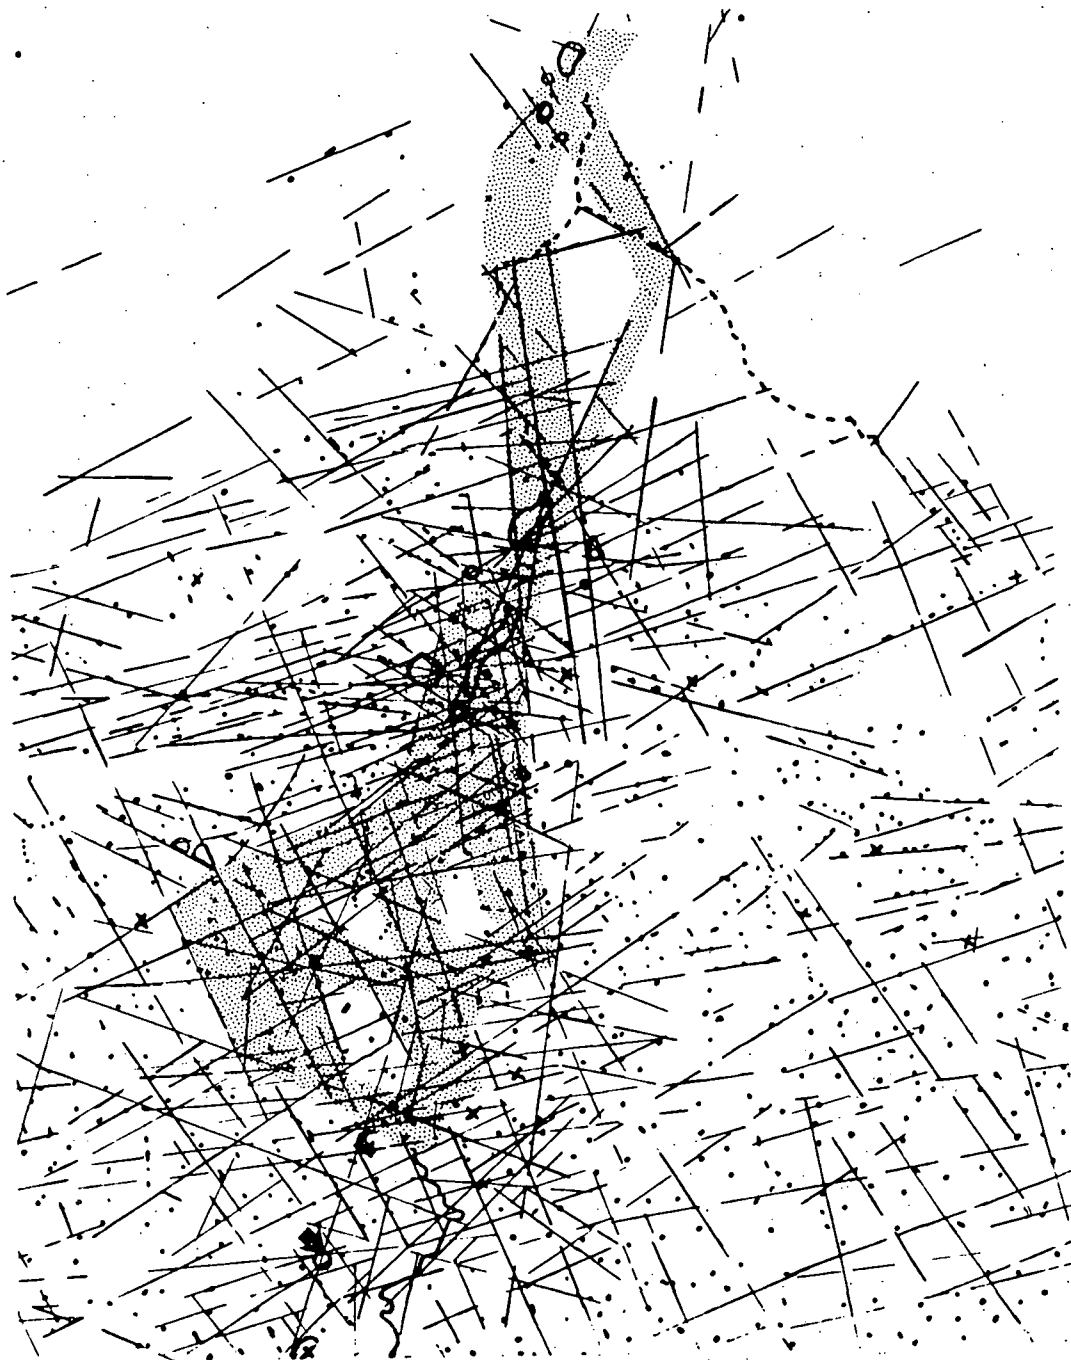
Figure E21 - Map of lineaments and sinkholes for Camuy Cave area. The gray stippled area represents the most probable locations of the underground system of the Camuy River. (from Rinker).

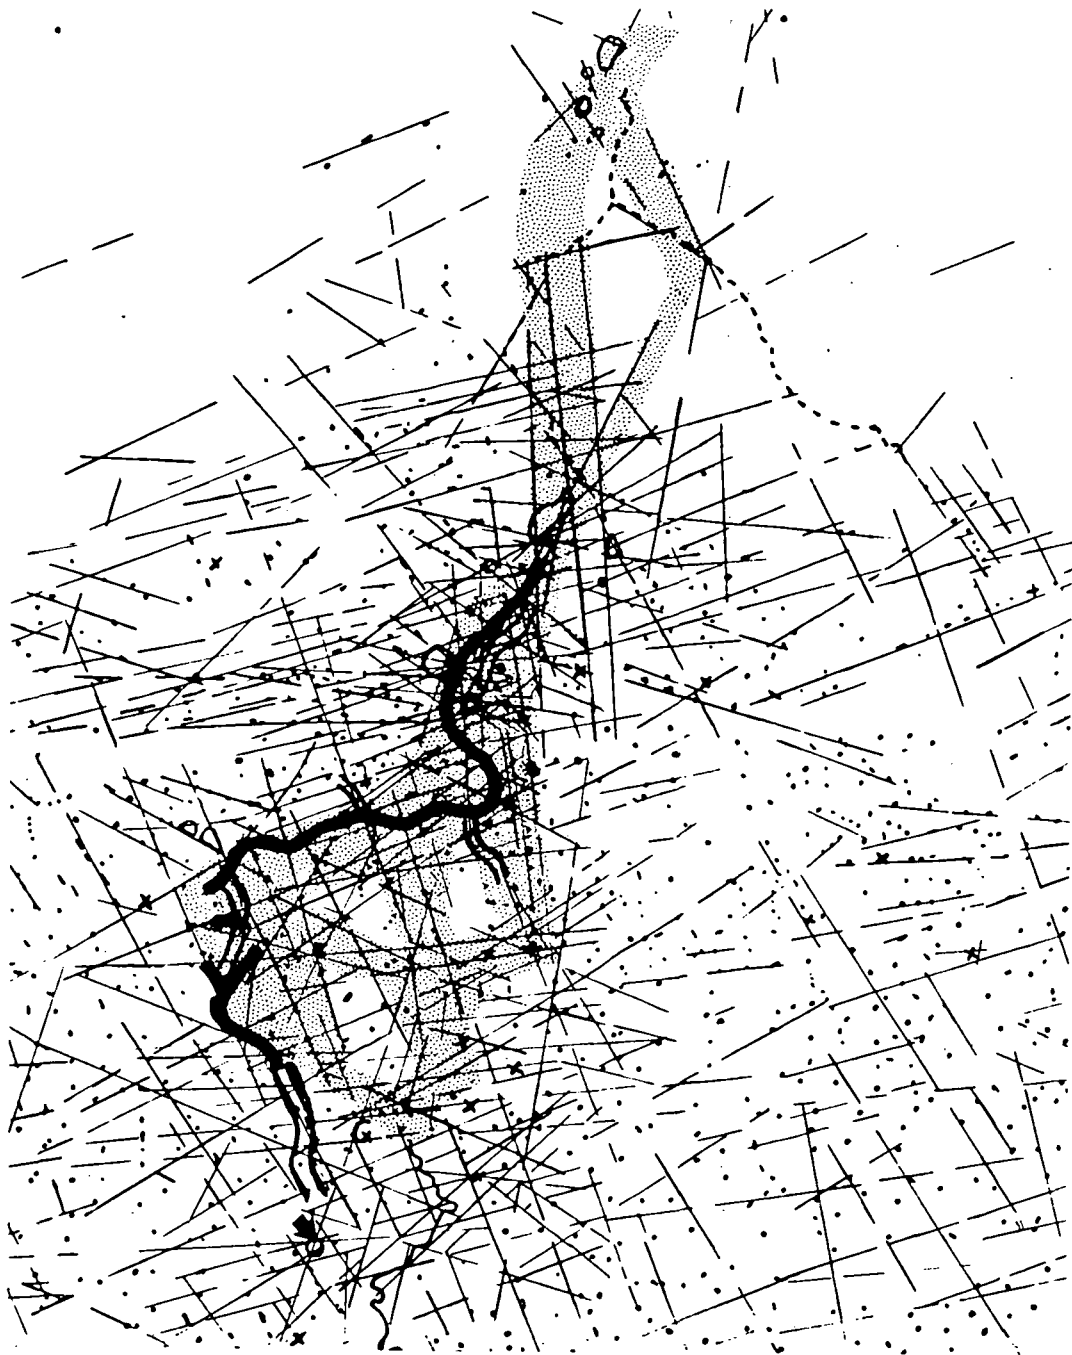
Figure E3 - Map of lineaments and sinkholes in the Camuy Cave area showing the approximate location of the known part of the cave. The agreement with the predicted probable location (gray stippled area) is generally good. (from Rinker).

In a 1973 study in the Camuy Cave area in Puerto Rico, Rinker used black and white photography to map lineaments and fracture traces in an effort to locate the path for the underground channel of the Camuy River. Portions of the cave through which the river flows were mapped along with the locations of some large sinkholes. By combining mapped sinkholes with fracture trace mapping, Rinker was able to predict possible routes of the subsurface channel (Figure E2). The results of his study correlated well with portions of the cave that had previously been mapped (Figure E3) (21).
