(NASA-CR-160995-Vol-1) TESTING OF AIRCRAFT PASSENGER SEAT CUSHION MATERIALS. FULL SCALE, TEST DESCRIPTION AND RESULTS, VOLUME 1 Final Report, 11 Mar. 1980 - 10 May 1981 (Douglas Aircraft Co., Inc.) 109 p

Testing of Aircraft Passenger Seat
Cushion Materials — Full Scale — Test Description
and Results

McDonnell Douglas Corporation Douglas Aircraft Company Long Beach, California 90846

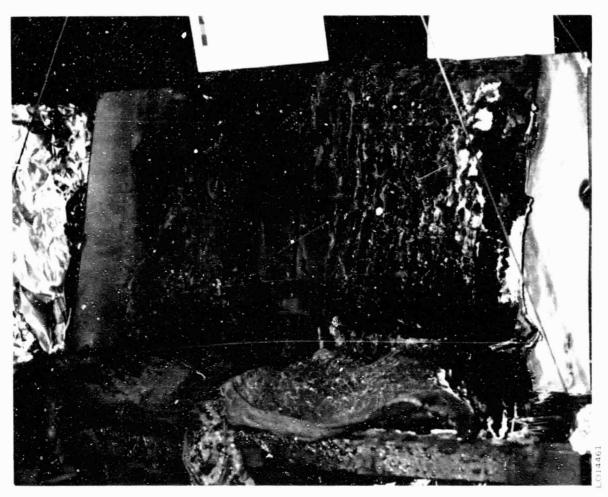
FIGURE A-1. CONFIGURATION 1 - RADIANT PANEL

- . 90 PERCENT WOOL 10 PERCENT NYLON
- . COTTON MUSLIN
- . URETHANE FOAM

In the baseline tests both initial ignition sources resulted in complete burning of all cushion materials.

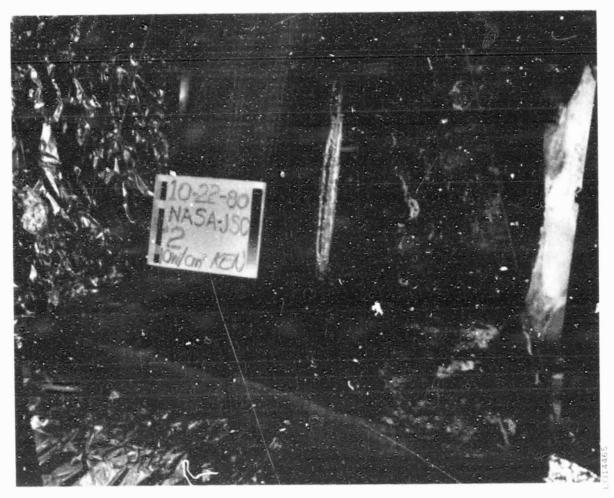
FIGURE A-2. CONFIGURATION 2 - RADIANT PANEL

- . 90 PERCENT WOOL 10 PERCENT NYLON
- DURETTE BATTING
- NOMEX III
- · URETHANE FOAM

The radiant panel melted/burned the urethane, hollowing out the right seat cushions, and lightly damaging the left seat back and bottom cushions. The fuel pan melted/burned the urethane, hollowing out the right seat bottom cushion completely and the left seat bottom cushion partially, leaving both right and left back cushions with minor if any damage.

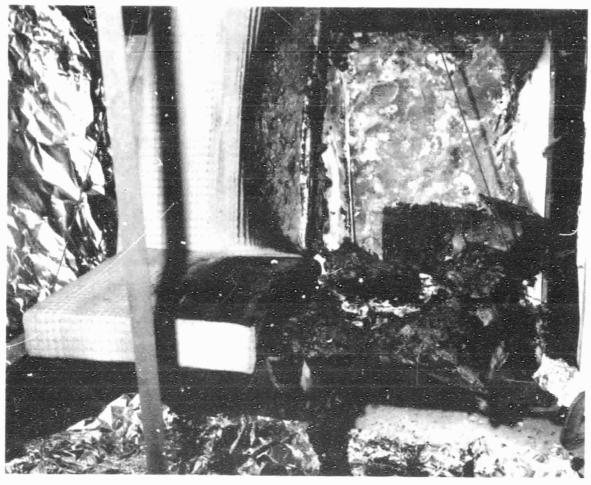
FIGURE A-3. CONFIGURATION 3 - RADIANT PANEL

- 90 PERCENT WOOL 10 PERCENT NYLON
- VONAR 3 PS
- COTTON MUSLIN
- URETHANE FOAM

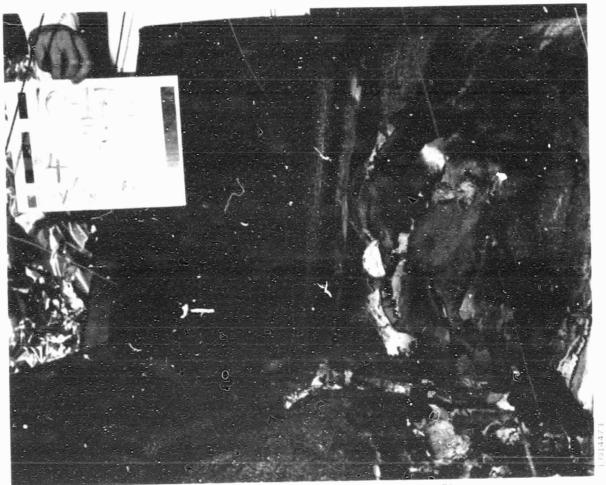
FIGURE A 4. CONFIGURATION 4 - RADIANT PANEL

- . KERMEL WOOL BLEND
- NOMEXIII
- 1 2 IN 1S 200 NEOPRENE FOAM
- URETHANE FOAM
- AIREX FLOTATION FOAM

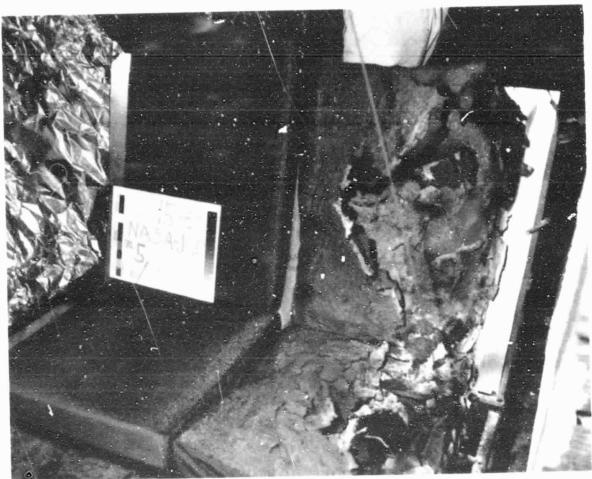
FIGURE A.5. CONFIGURATION 5 - RADIANT PANEL

- KERMEL WOOL BLEND
- NOMEX III
- 12 IN L. 700 NEOPRENE FOAM
- URETHANE FOAM

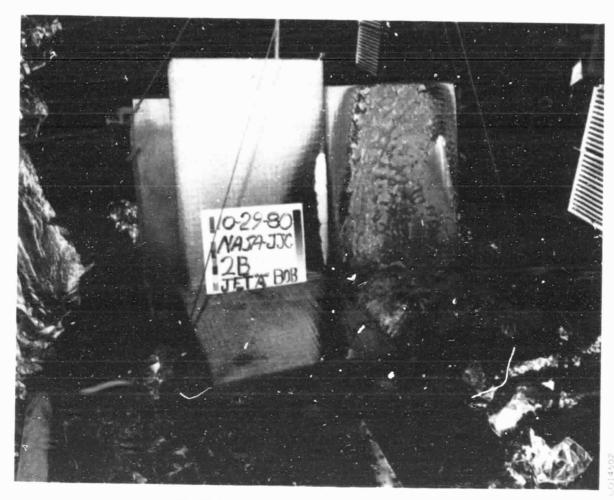
FIGURE A 10. CONFIGURATION 2 - FUEL PAN

- 90 PERCENT WOOL TO PERCENT NYLON
- DURETTE BATTING
- NOMEX III
- URETHANE FOAM

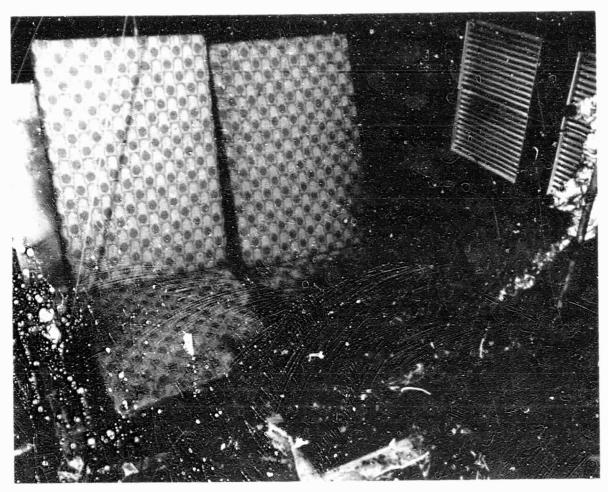
FIGURE A-16. CONFIGURATION 8 - FUEL FAN

- 100 PERCENT WOOL
- · COTTON MUSLIN
- POLYIMIDE FOAM
- AIREX FLOTATION FOAM

All rats survived the cushion burn tests with one exception. One rat died in the fuel pan fire testing of Seat Cushion Configuration 8. Death of the rat was due to cardiac arrest (CA) and occurred one minute after completion of the 30-minute test. No autopsy was performed on the rat as this was beyond the scope of the program. Gas analysis data showed no unusual quantities of toxic gas for Configuration 8 when compared to the other configurations.
