Endurance Test with Large-Bore Tapered-Roller Bearings to 2.2 Million DN

Richard J. Parker
Lewis Research Center
Cleveland, Ohio

Prepared for the
Joint Lubrication Conference
cosponsored by the American Society of Lubrication Engineers
and the American Society of Mechanical Engineers
New Orleans, Louisiana, October 5-7, 1981

ENDURANCE TESTS WITH LARGE-BORE TAPERED-ROLLER
BEARINGS TO 2.2 MILLION DN

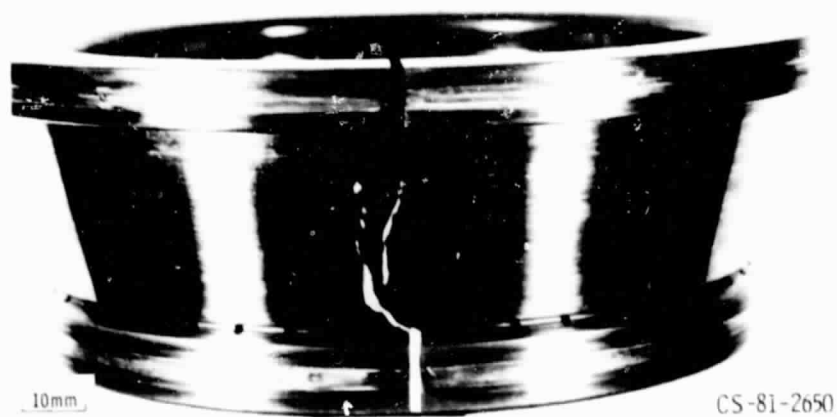
Figure 7. - Fractured cone of AISI M-50 bearing S/N 78-10 after 188 hours of operation at 18 500 rpm.

The cone of bearing S/N 78-10, with the complete fracture, is shown in figure 7. A portion of the initial crack and advanced stages of fracture are shown in figure 8. Initial crack dimensions are approximately 22 mm (0.87 in.) long and 6 mm (0.24 in.) deep.

Fatigue spalling is noted in figures 5 and 7 adjacent to the cracks. It is believed that the fatigue cracks, related initially to the spalling pro-

cess, propagated at an accelerated rate due to the presence of the superimposed high hoop tensile stress field in the cones. In the case of bearing serial number 78-10, the crack propagated to its critical value and destructive fracture occurred. Fortunately, the test rig was shut down before complete fragmentation of the cone occurred. The crack in bearing S/N 78-9, although at an advanced stage, had not yet reached the critical fracture stage.

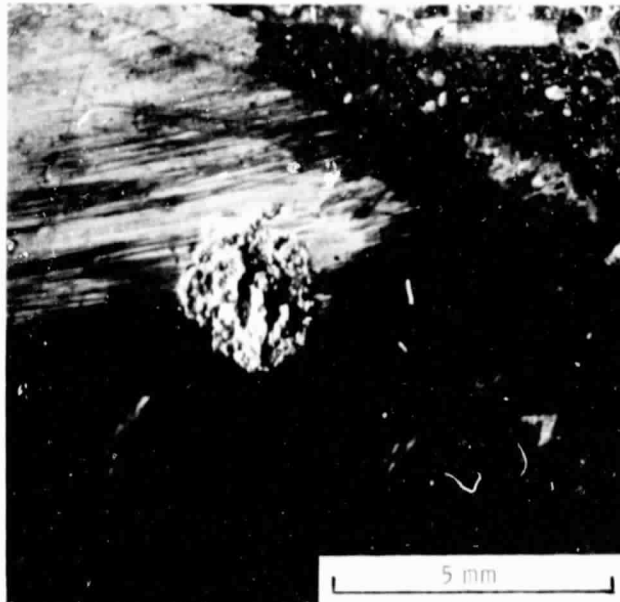
Figure 9. - Fatigue spall on cone raceway of CBS-1000M bearing S/N 76-17 after 135 hours of operation at 18 500 rpm.

CBS 1000M bearing tests. - Five computer optimized, high-speed design tapered roller bearings made of case-carburized CBS 1000M material were also life tested at conditions identical to those of the AISI M-50 bearings. Four of these bearings ran to the 1100 hour cutoff time without failure. One test resulted in a severe failure of one test bearing after 135 hours as a result of failure detection and shutdown system malfunction. The extent of damage was too great to determine the origin or cause of the failure. However, close observation revealed at least two spalls in the cone raceway. The largest spall is shown in figure 9. No cracks or fracture of the cone were observed although considerable damage to the raceway, cone rib and cage occurred. This result offers some, although admittedly meager, evidence that a high-temperature, case-carburized material such as CBS 1000M can resist fracture or cracking at conditions of high tensile hoop stress after spalling and significant cone raceway damage had occurred.
