NATIONAL ADVISORY COMMITTEE FOR AERONAUTICS

No. 1598

EFFECTS OF ICE FORMATIONS ON AIRPLANE PERFORMANCE
IN LEVEL CRUISING FLIGHT

By G. Merritt Preston and Calvin C. Blackman

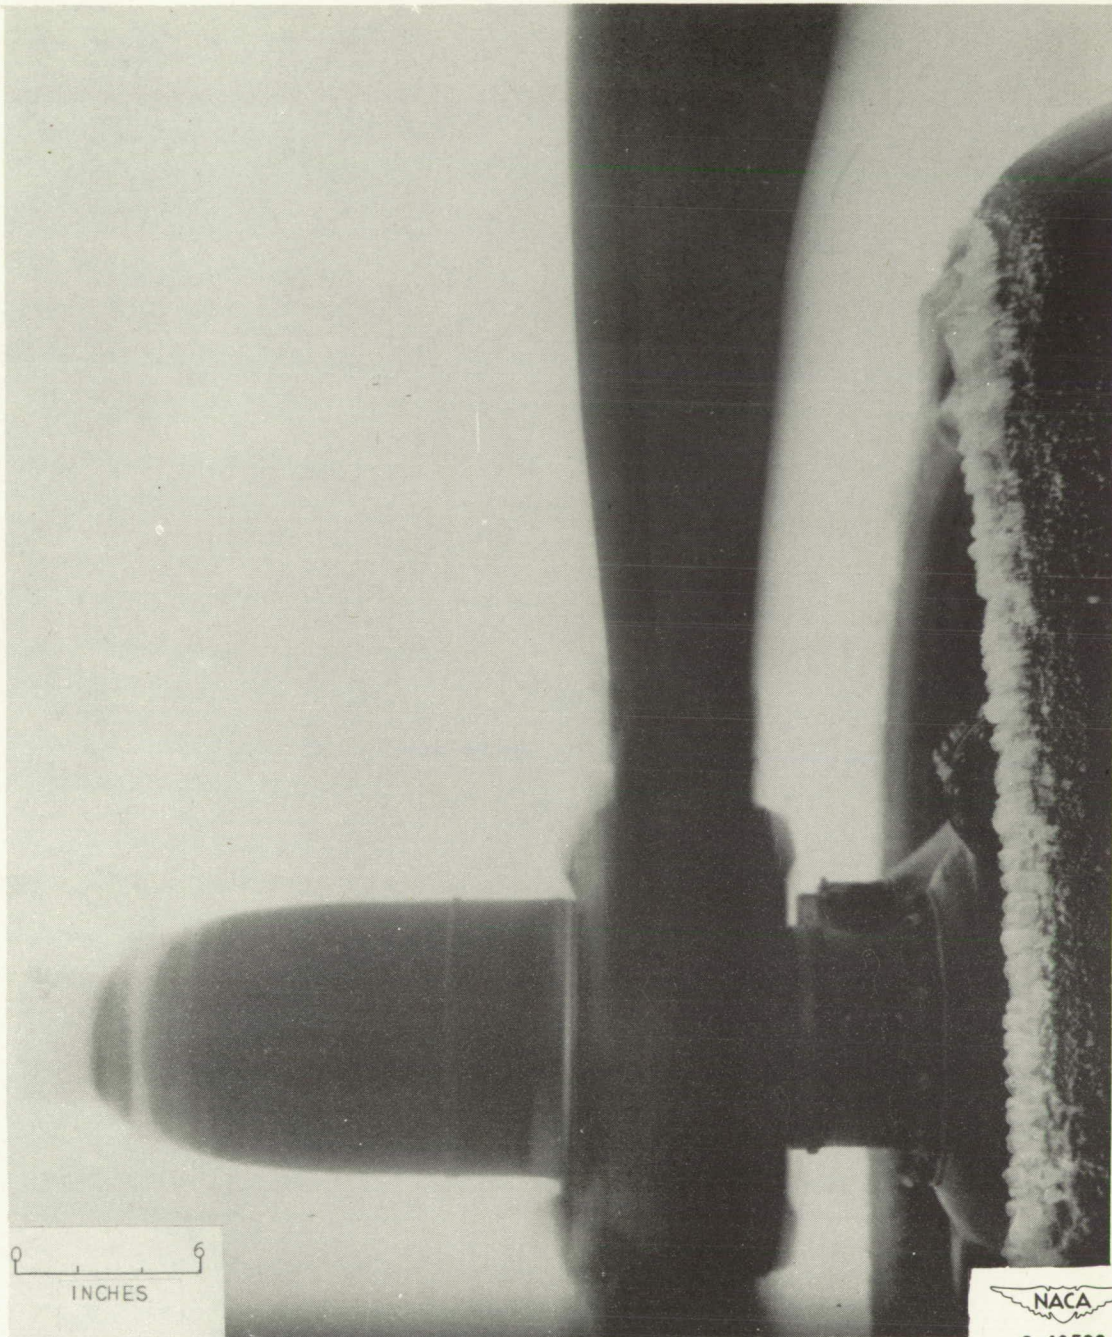
Figure 10. - Formation of ice on leading edge of cowl and spinner.
Average icing rate, 4 inches per hour; liquid-water content, 0.4 gram
per cubic meter; droplet size, 17 microns.

Photographs of the resulting ice formations are shown in figures 7 to 13. Front and side views of the ice formation on the loop-antenna housing are shown in figure 7. Equally heavy ice collected on the antenna mast and on instrument-landing-system receiving antennas (fig. 8). Ice on the nose of the airplane was photographed on the ground after 15 minutes of flight in temperatures above freezing (fig. 9). Thin, rough, glaze-ice deposits extended well beyond the principal ice accretion. Several large isolated pieces indicate that the total formation was much larger during the flight. Ice on the leading edge of the engine cowling (fig. 10) was uniform but noticeably smaller than ice formations on the other components of the airplane. The ice formations on the inboard-wing panels were relatively small (fig. 11). The size of the formation can be judged by the 1-inch reference stripes on the wing surface. Some ice was lost from the outboard-wing panels

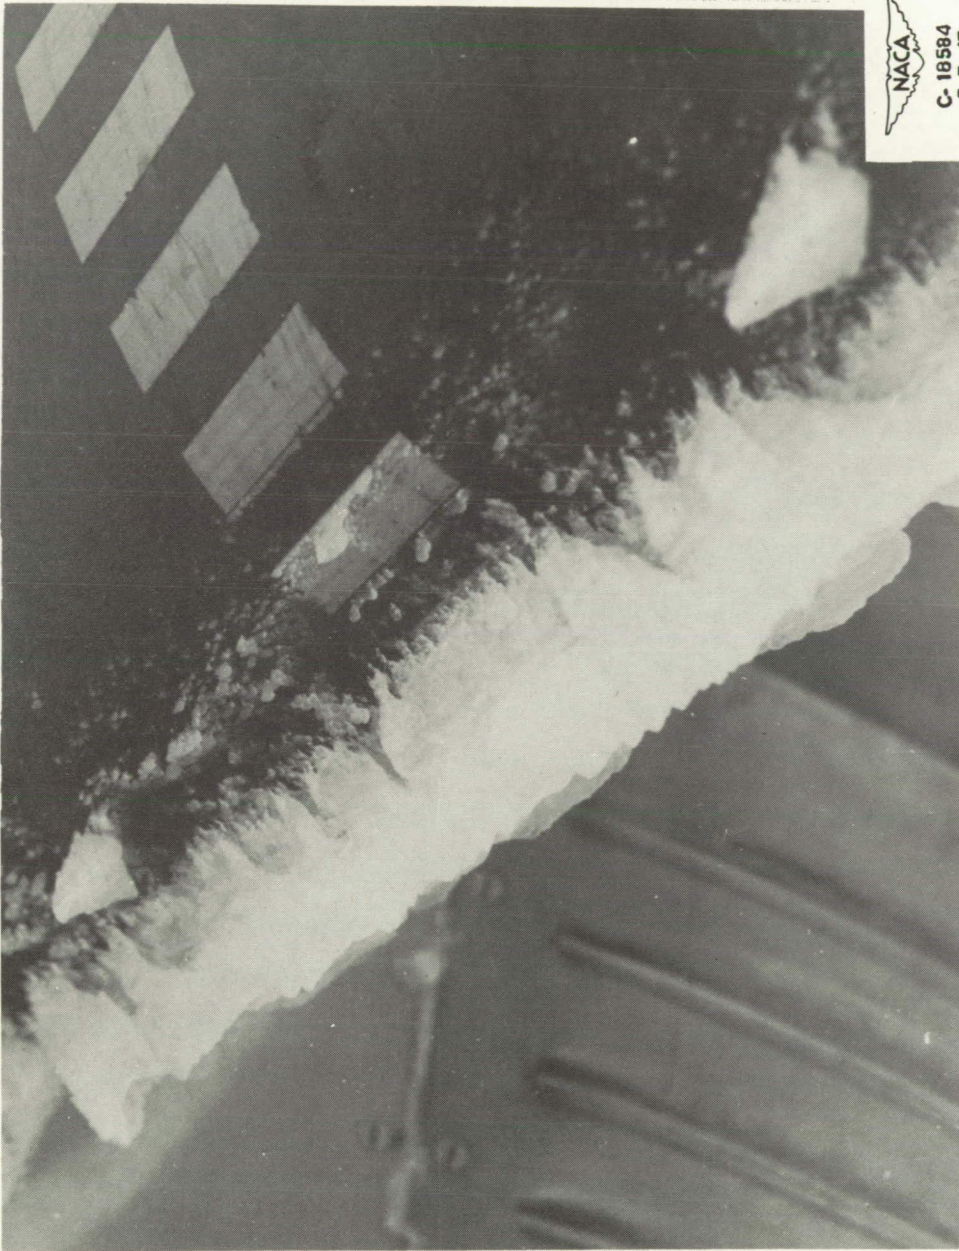
Figure 11. - Formation of ice on inboard-wing panel of airplane. Average icing rate, 4 inches per hour; liquid-water content, 0.4 gram per cubic meter; droplet size, 17 microns. (Painted stripes are 1 in. wide.)

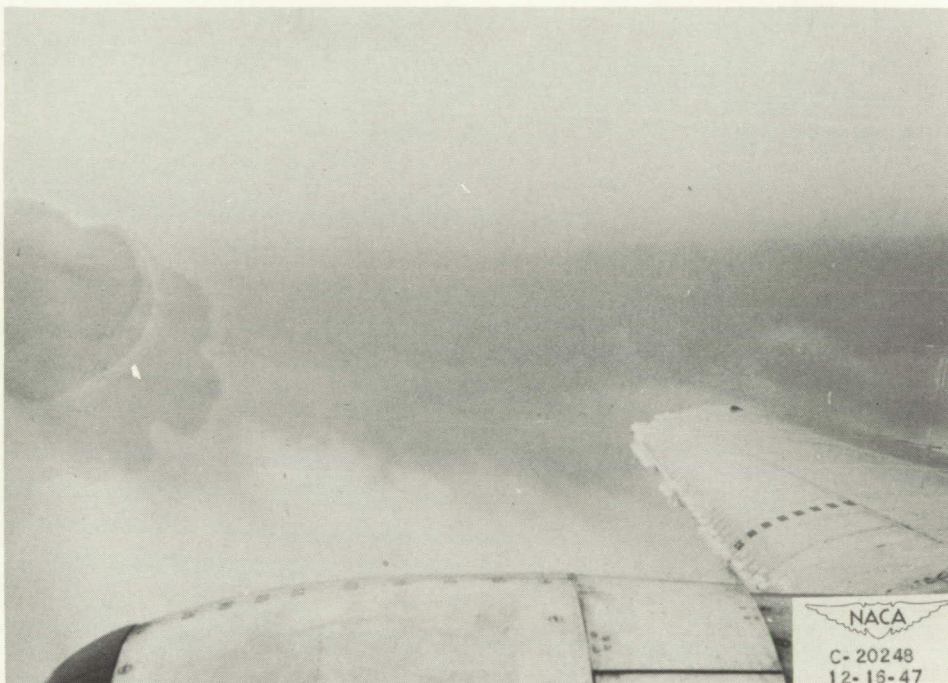
Figure 12. - Formation of ice on outboard-wing panel showing sections of ice lost by wing flexure. Average icing rate, 4 inches per hour; liquid-water content, 0.4 gram per cubic meter; droplet size, 17 microns. (Painted stripes are 1 in. wide.)

(fig. 12), which was probably caused by the air loads on the ice and wing flexure. The photograph of the ice on the horizontal stabilizer (fig. 13) indicates the severity of the icing condition and the shape of the ice formation. Figure 13 also shows that some ice was lost because of air loads and flexure.

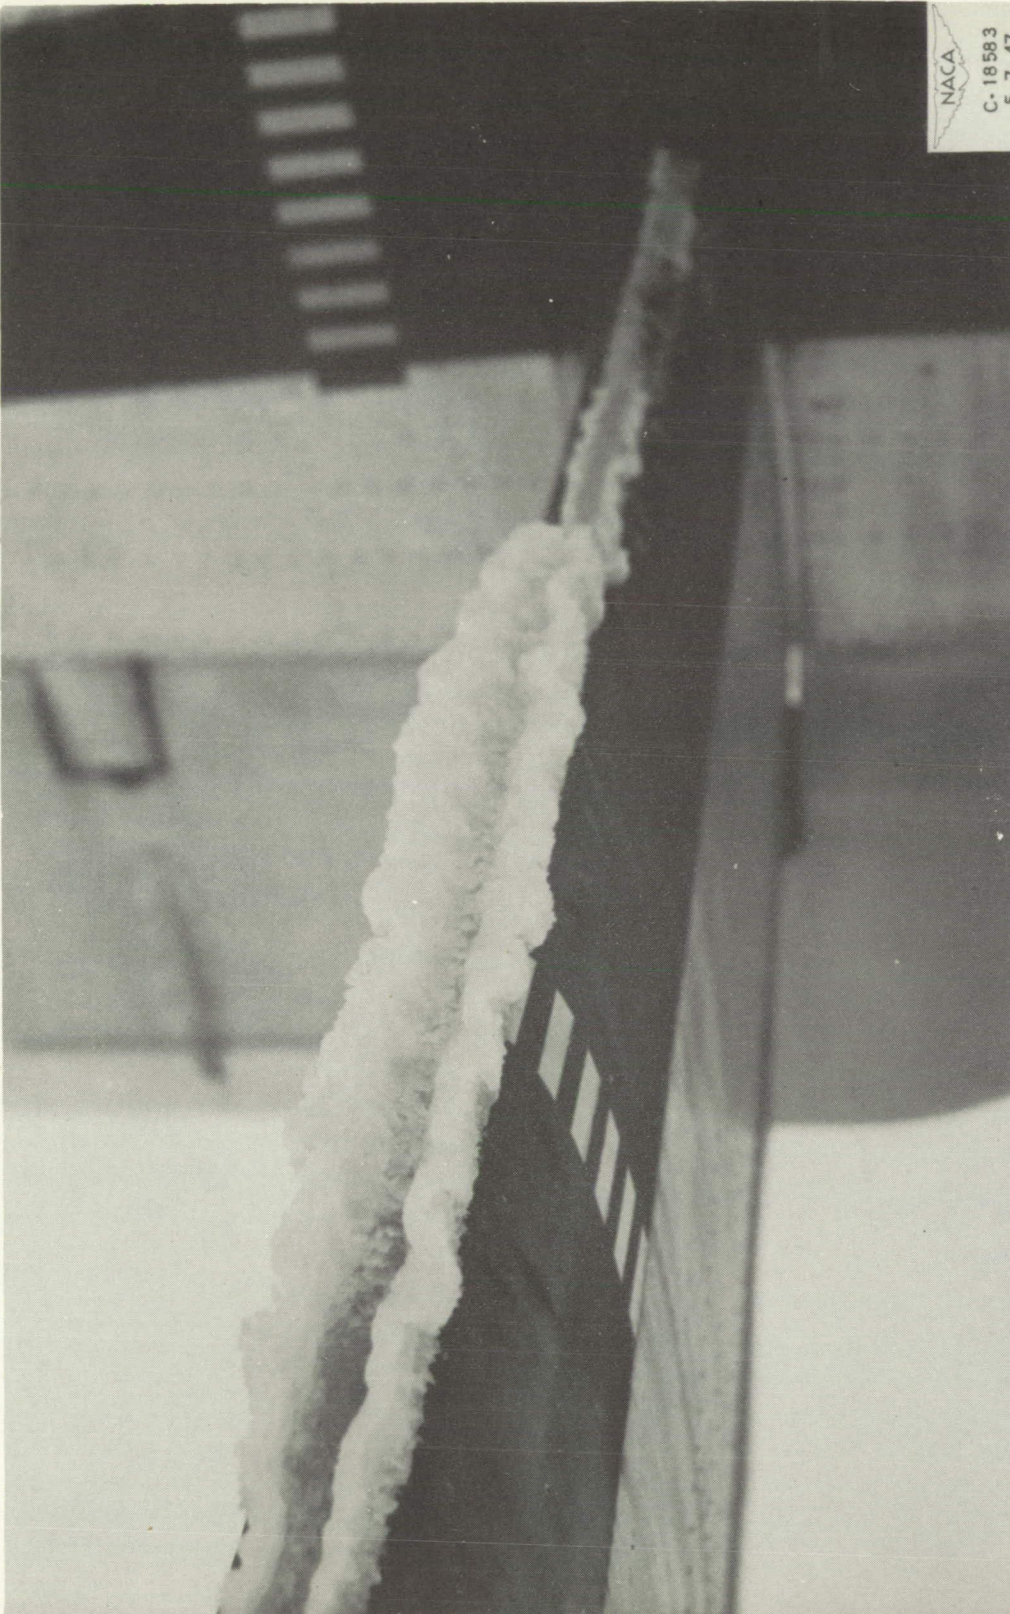
Figure 13. - Formation of ice on horizontal stabilizer. Average icing rate, 4 inches per hour; liquid-water content, 0.4 gram per cubic meter; droplet size, 17 microns. (Painted stripes are 1 in. wide.)
