NASA TM-82440

MSFC EVALUATION OF THE SPACE FABRICATION DEMONSTRATION SYSTEM (BEAM BUILDER)

By E. O. Adams and C. N. Irvine
Materials and Processes Laboratory

September 1981

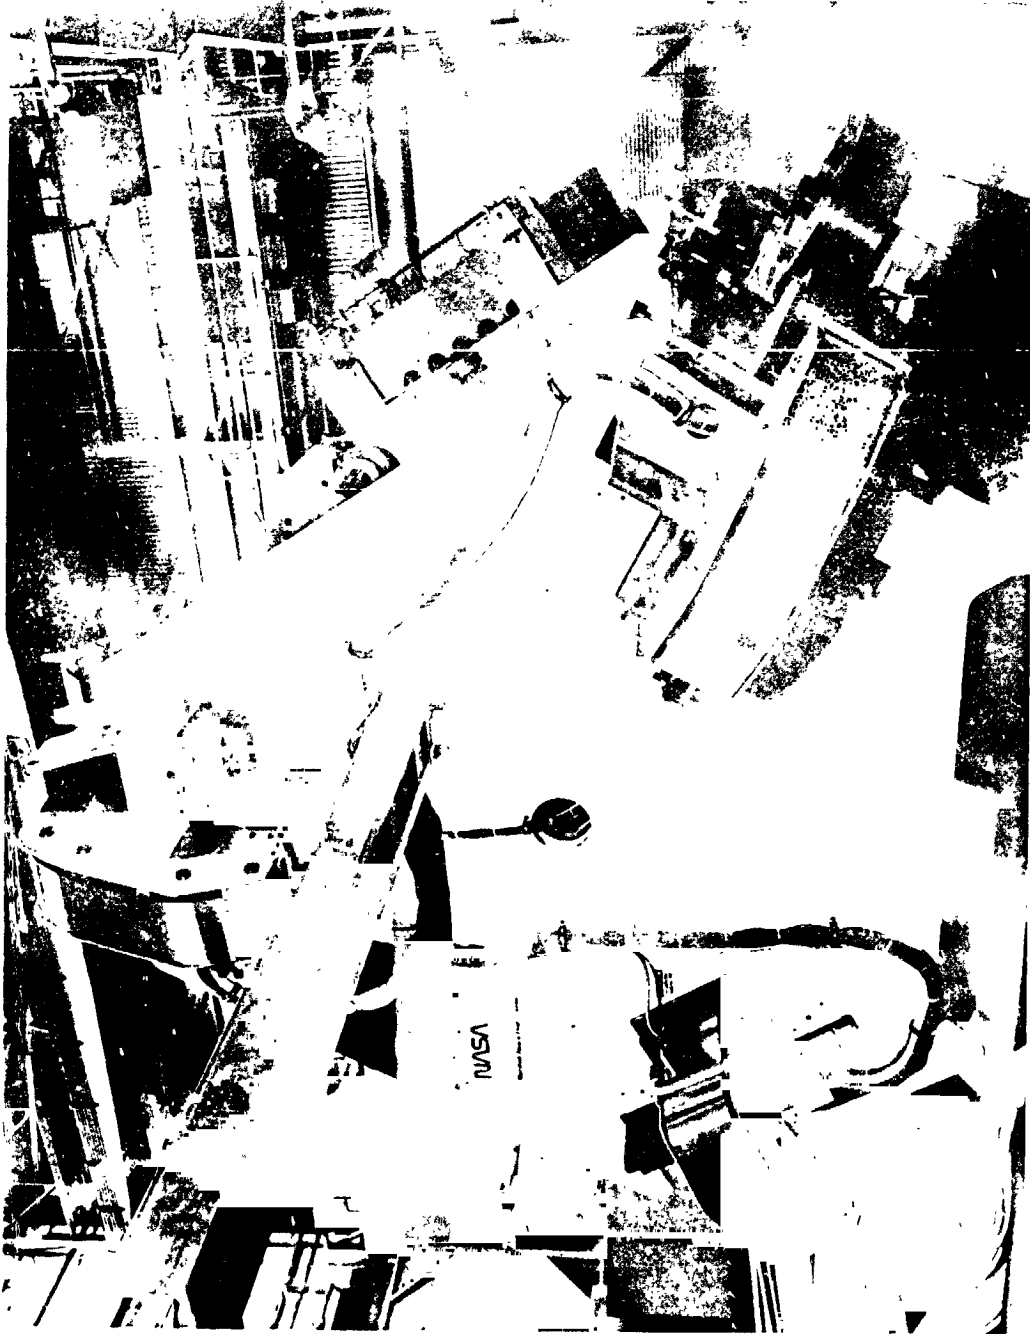
Figure 9. Feed guide system.

Three sets of five rollers (Fig. 9) constitute the feed guide system. This system dispenses and guides the aluminum flat material into the Rolling Mills System. The alignment of the guiding rolls is important for the fabrication of the cap members.

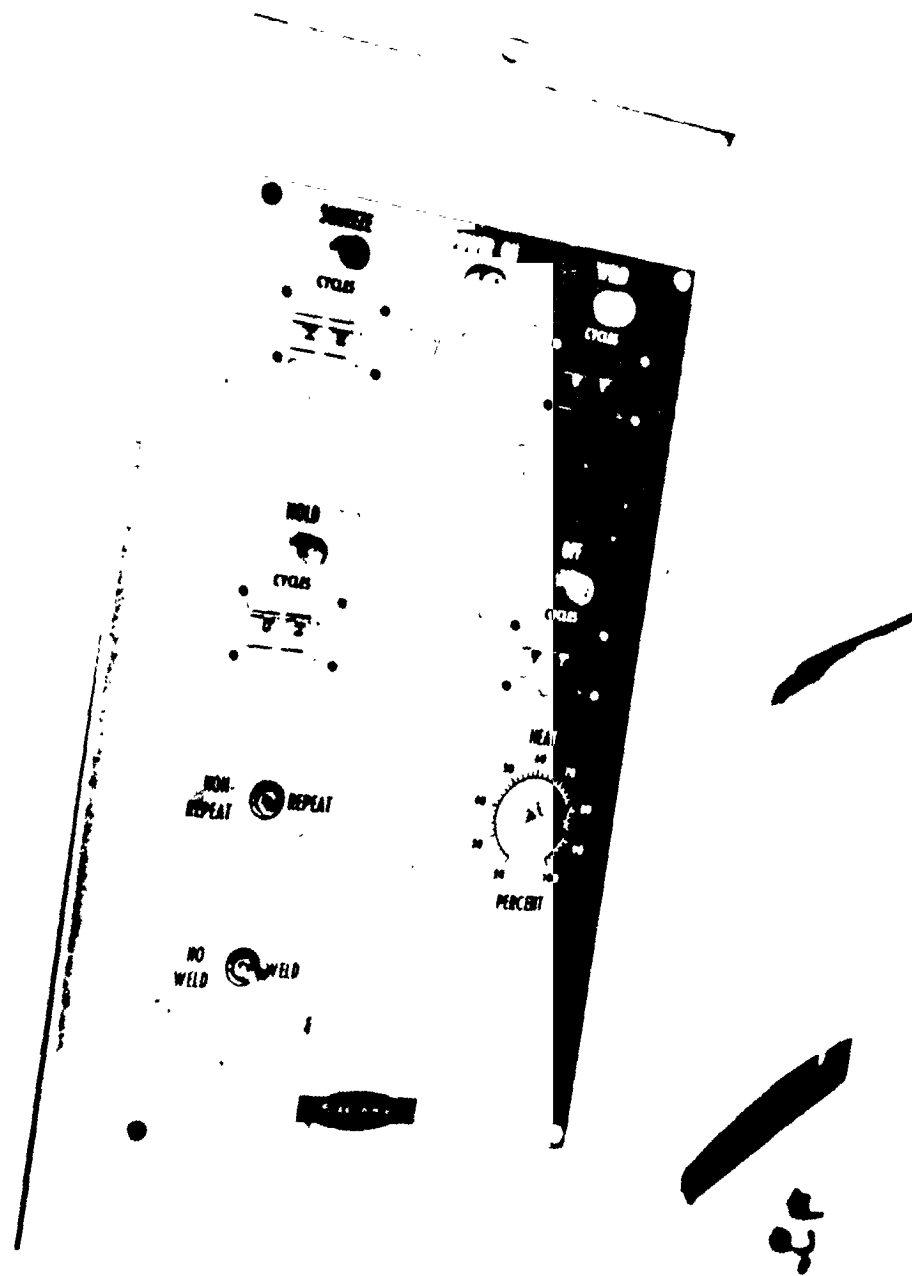
Figure 15. Sciaky weld controller.

Before turning the Sciaky weld control circuit breaker switch on, the water, for cooling the system, must be on. After this switch has been actuated, the Sciaky weld controller must have the following setting.

- 1) Weld controller "On" (lower toggle switch)
- 2) Squeeze 10 cycles
- 3) Hold 02 - cycles
- 4) Non-repeat (toggle switch)
- 5) Weld - 01 cycle
- 6) Off - 10 cycles
- 7) Weld "On" (toggle switch)
- 8) Heat % - 84 for vertical braces & 87 for diagonal braces
- 9) Transformer 1, TAP 3
- 10) Transformer 2, TAP 3
- 11) Transformer 3, TAP 4
- 12) Transformer 4, TAP 3
- 13) Transformer 5, TAP 4
- 14) Transformer 6, TAP 4.
