Development of a High-Temperature Durable Catalyst for Use in Catalytic Combustors for Advanced Automotive Gas Turbine Engines

H. Tong, G. C. Snow, E. K. Chu, R. L. S. Chang,
M. J. Angwin, and S. L. Pessagno
Energy & Environmental Division
Acurex Corporation

September 1981

Prepared for
NATIONAL AERONAUTICS AND SPACE ADMINISTRATION
Lewis Research Center
Under Contract DEN 3-83

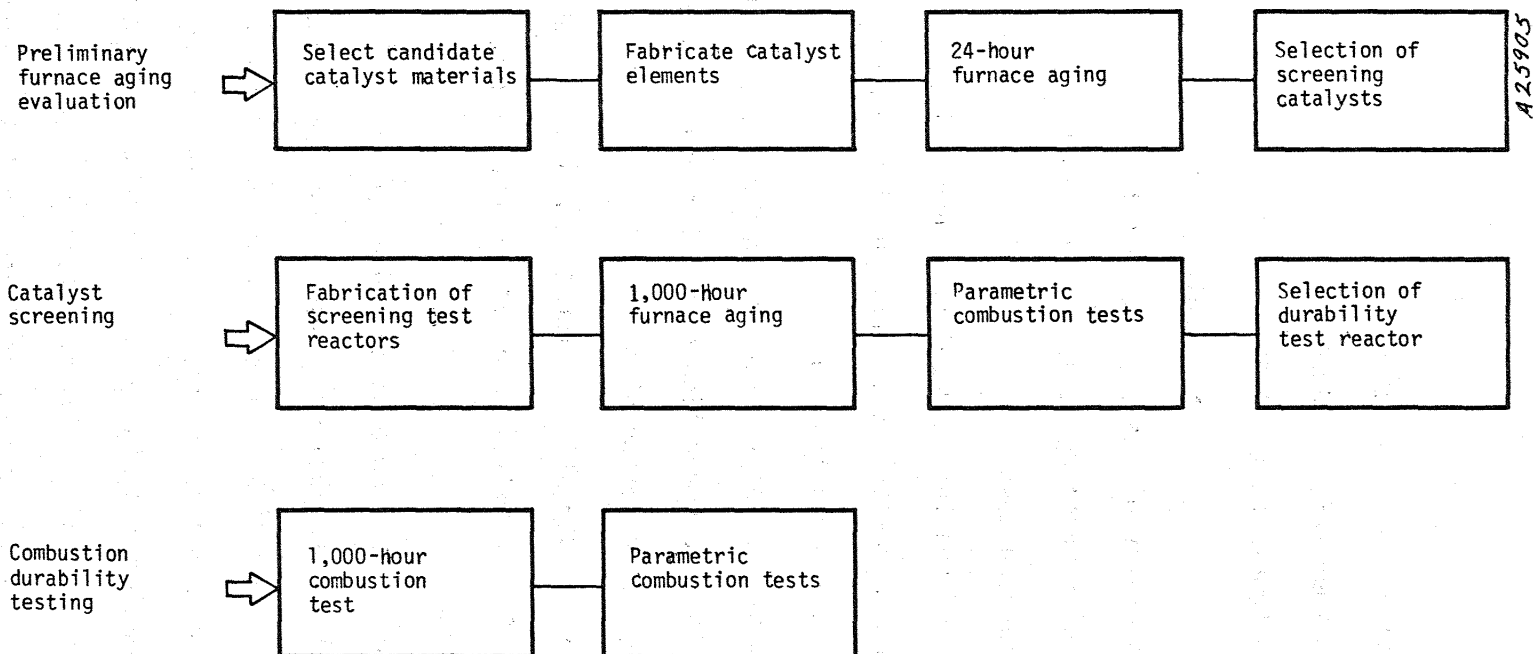
Figure 1-1. Program Technical Approach

In the preliminary furnace aging evaluation, 14 candidate catalytic

reactor concepts, consisting of a catalyst and substrate combination, were selected from a larger number of recommendations from catalyst suppliers. These candidates were then fabricated and aged in a high-temperature (1,700K) furnace for 24 hours. Through pre- and posttest examinations, six catalytic reactor concepts were selected for further catalyst screening.

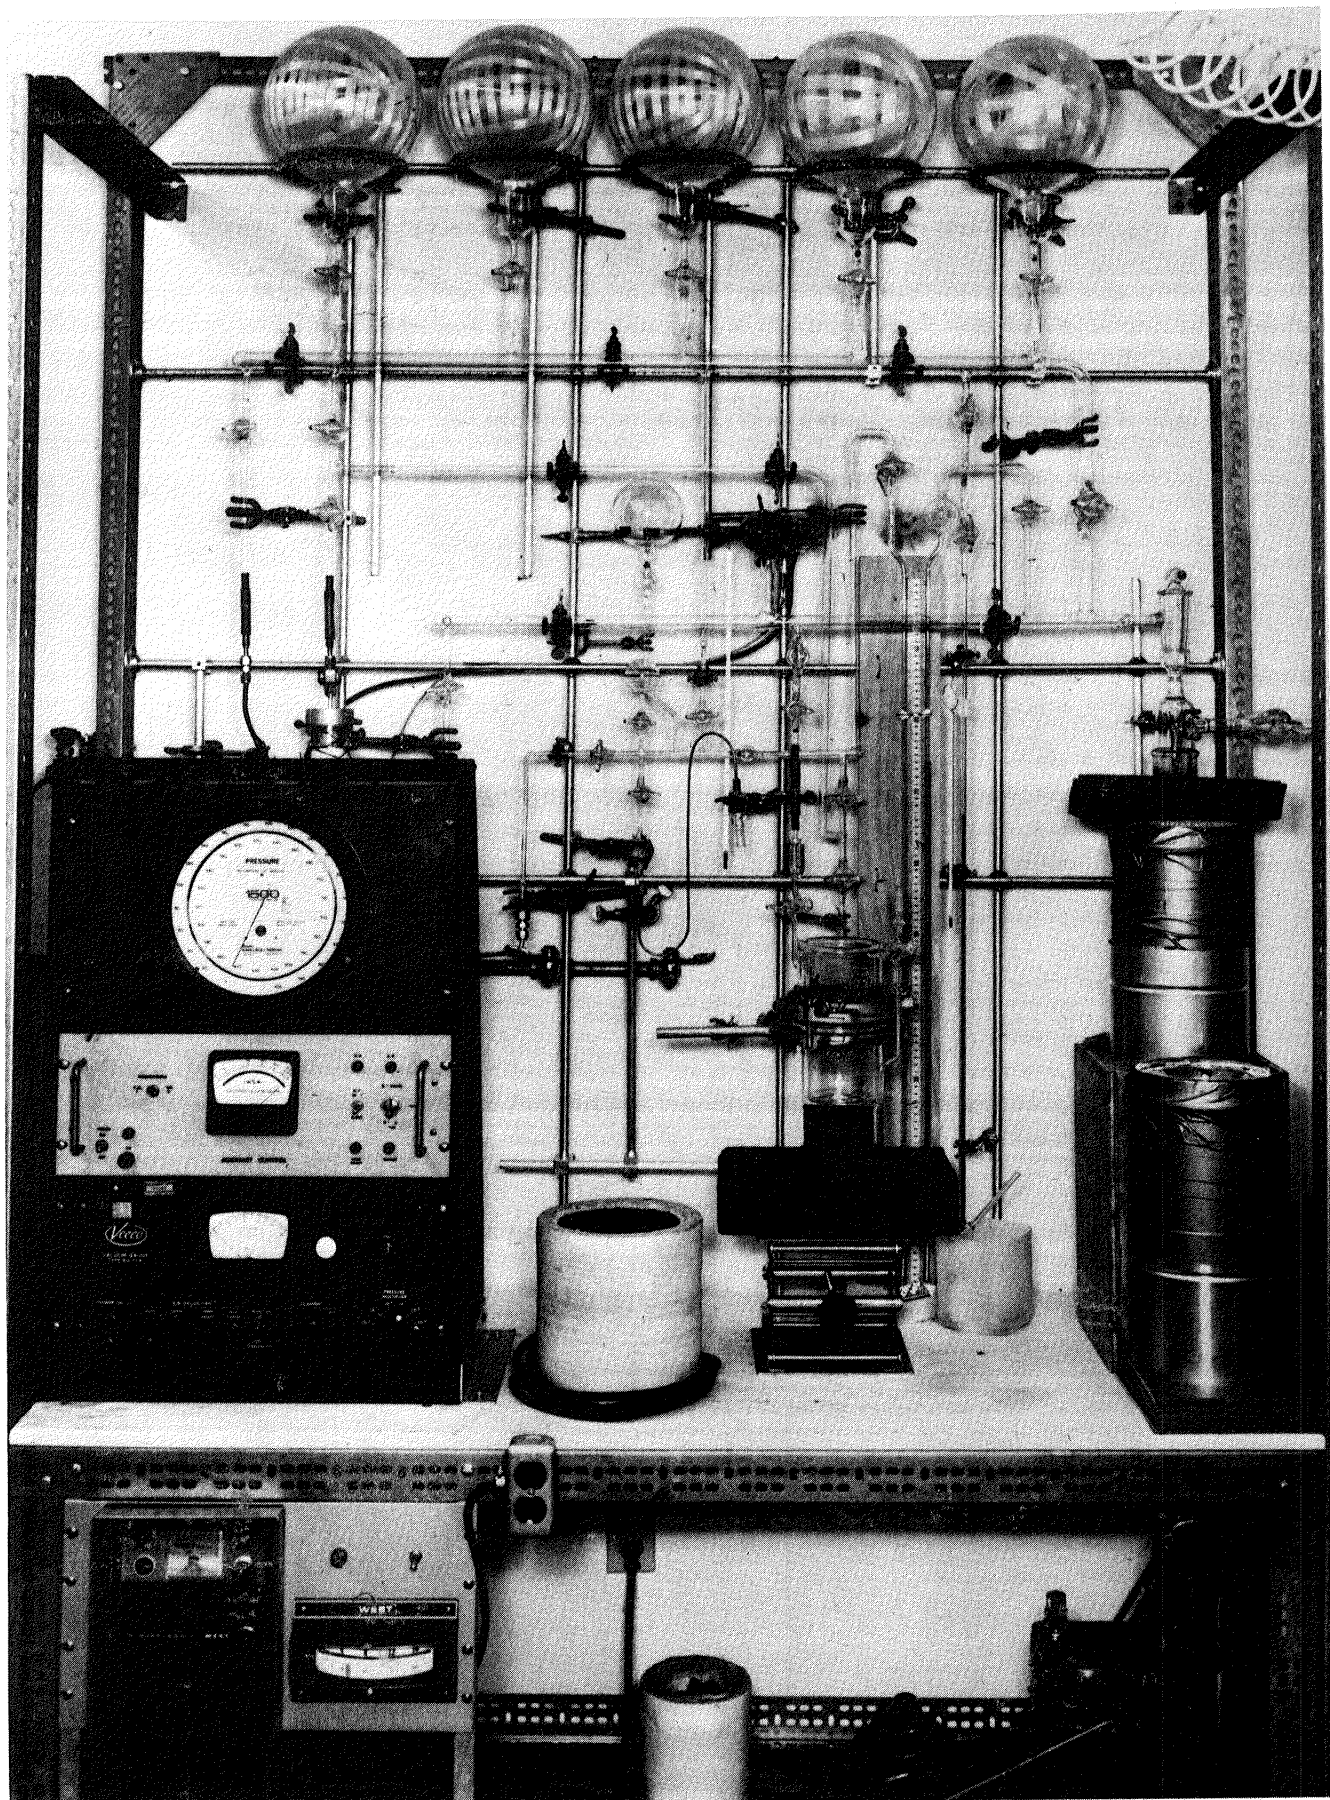
Figure 2-1. High Vacuum Gas Adsorption Apparatus

Experimentally, it is found that a plot of $P/V (P_0 - P)$ versus P/P_0 is linear in the range of relative pressures from 0.05 to 0.35. The slope is $(C-1)/V_m C$ and the intercept is $1/V_m C$. Thus, V_m can be found from the measured slope and intercept of this line. Total surface area can then be determined from equation 2-1.

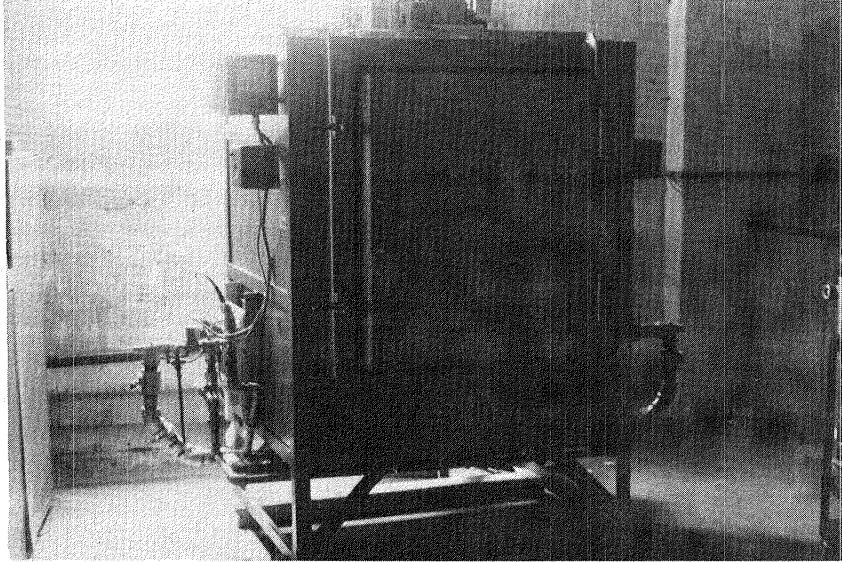
Figure 2-2. Furnace

For aging tests, the catalysts are placed in the center of the furnace, supported by a plate of silicon carbide raised off the floor of the furnace. The catalyst test area is surrounded by six plates of silicon carbide, which shield the catalysts from the radiation of the furnace walls. Figure 2-2 shows the furnace and figure 2-3 shows the "radiation shield" box of silicon carbide. Figure 2-4 shows a typical arrangement of catalysts in place within the box; however the catalysts are hidden from view by their protective cylindrical alumina sheath. Figure 2-5 shows a typical catalyst in its protective sheath. Each

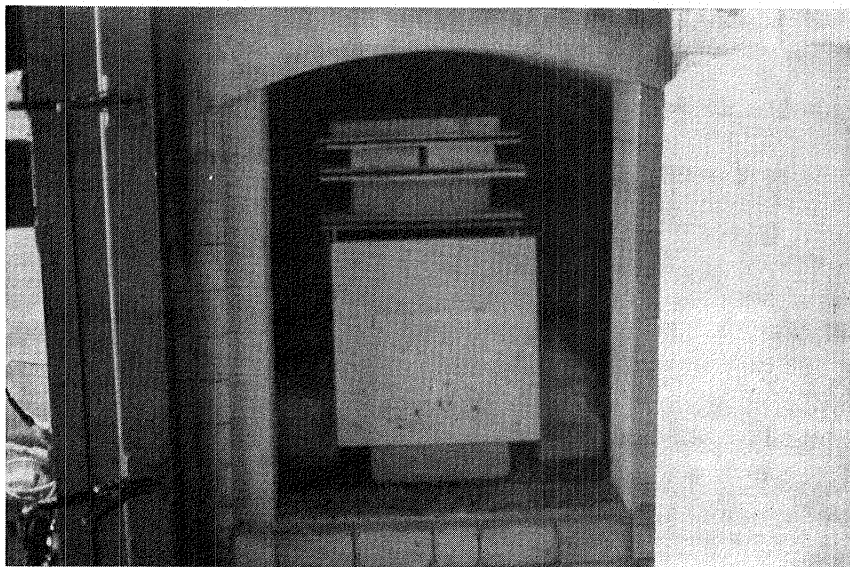
Figure 2.3. Radiation Shield in Furnace

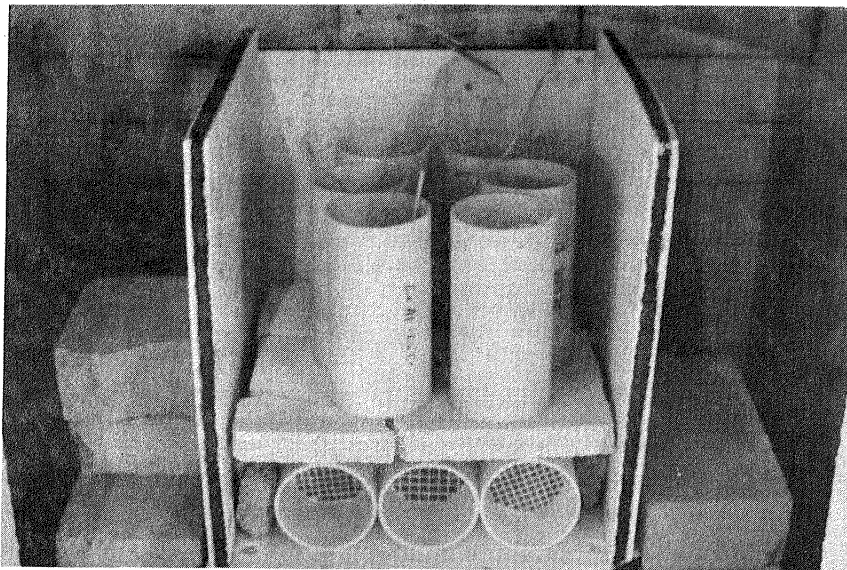
Figure 2-4. Catalysts in Place Within Furnace

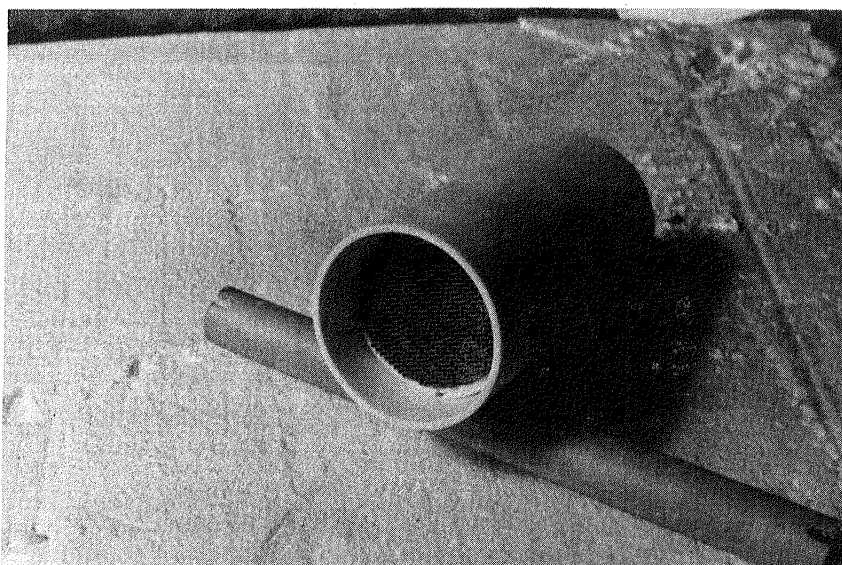
Figure 2-5. Catalyst in Sheath, Out in Furnace

catalyst is supported (within its sheath) by a small piece of alumina, so catalysts do not rest on the silicon carbide base plate.

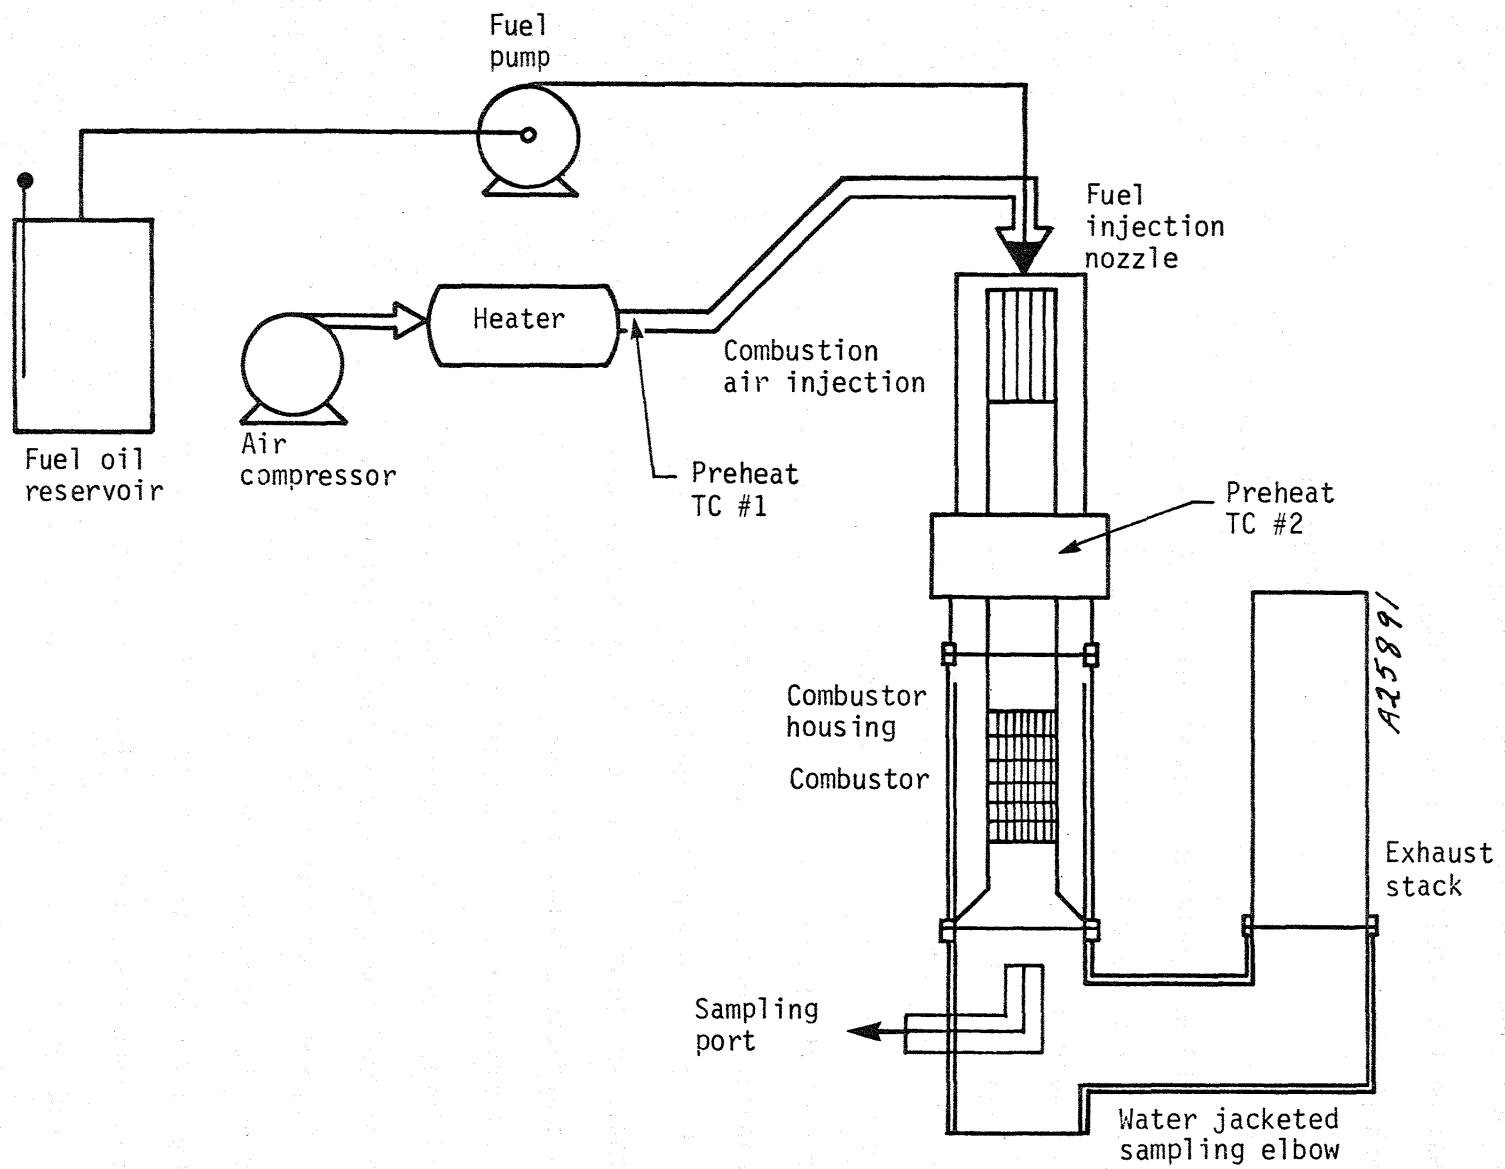
Figure 2-6. Test Facility Schematic

The preheat temperature of the air flowing to the reactor was measured at two locations as shown in figure 2-6. One thermocouple

(preheat TC #1) was located in the main supply pipe downstream of the heaters and immediately upstream of the air injection manifold. The second thermocouple (preheat TC #2) was located midway between the fuel nozzle and the reactor bed in the fuel-air preparation spool.

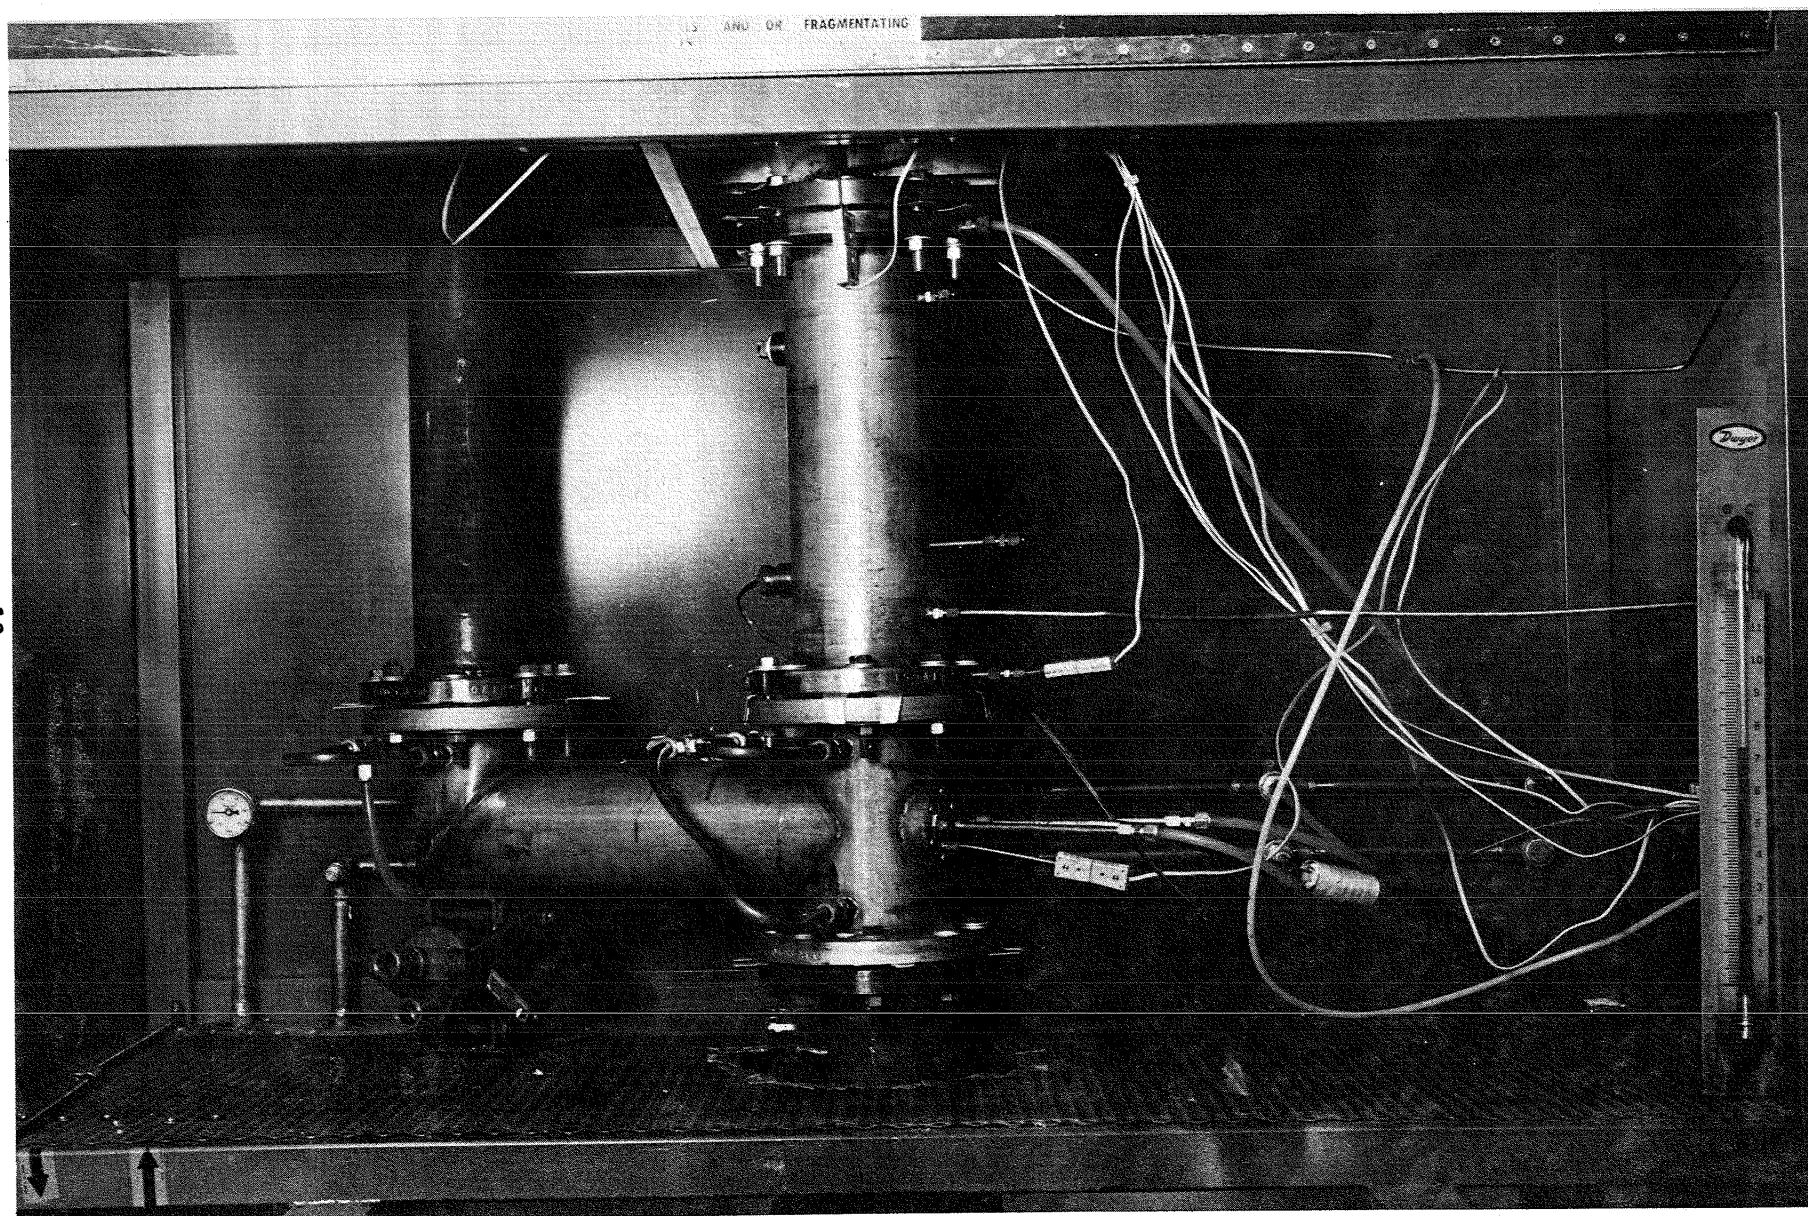
Figure 2-7. Acurex Catalytic Combustion Test Facility

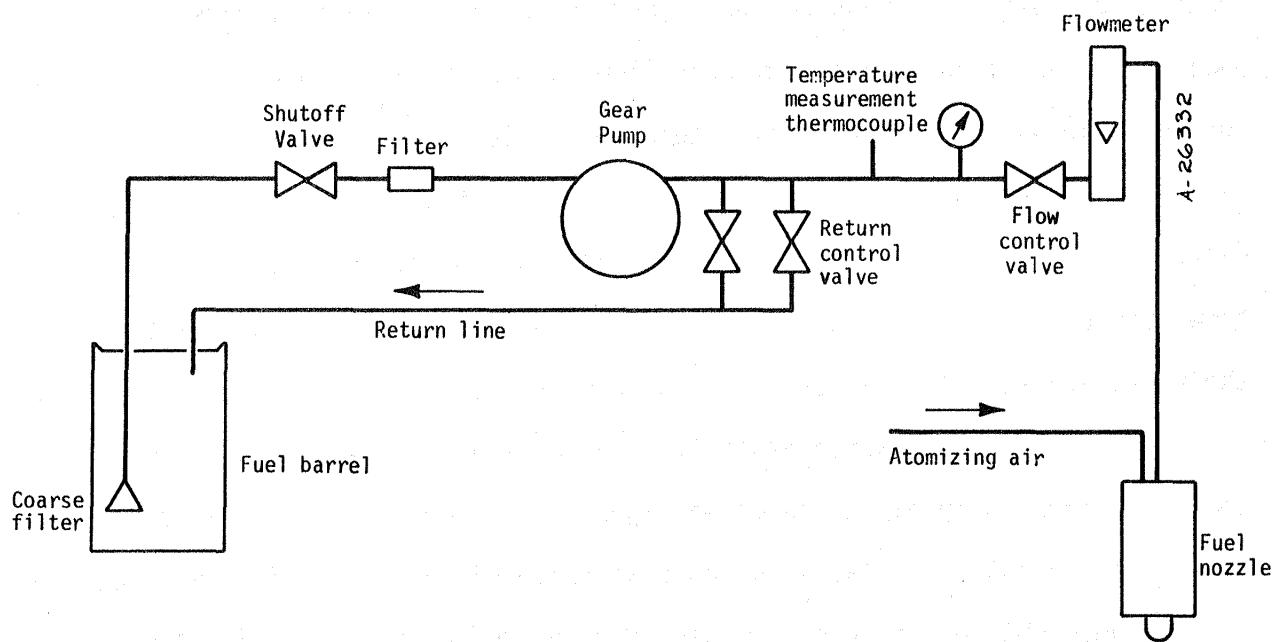
Figure 2-8. Liquid Fuel Delivery System

A pressurized air atomization fuel nozzle is used to deliver the liquid fuels, and is located at the top of the mixing chamber. The nozzle was modified from a Spraying Systems Company design (Model 1/4 JALL) by replacing viton seals with Teflon and constructing a cooling air jacket to surround the liquid passages. This cooling was necessary to prevent fuel coking in the passages since the nozzle senses heating both from the preheat temperature and radiation from the catalyst bed. Also, it was found that maximizing the atomizing airflow enhanced cooling and prevented clogging of the spray orifice.

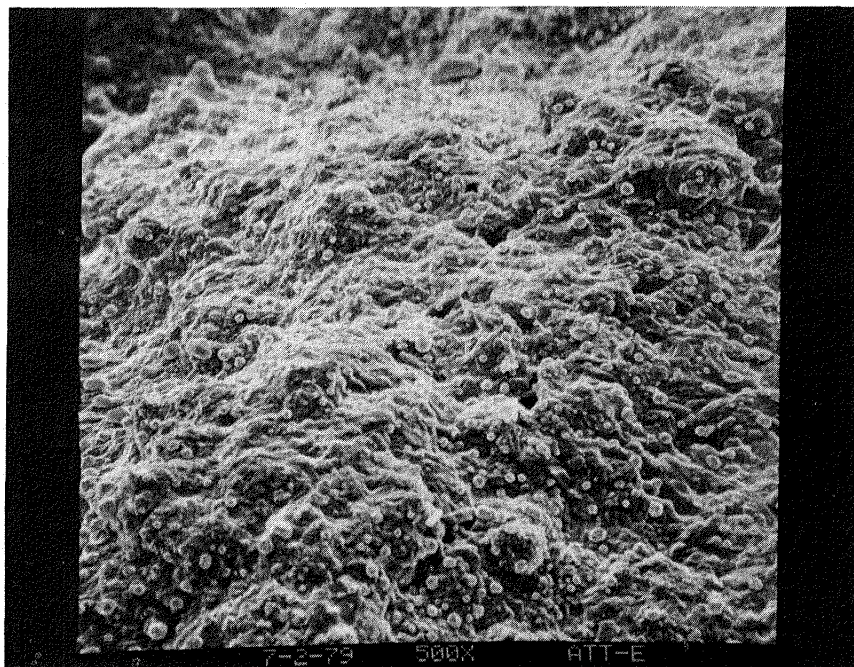
**Figure 4-1. SEM photograph, 500X Magnification,
Surface of ATT-E Before Aging**

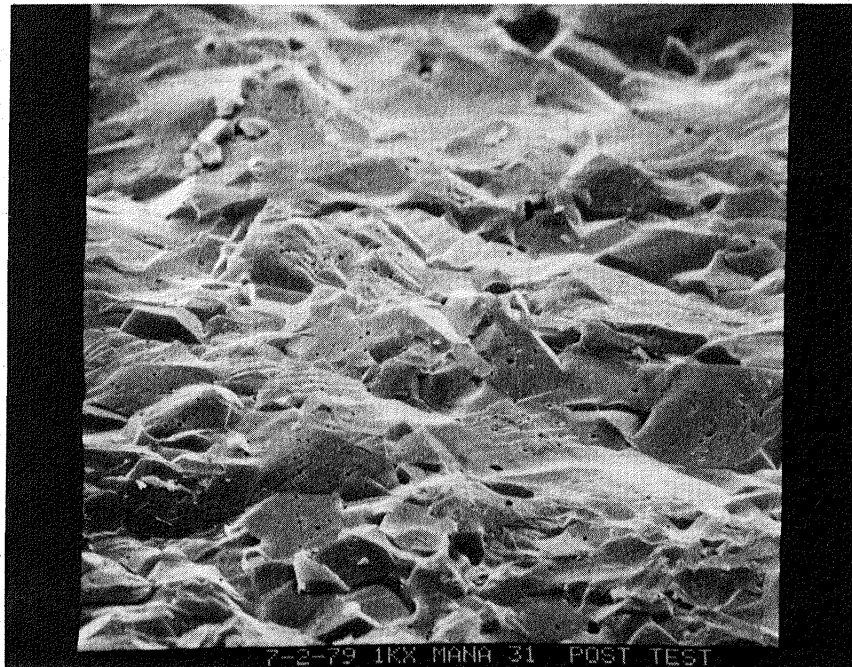
**Figure 4-2. SEM Photograph, 1,000X Magnification,
Surface of ATT-B Before Aging**

This monolith was manufactured in the same way as the previous monolith, pressed from the reacted powder, sintered, drilled, and resintered. An active monolith of this type had not previously been combustion-tested, but combustion tests of LaCrO_3 on alumina were very good (see description under ATT-E). Posttest visual inspection of this catalyst showed no change, as expected. Pretest and posttest SEM analysis

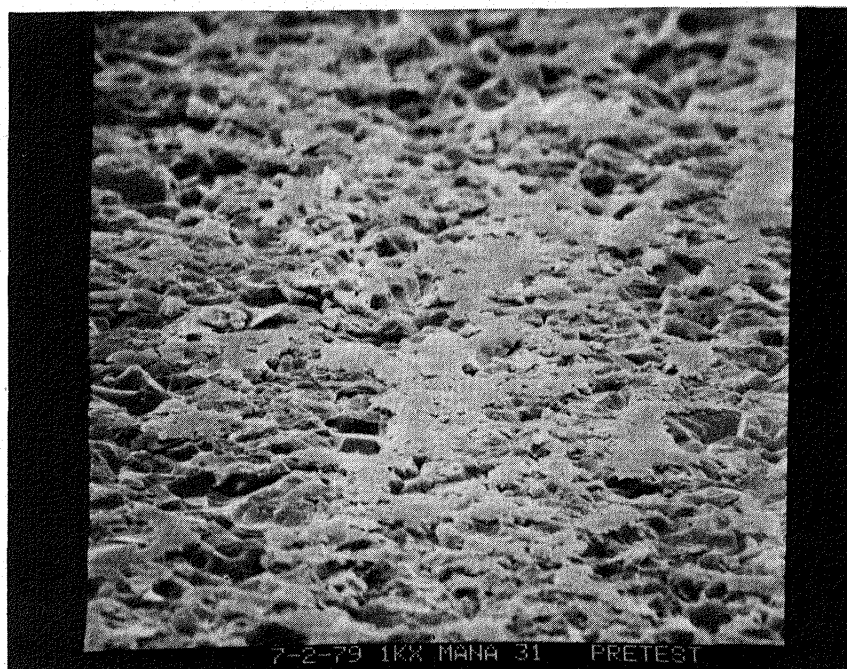
**Figure 4-3. SEM Photograph, 1,000X Magnification,
Surface of ATT-B After 24 Hours of Aging**

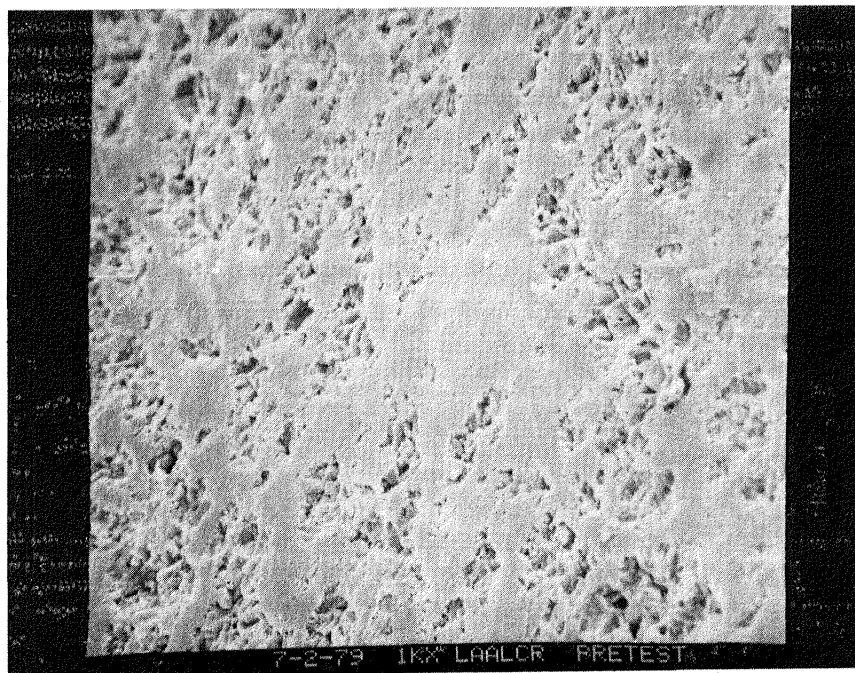
Figure 4-4. SEM Photograph, 1,000X Magnification, Surface of ATT-C Before Aging

showed a more granular surface posttest (figures 4-4 and 4-5). Pre- and posttest elemental analysis show the posttest sample to be depleted in chromium and alumina. In the light of this unexpected result, a fracture surface of the posttest sample was examined. In the fracture surface, lanthanum, chromium, and aluminum were present in quantities similar to the original amount.

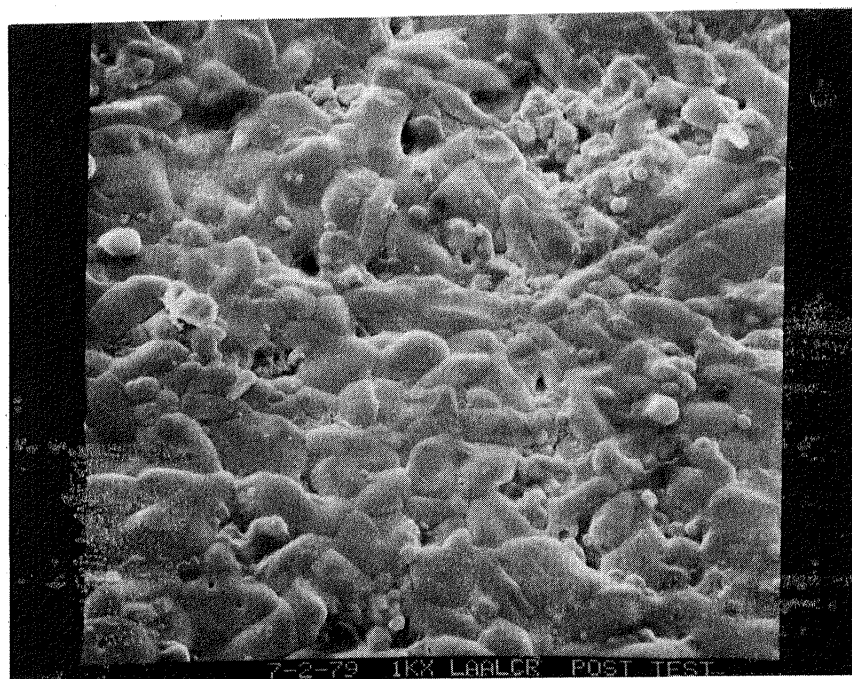
Figure 4-5. SEM Photograph, 1,000X Magnification, Surface of ATT-C After 24 Hours of Aging

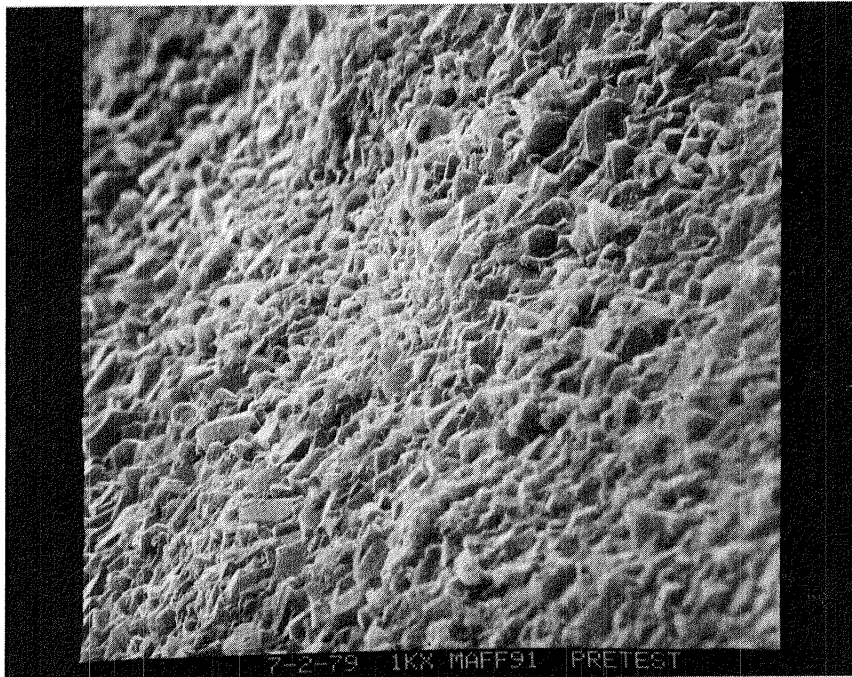
**Figure 4-6. SEM Photograph, 1,000X Magnification,
Surface of ATT-F Before Aging**

Pre and posttest SEM analysis showed a rough, crystalline surface for the bulk sample, and a more porous surface for the "rusty" sample (figures 4-6, 4-7, and 4-8). Pre- and posttest chemical analysis of rusty and nonrusty sections were the same within instrument reliability.

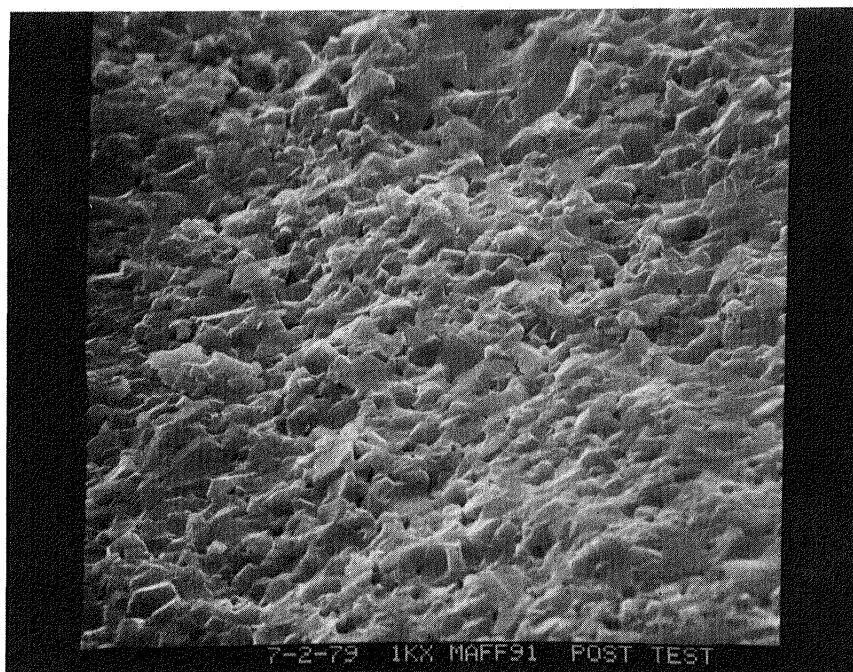
Figure 4-7. SEM Photograph, 1,000X Magnification, Surface of ATT-F After 24 Hours of Aging

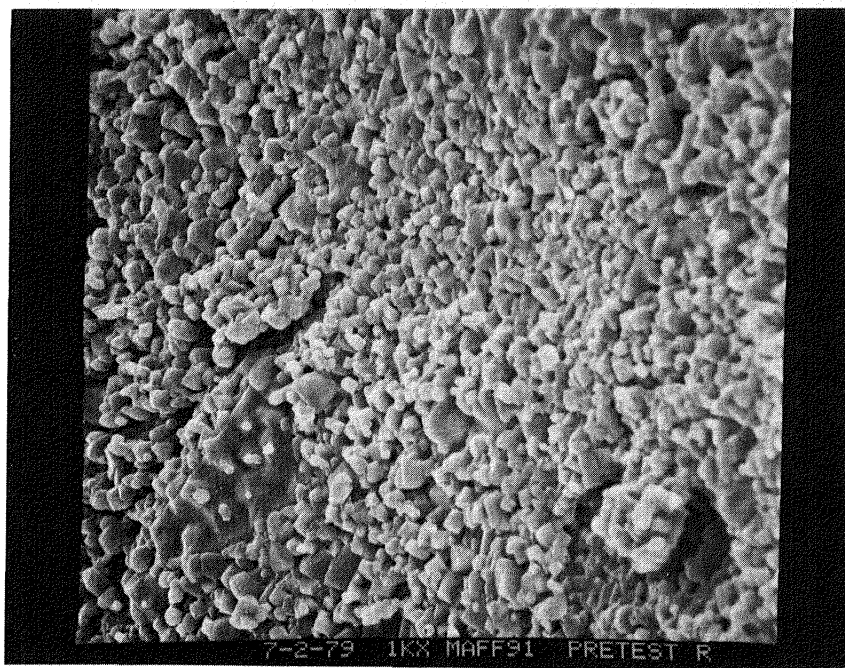
Figure 4-8. SEM Photograph, 1,000X Magnification, Surface of ATT-F After 24 Hours of Aging (Rusty Area)

This sample had "rusty" light-brown colored deposits on the surface, both pre- and posttest. It is hypothesized that these areas are MgFe_2O_4 -type spinel (probably $\text{MgAl}_2\text{O}_4 \cdot \text{MgFe}_2\text{O}_4$ solid solution) in which all the iron is in the +3 oxidation state.

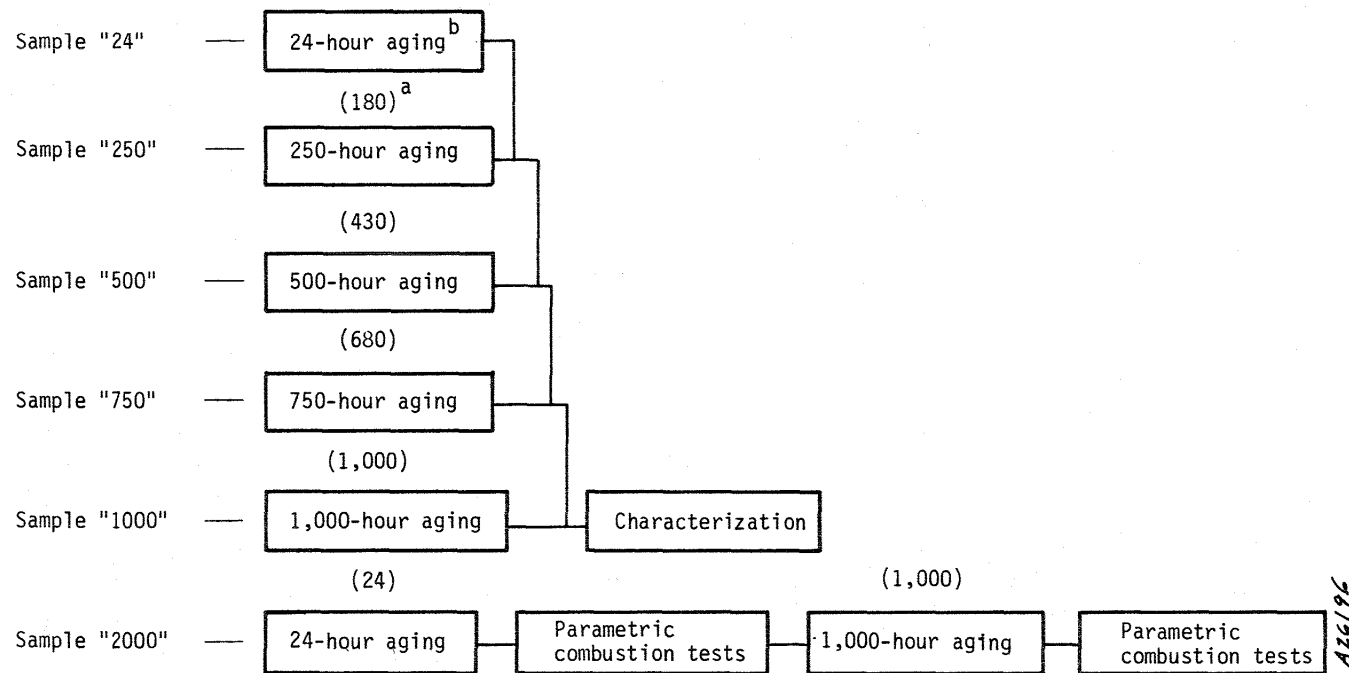
Figure 5-1. Furnace Aging and Combustion Screening Test Plan

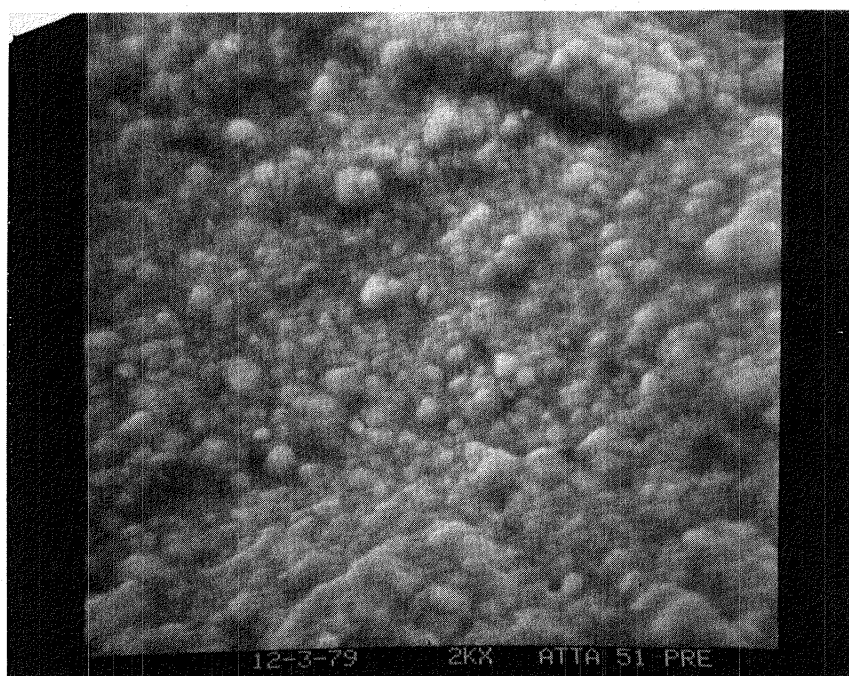
Figure 5-6. SEM Photograph, 2000X Magnification, Surface of ATT-A Before Aging

to Pt deleted. A pretest SEM of the lead element surface is shown in figure 5-6.

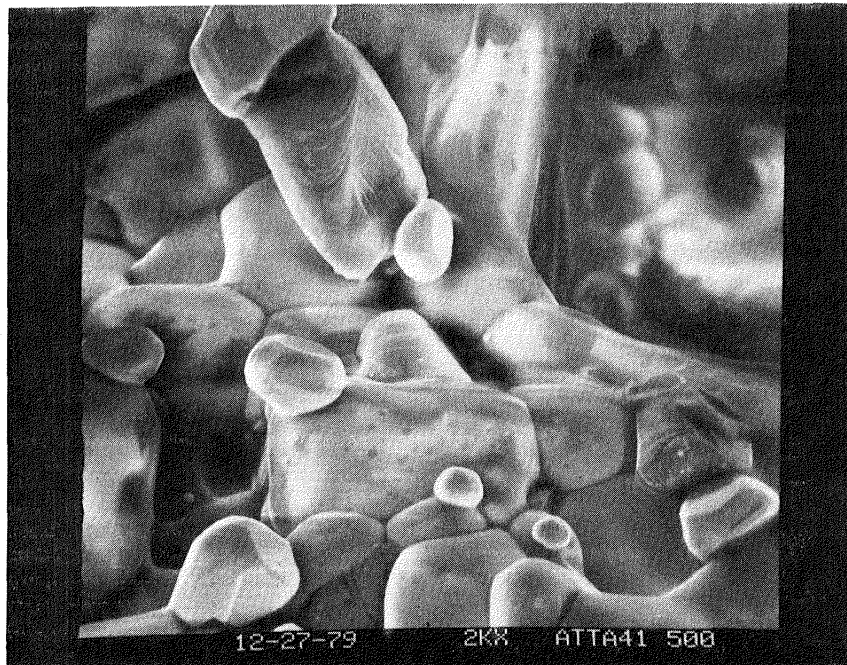
Figure 5-8. SEM Photograph, 2000X Magnification, Surface of ATT-A After 430 Hours of Aging

After 430 hours of furnace testing, the material was fragile and lighter green in color. Visual and SEM examination (figure 5-8) showed considerable platinum agglomeration over a surface essentially depleted in nickel. It was assumed from the even gray-green color of fracture surfaces of the monolith that considerable nickel interaction with the substrate had taken place. There was no substantive change after 680 hours, though platinum-rich and crystalline areas of nickel substrate

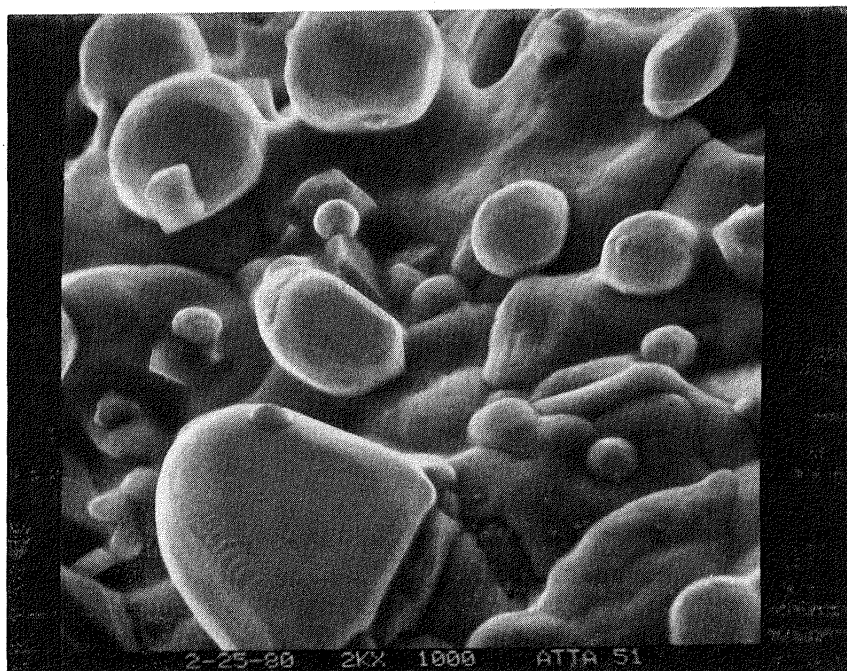
Figure 5-9. SEM Photograph, 2000X Magnification, Surface of ATT-A After 1000 Hours of Aging

solid solution were identified. After 1,000 hours, the material looked essentially the same (figure 5-9).

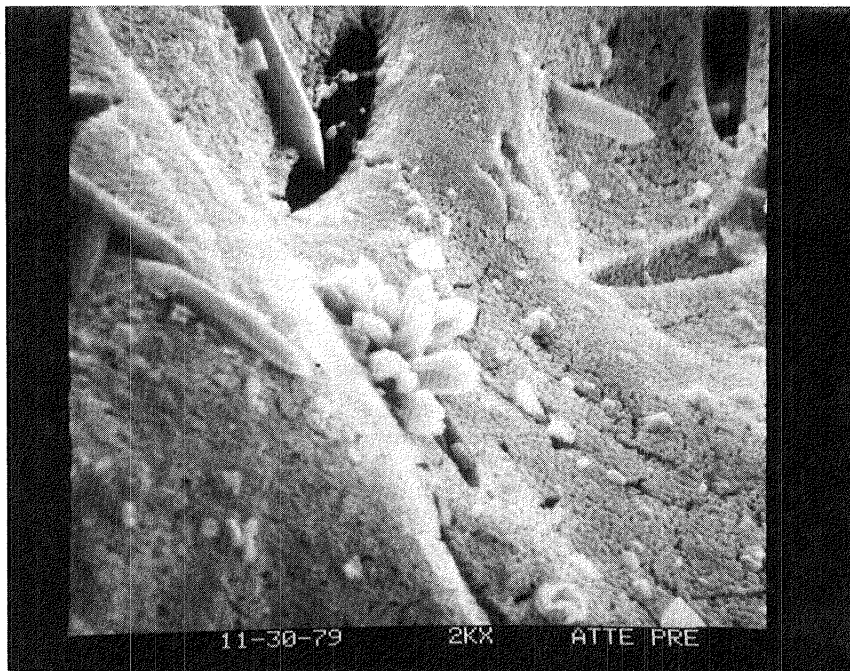
Figure 5-12. SEM Photograph, 2000X Magnification, surface of ATT-E Before Aging

SEM examination of the pretest catalyst (figure 5-12) showed crystals; X-ray analysis showed these crystals to be platinum sulfide. Elemental analysis of other areas showed a mixture of lanthanum, chromium,

platinum, sulfur, and chlorine. The presence of sulfur and chlorine is indicative of incomplete calcining when the catalyst was prepared.

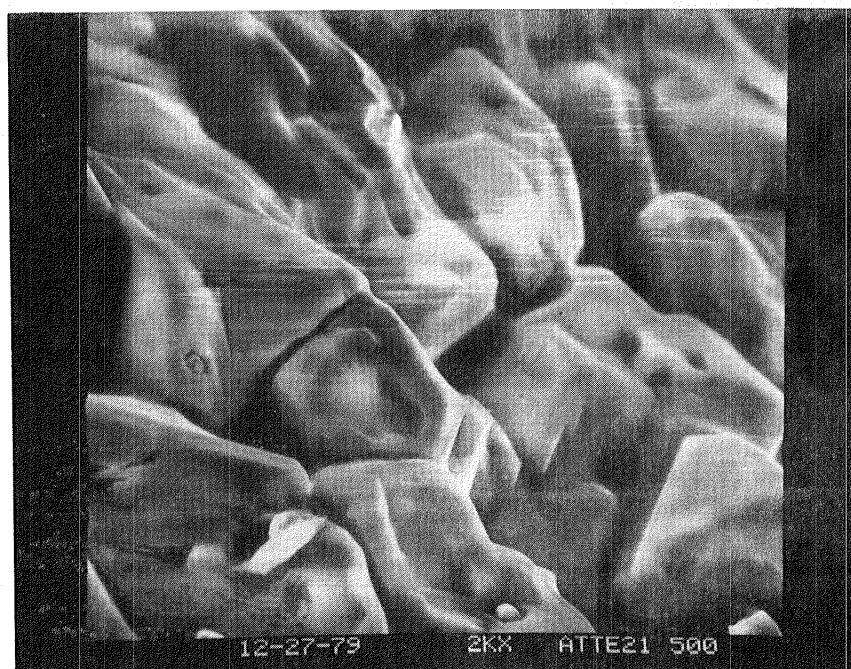
Figure 5-15. SEM Photograph, 2000X Magnification, Surface of ATT-E After 430 Hours of Aging (Purple Area)

The purple areas of the catalyst (figure 5-15) showed an irregular surface which, when analyzed, contained aluminum and chromium with small amounts of platinum and no lanthanum. The purple color was due to the formation of a chromia-alumina solid solution. The grey area of the catalyst (figure 5-16) showed the presence of chromium and lanthanum and considerable amounts of platinum. Shiny platinum particles covered much of the surface.

except for some bright purple areas. These and the more general grey background were examined by SEM and Kevex elemental analysis.

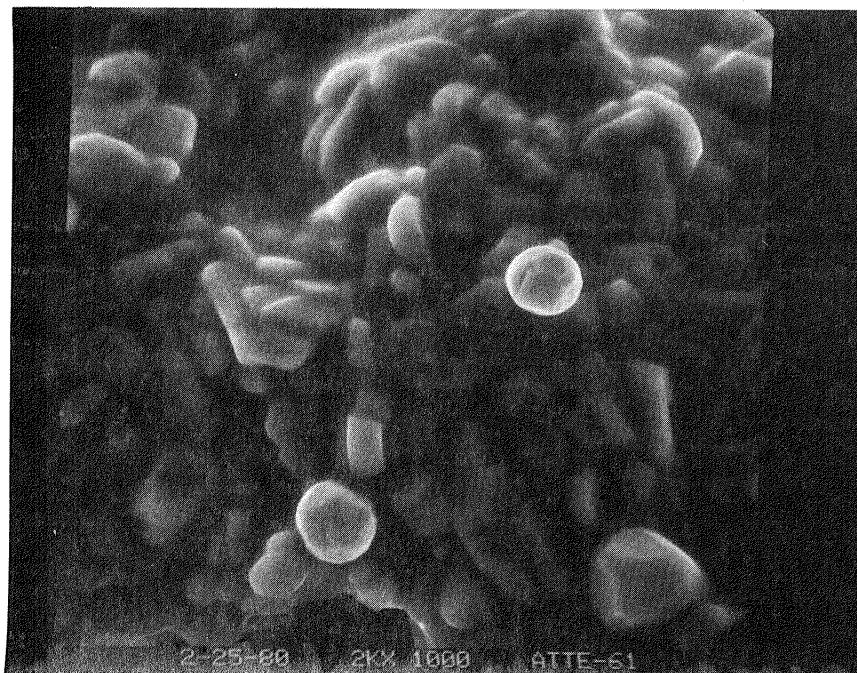
Figure 5-17. SEM Photograph, 2000X Magnification, Surface of ATT-E After 1000 Hours of Aging

After 1,000 hours, the surface was variegated in color. The "background" area was examined by SEM (figure 5-17), as was the "blue" area (figure 5-18). The background was deficient in platinum and chromium compared to the original, containing considerable amounts of glassy magnesia and silica impurities, and some platinum crystals.

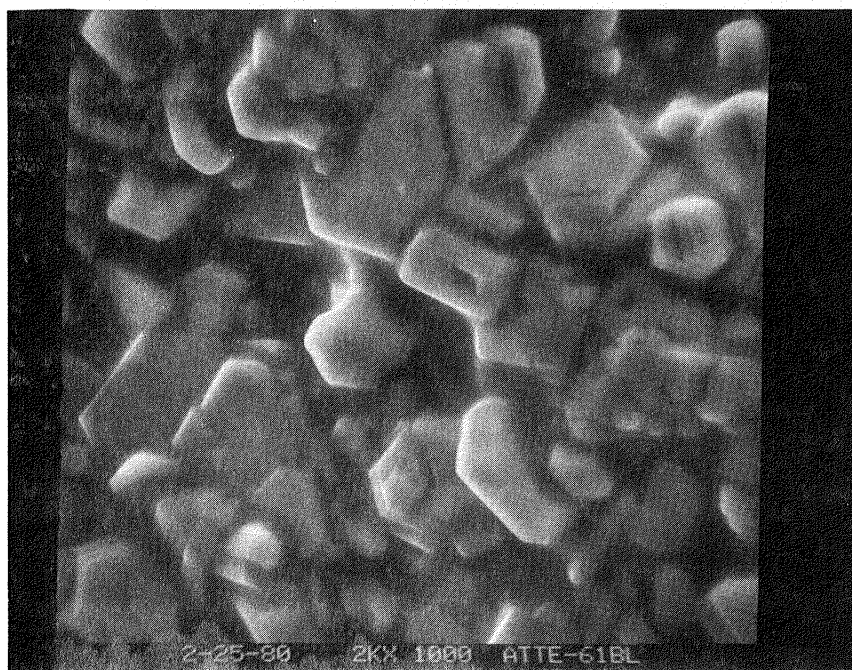
Figure 5-18. SEM Photograph, 2000X Magnification, Surface of ATT-E After 1000 Hours of Aging (Blue Area)

The blue area's surface had no platinum crystals, but contained iron, nickel, and thoria as impurities. The surface consisted of crystals of alumina and lanthanum in a glassy matrix.
