Development of a High-Temperature Durable Catalyst for Use in Catalytic Combustors for Advanced Automotive Gas Turbine Engines

H. Tong, G. C. Snow, E. K. Chu, R. L. S. Chang,
M. J. Angwin, and S. L. Pessagno
Energy & Environmental Division
Acurex Corporation

September 1981

Prepared for
NATIONAL AERONAUTICS AND SPACE ADMINISTRATION
Lewis Research Center
Under Contract DEN 3-83

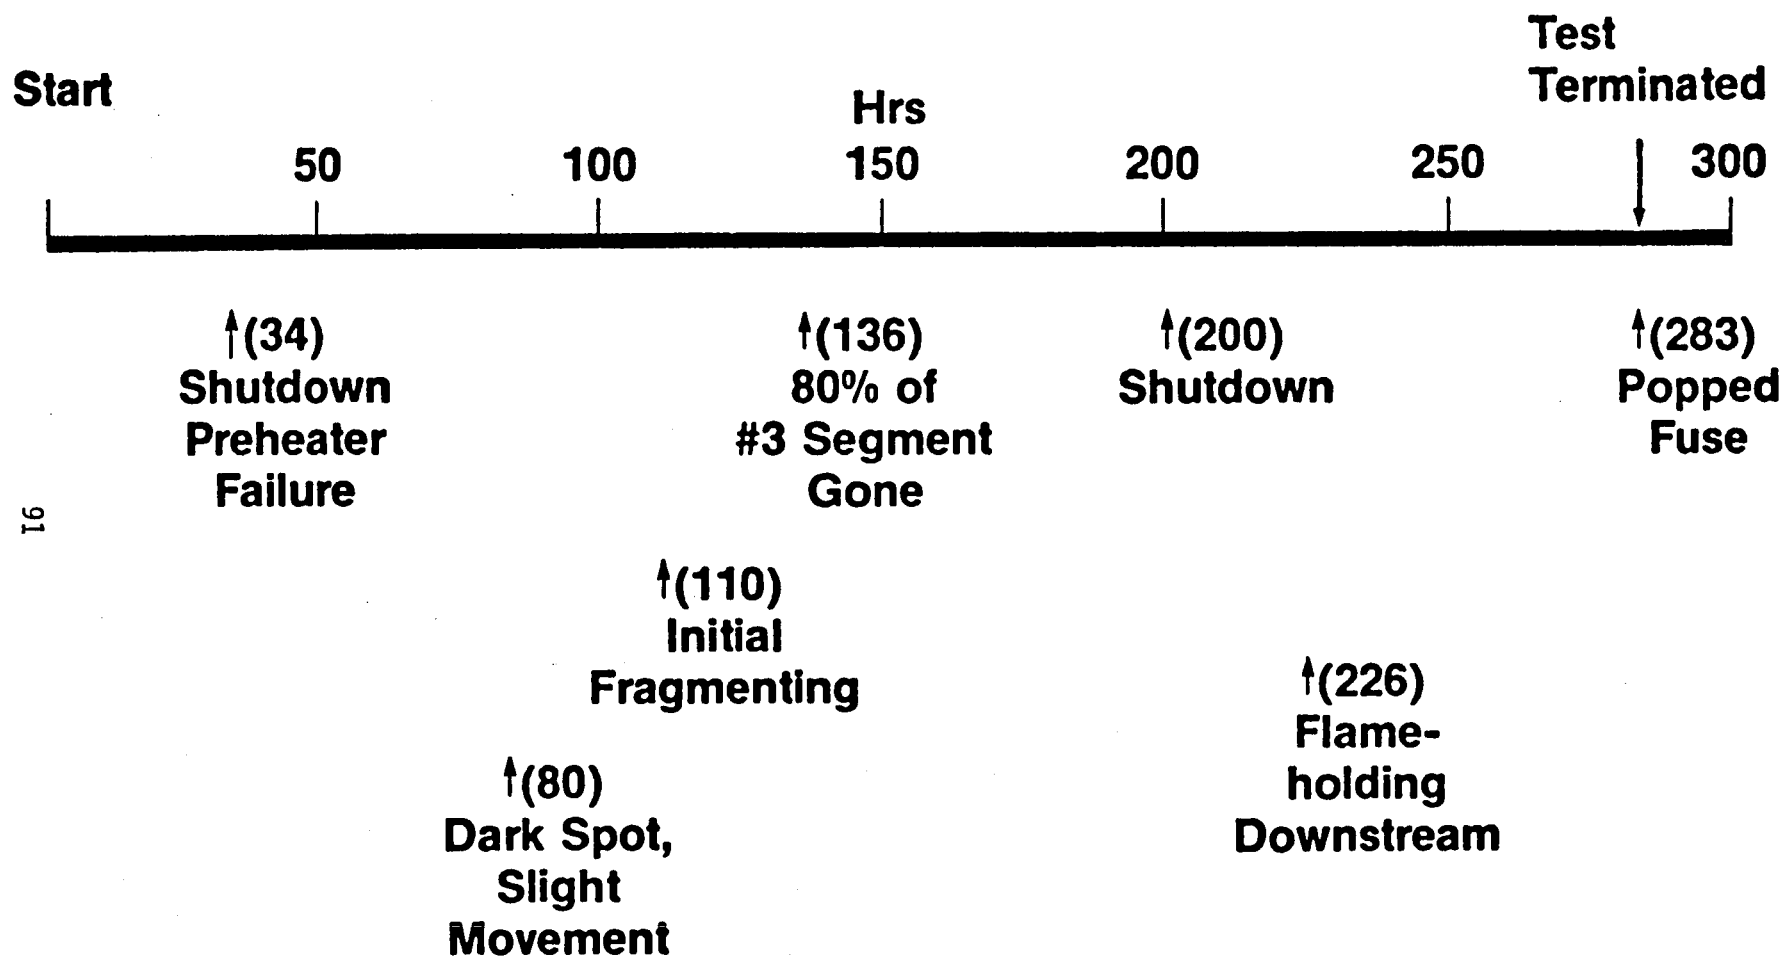
Figure 6-1. Combustion Durability Test

was, however, unchanged; that is, the emissions remained low. Small pieces of this catalyst element continued to fall out for the next 90 hours. At hour 136, about 80 percent of the third element had fallen out. By about hour 200, essentially all of the third element had fallen out and the reactor was reduced to two elements (5.0 cm). Also at about hour 200, a faulty alarm indication caused an automatic shutdown of the fuel flow to the facility. The faulty transducer was overridden, the facility restarted, and testing continued.

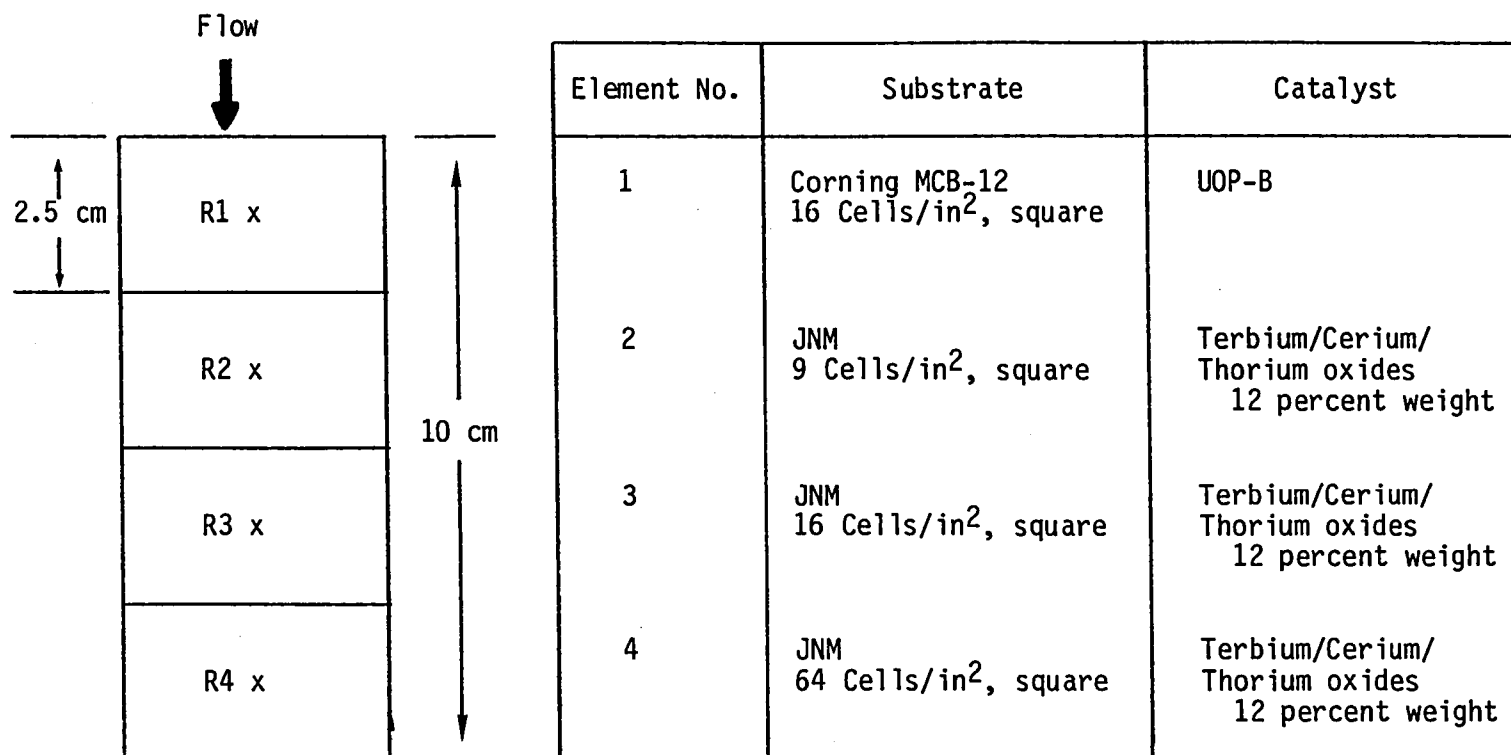
Figure 7-1. Phase II Durability Reactor Description

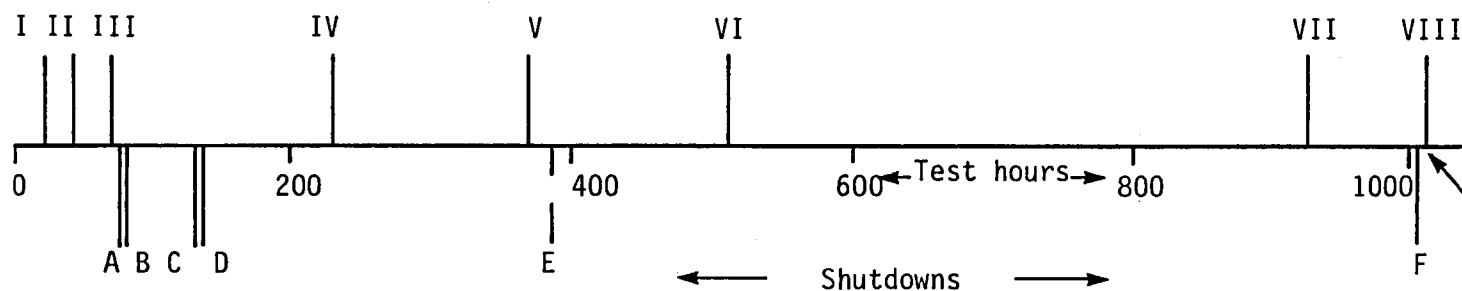
Figure 7-2. Phase II 1000-Hour Durability Event Chart

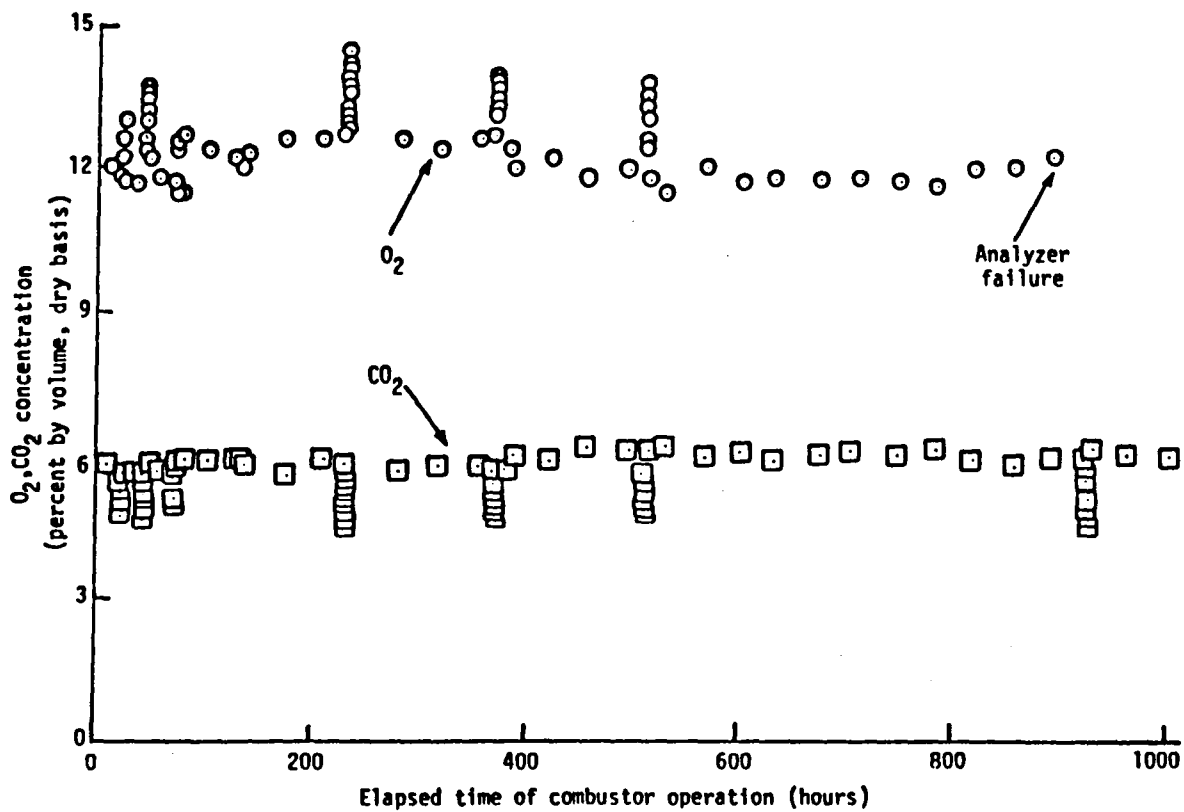
Figure 7-3. Phase II Durability Test O₂ and CO₂ Emission Levels

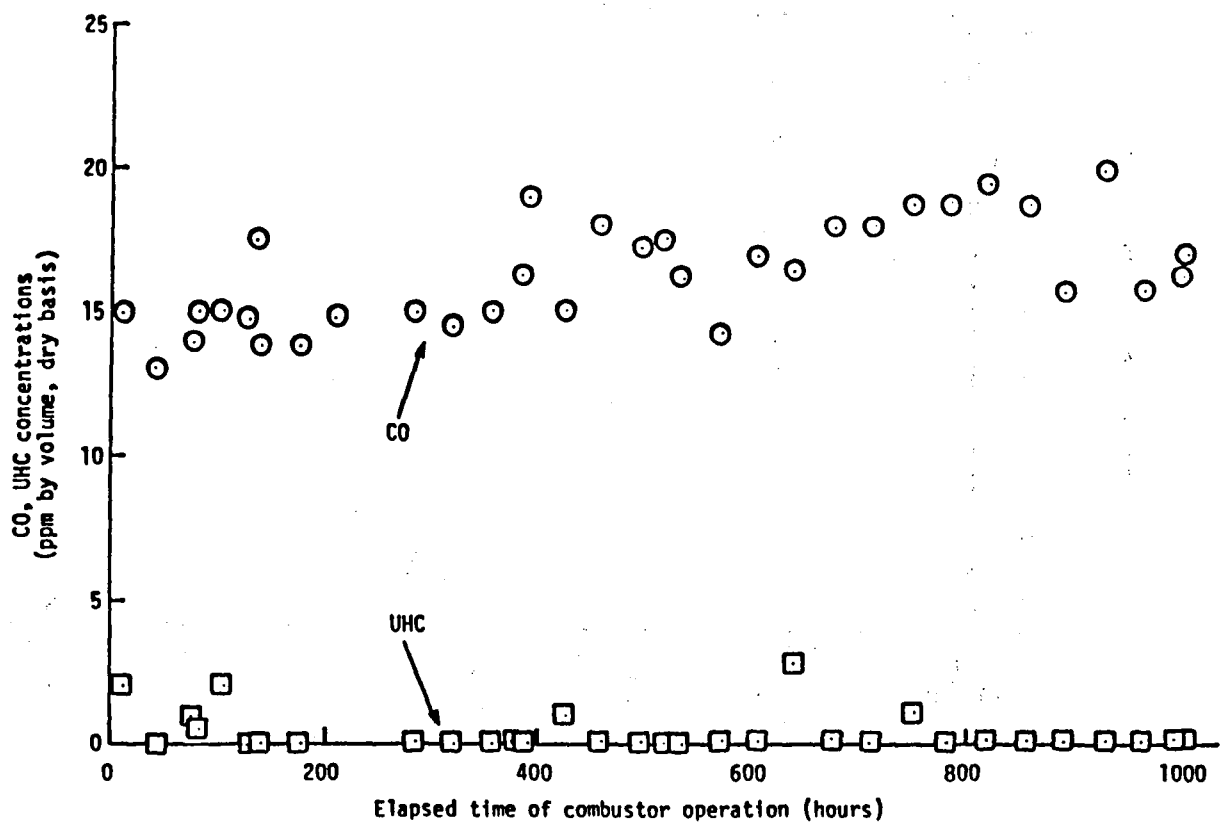
Figure 7-4. Phase II Durability Test CO and UHC Emission Levels

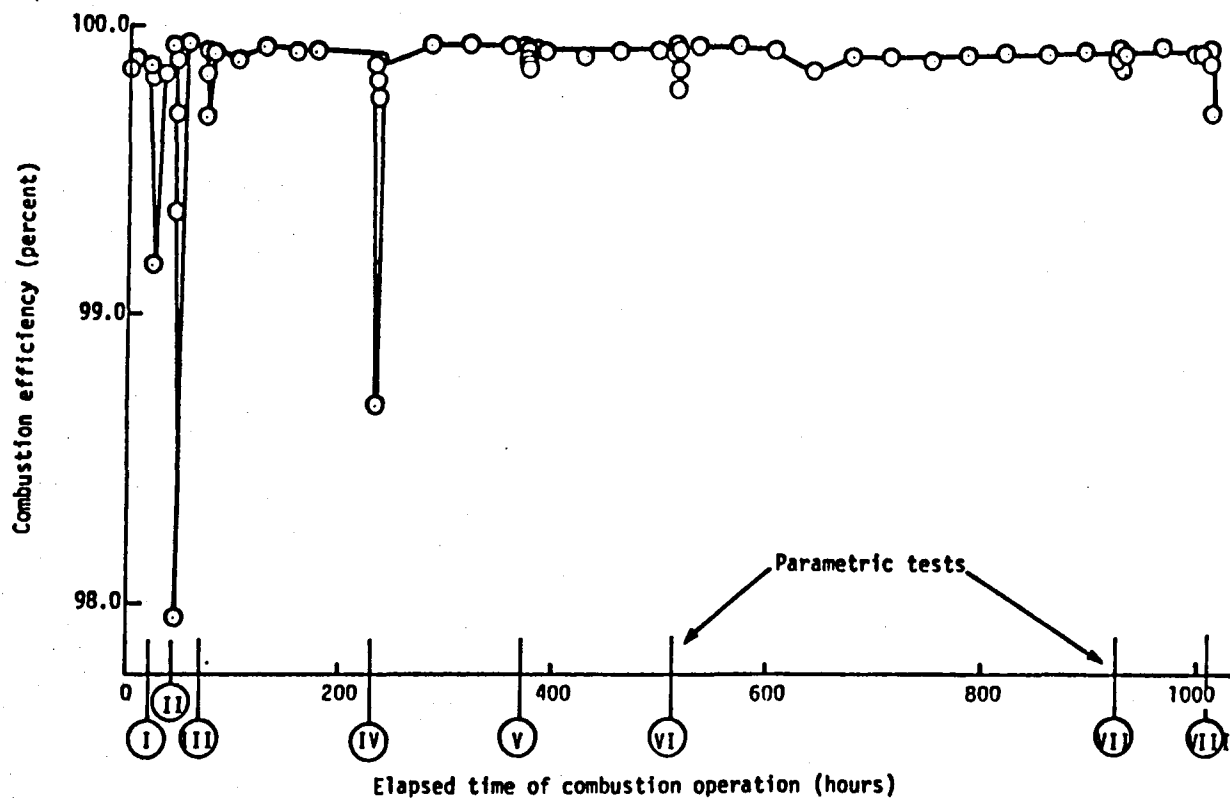
Figure 7-5. Phase II Durability Test Combustion Efficiency Performance

In spite of the slight carbon monoxide increase, figure 7-5 shows that the calculated combustion efficiency remained high throughout the durability tests. The only major influence on combustion efficiency was the parametric tests.

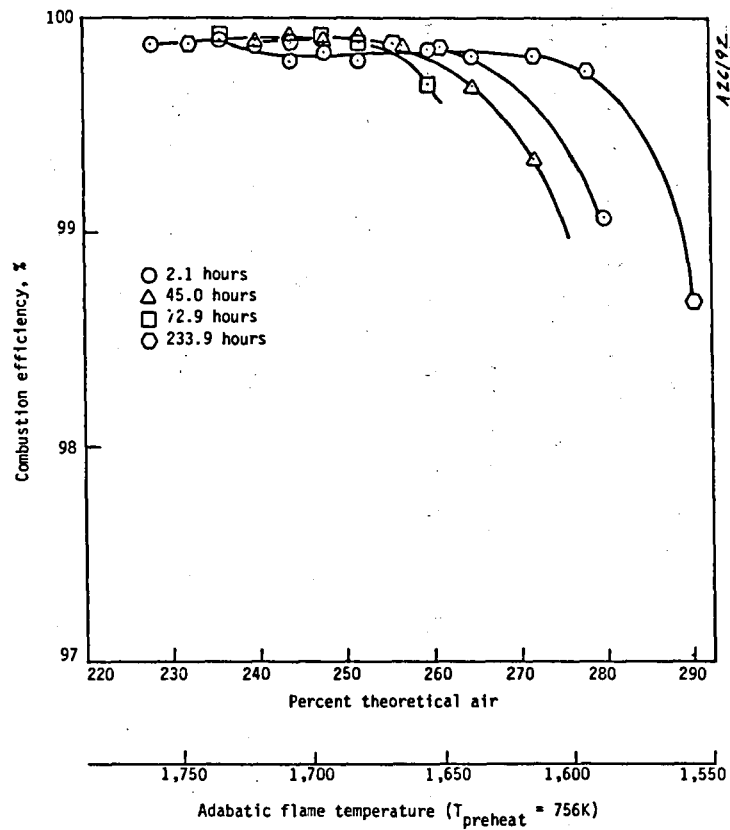
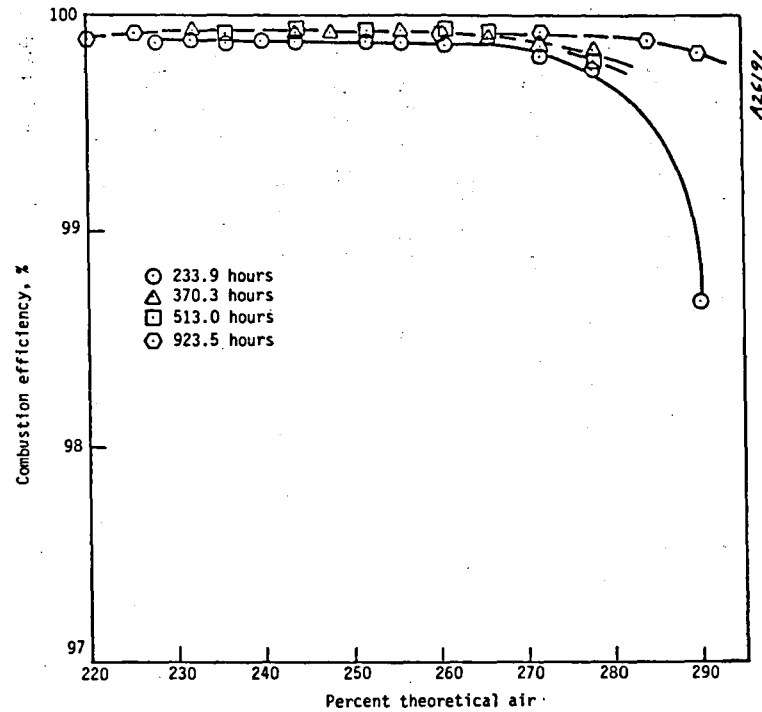
Figure 7-6. Parametric Test -- Effect of Turndown on Combustion Efficiency

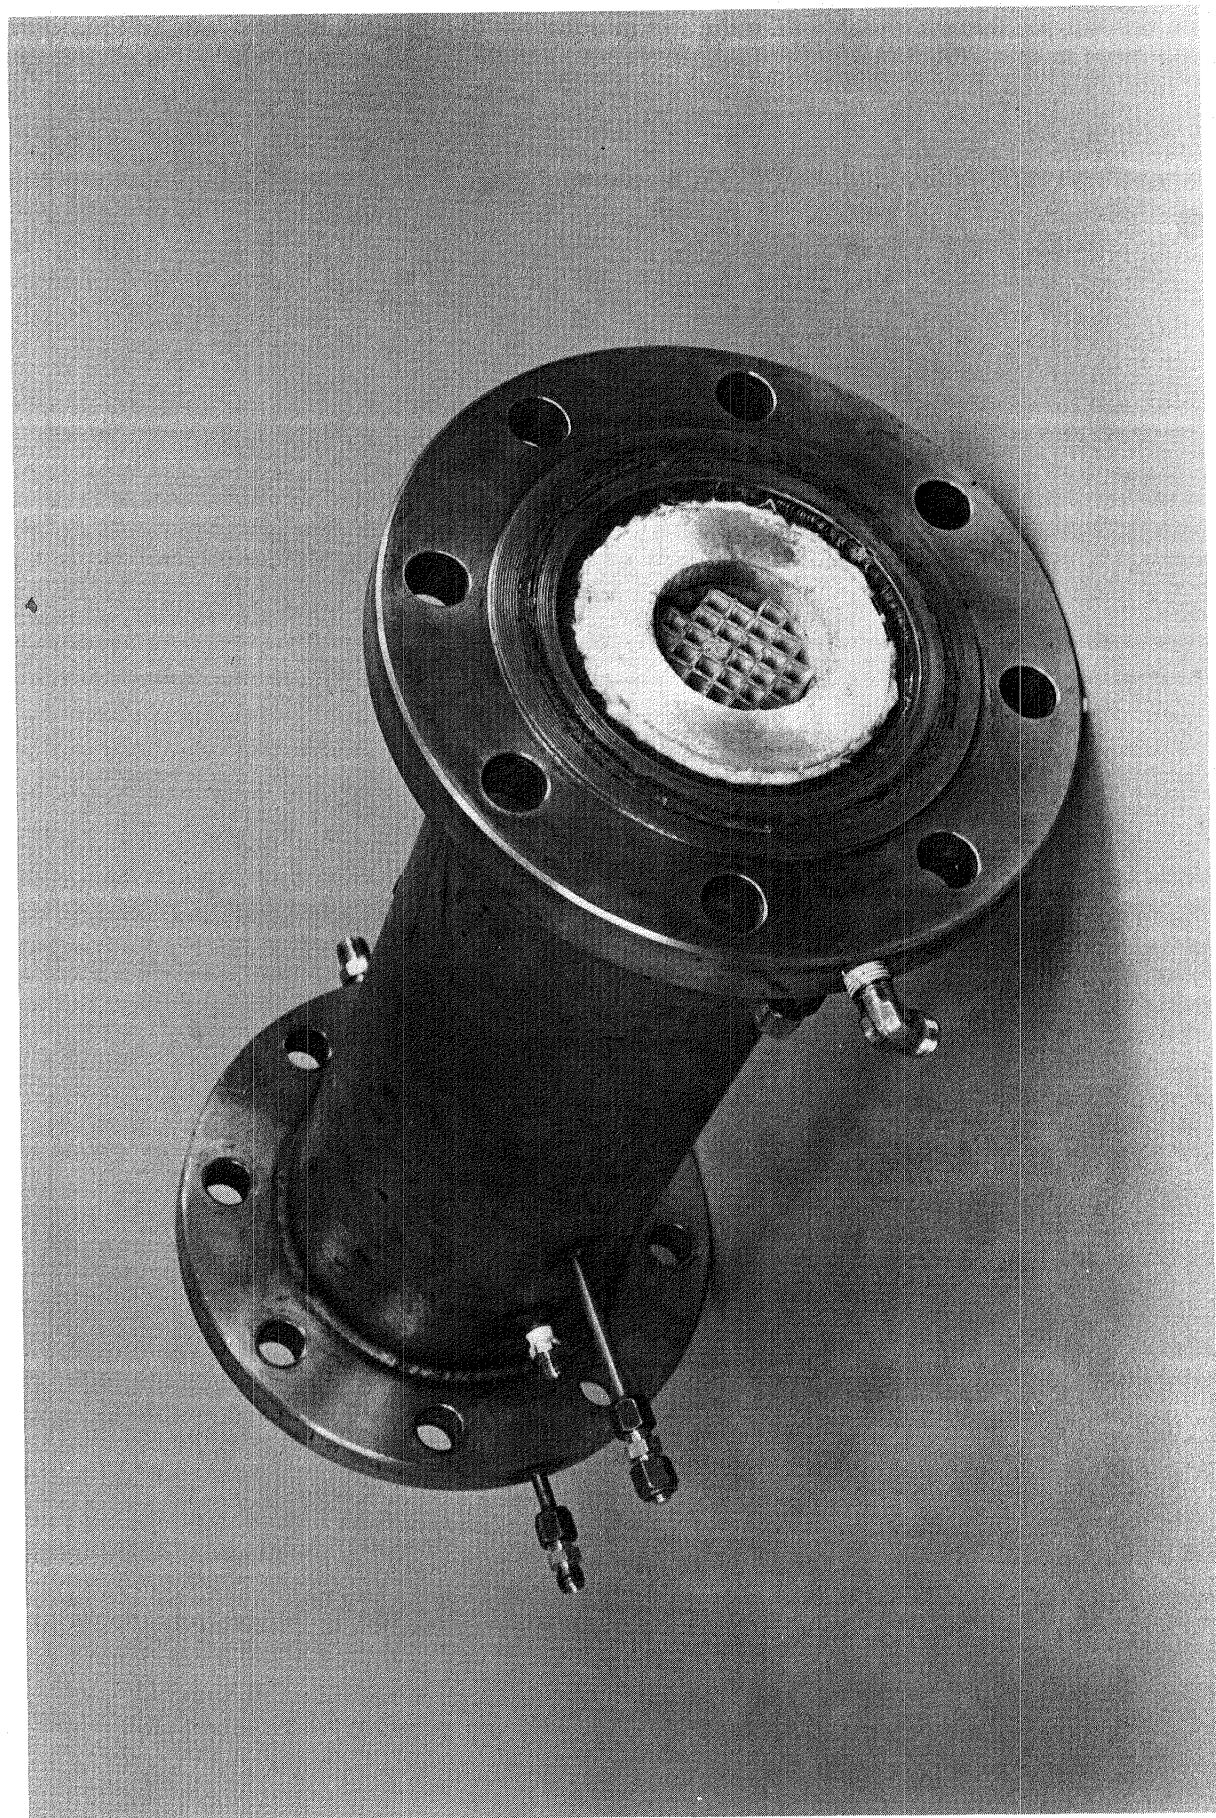
Figure 7-7. Noble Metal Element of Durability Reactor (Posttest)

Following the combustion durability test, the reactor was removed for inspection. The surface appeared much lighter in color, indicating a probable loss of catalyst coating. Structurally, the monolith had distorted slightly and fused to the refractory holder, but major cracks, loss of substrate, or other damage had not occurred. Photographs of the noble metal lead element and the metal oxide exit segment in the refractory holder are shown in figures 7-7 and 7-8 respectively.

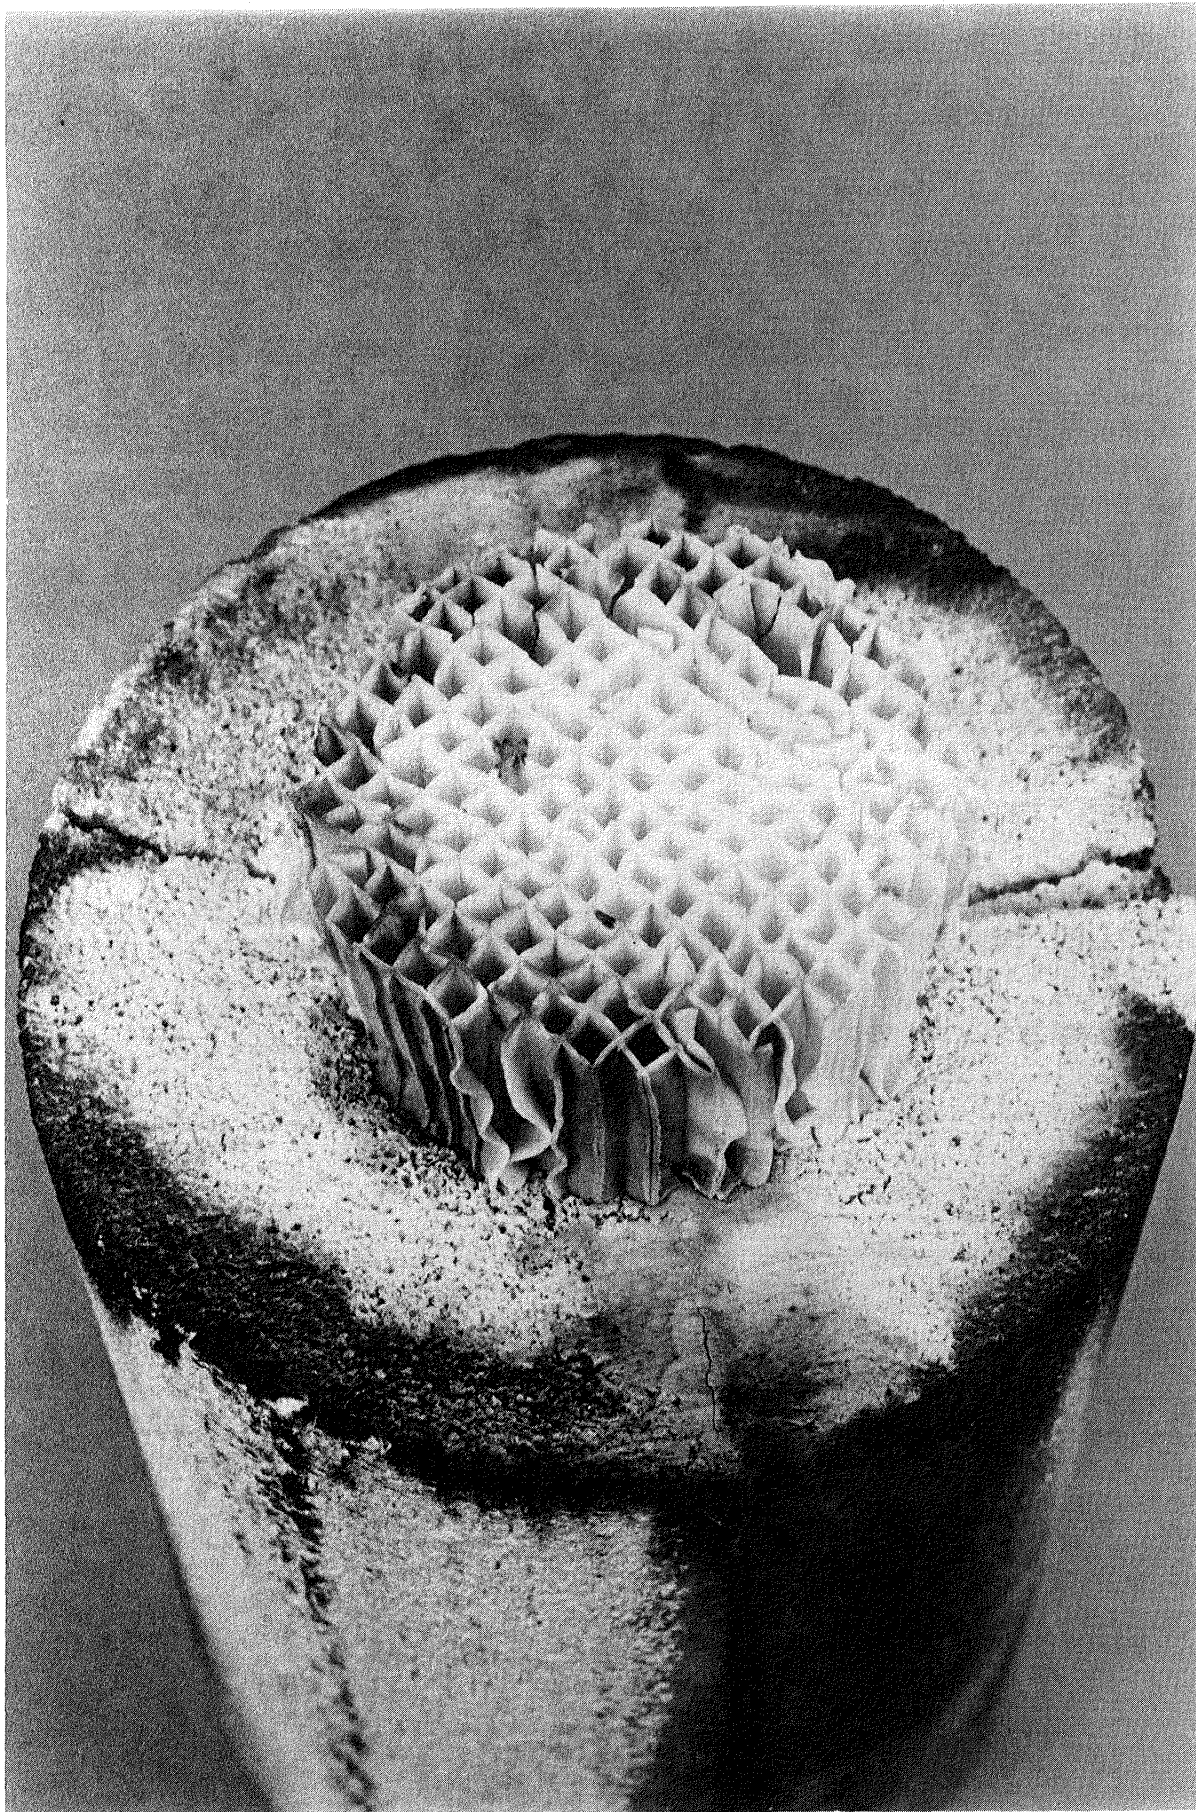
Figure 7-8. Metal Oxide Element of Durability Reactor (Posttest)

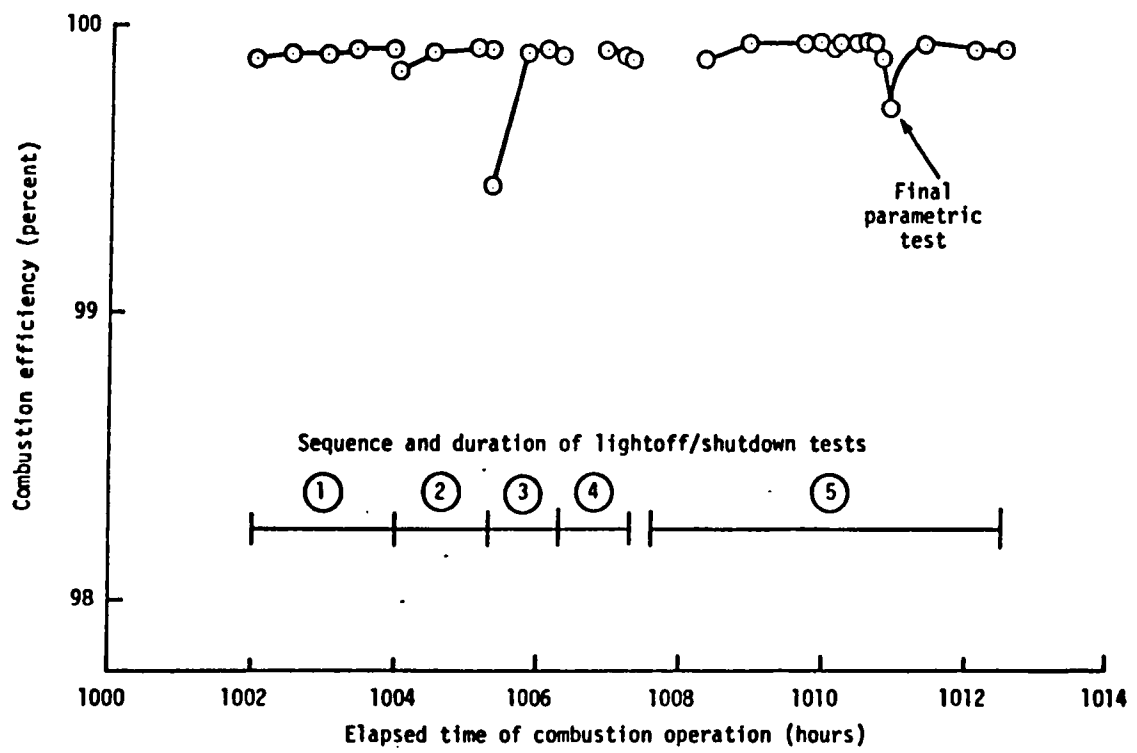
Figure 7-9. Thermal Cycling Performance

In similar combustion tests conducted at the NASA Lewis Research Center (reference 14), stable combustion conditions were more difficult to achieve with propane than with diesel fuel. The difficulties encountered in the current test program therefore suggest that the vaporization of the diesel fuel was probably incomplete. An alternate, though less significant problem, may be the uniformity of the fuel-air mixture at the front face of the reactor. A final inspection of the disassembled reactor revealed no further damage or change due to the cycling tests.

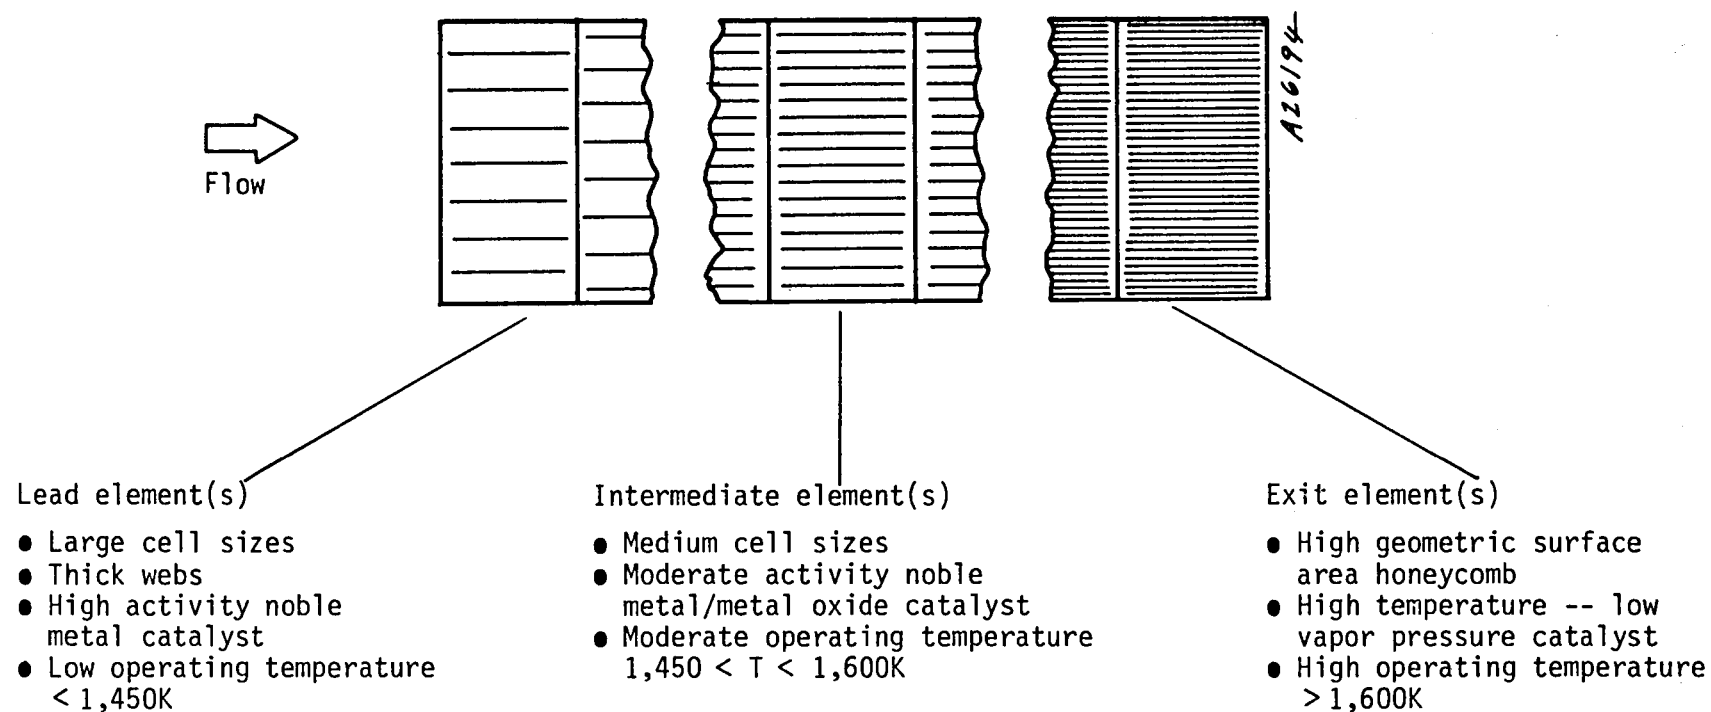
Figure 8-1. Proposed Durable High Temperature Catalytic Reactor Concept

A durable graded-cell, graded-catalyst reactor for high-temperature combustors would be designed as shown in figure 8-1. The lead element would be a large cell, thick web honeycomb with a very active noble metal catalyst. The cell size, web thickness, and element length would be selected such that the energy balance would result in a mean element temperature between 1,250K and 1,450K. At these temperatures a noble metal catalyst would have a reasonably long life. The high catalytic activity of the noble metal and the lower transfer coefficients on the thick web honeycomb would promote stable combustion conditions. The downstream honeycomb elements would be a fine cell structure with a high geometric surface area to encourage rapid heating of the gas phase. This will result in significant gas phase reactions which, in turn, result in high combustion efficiency and low CO emissions. Since these elements operate at high temperatures (near adiabatic conditions) even moderate to low activity catalysts would be sufficient to maintain diffusion limited surface reaction rates. In this zone of the catalytic reactor, catalyst durability is more important than high catalytic activity. Therefore, the

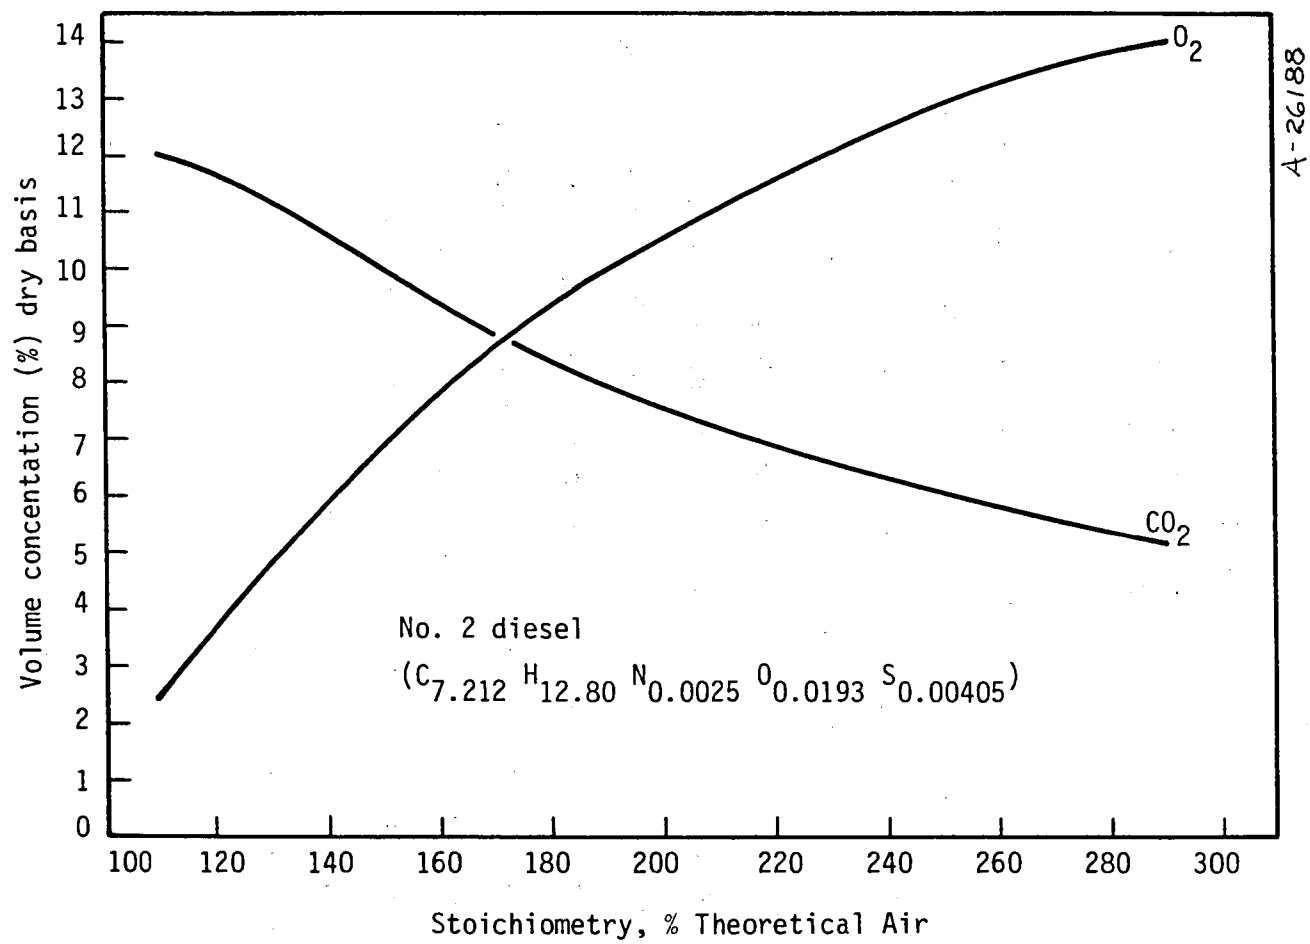
Figure A-1. CO₂ and O₂ Emissions for Diesel/Air Combustion at 1 atm pressure and 900°F Air Preheat

In the measurement of exhaust gas concentrations in the Acurex Catalytic Combustion Test Facility, the CO₂ measurement is more accurate than the O₂ measurement. The stoichiometry and adiabatic flame temperatures based on emissions as shown in tables 7-2 through 7-5 were therefore determined with the CO₂ concentration. The O₂ concentrations were used only as qualitative checks.

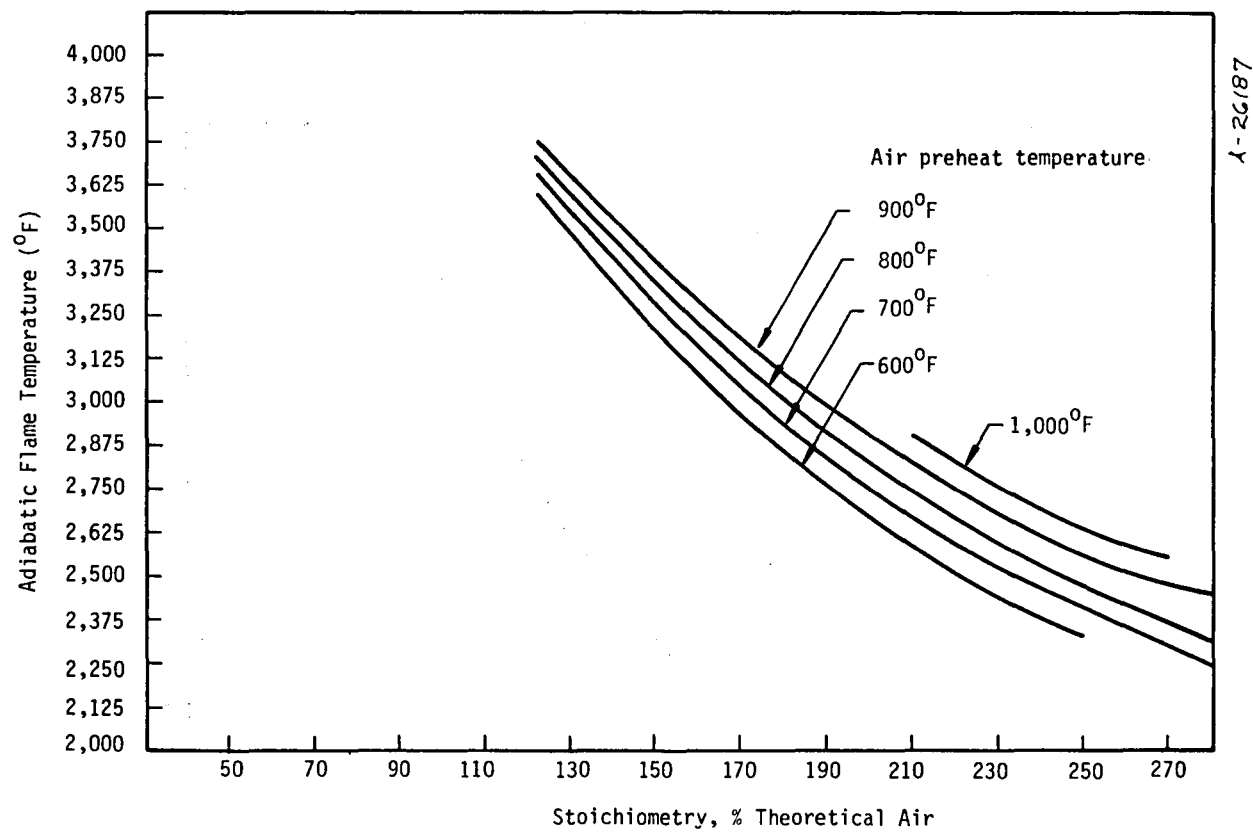
Figure A-2. Adiabatic Flame Temperature for Diesel/Air Combustion at 1 atm Pressure

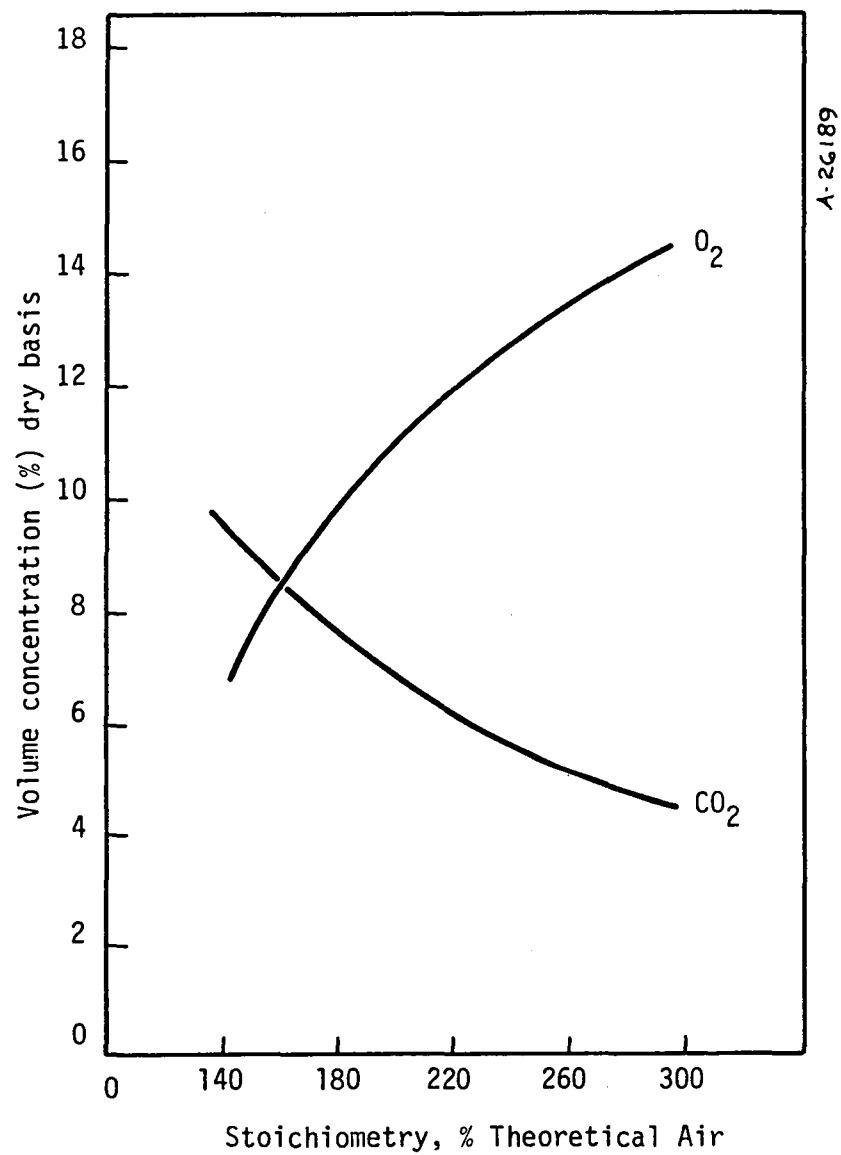
Figure A-3. CO₂ and O₂ Emissions for Propane/Air Combustion at 1 atm Pressure and 700°F Air Preheat

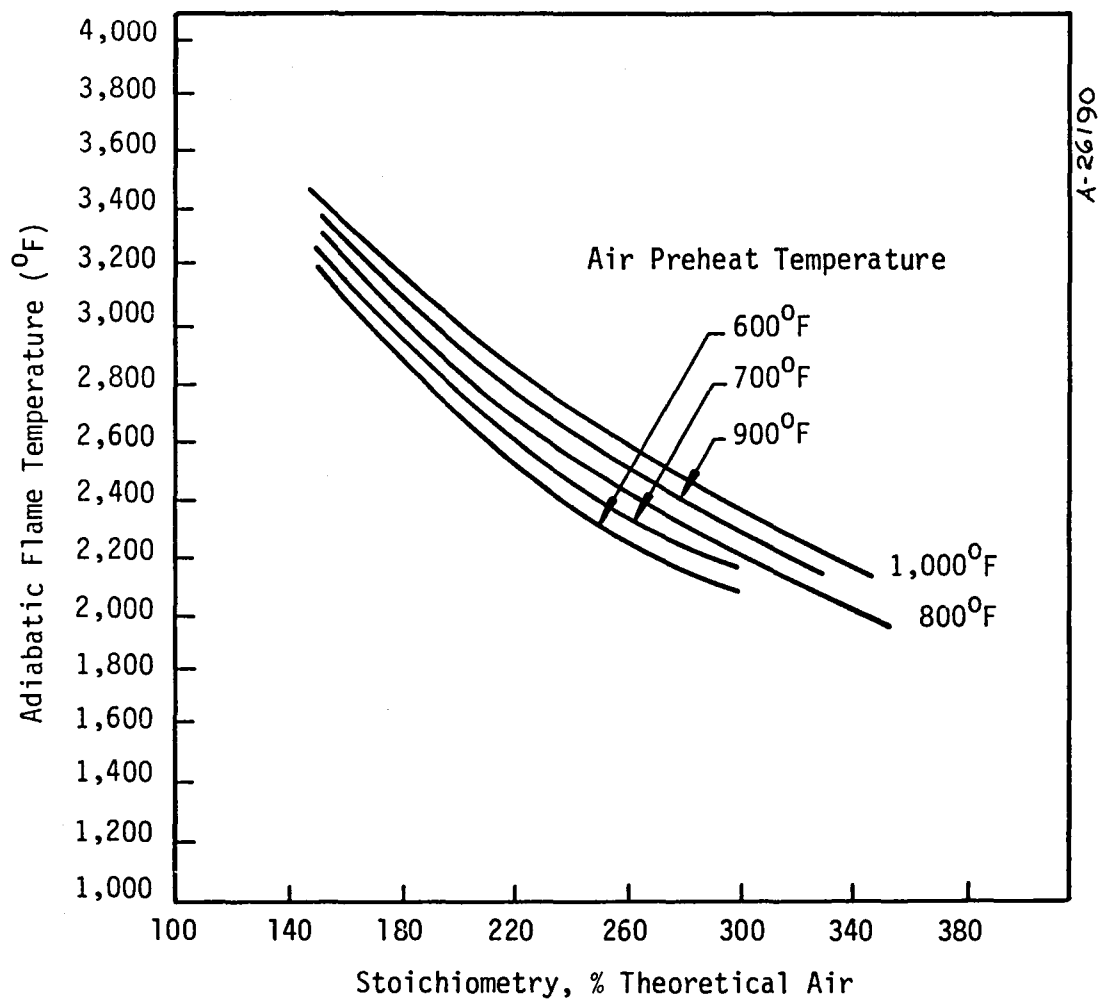
Figure A-4. Adiabatic Flame Temperature for Propane/Air Combustion at 1 atm Pressure
