Evaluation of Lightning Accommodation Systems for Wind- Driven Turbine Rotors

H. Bankaitis
National Aeronautics and Space Administration
Lewis Research Center

March 1982

Prepared for
U.S. DEPARTMENT OF ENERGY
Conservation and Renewable Energy
Division of Wind Energy Systems

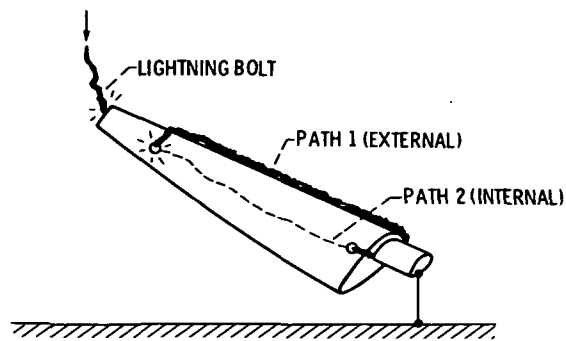
Figure 4. - External charge transfer and internal streamering.

The lightning accommodation system concepts for use with composite-structural-material blades were based on the objectives of preventing the lightning strike's electrical components and the accompanying energies from penetrating the composite material structure and also preventing any internal streamering, as illustrated schematically in figure 4.

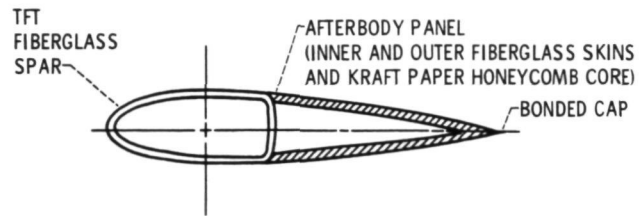
Figure 6. - Kaman test specimen.

In general the test samples representative of the two types of composite structural materials consisted of a full-scale chordwise dimension of the rotor blade and 4.6- to 6.1-m span with appropriate simulation of the steel hub adapter at the root end. The test sample representative of the epoxy-fiberglass materials was manufactured by Kaman Aerospace and is illustrated in figure 6. The test sample was a 4.6-m-span rotor blade section consisting of an all-fiberglass D-spar, an afterbody of fiberglass-faced-paper honeycomb panels, and a steel hub adapter installed at the inboard end of the spar. The wall thickness of the hollow D-spar was approximately 2.5 cm, and the afterbody panels consisted of 5-cm-thick honeycomb core panels with 15-mm-thick epoxy-fiberglass skins. There were no metal parts inside the test sample. However, the sample was stored and then transported from Connecticut to the Florida test site unprotected from environment and as a result was thoroughly soaked by rain. It was used in the "as is" condition during the initial 27 exposures in the high-voltage, long-arc tests.

This series of tests were conducted by Lightning and Transients Research Institute on the Kaman Aerospace sample illustrated in figure 6 and described in the section TEST SAMPLES.

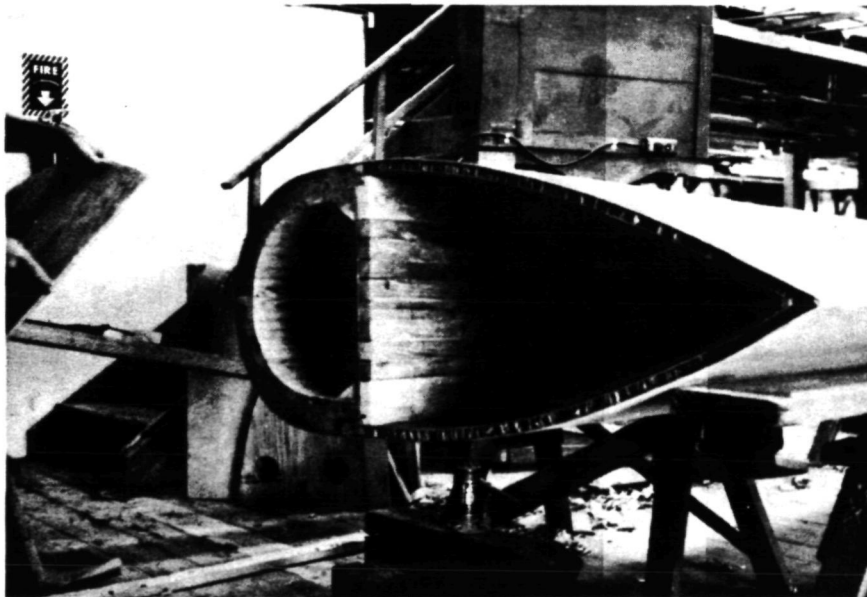
Figure 7. - Cross section of Gougeon Bros. test specimen.

The test sample representative of the wood-epoxy composite structural material is shown in figure 7. The sample was a 6-m span with an all-wood laminate D-spar and plywood-sandwiched 5.1-cm-thick honeycomb core tail panels. The wood laminate D-spar was approximately 3.8 cm thick. The outer surface of the sample was covered with 0.13-mm-thick epoxy-soaked fiberglass cloth. An aluminum rod approximately 1.8 m long was installed along the inside of the leading edge of the D-spar to simulate internal wiring or other metallic components. This rod was retained in the test specimen throughout the test sequence. For the high-current damage test a 61-cm by 61-cm square plywood Nomex sandwich panel, as illustrated in figure 8 was used. Aluminum screen was bonded under a 0.13-mm-thick layer of fiberglass cloth.

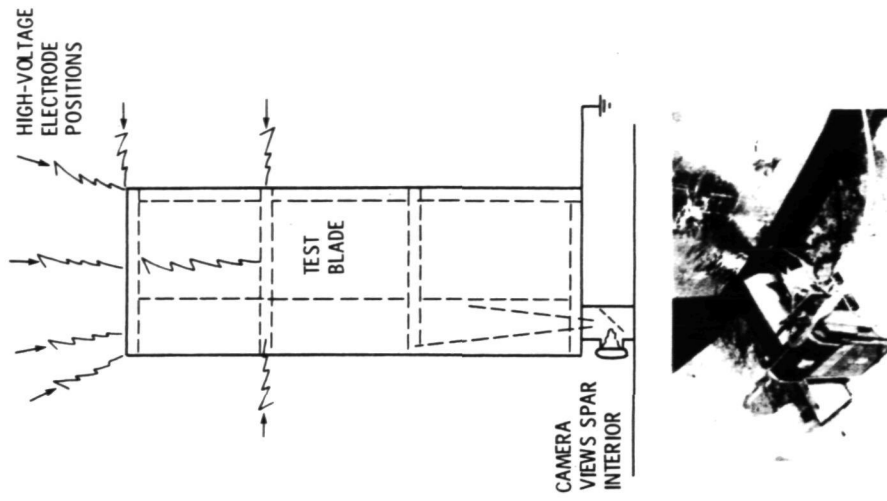
Figure 9. - Kaman's test specimen arrangement for high-voltage, long-arc tests, with camera for viewing spar interior shown removed from spar. (From ref. 3.)

interior by a camera through a mirror, as illustrated in figure 9. The test sequence is illustrated in the individual photographs in figures 10 to 16. These initial strikes did puncture the tip and penetrate the blade interior as shown in figures 10(a) and (b). Additional strikes imparted on the test sample at various locations on the tip exhibited stitching in and out through the aft panels from tip to root. These are illustrated in figure 11.

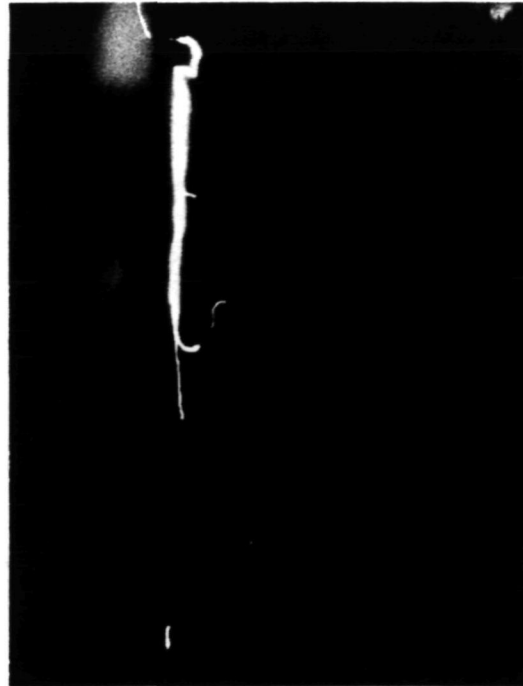
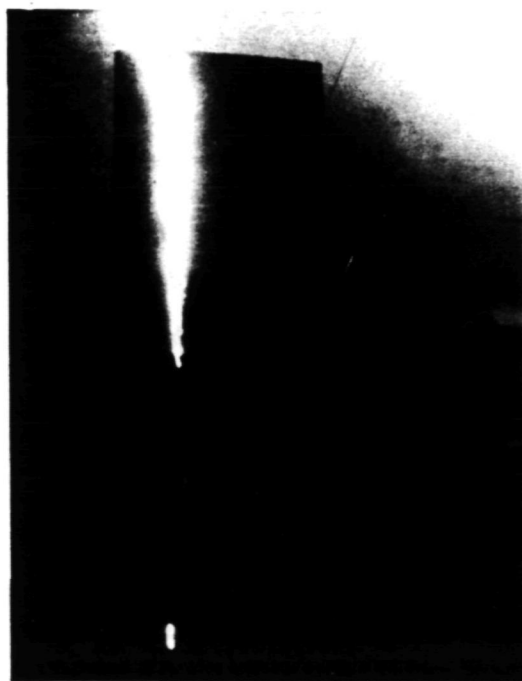
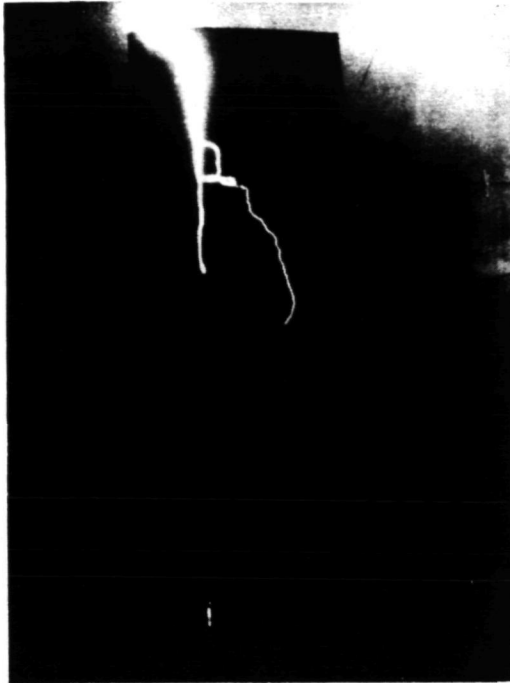
(a) Attachment at tip.

(b) Attachment at tip cap with external surface flashover and some stitching.

(c) Attachment at tip with external surface flashover.

(d) Attachment at tip with external surface flashover followed by stitching and resurfacing.

Figure 11. - Long-arc attachment test series on Kaman specimen, (From ref. 3.).

(e) Attachment at tip with external surface flashover and internal stitching (streamering).

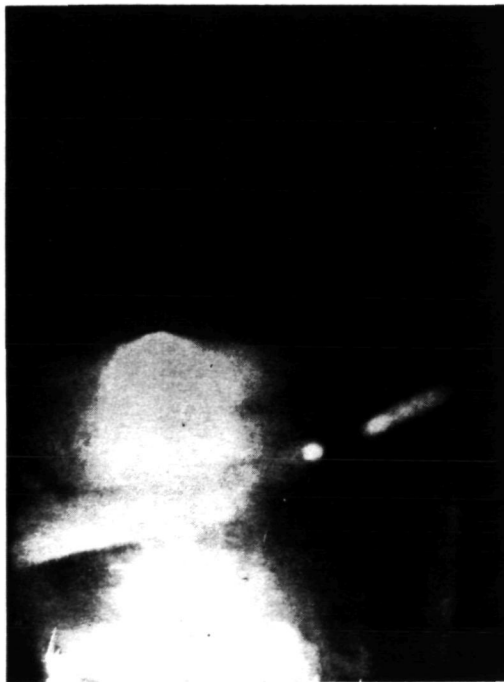
Figure 12. - Internal camera record of streamering in Kaman specimen. (From ref. 3.)

Partial penetration through the interior of the trailing-edge box is shown in figure 12. Had these discharges been high-current natural lightning strikes, catastrophic structural damage would most likely have ensued. Thus a lightning accommodation system is required for this particular type of rotor blade structure.

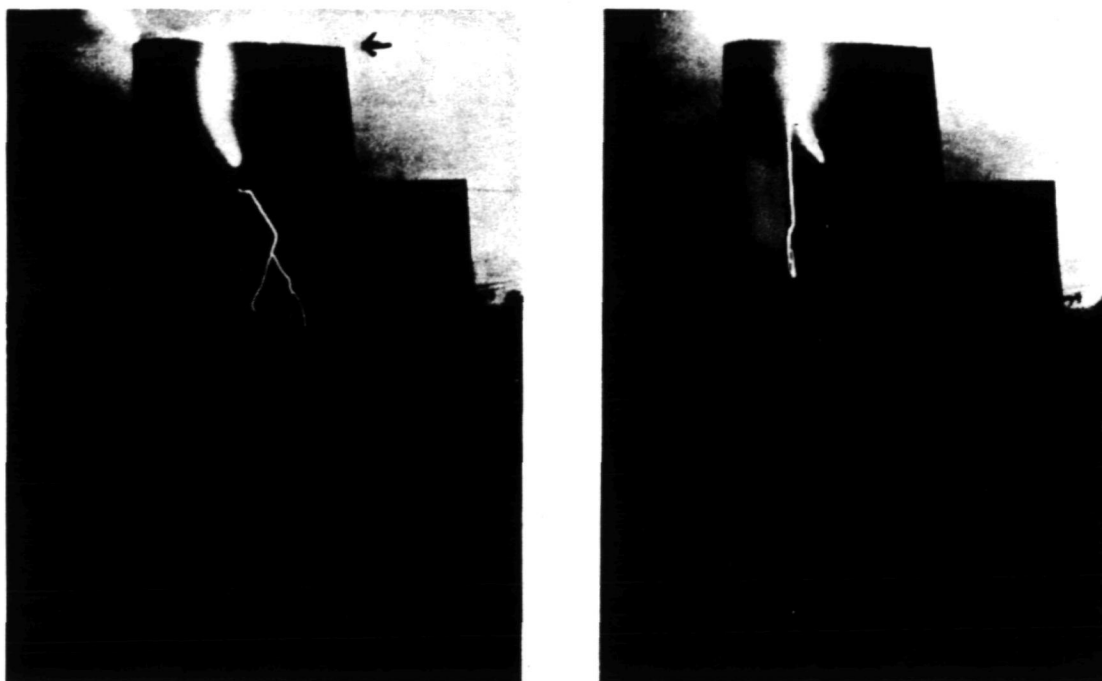
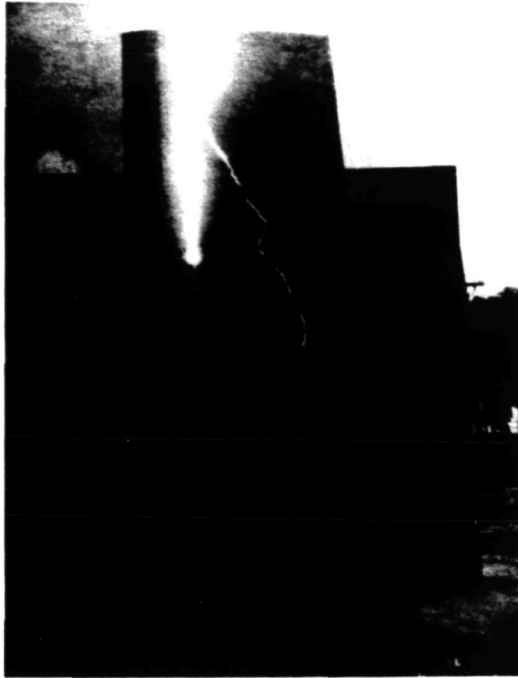
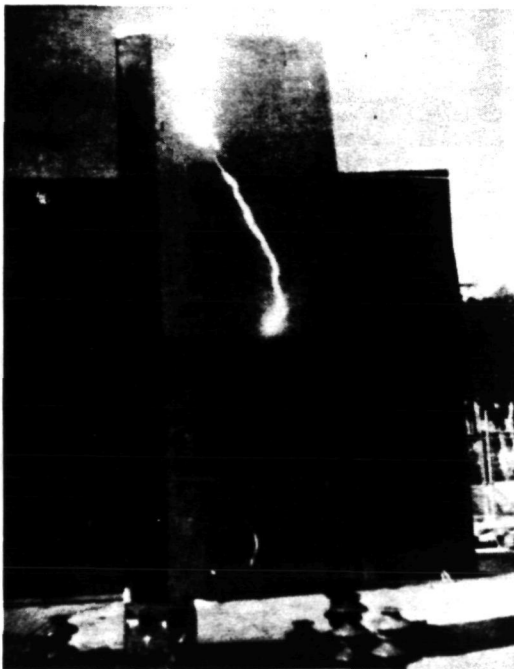
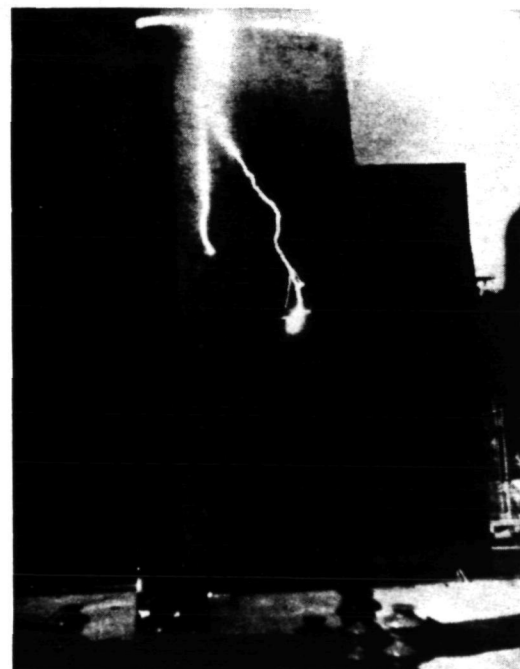
(a) Attachment on cap surface with flashover and some stitching.

Figure 13. - Long-arc attachment test series on Kaman specimen with metal tip cap. (From ref. 3.)

(b) Attachment on cap surface with external flashovers to metal base.

A full-chord metal cap was simulated by adding aluminum foil to form a 7.6-cm skirt inboard of the tip of the blade and was submitted to the high-voltage discharge. The discharge struck the foil cap and propagated over the exterior path along the afterbody. Moreover, it eventually penetrated the afterbody in areas away from the blade tip, as shown in figure 13.

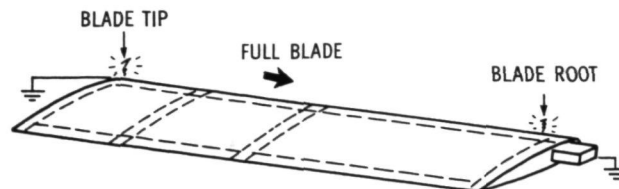
Figure 17. - Kaman test specimen arrangement for high-current damage tests. (From ref. 3.)

The test specimen with the aluminum foil placement, shown in figure 17, was repositioned horizontally for high-current damage tests. The objectives of this series of tests were to determine the capability of the potential lightning accommodation system (fig. 17) to sustain the 200-kA lightning current and, more importantly, to determine whether the discharge would be dissipated along the conductive paths without causing damage to the composite structure.

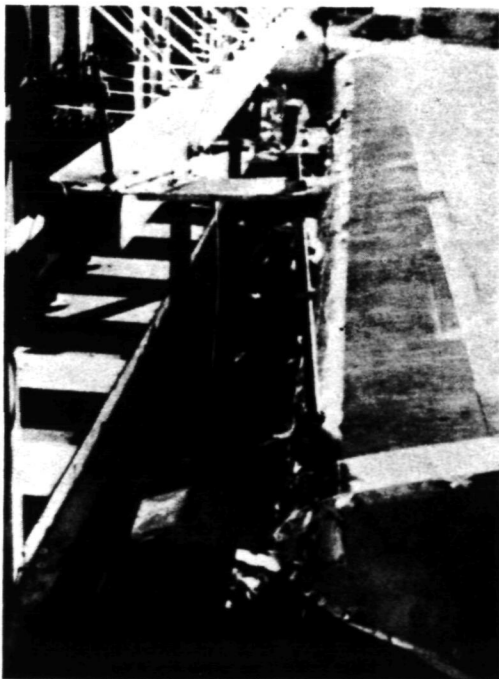
(a) Leading edge.

(b) Hub area.

(c) Tip leading edge - full blade.

(d) Atop of leading edge.

Figure 19. - Foil damage as result of high-current tests. (From ref. 3.)

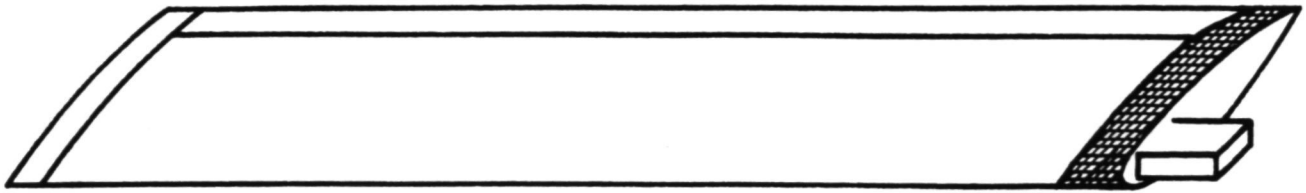
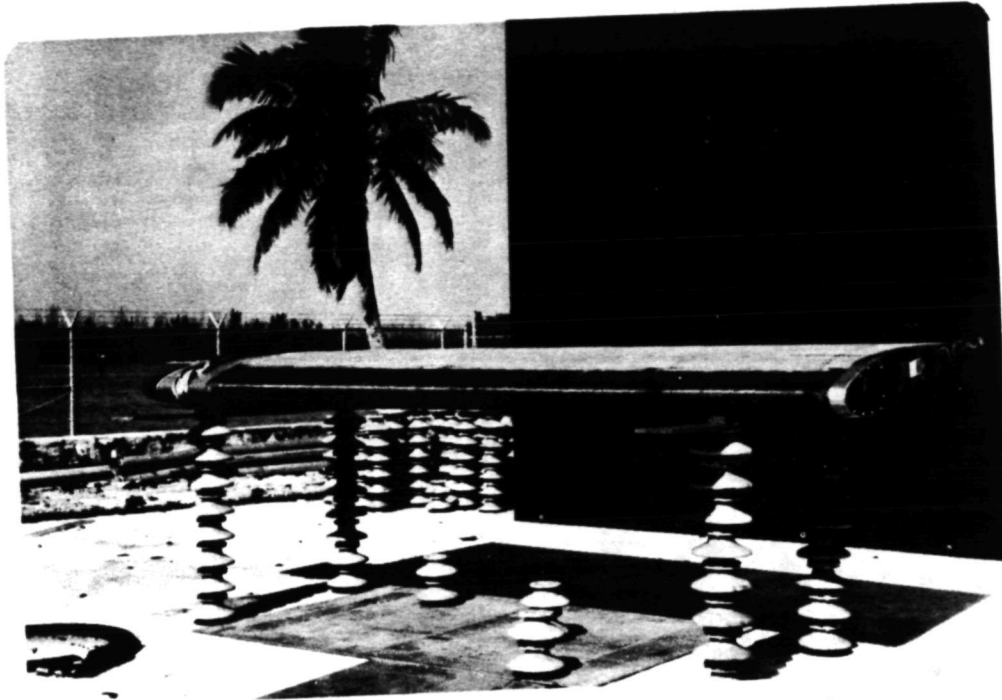
Figure 20. - Lightning accommodation system concept for Kaman blade design.

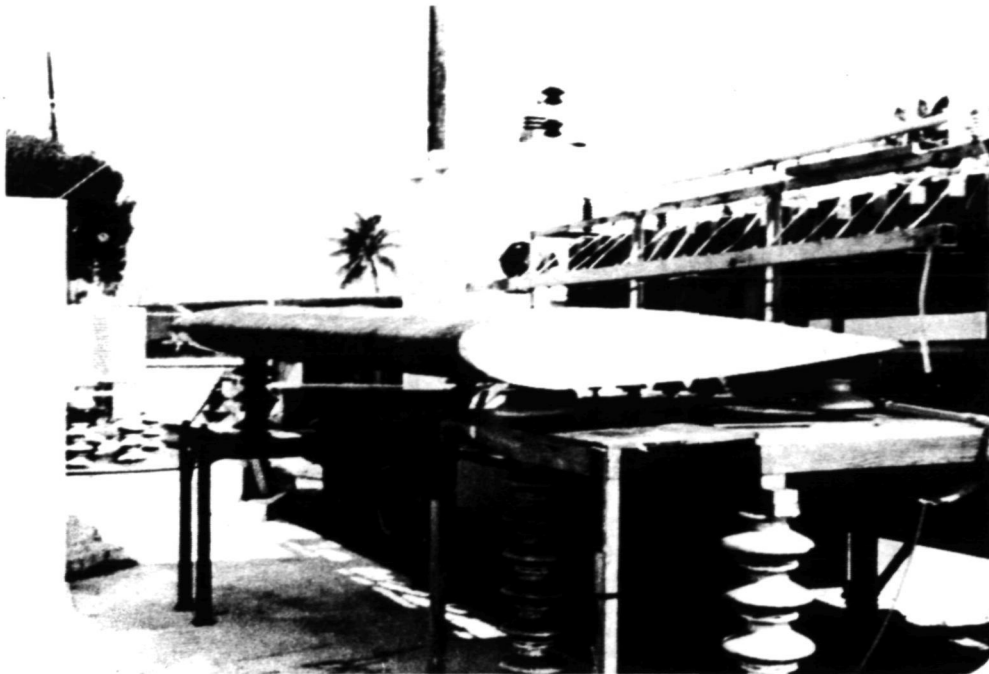
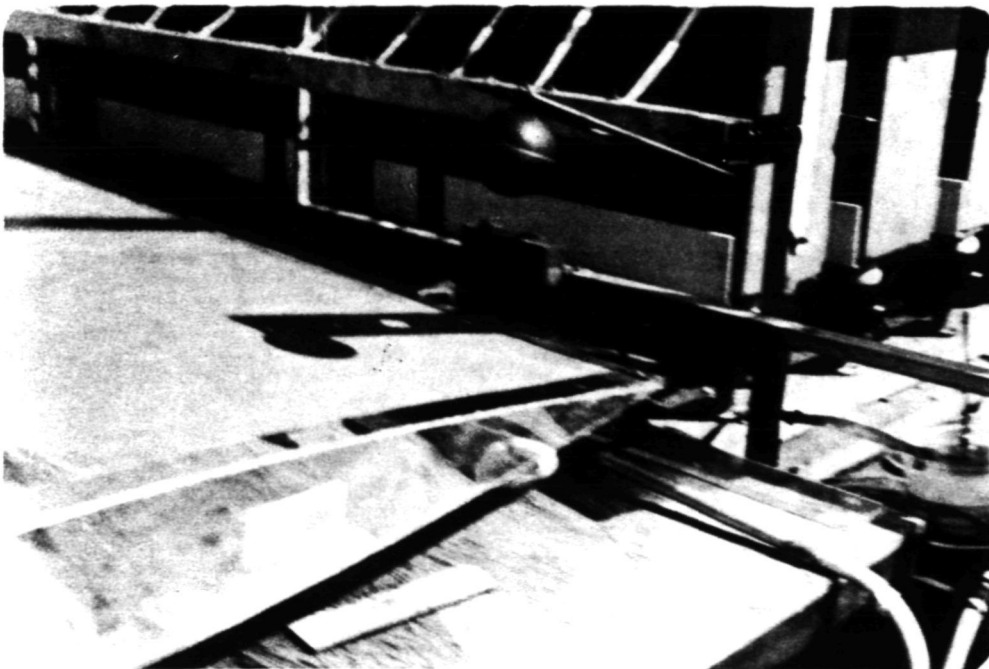
(a) Overall view.

(b) Closeup of electrode.

Figure 22. - Kaman test specimen arrangement for second series of high-current damage tests.

The second set of high-current damage tests proved to be more venturesome. The test setup (fig. 22) and currents were within the desired calibration range and magnitude, as in the first set of high-current damage tests. In the first test of the second set of high-current damage tests a strike on the tip cap discharged a 229-kA current along a 51-cm-long section of the flat, braided cable fastened to the rotor blade test specimen surface with contact cement. The 51-cm-long section of cable was blown off, as shown in figure 23. The result was very surprising to the personnel present at the test site. The primary cause of the outcome was the electromagnetic force produced by the abrupt direction change in lightning current flow. In setting up for the test we had overlooked the need to insure that the radius of bend of the conductor was not less than 20.3 cm even though the angle was not less than 90° (ref. 8). The most unexpected result was the catastrophic failure of the down-conductor (i.e., the curling and excessive distortion of the flat, braided cable). Previous test reports had stated that currents of such magnitude were successfully carried without any significant distortion. Review of the observations with the author of these reports disclosed that the same type of distortion had been observed and judged not to be significant. Such a judgment by itself may not be improper. However, in light of the total rotor blade structure and the cable being an integral part of the structure, the distortion as experienced becomes a source of concern. Specific concerns are potential irreparable structural damage to the rotor blade or irreparable damage only to the down-conductor that would require replacement of the total lightning accommodation system. Either occurrence would result in extensive machine downtime and exorbitant repair costs.

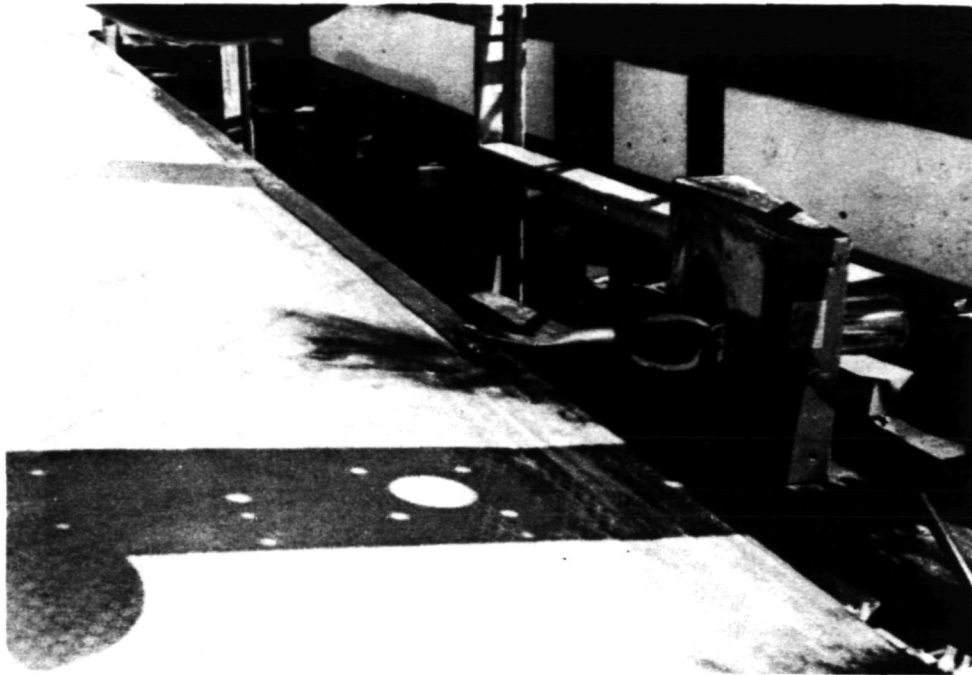
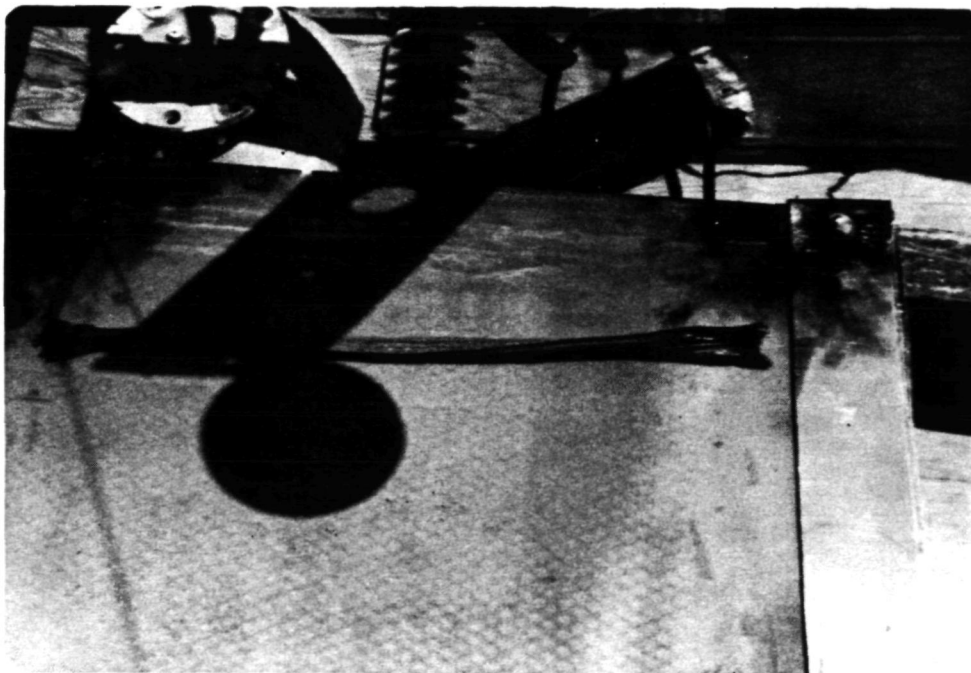
(a) Post-test damage.

(b) Blown-off segment.

Figure 23. - Blown-off flat, braided-cable down-conductor.

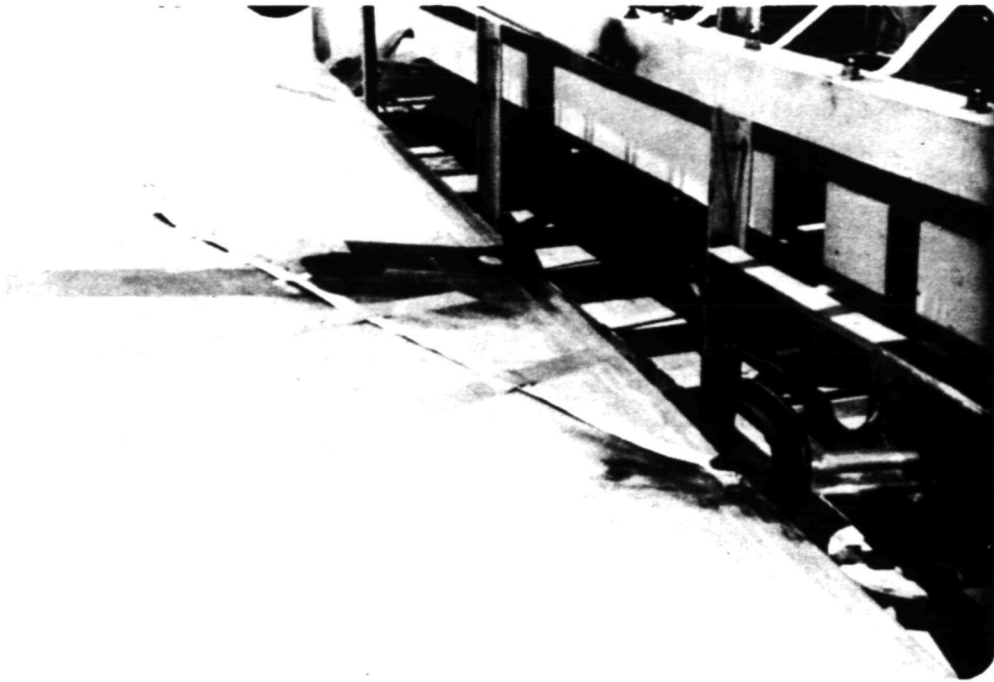
Figure 24. - Test arrangement for progressively higher current damage tests.

in figure 24. None of the strokes caused damage to the rotor blade sample. The current levels through the braided cable and the observed cable condition are given in table II.

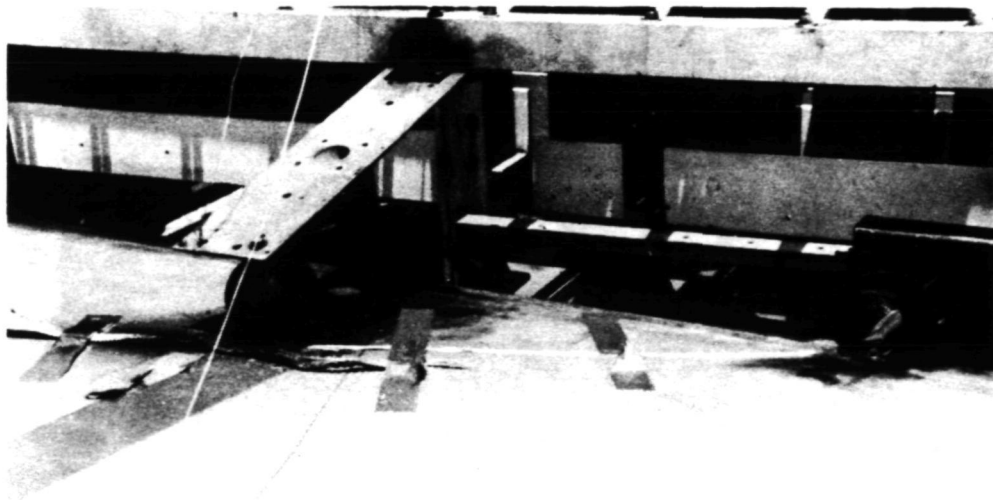
Figure 25. - Aftermath of 246-kA current passage through sample.

The aftermath of the last current shot in table II is illustrated in figure 25. Note that a goodly portion of the braided cable is missing (right side of the figure) and the remainder is badly distorted.

Current, A	Observed cable condition
50 000	No damage
83 000	Slight tubular curling
133 000	More pronounced tubular curling but no breakage
181 000	Complete curling and slight shredding
246 000	Braid torn loose and shredded

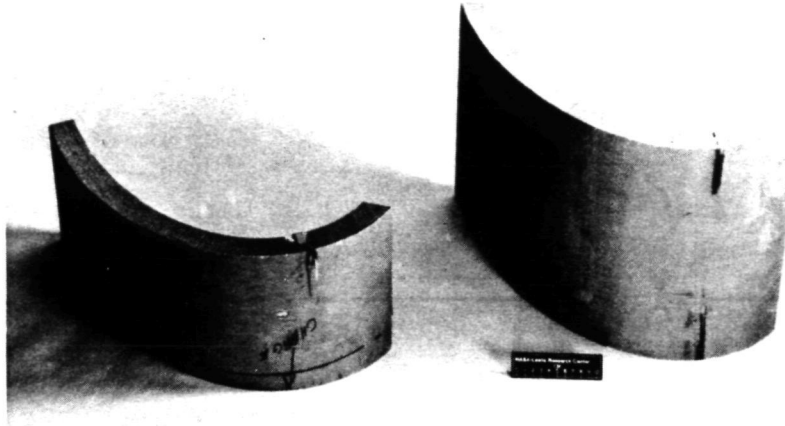
C-80-4993

Figure 40. - External surface view at point of leading-edge penetration. (From ref. 4.)

After the test specimen was returned to Lewis, it was dissected at the points of puncture. The evidence of arc penetration through the epoxy-wood structure is shown in figures 40 and 41. It is interesting to note that the carbonaceous trail of penetration ends at the internal surface of the wall. No other trace of the carbonaceous arc trail could be found.

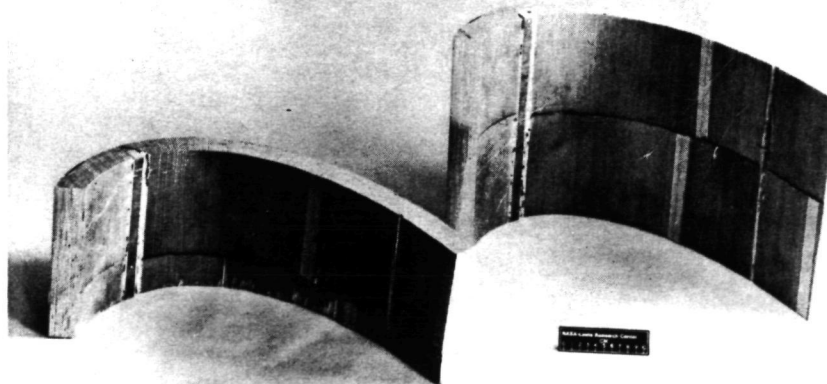
C-80-4994

Figure 41. - Internal surface view at point of leading-edge penetration. (From ref. 4.)

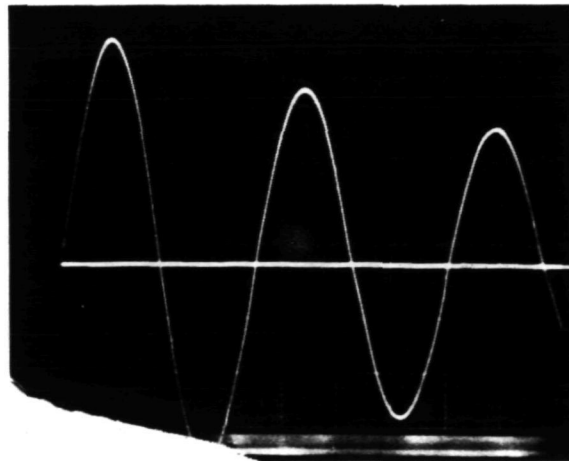
Figure 43. - High-current damage test waveform. (From ref. 4.)

A captive discharge generator, shown in figure 42 (ref. 4), was used for the high-current damage test. The high-current waveform shown in figure 43 was monitored with a wide-band-pulse current transformer rated at 250 kA, a current-time product of 64 As with a frequency response of 1 Hz to 100 MHz. The ferrite core had a 100-turn secondary winding terminated in a low-inductance coaxial resistor of $0.01\Omega \pm 0.1$ percent. The voltage across the resistor was carried by a double-shielded coaxial cable to a type 7704A Tektronix oscilloscope housed in a shielded room.

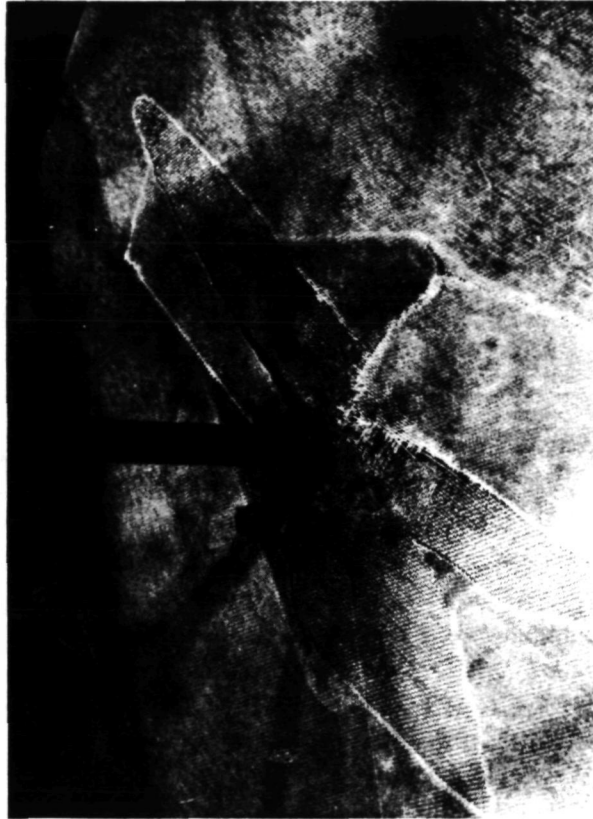
Figure 44. - Aftermath of high-current passage through Nomex afterbody panel. (From ref. 4.) -
