FLAT-PLATE SOLAR ARRAY PROJECT

QUARTERLY REPORT

INVESTIGATION OF THE HYDROCHLORINATION OF SiCl_4

"Investigation of the Hydrochlorination of SiCl_4 ,"

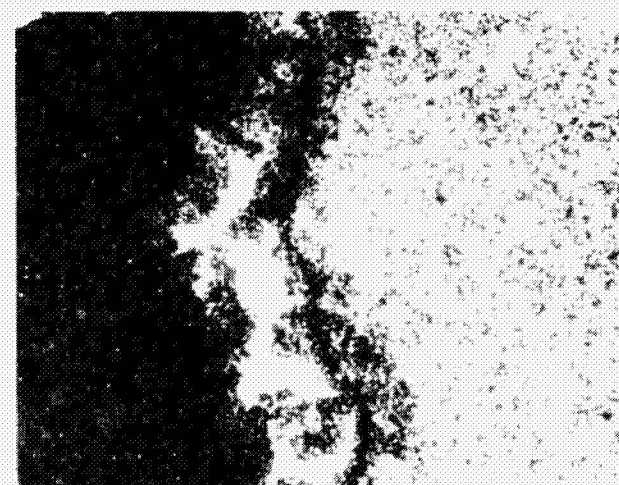
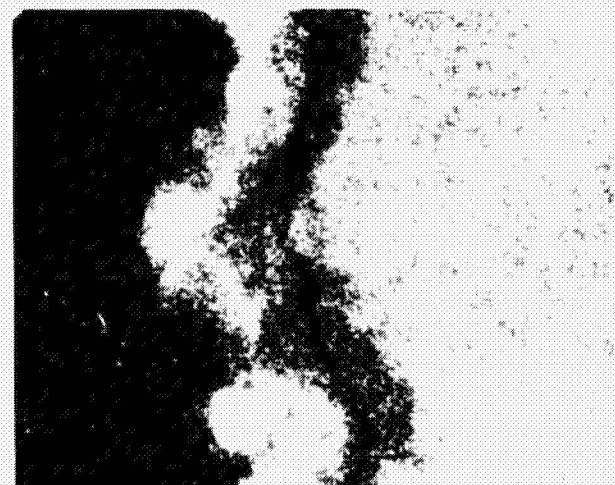
FIGURE VI CORROSION TEST ON INCOLOY 800H: SCANNING
ELECTRON MICROGRAPH OF CROSS SECTIONAL
AREA AND X-RAY MAPS

Chlorine X-ray Distribution Photo 8 40000

Figure VI shows the SEM analysis on a cross sectional area of the Incoloy 800H test sample and the X-ray maps of silicon, chlorine, nickel, chromium and iron. The presence of chlorine in the silicide film is interesting, since no significant amount of chlorine was detected in the silicide

film on the nickel test sample. The chlorine, most likely in the form of metal chlorides, appears to concentrate at the boundary between the silicide film and the base metal (see Figure VI, chlorine X-ray map). The presence of chloride in the silicide film may explain the reactivity of this silicide film toward air and moisture. Metal chlorides, FeCl_3 , NiCl_2 , CrCl_3 and Si-Cl readily react and dissolve in water to form hydrochloric acid which, in turn, can attack the metal-silicide deposits. The X-ray distribution maps also show segregations of silicon and the three basic metallic elements, Ni, Cr and Fe, which make up the Incoloy 800H alloy. For example, Si appears to concentrate more at the outside portion of the silicide film. On the other hand, nickel appears to concentrate more at the silicide-Incoloy 800H boundary. Chromium and iron are distributed more evenly at the middle section of the silicide film.

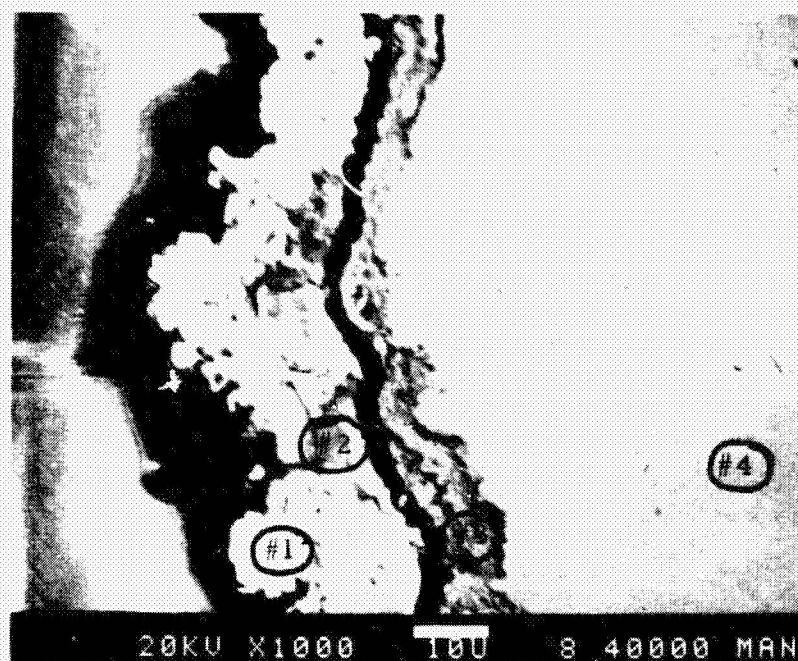
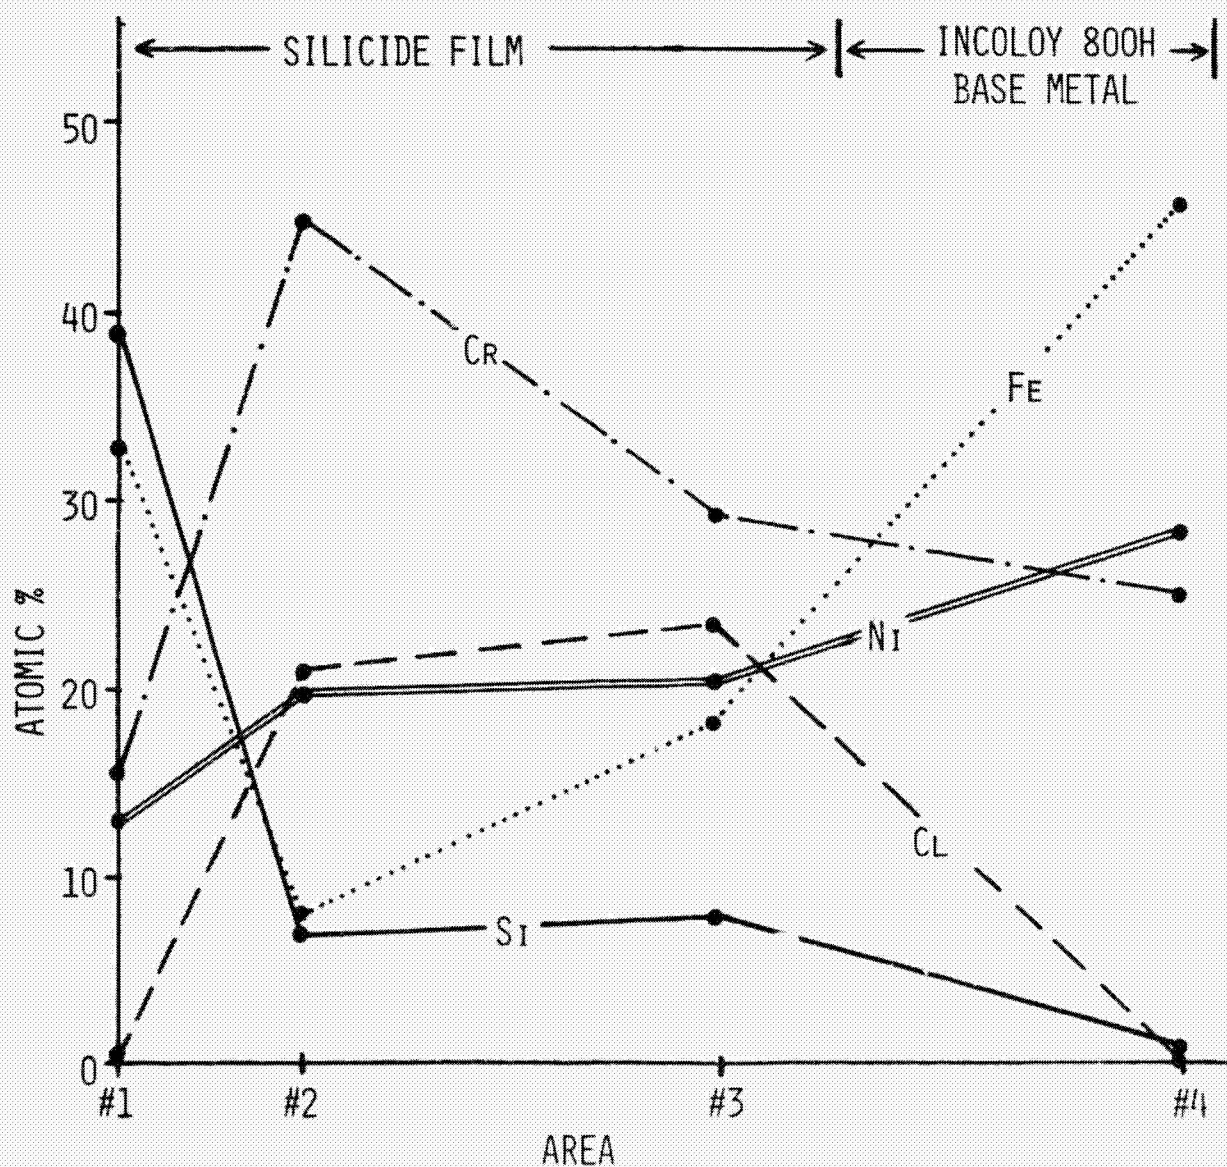
FIGURE VII

CORROSION TEST ON
INCOLOY 800H
238 HOURS @ 500°C,
300 OSIG, $H_2/SiCl_4 = 2$
SEM ANALYSIS OF
CROSS SECTIONAL AREA

Figure VII summarizes the results of the EDAX analysis on four different areas of a cross sectional area of the Incoloy 800H test sample. Results of the EDAX analysis are plotted in a graph shown in Figure VII. The graph in Figure VII confirms the high degree of segregations of the elements at different locations of the silicide film. This high degree of segregation is not unexpected. In such a multi-component system, there must be many metal-silicon phases as well as many metal-metal phases. The composition of the silicide film on Incoloy 800H is therefore very complex. A plausible mechanism on the formation of the silicide protective film is discussed in the following.
