NASA Technical Memorandum 84554

**EFFECTS OF SIMULATED LIGHTNING ON
COMPOSITE AND METALLIC JOINTS**

William E. Howell and J. Anderson Plumer

October 1982

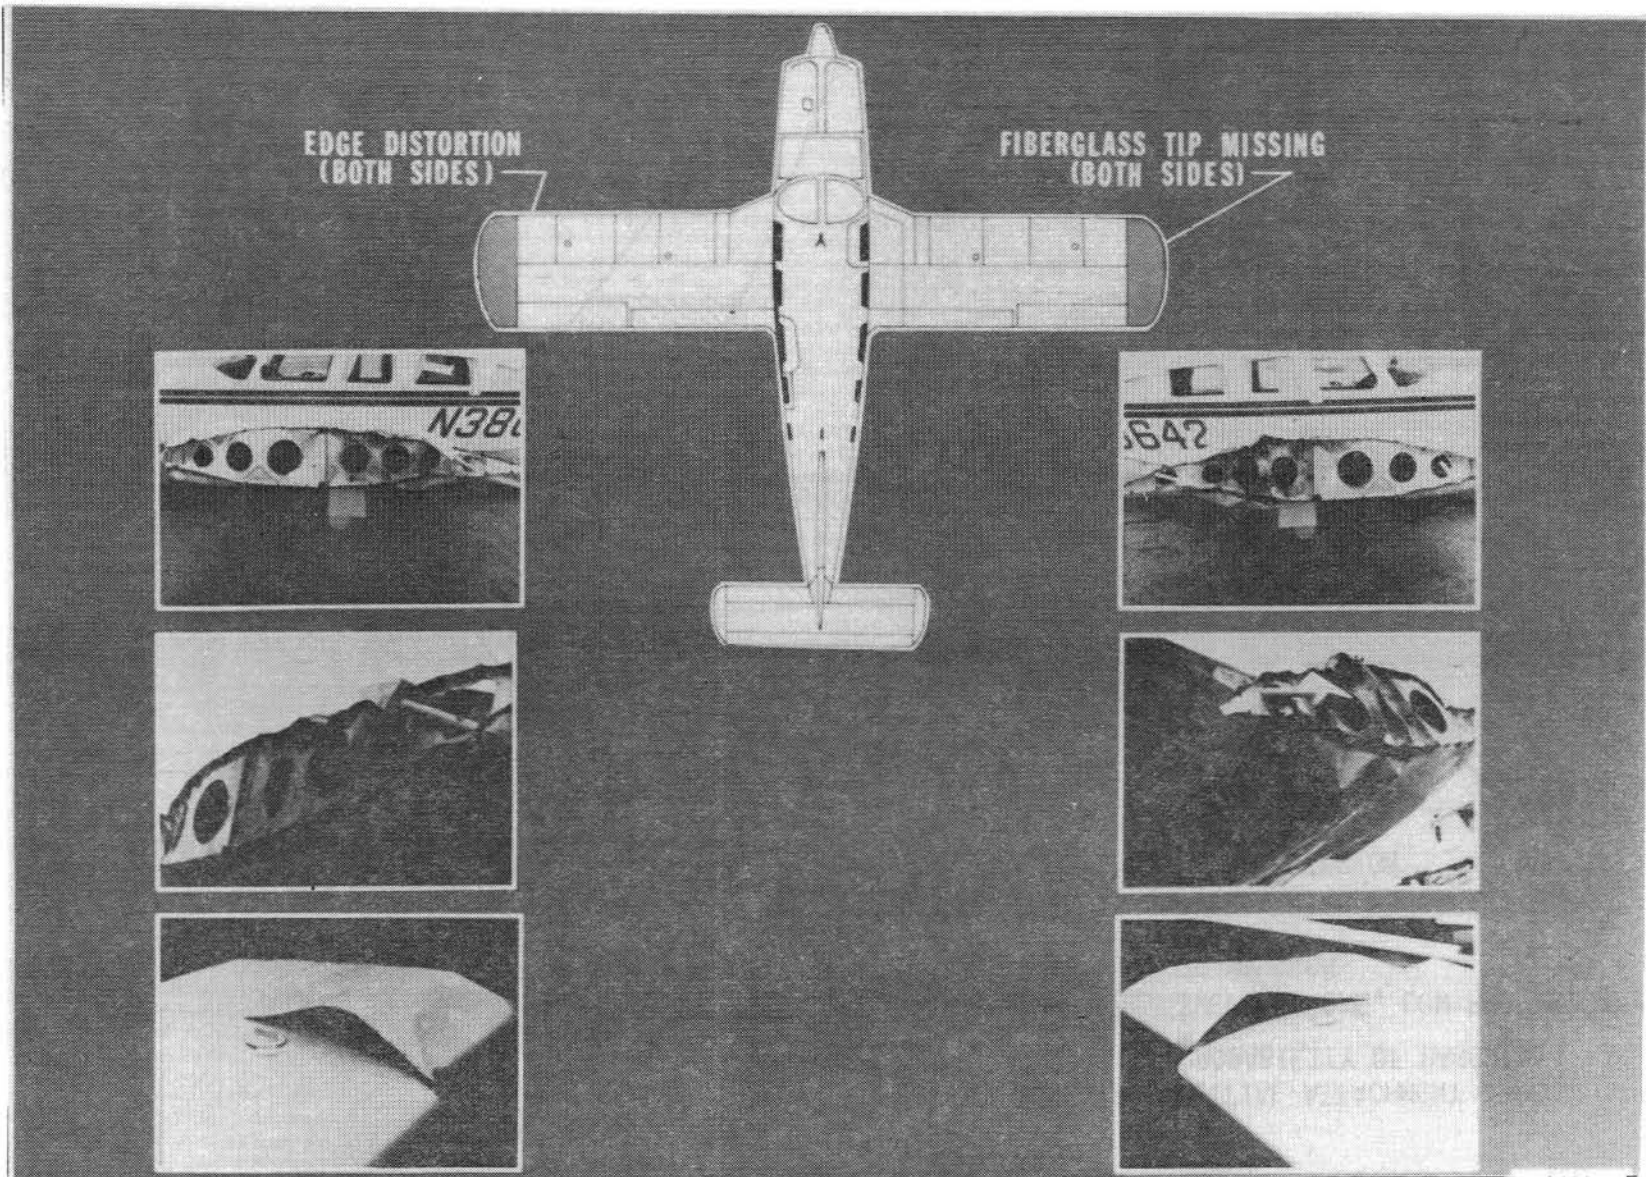
Figure 1. - Lightning damage to a general aviation aircraft.

The results of a strike on a general aviation aircraft is shown in figure 1 and indicates the need to ensure electrical safety in all aircraft designs and fabrication methods. The lightweight fiberglass wing tips on the aircraft in figure 1 represent a general class of wing tip construction used on single and light twin engine aircraft. Navigation lights are mounted on these dielectric wing tips. As indicated by the damage shown in figure 1, adequate paths for the current associated with the lightning strike were not

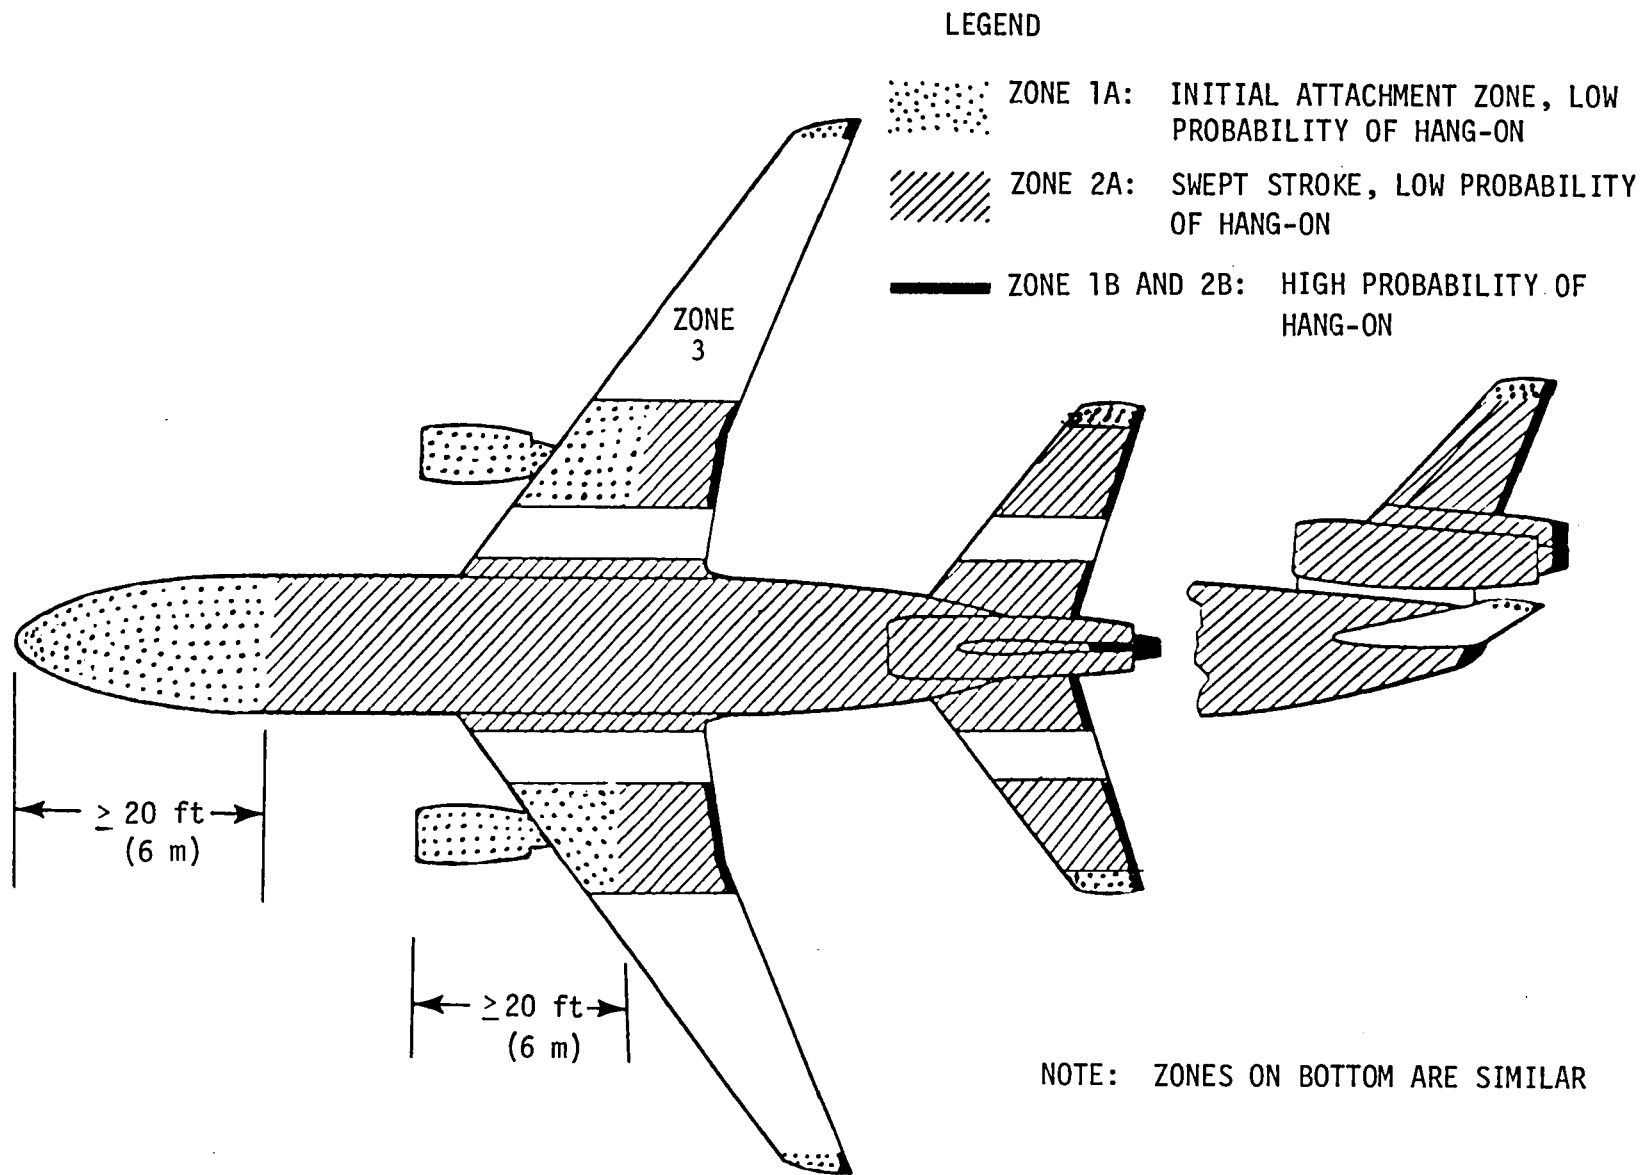
Figure 2. - Aircraft lightning attachment zones.

The aircraft strike zones (fig. 2) are described in reference 5 and differ from those specified by the FAA in reference 6. Reference 7 provides a detailed discussion of the strike zones in references 5 and 6 and of the need for more refinement in the definition of strike zones.

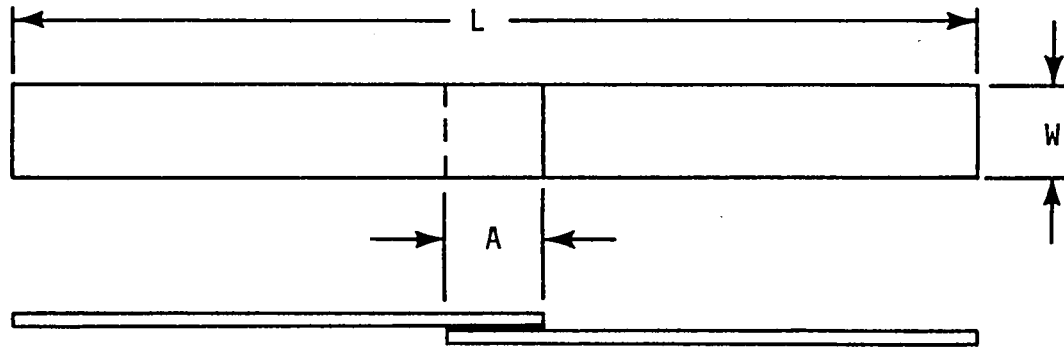
ALUMINUM		GRAPHITE/EPOXY	
	BURRED	DEBURRED	SHORT OVERLAP	LONG OVERLAP
A	0.50 1N. (1.27 CM)	0.50 1N. (1.27 CM)	0.25 1N. (0.64 CM)	0.75 1N. (1.90 CM)
L	7.0 1N. (17.8 CM)	9.0 1N. (22.9 CM)	12.0 1N. (30.5 CM)	11.0 1N. (27.9 CM)
W	1.00 1N. (2.54 CM)	1.00 1N. (2.54 CM)	2.00 1N. (5.08 CM)	2.00 IN. (5.08 CM)

Figure 3. - Single-lap bonded joint specimen.

Aluminum Adherends. - The specimens were 1.00 in. (2.54 cm) wide with an overlap of 0.50 in. (1.27 cm) (see fig. 3). Two sets of specimens were fabricated from sheared aluminum. One set was not deburred and was bonded using normal fabrication techniques which do not control bondline thickness. The adherends were bonded together with the burred surfaces facing each other. This orientation caused most of the specimens to be conductive across the joint. Nominal bondline thickness ranged from 0.001 to 0.009 in. (0.002 to 0.023 cm). The first eight adhesive systems listed in table 2 were used to bond this set of specimens.

Graphite/epoxy adherends. - Two sets of specimens were fabricated. Each specimen in the first set was 2.00 in. (5.08 cm) wide with an overlap of 0.25 in. (0.64 cm) as indicated in figure 3. Such a small overlap is not sufficient for bondline shear strength tests so the specimens were used only for voltage/current sparking threshold evaluations. Nominal bondline thicknesses were 0.003, 0.007, 0.010, 0.015, and 0.020 in. (0.008, 0.018, 0.025, 0.038, and 0.051 cm). A non-conductive adhesive, EA-9628 (see table 2), was used to bond the specimens. The adherends consisted of 4 plies of T300/934 fabric with an orientation of [+45, 0, 90, -45].

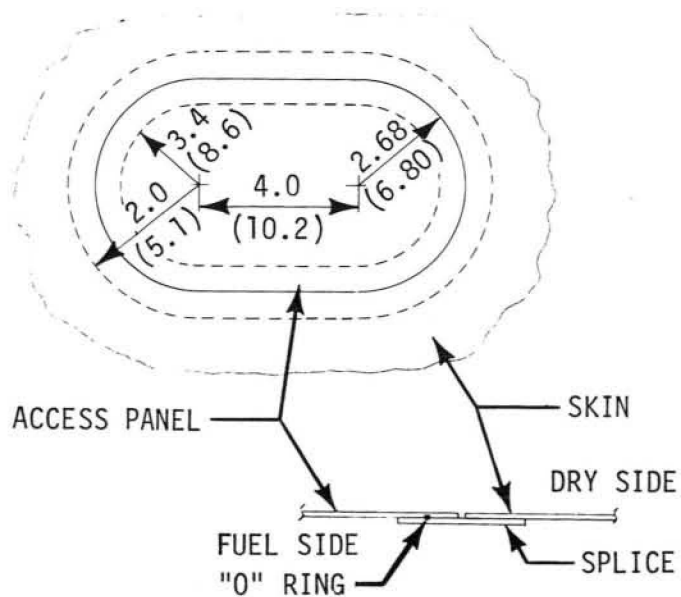
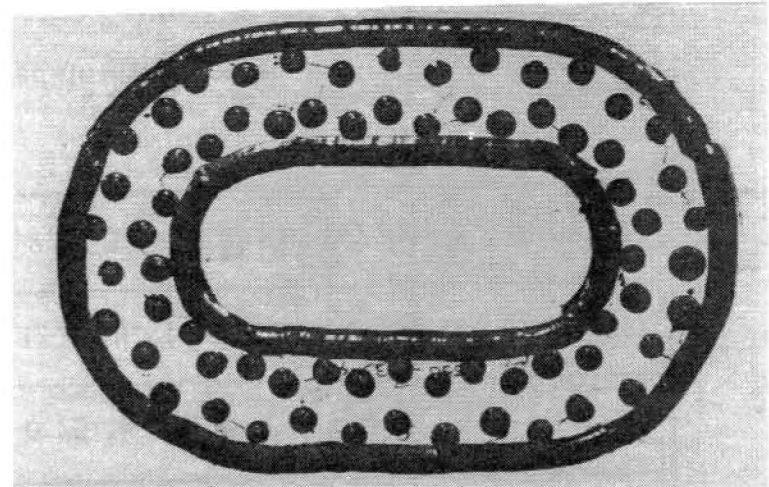
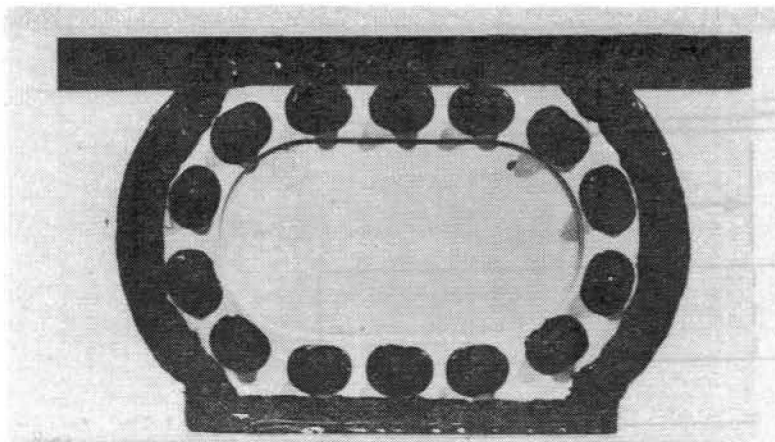
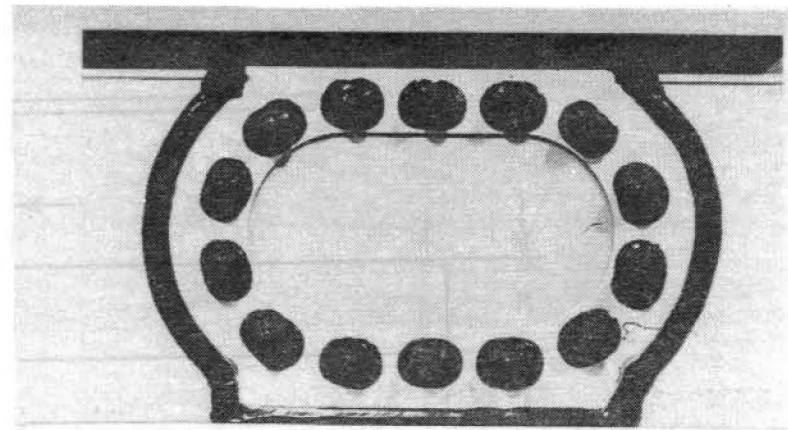
(a) Access/inspection panel details.

(b) Access/inspection panel with staggered row of rivets.

(c) Access/inspection panel with single row of rivets.

(d) Access/inspection panel with splice bonded to skin.

Figure 4. - Aluminum access/inspection panels. Dimensions are given in inches (centimeters).

Aluminum skins. - Each specimen consisted of a full size fuel cell access/inspection panel, the associated splice ring, and a portion of the outer skin (fig. 4). Three combinations of riveted and bonded splice-to-skin attachment designs were fabricated. All dome nuts and joint edges on the fuel side were sealed with fuel cell sealant similar to that applied to the interior of aircraft wings.

Aluminum skins. - Using the test circuit shown in figure 8, an electric spark was struck to the panel. The current was conducted through the mechanically fastened or bonded splice to the skin (refer to figure 4(a)). The internal surface, or fuel side, of the panel was enclosed and a camera was used to photograph any sparking. The procedure was used to determine

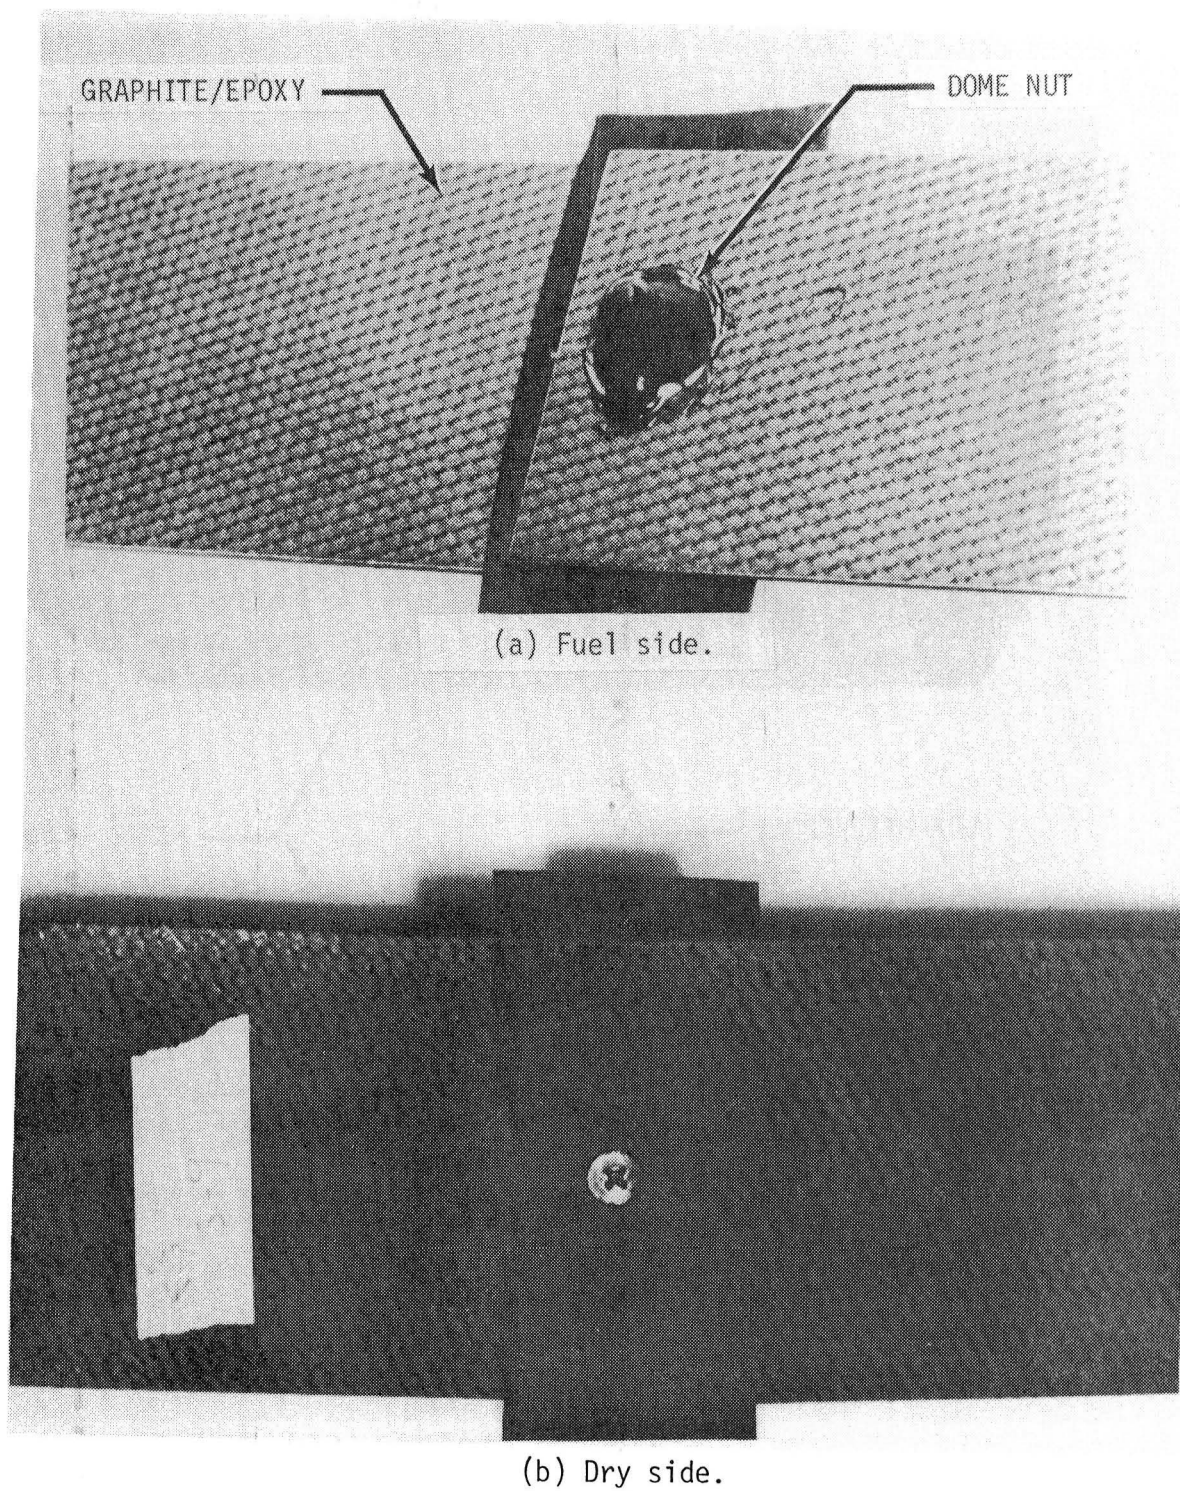
Figure 5. - Graphite/epoxy access/inspection panel specimen.

Graphite/epoxy skins. - The specimens consisted of strips of laminate bolted together with one dome nut fastener instead of an entire access/inspection panel. The two laminates were electrically insulated except through the fastener (fig. 5). The specimens were designed to permit a determination of the current that one fastener could conduct without sparking. It was

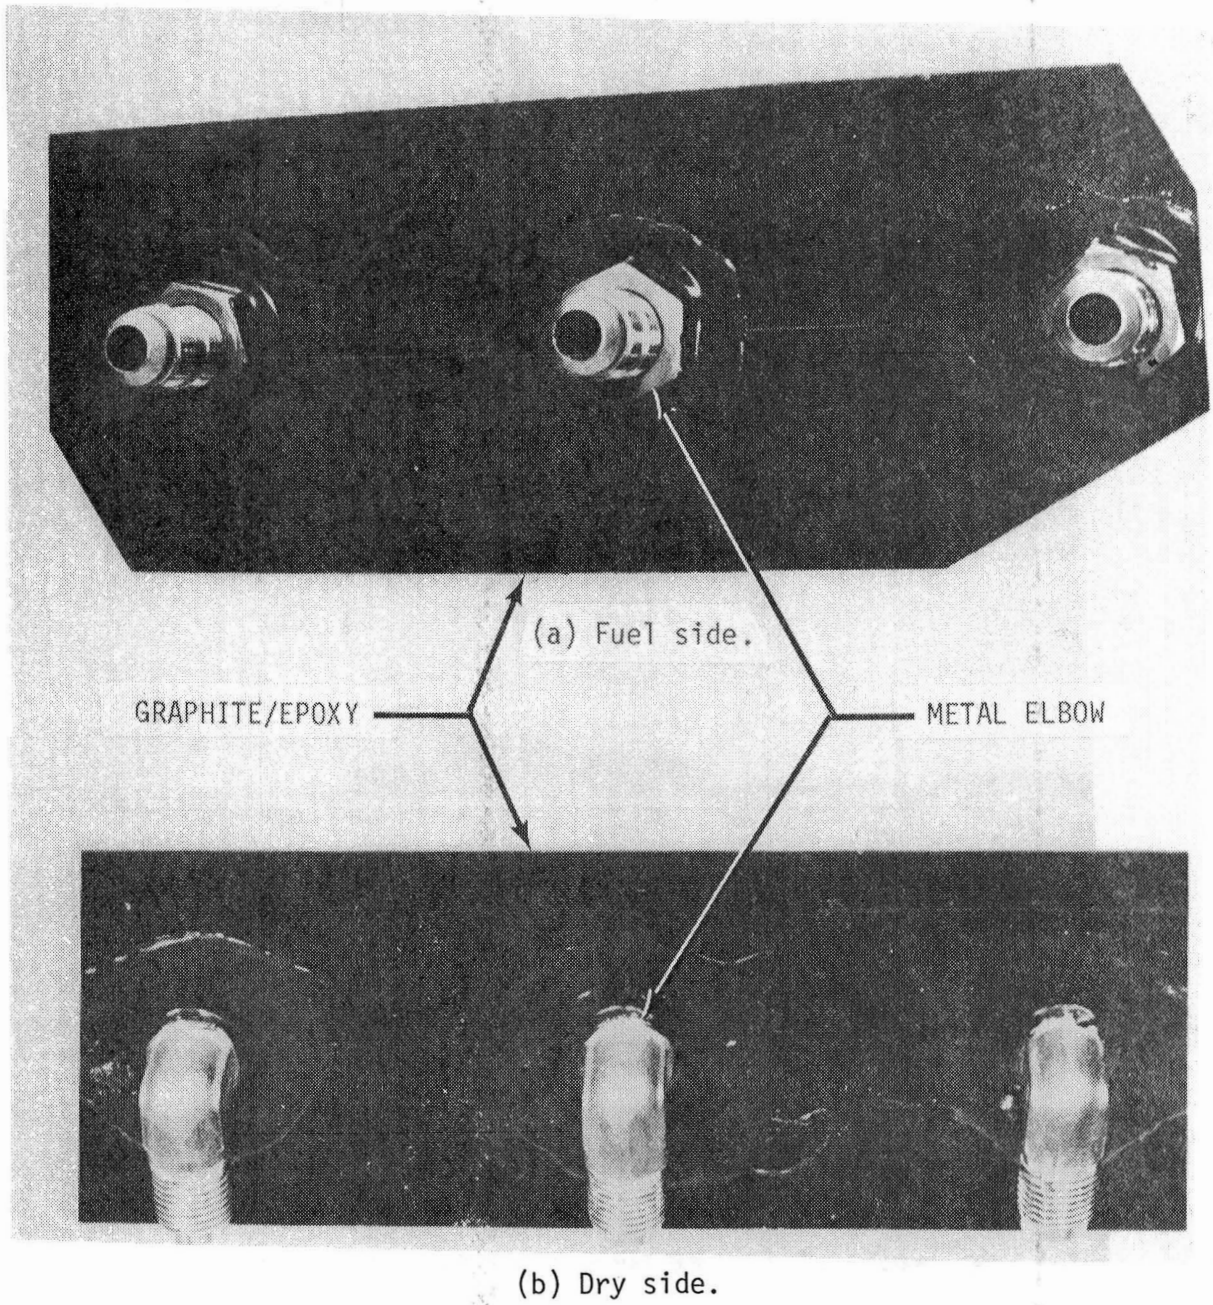
Figure 6. - Metal fuel feed-through elbow specimens.

Metal fuel feed-through elbows used in aircraft fuel lines were mounted on a graphite/epoxy laminate (fig. 6). Fuel tank sealant was applied around the bulkhead flanges of the elbows. The specimen represents metal fuel line attachments through wing ribs or other aircraft structures. Each elbow mounted on the panel was used as an individual test specimen to determine sparking threshold.

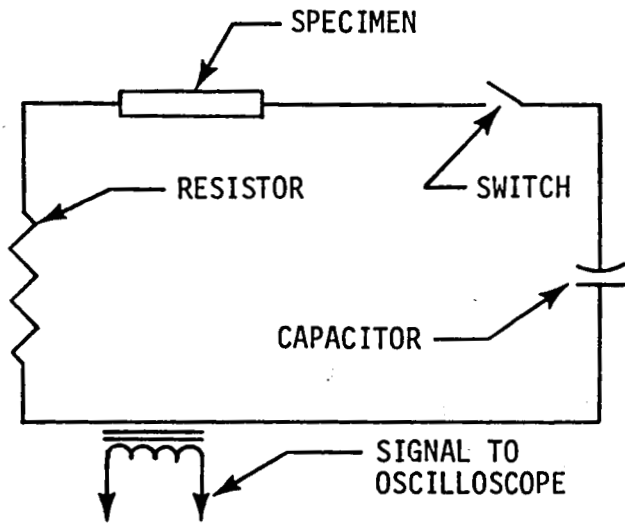
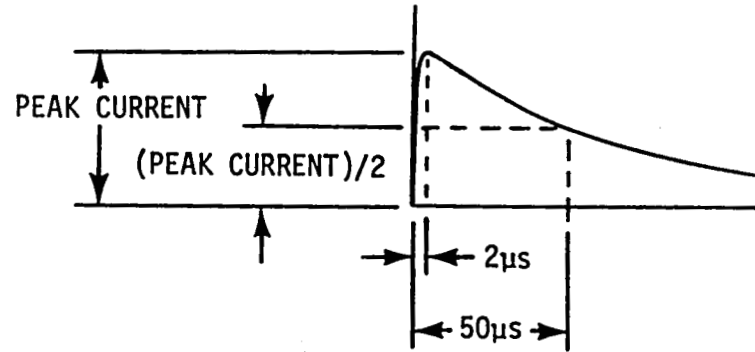
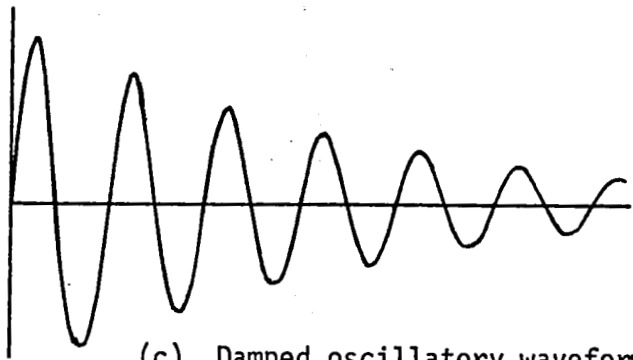
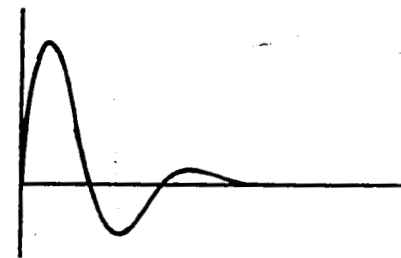
(a) Test circuit

(b) Critically damped 2 X 50 waveform

(c) Damped oscillatory waveform

(d) Damped waveform used to test composite adherends

Figure 7. - Circuit and waveforms used for tests on single-lap bonded joint specimens.

Aluminum adherends. - Each specimen was mounted in the test circuit shown in figure 7(a). The circuit was critically damped and produced the desired waveform shown in figure 7(b). The waveform simulates that of a lightning strike and was used to conduct tests at current levels of 1 and 5 kA. The test equipment did not have the capability of producing the same waveform at higher current levels. Therefore, the resistor was removed from the circuit before tests were conducted at 10 and 50 kA. With the resistor removed, the oscillating current waveform shown in figure 7(c) was produced.

Graphite/epoxy. - The specimens were tested in the electrical circuit shown in figure 7(a), except the resistor was removed because the resistance of the specimens was sufficient to nearly critically damp the circuit (fig. 7(d)). Each composite joint was enclosed and a camera was used to obtain photographic evidence of sparking. These tests were conducted over a current range of 0.035 to 5.6 kA to determine sparking and structural damage thresholds.

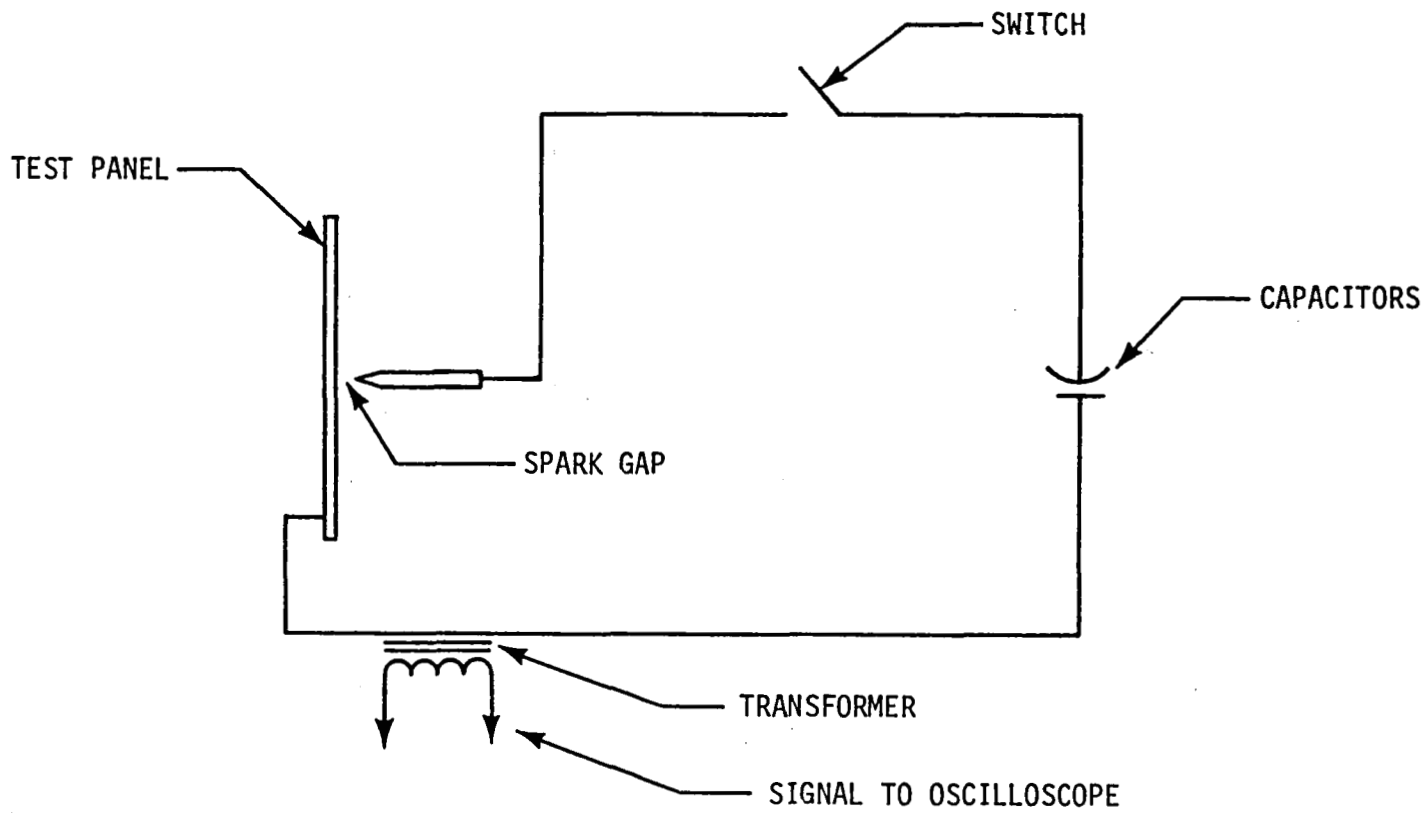
Figure 8. - Circuit used to test aluminum access/inspection panels.

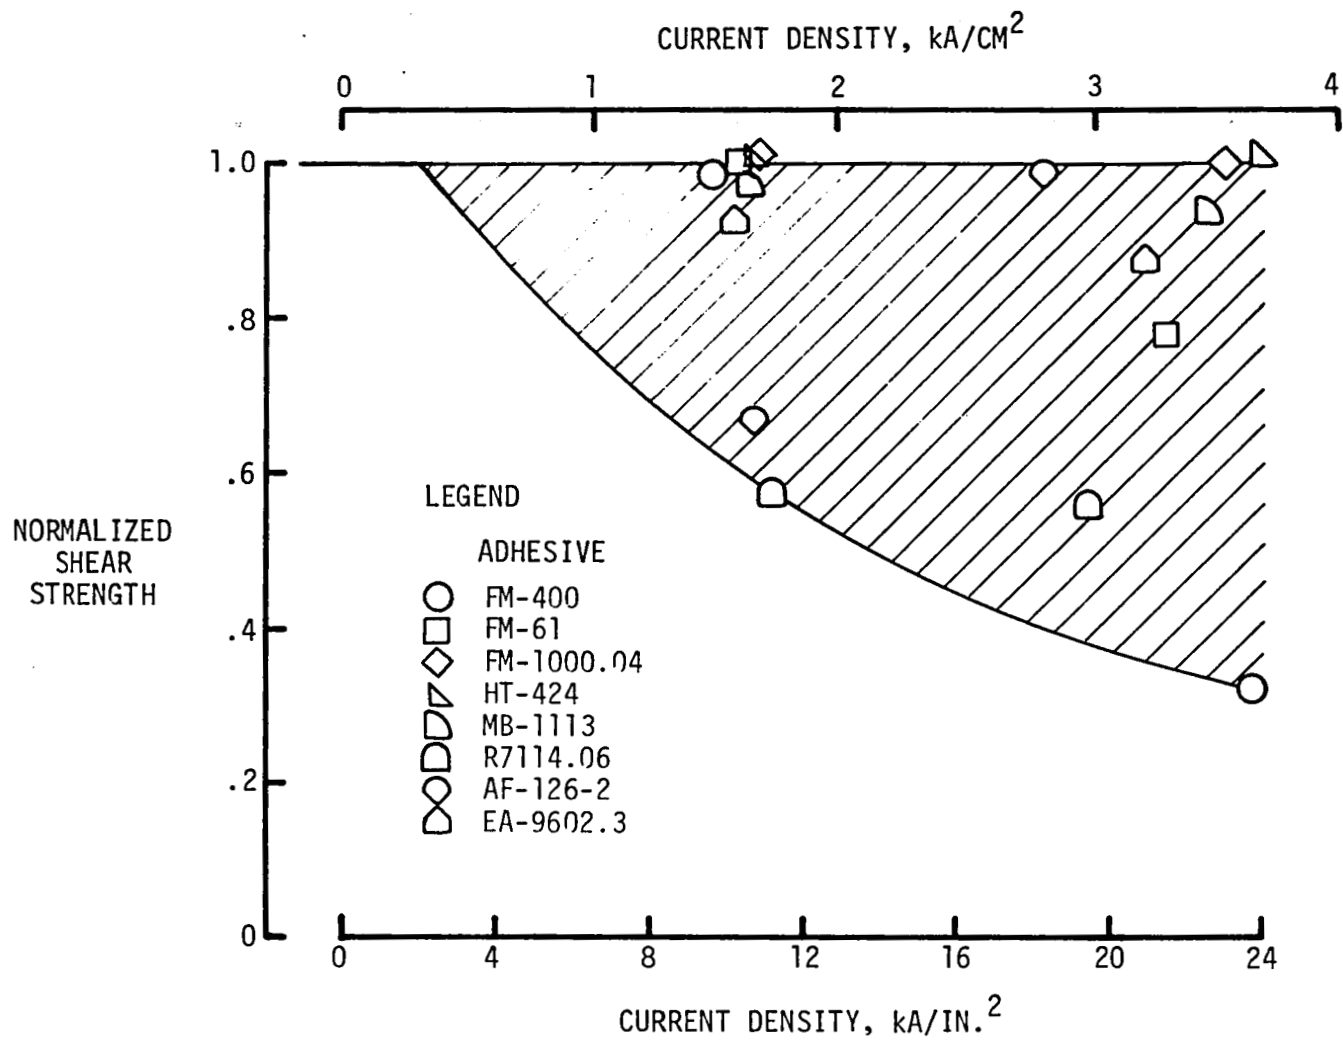
Figure 9. - Effect of current density on shear strength of aluminum single-lap joint specimens.

Aluminum adherends. - Test results for the first set of specimens (the ones not deburred and with bondline thickness not controlled) are presented in figure 9. Tests were conducted at current levels of 2, 10, 20, and 100 kA/in.² (0.31, 1.55, 3.10, and 15.50 kA/cm²). Tensile tests conducted on specimens exposed to no current and to 2 kA/in.² (0.31 kA/cm²) showed no shear strength degradation for all the adhesives tested. A current density of 2 kA/in.² (0.31 kA/cm²) represents the normally expected lightning threat. Some of the adhesive systems tested experienced no damage at current densities as high as 24 kA/in.² (3.72 kA/cm²). Other adhesives were significantly degraded at a current density of 10 kA/in.² (1.55 kA/cm²). Damage was caused by sparking through the adhesive as shown in figure 10. All specimens tested at a current density of 100 kA/in.² (15.50 kA/cm²) were totally destroyed. With the facing burs, most of the joints were electrically conductive. Even so, the specimens experienced external sparking, from the end of one adherend to the surface of the other adherend, at all current levels.

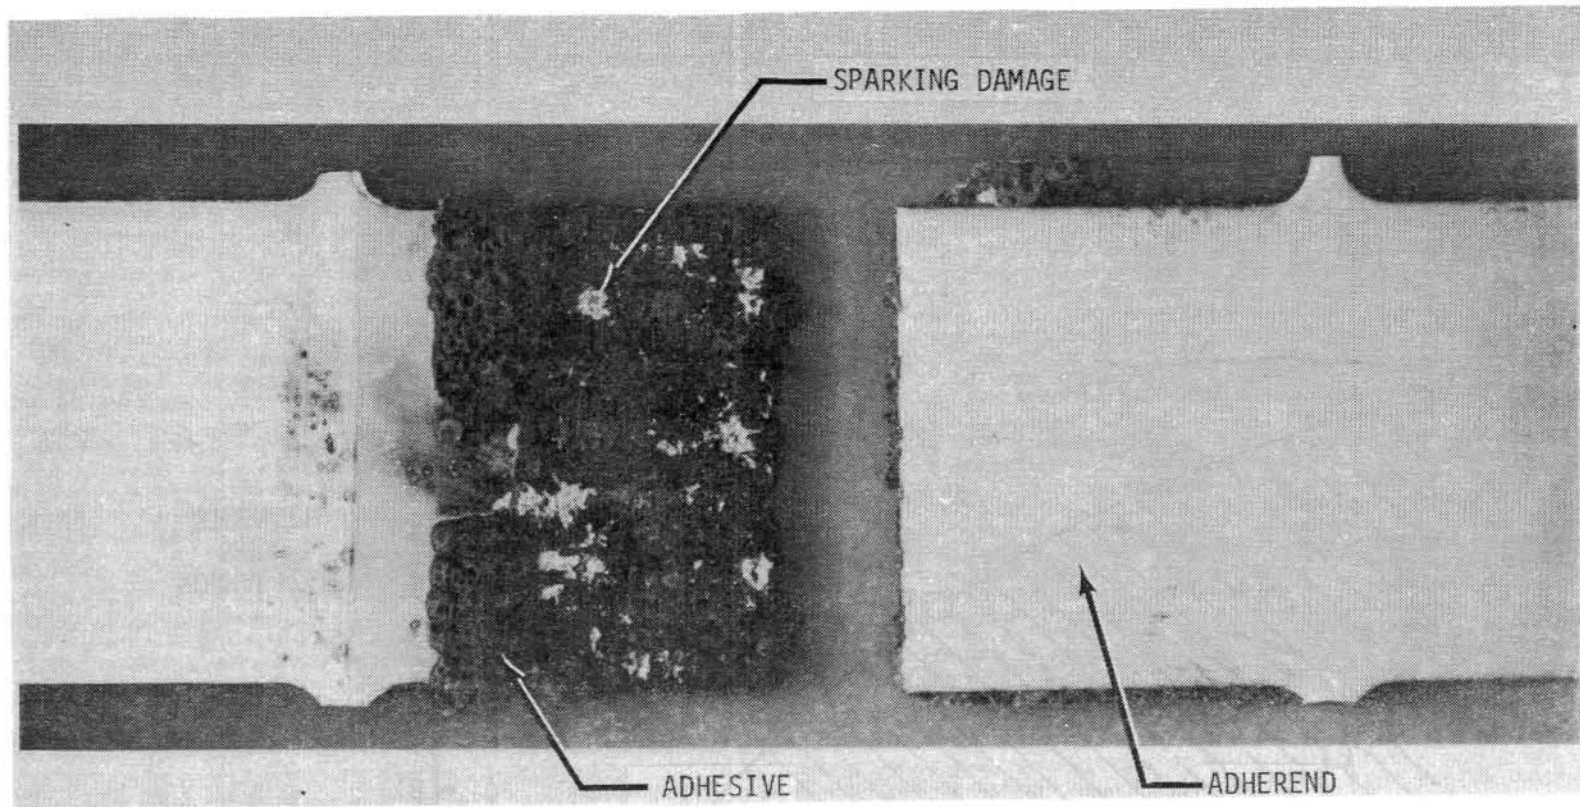
Figure 10. - A failed aluminum single-lap bonded joint specimen.

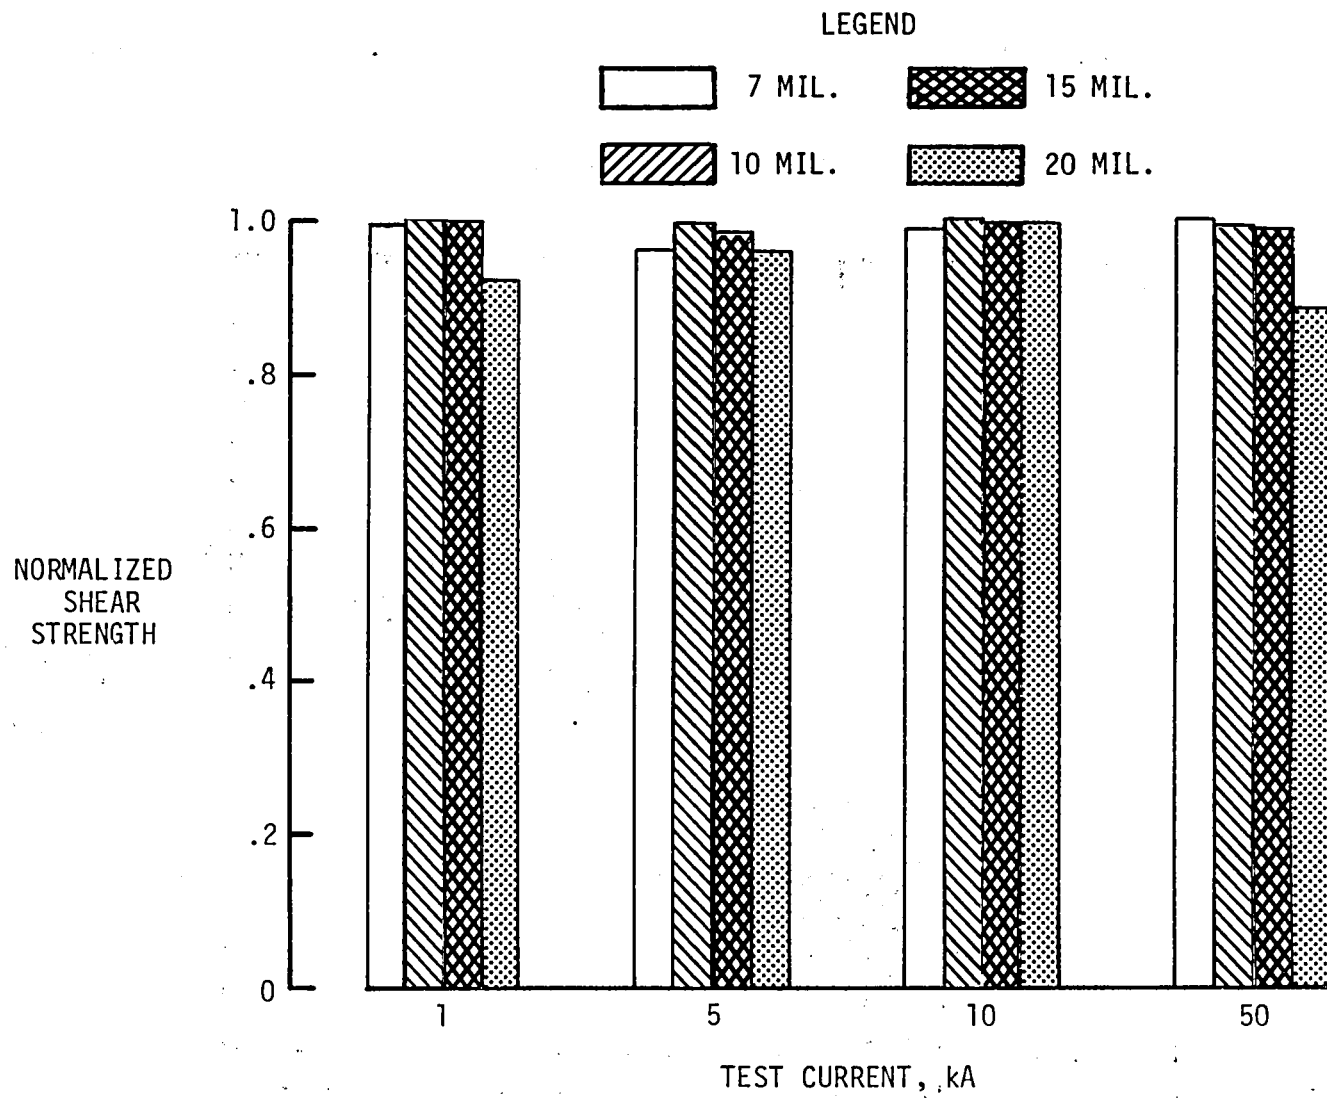
Figure 11. - Effect of bondline thickness on shear strength of aluminum single-lap joint specimens.

The second set of specimens with aluminum adherends (the ones deburred and with controlled bondline thicknesses) experienced no appreciable strength degradation through the entire current density range (fig. 11). The specimens with the thickest bondline did, however, experience a slight decrease in strength at test current levels of 1 and 50 kA. There was no tendency for sparking to occur through the adhesive. All the specimens sparked externally from the edge of one adherend to the surface of the other adherend at all test current levels.

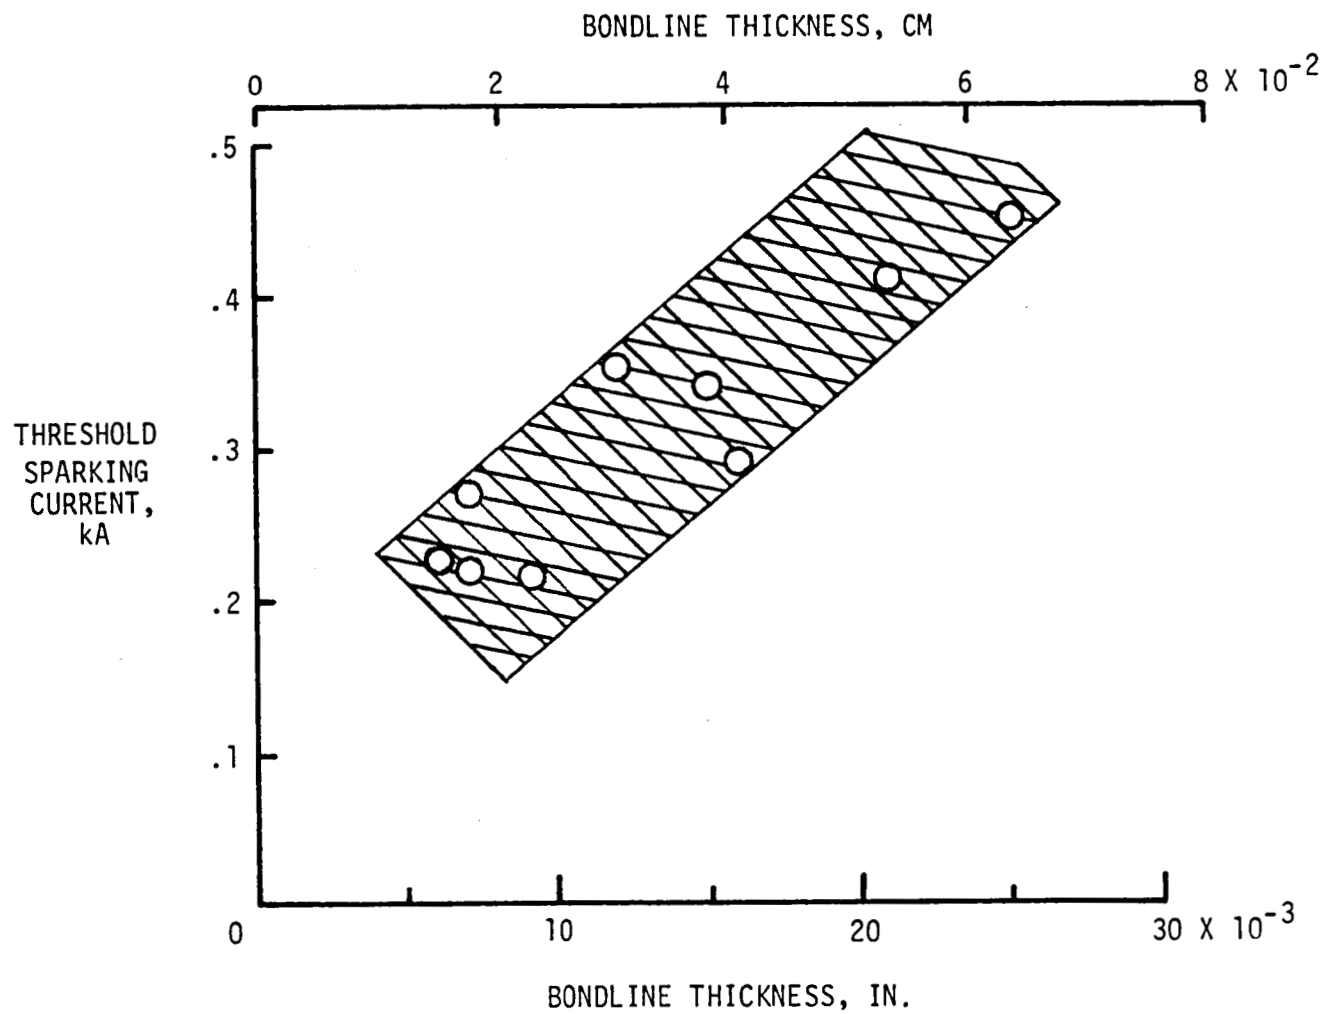
Figure 12. - Sparking threshold as a function of bondline thickness for graphite/epoxy single-lap joint specimens.

Graphite/epoxy adherends. - The first set of specimens (the ones with an overlap of only 0.25 in. (0.64 cm)) experienced external sparking at current levels between 0.215 and 0.450 kA as shown in figure 12. There was no evidence of sparking through the adhesive; therefore, no shear strength degradation should have been caused by the current. The sparking occurred across the joint from the edge of one adherend to the surface of the other adherend.

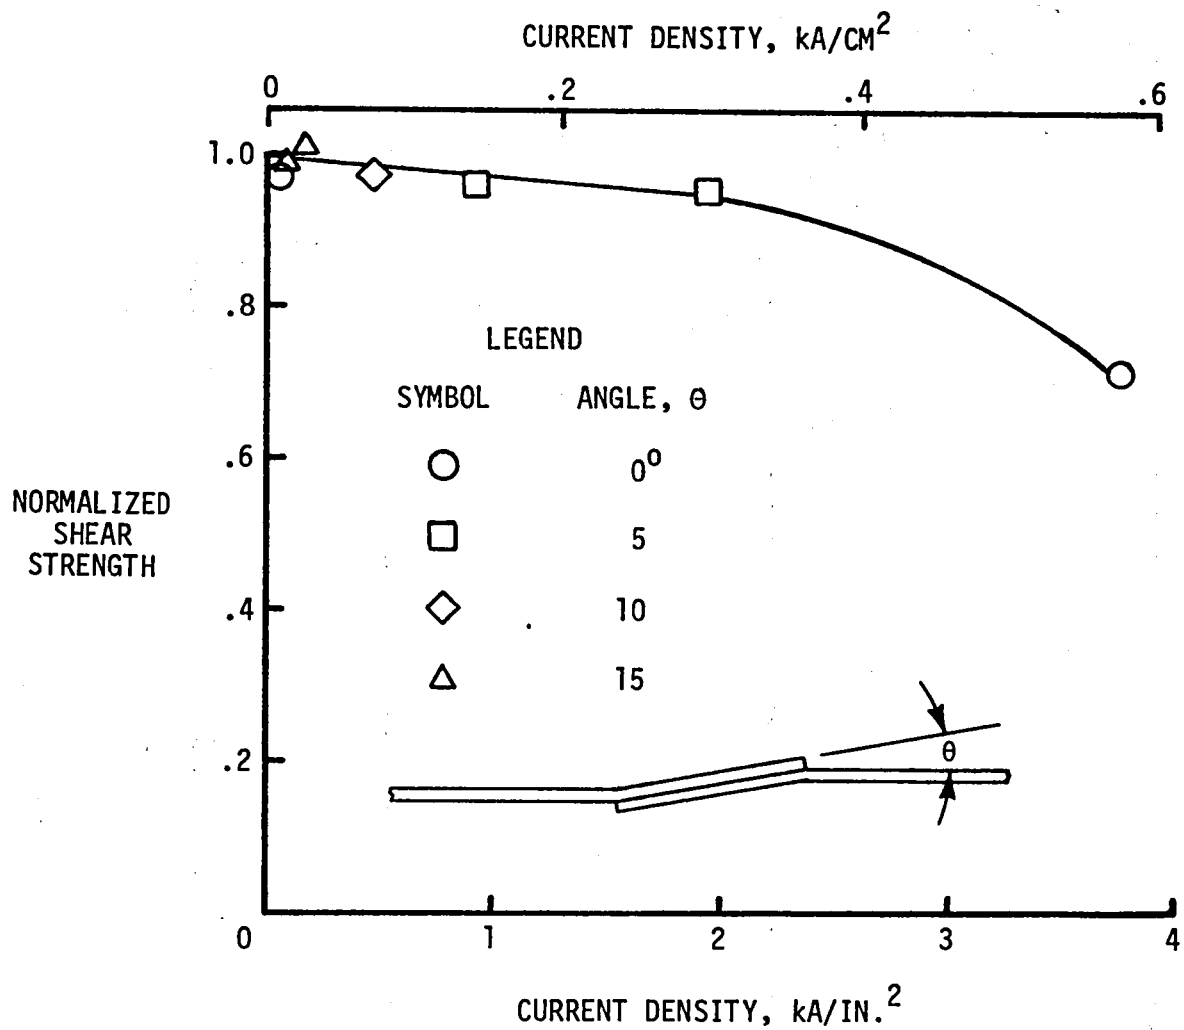
Figure 13. - Effect of current density on the shear strength of graphite/epoxy single-lap bonded joint specimens.

The data obtained for the second set of specimens (the ones with an overlap of 0.75 in. (1.91 cm)) are presented in figure 13. In order to isolate any effect of overlap angle on the test results, the data were normalized to baseline shear strength data for specimens with the same overlap angles. The curve is drawn through individual data points. For the test range of 0-2 kA/in.² (0-0.31 kA/cm²), the scatter in the data is typical of bonded joint tests. At a current density of 3.75 kA/in.² (0.58 kA/cm²), however, structural damage was induced in the joint as indicated by a 30 percent decrease in the joint shear strength.

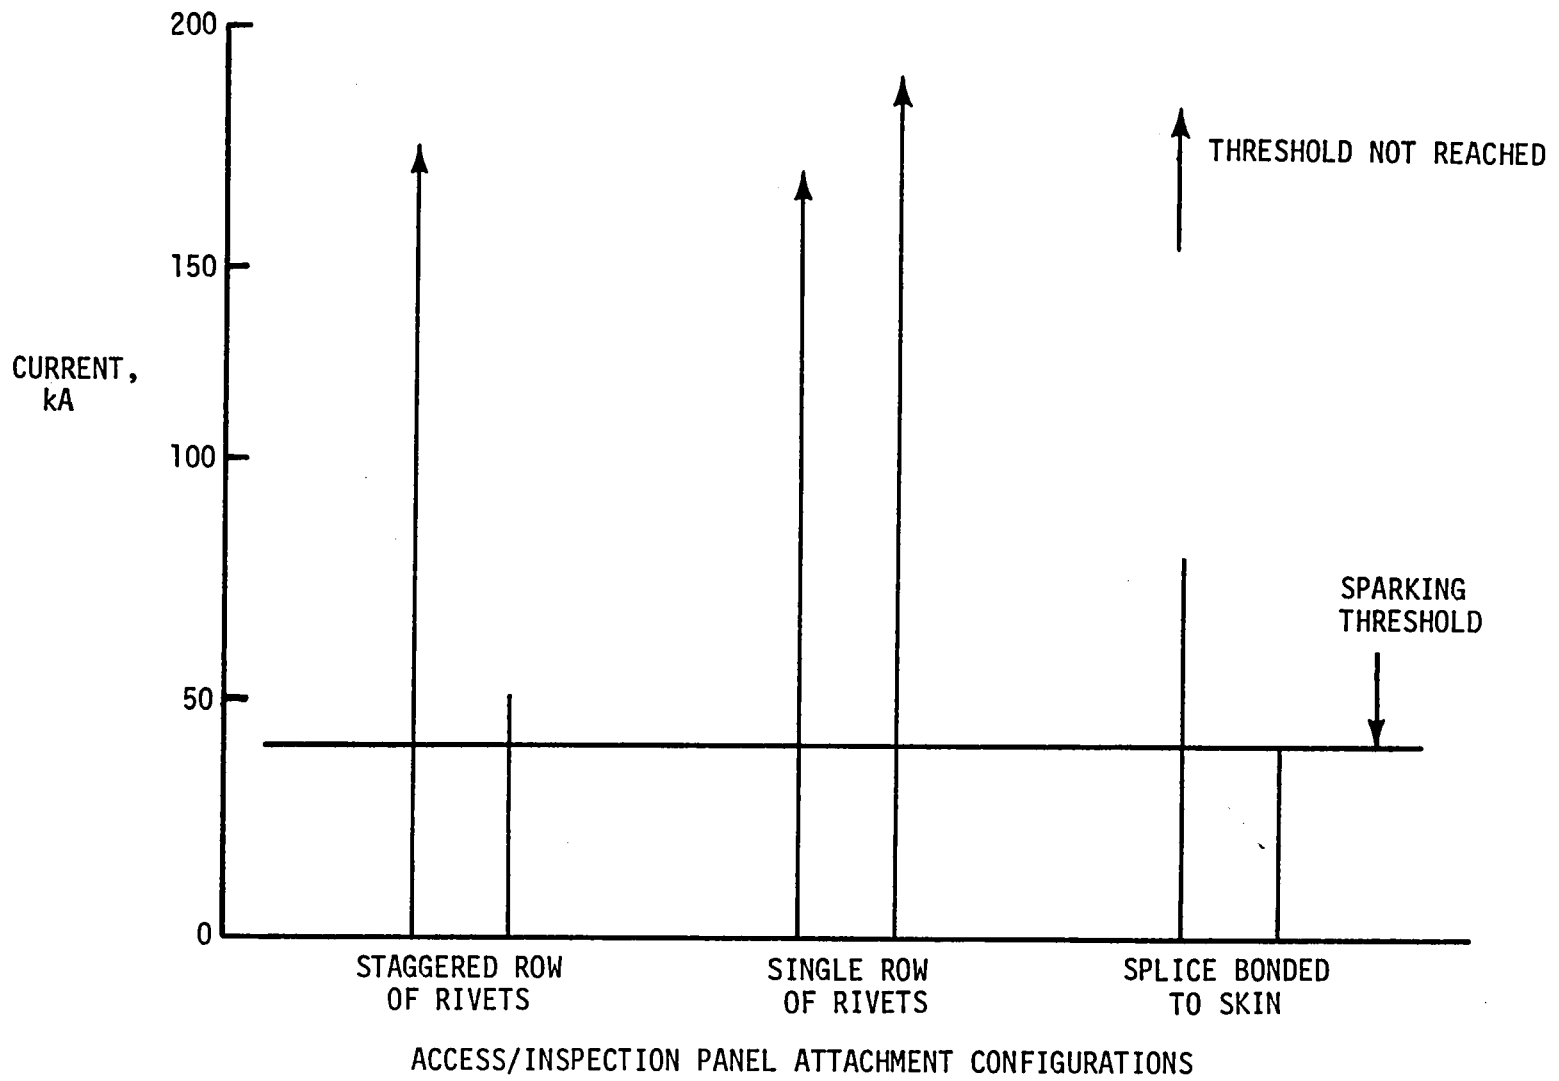
Figure 14. - Sparking threshold for the aluminum access/inspection panels.

Aluminum skins. - The sparking threshold determined for these specimens is shown in figure 14. As indicated in the figure, there is considerable scatter in the sparking threshold of similar specimens. Safety dictates, however, that the minimum observed sparking current values be of primary importance. For the rivet patterns tested, no sparking through the fuel tank sealant occurred below approximately 40 kA. For the limited number of tests performed, 40 kA was the minimum sparking current observed. More tests are required to statistically determine the minimum sparking threshold. Except for the single row of rivets, which did not exhibit sparking throughout the range of test currents, the rivet pattern did not significantly affect the sparking threshold. Figure 15 shows the location of sparking and damage in aluminum access/inspection panels. For the test configuration with the splice bonded to the skin, a strike or restrike with a current level higher than 40 kA could cause sparking past the "O" ring seal which would destroy the fuel tank integrity (fig. 15(c)).
