NASA Technical Memorandum 84554

**EFFECTS OF SIMULATED LIGHTNING ON
COMPOSITE AND METALLIC JOINTS**

William E. Howell and J. Anderson Plumer

October 1982

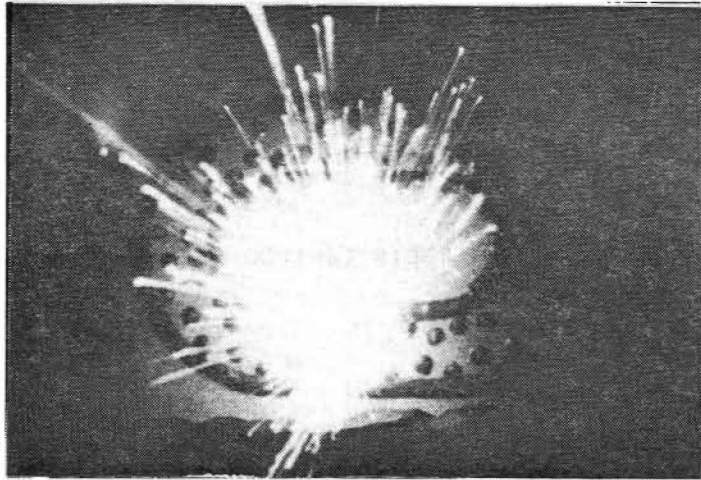
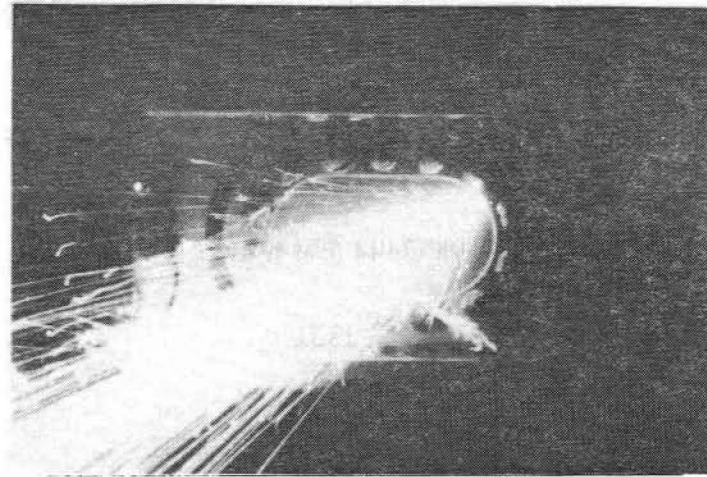
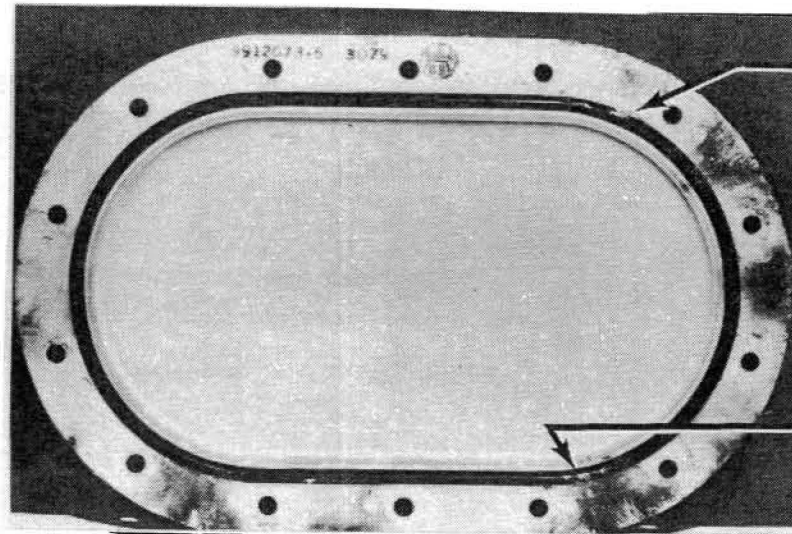
(a) Sparking at Panel-to-splice rivet
(Staggered row of rivets design)

(b) Sparking at panel-to-skin interface
(Bonded splice-to-skin design)

DAMAGE ACROSS "O" RING

(c) Sparking damage of bonded splice-to-skin panel

Figure 15. - Sparking and damage of aluminum access/inspection panels.

Aluminum skins. - The sparking threshold determined for these specimens is shown in figure 14. As indicated in the figure, there is considerable scatter in the sparking threshold of similar specimens. Safety dictates, however, that the minimum observed sparking current values be of primary importance. For the rivet patterns tested, no sparking through the fuel tank sealant occurred below approximately 40 kA. For the limited number of tests performed, 40 kA was the minimum sparking current observed. More tests are required to statistically determine the minimum sparking threshold. Except for the single row of rivets, which did not exhibit sparking throughout the range of test currents, the rivet pattern did not significantly affect the sparking threshold. Figure 15 shows the location of sparking and damage in aluminum access/inspection panels. For the test configuration with the splice bonded to the skin, a strike or restrike with a current level higher than 40 kA could cause sparking past the "O" ring seal which would destroy the fuel tank integrity (fig. 15(c)).

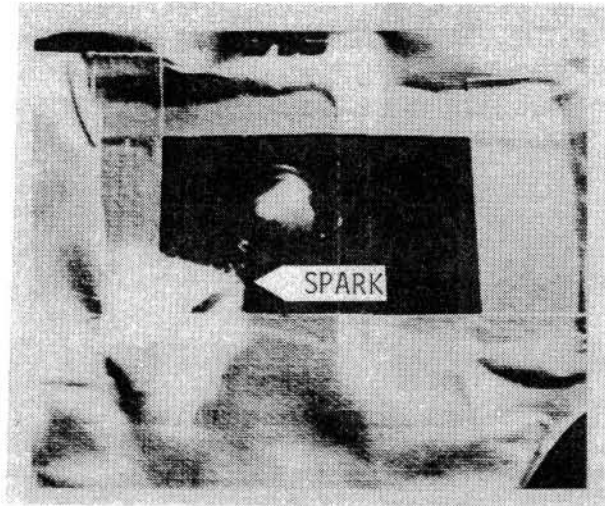
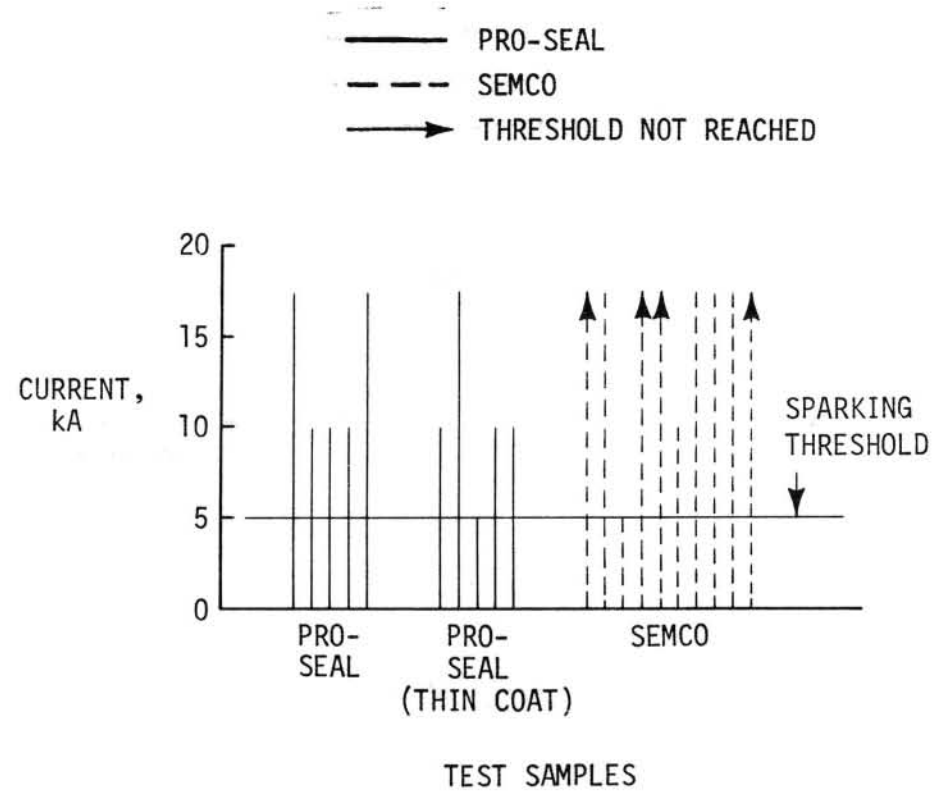
(a) Spark on fuel side.

(b) Sparking threshold.

Figure 16. - Sparking and sparking threshold for access/inspection panel dome nut on graphite/epoxy structure.

Graphite/epoxy skins. - Tests were conducted to determine the threshold for sparking through the fuel tank sealant on the fuel side of dome nut fasteners (fig. 16(a)). Figure 16(b) is a plot showing sparking threshold for the fasteners and fuel tank sealants evaluated. Figure 16(b) indicates that there is considerable scatter in the data. Some specimens sparked at 5 kA whereas other specimens did not spark at the highest test current of 17 kA. For the configuration tested, an individual dome nut fastener, treated with fuel tank sealant conducted up to 5 kA of current without sparking. Although two different sealants were evaluated, it is beyond the scope of this paper to discuss the relative merits thereof.

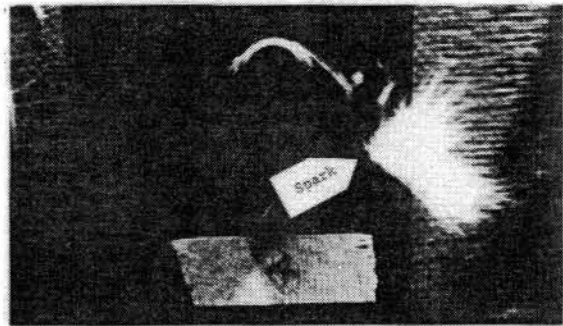
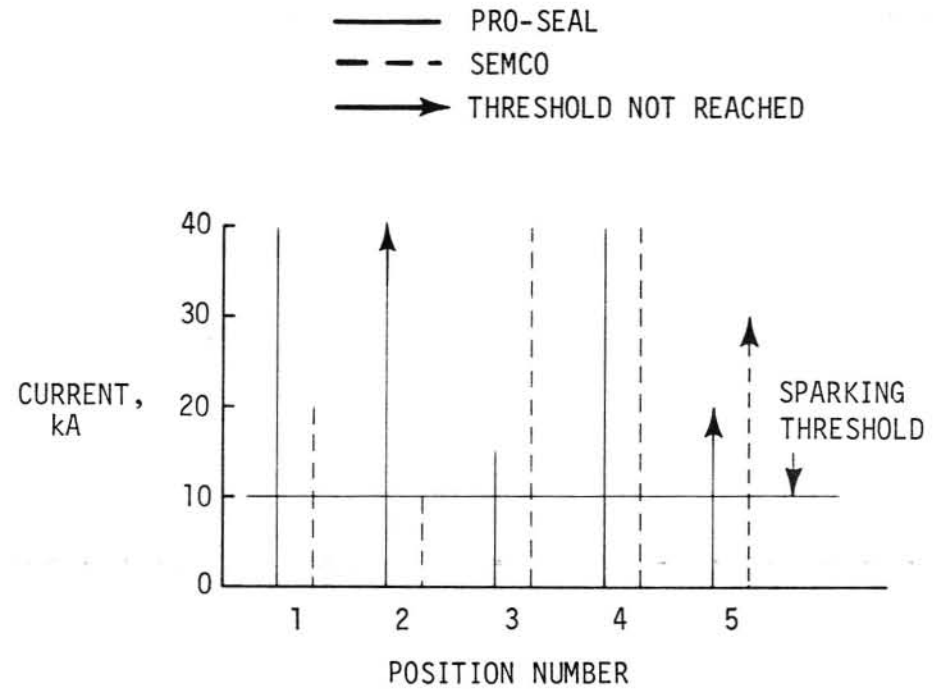
(a) Spark on fuel side.

(b) Sparking threshold.

Figure 17. - Sparking and sparking threshold for metal fuel feed-through elbows on graphite/epoxy structure.

The threshold for sparking through the fuel tank sealant on the metal fuel feed-through elbows was determined. Sparking through the fuel tank sealant at one of the test specimens is shown in figure 17(a) and the sparking data are presented in figure 17(b). There is considerable scatter in the data ranging from a low sparking current of 10 kA to a high current of 40 kA at which one specimen did not spark. The minimum sparking threshold observed was 10 kA.
