CREEP-RUPTURE BEHAVIOR OF SIX CANDIDATE STIRLING ENGINE IRON-BASE SUPERALLOYS IN HIGH PRESSURE HYDROGEN

VOLUME 1 - AIR CREEP-RUPTURE BEHAVIOR

S. Bhattacharyya
IIT RESEARCH INSTITUTE
10 West 35th Street
Chicago, Illinois 60616

DECEMBER 1982

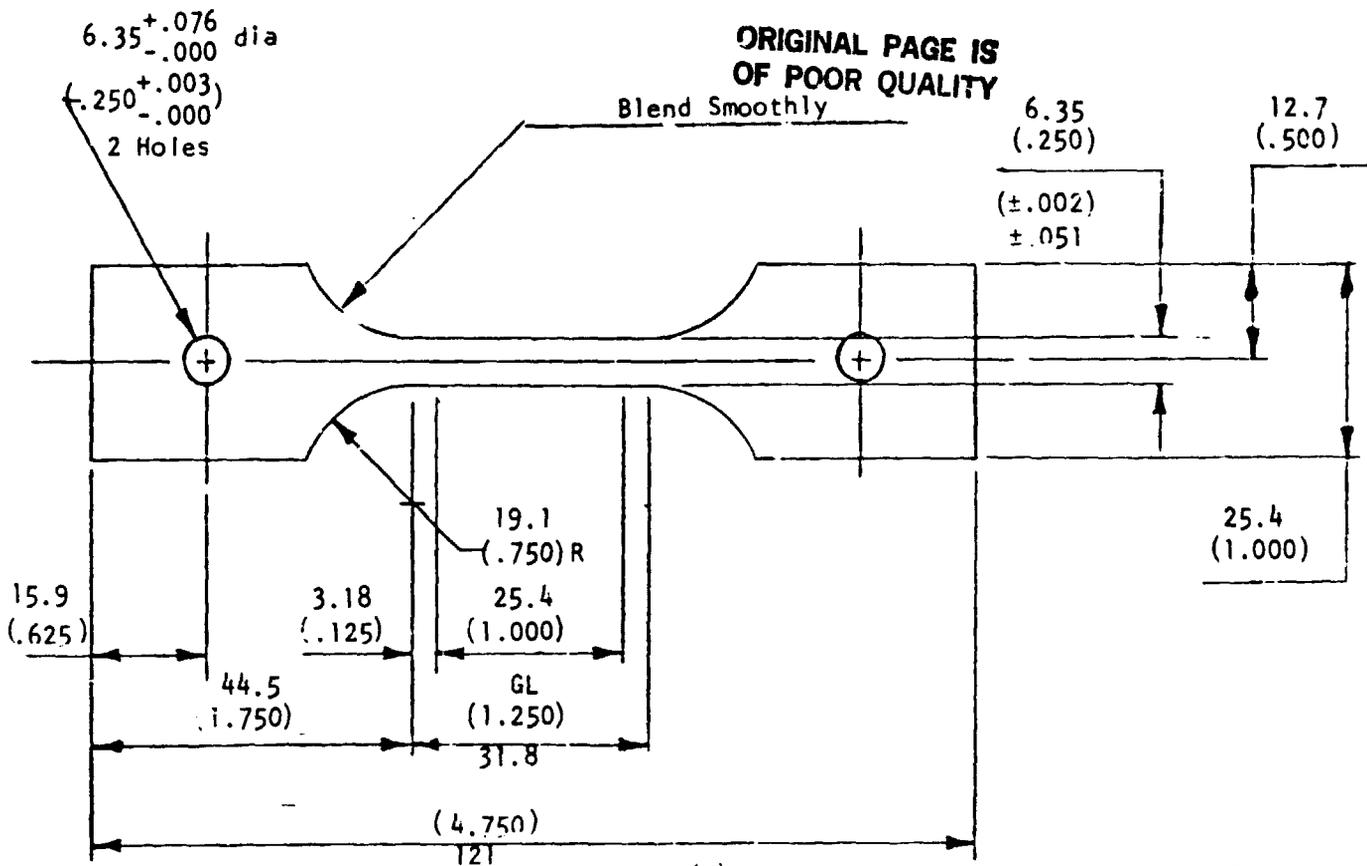
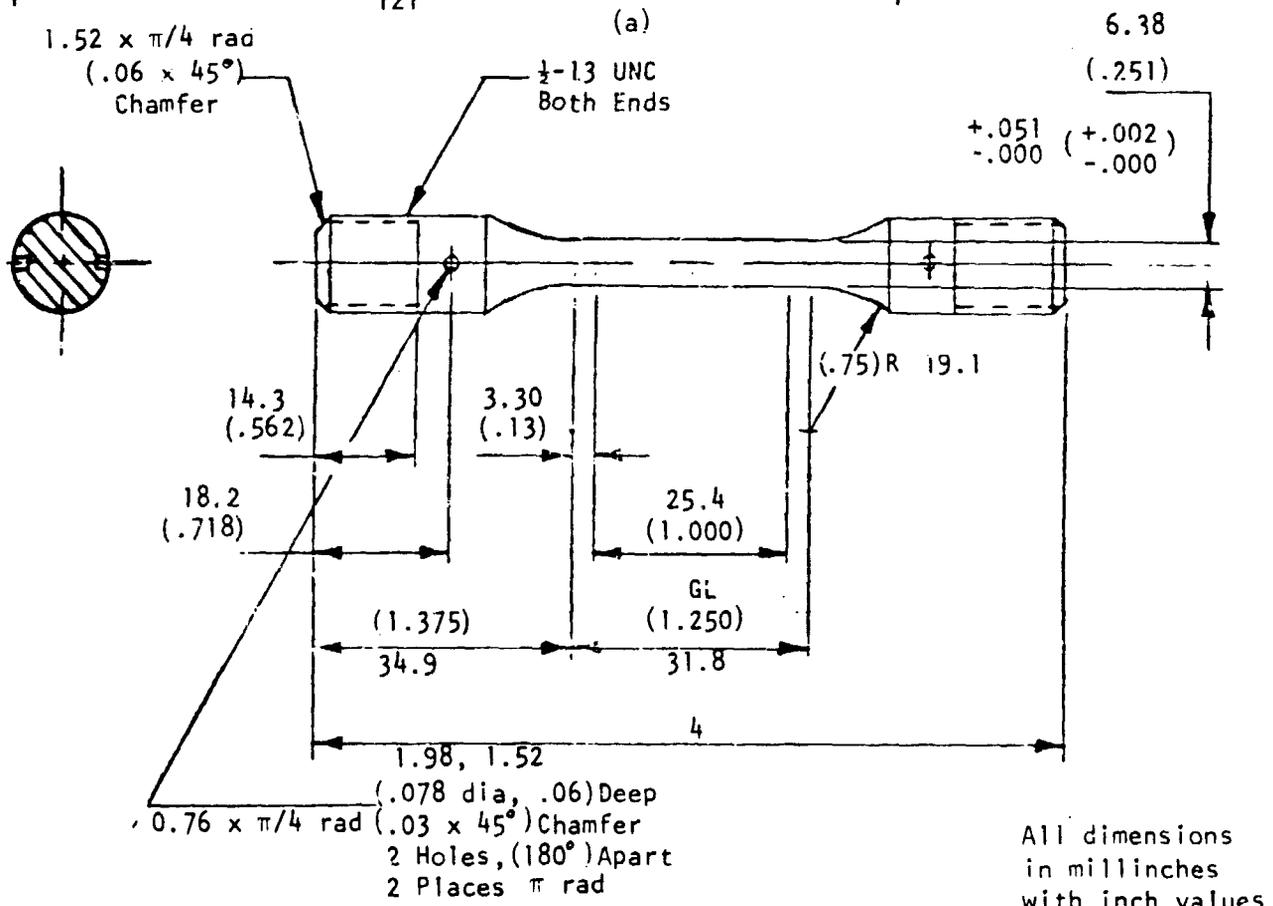
All dimensions
in millinches
with inch values
given in
parentheses

Figure 1. Creep-rupture specimen design. (a) Wrought (sheet), (b) cast.

Specimen dimensions were measured to $\pm 25.4 \mu\text{m}$, and the cross-sectional areas were calculated to three significant digits. Both the sheet and round specimens had a length/width (dia) ratio of 4, and the reduced section length was 31.8 mm. Extensometers were attached to the specimen shoulders. The fractured specimens were fitted together, and the distance separating the extensometer positions were measured to obtain the total extension. To calculate elongation (as percent), the divisor was taken as the adjusted length of the reduced section as defined in ASTM E139.

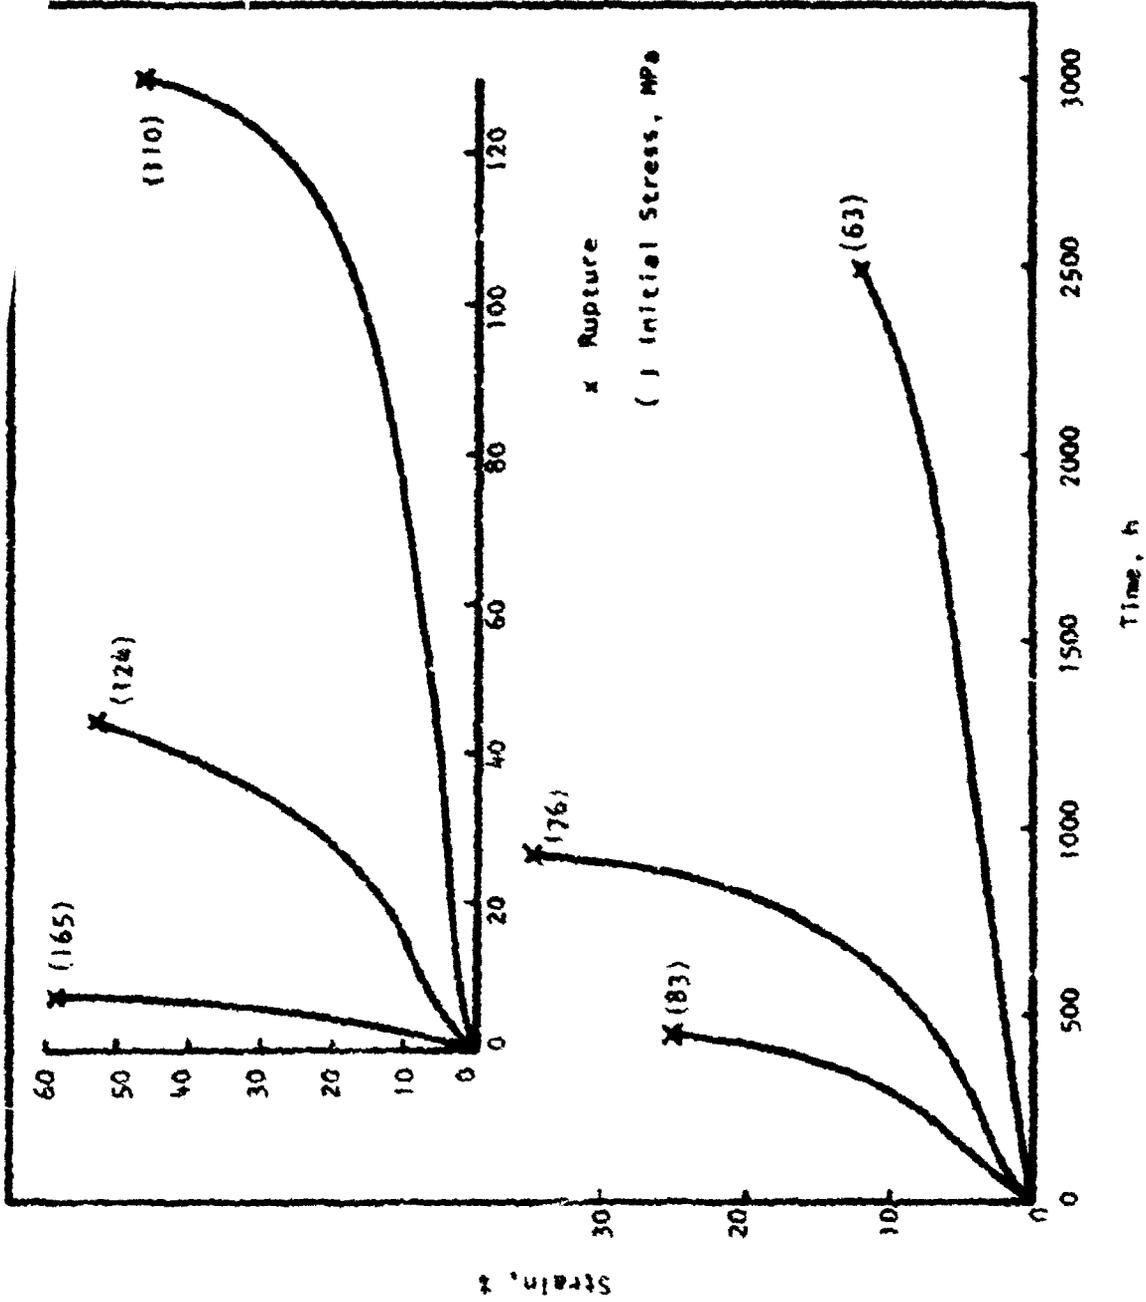
Figure 4. Creep curves for M-155 tested at 815°C in air.

In both Figs. 4 and 5, the creep curves show the three stages of creep--primary, secondary, and tertiary--leading to rupture. The extent of the secondary creep range and the onset of tertiary creep as well as the duration of tertiary creep stage leading to fracture depend on alloy structure and stress levels. In the cast alloy CRM-6D, the tertiary stage is considerably shorter than that in the wrought alloy N-155, and the total strain is also much less.

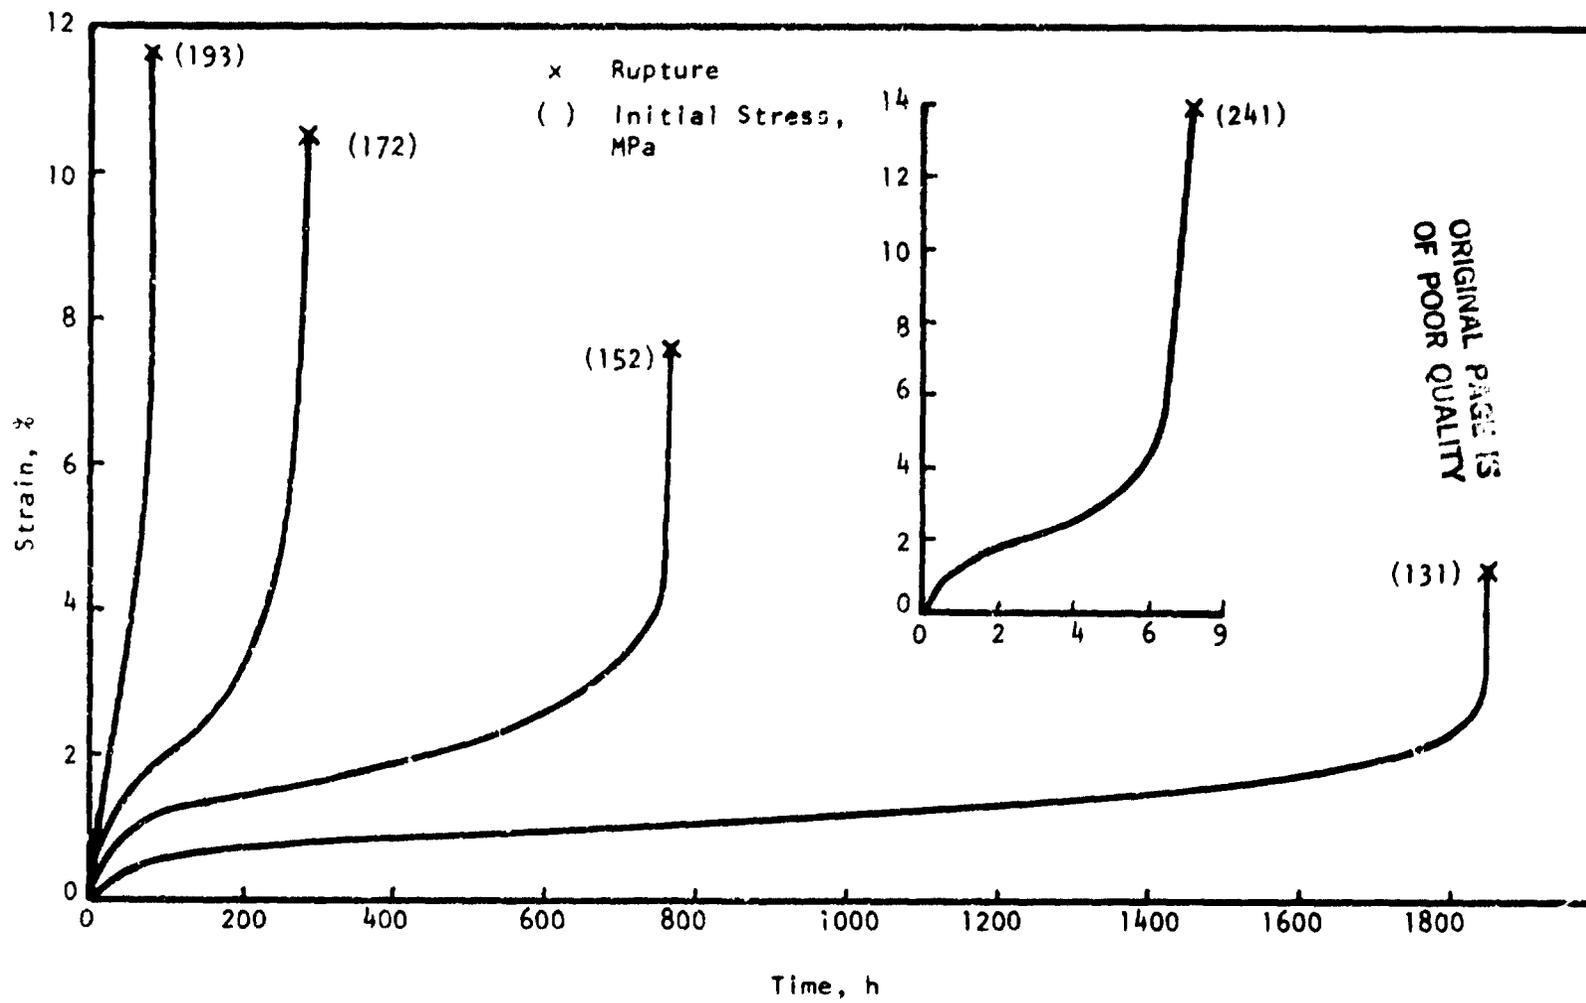
Figure 5. Creep curves for CRM-6D tested at 815°C in air.

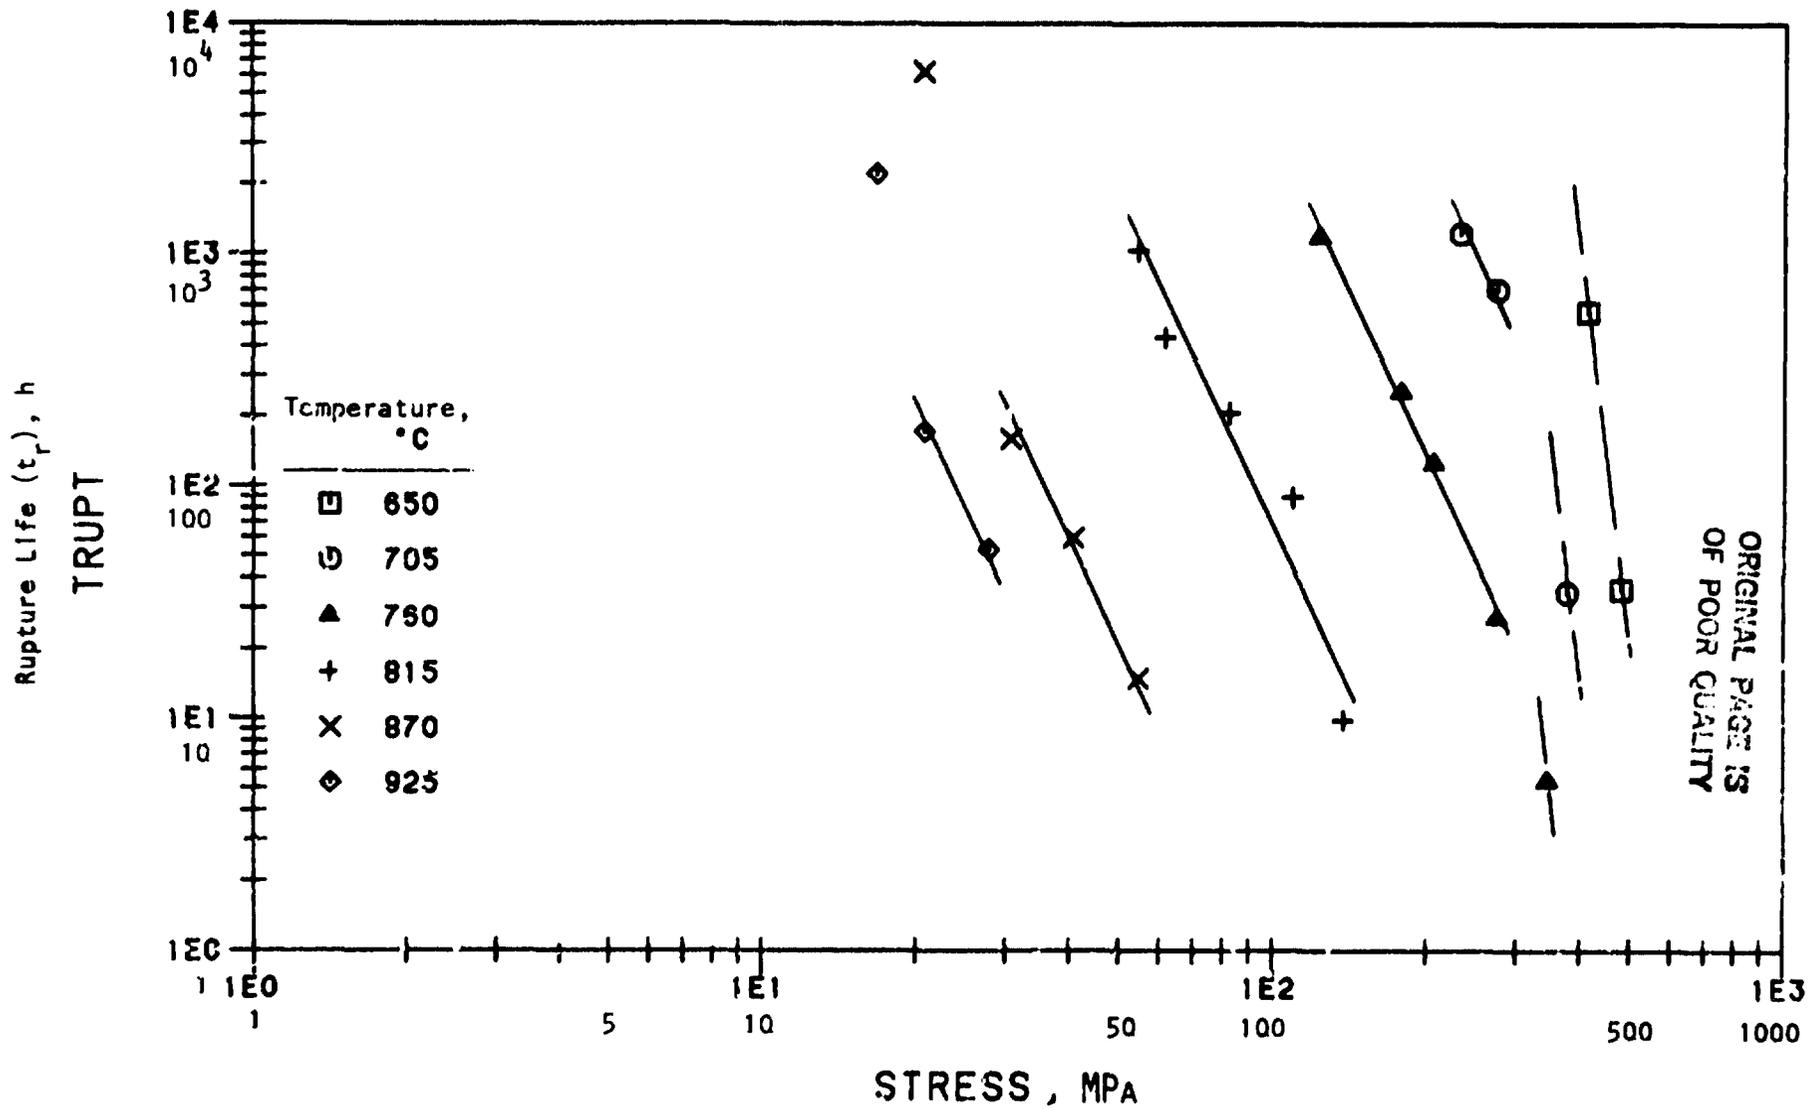
Figure 6. Stress vs. rupture life of A-286 in air.

Based on these correlations, the data were fitted graphically to obtain rupture life vs. stress relationships shown in Figs. 6 to 11 for the six alloys. In all the figures, the regression lines were fitted to the data analyzed. The remaining data at the higher and lower temperature levels are also plotted on these figures. At these temperatures, the data were too few to obtain the slopes which differ from the slopes of the fitted lines indicating a different model of creep at these extreme temperature ranges.

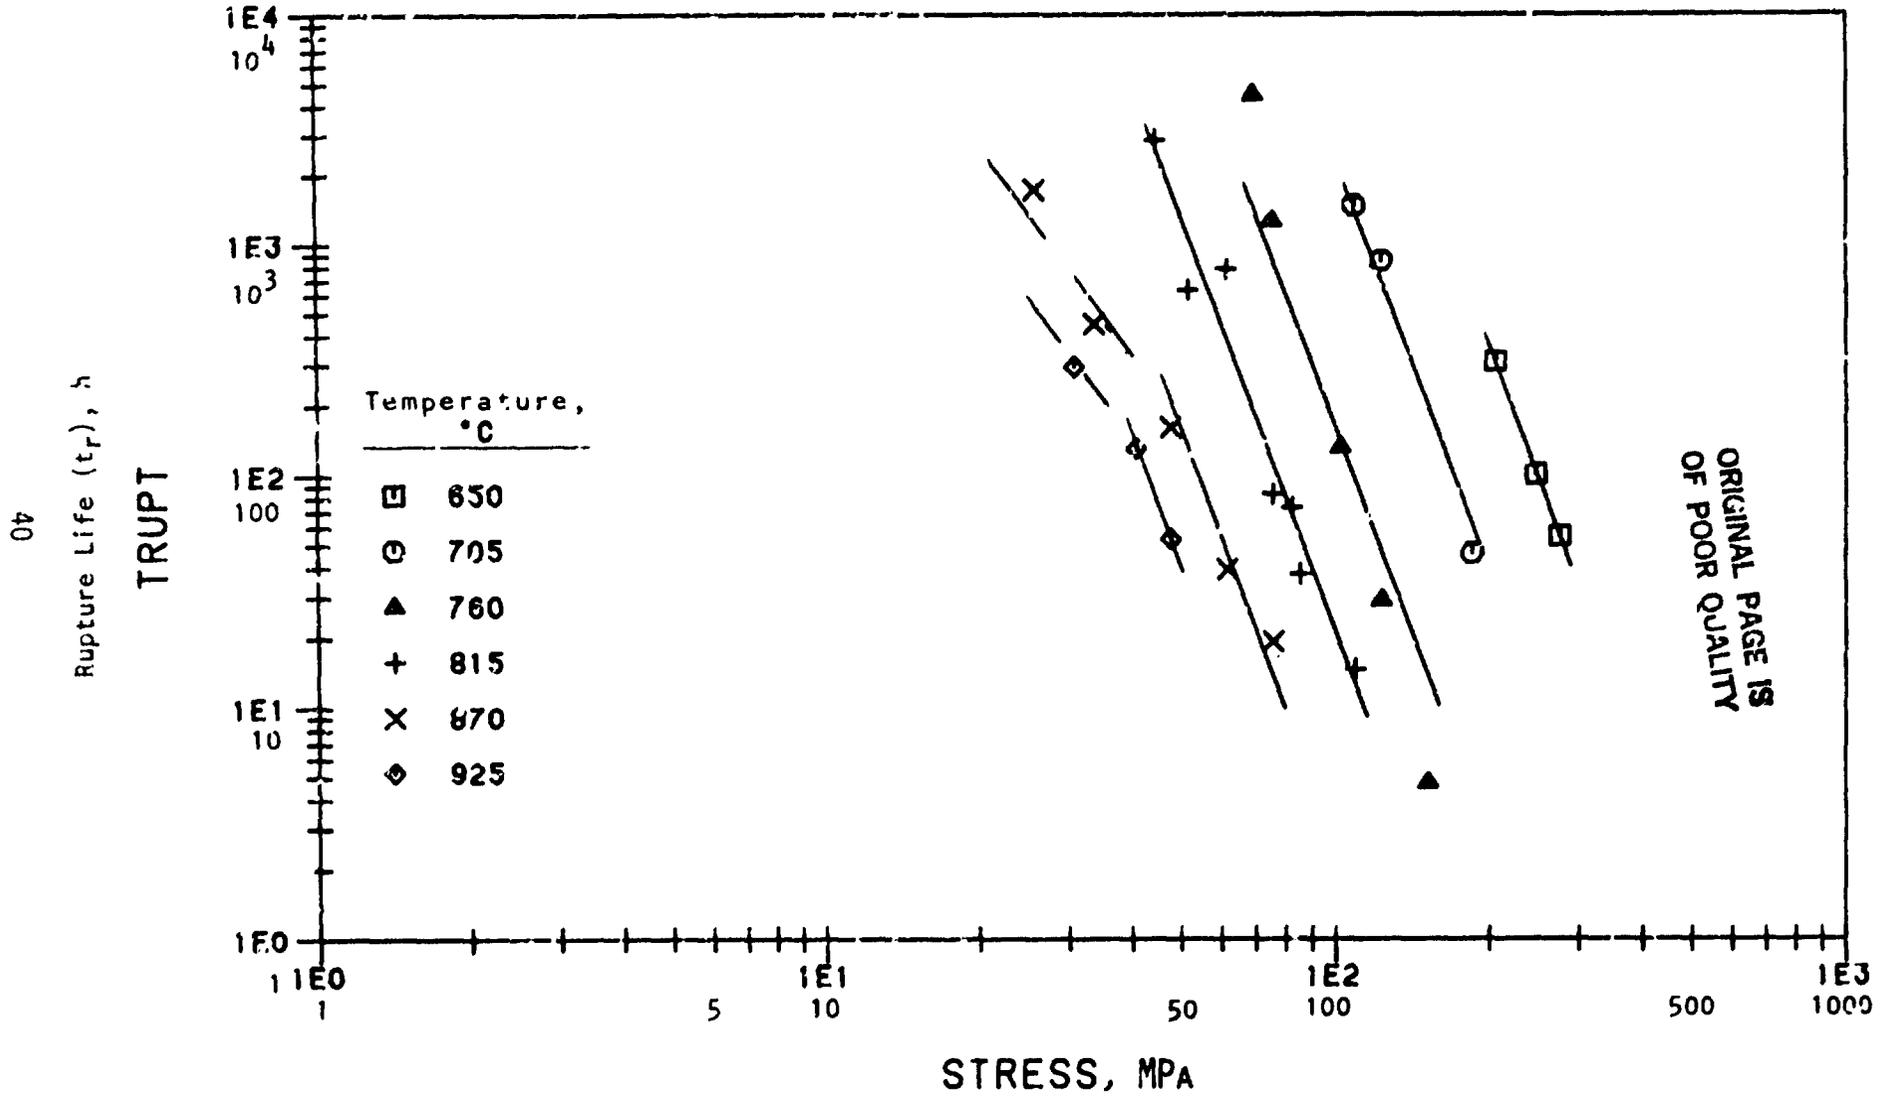
Figure 7. Stress vs. rupture life of IN 800H in air.

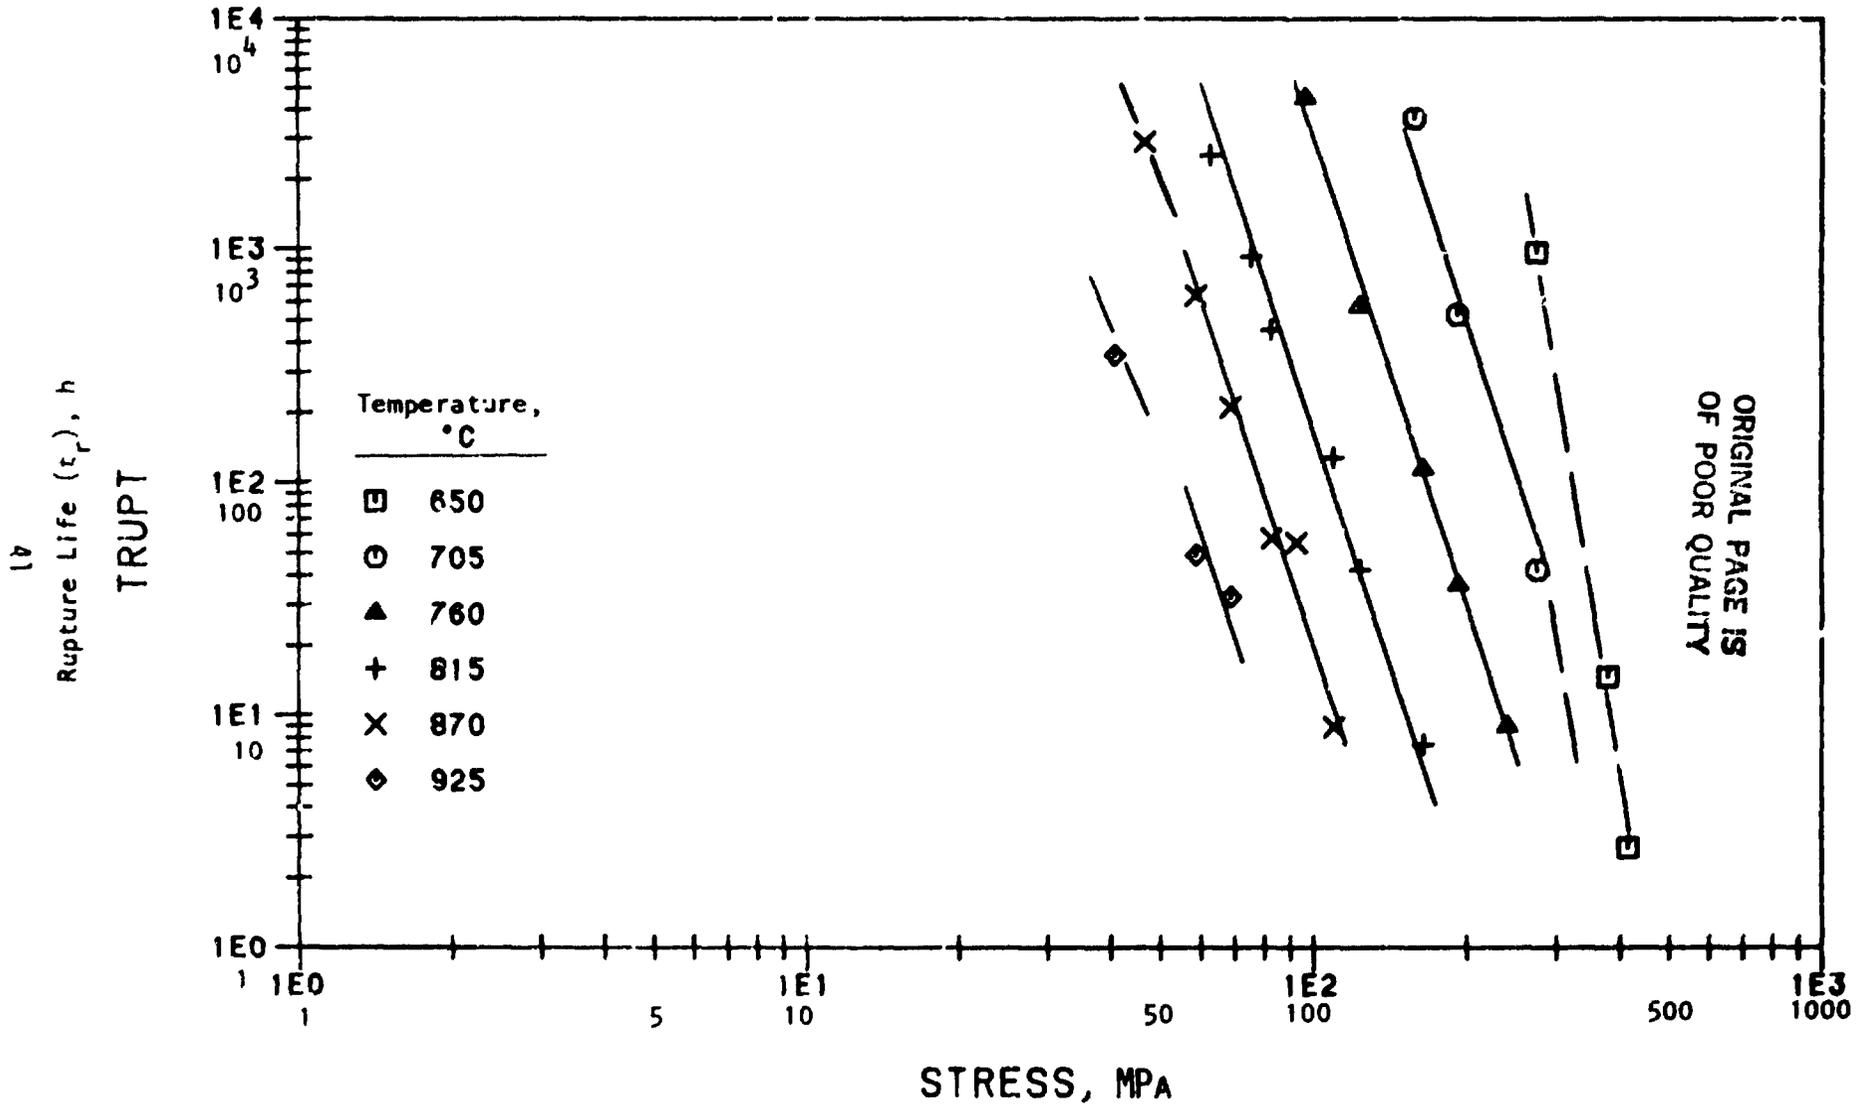
Figure 8. Stress vs. rupture life of N-155 in air.

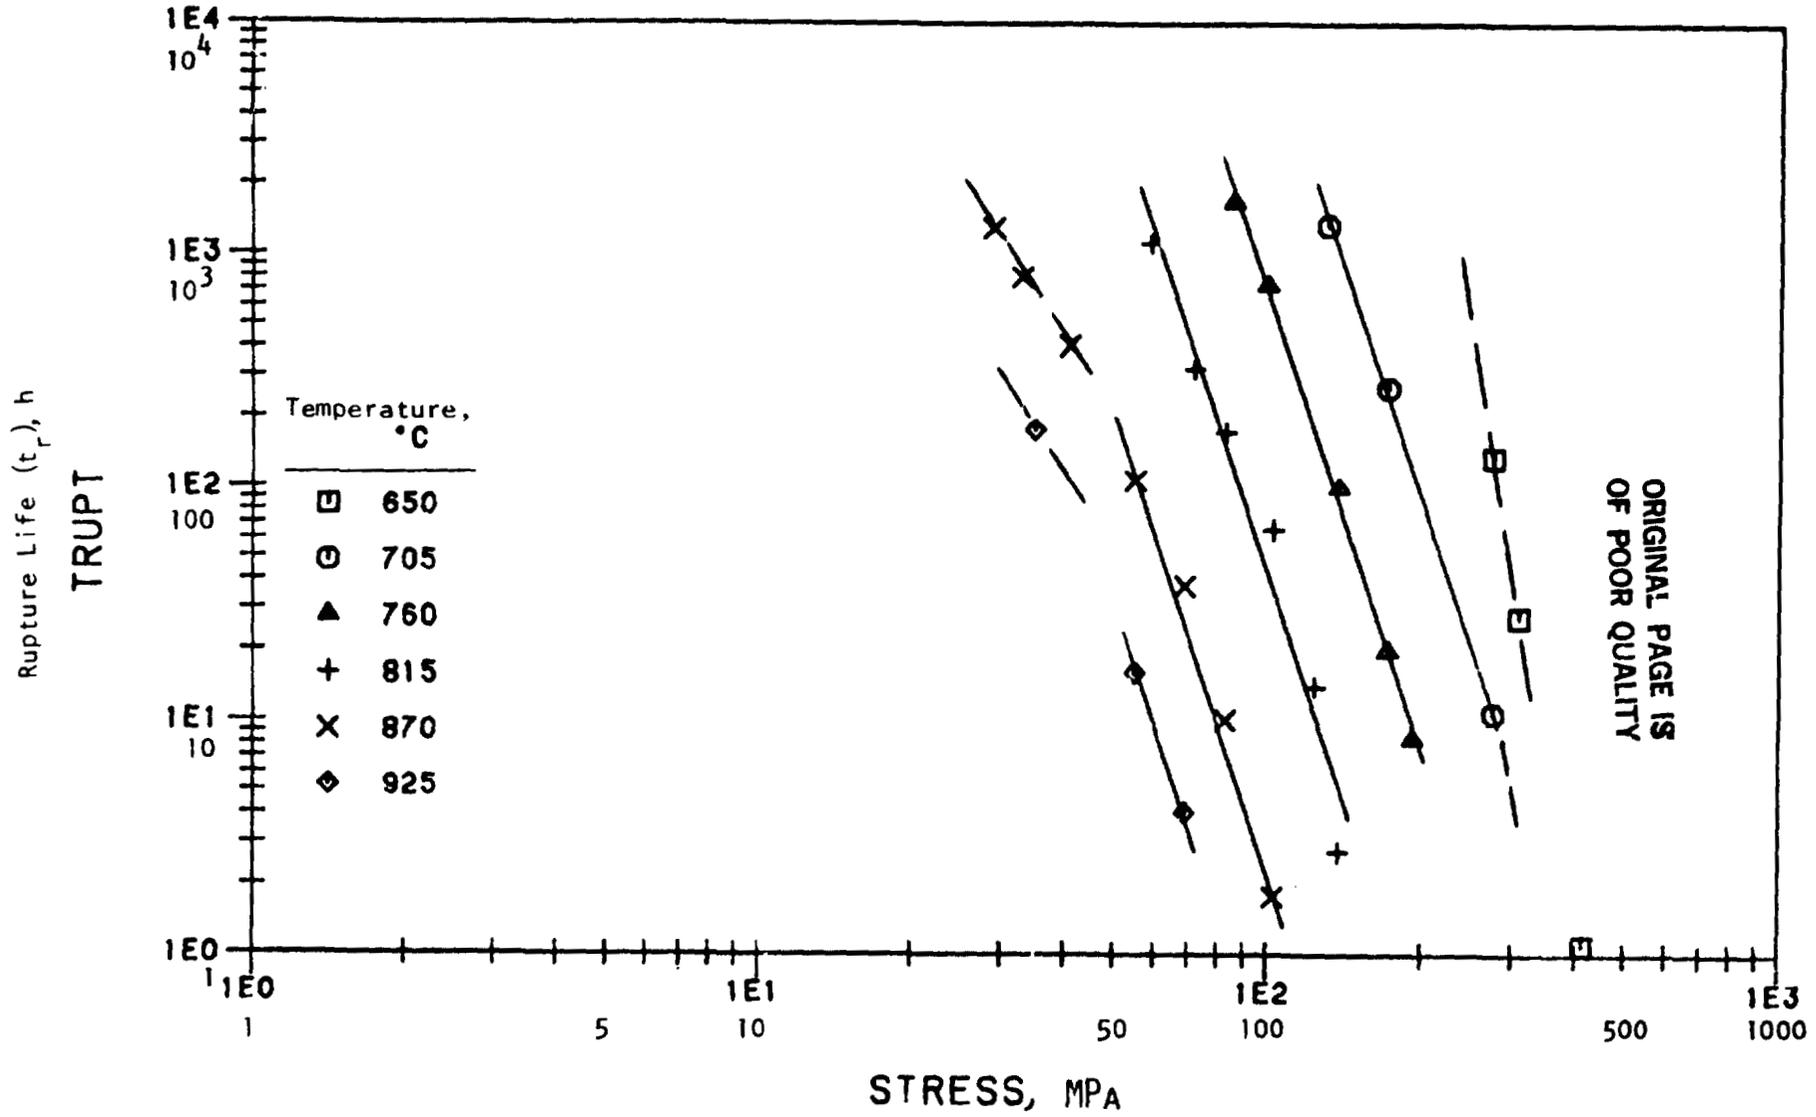
Figure 9. Stress vs. rupture life of 19-9DL in air.

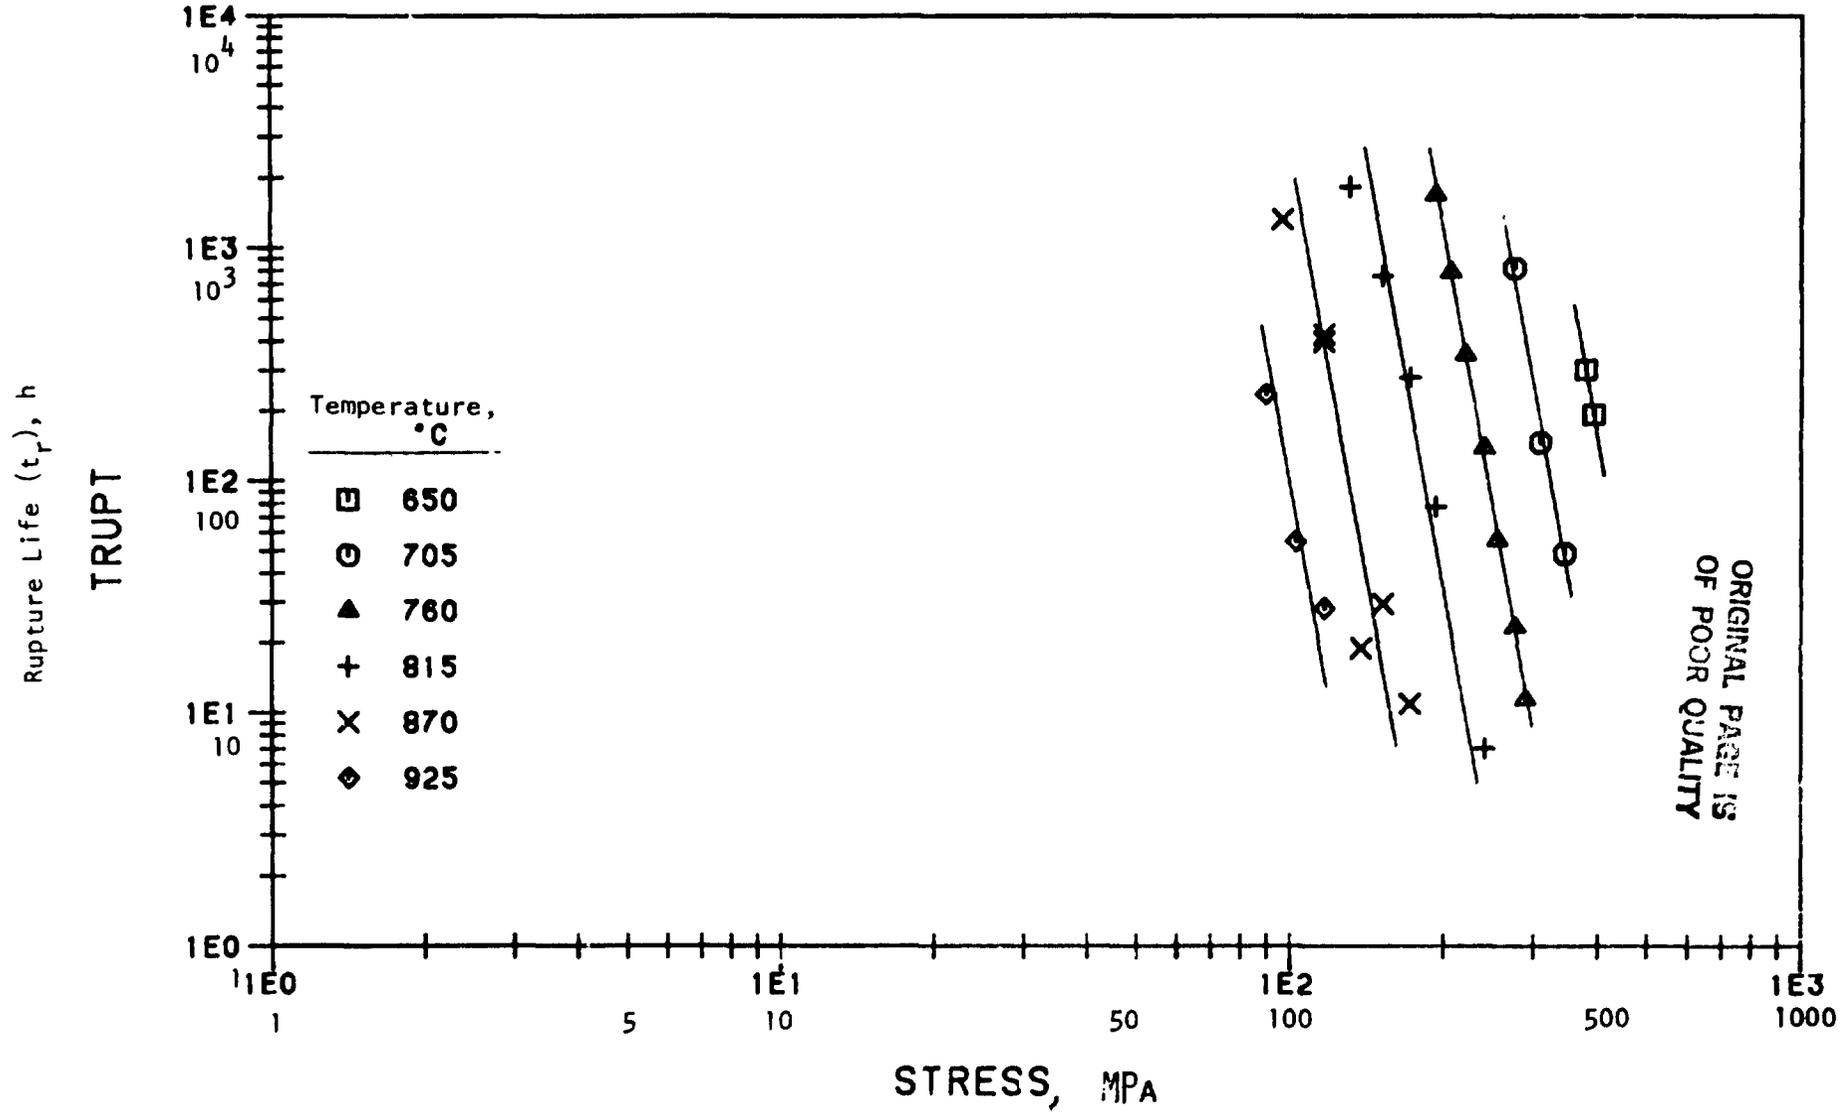
Figure 10. Stress vs. rupture life of CRM-6D in air.

CRM-6D had a very high slope of -12.3, almost twice as large as that of the wrought alloys, indicating that its rupture life is far more sensitive to small stress fluctuations than that for the wrought alloys. The cast alloy XF-818 at the higher temperature range (760° to 815°C) has a slope significantly smaller than that of CRM-6D and only 20% more than that of the mean slope of the three wrought alloys mentioned above. This indicates that the rupture life of XF-818 will not be affected as seriously as that of CRM-6D at these temperatures due to small fluctuations of stress. On the other hand, at the low temperature ranges of 650° and 705°C, the XF-818 slope of -15.34 is the highest observed in this study and indicates a drastic potential loss in rupture life at these temperatures with a small increase in operating stress. More data at the lower temperatures in tests for long rupture lives will be desirable to more fully substantiate this behavior.

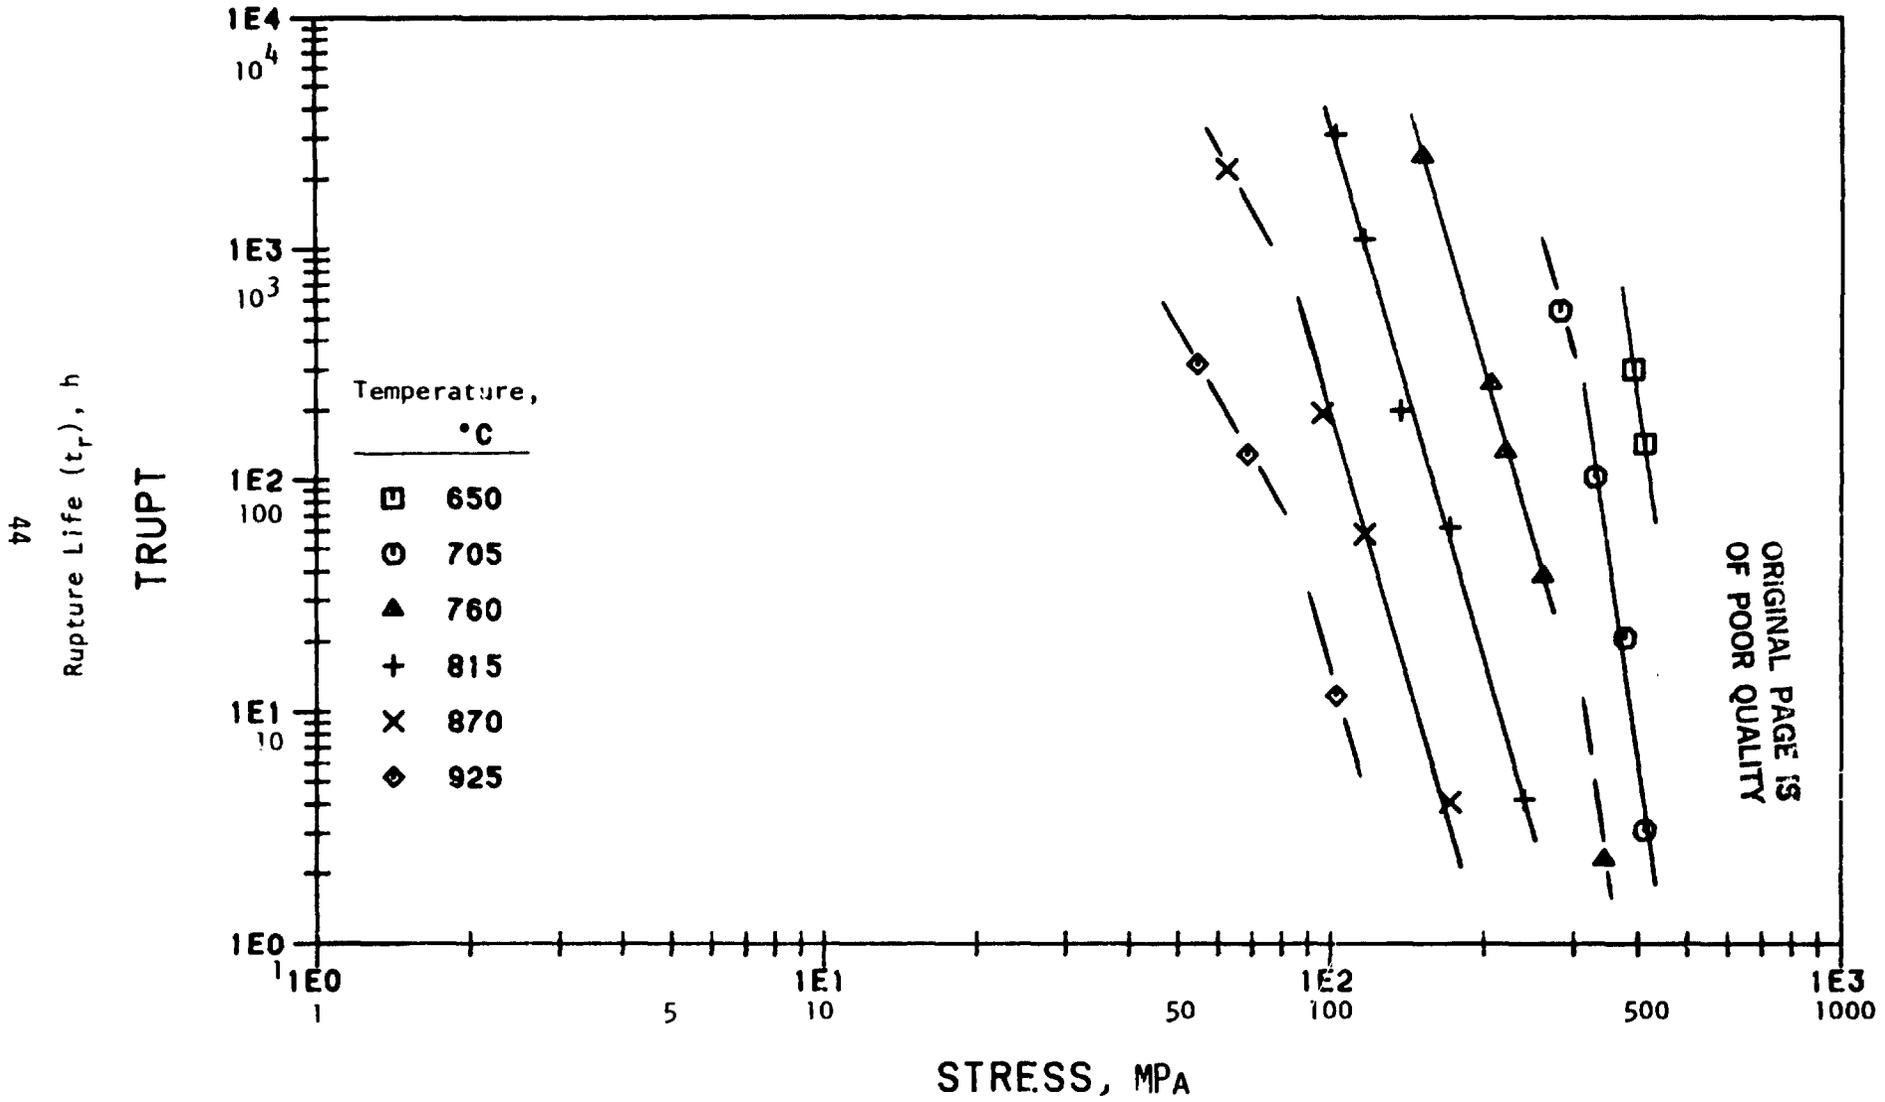
Figure 11. Stress vs. rupture life of XF-818 in air.

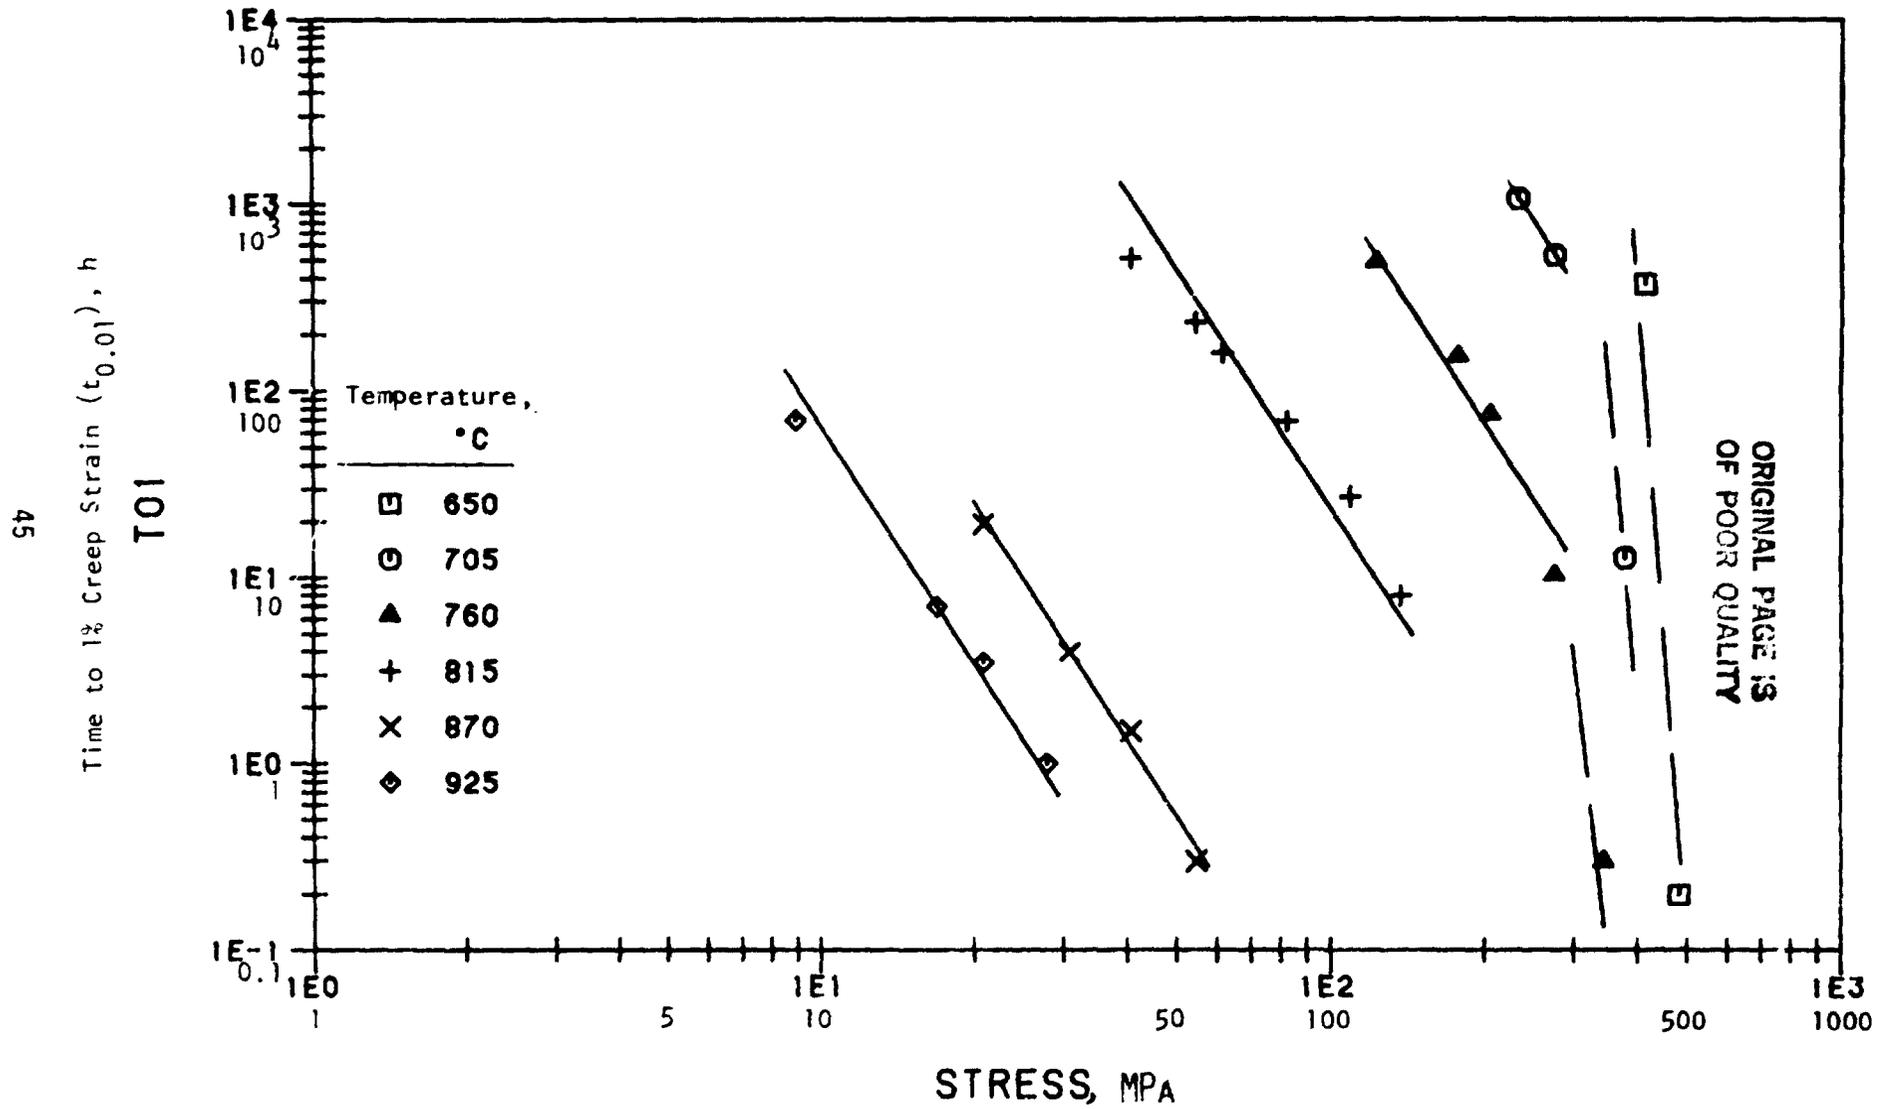
Figure 12. Stress vs. time to 1% creep strain of A-286 in air.

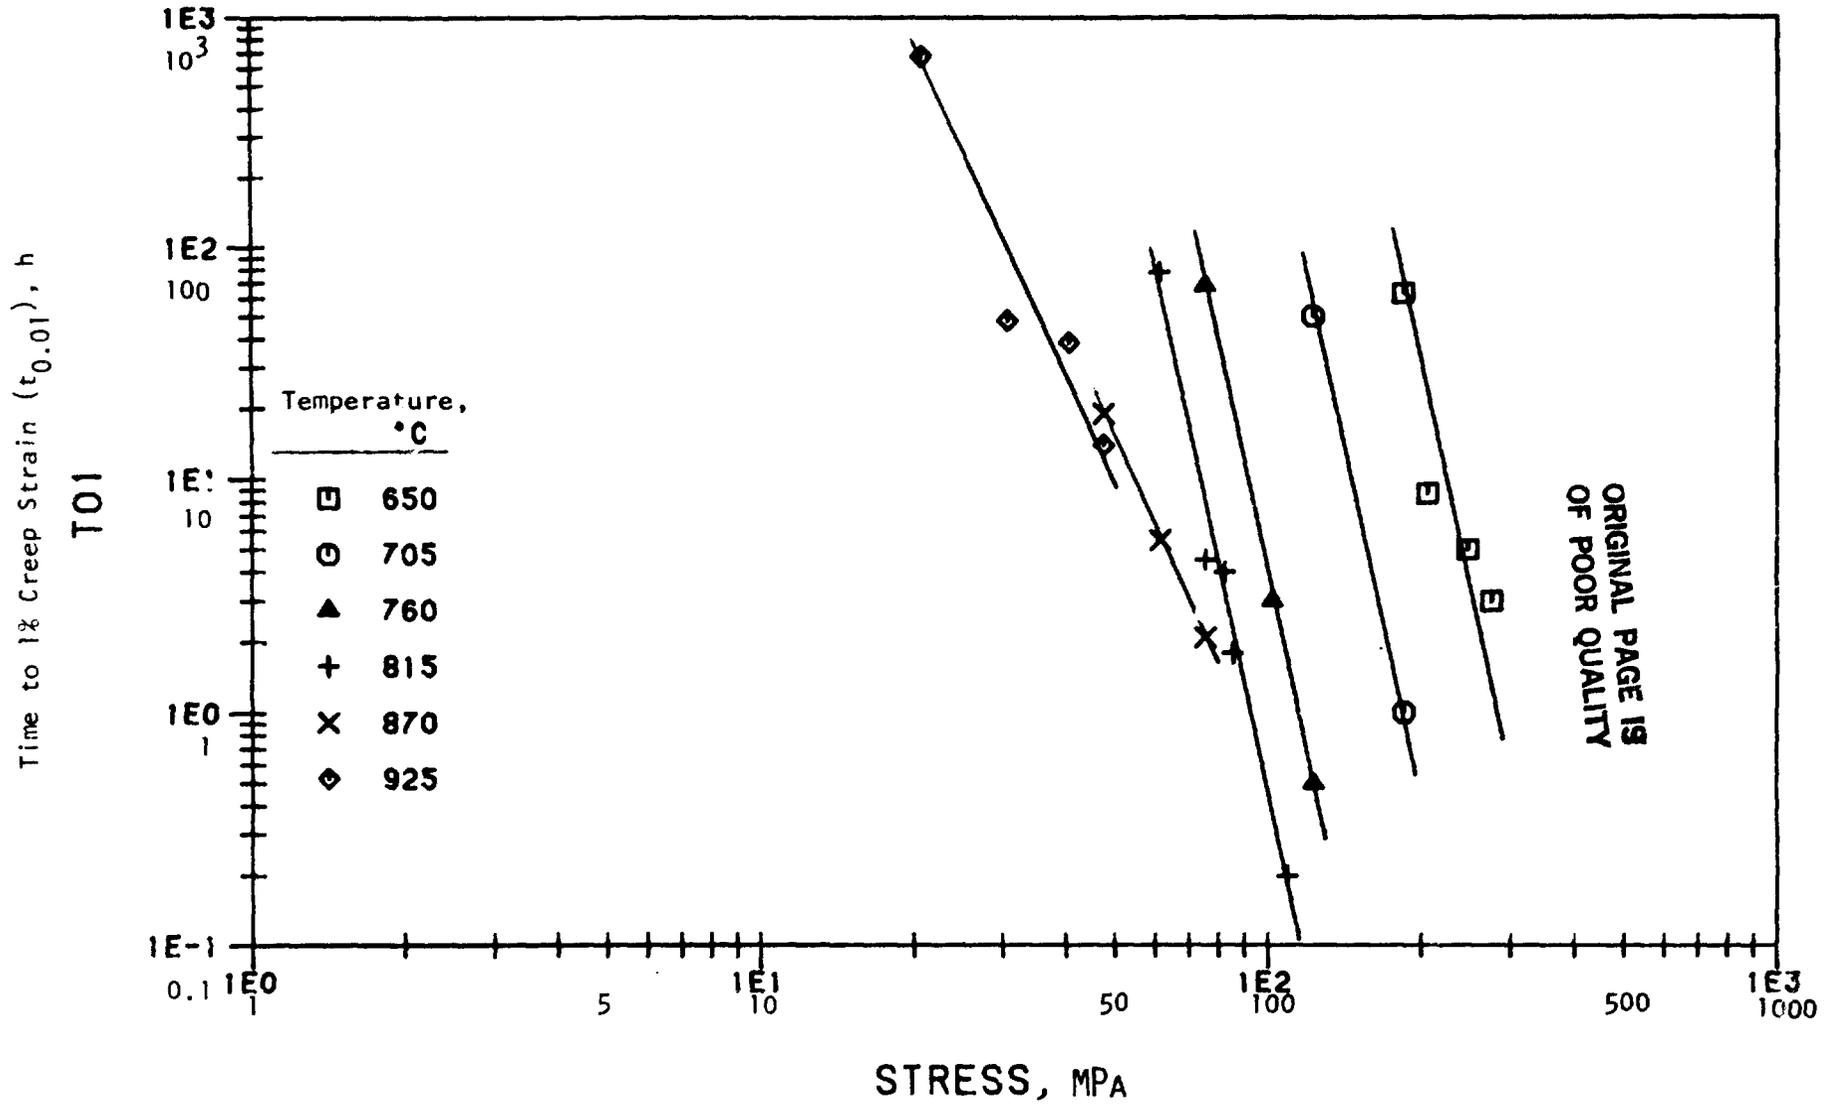
Figure 13. Stress vs. time to 1% creep strain of IN 800H in air.
