CREEP-RUPTURE BEHAVIOR OF SIX CANDIDATE STIRLING ENGINE IRON-BASE SUPERALLOYS IN HIGH PRESSURE HYDROGEN

VOLUME 1 - AIR CREEP-RUPTURE BEHAVIOR

S. Bhattacharyya
IIT RESEARCH INSTITUTE
10 West 35th Street
Chicago, Illinois 60616

DECEMBER 1982

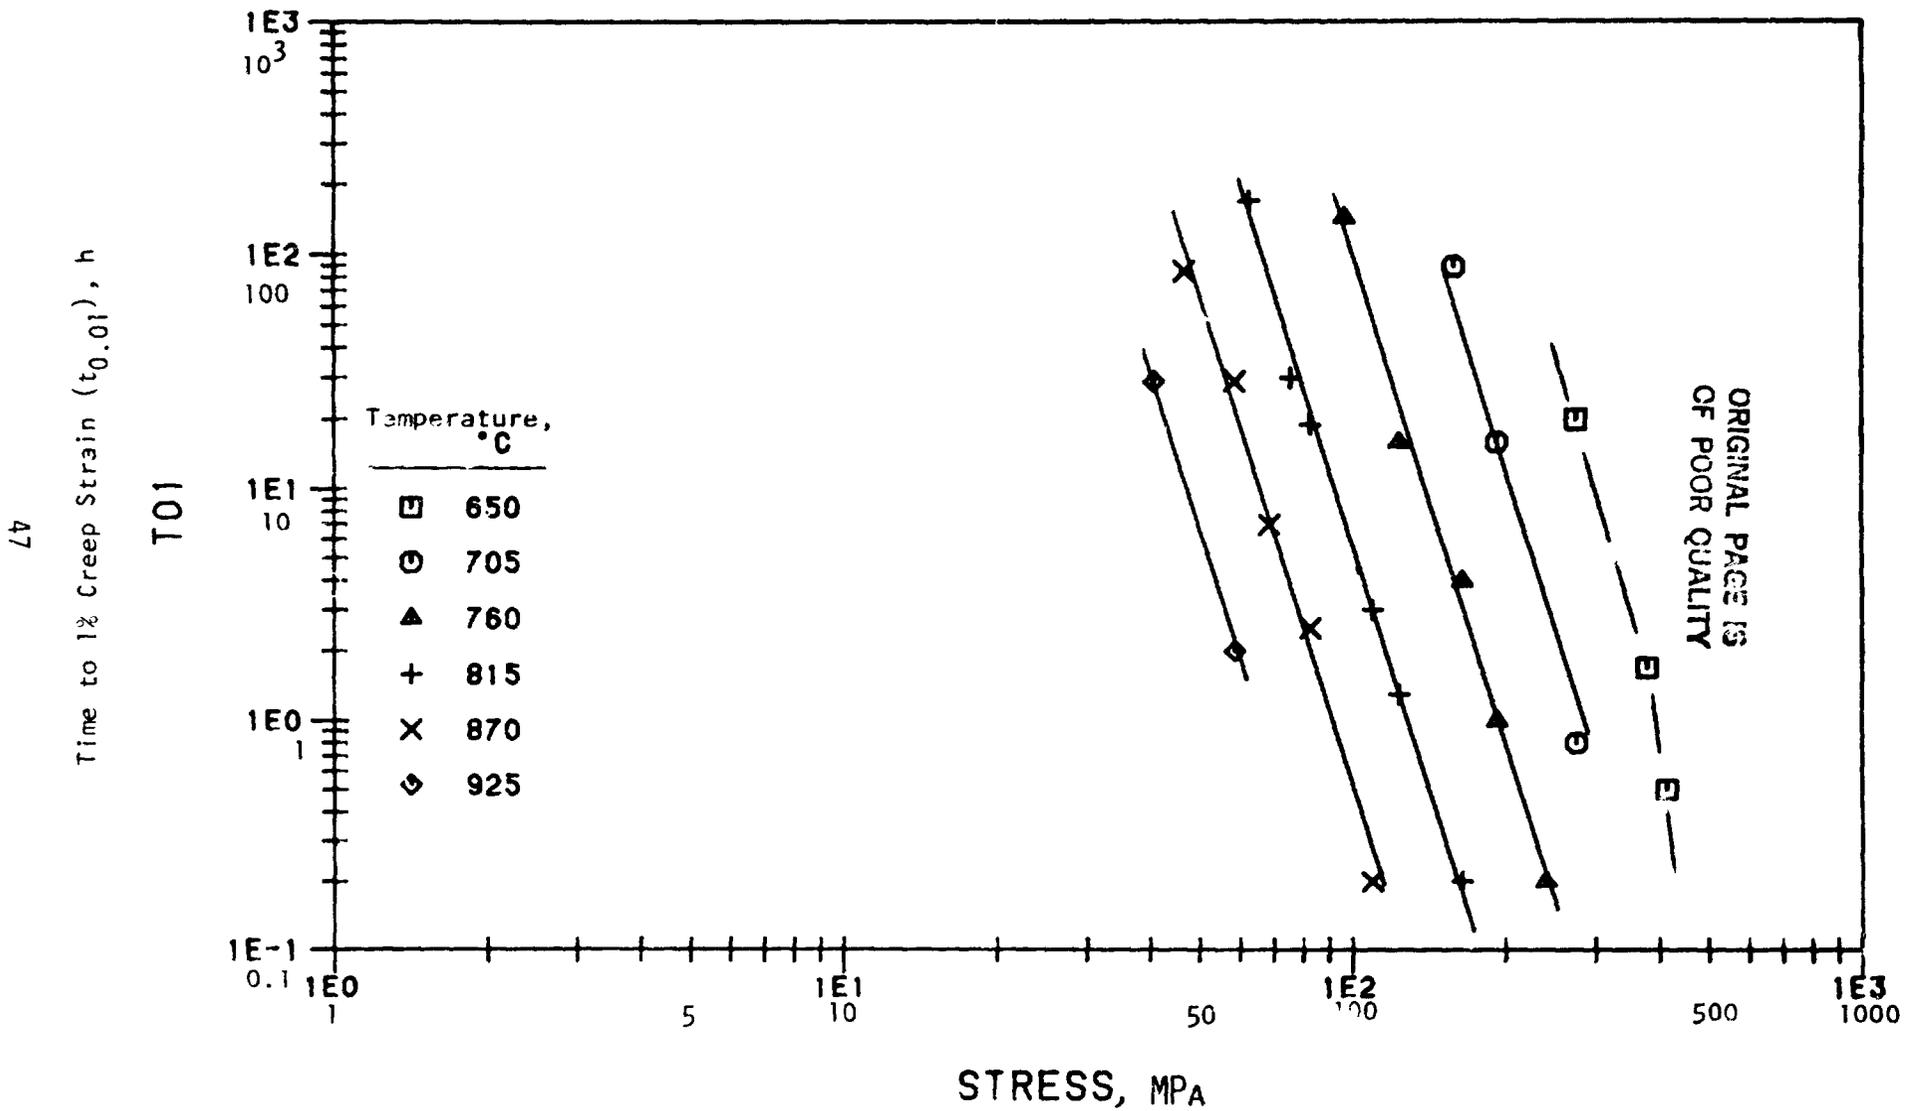
Figure 14. Stress vs. time to 1% creep strain of N-155 in air.

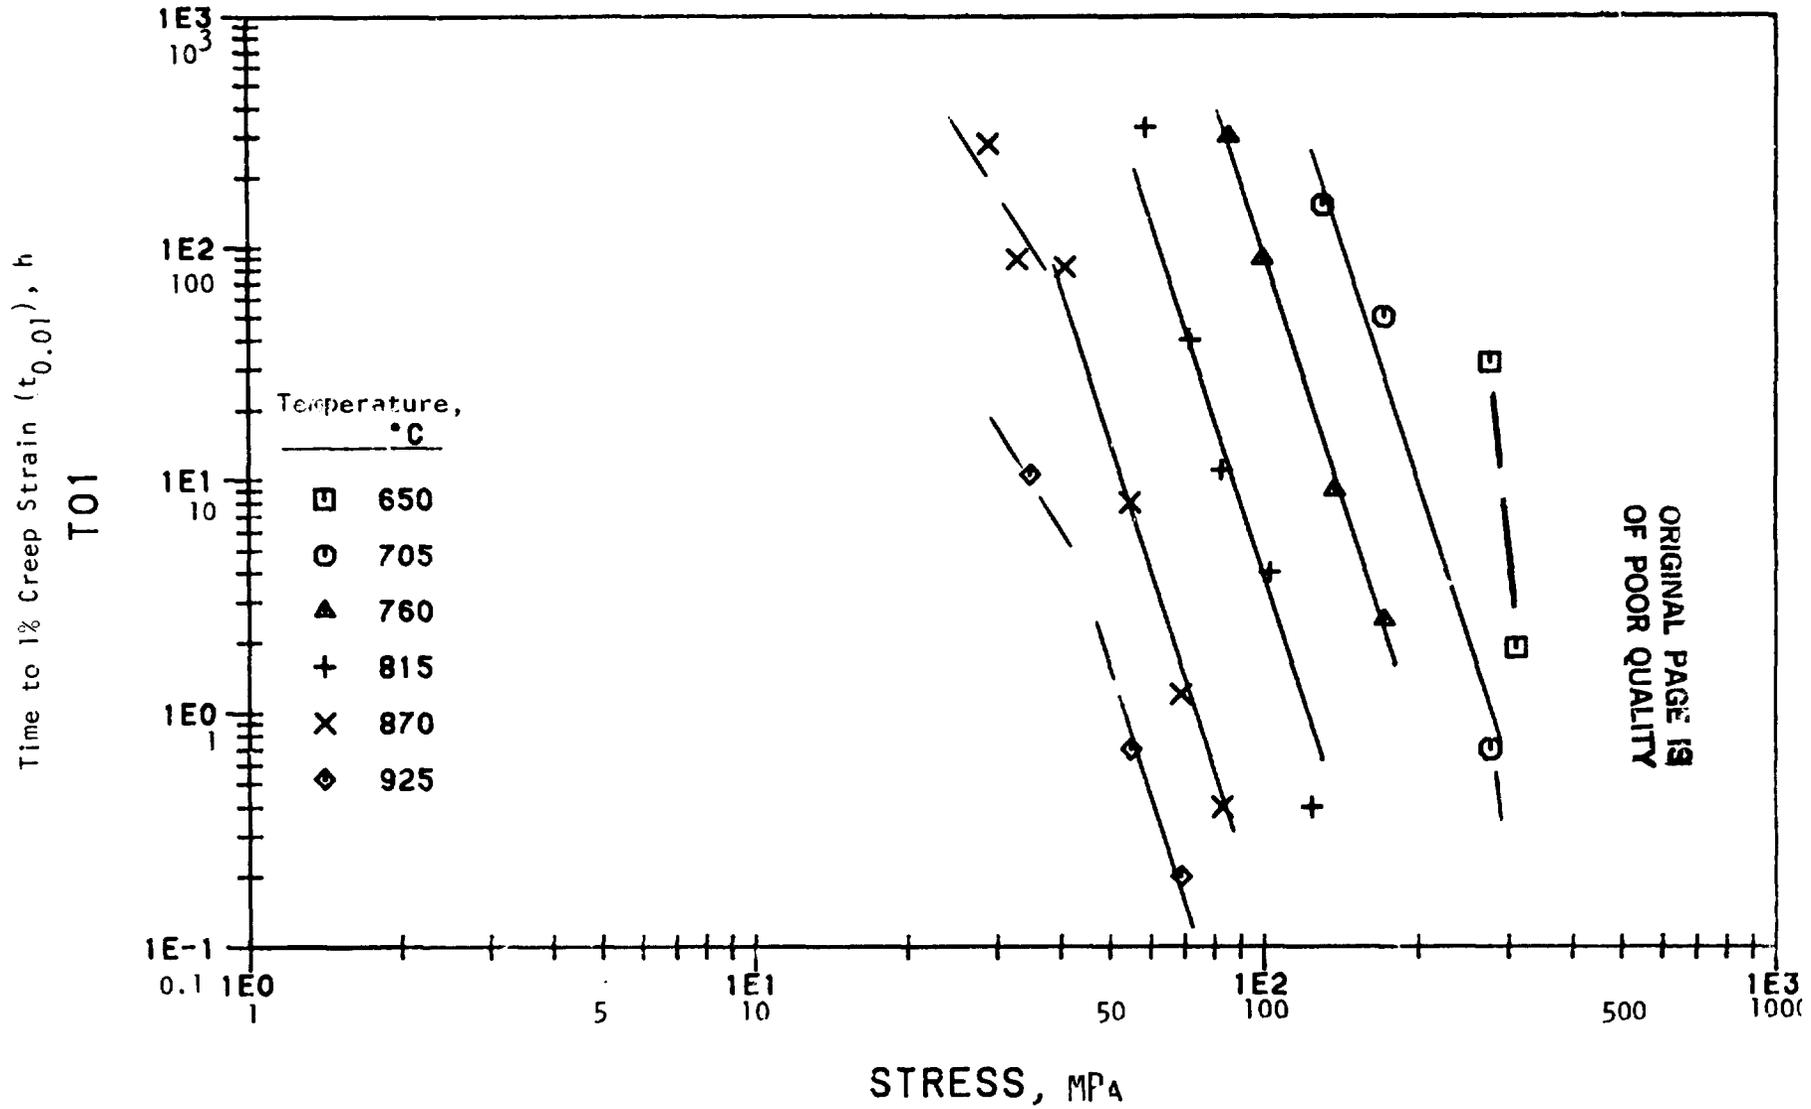
Figure 15. Stress vs. time to 1% creep strain of 19-9DL in air.

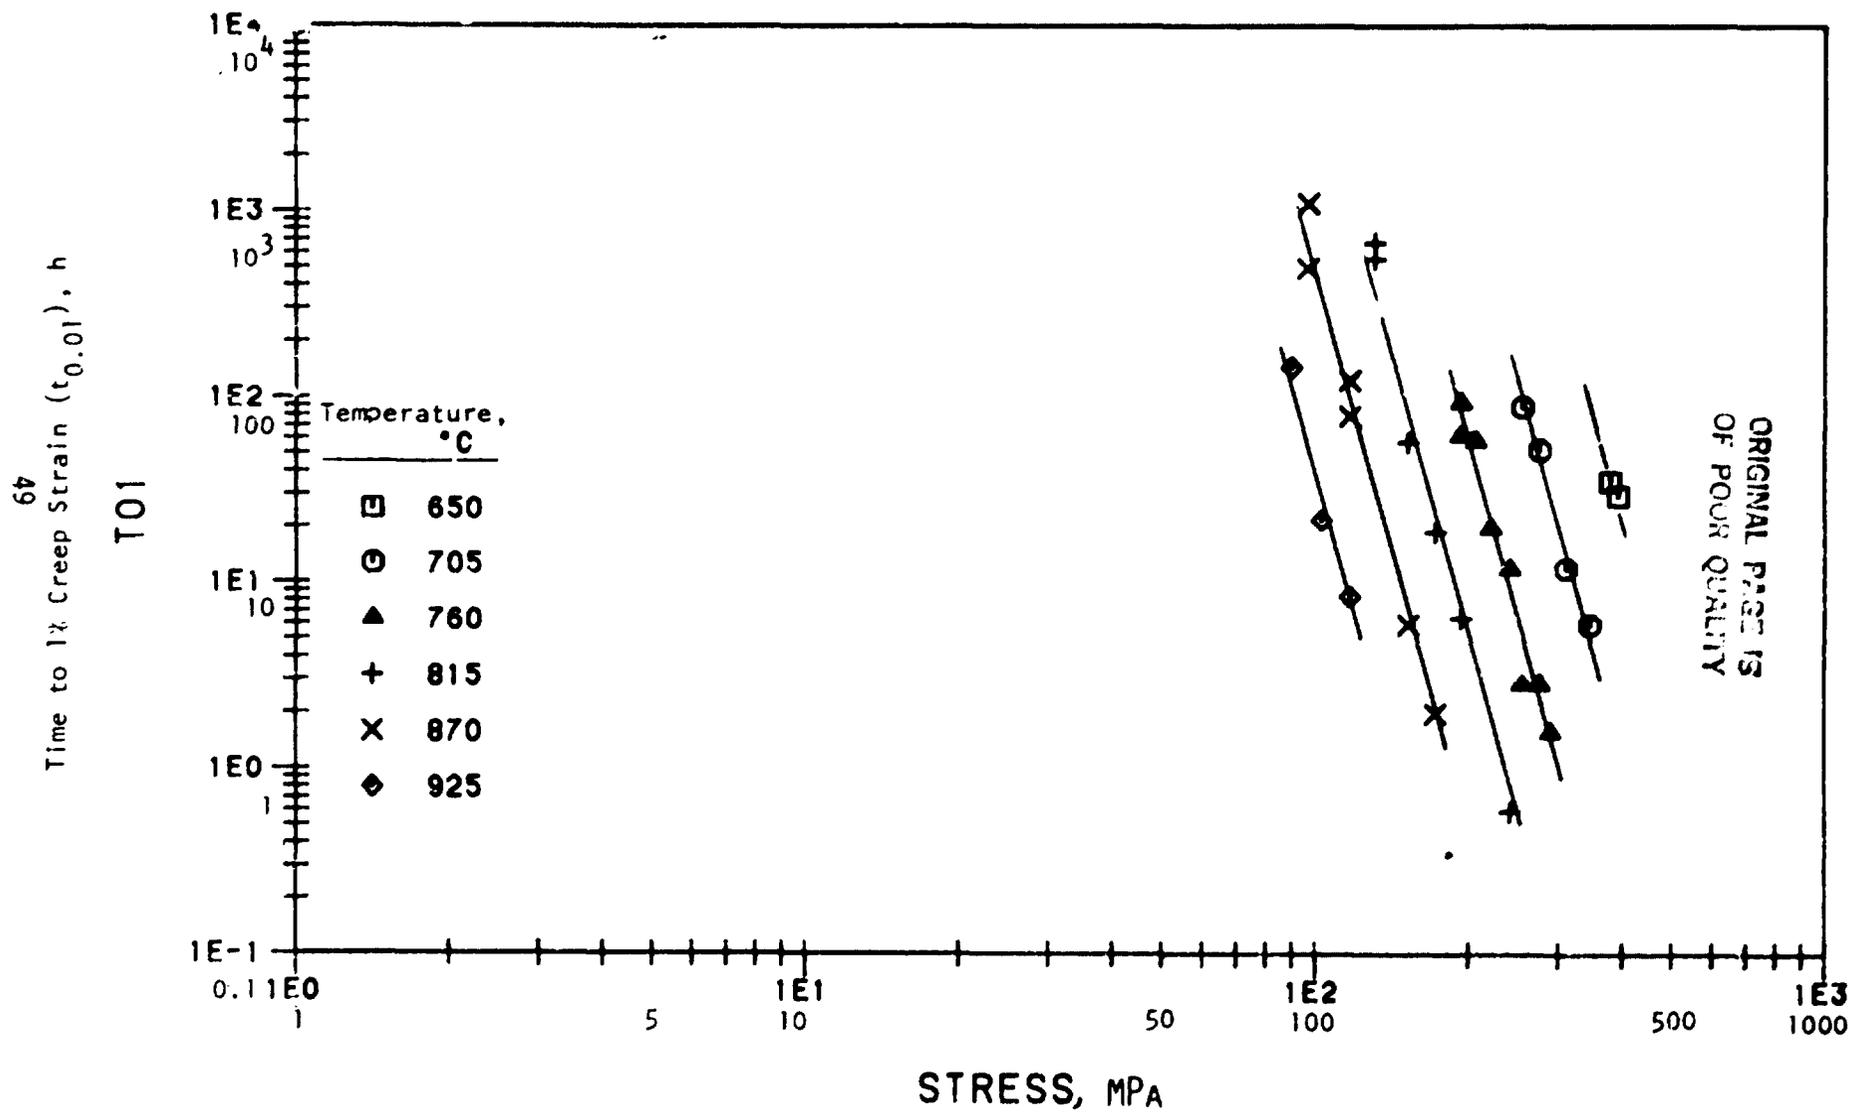
Figure 16. Stress vs. time to 1% creep strain of CRM-6D in air.

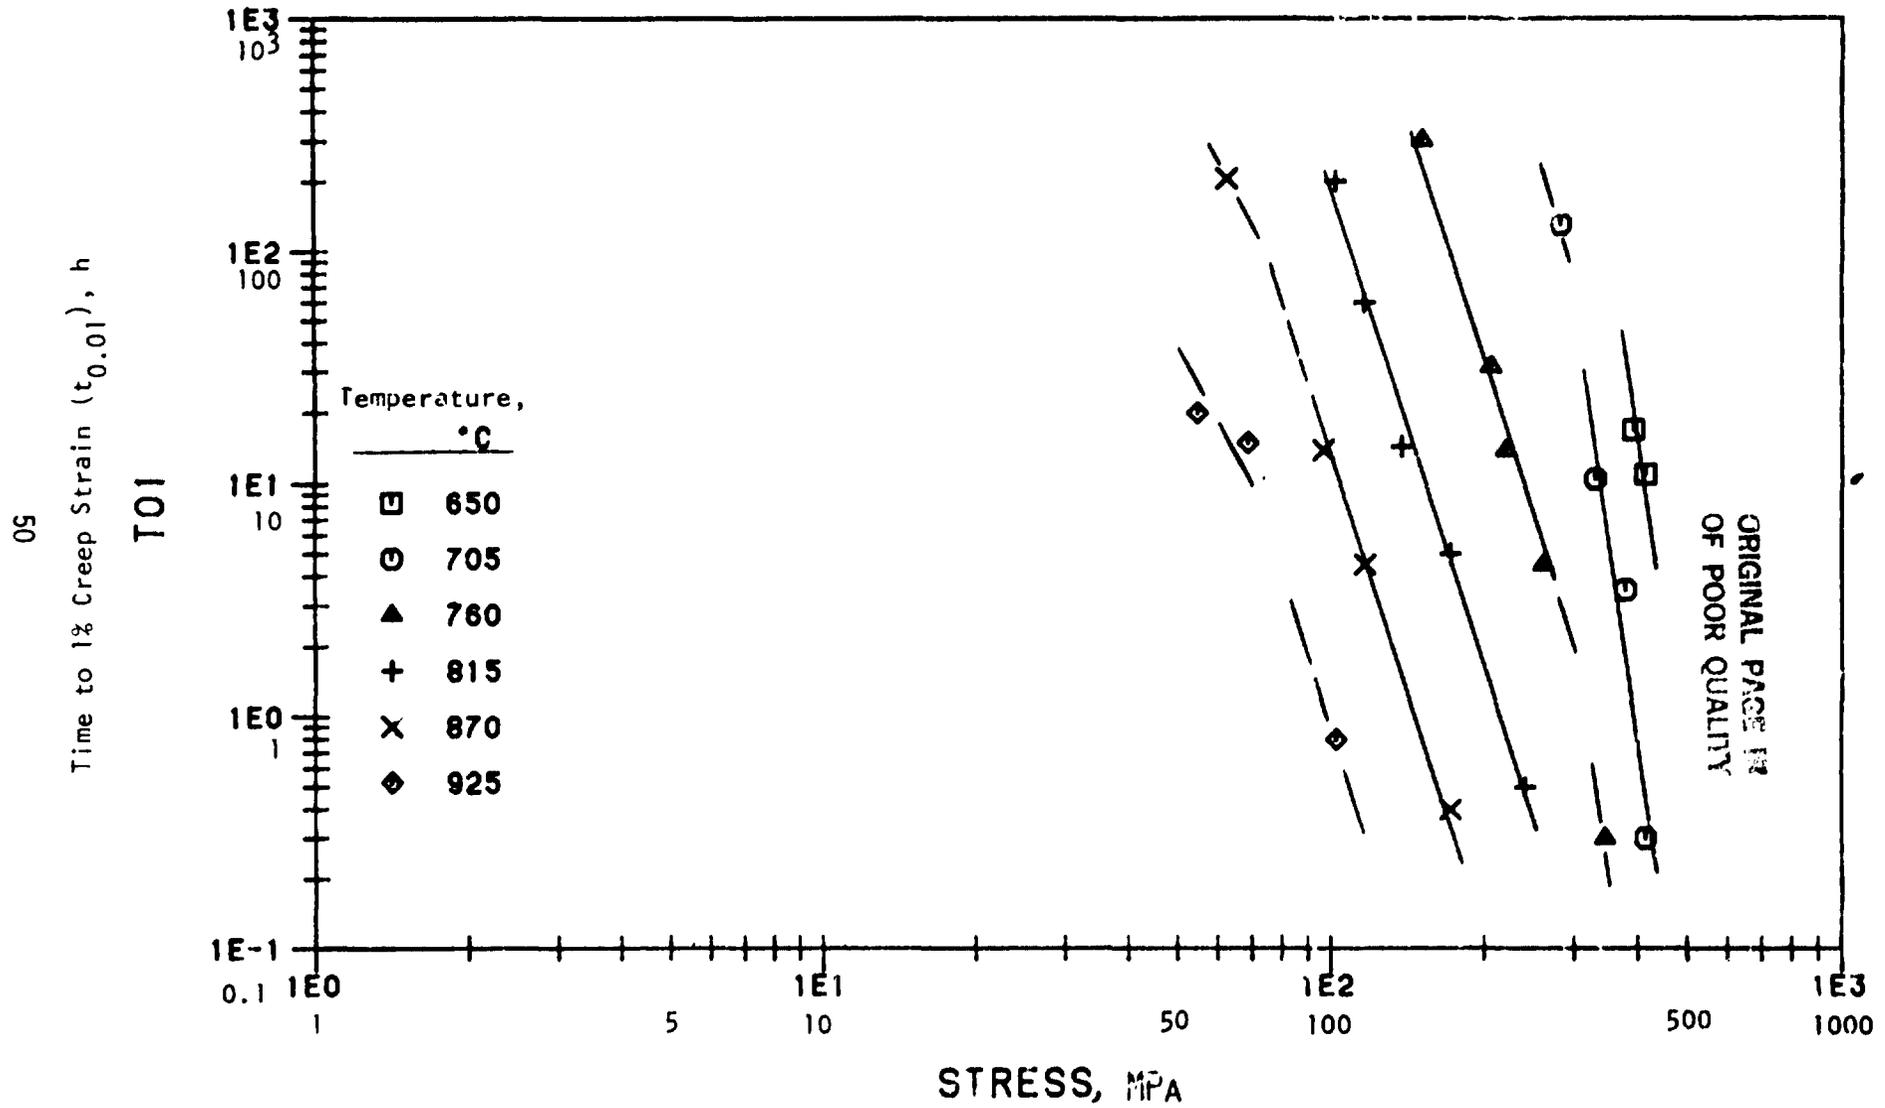
Figure 17. Stress vs. time to 1% creep strain of XF-818 in air.

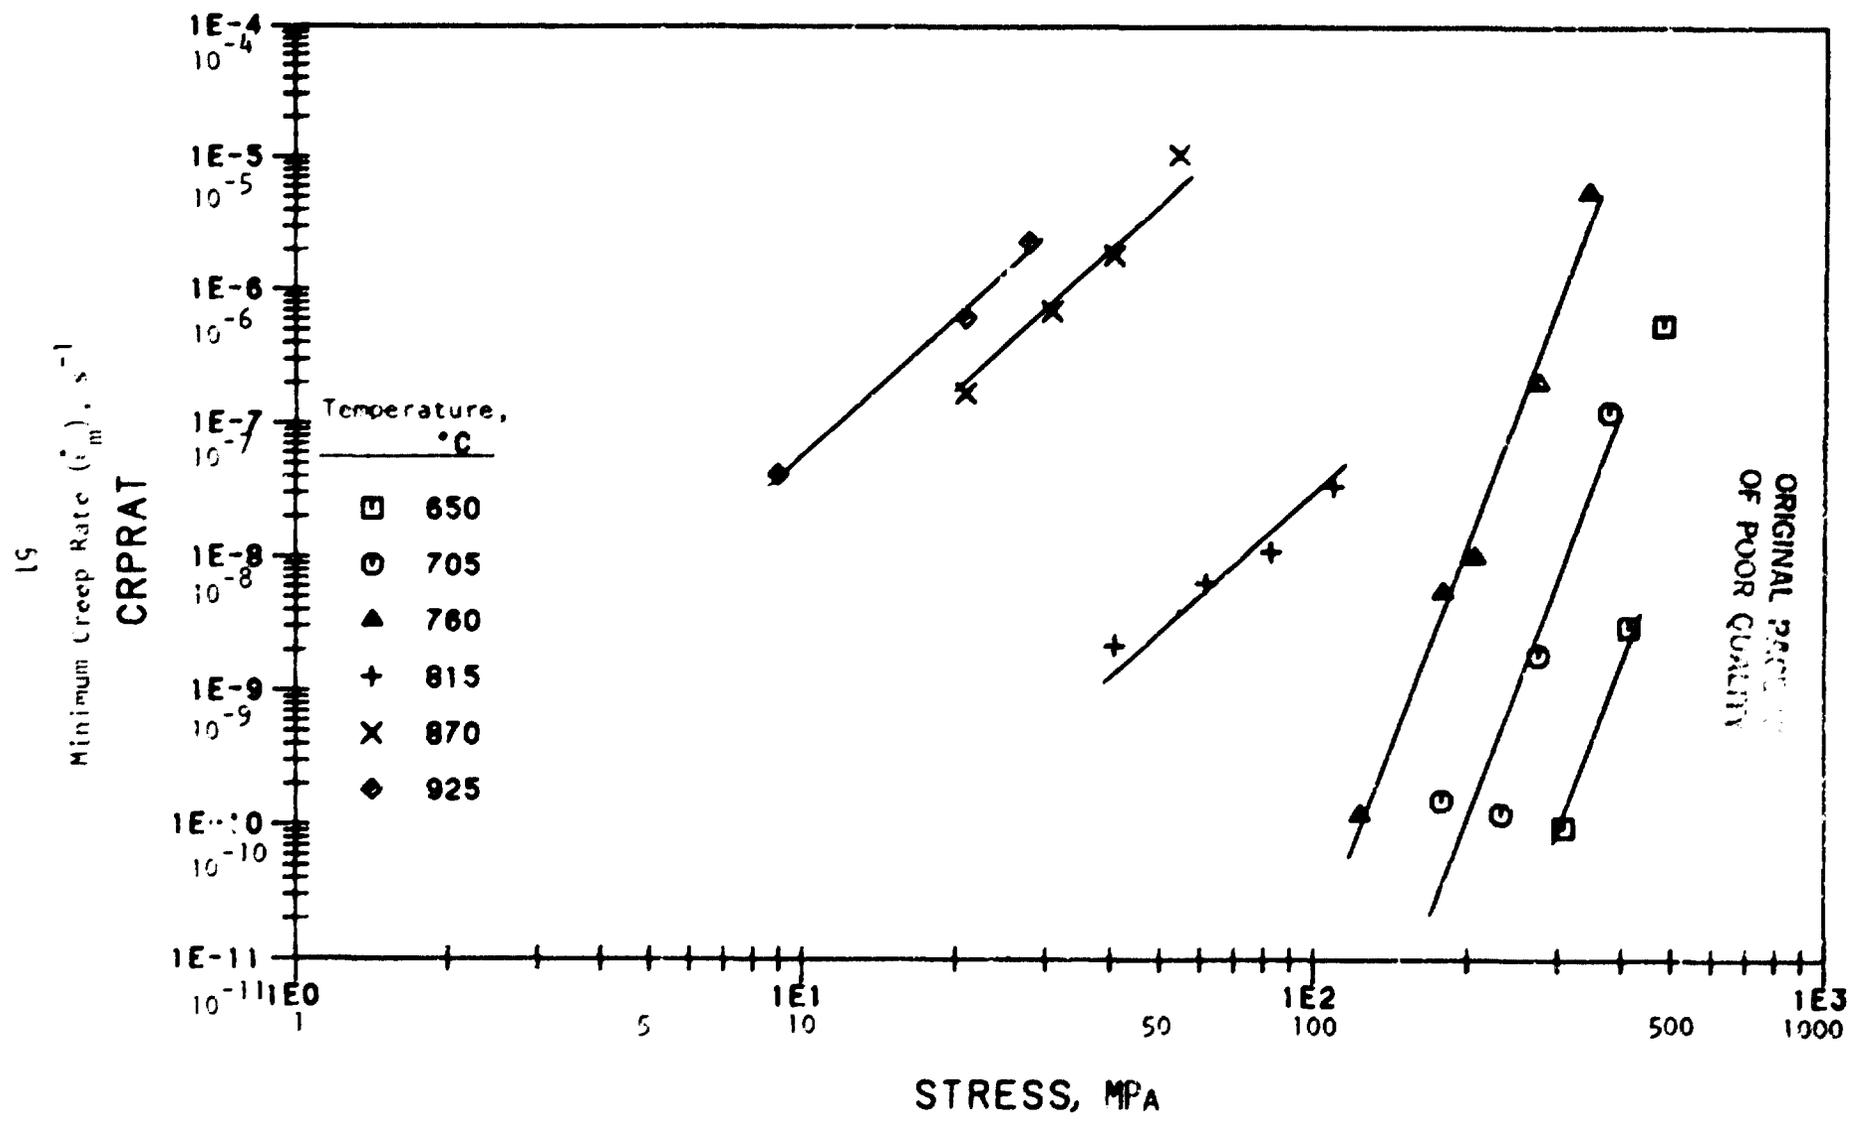
Figure 18. Stress vs. minimum creep rate of A-286 in air.

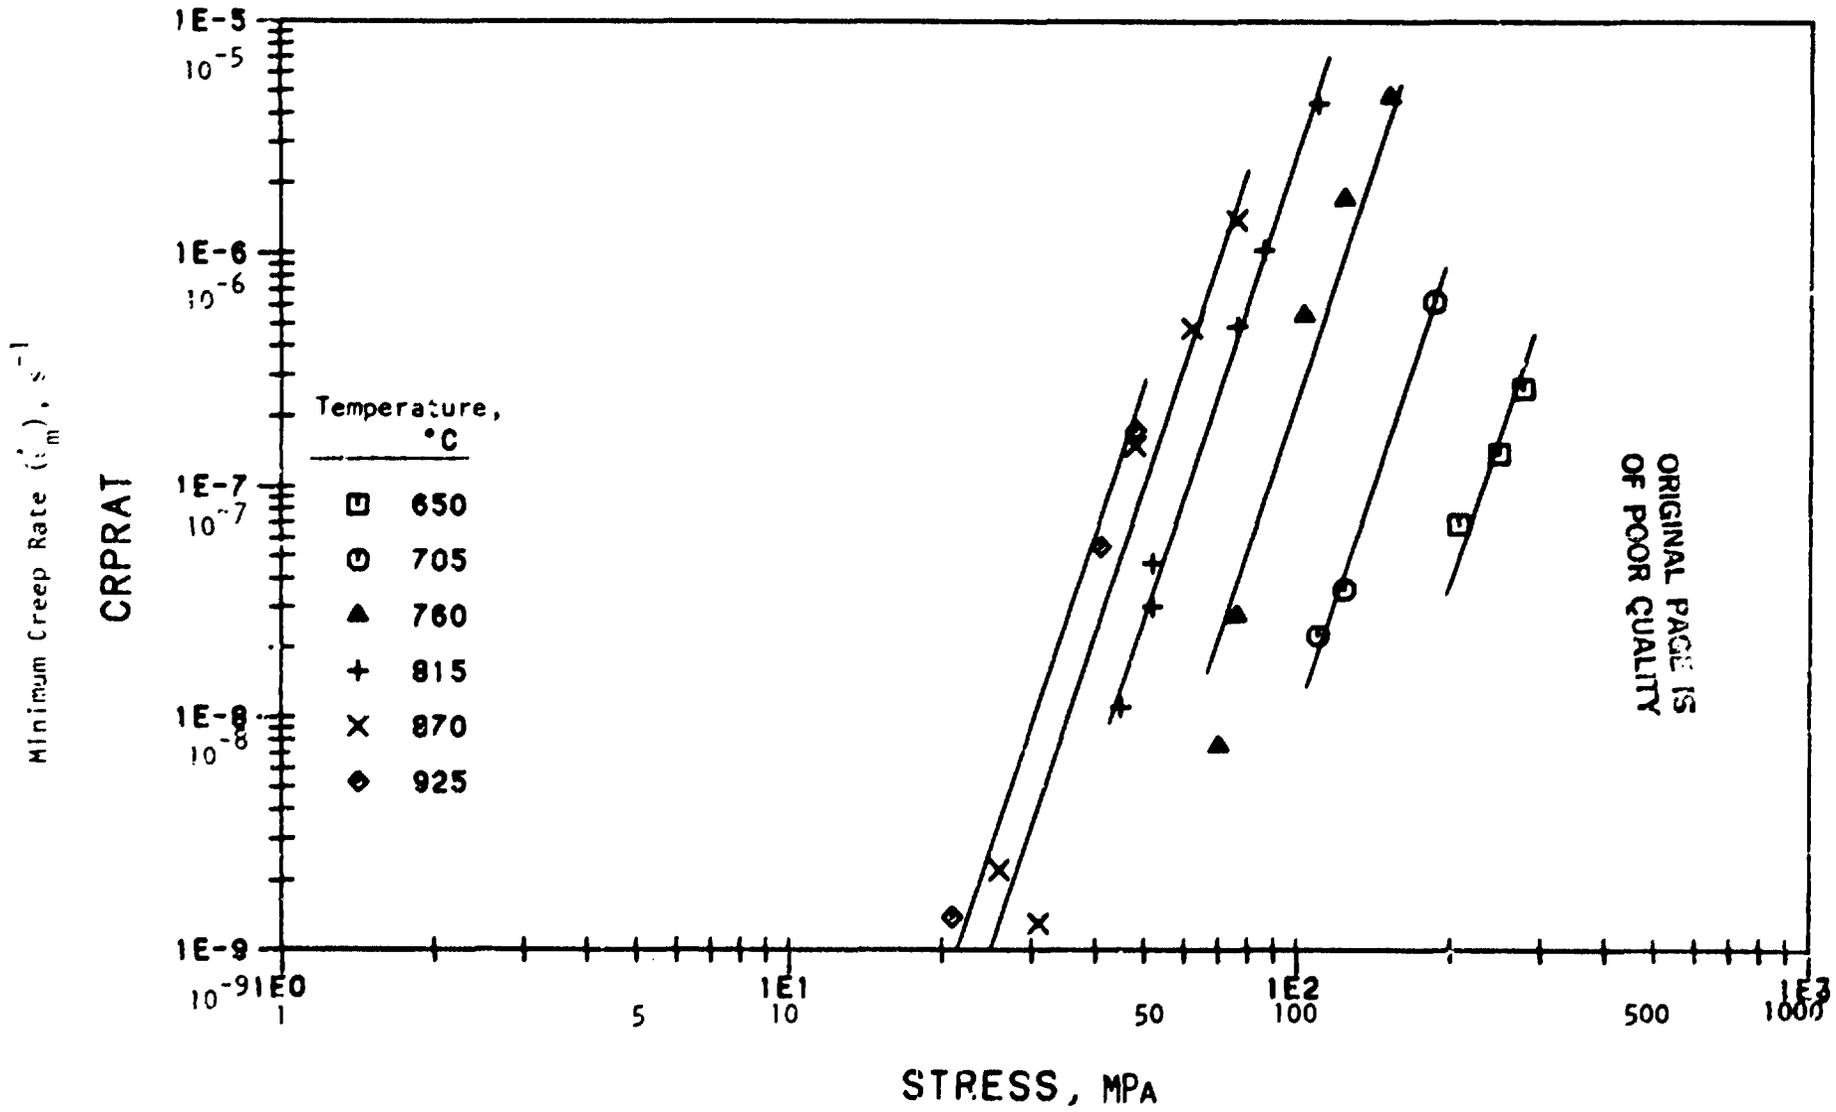
Figure 19. Stress vs. minimum creep rate of IN 800H in air.

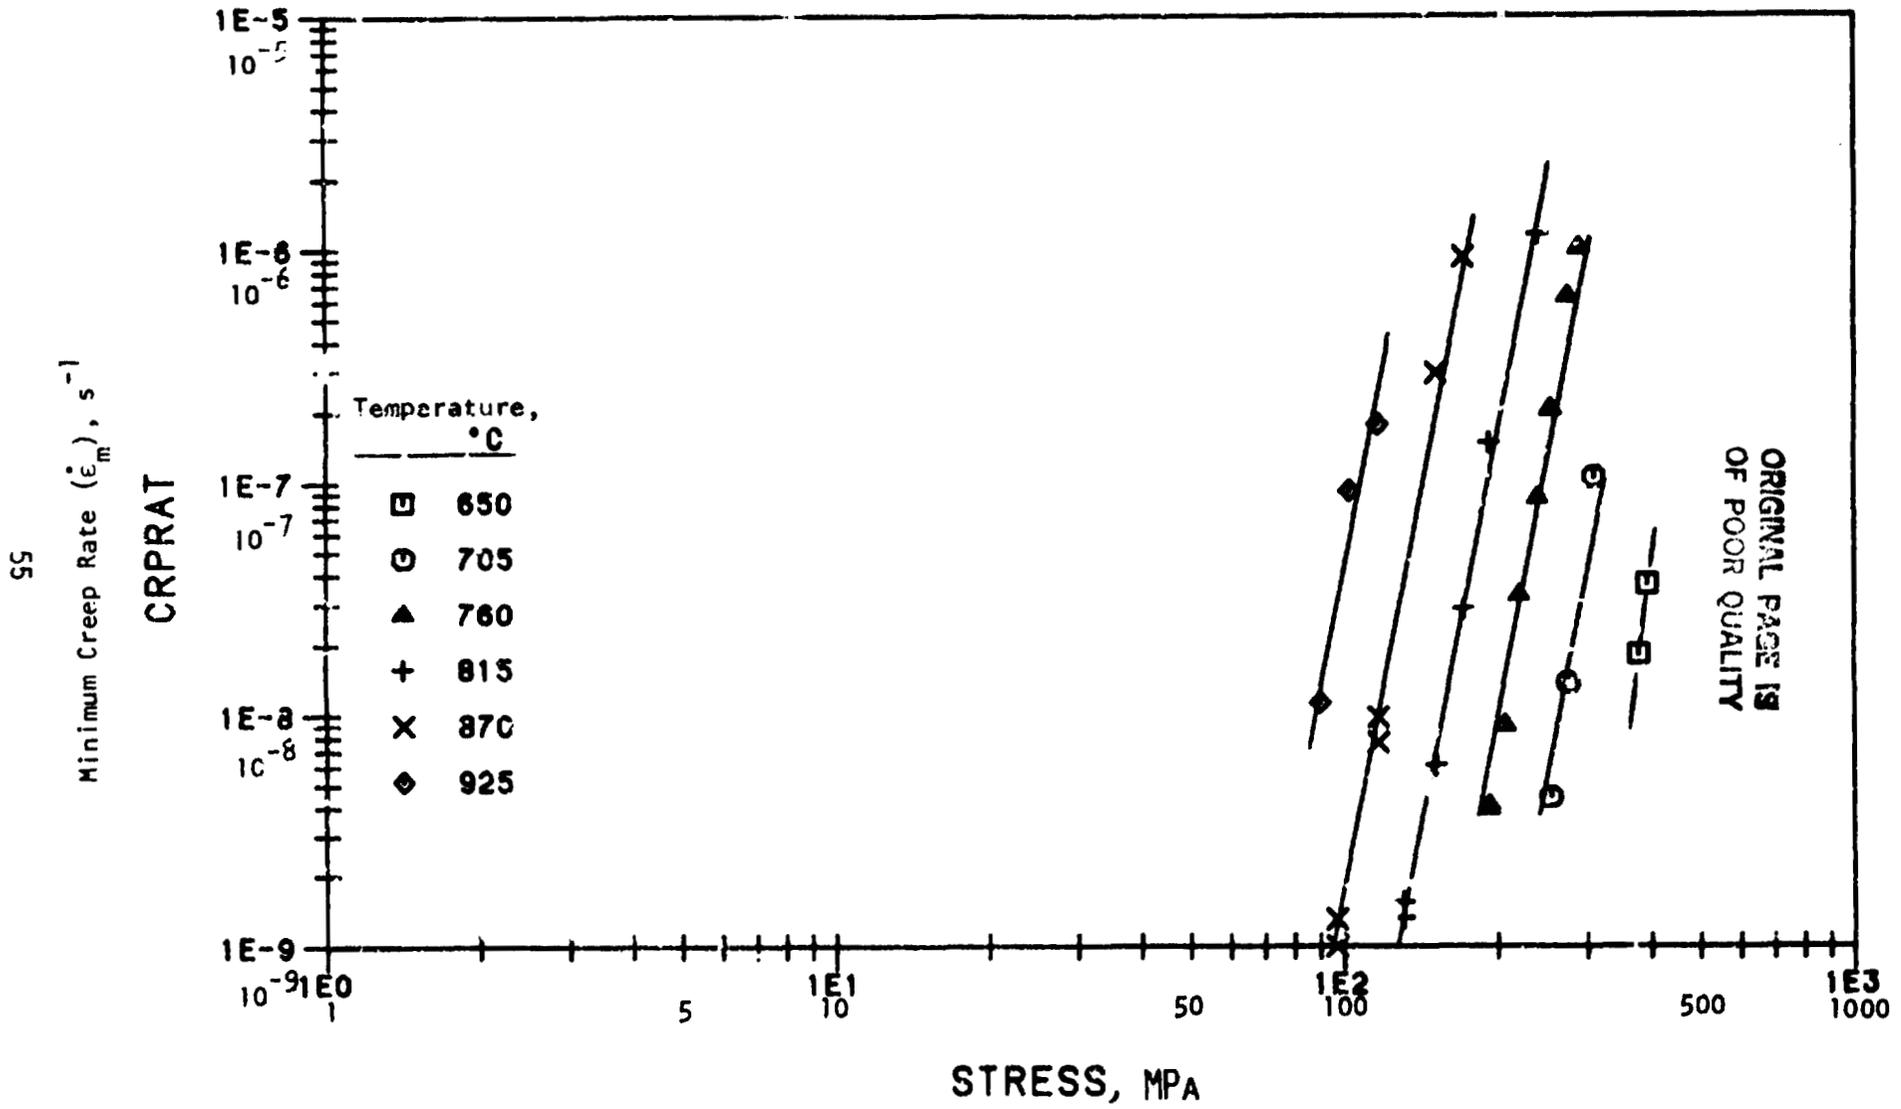
Figure 22. Stress vs. minimum creep rate of CRM-6D in air.

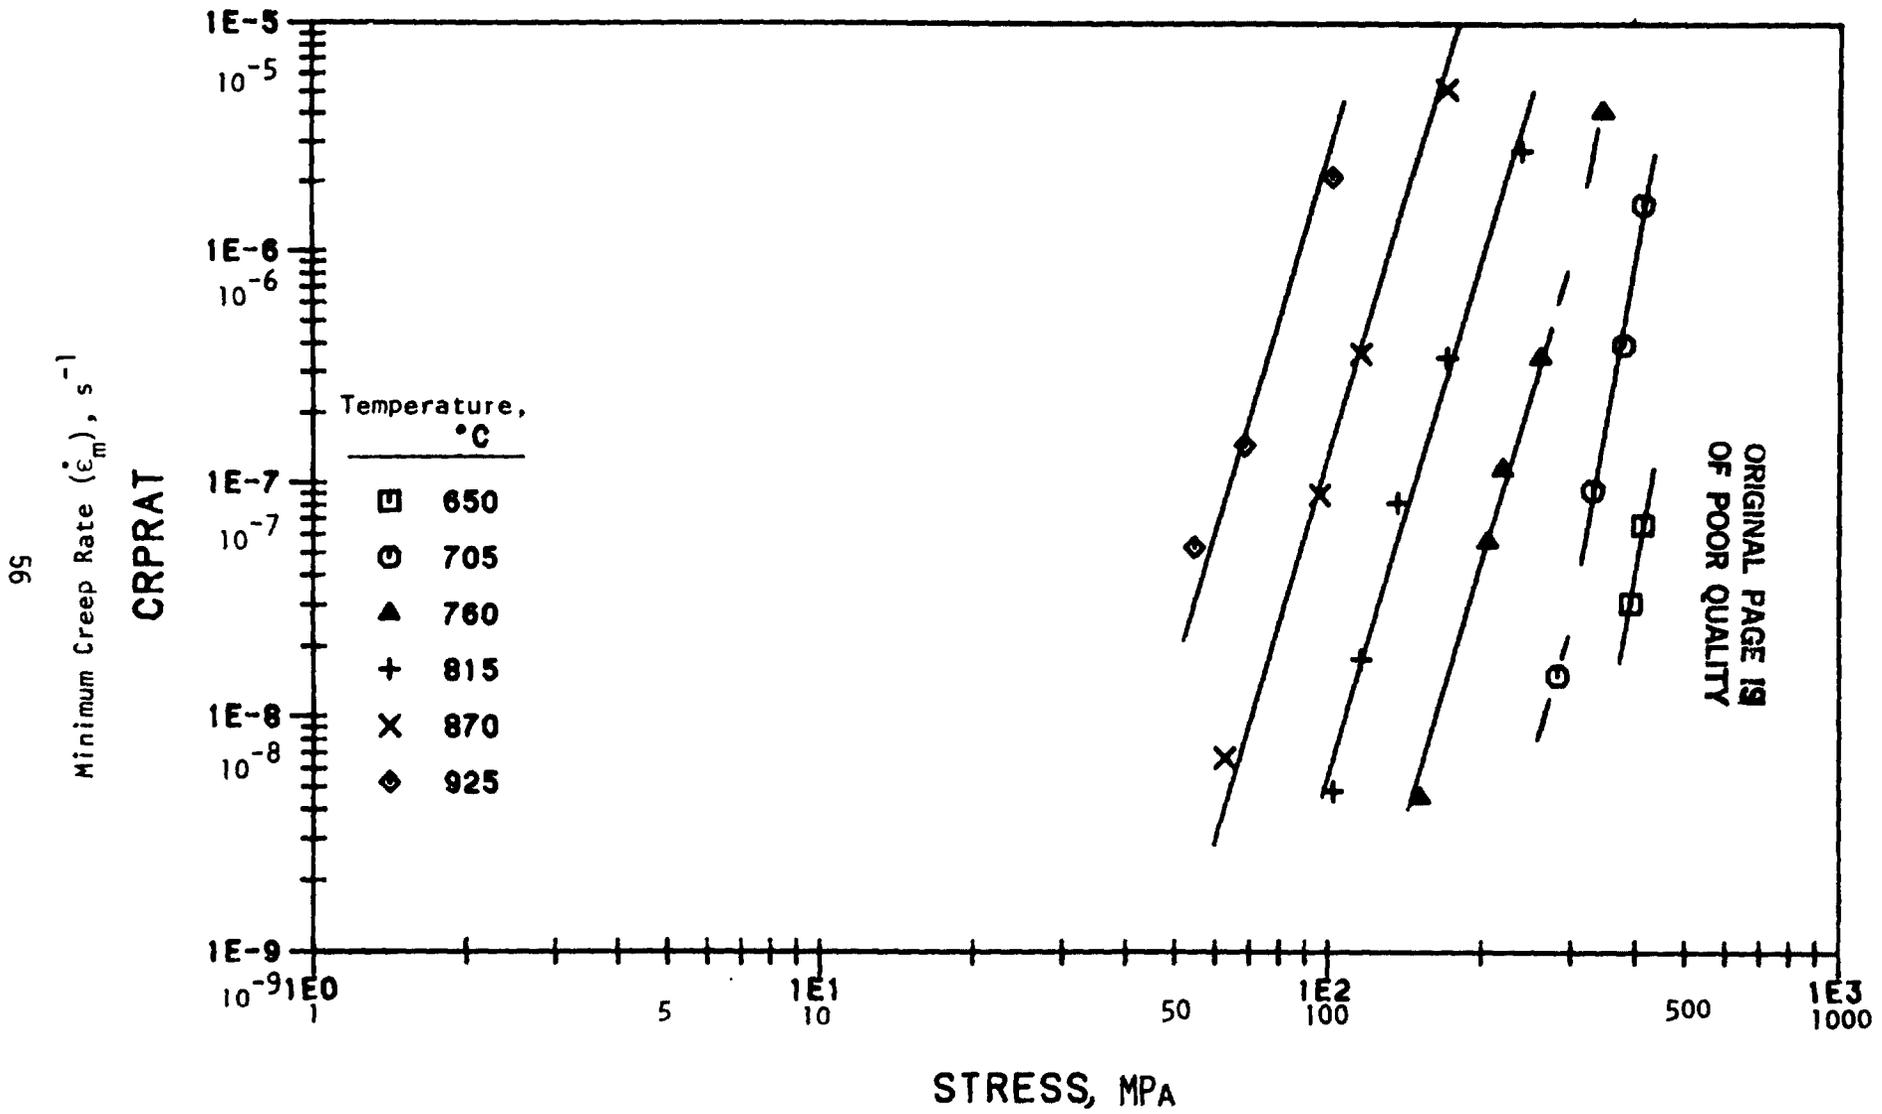
Figure 23. Stress vs. minimum creep rate of XF-818 in air.

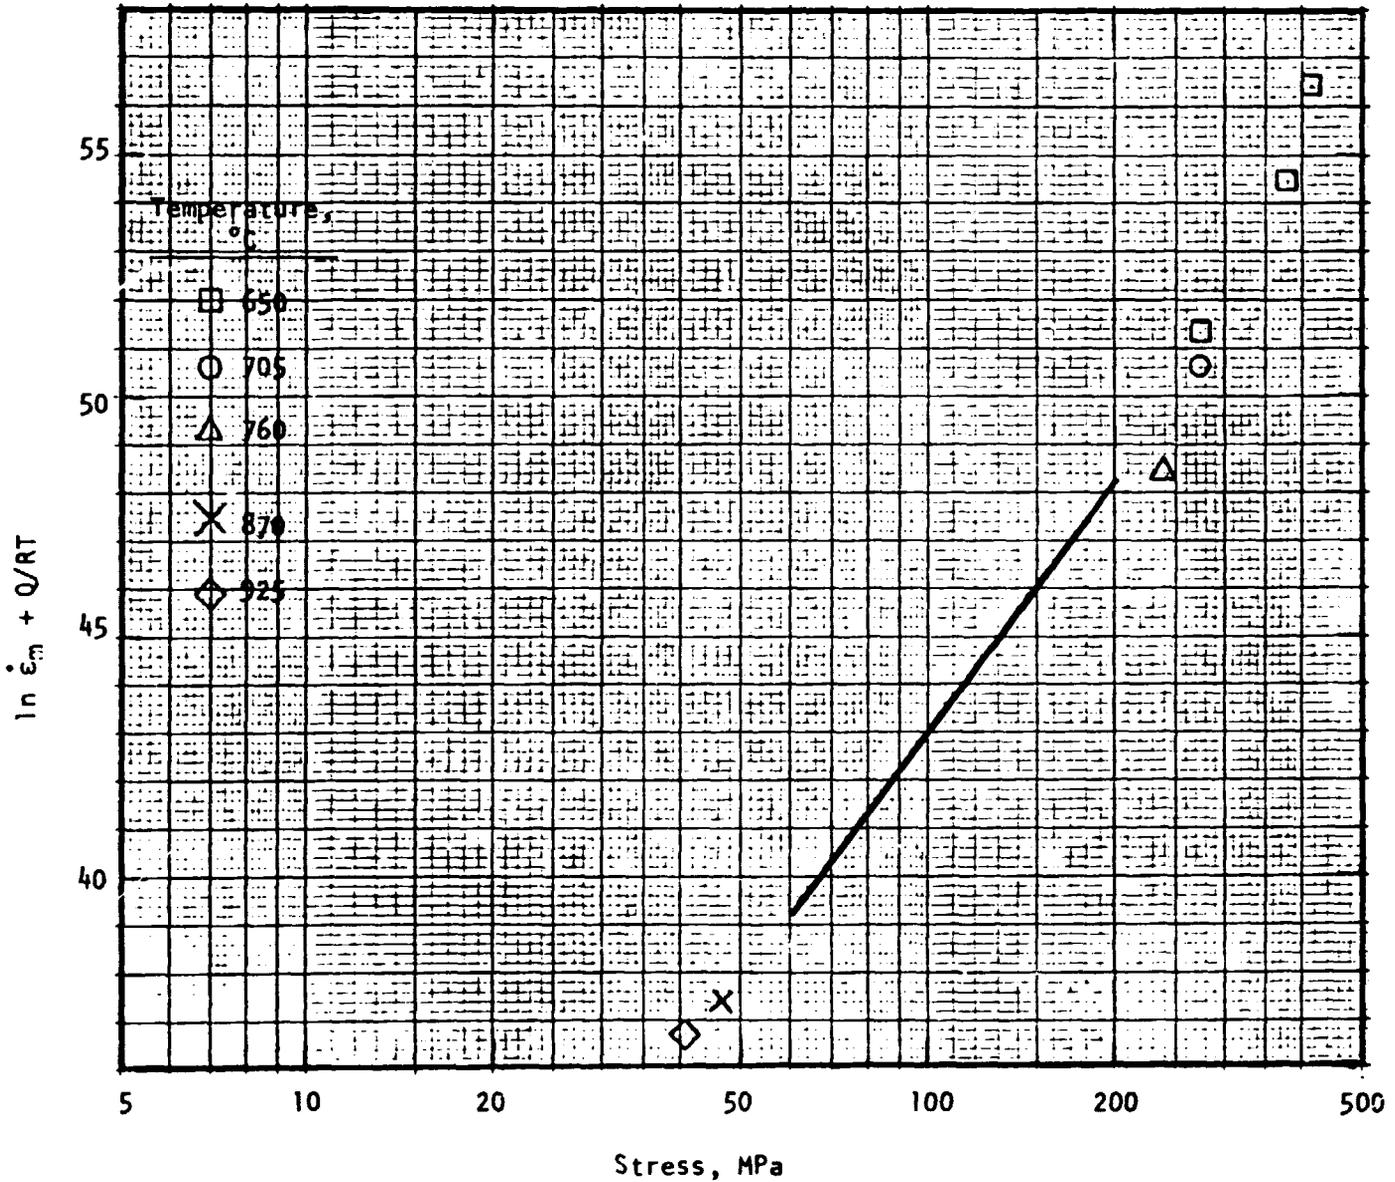
Figure 24. Temperature-compensated minimum creep rate vs. stress for N-155 tested in air (Case 2B, including Cases 2A and 2C shown separately).

Except for Case 2C (for $\sigma > 300$ MPa, at 650° and 705°C), the average slope is 6.92 and compares well with the simpler earlier analysis which gave a value of 7.35. The higher value of 12.6 for case 2C is also similar to the earlier value of 12.5 for similar subset conditions.

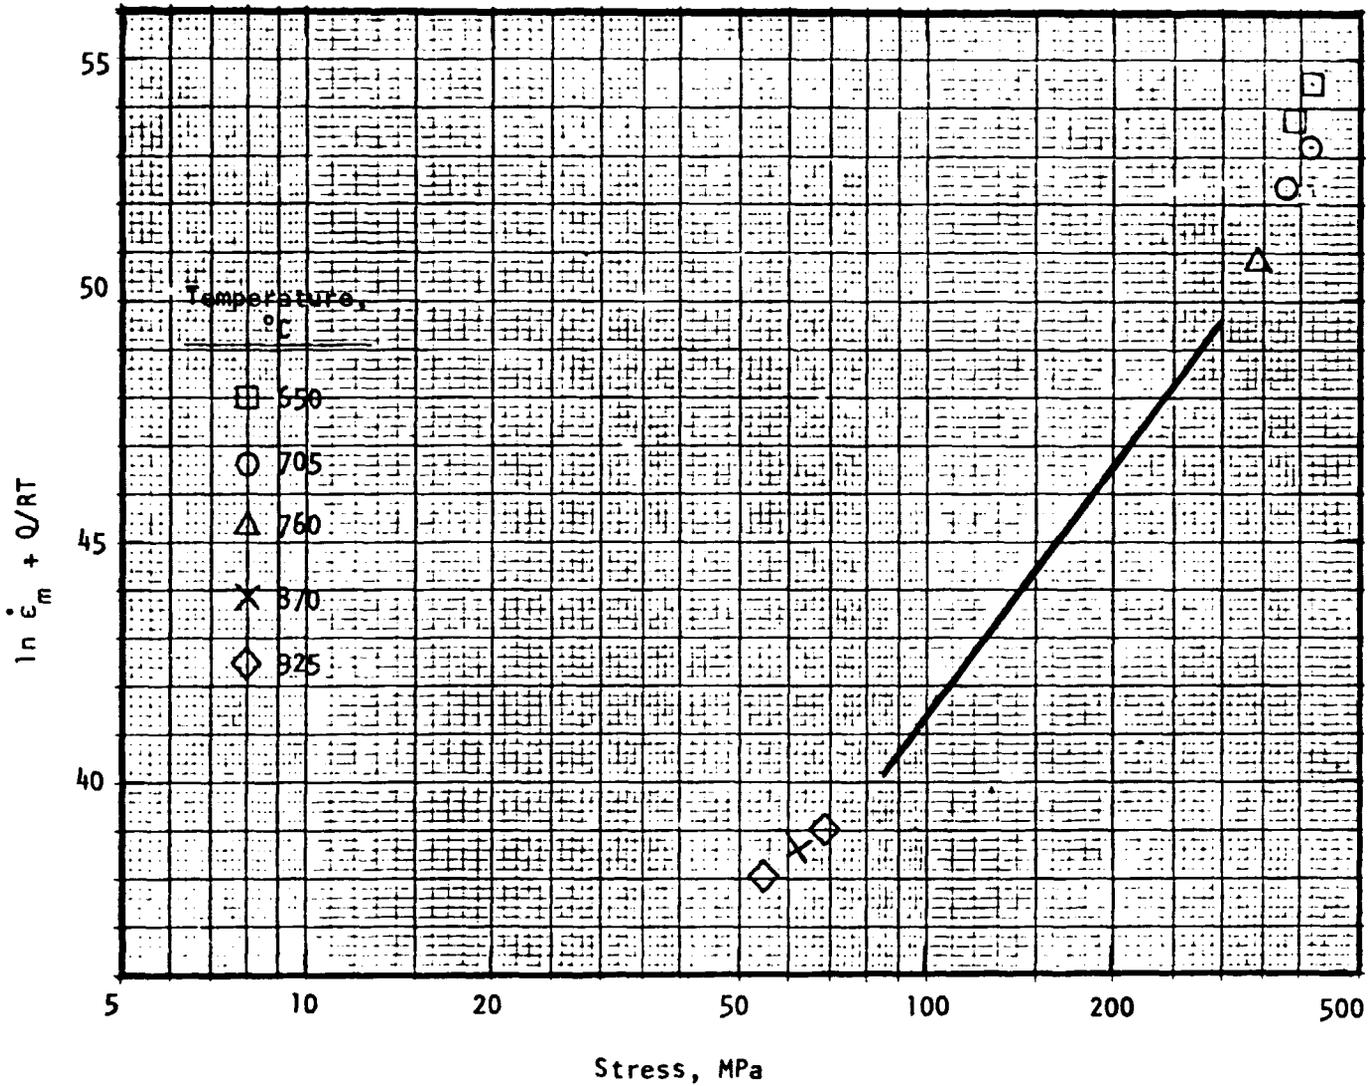
Figure 25. Temperature-compensated minimum creep rate vs. stress for XF-818 tested in air (Case 2B, including Cases 2A and 2C shown separately).

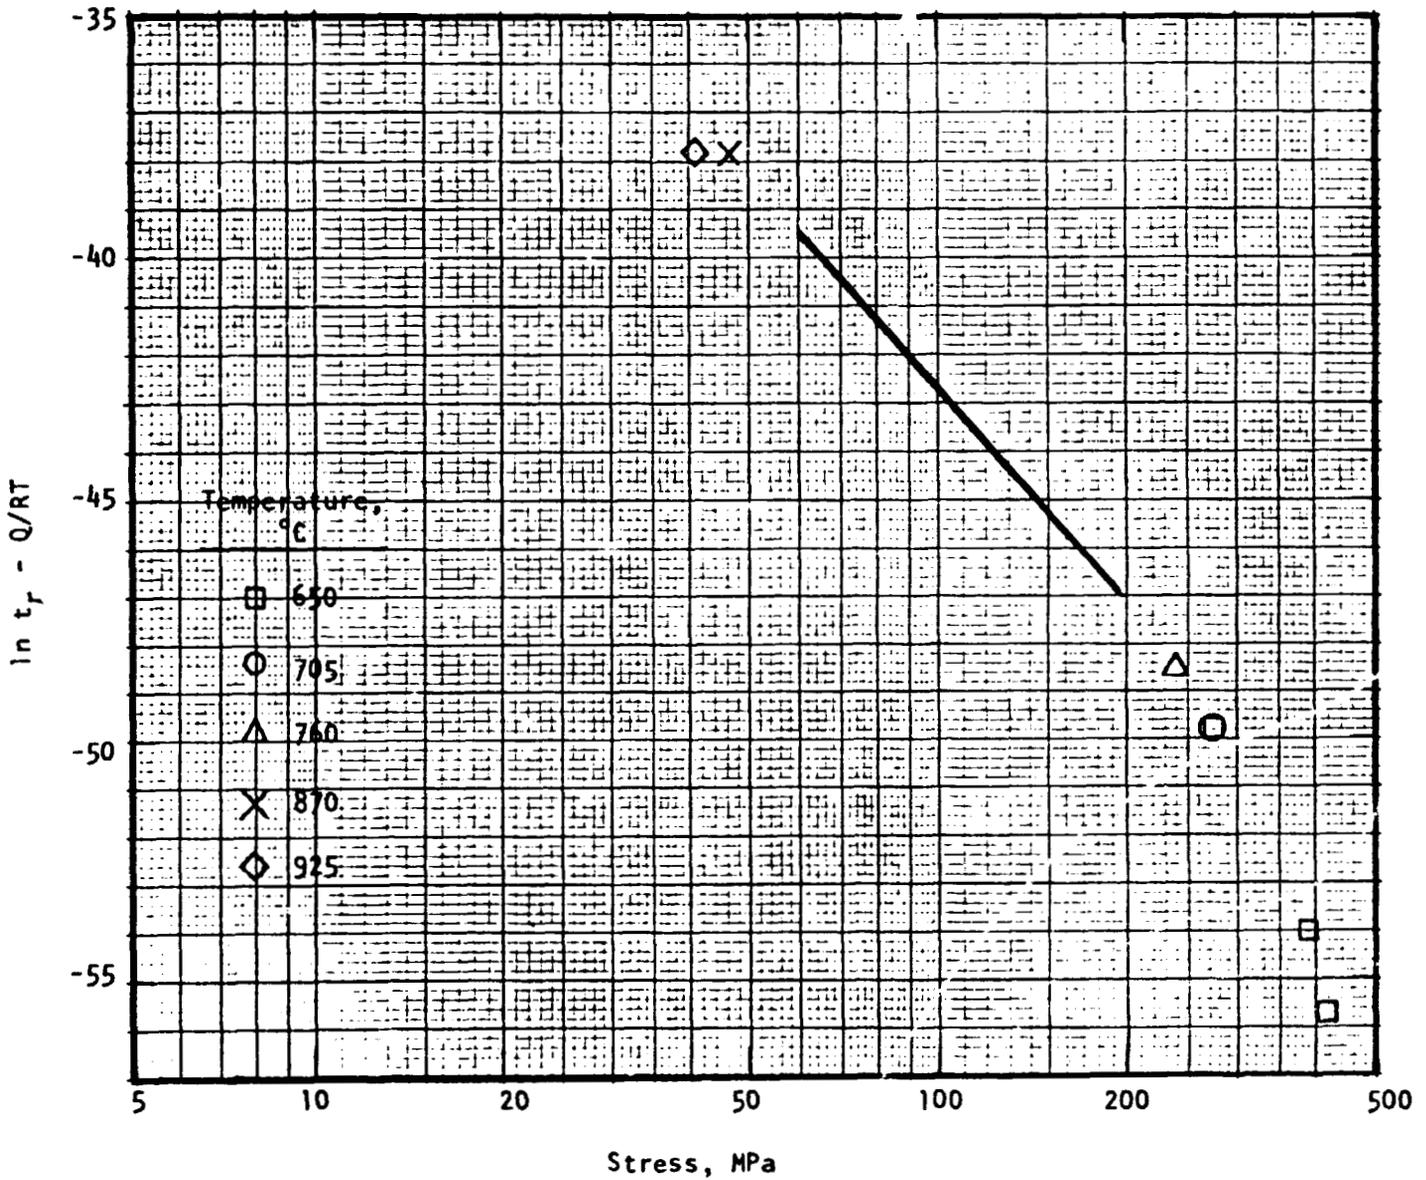
Figure 26. Temperature-compensated rupture life vs. stress for N-155 tested in air (Case 2B, including Cases 2A and 2C data shown separately).
