CREEP-RUPTURE BEHAVIOR OF SIX CANDIDATE STIRLING ENGINE IRON-BASE SUPERALLOYS IN HIGH PRESSURE HYDROGEN

VOLUME 1 - AIR CREEP-RUPTURE BEHAVIOR

S. Bhattacharyya
IIT RESEARCH INSTITUTE
10 West 35th Street
Chicago, Illinois 60616

DECEMBER 1982

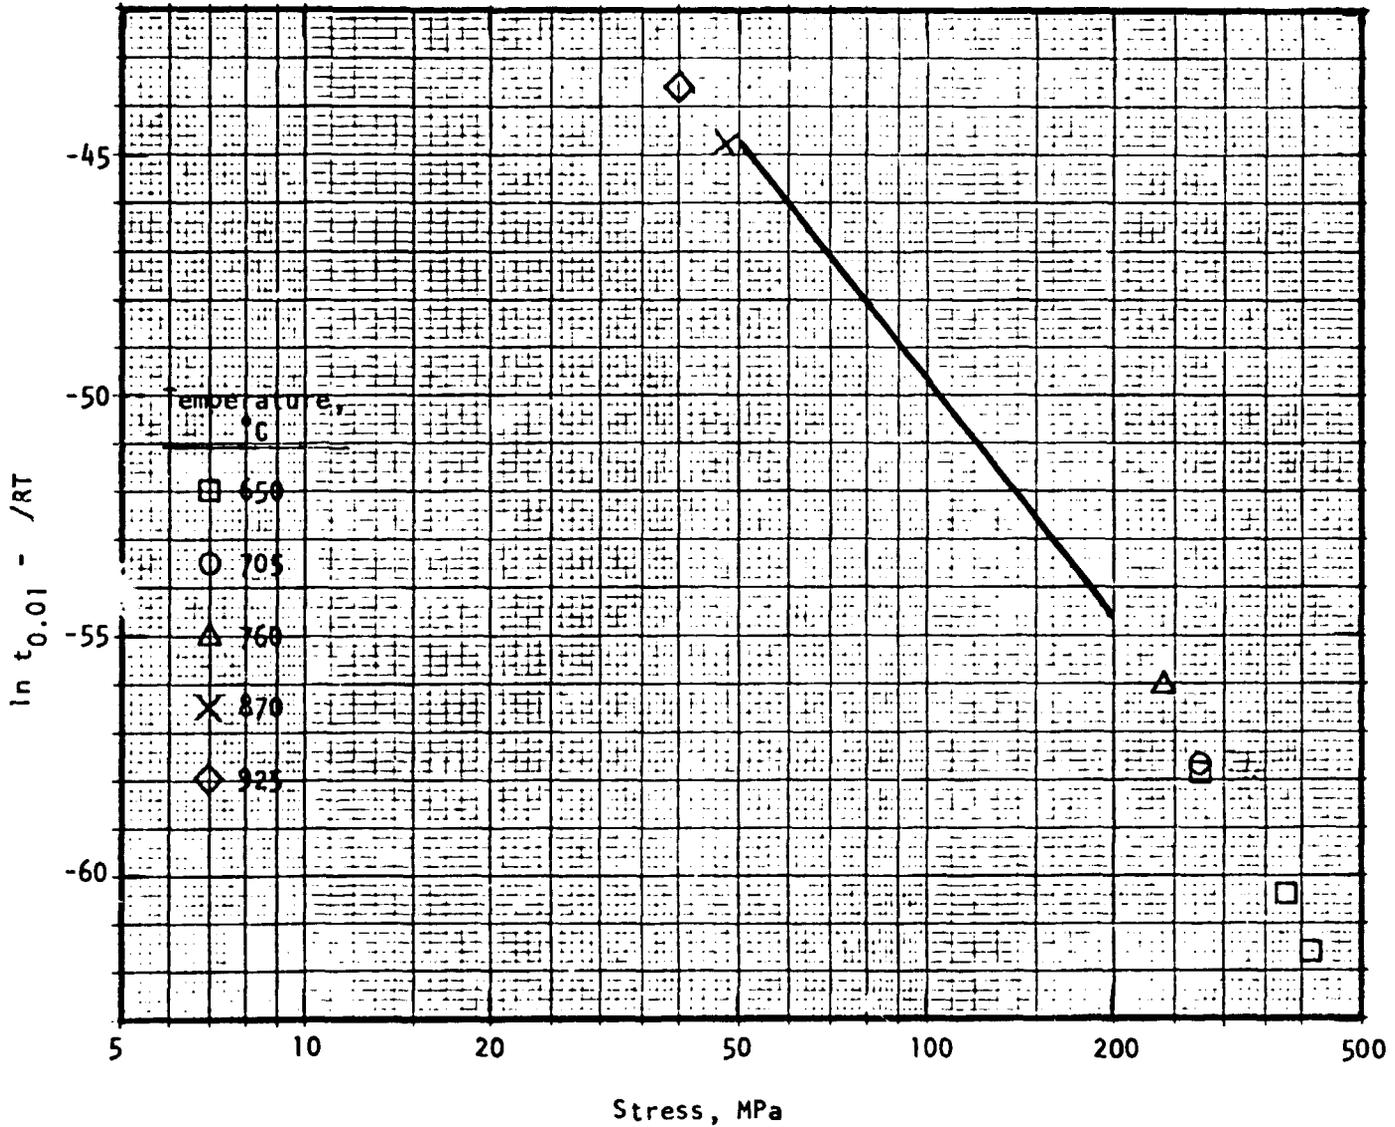
Figure 27. Temperature-compensated time to 1% creep strain vs. stress for N-155 tested in air (Case 2B, including Cases 2A and 2C shown separately).

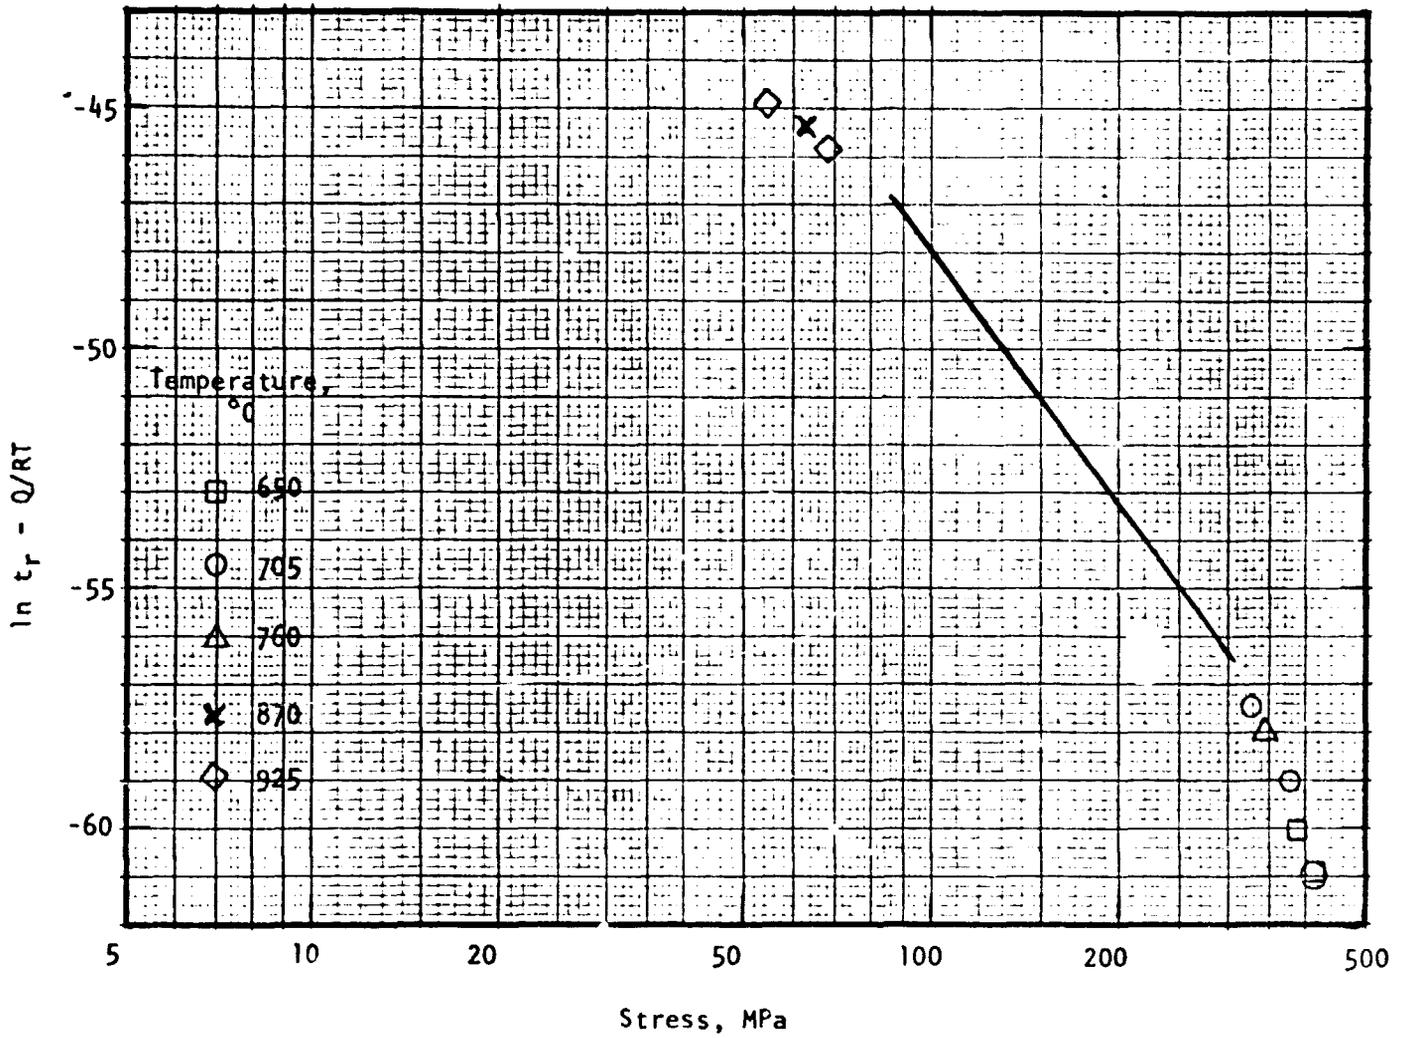
Figure 28. Temperature-compensated rupture life vs. stress for XF-818 tested in air (Case 2B, including Cases 2A and 2C data shown separately).

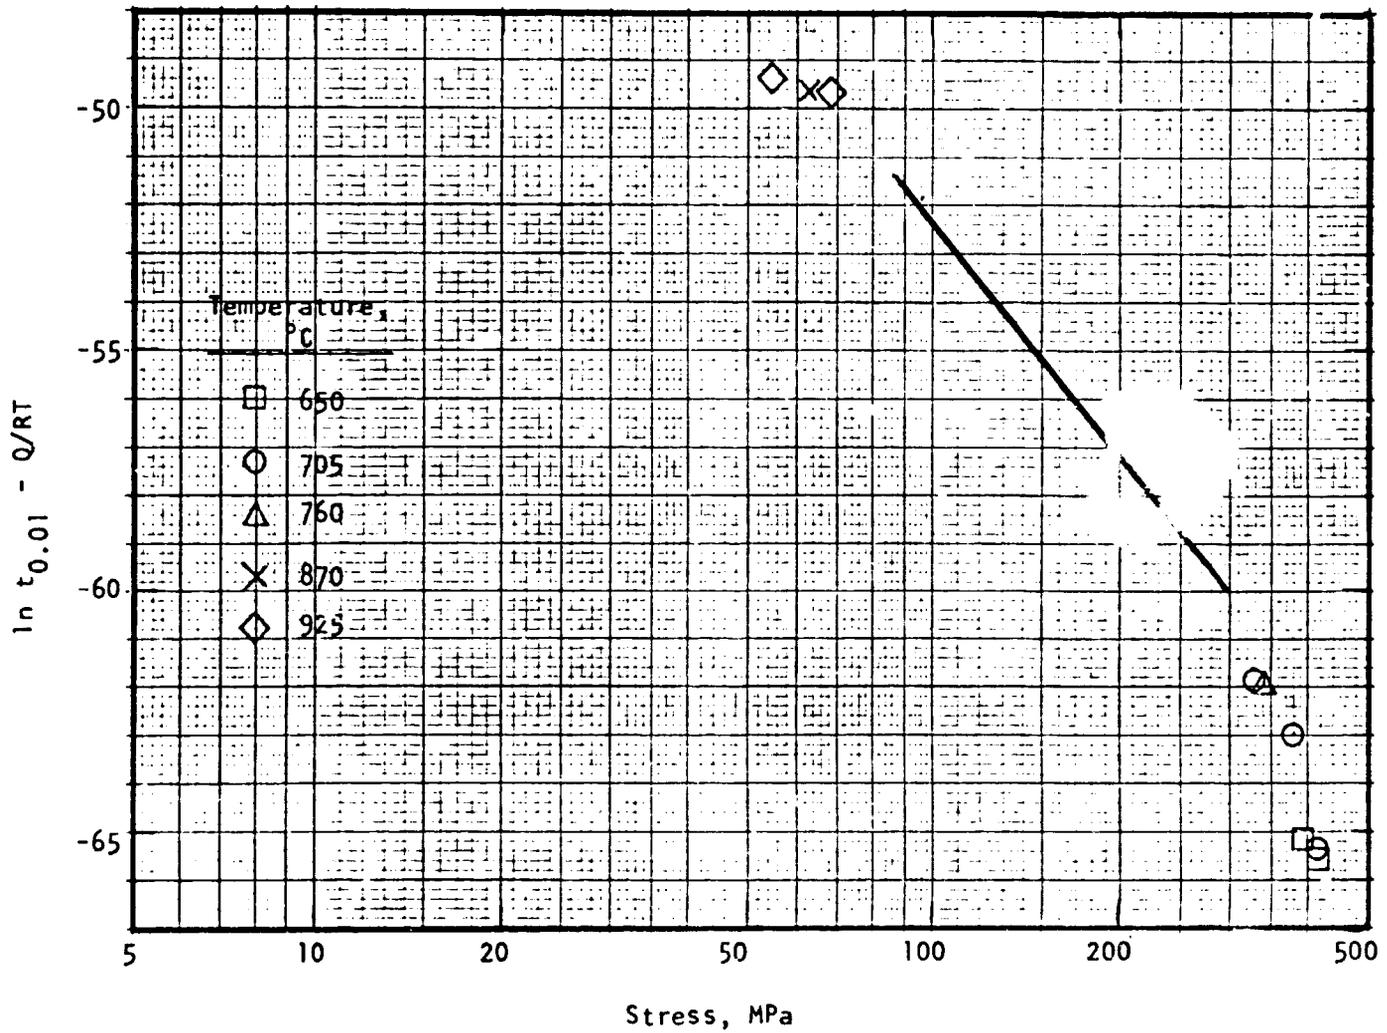
Figure 29. Temperature-compensated time to 1% creep strain vs. stress for XF-818 tested in air (Case 2B, including Cases 2A and 2C shown separately).

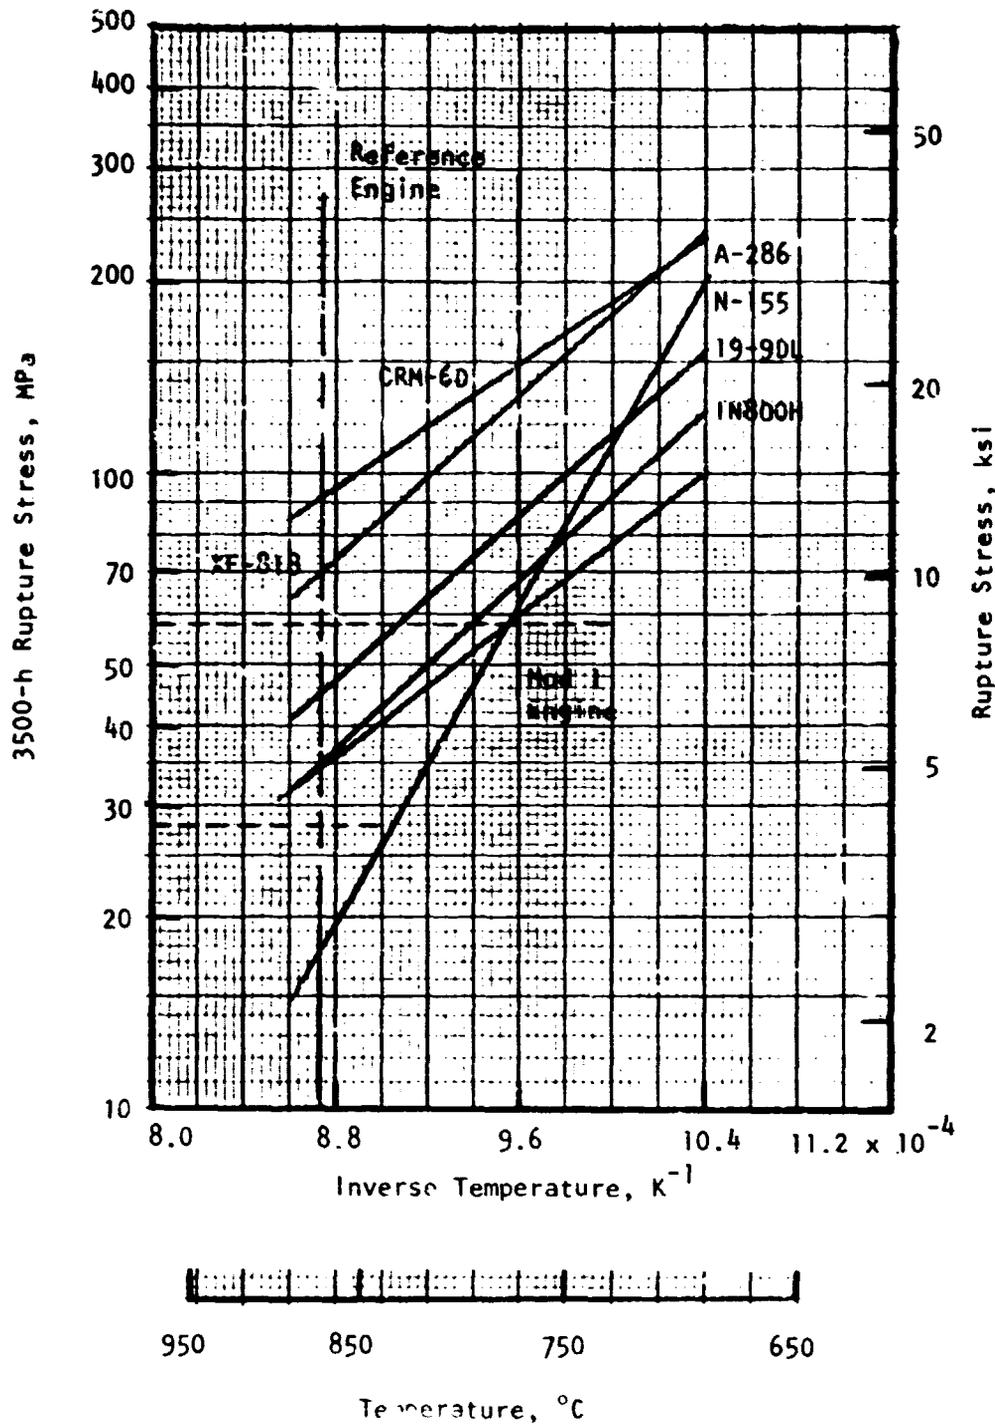
Figure 30. Estimated 3500-hour rupture stress of six alloys tested in air.

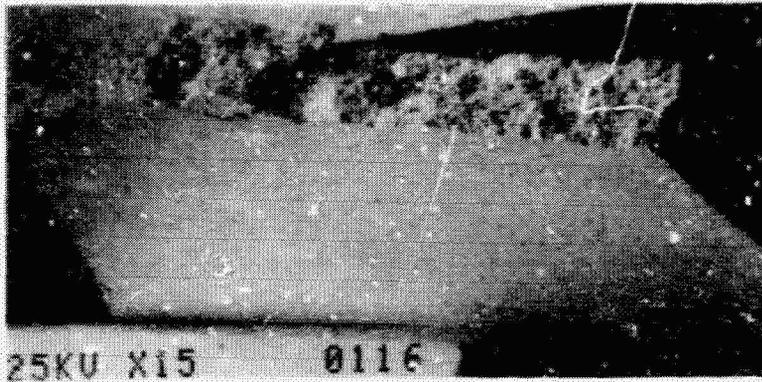
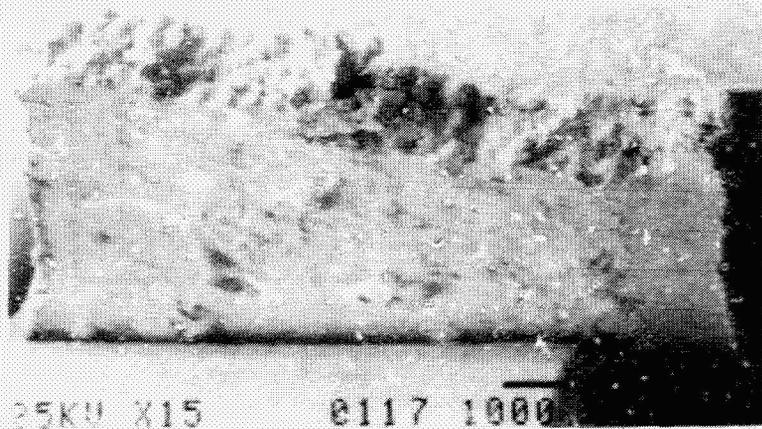
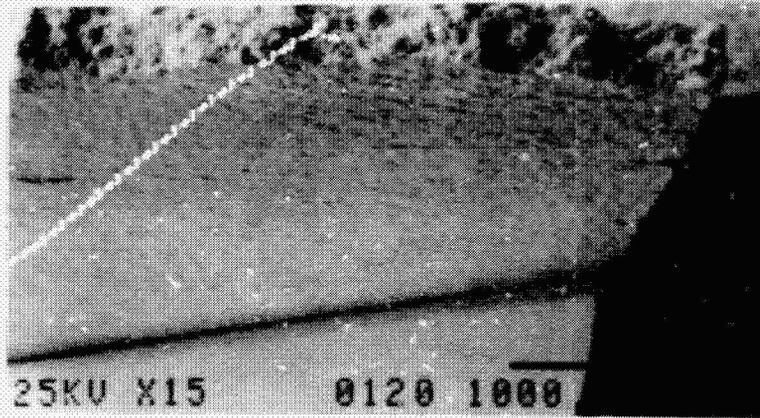
Figure 31. Typical macrofractographs of wrought specimens creep-rupture tested in air. (a) 19-9DL, 815°C, 59 MPa; (b) 19-9DL, 870°C, 29 MPa; (c) A-286, 815°C, 55 MPa; (d) N-155, 870°C, 47 MPa; (e) N-155, 815°C, 63 MPa; (f) IN 800H, 760°C, 70 MPa; and (g) IN 800H, 815°C, 45 MPa. (All 15X)

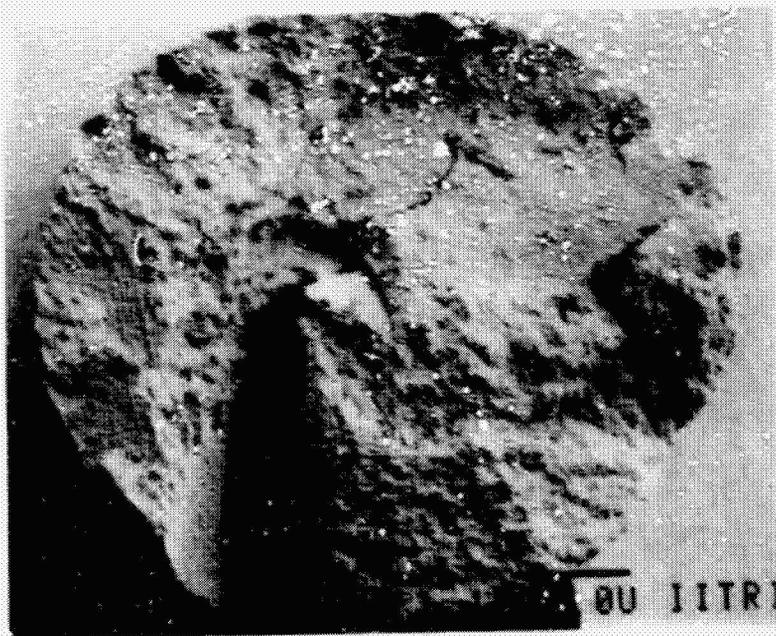
Figure 33. Typical macrofractographs of the cast specimens creep-rupture tested in air. (a) XF-818, 760°C, 152 MPa; (b) XF-818, 815°C, 103 MPa; (c) CRM-6D, 760°C, 193 MPa; and (d) CRM-6D, 870°C, 117 MPa.

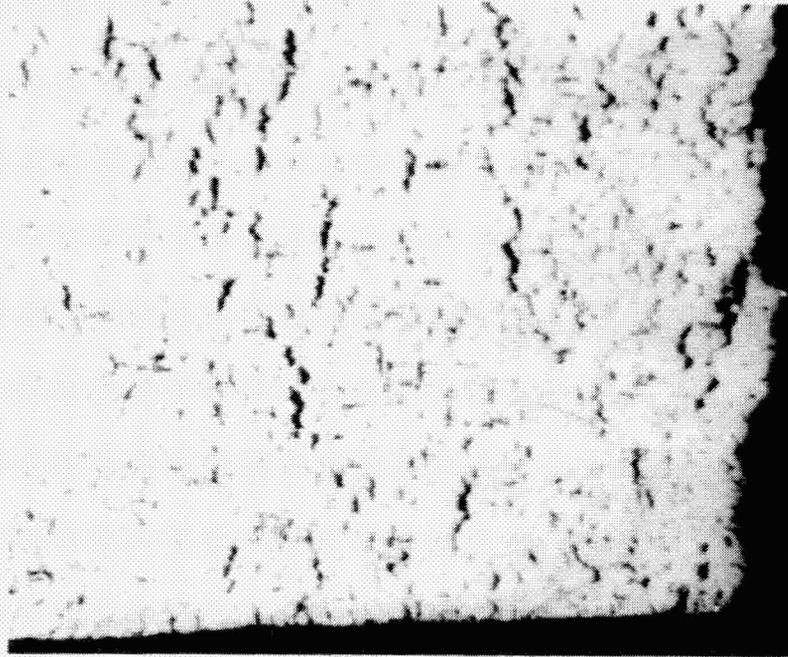
Neg. No. 54596

Figure 35. Typical optical and SEM photomicrographs of cross-sections from 19-9DL specimen creep-rupture tested in air. (a) Optical, 870°C, 29 MPa; and (b) SEM, 815°C, 59 MPa.

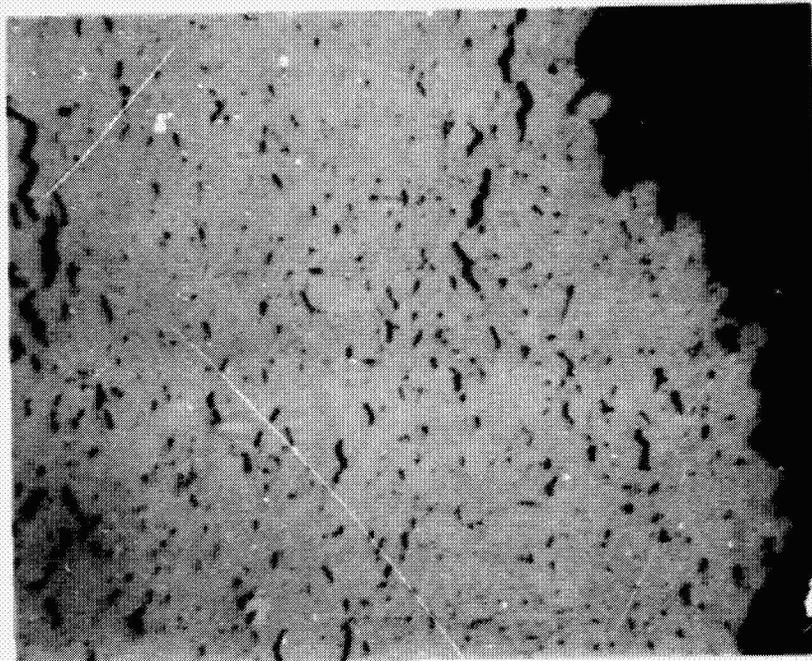
Neg. No. 54597

Figure 36. Typical optical and SEM photomicrographs of cross-sections from A-286 specimen creep-rupture tested in air, 815°C, 55 MPa. (a) Optical, (b) SEM.

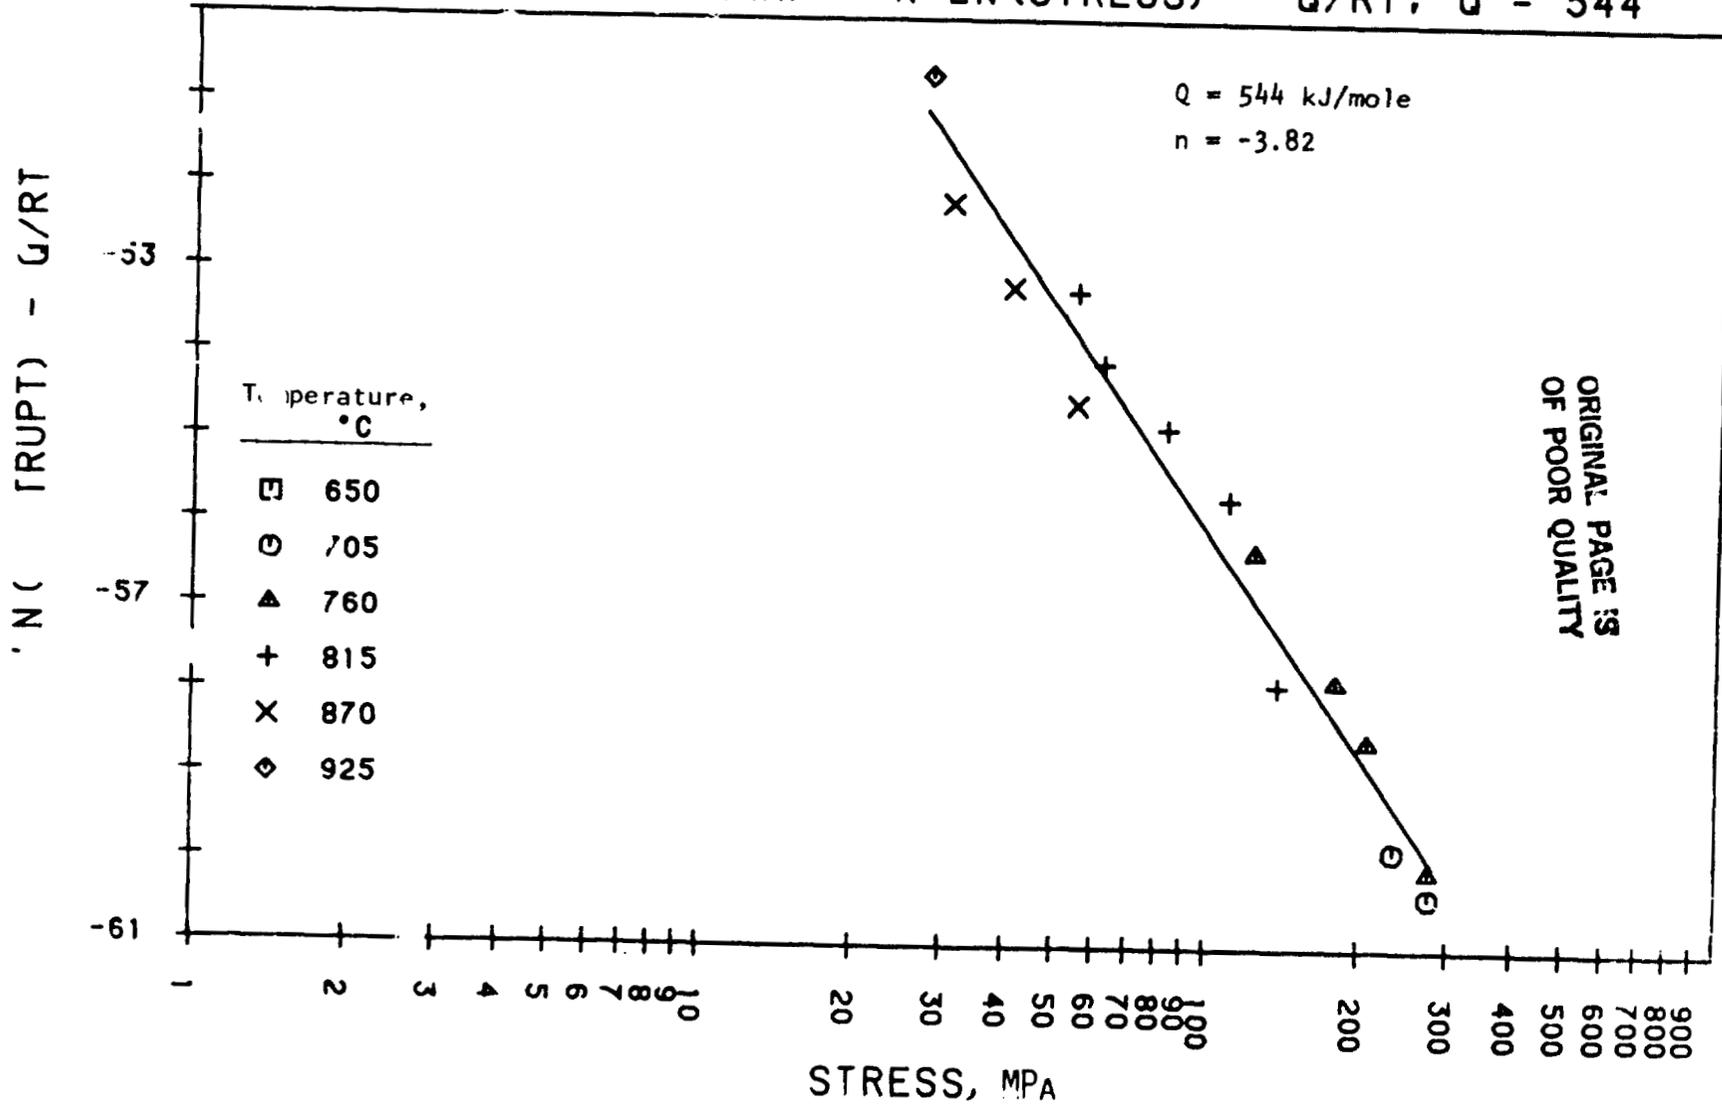
A-286 IN AIR - CASE 2B
 $\ln(\text{TRUPT}) = \ln(K) + n \ln(\text{STRESS}) - Q/RT, Q = 544$

Figure C-1. Temperature-compensated rupture life vs. stress for A-286 tested in air (Case 2B).

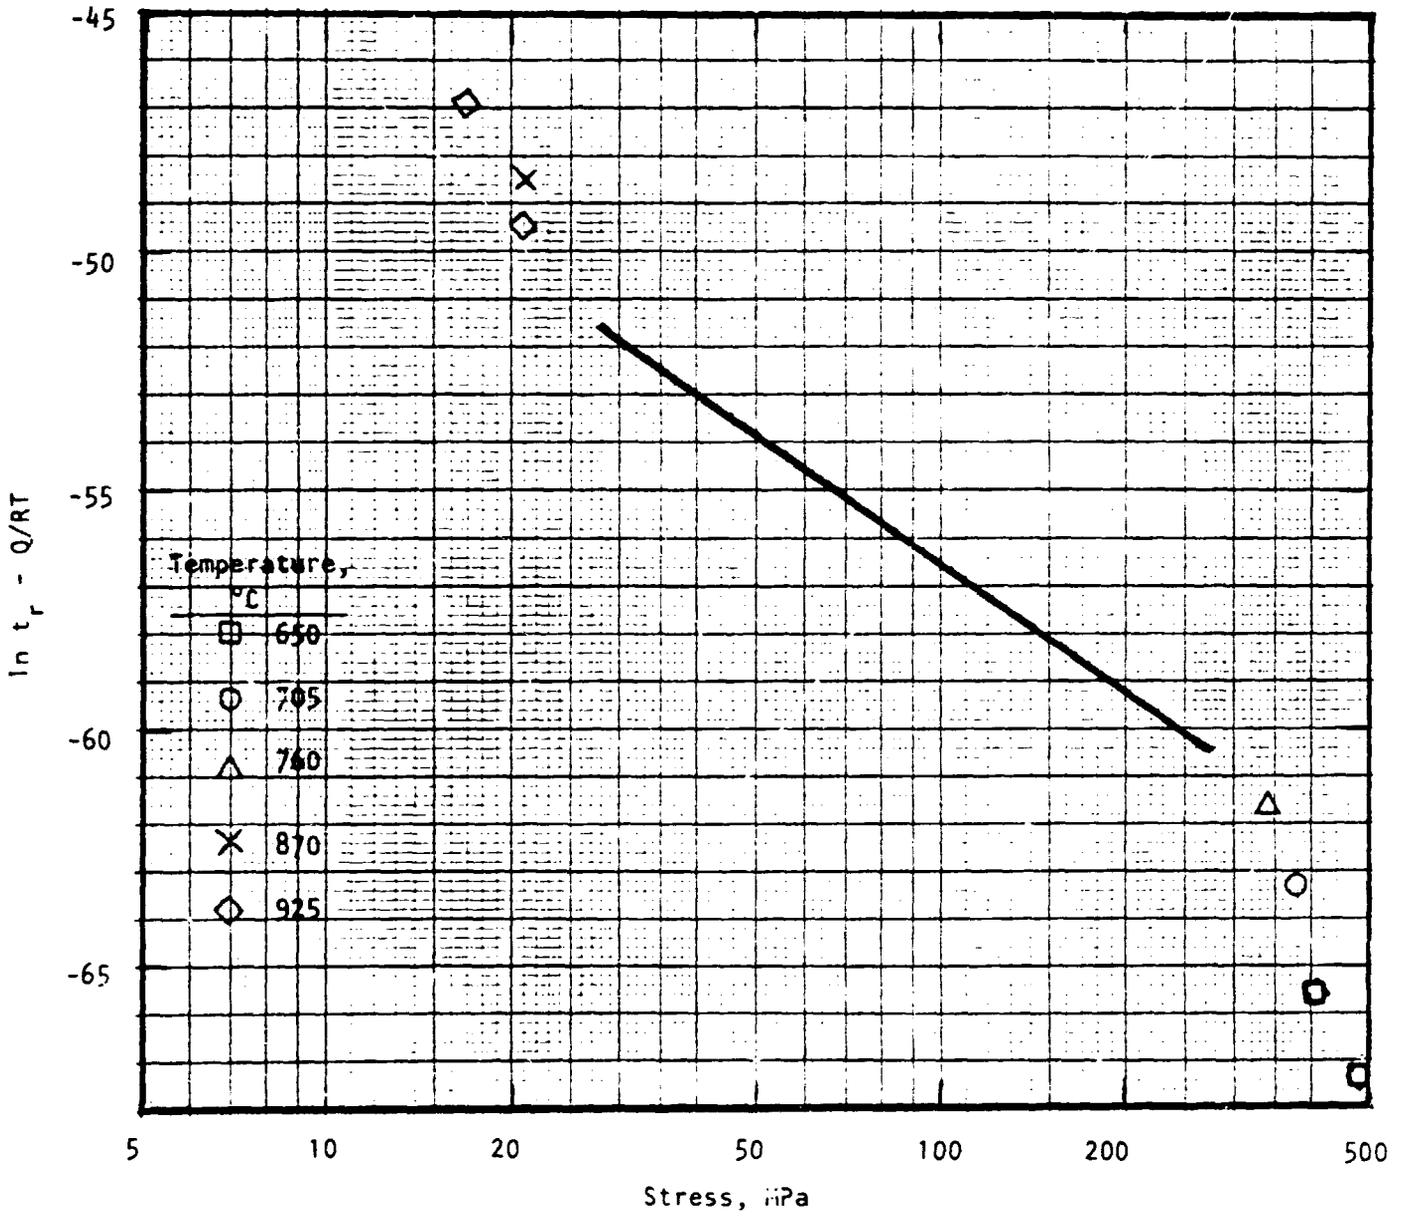
Figure C-2. Temperature-compensated rupture life vs. stress for A-286 tested in air (Case 2B, including Cases 2A and 2C data shown separately).

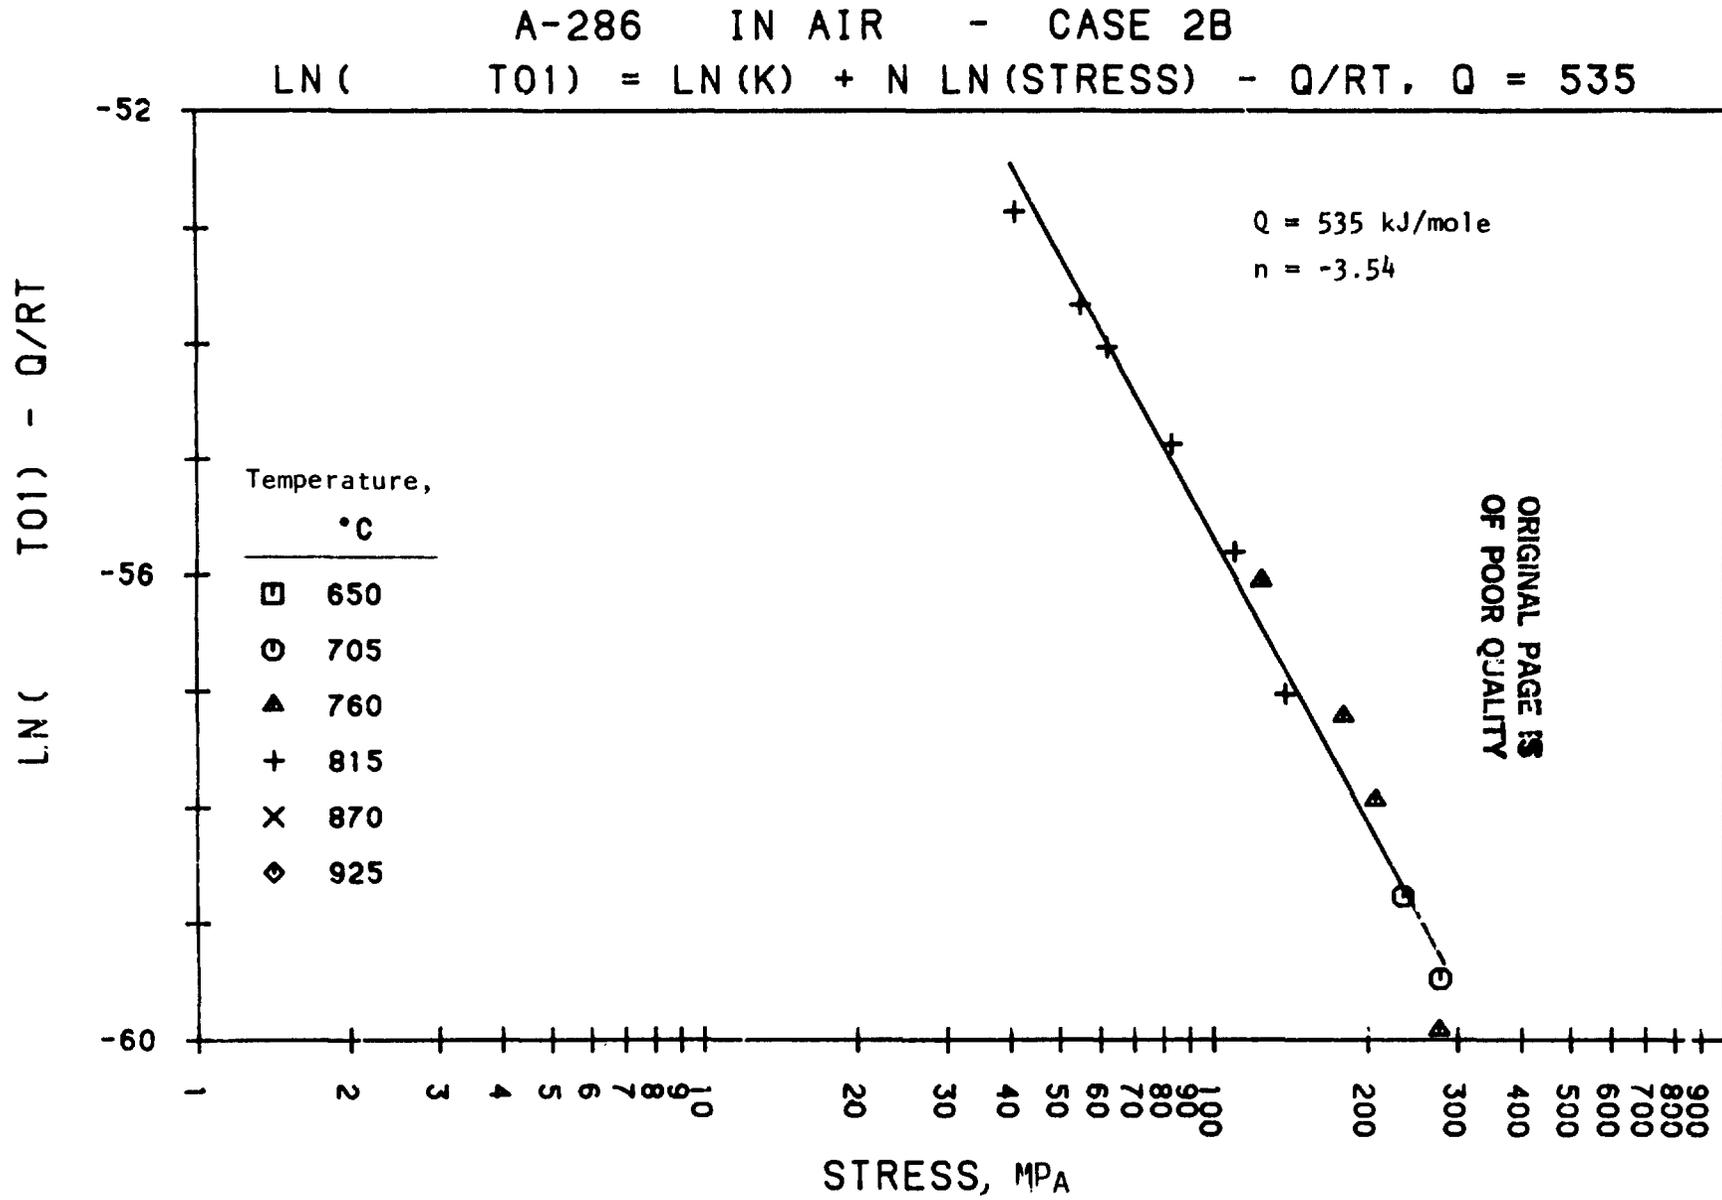
Figure C-3. Temperature-compensated time to 1% creep strain vs. stress for A-286 tested in air (Case 2B).

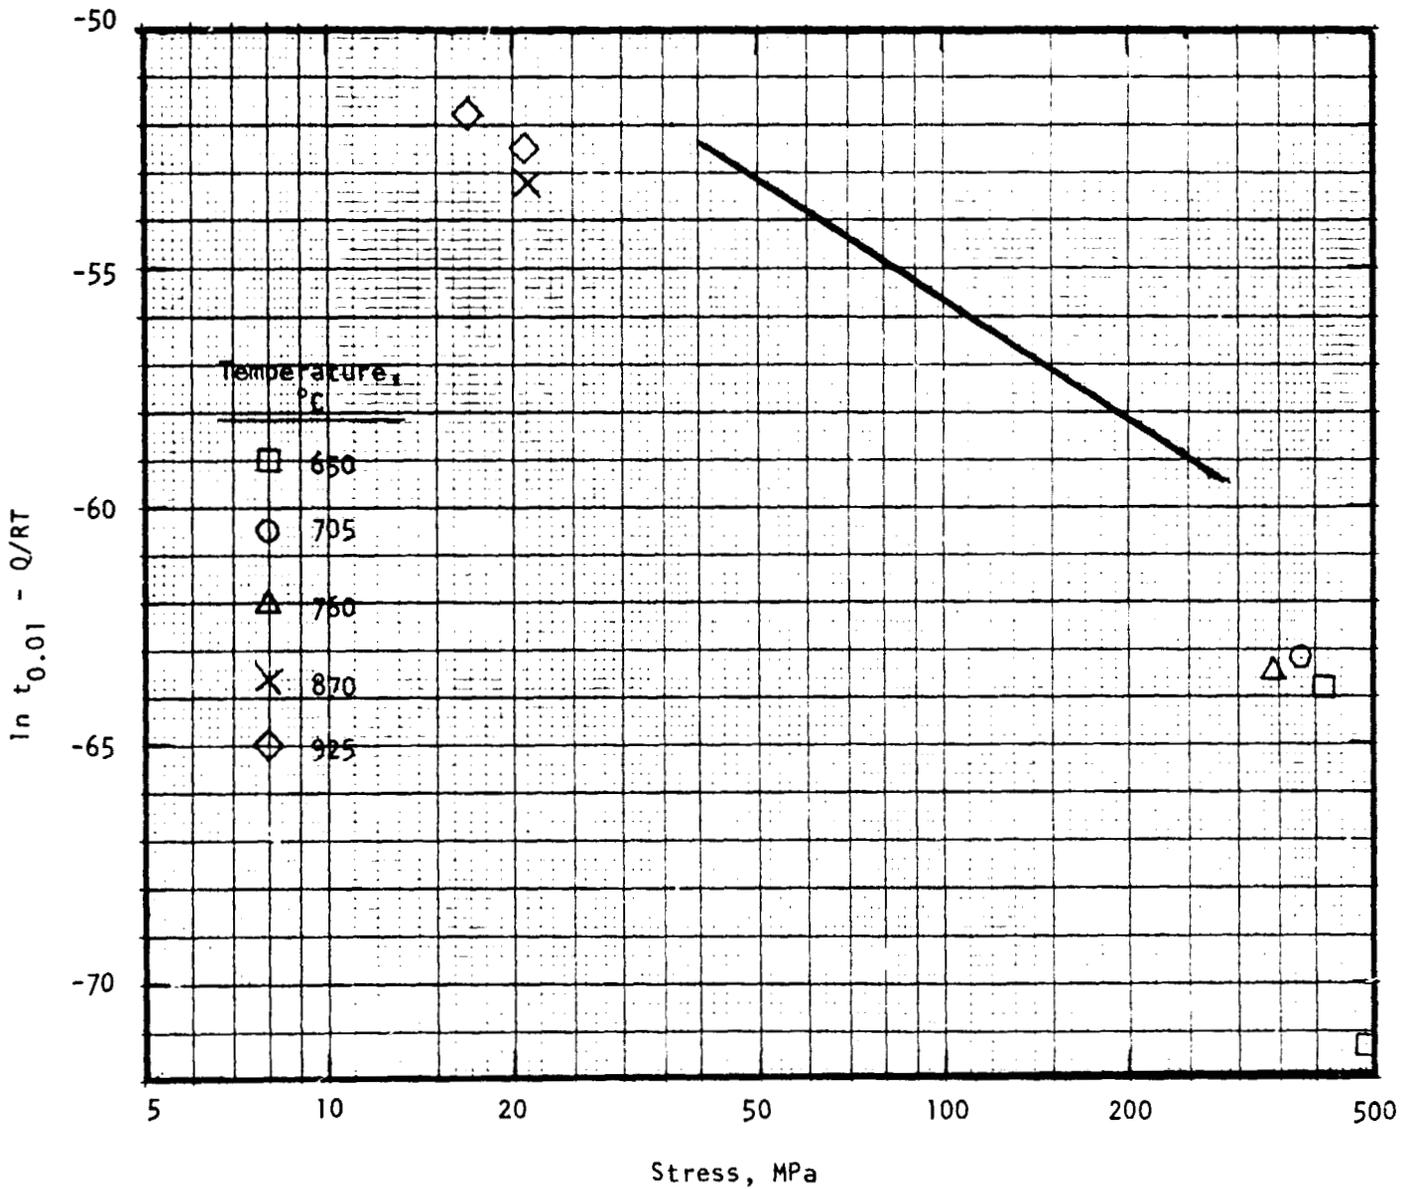
Figure C-4. Temperature-compensated time to 1% creep strain vs. stress for A-286 tested in air (Case 2B, including Cases 2A and 2C shown separately).

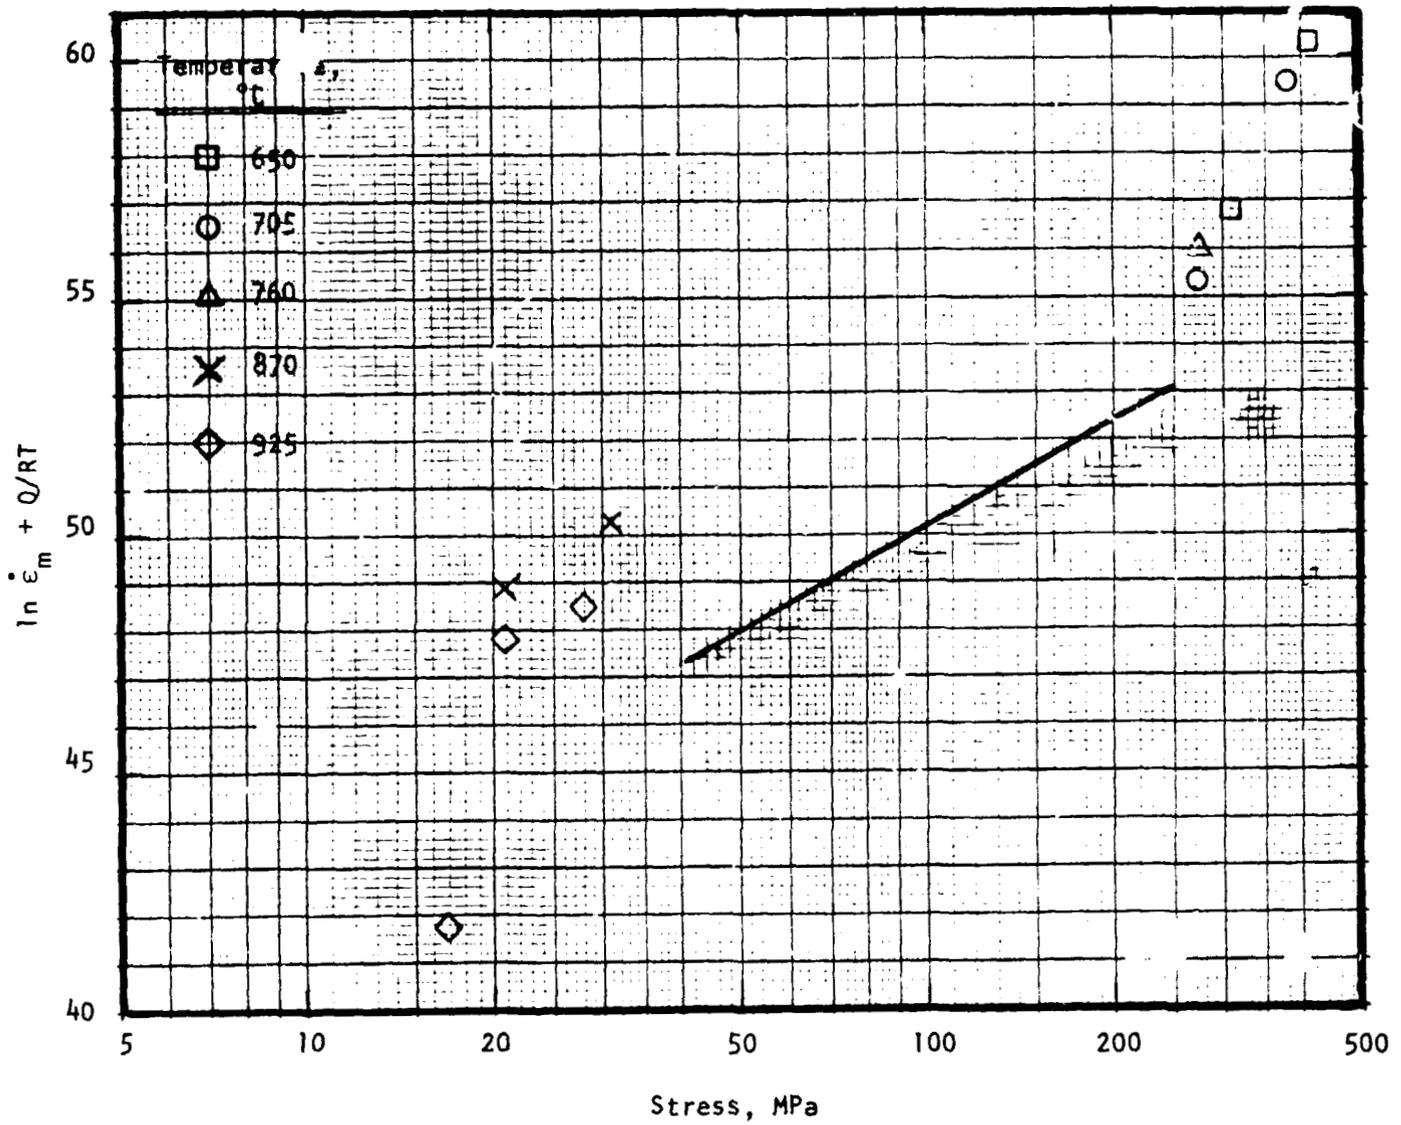
Figure C-6. Temperature-compensated minimum creep rate vs. stress for A-286 tested in air (Case 2B, including Cases 2A and 2C shown separately).

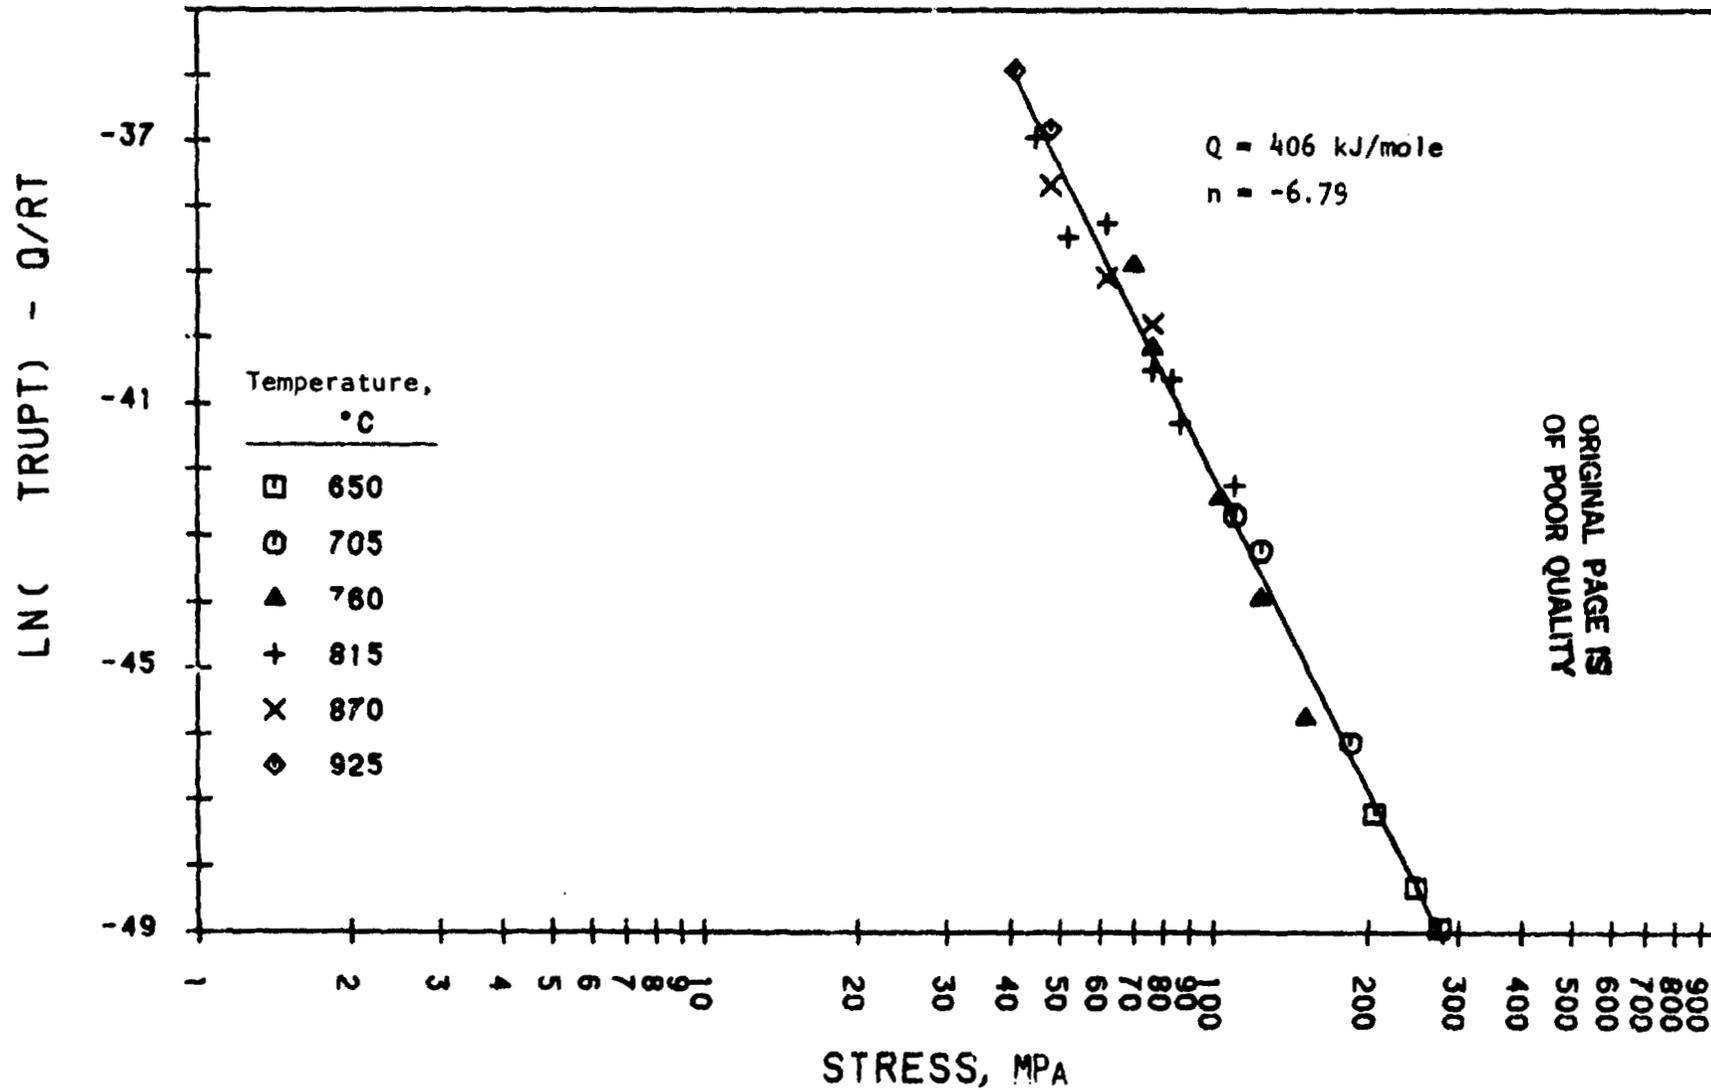
IN 800 IN AIR - CASE 2B
 $\ln(\text{TRUPT}) = \ln(K) + n \ln(\text{STRESS}) - Q/RT, Q = 406$

Figure C-7. Temperature-compensated rupture life vs. stress for IN 800H tested in air (Case 2B).

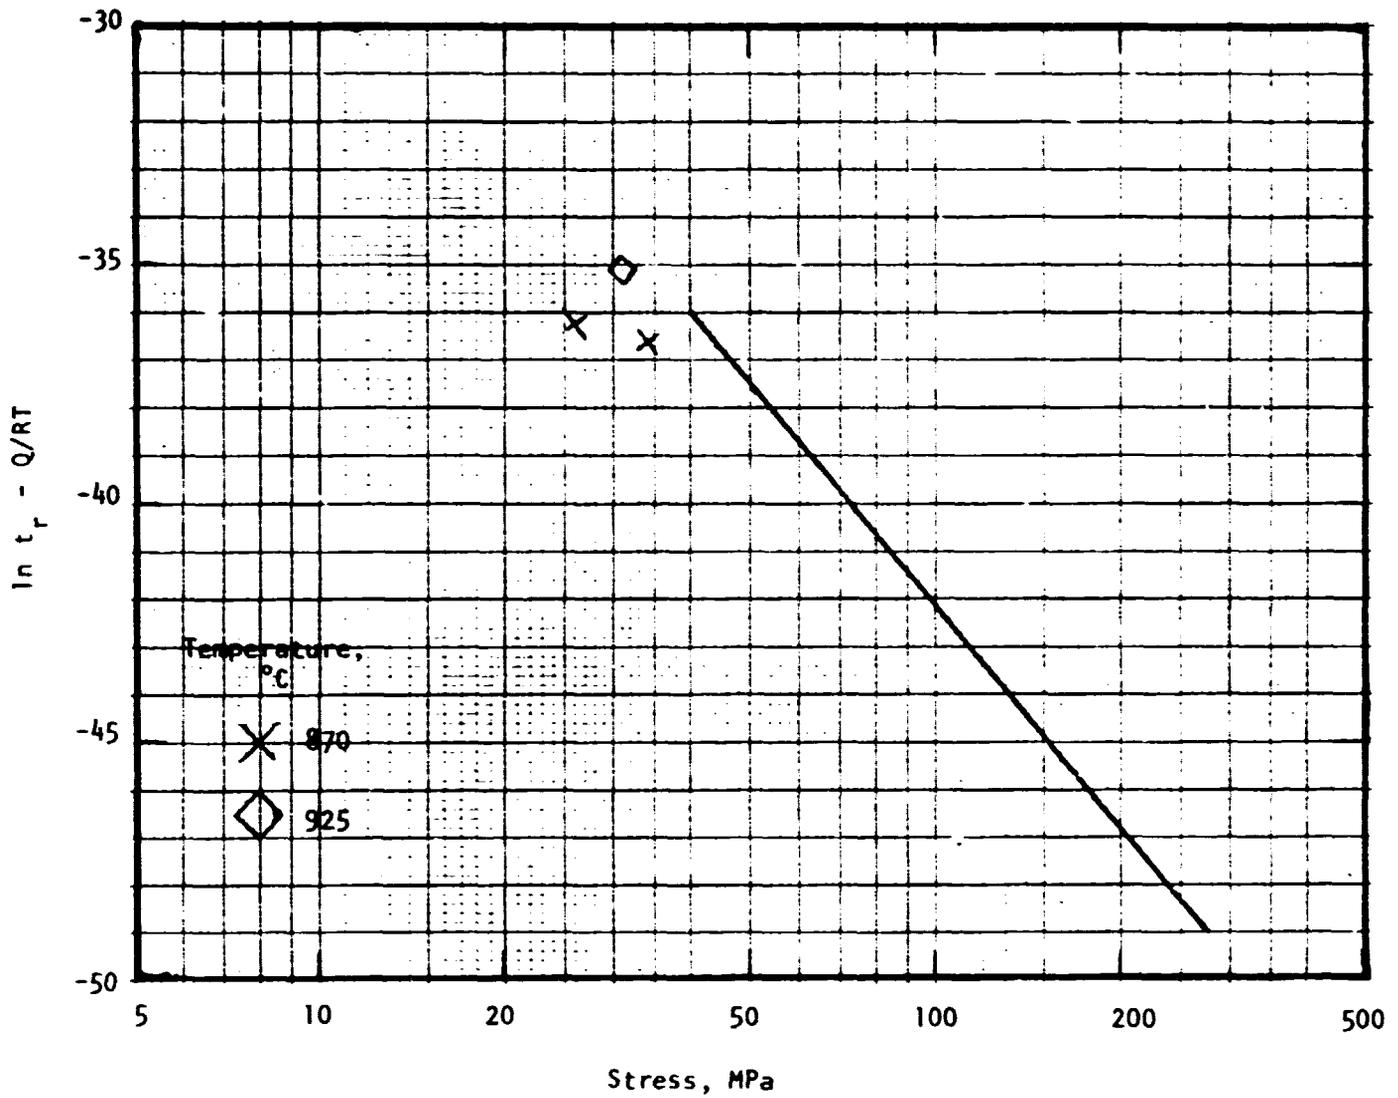
Figure C-8. Temperature-compensated rupture life vs. stress for IN 300H tested in air (Case 2B, including Cases 2A and 2C data shown separately).

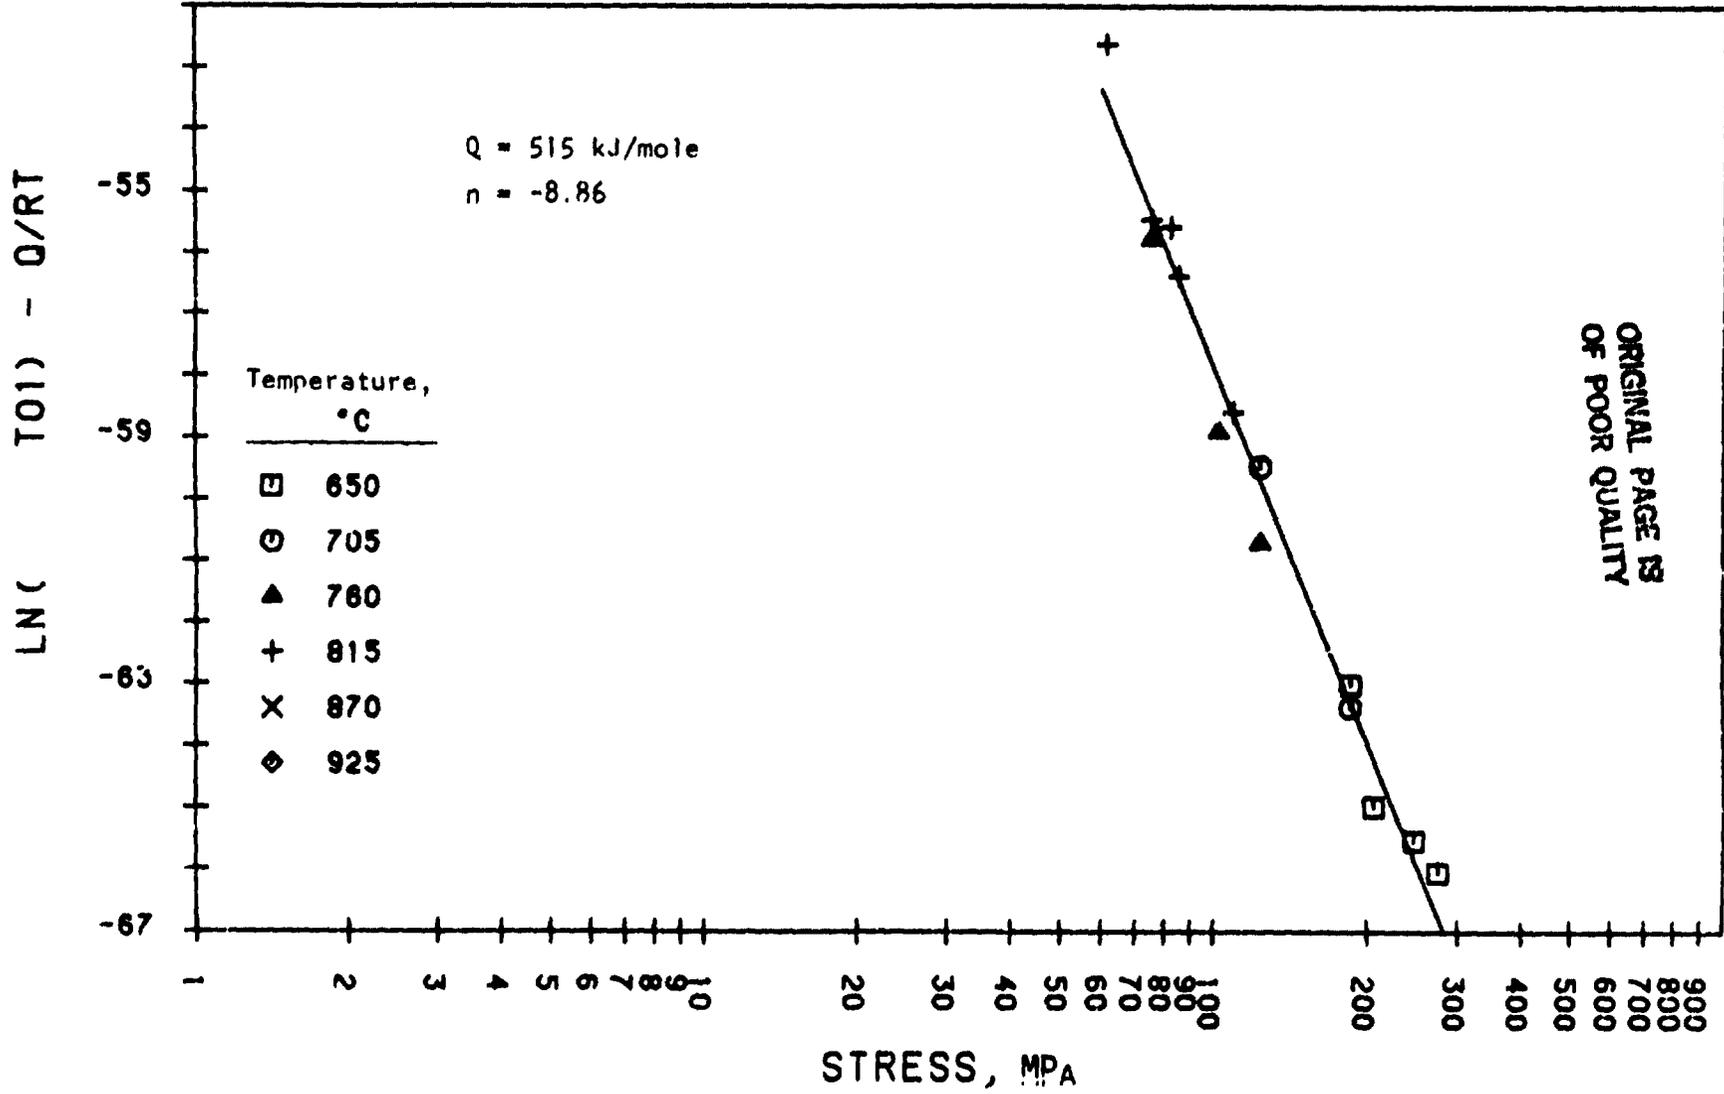
$$\ln(T_01) = \ln(K) + n \ln(\text{STRESS}) - Q/RT, Q = 515$$

Figure C-9. Temperature-compensated time to 1% creep strain vs. stress for IN 800H tested in air (Case 2B).
