CREEP-RUPTURE BEHAVIOR OF SIX CANDIDATE STIRLING ENGINE IRON-BASE SUPERALLOYS IN HIGH PRESSURE HYDROGEN

VOLUME 1 - AIR CREEP-RUPTURE BEHAVIOR

S. Bhattacharyya
IIT RESEARCH INSTITUTE
10 West 35th Street
Chicago, Illinois 60616

DECEMBER 1982

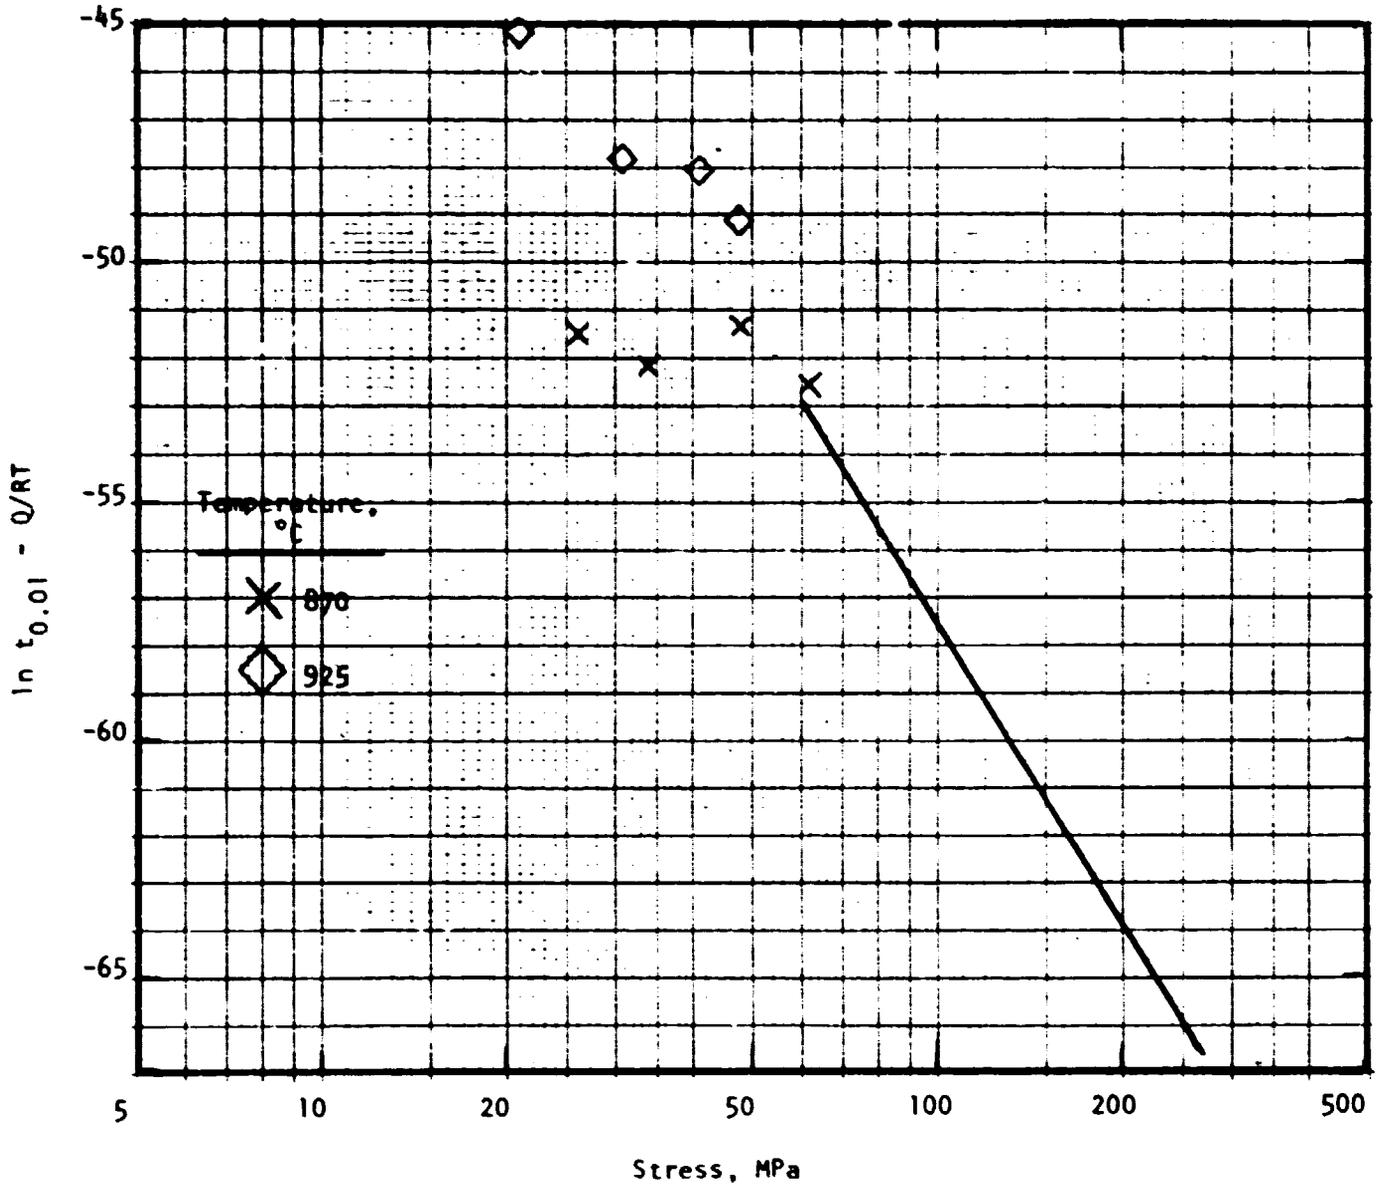
Figure C-10. Temperature-compensated time to 1% creep strain vs. stress for IN 800H tested in air (Case 2B, including Cases 2A and 2C shown separately).

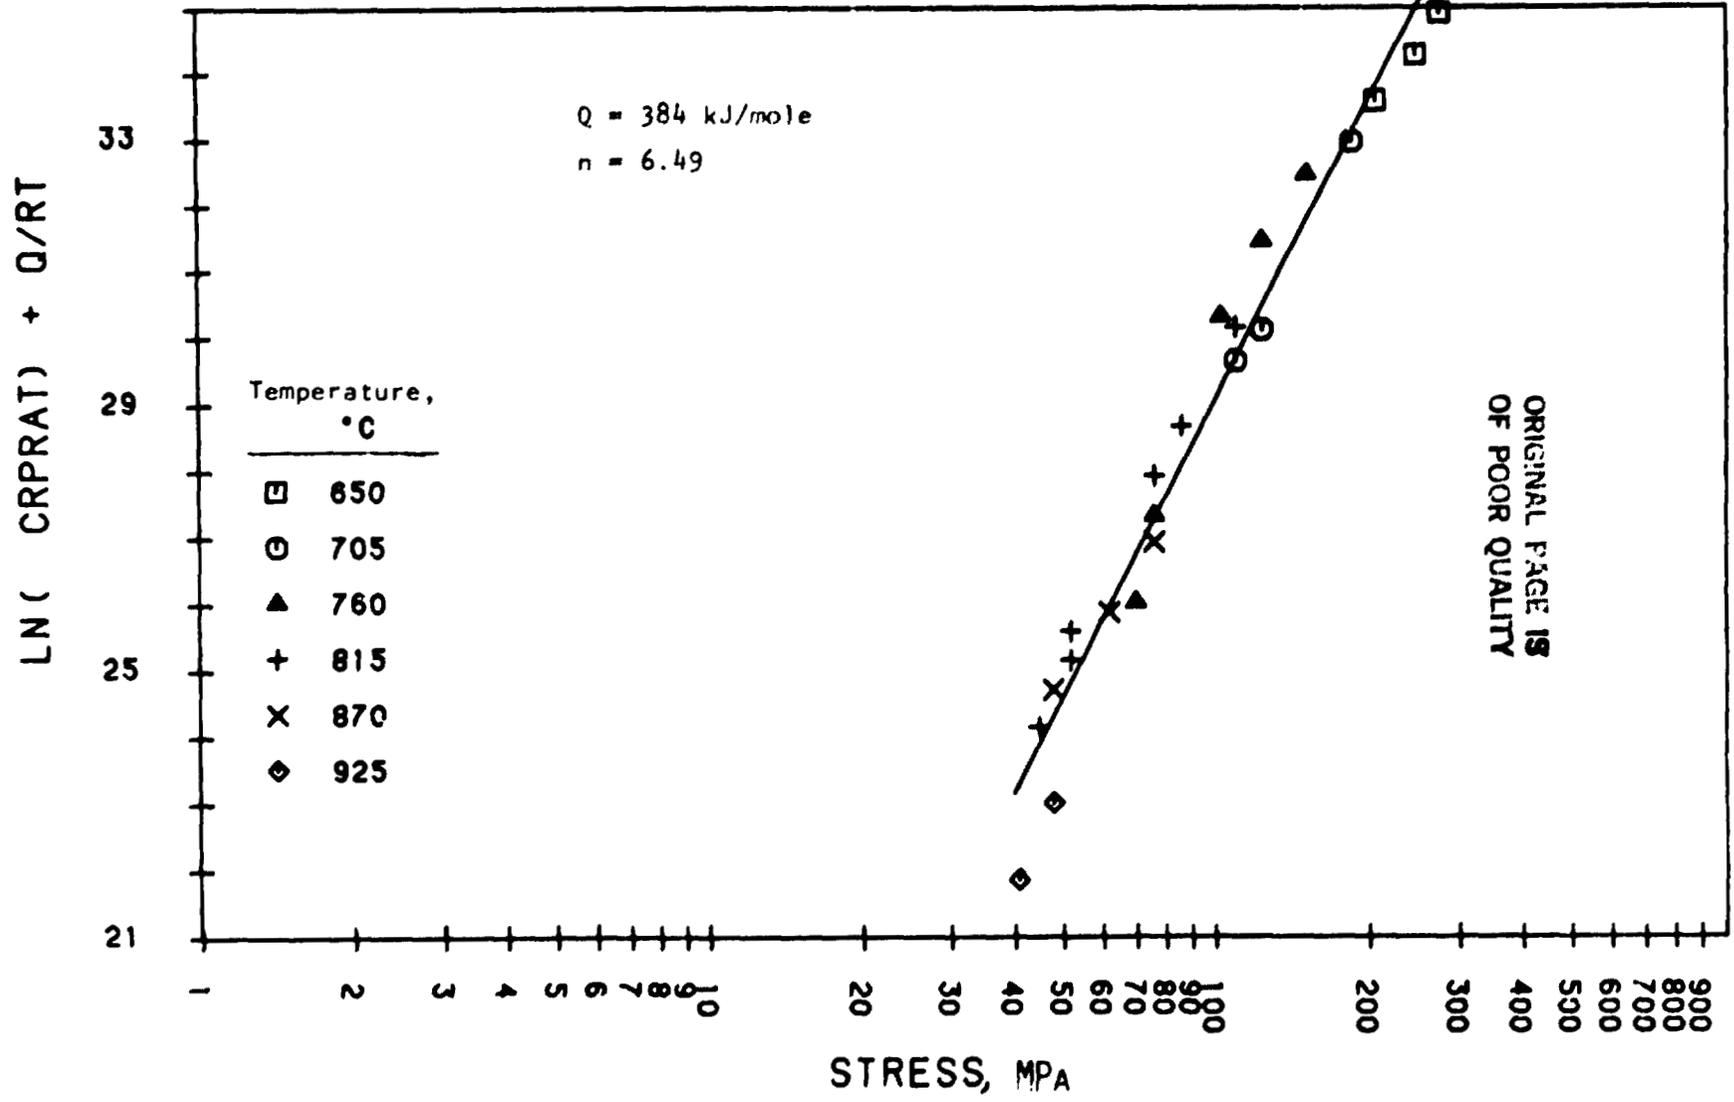
$$\ln(\text{CRPRAT}) = \ln(K) + n \ln(\text{STRESS}) + Q/RT, \quad Q = 384$$

Figure C-11. Temperature-compensated minimum creep rate vs. stress for IN 800H tested in air (Case 2B).

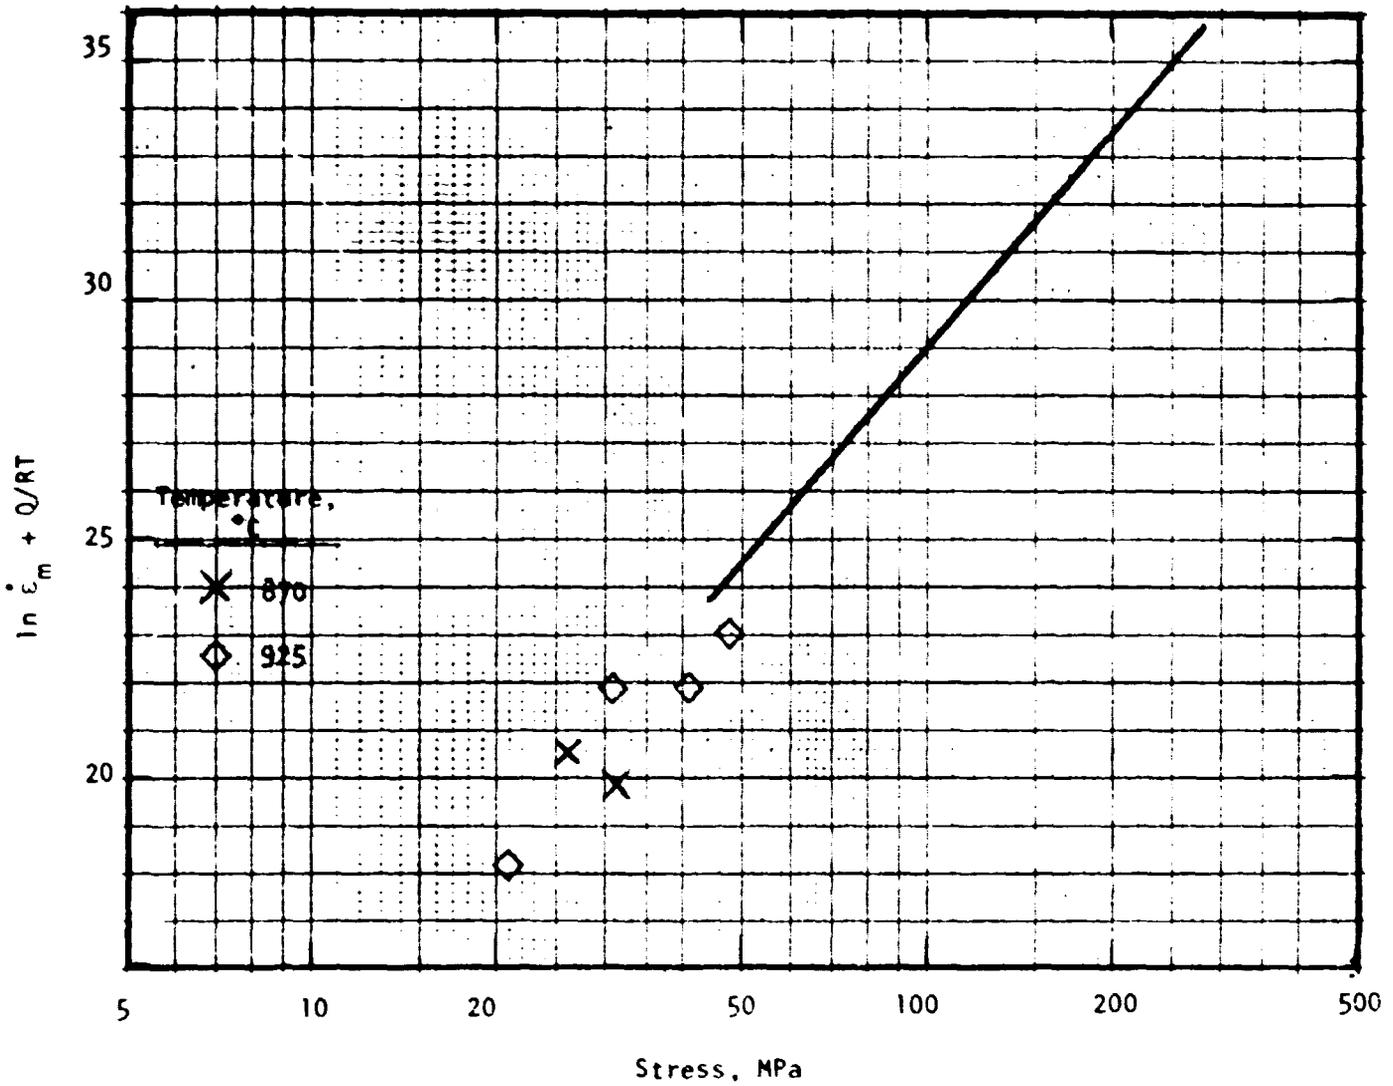
Figure C-12. Temperature-compensated minimum creep rate vs. stress for IN 800H tested in air (Case 2B, including Cases 2A and 2C shown separately).

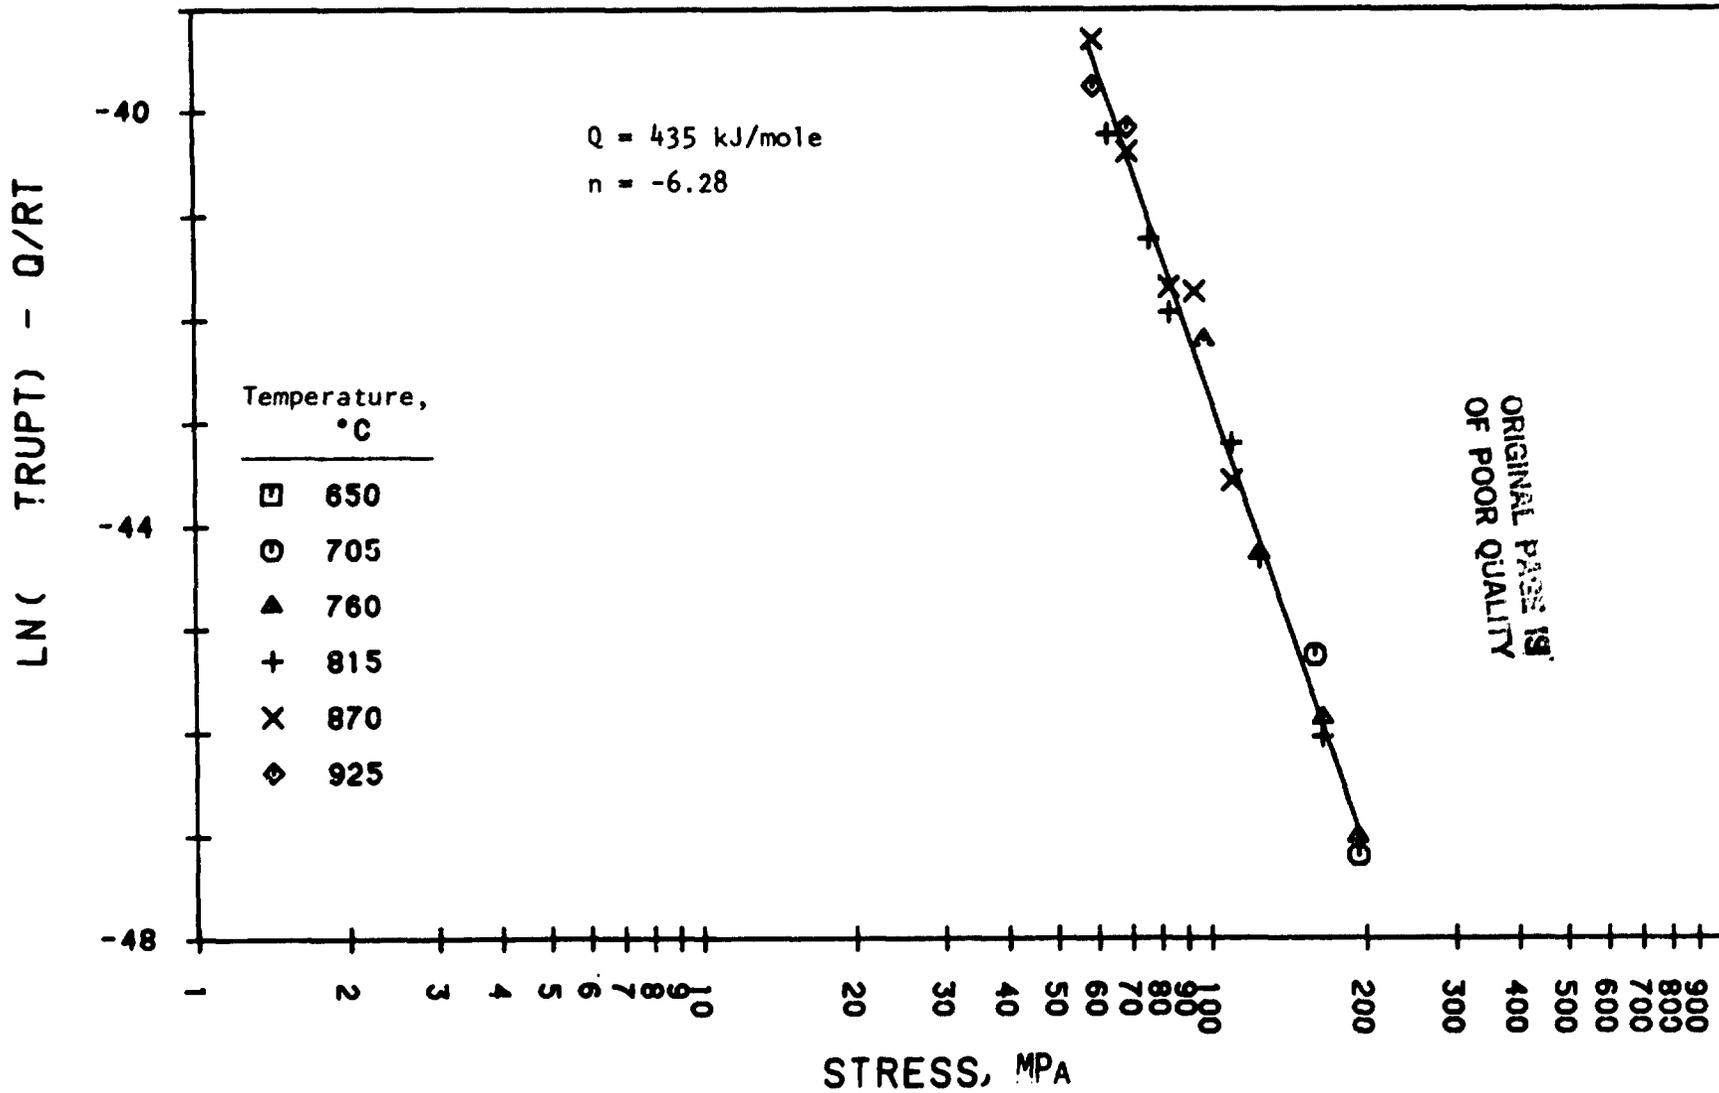
N-155 IN AIR - CASE 2B
 $\text{LN}(\text{TRUPT}) = \text{LN}(K) + N \text{LN}(\text{STRESS}) - Q/RT, Q = 435$

Figure C-13. Temperature-compensated rupture life vs. stress for N-155 tested in air (Case 2B).

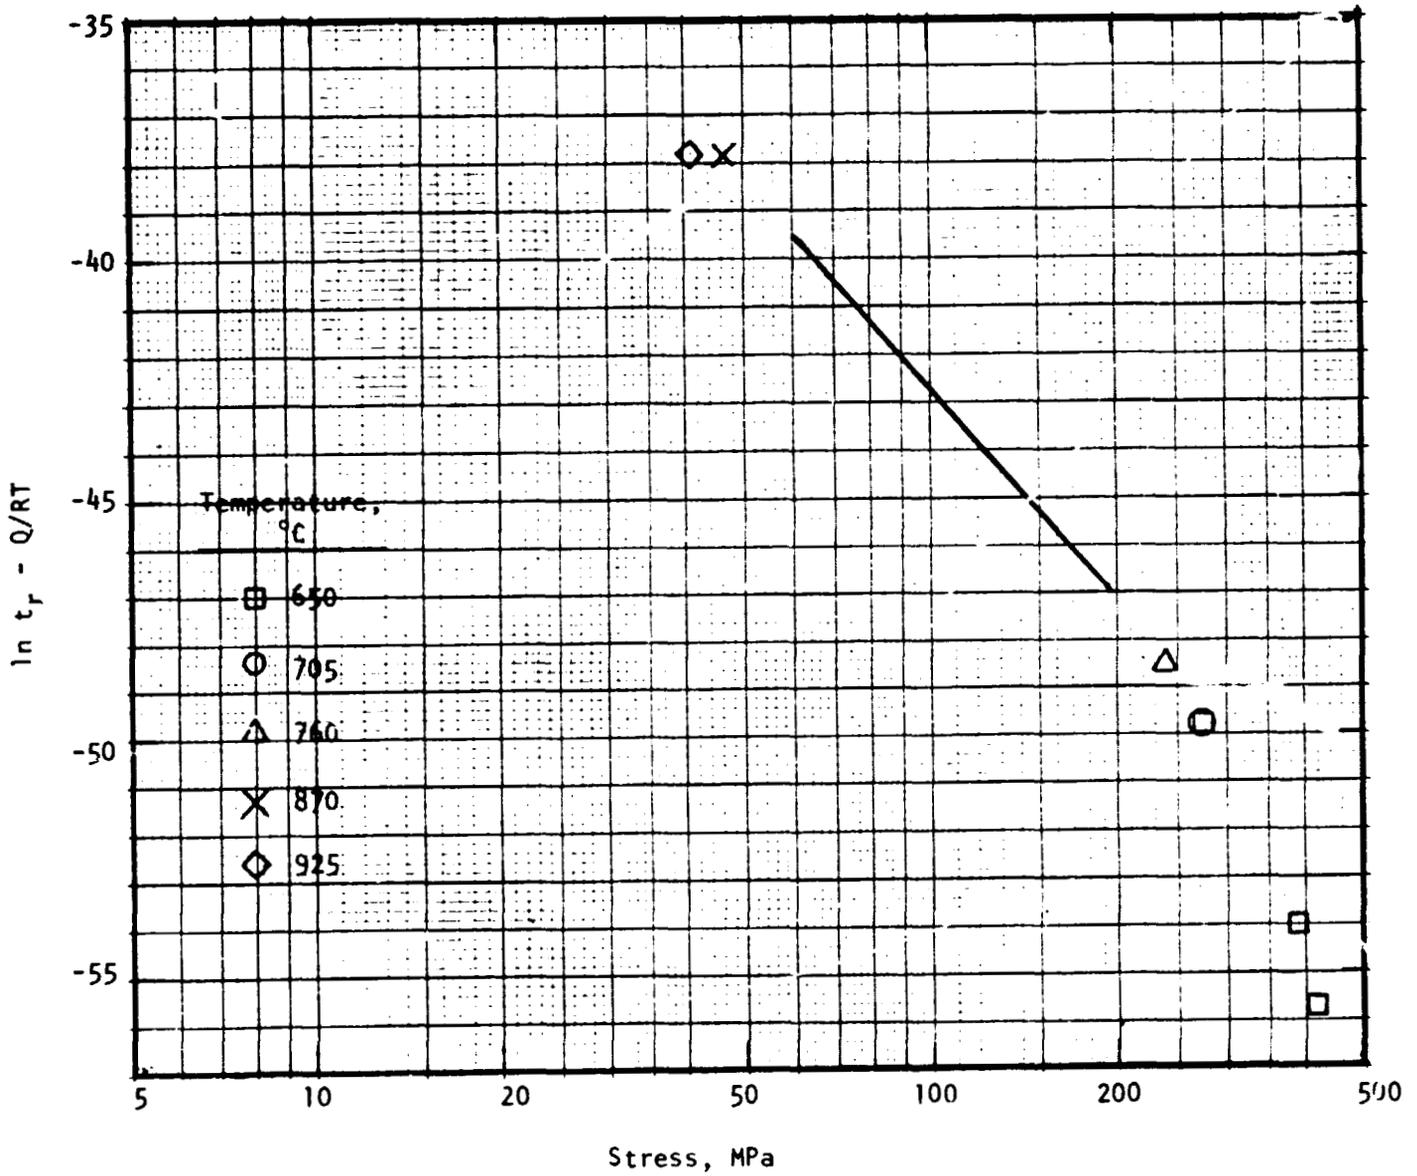
Figure C-14. Temperature-compensated rupture life vs. stress for N-155 tested in air (Case 2B, including Cases 2A and 2C data shown separately).

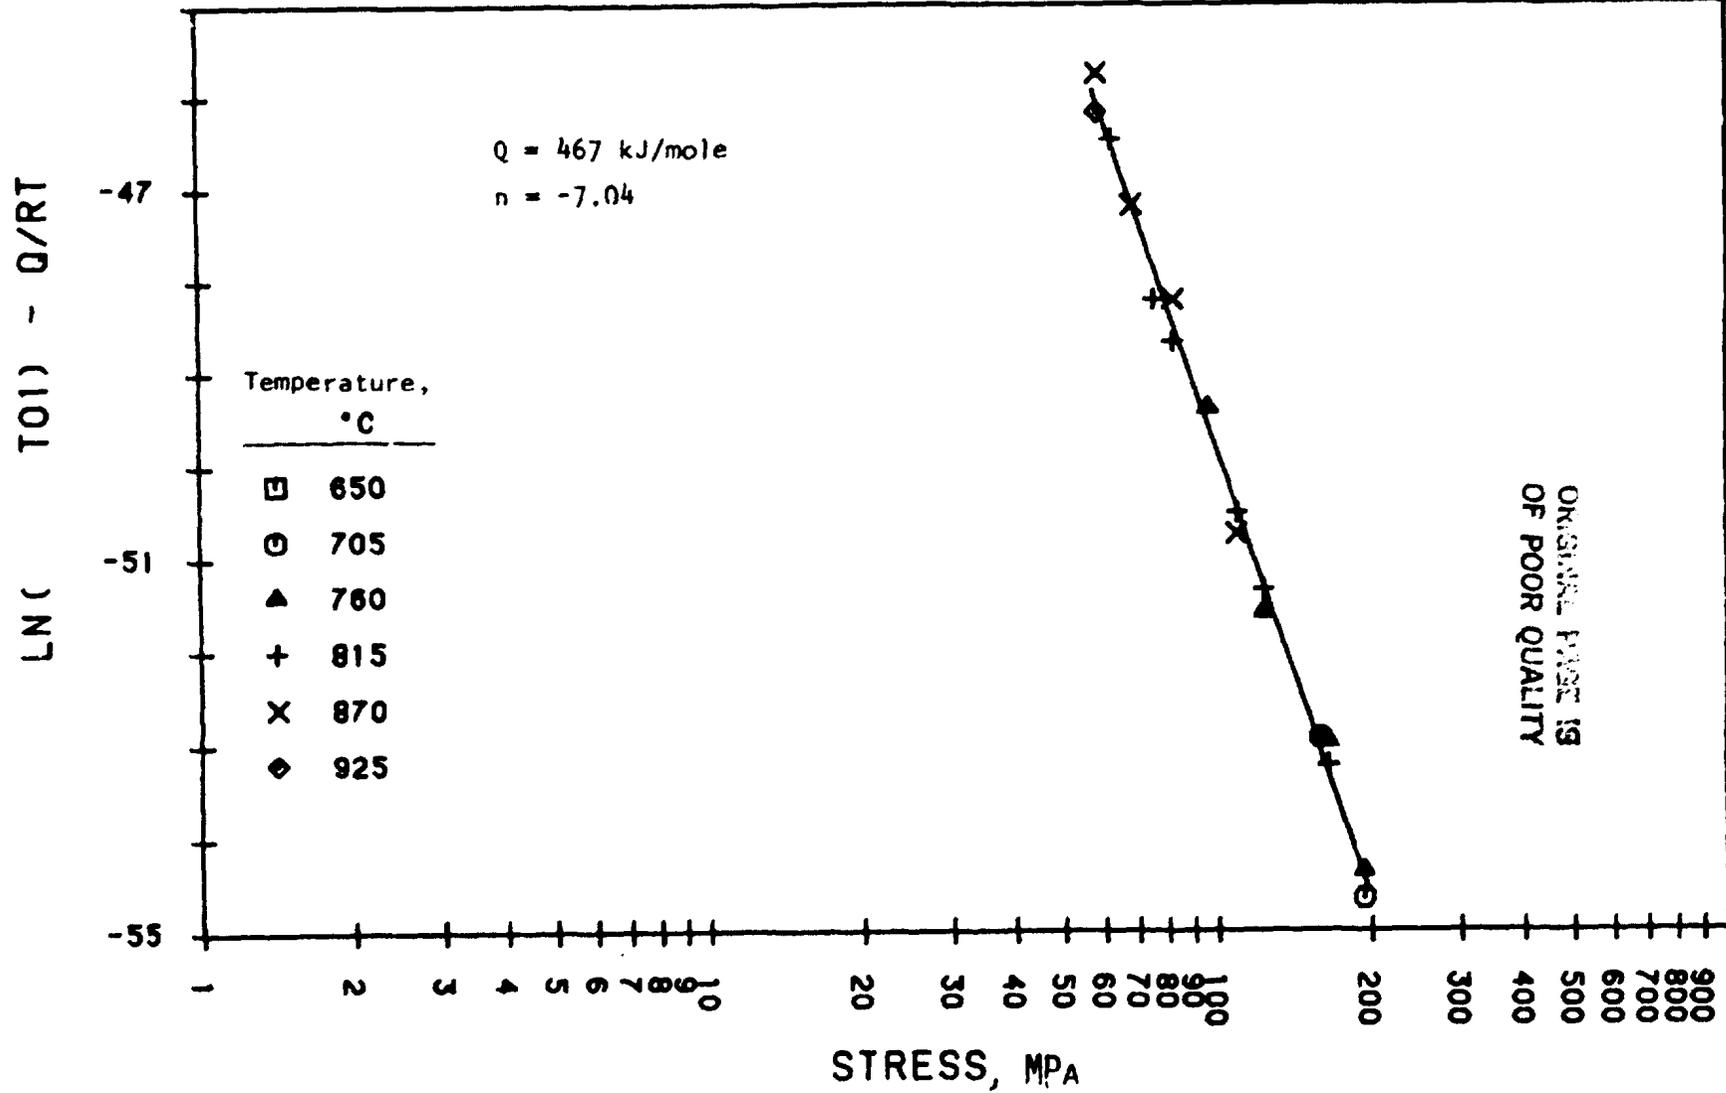
Figure C-15. Temperature-compensated time to 1% creep strain vs. stress for N-155 tested in air (Case 2B).

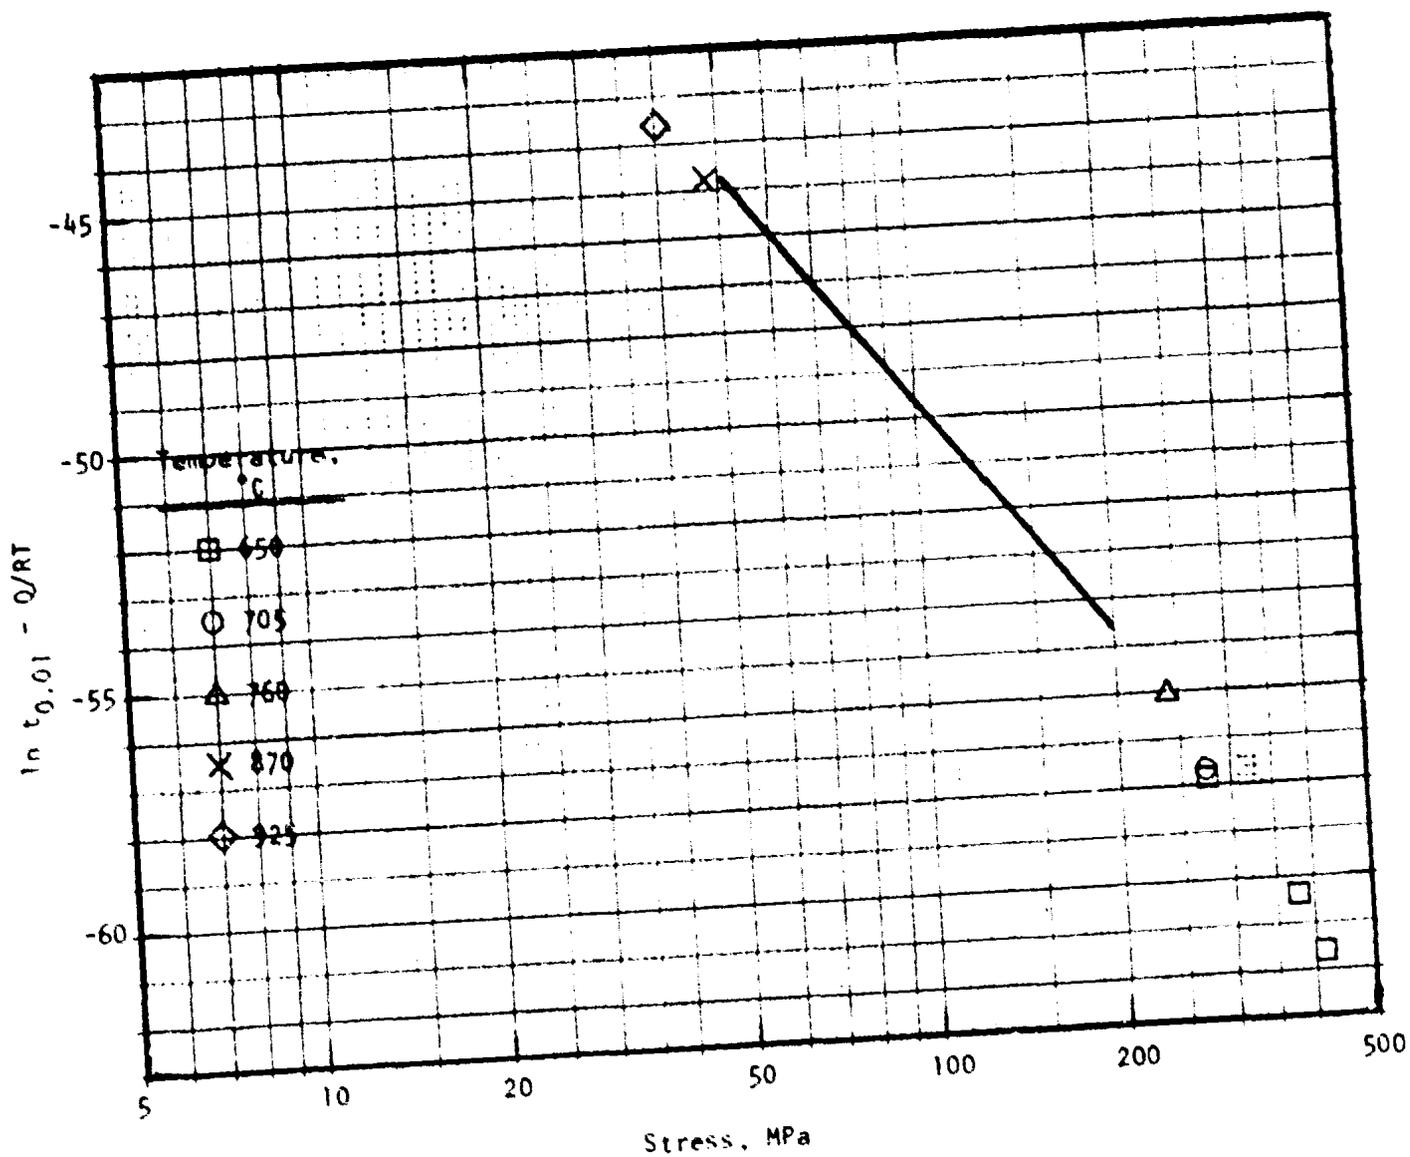
Figure C-16. Temperature-compensated time to 1% creep strain vs. stress for N-155 tested in air (case 2B, including cases 2A and 2C shown separately).

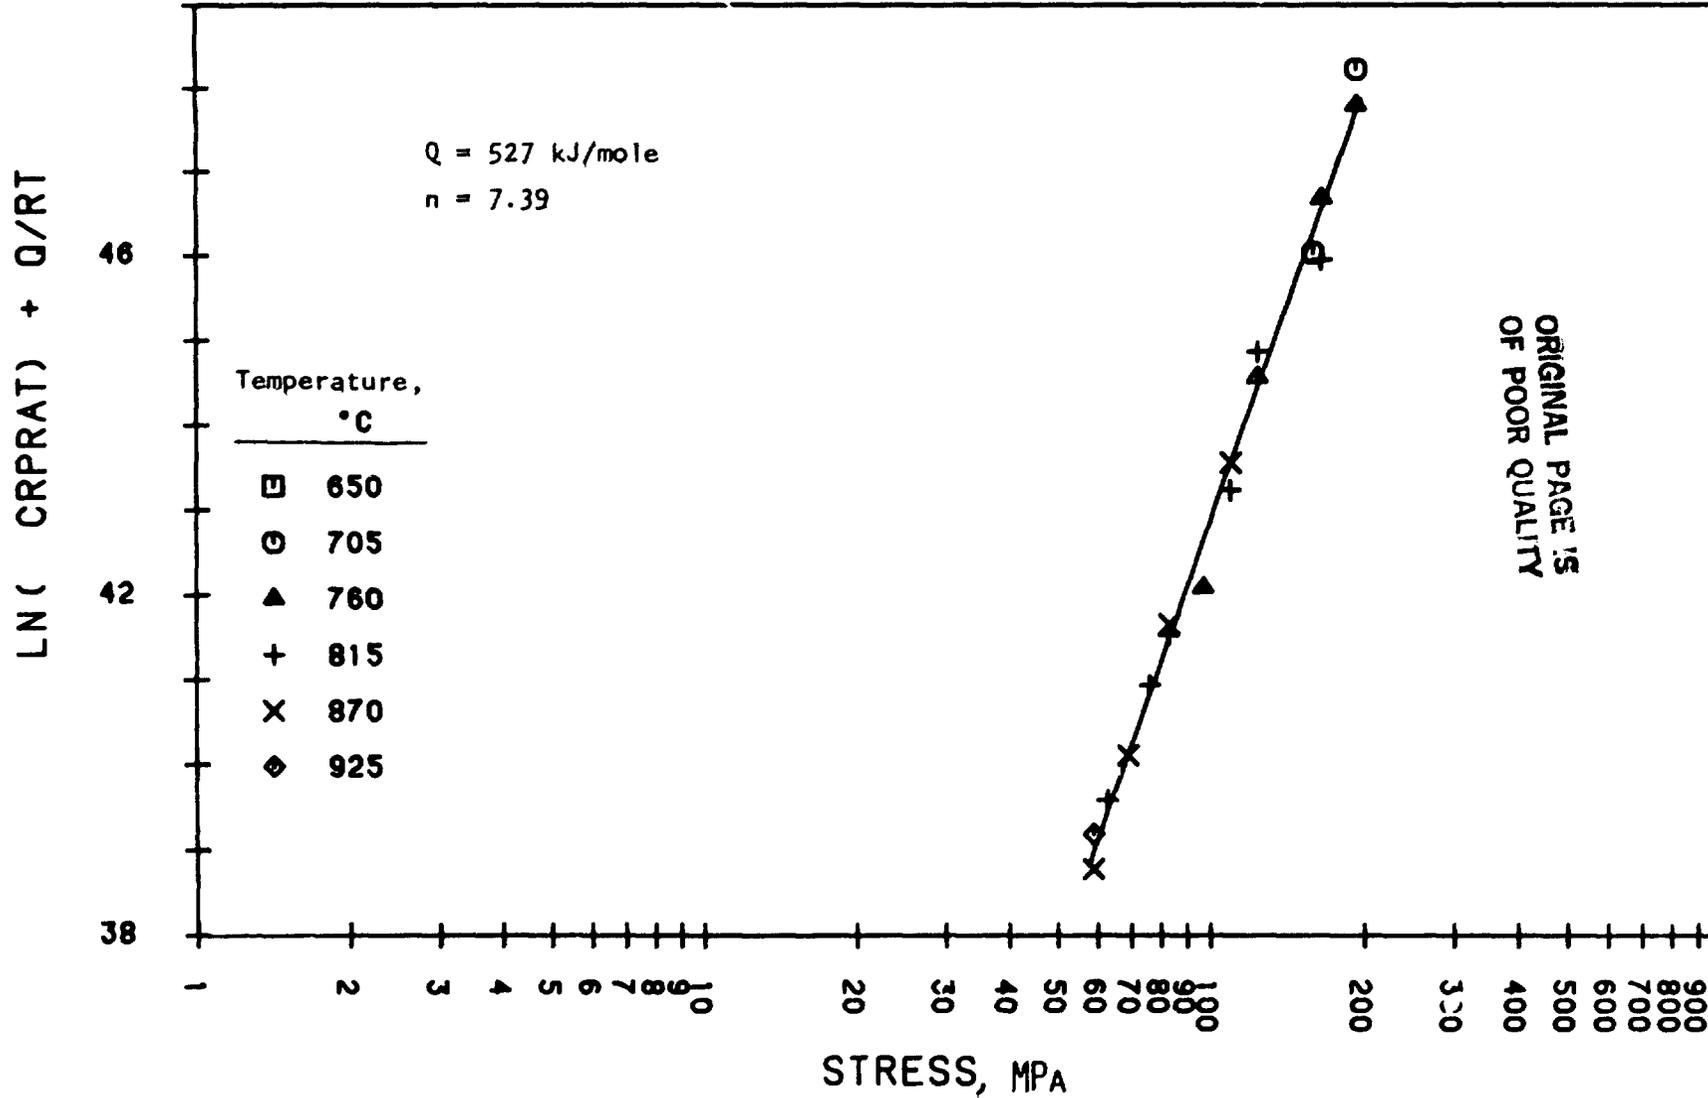
$$\text{LN}(\text{CRPRAT}) = \text{LN}(K) + N \text{LN}(\text{STRESS}) + Q/RT, Q = 527$$

Figure C-17. Temperature-compensated minimum creep rate vs. stress for N-155 tested in air (Case 2B).

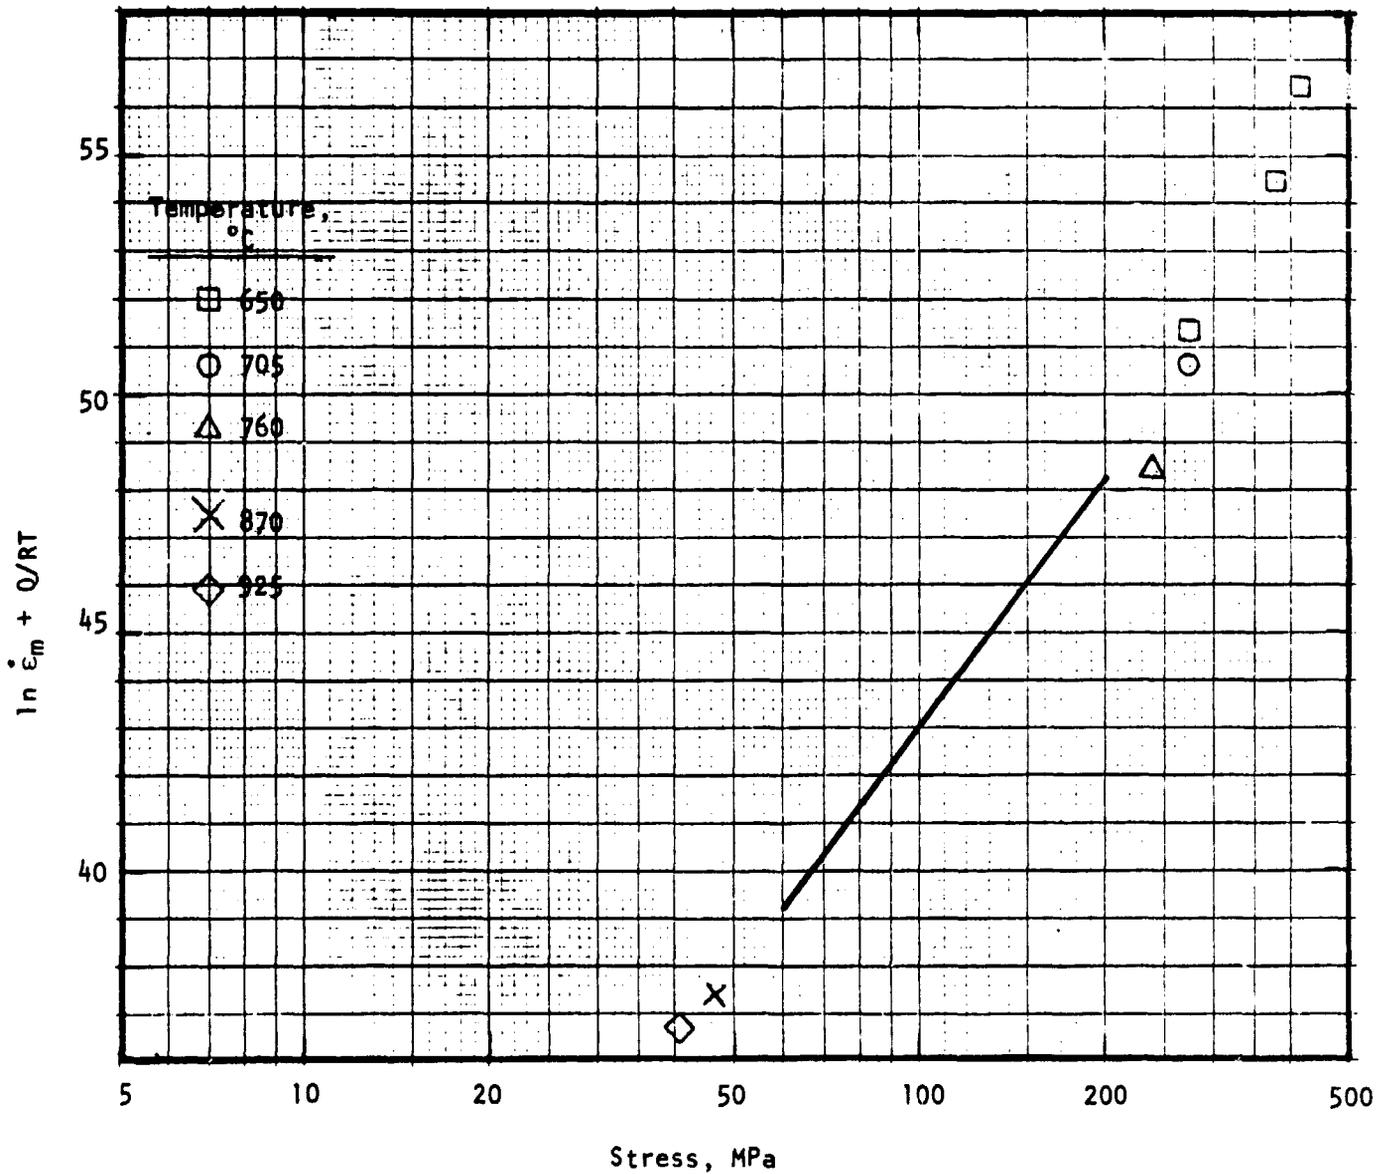
Figure C-18. Temperature-compensated minimum creep rate vs. stress for N-155 tested in air (Case 2B, including Cases 2A and 2C shown separately).

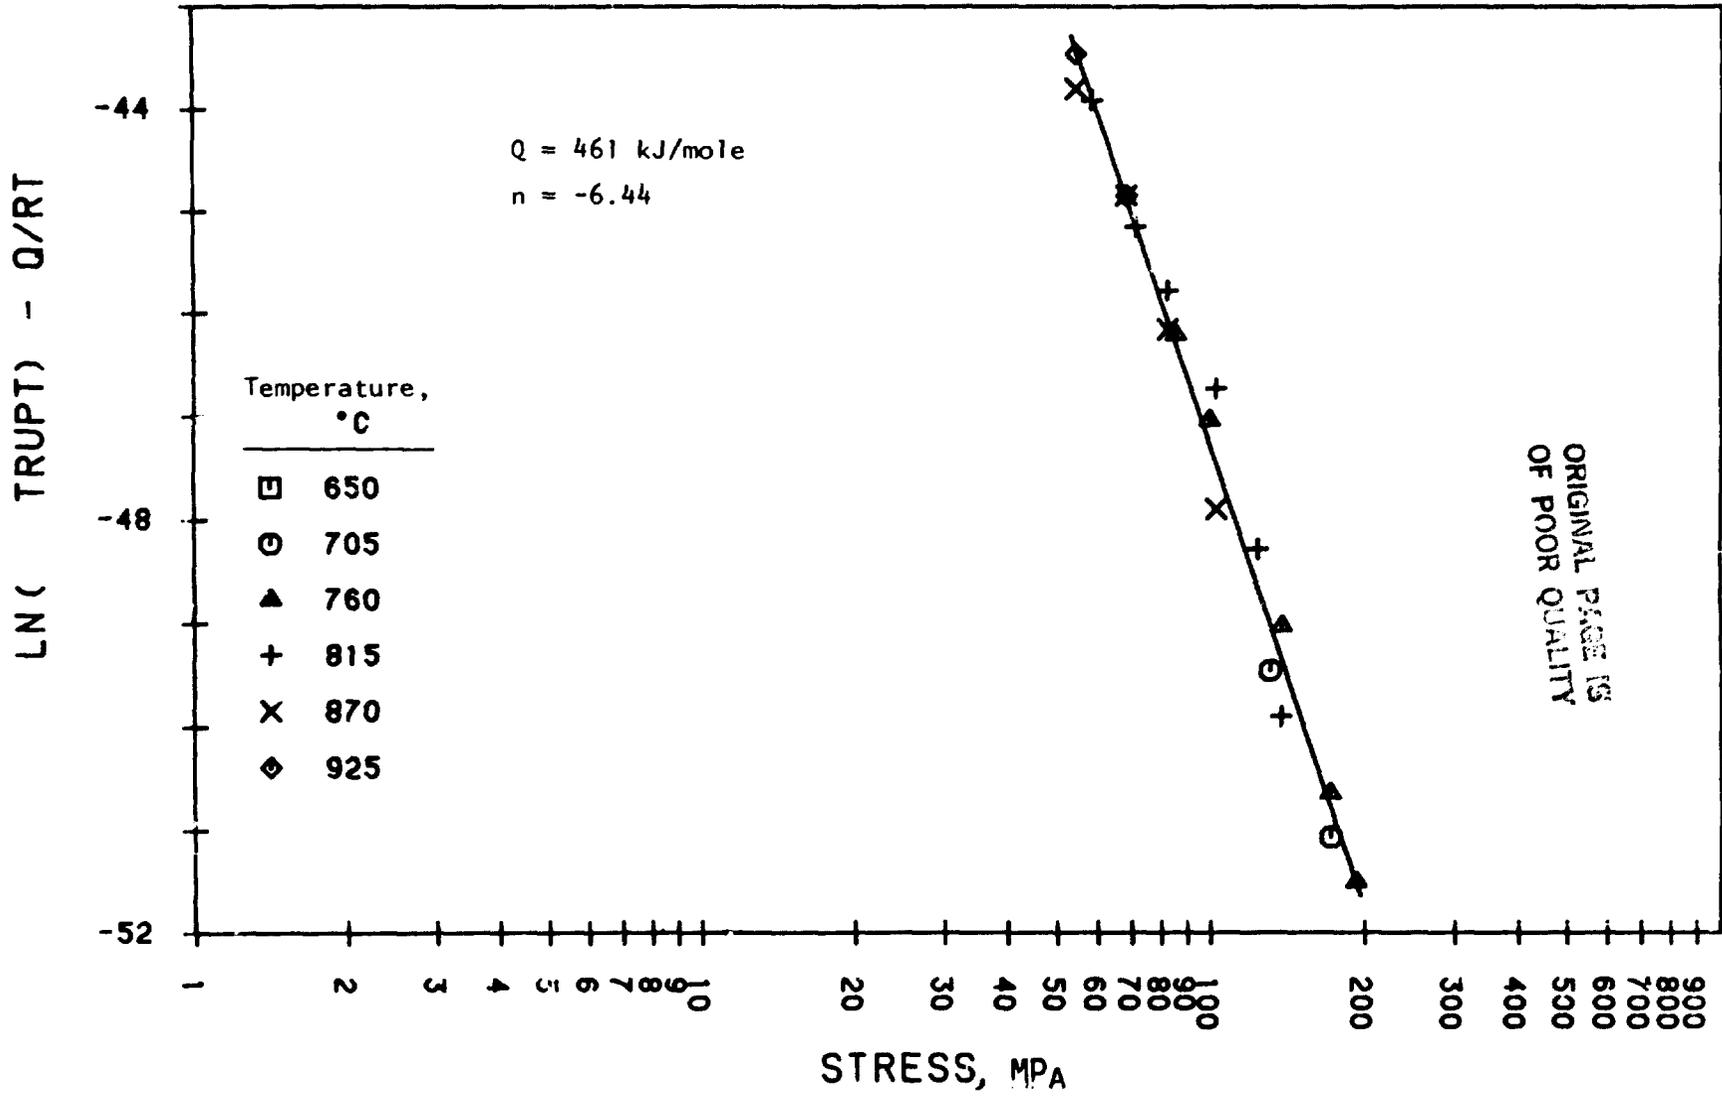
19-9DL IN AIR - CASE 2B
 $\ln(\text{TRUPT}) = \ln(K) + n \ln(\text{STRESS}) - Q/RT, Q = 461$

Figure C-19. Temperature-compensated rupture life vs. strain for 19-9DL tested in air (Case 2B).

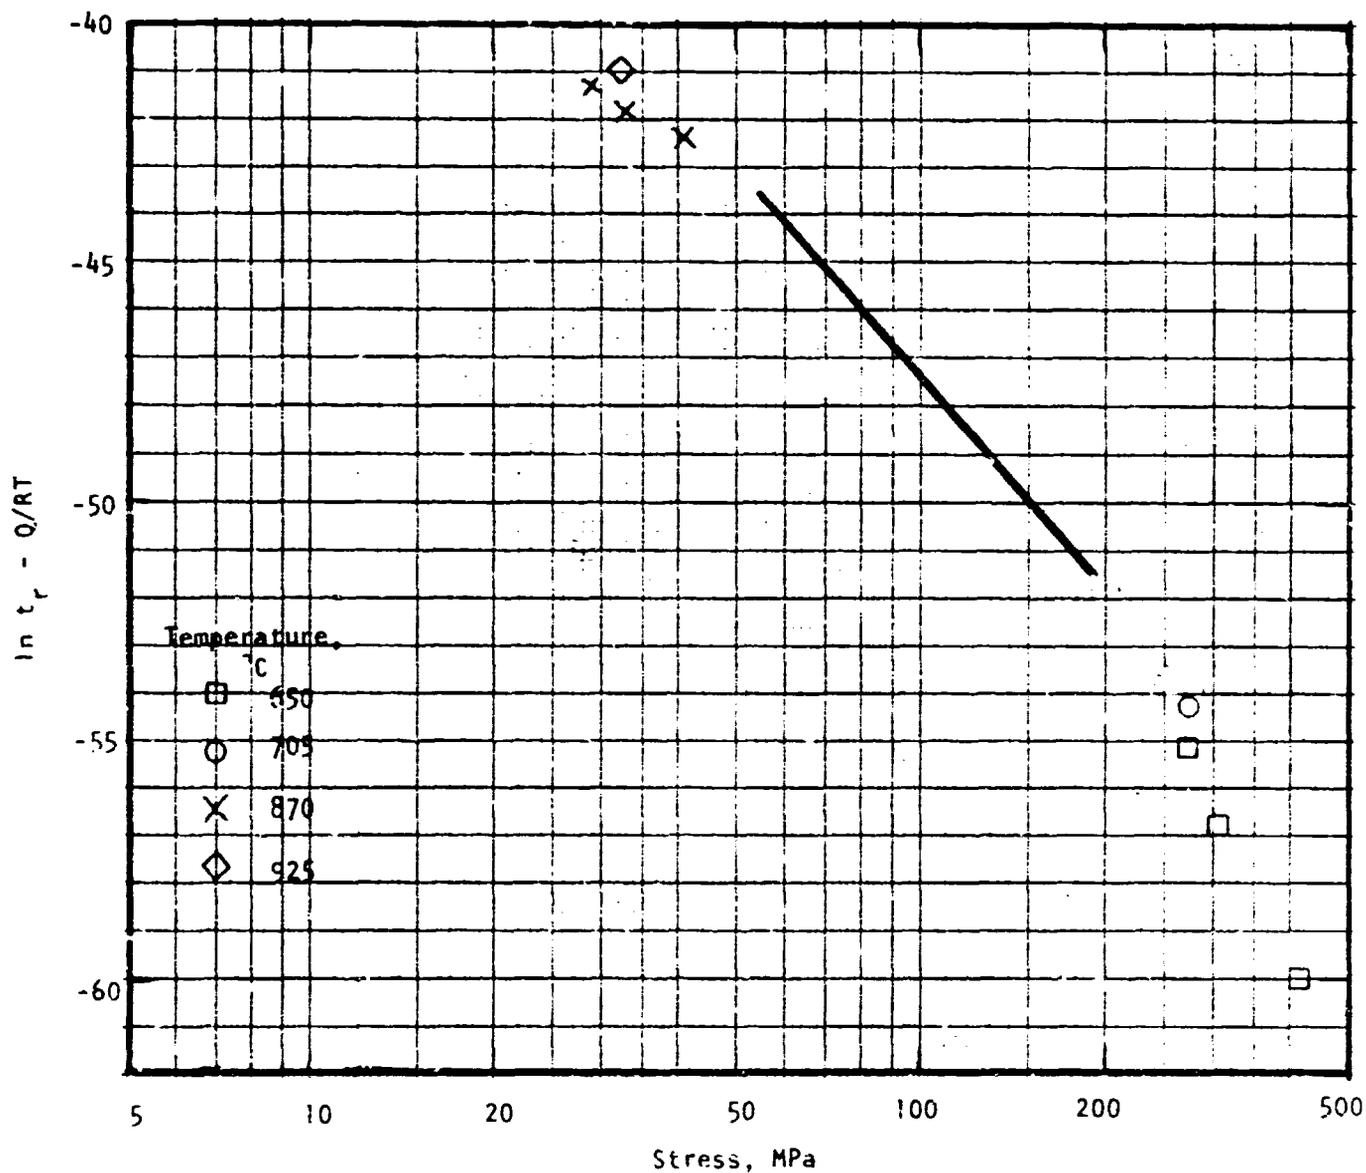
Figure C-20. Temperature-compensated rupture life vs. stress for 19-9DL tested in air (Case 2B, including Cases 2A and 2C data shown separately).

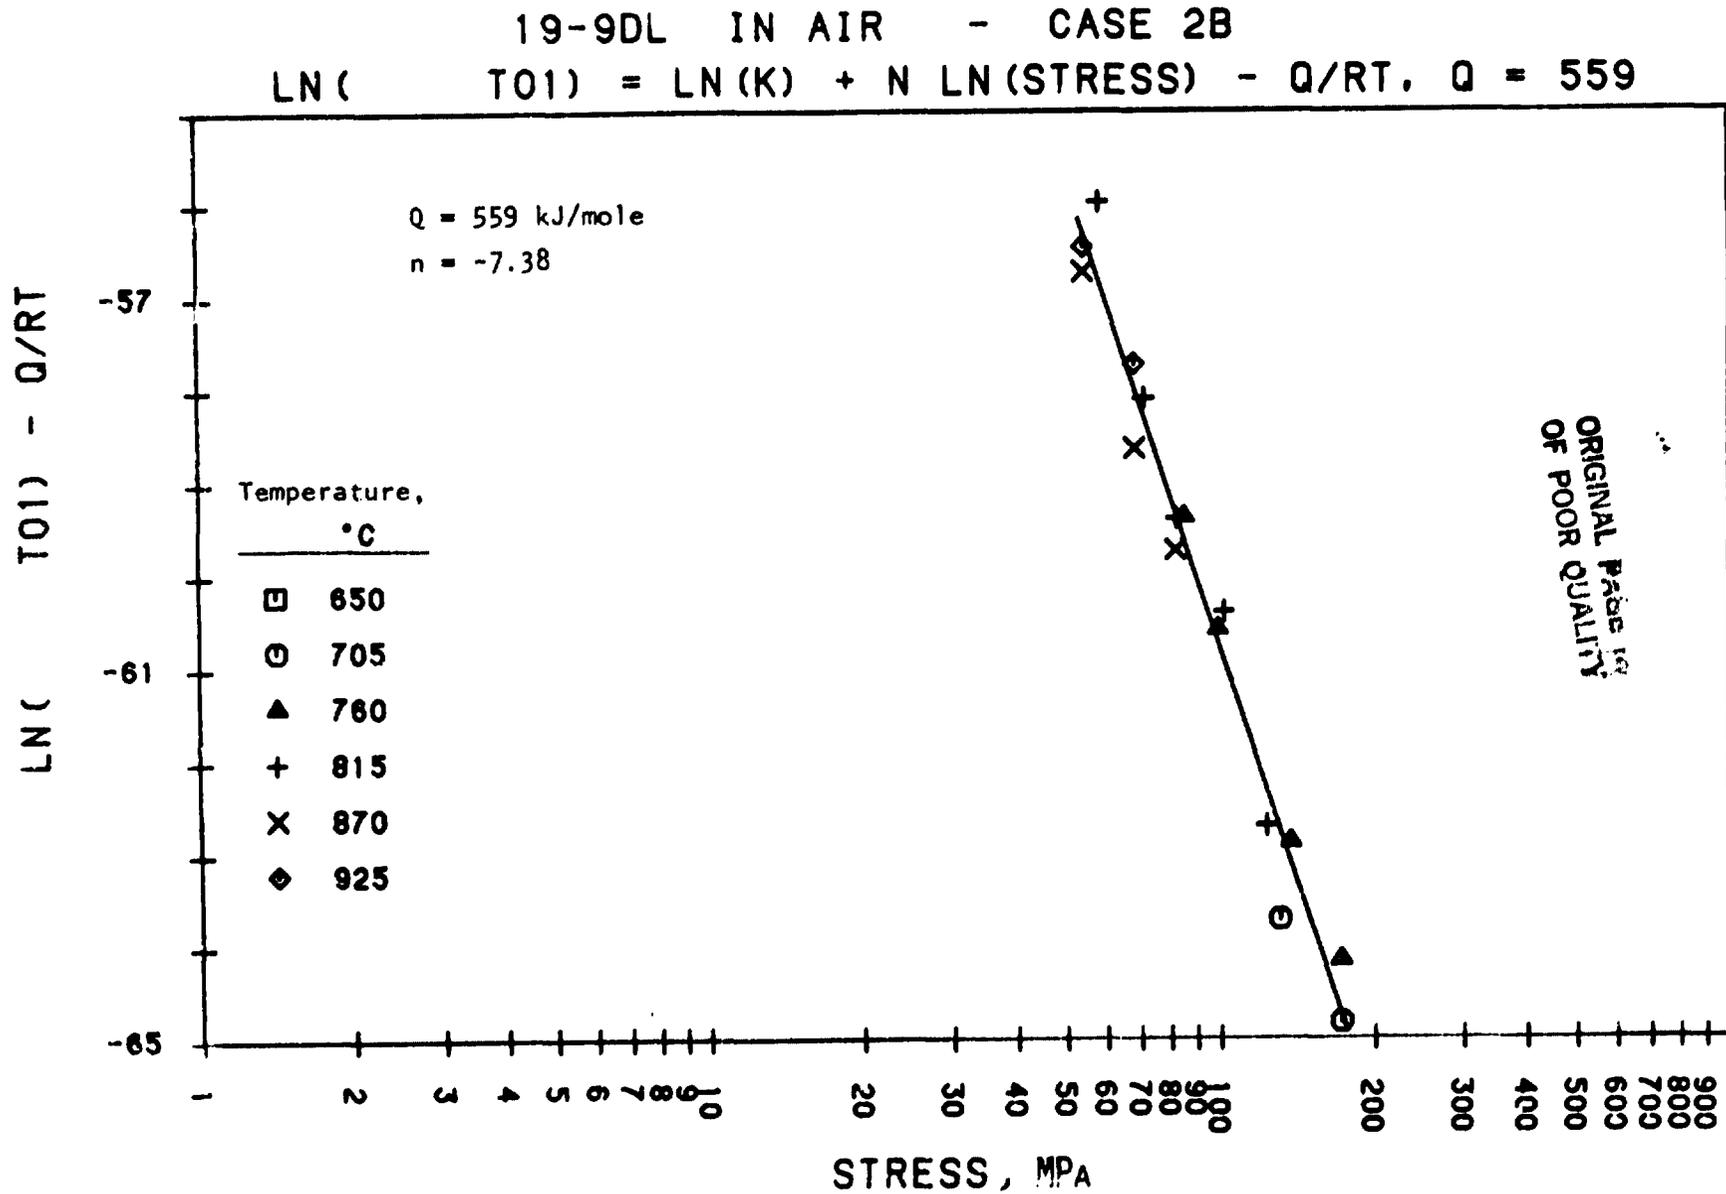
Figure C-21. Temperature-compensated time to 1% creep strain vs. stress for 19-9DL tested in air (Case 2B).

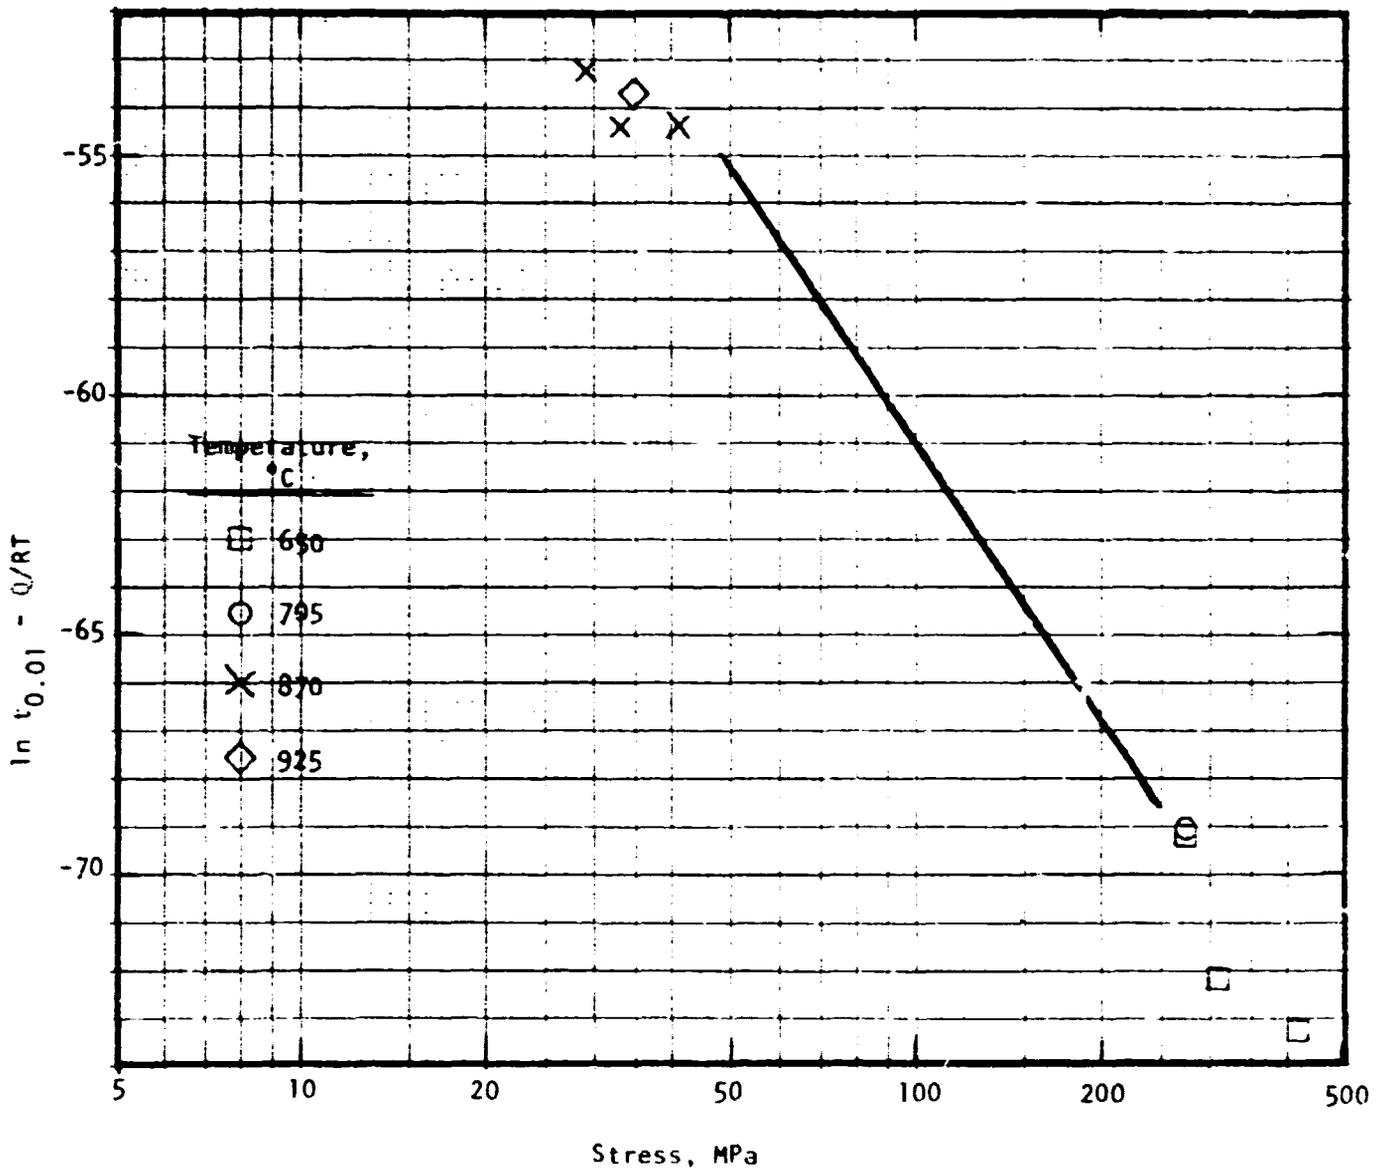
Figure C-22. Temperature-compensated time to 1% creep strain vs. stress for 18-90L tested in air (Case 2B, including Cases 2A and 2C shown separately).
