CREEP-RUPTURE BEHAVIOR OF SIX CANDIDATE STIRLING ENGINE IRON-BASE SUPERALLOYS IN HIGH PRESSURE HYDROGEN

VOLUME 1 - AIR CREEP-RUPTURE BEHAVIOR

S. Bhattacharyya
IIT RESEARCH INSTITUTE
10 West 35th Street
Chicago, Illinois 60616

DECEMBER 1982

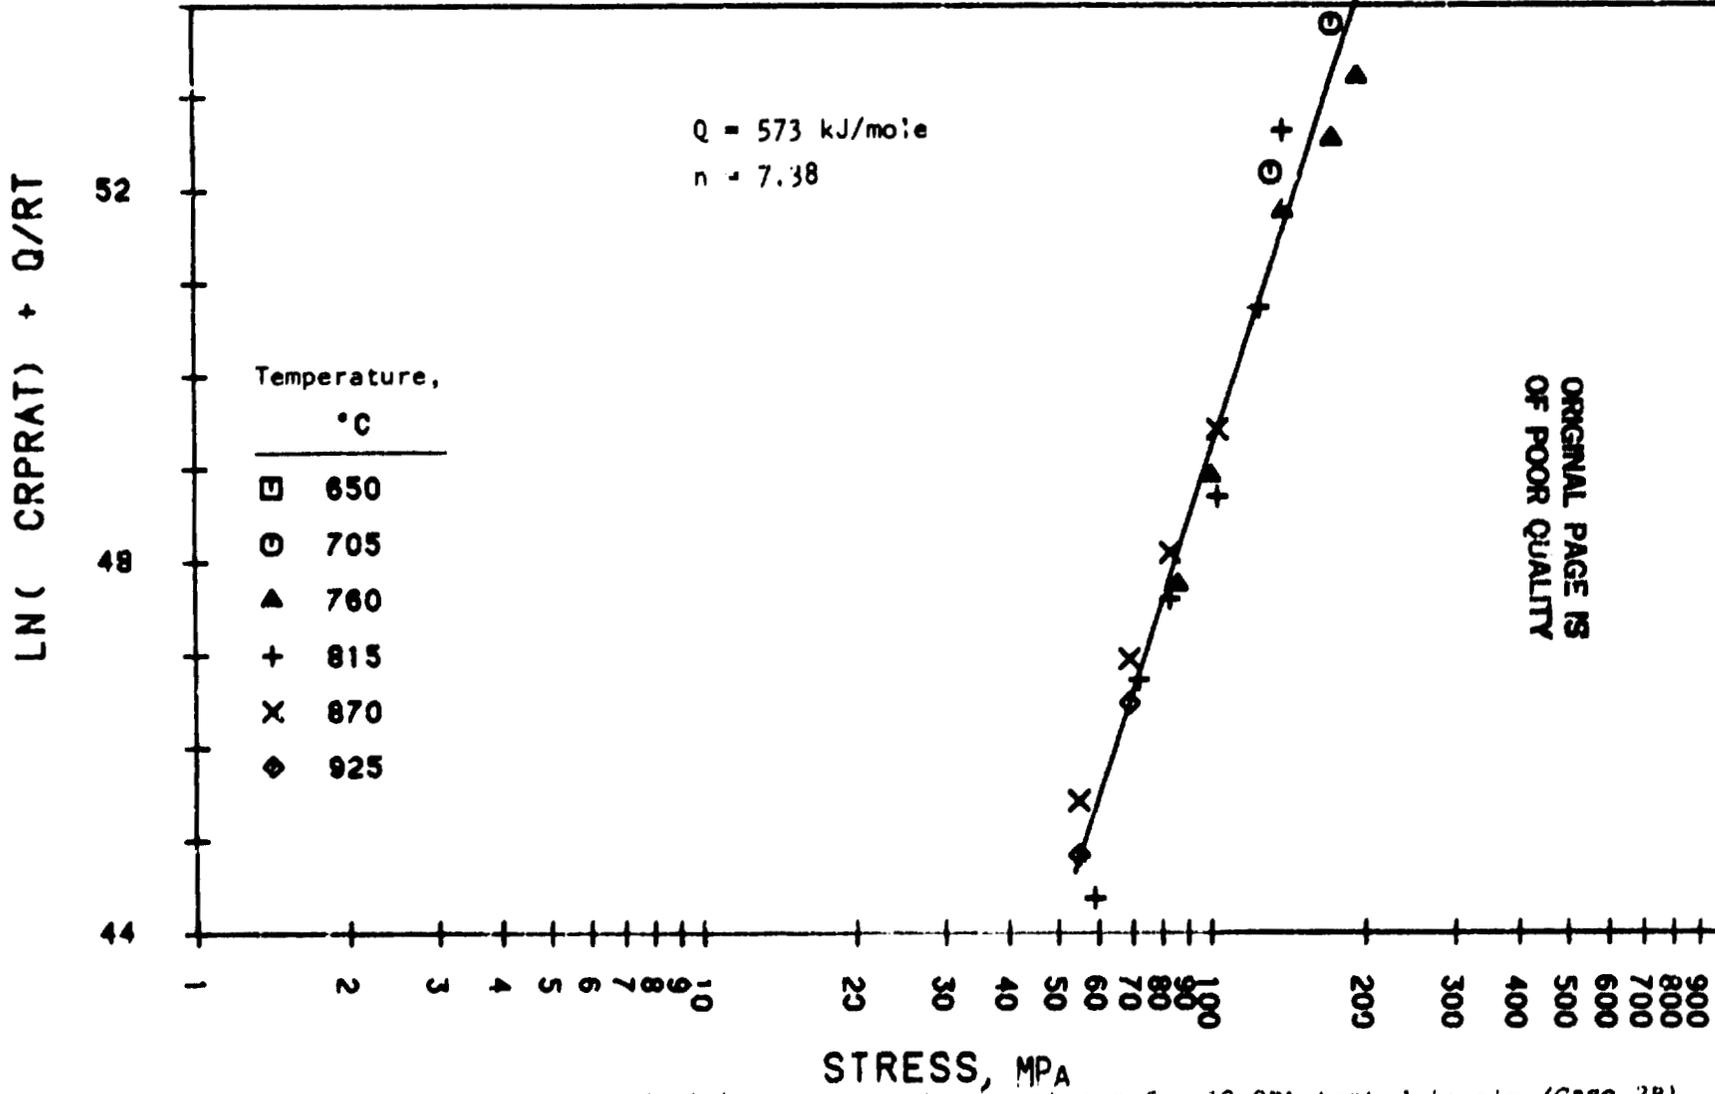
Figure C-23. Temperature-compensated minimum creep rate vs. stress for 19-9DL tested in air (Case 2B).

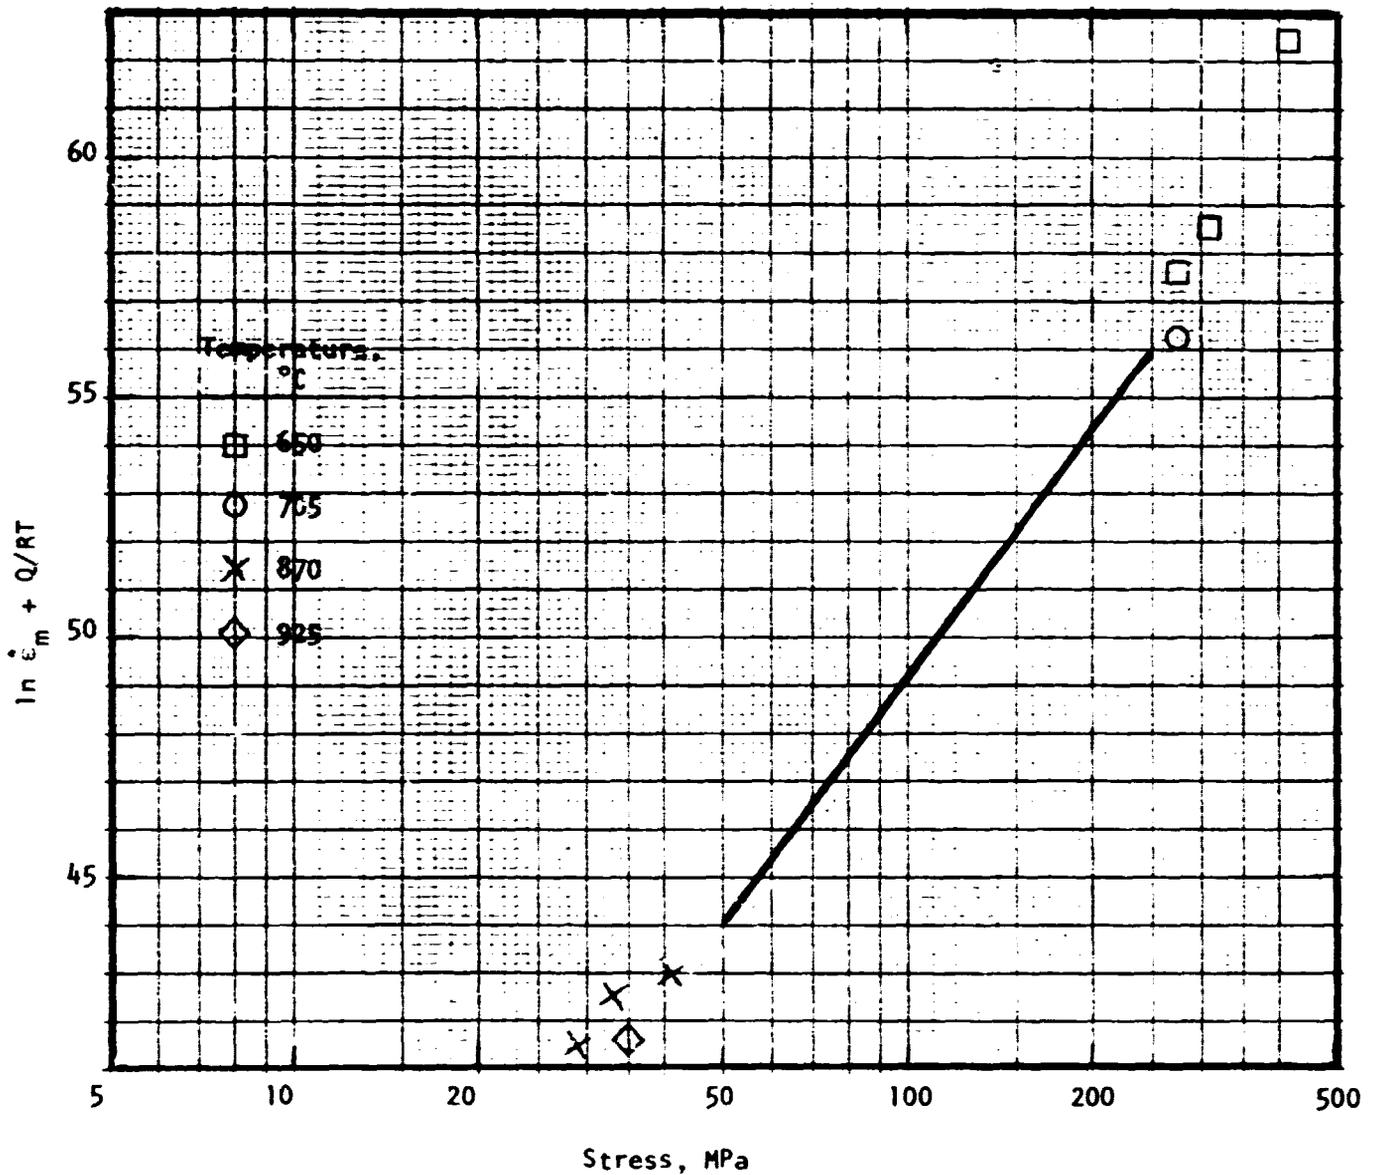
Figure C-24. Temperature-compensated minimum creep rate vs. stress for 19-9DL tested in air (Case 2B, including Cases 2A and 2C shown separately).

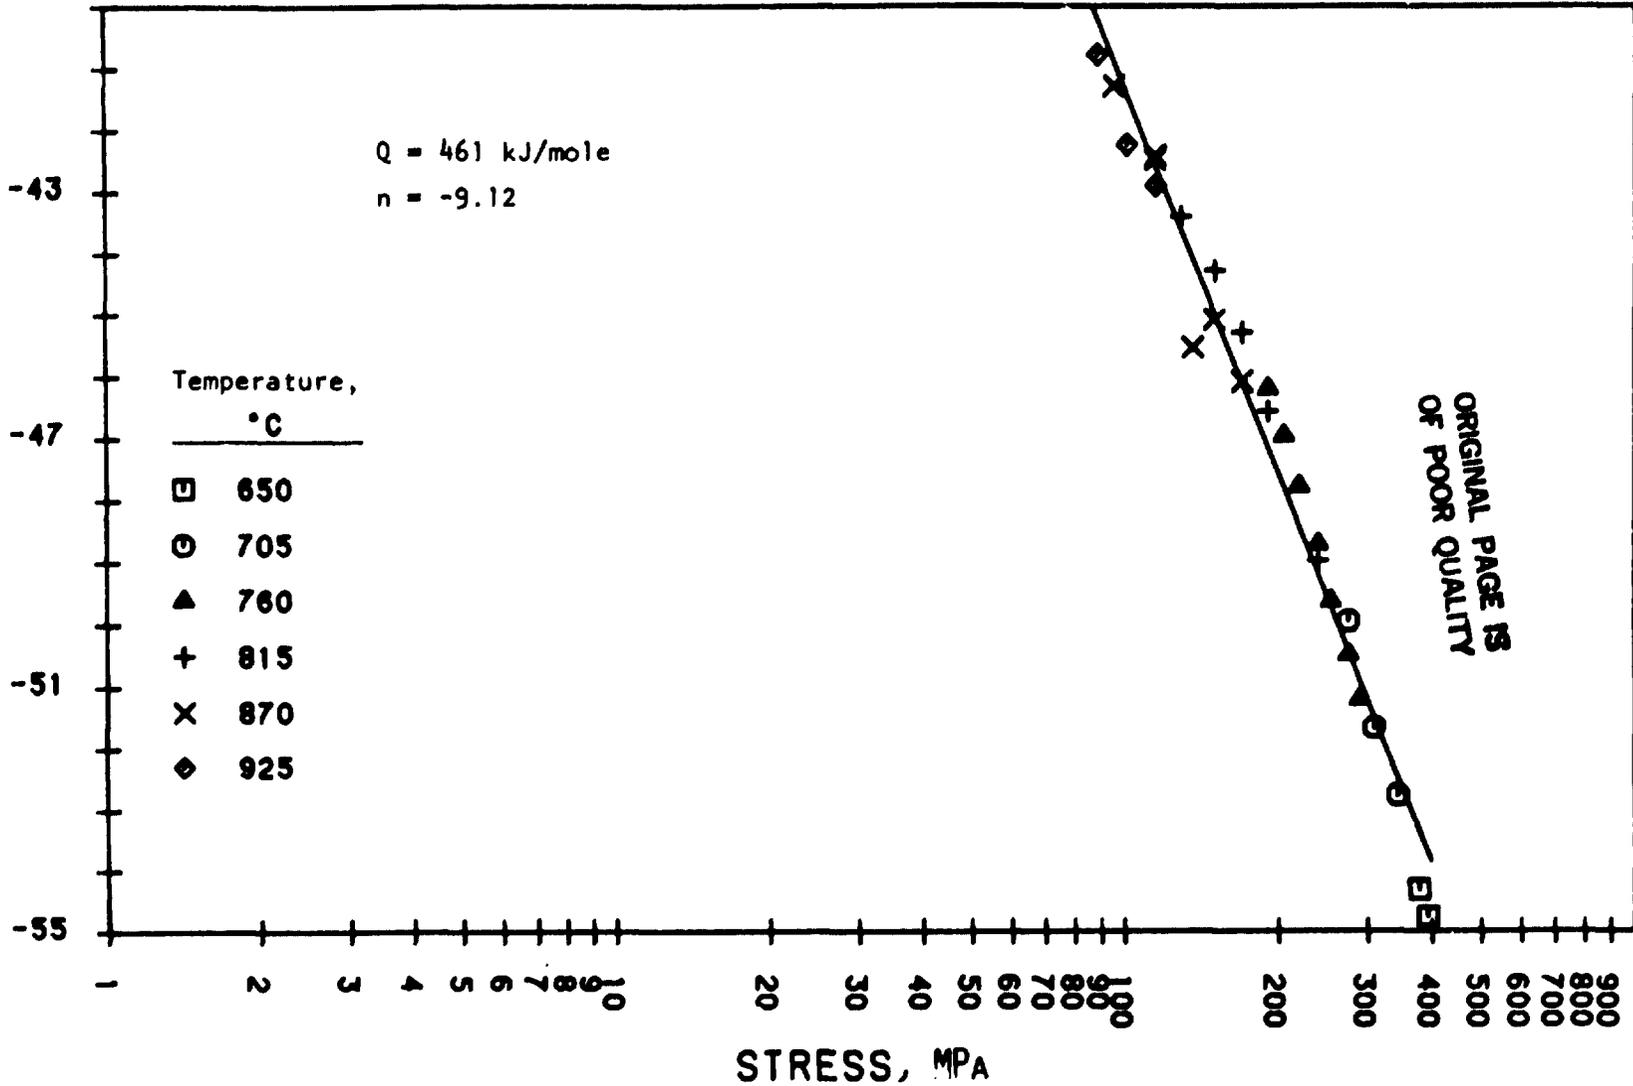
Figure C-25. Temperature-compensated rupture life vs. stress for CRM-6D tested in air (Case 2B).

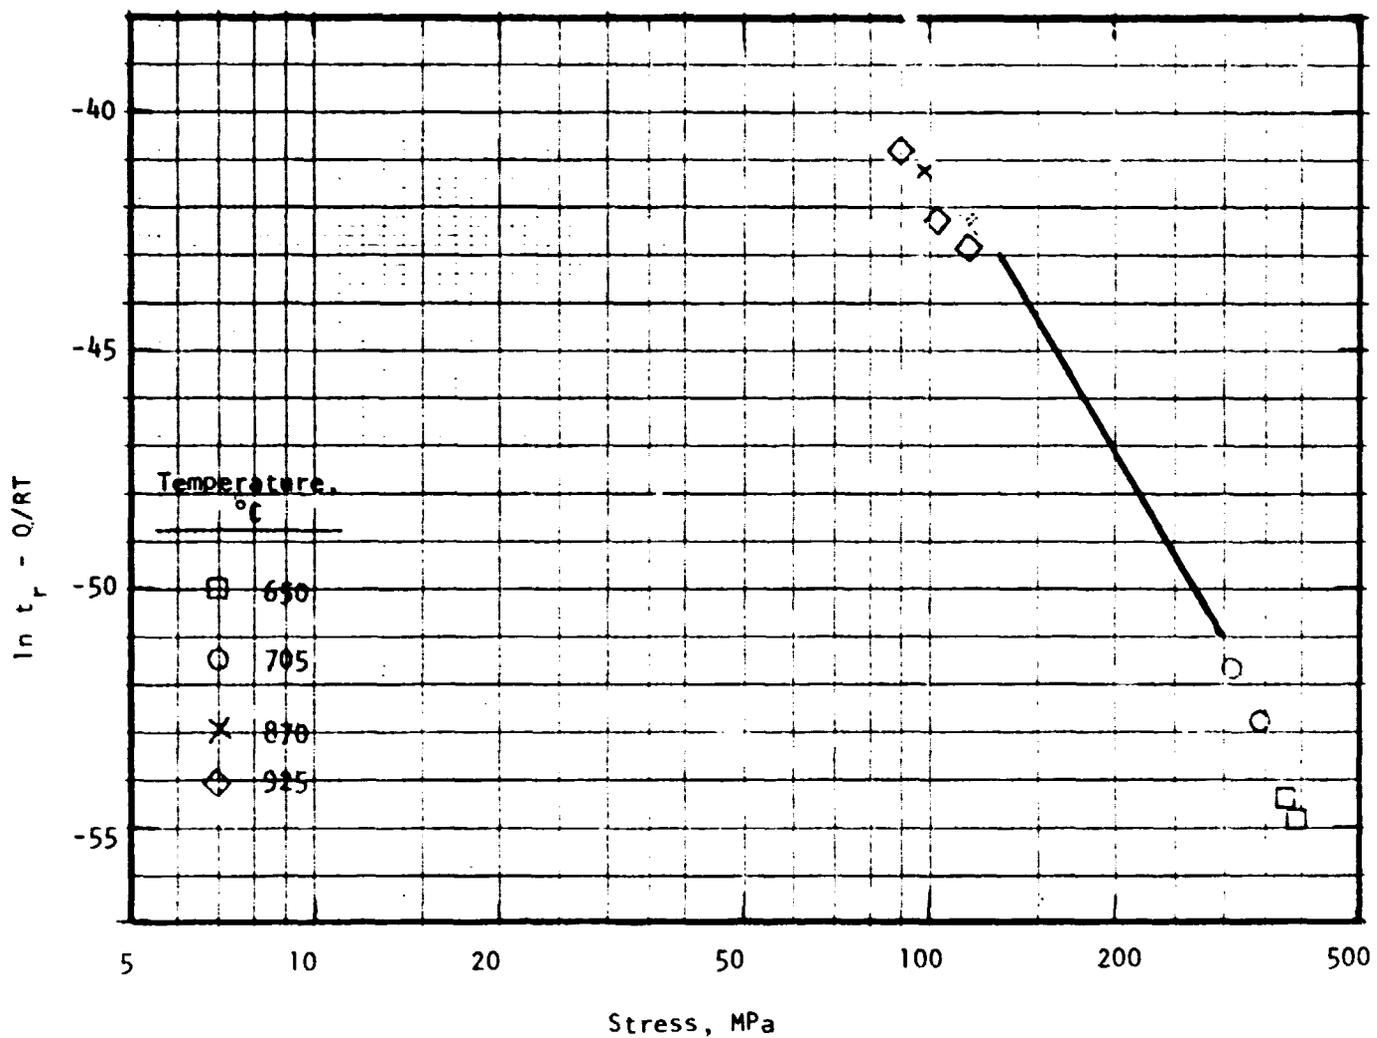
Figure C-26. Temperature-compensated rupture life vs. stress for CRM-6D tested in air (Case 2B, including Cases 2A and 2C data shown separately).

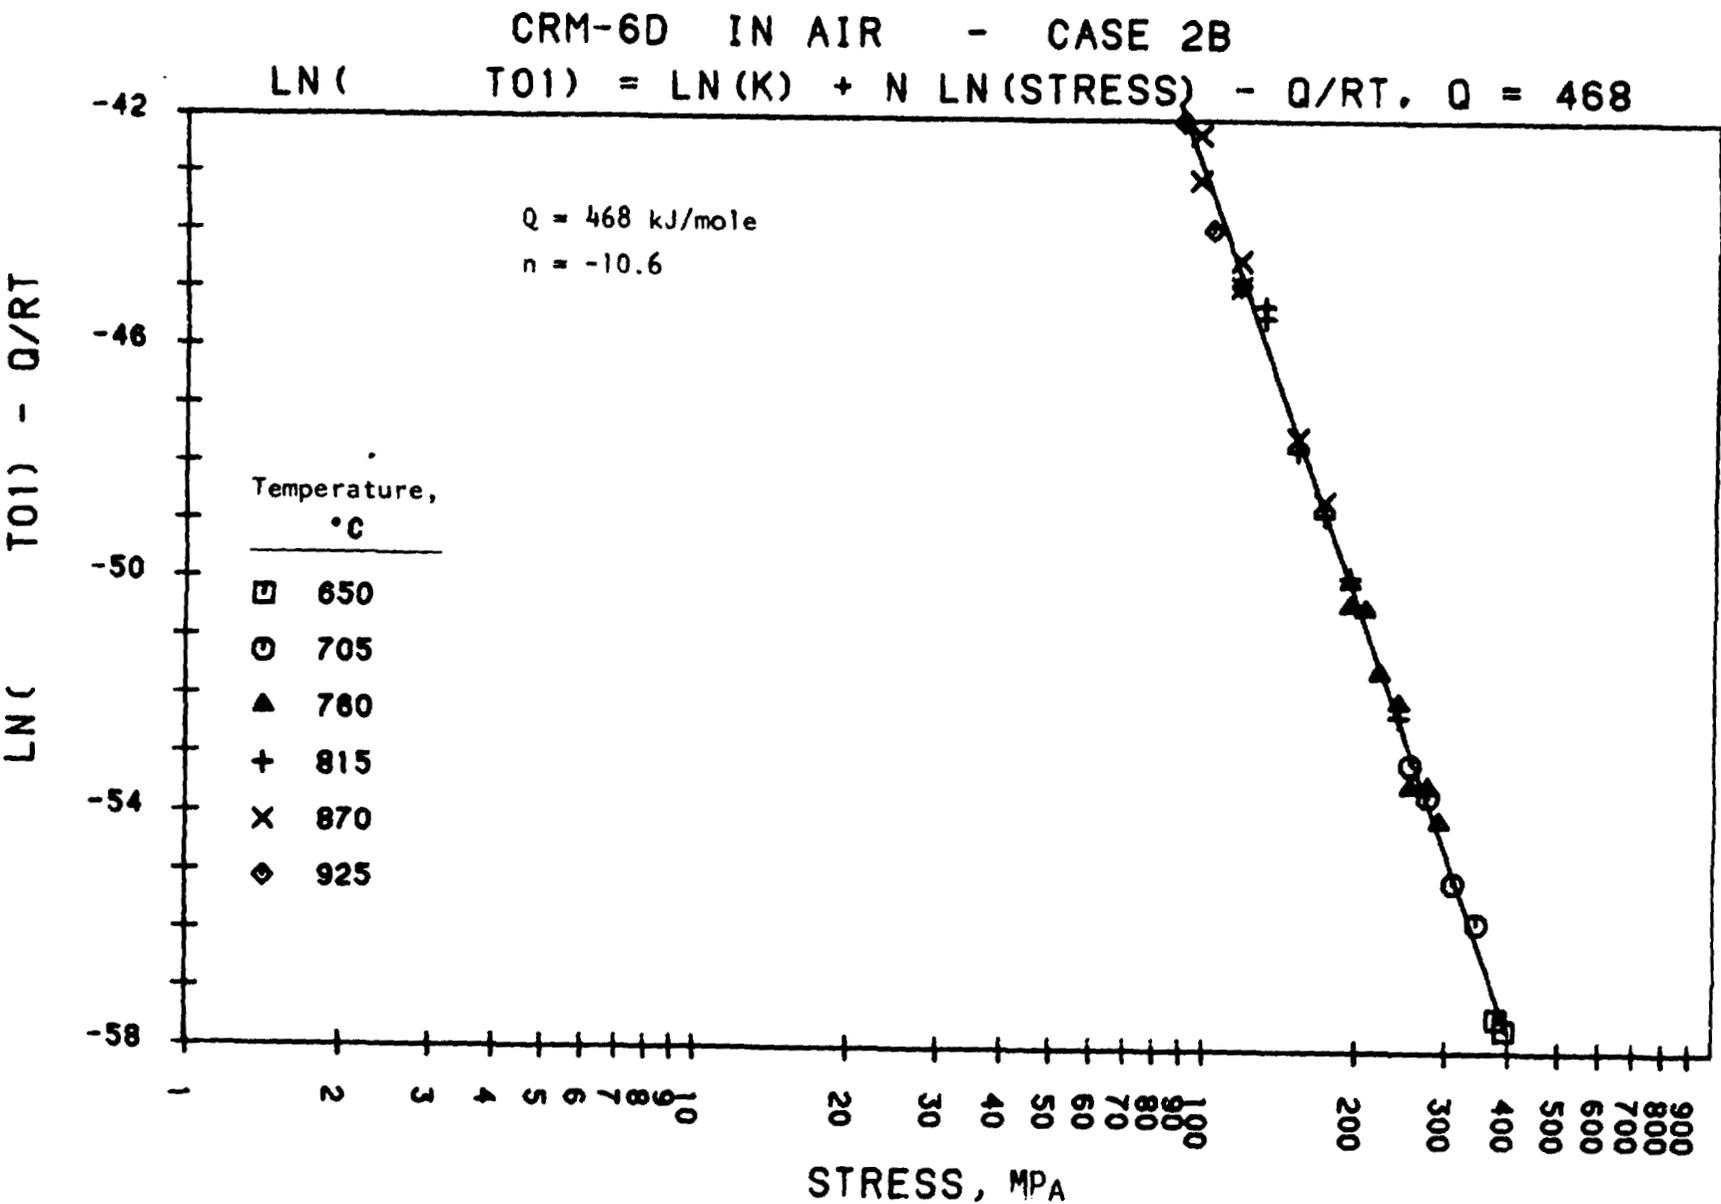
Figure C-27. Temperature-compensated time to 1% creep strain vs. stress for CRM-6D tested in air (Case 2B).

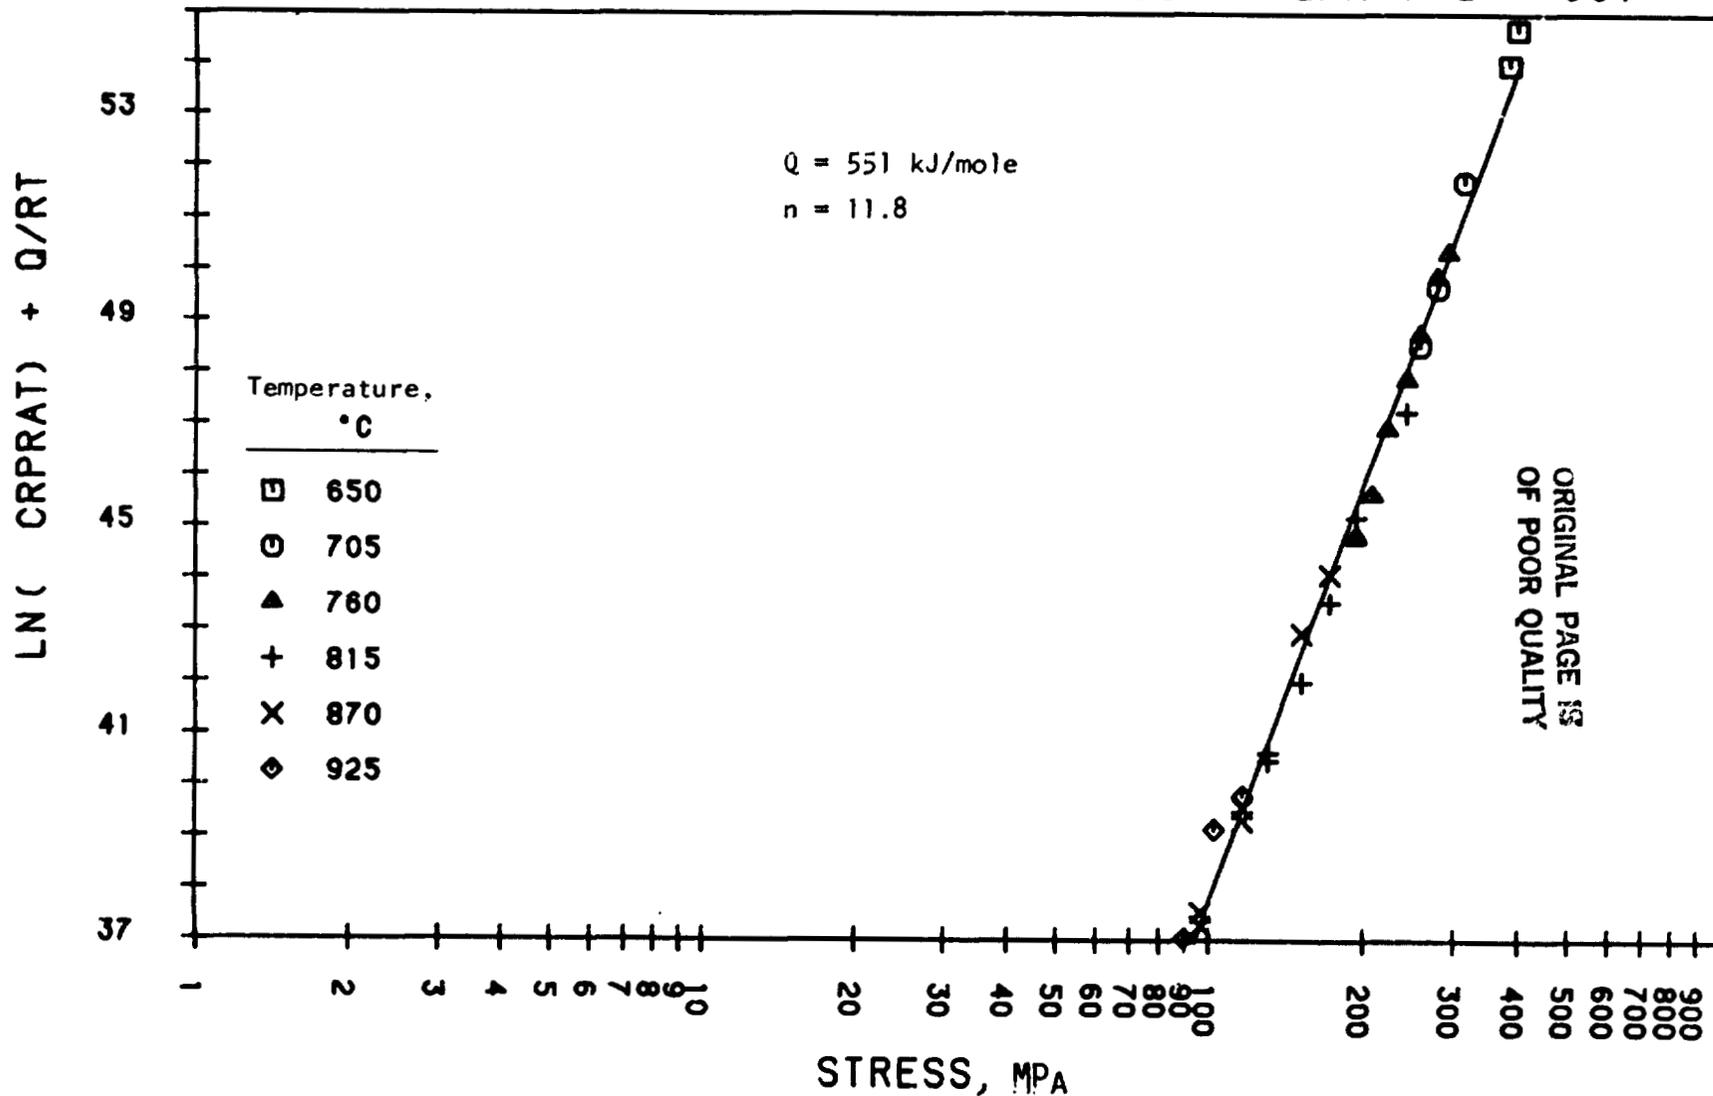
$$\ln(\text{CRPRAT}) = \ln(K) + n \ln(\text{STRESS}) + Q/RT, \quad Q = 551$$

Figure C-29. Temperature-compensated minimum creep rate vs. stress for CRM-6D tested in air (Case 2B).

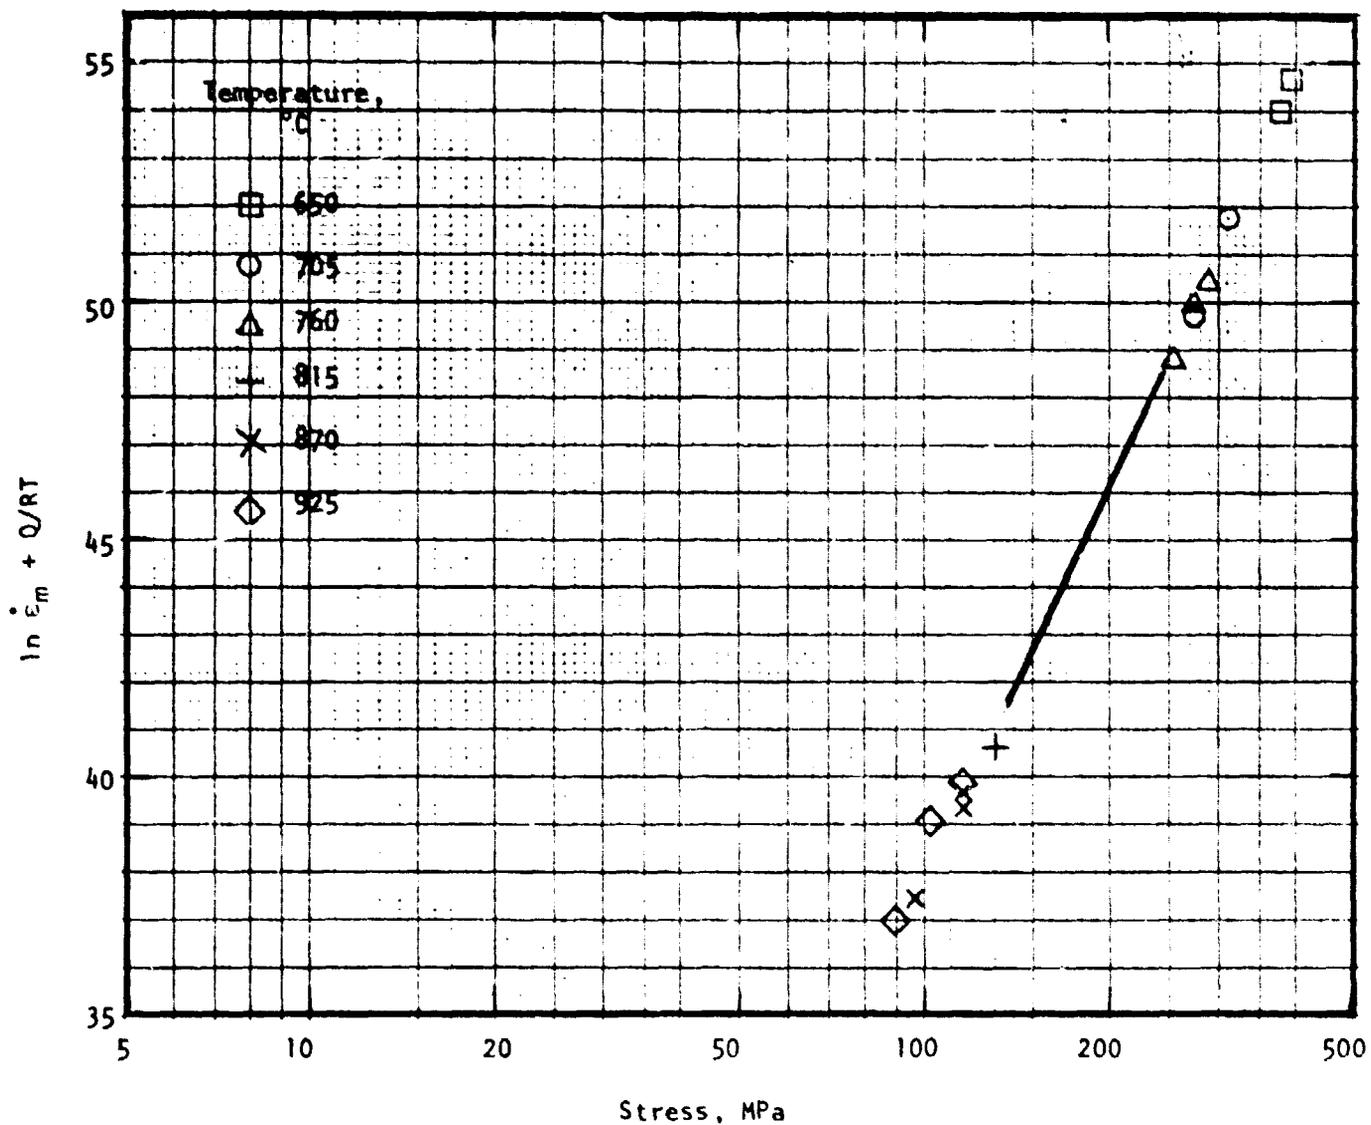
Figure C-30. Temperature-compensated minimum creep rate vs. stress for CRM-6D tested in air (Case 2B, including Cases 2A and 2C shown separately).

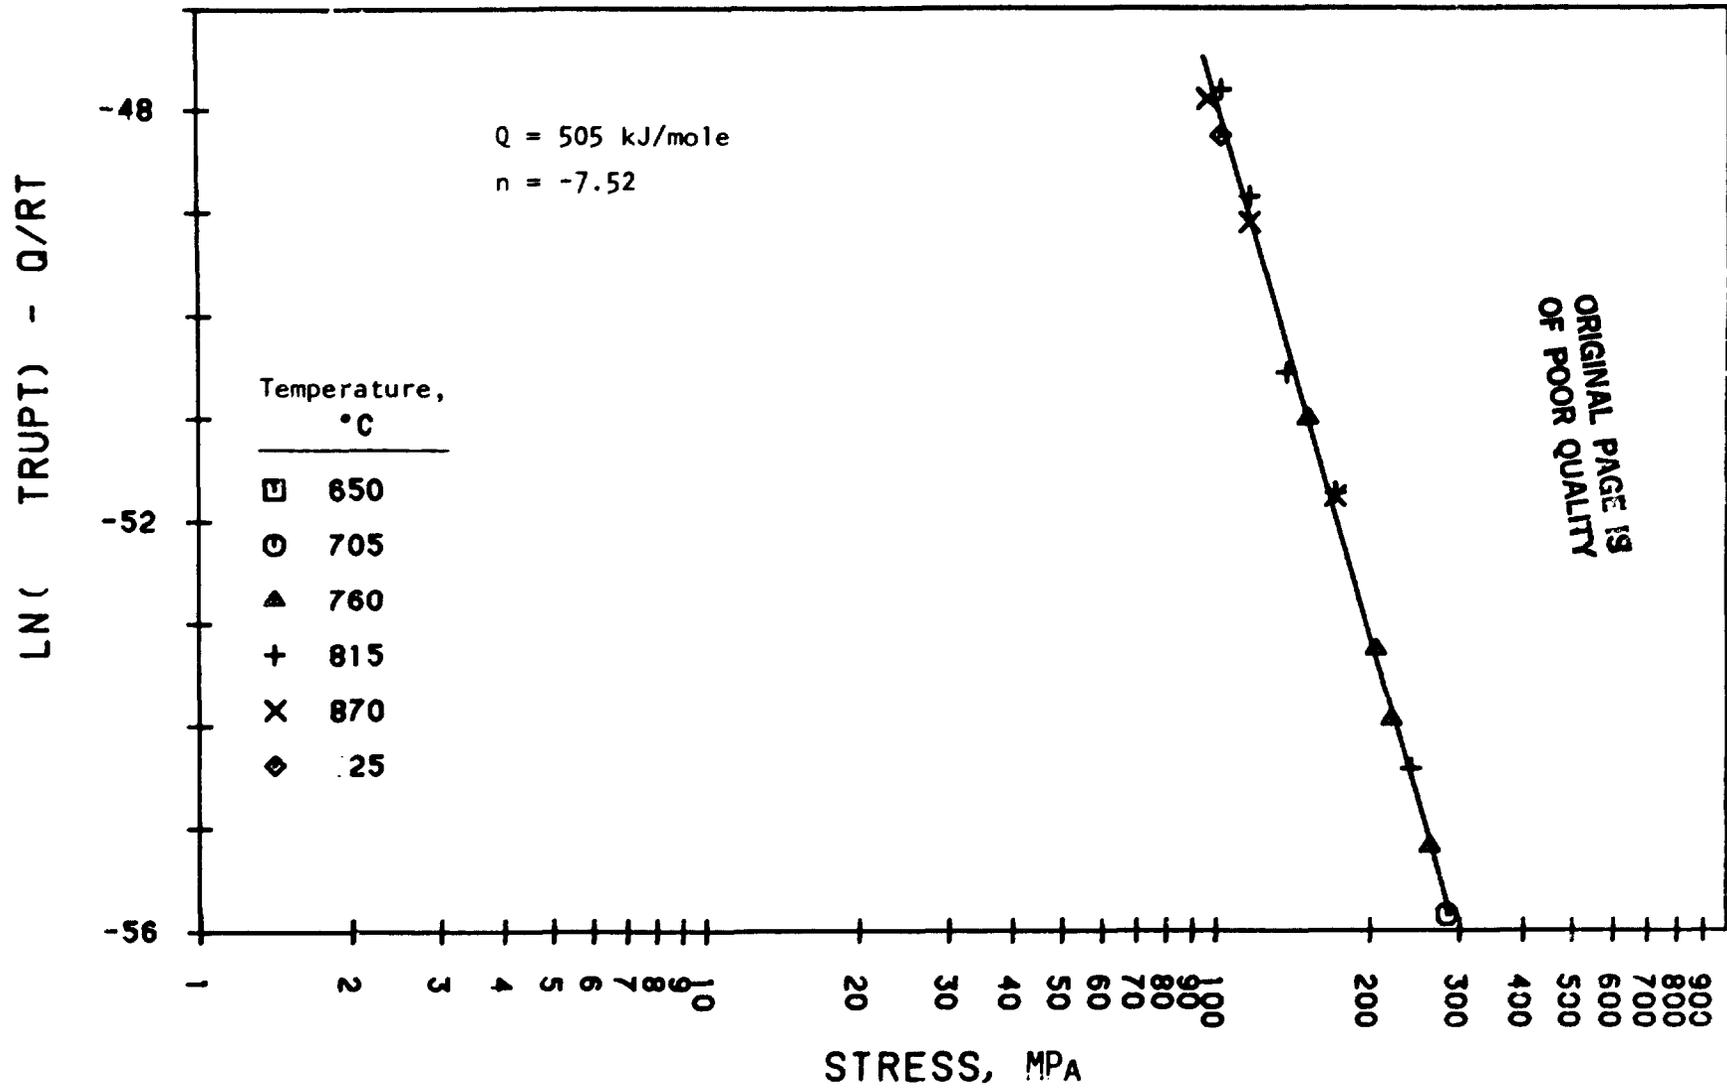
$$\ln(\text{TRUPT}) = \ln(K) + n \ln(\text{STRESS}) - Q/RT, \quad Q = 505$$

Figure C-31. Temperature-compensated rupture life vs. stress for XF-818 tested in air (Case 2B).

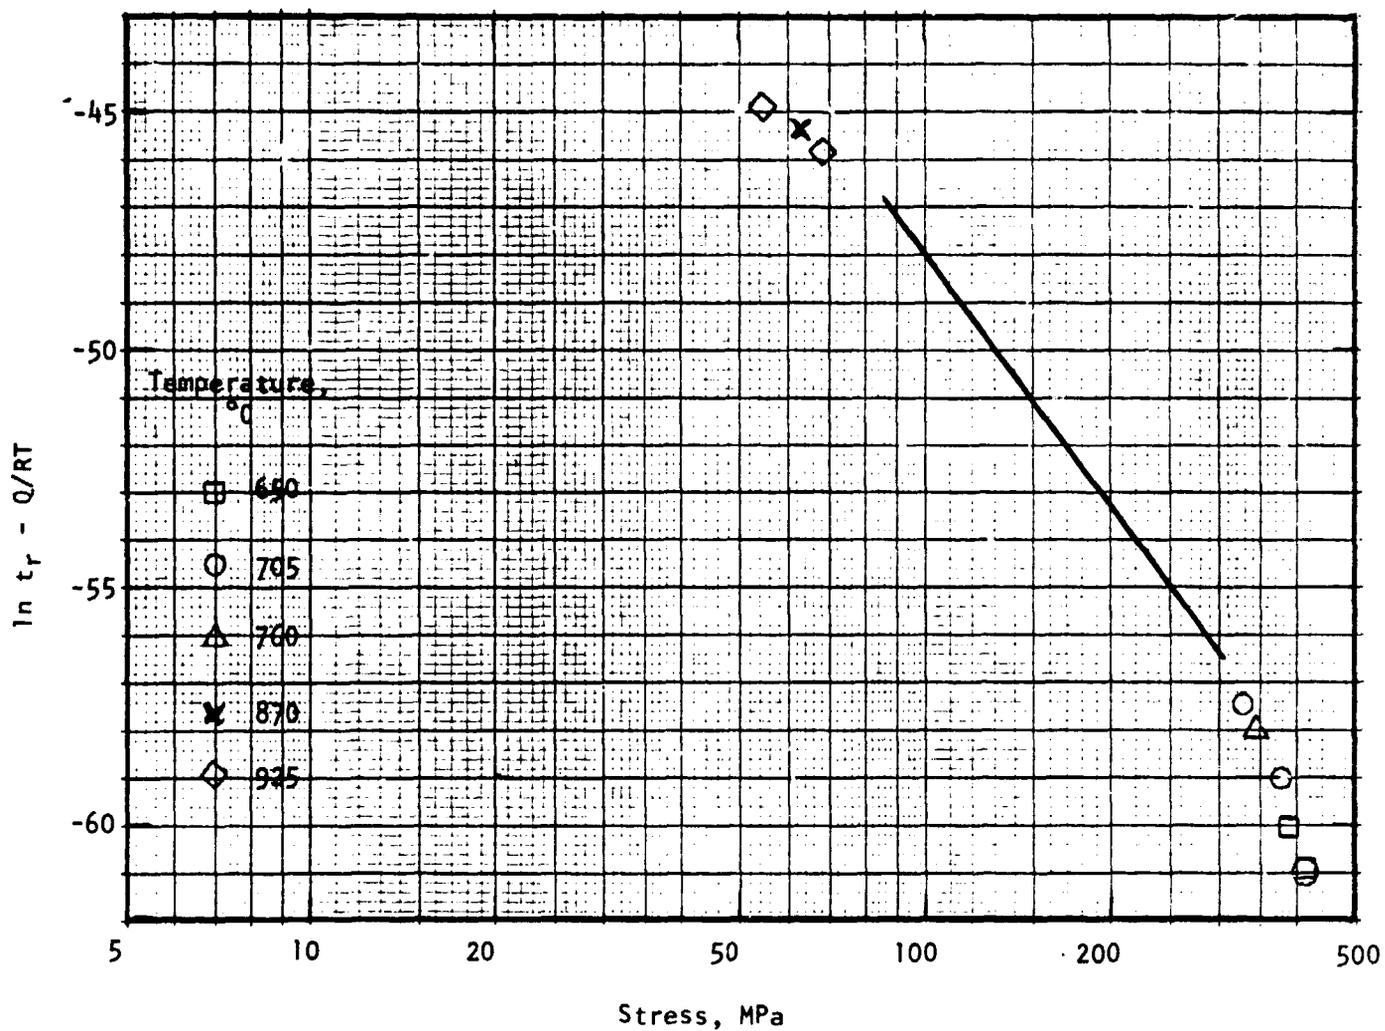
Figure C-32. Temperature-compensated rupture life vs. stress for XF-318 tested in air (Case 2B, including Cases 2A and 2C data shown separately).

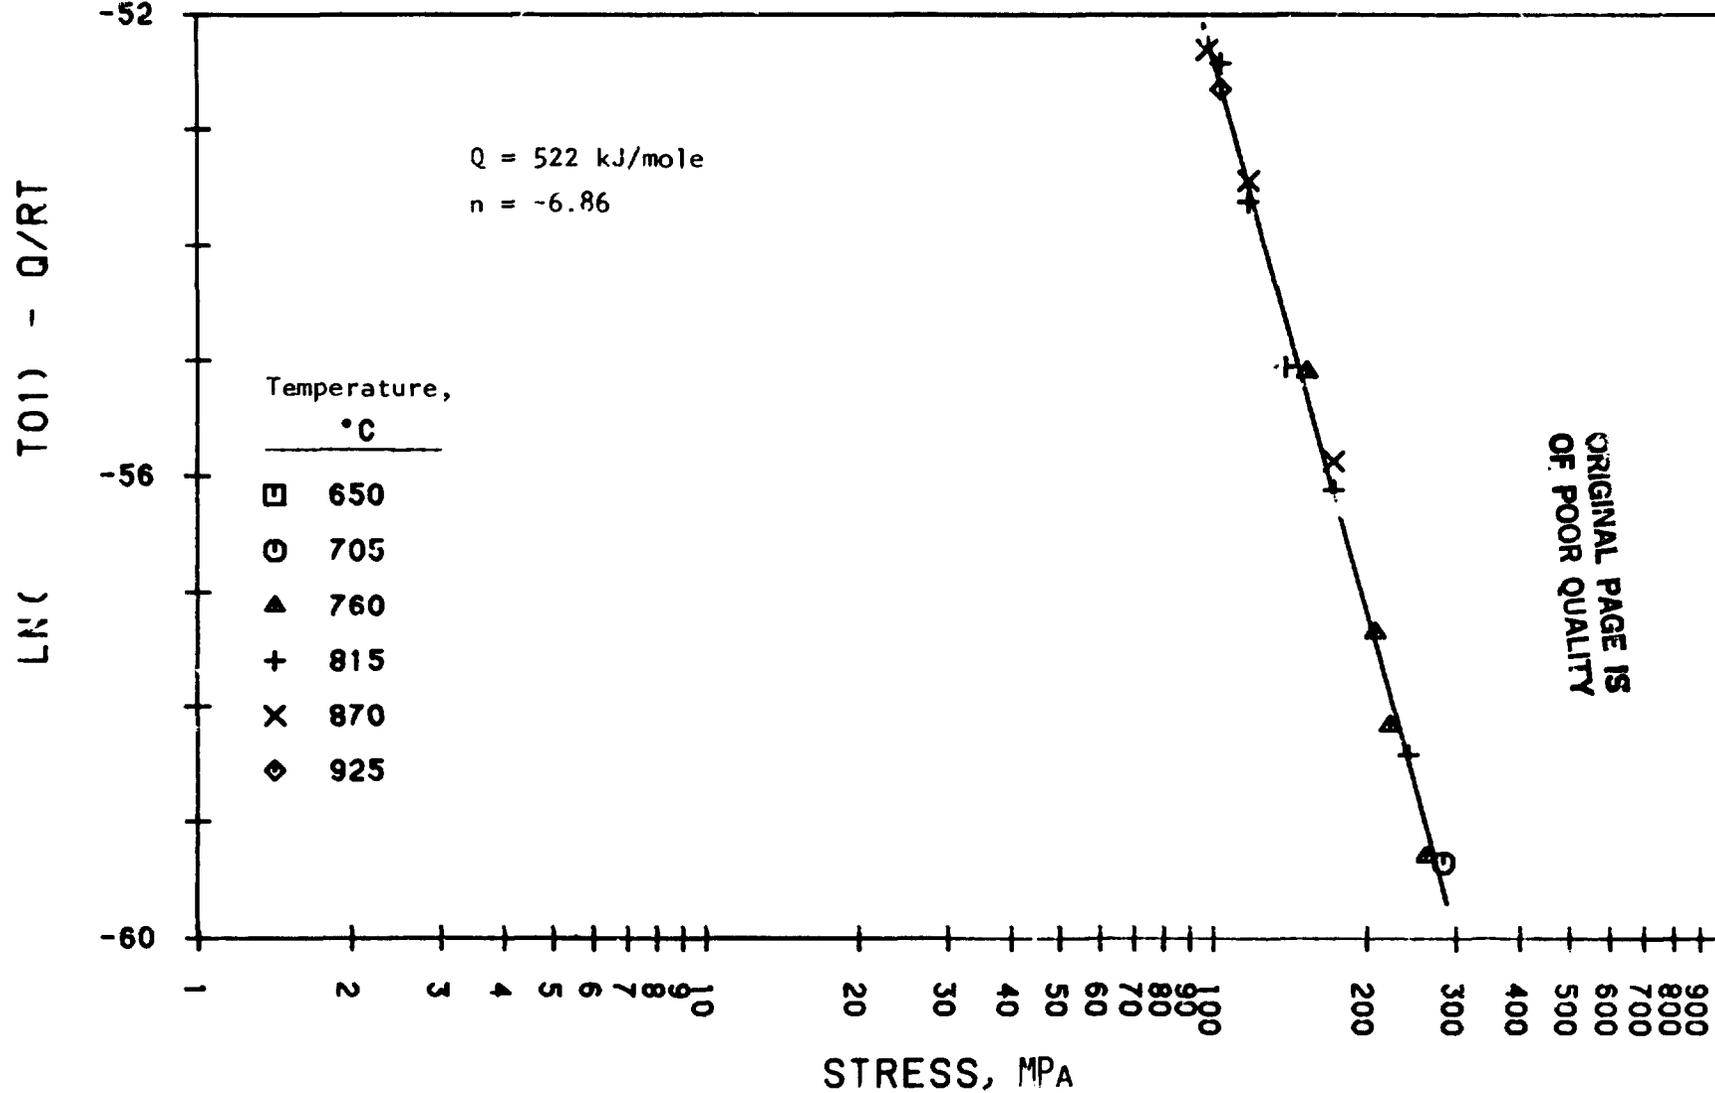
$$\ln(t_{0.01}) = \ln(K) + n \ln(\text{STRESS}) - Q/RT, \quad Q = 522$$

Figure C-33. Temperature-compensated time to 1% creep strain vs. stress for XF-818 tested in air (Case 2B).
