INTUMESCENT COATING DEVELOPMENT

(NASA-CR-17C737) INTUMESCENT COATING
DEVELOPMENT Final Report, 18 Jul. 1981 - 17
Jul. 1982 (Dayton Univ., Ohio.) 44 p
HC A03/MF A01

Ival O. Salyer and
Charles W. Griffen

Final Report Covering the Period:
July 18, 1981 through July 17, 1982

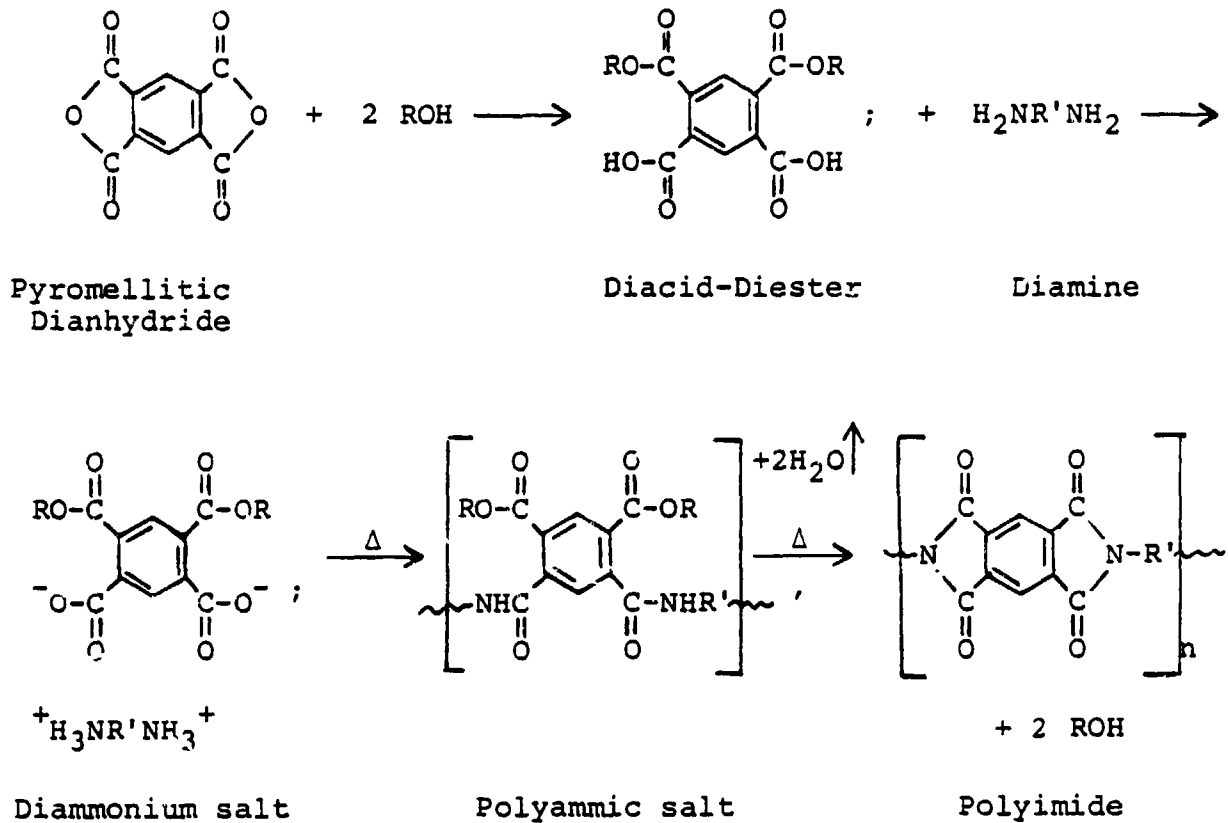
Figure 1. Polyimide Reaction.

Polyimides are used primarily for their high thermal resistance. They can be prepared by the reaction of aromatic dianhydrides, such as pyromellitic dianhydride, with alcohols to form a diacid-diester. Further reaction with a diamine yields the diammonium salt which, upon heating, dehydrates to form the polyamic acid. Further heating yields primarily the polyimide and an alcohol which, depending on the reactants and conditions, may act as a built-in blowing agent to produce an insulative foam; Reference Figure 1.

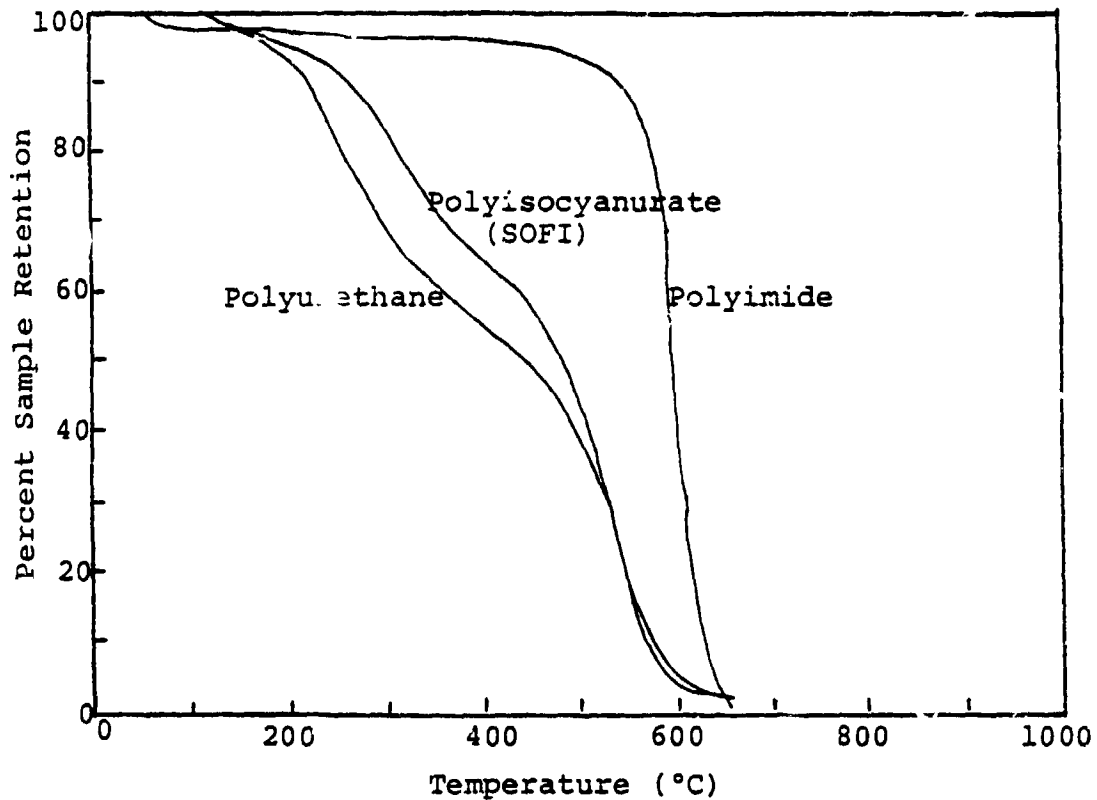
Figure 2. Thermogravimetric Analysis of Foams in Air at 10°C/Minute.

Polyimide resin R7271 (Monsanto) has been used by itself or with minor additions to produce preformed foam and intumescent coatings for several high temperature applications. The commercial resin is B-staged to form a fine, gold-colored powder. Using carefully selected heating conditions, the polyamic acid melts and upon further heating, releases alcohol as a built-in blowing agent. The resultant very low density foam cures with additional heat to form the low density, flexible, heat resistant polyimide foam. Thermogravimetric analysis of the polyimide foam as shown in Figure 2 illustrates the thermal resistance in comparison with polyisocyanurate (SOFI) and polyurethane foams.

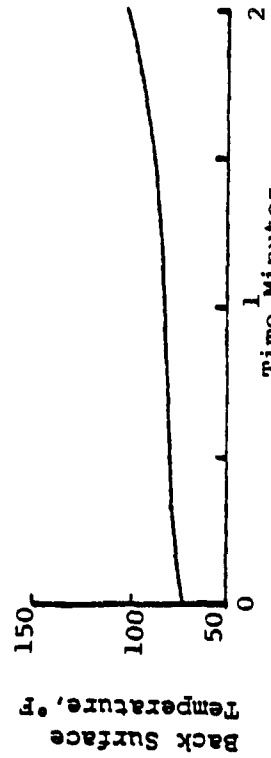
1. Uncoated Control.
2. Polyimide intumescent coating (PIC),
13 mils (approximately 62 lbs / 700 ft²).
3. PIC, 19 mils, sides also coated.
4. PIC, 18 mils, after coating dried, 1/4"
wide crack cut in SOFI, extending to
aluminum substrate

Hard, charred crust on surface; SOFI did not crack or char completely to the aluminum substrate, top edges shrank, 3/8" thick uncharred layer.

The uncoated SOFI control samples formed a hard surfaced, charred layer with no surface cracks, and still had a 3/8" layer of uncharred foam remaining after the two minute exposure. These results would be repeated in subsequent tests and it presented problems in interpreting the exposure results of the coated samples. The three other SOFI samples had been coated with the polyimide coating. The results on these samples indicated additional thermal protection with 40% additional thickness of uncharred foam; there was no significant difference in protection provided by 13 to 19 mil coating thickness, there were no indications of cracks developing during exposure, the intumescent coating did not cover and protect 1/4" wide pre-cut cracks, and applying the coating to the sides of the foam did not significantly improve the thermal protection. Thermocouples on the back surface were used on subsequent samples to record the temperature rise.

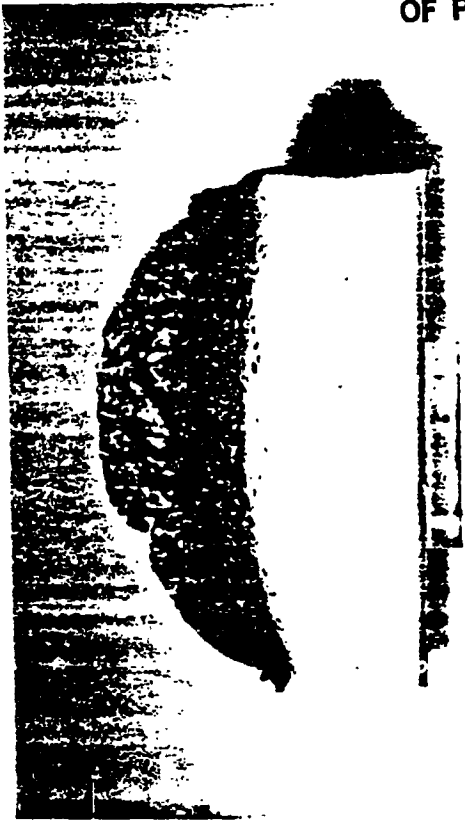
Excellent thermal resistance with no cracks formed and very little charred SOFI.

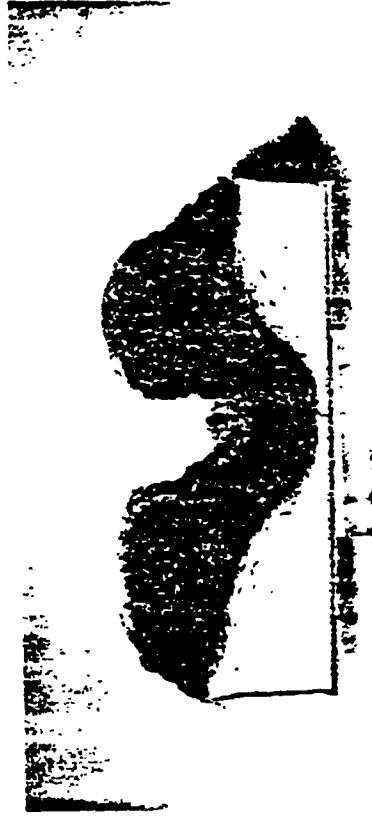
Extensive charring along crack almost to metal substrate.

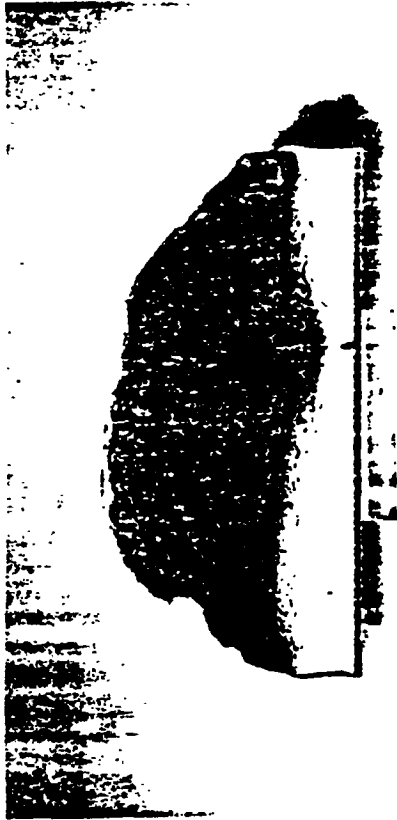
Good intumescence but TiO₂ was needed to reflect heat; the crack sealed but the charring extended almost to the metal substrate.

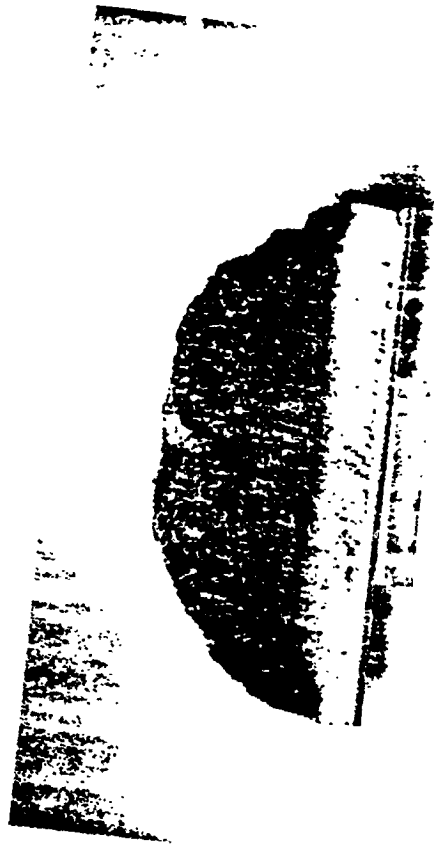
1/16" cracks closed readily, good intumescence and good thermal resistance.

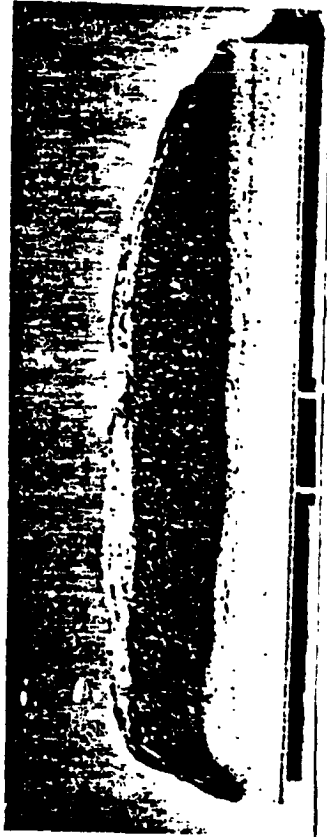
Very good thermal protection; no surface cracks developed with result that charred areas did not extend to aluminum substrate.

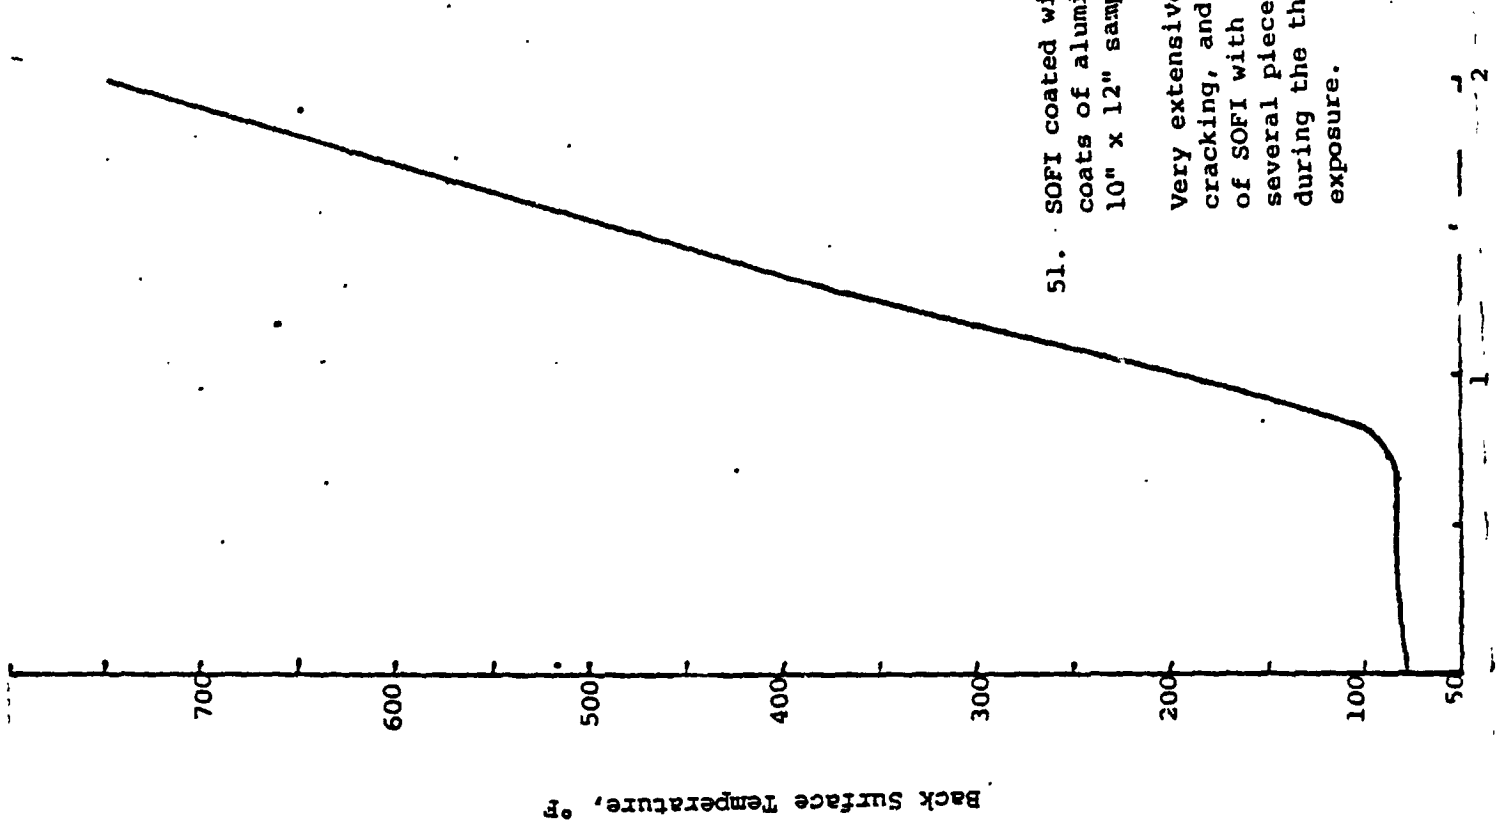
51. SOFI coated with two coats of aluminum paint 10" x 12" sample.

Very extensive burning, cracking, and charring of SOFI with loss of several pieces of SOFI during the thermal exposure.
