NASA Technical Memorandum 83362

Processing of Fused Silicide Coatings for Carbon-Based Materials

James L. Smialek
Lewis Research Center
Cleveland, Ohio

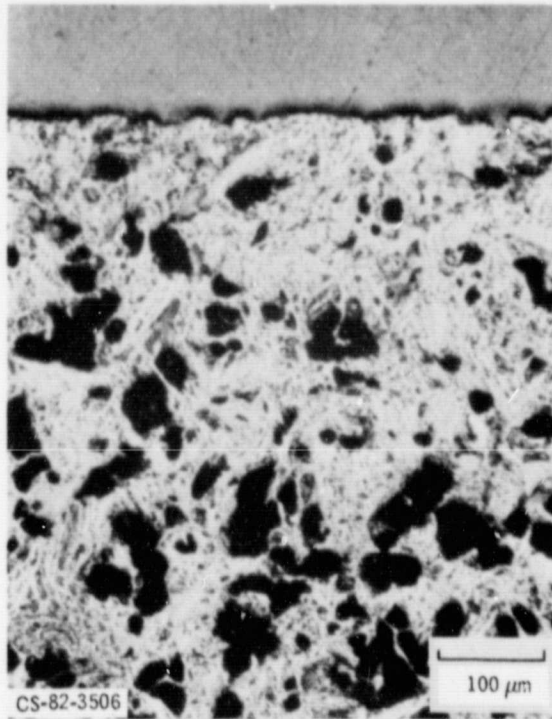
Figure 1. - Porous microstructure of as-received ATJ graphite.

Coupons of ATJ graphite were machined to a size of 0.25 x 1.25 x 2.50 cm. The graphite was 73 percent dense and exhibited a substantial amount of large porosity, Fig. 1. Slurry mixtures of Al + Si or Ni + Si powders (-325 mesh) were made using a nitrocellulose lacquer vehicle. The slurries were sprayed onto the coupons, allowed to air dry, and vacuum sintered between 1100° and

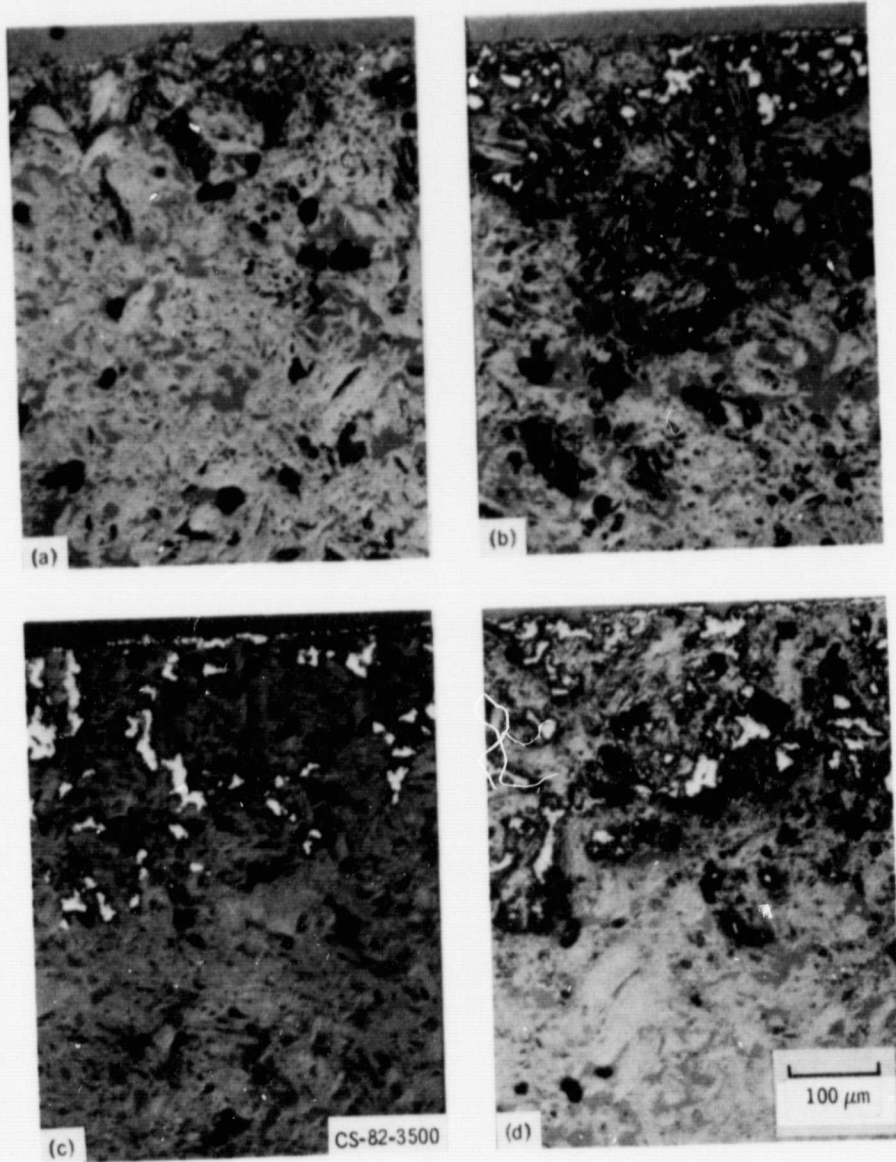
(a) Al-12 Si,
(c) Ni-29 Si,

(b) Al-50 Si,
(d) Ni-50 Si.

Figure 2. - Microstructures of Al-Si and Ni-Si coatings on ATJ graphite sintered at 1300 C, for 2 hour.

The microstructures of these coatings are shown in Fig. 2. The Al-12 Si coating has very little metallic coating phase or reaction zone apparent. The Al-50 Si coating has more metallic coating phase present in an external layer as well as in the pores of the substrate. This is also true of the Ni-Si coatings. These coatings show penetrations of 300 μm ; however, the external coating is only 10 μm thick and is not exceptionally uniform.

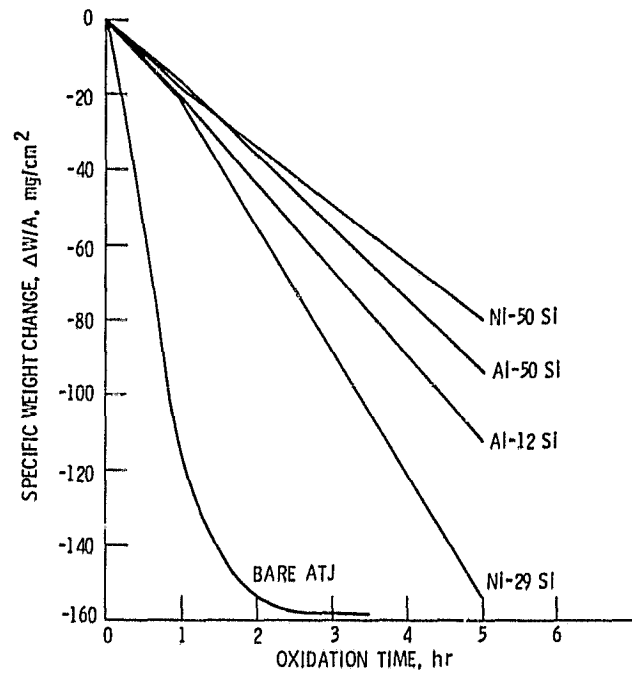
Figure 3. - 1200⁰ C cyclic oxidation of Al-Si and Ni-Si coatings.

The cyclic oxidation behavior at 1200° C is shown in Fig. 3. Very little protection of the graphite substrate was offered by any of the coatings. Visual inspection showed the Al-Si coatings to be uniformly attacked by the oxidation exposure as would be expected for a thin porous structure. The Ni-Si coatings themselves, however, appeared to be quite oxidation resistant: they were metallic in appearance with only a thin tarnish oxide layer. The failure mode of the Ni-Si coated graphite was by local attack of the specimen backside, where wetting and coverage was poor, and where the slurry had formed discrete molten globules rather than a uniform layer.

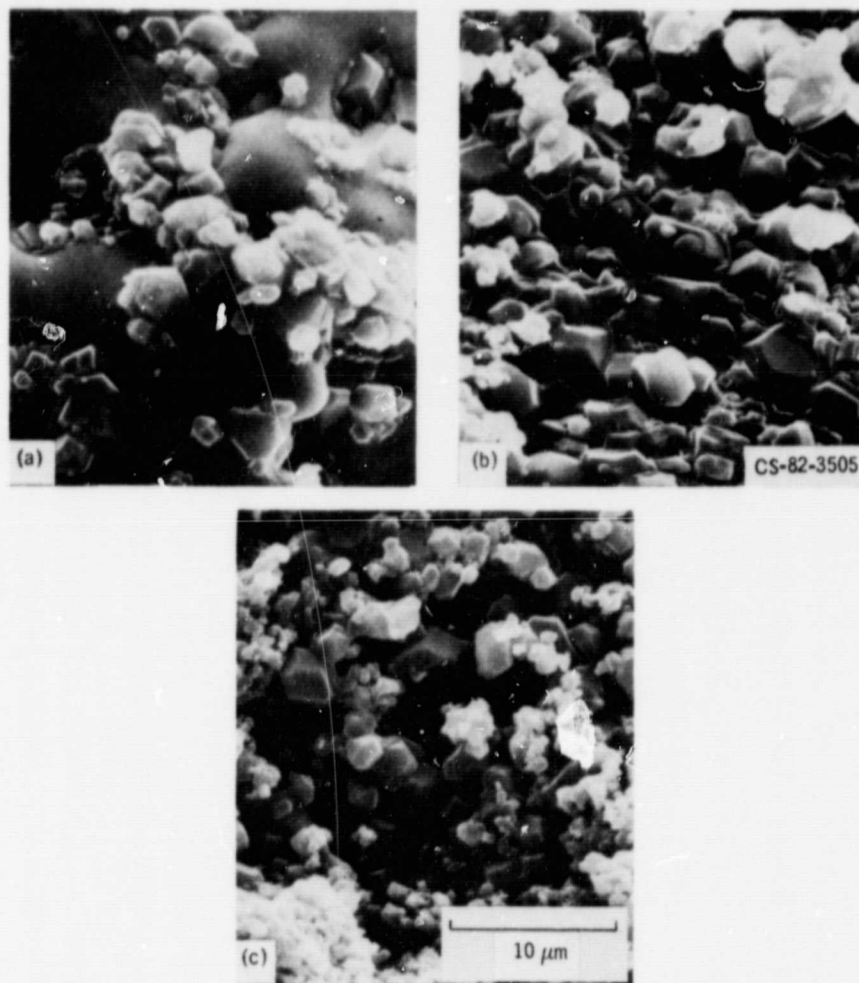
(a) Ni-70 Si, $T_s = 1325^\circ\text{C}$.

(b) Ni-90 Si, $T_s = 1430^\circ\text{C}$.

(c) 100 Si, $T_s = 1437^\circ\text{C}$.

Figure 4. - Effect of coating composition surface structure for as-sintered Ni-Si coatings.

As-sintered Si-rich coatings are shown in Fig. 4. The Ni-70 Si coating shows a substantial amount of smooth fused coating surface, which, from XRD analysis, is most likely metallic Ni-Si compounds and Si. The small particles with crystallographic facets are then likely to be SiC which formed from reaction with carbon which had diffused outward from the substrate. Some coating cracks were observed at lower magnifications. The Ni-90 Si coating shows a substantial increase in the number of crystals which appear to be well-sintered together, possibly by a prior liquid phase. The 100 percent Si coating appears only partially sintered and deep depressions between the crystallite agglomerates are apparent. These depressions and the lack of complete sintering may provide enough gas paths for direct oxidation of the substrate. The reason why Ni-90, 95, and 100 Si coatings appeared sintered and not fused, even when processed above the melting point of the coating, is not known. Probably most of the molten coating had infiltrated pores, leaving only the Si which reacted to form SiC.

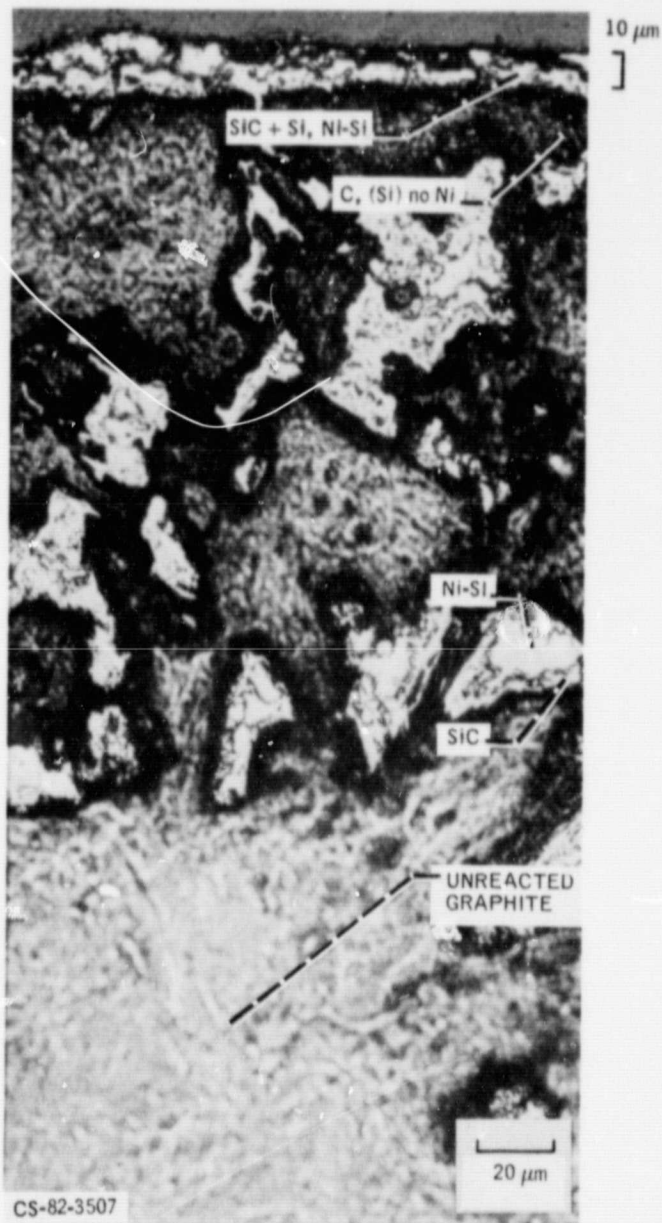
Figure 5. - Cross-section of Ni-70 Si coating processed at $1325^{\circ}\text{C}/5$ min. and oxidized at 1200°C for 5 hr. Coating has penetrated pores and the outer layer has protected the unreacted graphite in most areas.

The microstructure of the Ni-70 Si coating in cross-section is shown in Fig. 5. This is an intact area of the coating after oxidation at 1200° C for 5 hrs, but serves to illustrate the as-sintered coating structure and phases as well. An outer 10 μ m layer of reasonably continuous and uniform SiC, Ni-Si, and Si coating is apparent. The pores near the surface have been filled with a liquid Ni-Si phase to a depth of about 180 μ m. The external layer and the filled pores of both these areas show some internal structures which are probably SiC precipitates. A microprobe study of these areas showed high levels of Ni in the penetrated pores with amounts of Si consistent with the formula

for Ni_2Si . In this phase the carbon content was very low. In adjacent phases the Si and C contents were more consistent with SiC , and the Ni content was low. The dark areas between the filled pores showed only C with a trace of Si and no Ni.

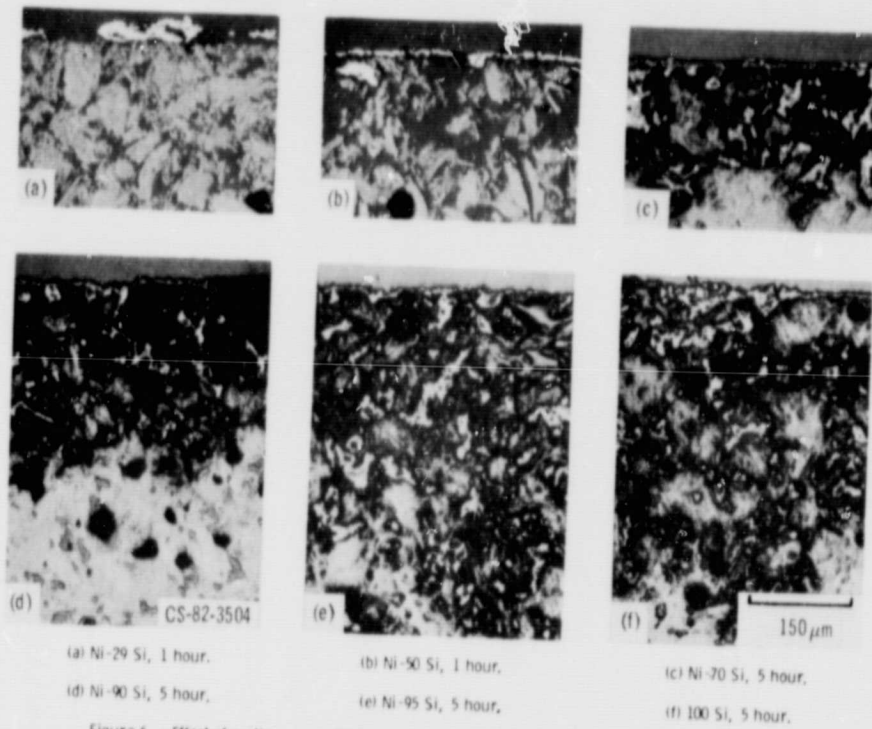
Figure 6. - Effect of coating composition on microstructure and protection in 1200 C oxidation.

Microstructural examination (Fig. 6) showed that the Ni-29 Si and Ni-50 Si coatings were non-uniform and that substantial oxidation of the underlying graphite occurred. The Ni-70 Si coating by comparison is quite intact as discussed previously. The Ni-90 Si, Ni-95 Si, and 100 Si coatings all show a substantial amount of pore penetration by a liquid phase as well as some coverage by a fused surface layer which was not evident from the SEM observations. The penetration depth increased with the sintering temperature of each of these specimens. However, the external layers were apparently not fully sintered as substantial oxidation of the graphite is evidenced by the excessive subsurface porosity.

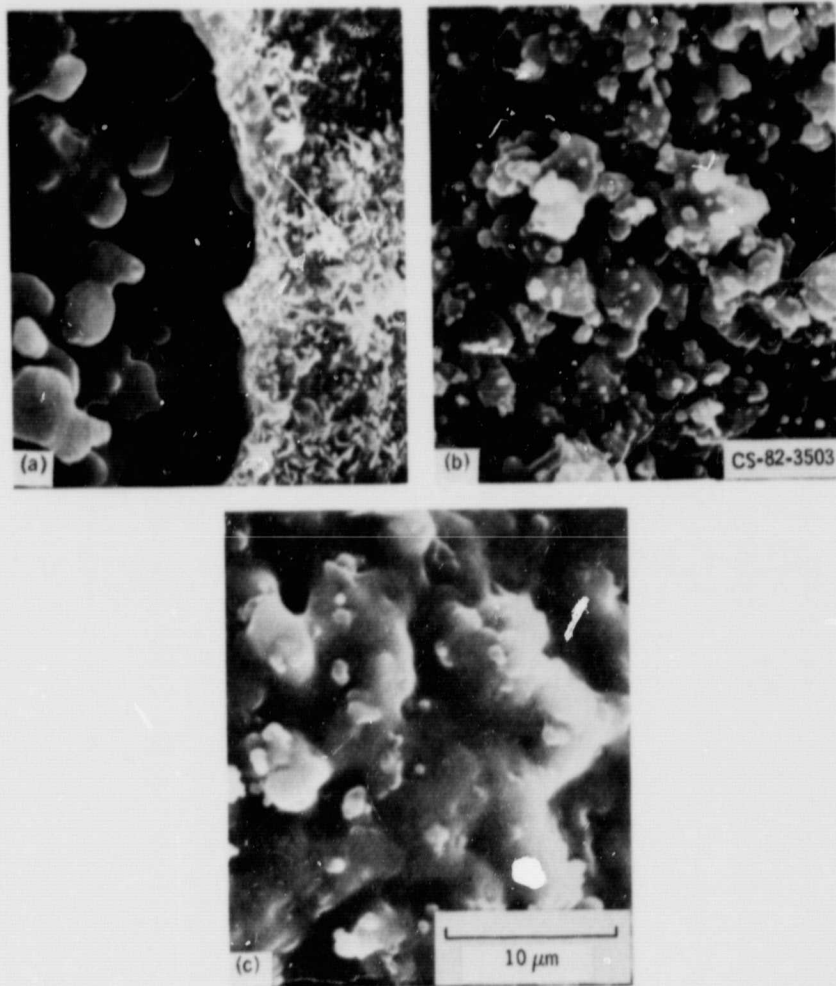
- (a) Ni-70 Si,
- (b) Ni-90 Si,
- (c) Ni-95 Si.

Figure 7. - Surface structure of Ni-Si coatings oxidized at 1200°C for 5 hours.

The outer surfaces of the oxidized specimens were also examined by SEM. As shown in Fig. 7, the Ni-70 Si coating was generally quite uniform with a textured surface of small oxide needles. In the particular area shown, the coating had cracked off and revealed the Ni-Si globular penetrations. The Ni-90 Si coating still showed discreet SiC crystallites, whereas the Ni-95 Si coating appeared to be covered by a layer of glassy oxide. The oxide phases could not be conclusively identified because post-test XRD only showed a weak pattern for SiO_2 α -cristobalite. No glassy SiO_2 peak was observed in the XRD pattern. Some Al_2O_3 was also found for Ni-70 Si and Ni-95 Si which was probably due to contamination from the Al_2O_3 tubes in the oxidation furnace.

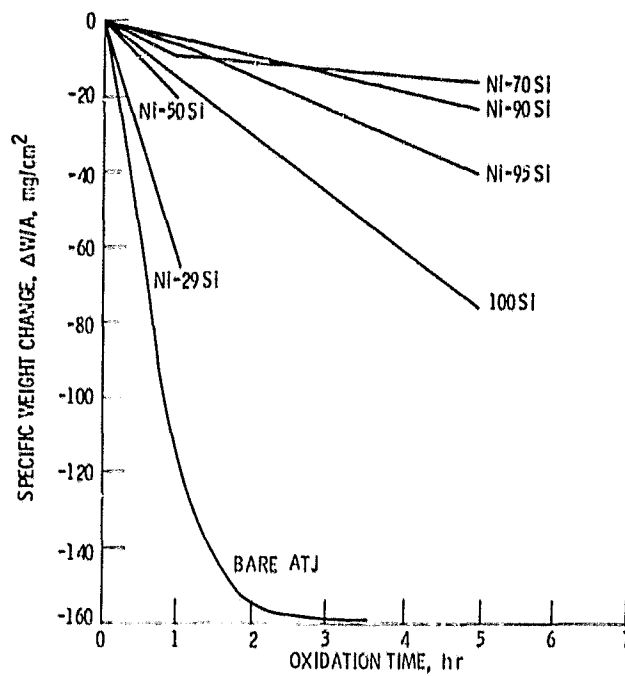
Figure 8. - Compositional effects on the 1200° C cyclic oxidation behavior of Ni-Si coatings (25 mg/cm²).

The weight change data for the oxidation test is shown in Fig. 8. Both the Ni-29 Si and Ni-50 Si specimens were so badly attacked that testing was stopped after one hour. The Ni-50 Si coating itself appeared quite oxidation resistant, but the delamination and lack of coverage on the specimen underside caused its poor performance. The Ni-70 Si and Ni-90 Si coatings both had the most intact outer coating layer; thus these exhibited the most protection. The failure of these coatings may have been due to fine coating cracks. Failure started at coating edges and corners for both the Ni-70 Si coatings. The 100 Si coating was apparently porous as the coating failed in a uniform manner.

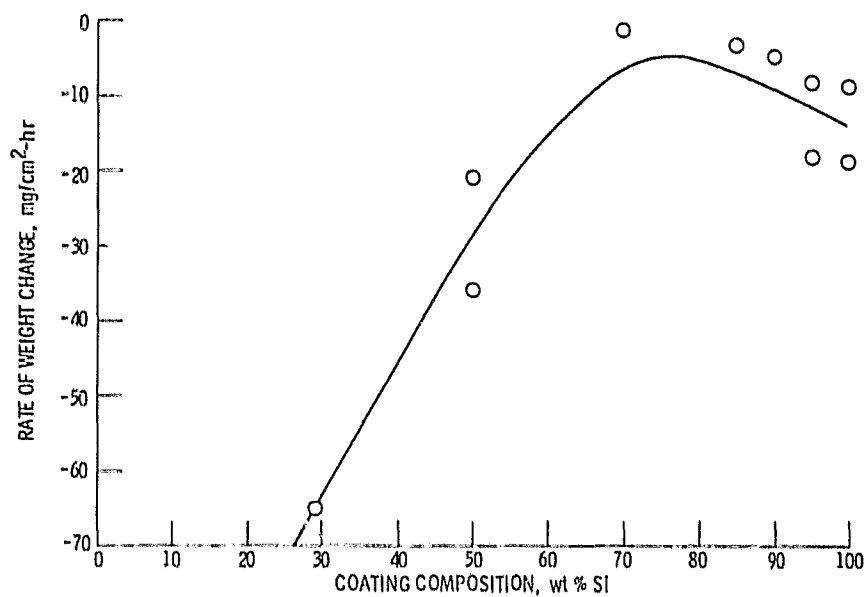
Figure 9. - Compositional dependence of oxidation behavior of Ni-Si coatings.

A relationship between the coating behavior and coating composition could be surmised from the gravimetric curves. This dependence is shown more clearly in Fig. 9, where the rate of weight change is plotted against coating composition. The best performance is indicated to be between 70 and 90 percent Si, as would be expected for the coatings showing the best coverage with a dense external layer. The higher Si coatings showed less protection due to the porous sintered nature of the external layer. Coating compositions in the Ni-70 Si to Ni-90 Si range, however, were extremely thin and sensitive to either the fine cracks or imperfect coverage at the edges. Also, flow of the coating to the specimen underside is very detrimental because this results in a thinner overall coating.

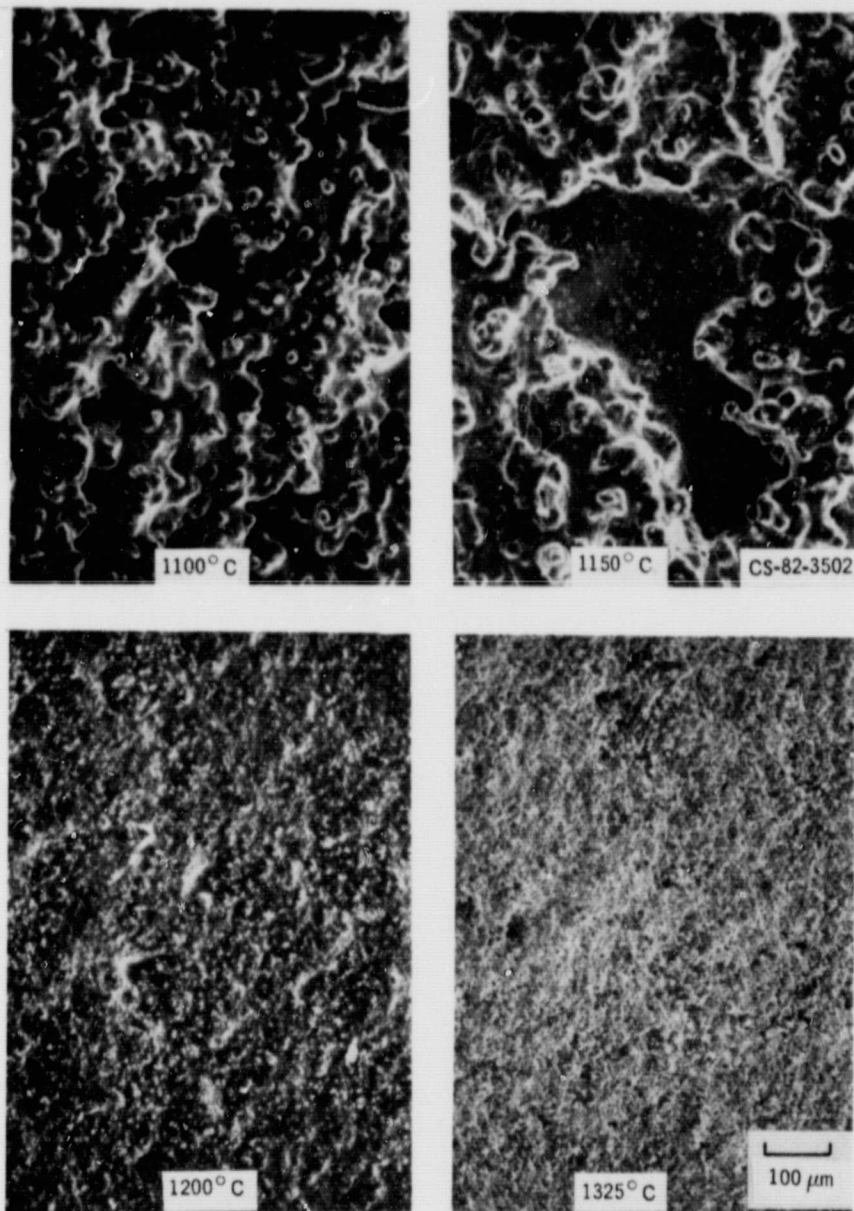
(a) Low magnification showing dramatic changes in surface roughness after sintering above 1200°C.

Figure 10. Ni-70 Si coating surface structure as a function of sintering temperature, 50 mg/cm², 1hr.

Consequently the sintering temperature was lowered even further, but the time was increased to one hr to allow the fusion, wetting, and infiltration process to occur completely and dissolve any residual solids, (table III, part (b)). The first three specimens showed that 1100° and 1150° C were too low for this to occur, but one hr at 1200° C produced an excellent coating in terms of wetting, uniformity, and fluidity. The changeover from partial to total fusion between 1100° and 1200° C can be seen in Fig. 10(a). What appeared visually as a very rough-textured, partially-sintered coating at 1100° C is seen to have some liquid phase sintering and particle agglomeration. At 1150° C discrete areas have fused and "wicked-in" to the substrate pores leaving depressed flat areas. At 1200° C the entire coating has melted to a uniform surface. At higher magnifications (Fig. 10 (b)), the surface of the 1100° and 1150° C coating agglomerates can be seen to be quite smooth on a microscale, whereas the 1200° C coating is textured due to the small faceted SiC crystallites.

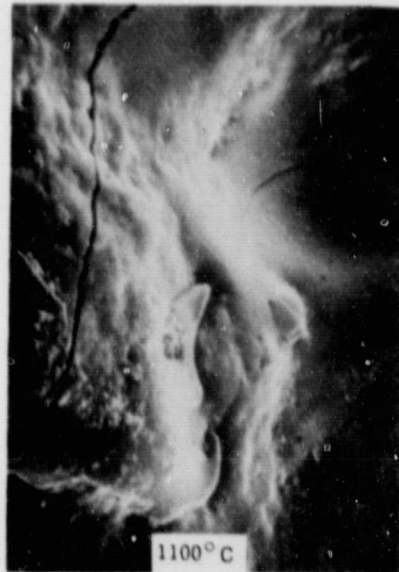
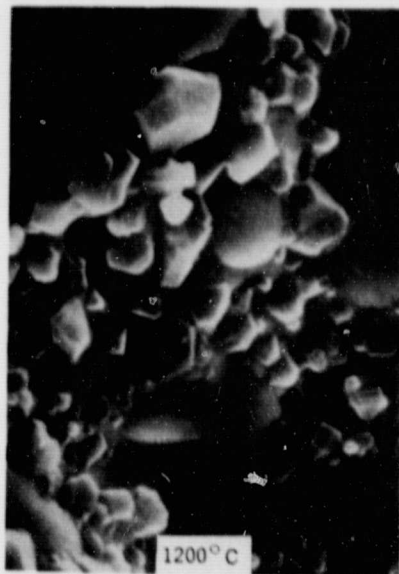
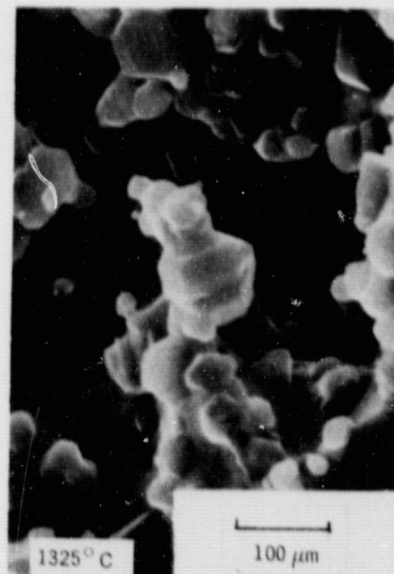
(b) High magnification showing increase in number of SiC crystallites.
Figure 10. - Concluded.

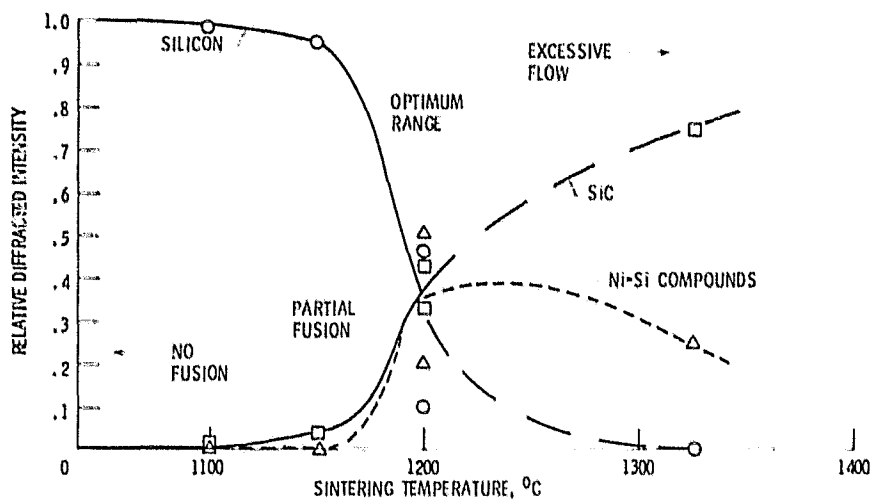
Figure 11. - Trends in estimated amounts of Ni-70 Si coating phases with sintering temperature (50 mg/cm², single-step for 1 hr.

The trend in the phase constituency with low sintering temperatures is shown in Fig. 11. Here relative amounts of phases were estimated by summing the intensity of all peaks up to $2\theta = 80^\circ$ and ratioing the summed intensity for one phase to that of the total sum. From this it is clear that substantial amounts of Si and Ni-Si compounds exist after one hr at 1200° C. Thus a double sintering step was employed to cause more complete reaction to form SiC. The 1200° C pre-sinters allowed optimum melting and wetting, and subsequent reacting at 1325° C allowed more SiC to form without excessive flow. An increased density of SiC crystallites was observed microscopically,

and the consumption of Si to form SiC is also indicated in Fig. 11.

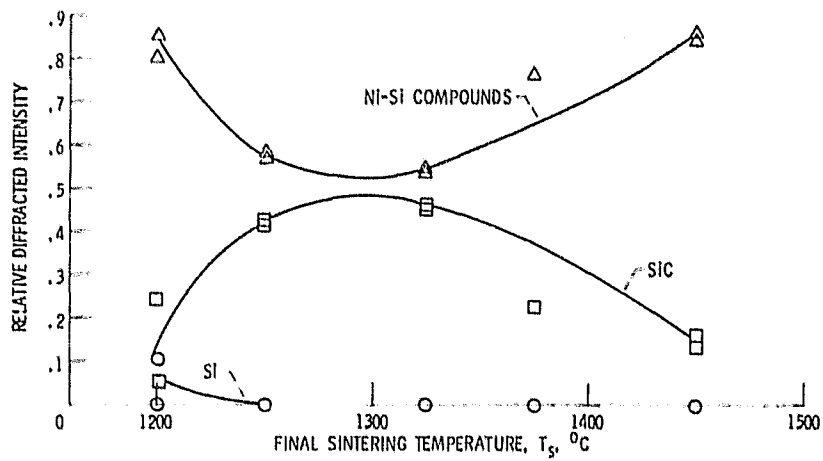
Figure 12. - Change in external coating phases with sintering temperature for the two-step Ni-70 coatings; 1200°C/1 hr + T_s/1 hr.

The estimated phase constituency of the two step coatings is shown in Fig. 12. The 1200° C/1 hr + 1200° C/1 hr sample contained a relatively large amount of the Ni-Si compounds compared to single-step coatings (Fig. 11). The 1200° C/1 hr + 1325° C/1 hr sample indicated a major decrease in the amount of the metallic phase, and a corresponding increase in the SiC phase. The 1200° C/1 hr + 1450° C/1 hr sample indicated again a large amount of Ni-Si compounds which is consistent with the observed remelting and lack of SiC crystallites at the surface. The surfaces of the Ni-70 Si coating sintered by the two-step process is shown in Fig. 13. In general, all the sintering temperatures produced coatings with a fused outer coating of Ni-Si compounds decorated with small crystals of SiC. The 1325° C sample, however, appeared roughest at low magnifications and had the highest concentration of SiC crystals at the surface. Also this coating did not exhibit any cracks, as opposed to the two others which had numerous cracks, spaced 100 μ m apart.

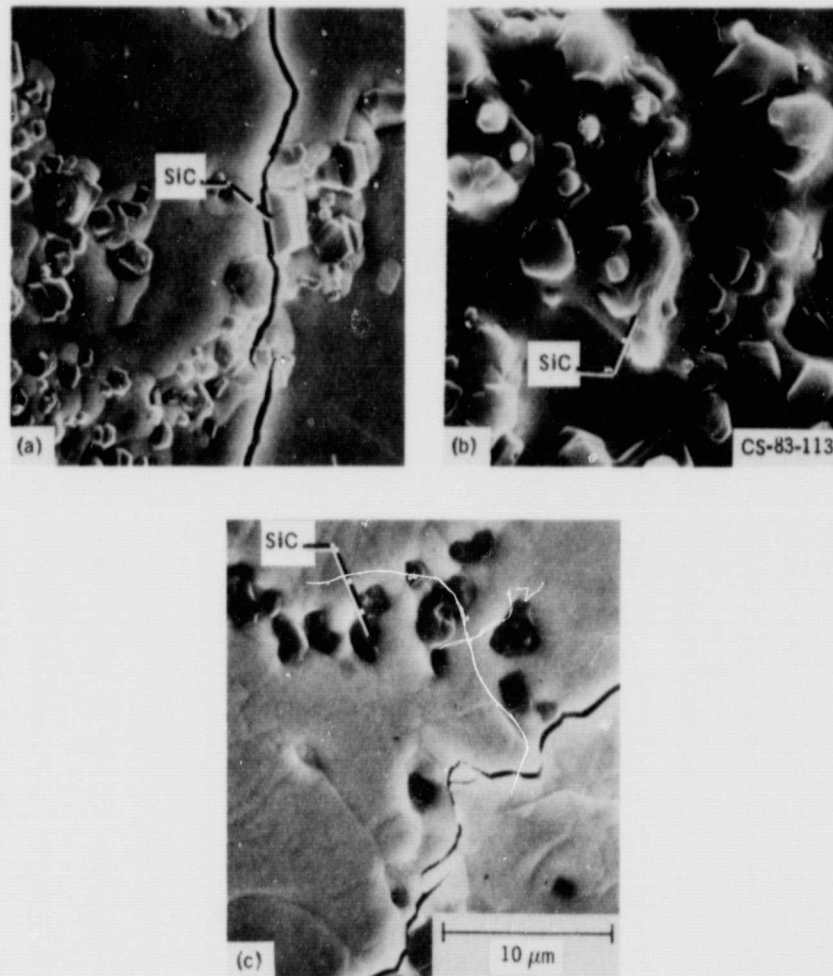
(a) 1200 C/1 hour + 1200 C/1 hour,

(b) 1200 C/1 hour + 1325 C/1 hour,

(c) 1200°C/1 hour + 1450°C/1 hour,

Figure 13. - Cracks and SiC crystallites in Ni-70 Si coatings sintered by the two-step process.

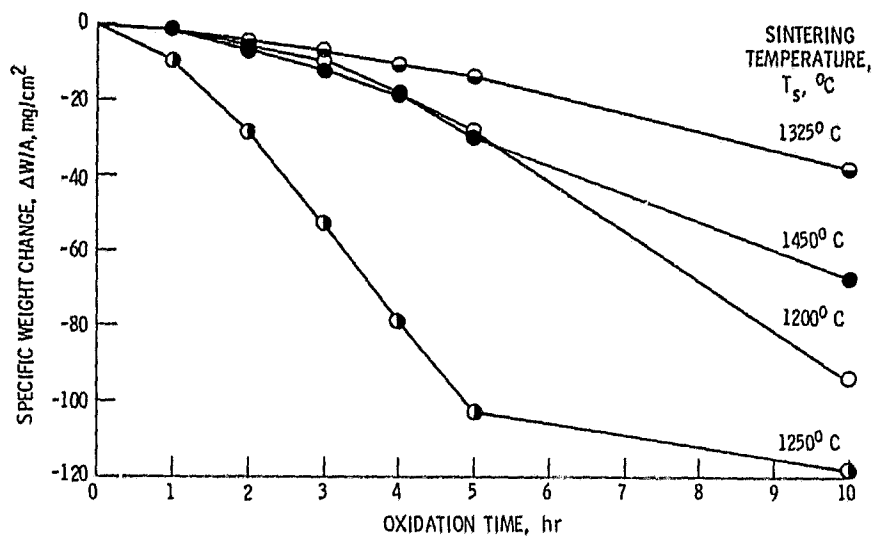
Figure 14. - 1200°C cyclic oxidation behavior of Ni-70 Si coatings sintered by the two-step process; 1200°C/1 hr + T_s /1 hr.

The oxidation resistance of the two-step coatings is shown in Fig. 14. The 1325° C coating showing no re-melting, flow, or cracks, and having the highest SiC content provided the best oxidation protection. This sample was

grey and appeared quite uniform after oxidation. The 1200° and 1450° C samples had nearly the same oxidation resistance, as might be expected from their similar appearance, microstructure, and phases. The 1200° C coating appeared metallic or light grey-blue and quite oxidation resistant except for a pinhole through the coating formed at 4 hr. The same was true for the 1450° C sample except for a pinhole formed at 2 hr. Yellow tinted oxide was also apparent after 10 hr. The 1250° C sample which had the poorest oxidation resistance, appeared tan with dispersed yellow and blue areas.

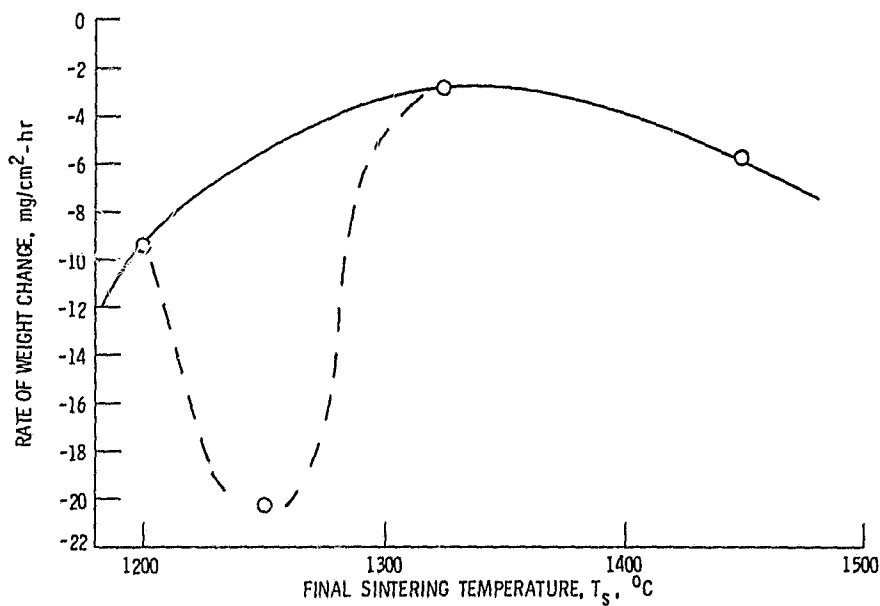
Figure 15. - Effect of sintering temperature on 1200°C oxidation behavior for Ni-70 Si two-step coating; 1200°C/1 hr + T_s /1 hr.

The rate of weight change as a function of the final sintering temperature is shown in Fig. 15. These rates were determined from the slope of the gravimetric curves averaged over the majority of the test. In general a broad maximum appears near the 1325° C area, however the 1250° C sample deviates from this trend. The reason for this is not known.

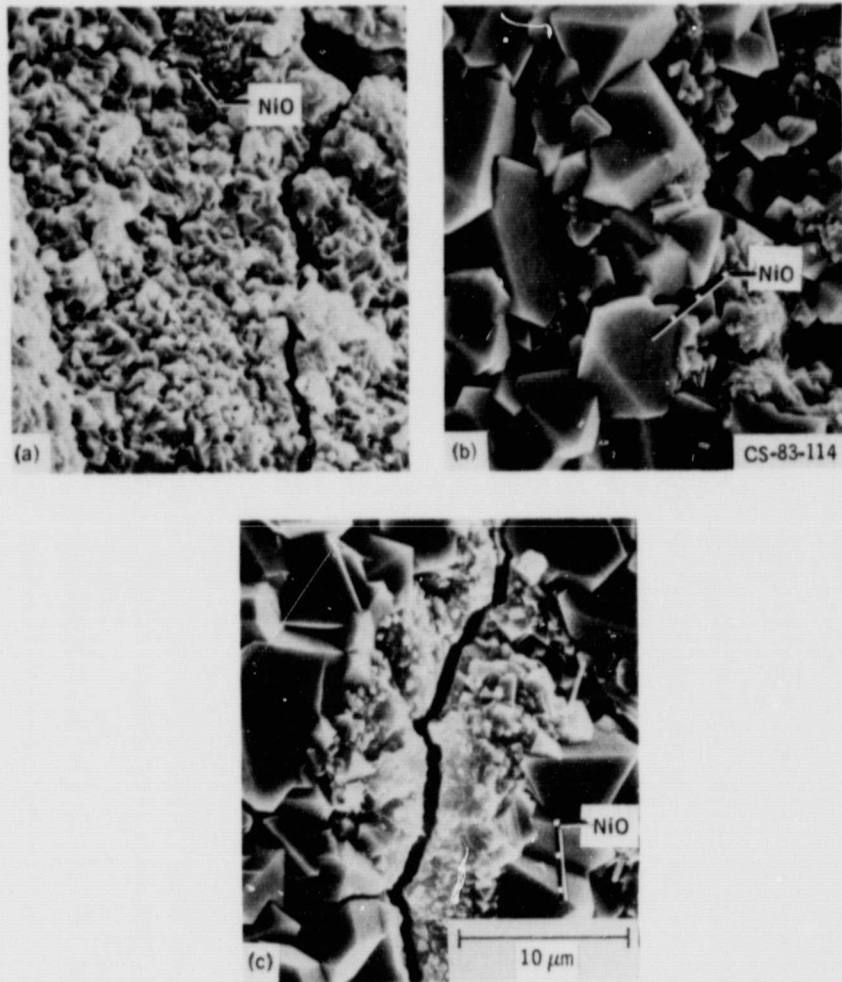
(a) 1200°C/1 hour + 1200°C/1 hour.

(b) 1200°C/1 hour + 1325°C/1 hour.

(c) 1200°C/1 hour + 1450°C/1 hour.

Figure 16. - Surface microstructure of NiO crystallites ($\approx \text{SiO}_2$) formed on two-step Ni-70 Si coatings oxidized at 1200°C for 10 hour.

The microstructure of the oxidized Ni-70 coatings is shown in Fig. 16. The cracks formed after sintering are still apparent in the 1200° and 1450° C specimens. These cracks have not healed by SiO₂ glassy formation and could therefore be a major contribution to coating failure. All the coatings exhibited faceted NiO crystals which were 1 to 2 μm for the 1200° C coating and up to 10 μm for the 1325° and 1450° C coating. NiO is known to grow rapidly at 1200° C, and this oxide formation would eventually lead to wearout of the thin coatings without protective SiO₂ formation.⁶ Again the 1325° C specimen

exhibited no obvious cracks or holes and the failure mechanism of this coating is not clear.

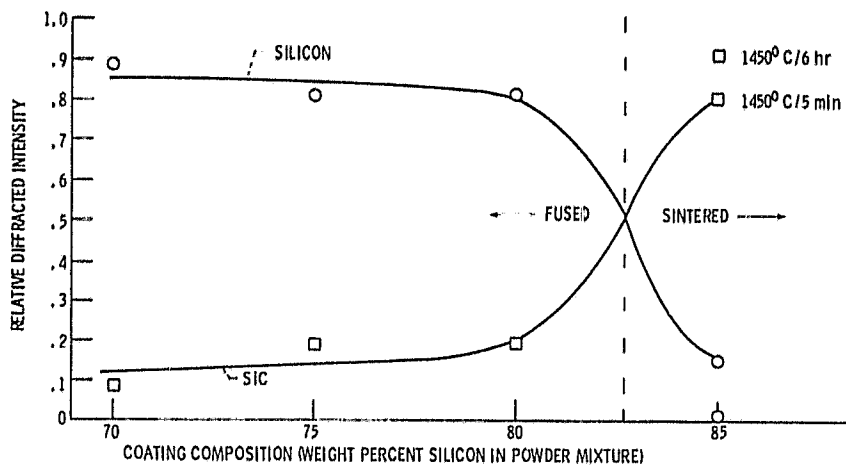
Figure 17. - Compositional effect on coating phases for short single-step process (1400°C/5 min.).

Slight modifications to the Ni-70 Si composition were also studied concurrently with the prior experiment. It was desired to determine whether increased Si contents could decrease the coating flow while still allowing melting and wetting to occur. Another motivation was to study the performance of various compositions processed by the two-step method. The single-step coatings, table IV, part (a), were sintered at 1400° C for only 5 minutes to minimize liquid running. The 70 and 75 percent Si coatings both fused to a metallic luster and ran to the bottom of the specimens, while the 85 percent Si coating appeared uniform, but not densely fused. X-ray diffraction data from these specimens showed that the fused 75 percent and 85 percent Si coatings were primarily Si, while the Ni-85 Si coating was primarily SiC, Fig. 17. The Ni-85 Si data shown here was obtained after heating to 1450° C for 5 min. and from a duplicate sample reheated to 1450° C for 6 hr. Neither coating showed any external signs of fusion, with either this higher temperature or longer-time sinter, but appeared uniformly grey, textured, and non-metallic. The only effect of the extra sintering time was to slightly increase the amount of SiC.

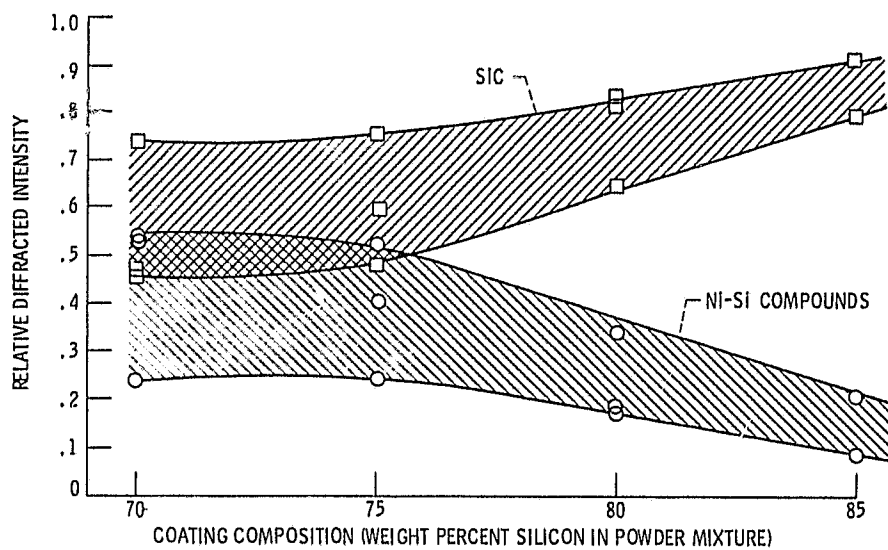
Figure 18. - Compositional effect on coating phases for long two-step process (1200°C/1 hr + 1325°C/1 hr).

The coatings processed by the two-step procedure (table IV, part (b)) were all uniform non-metallic grey, and showed no signs of excessive coating flow. Thus the two-step process again allowed for good coverage, but the density of the sintered coating may be in question. The trend in coating phase variation with composition is shown in Fig. 18. Wide scatter bands for

multiple specimens were observed, but in general the SiC phase increased with percent Si while the Ni-Si phases decreased.

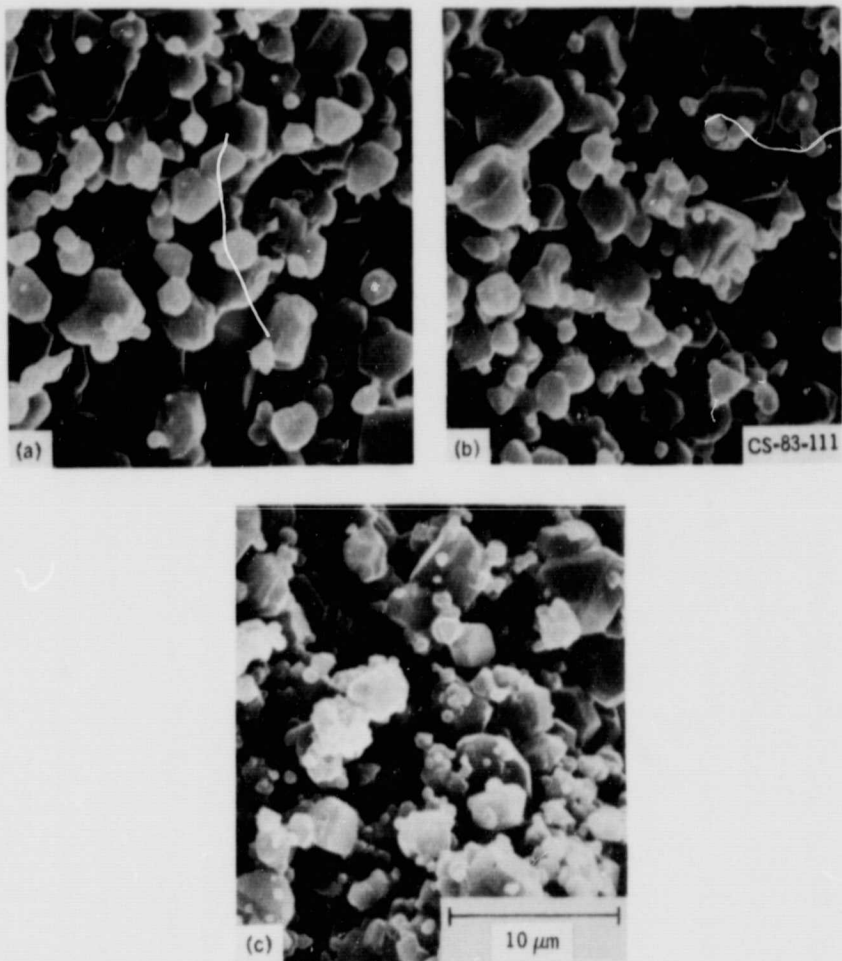
- (a) Ni-75 Si.
- (b) Ni-80 Si.
- (c) Ni-85 Si.

Figure 19. - Effect of silicon content on surface microstructure of high-Si coatings sintered by the two-step process ($1200^{\circ}\text{C}/1\text{ hour} + 1325^{\circ}\text{C}/1\text{ hour}$).

The surfaces of the high-silicon coatings sintered by the two-step process is shown in Fig. 19. All the coatings exhibit a rather porous open sintered structure with some faceted particles plus fine spherical particles. No cracks were observed. At low magnifications some very deep voids in the coating can be found for all three compositions. These are probably near areas of high porosity in the substrate where much of the molten coating has penetrated the graphite, leaving behind a hole in the coating. This type of defect was not noticed in the Ni-70 Si coatings where complete wetting and flow occurred for all temperatures $\geq 1200^{\circ}$ C.

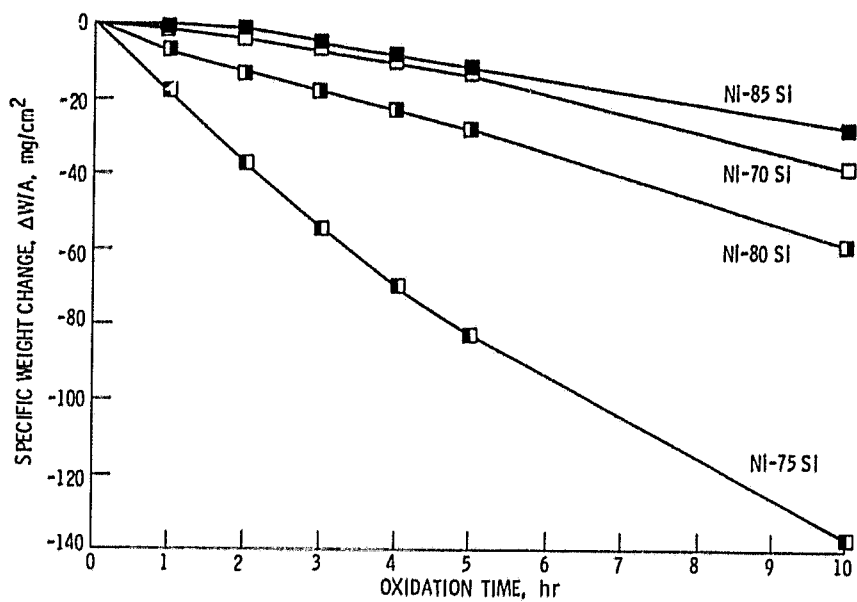
Figure 20. - 1200° C cyclic oxidation behavior of Ni-Si coatings sintered by the two-step process; 1200° C/1 hr + 1325° C/1 hr.

The oxidation behavior, Fig. 20, shows the high Si content coatings to be the most protective. The uniform appearance of these specimens indicated that they did not degrade in the localized defect mode as did the Ni-70 coatings of Fig. 14. The 75 percent Si coating was generally yellow-grey throughout the oxidation test; the 80 percent Si began as blue-grey and became slightly tan at 10 hr; the 85 percent Si began as a very dark charcoal grey, changing to a slightly blue-green tint at 10 hr.

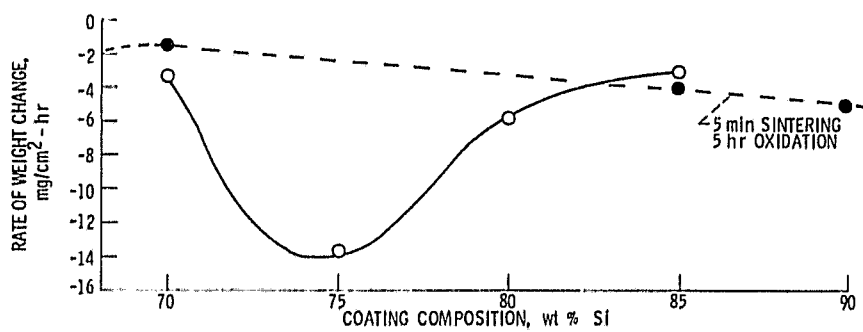
Figure 21. - Compositional effect on 1200° C oxidation behavior of the two-step Ni-Si coatings.

The rate of weight change as a function of coating composition is shown in Fig. 21. In general the 70, 80, and 85 percent Si coatings all exhibited nearly equivalent protection. The reason for the minimum at 75 percent Si is not known, although the major difference in microstructure from fused to sintered occurs at 70 to 75 percent Si. Except for Ni-75 Si, these rates of weight changes are similar to those observed in a 5 hr oxidation test of the single-step coating (Fig. 9).

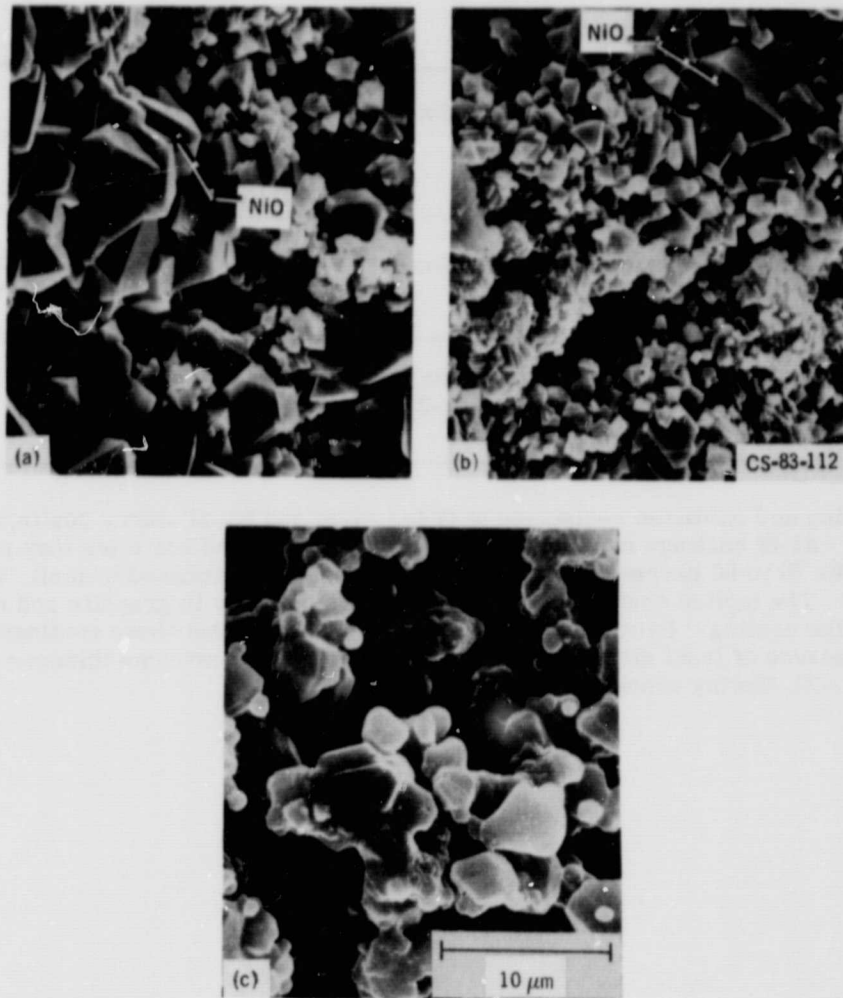
(a) Ni-75 Si.

(b) Ni-80 Si.

(c) Ni-85 Si.

Figure 22. - NiO crystallites and SiO_2 surface oxides formed after 1200°C oxidation for 10 hours, high-Si coatings, two-step process.

coating had only a weak SiO_2 pattern with no NiO which may account for the improved oxidation resistance. The surface structure of the oxidized coatings is shown in Fig. 22. The faceted NiO crystallites are apparent in the Ni-75 Si and Ni-80 Si coatings, but not in the Ni-85 coating. The Ni-85 coating also appears to be covered with a molten material, such as glassy SiO_2 , which was not apparent in the as-coated condition (Fig. 19). The sealing effect of such a glass plus the lack of NiO may be related to the better protection of this coating. It should also be noted that none of the high-silicon coatings showed obvious cracks before or after oxidation.
