DEMONSTRATION AND EVALUATION OF GAS TURBINE TRANSIT BUSES

BOOZ, ALLEN & HAMILTON INC.
TRANSPORTATION CONSULTING DIVISION

JUNE 1983

PREPARED FOR
NATIONAL AERONAUTICS AND SPACE ADMINISTRATION
LEWIS RESEARCH CENTER
UNDER CONTRACT DEN3 - 142

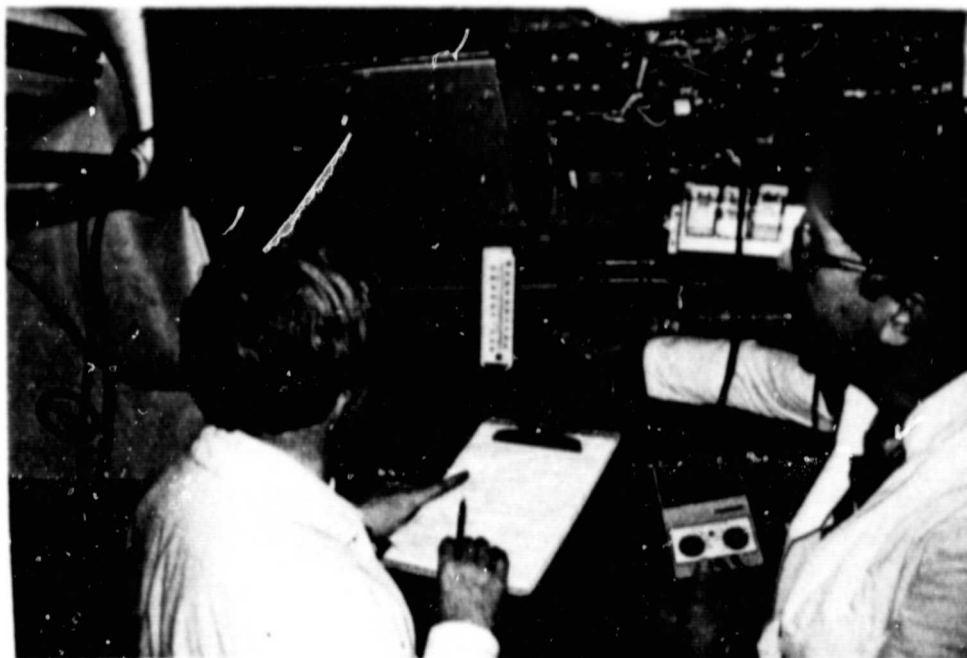
FIGURE III-12
Rear Apparatus Relay Box and
Engine Control Box Location

The rear apparatus relay box location in the diesel coach (under the rear seat support) interfered with the turbine engine when it was installed in the coach mockup. A new box was designed, fabricated and installed on the firewall of the engine compartment. On the initial trip to Baltimore with Coach #3319, failures occurred with this box because of high temperatures in the engine compartment, principally fusing of relay contacts and melting of plastic parts. It was necessary to find a cooler location to prevent these failures, and a more accessible spot for servicing the box in the field. Booz, Allen & Hamilton suggested a location inside the passenger compartment, over the rear seat, as shown in Figure III-12. It was also decided to relocate the engine control box from its location in the radio box in bay three to the same area. Both boxes were enclosed with a vacuum-formed cover that blended into the existing inside rear trim panels.

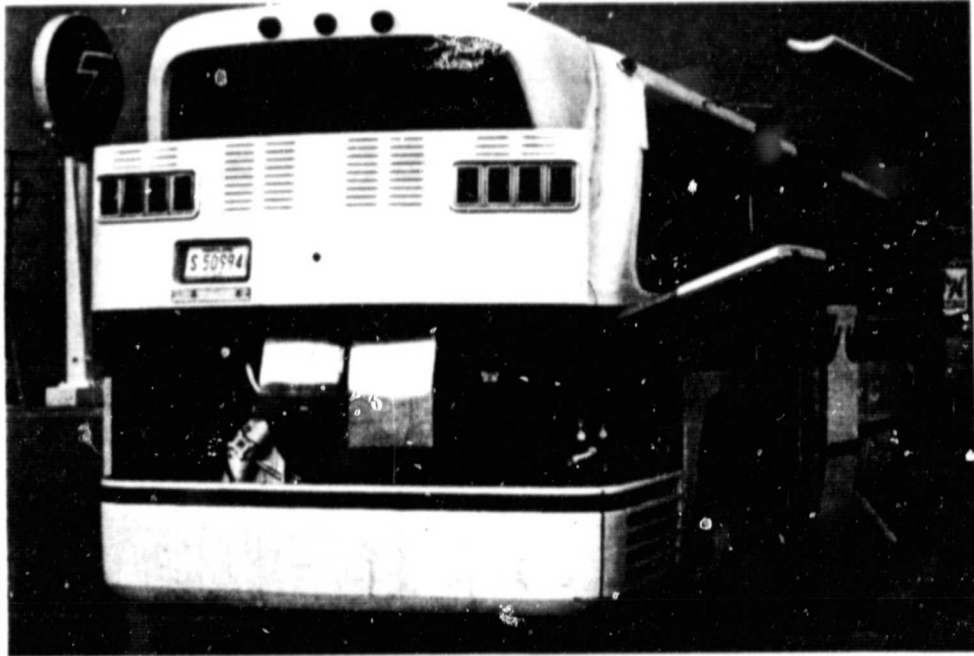
FIGURE III-14
Rear Engine Access Door Design

The test readings showed a vast improvement (25-30°F) with the rear door ajar and also with the lower side door covers removed. The readings with the rear door completely open showed that the temperature could be reduced further if more openings and a faster air flow from the oil cooler fan could be provided. Stainless steel louvers were incorporated into the rear engine access door, as shown in Figure III-14, for increased air flow through the engine compartment.

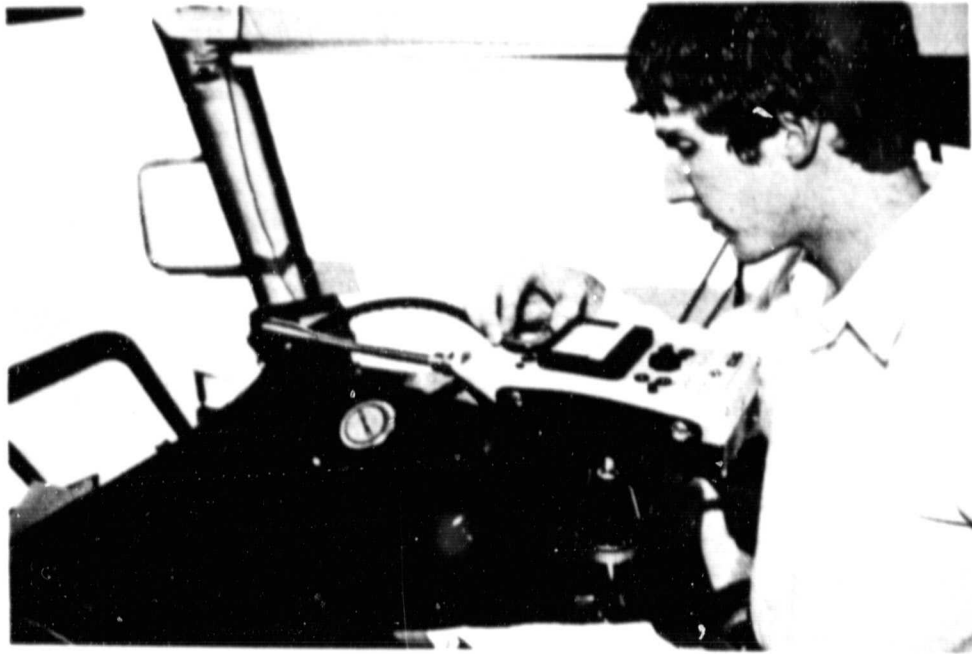
FIGURE IV-3
Interior Noise Level at Driver's Seat

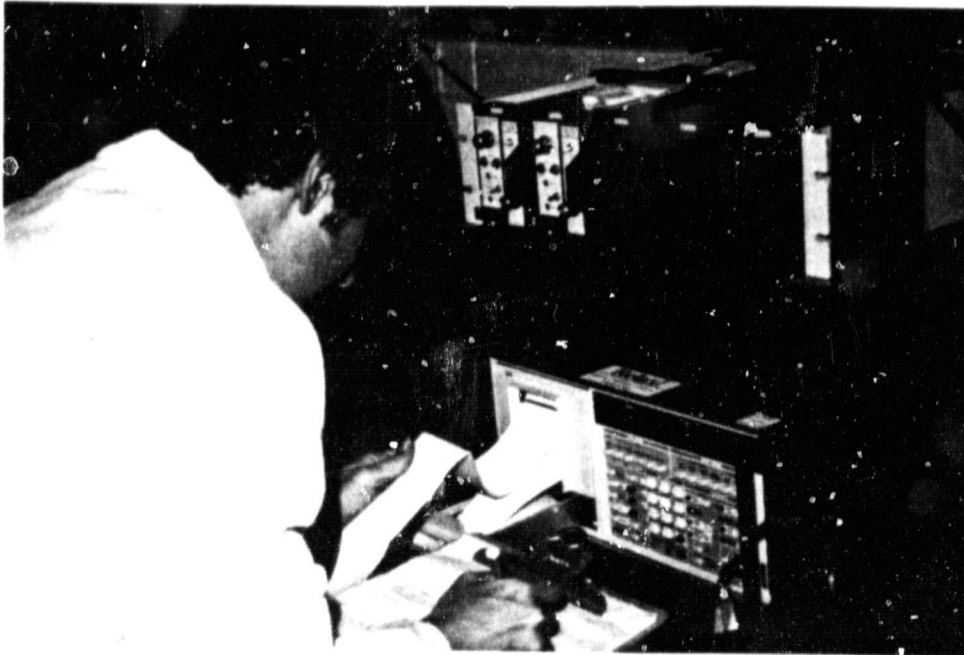
FIGURE IV-7
Digital Readout for Monitoring
Brake Temperatures

- Brakes--The coach was out of service approximately 9 days for brake replacement. During the first week of the systems tests the brake temperatures would not stabilize and the brake temperatures increased daily. On the sixth day

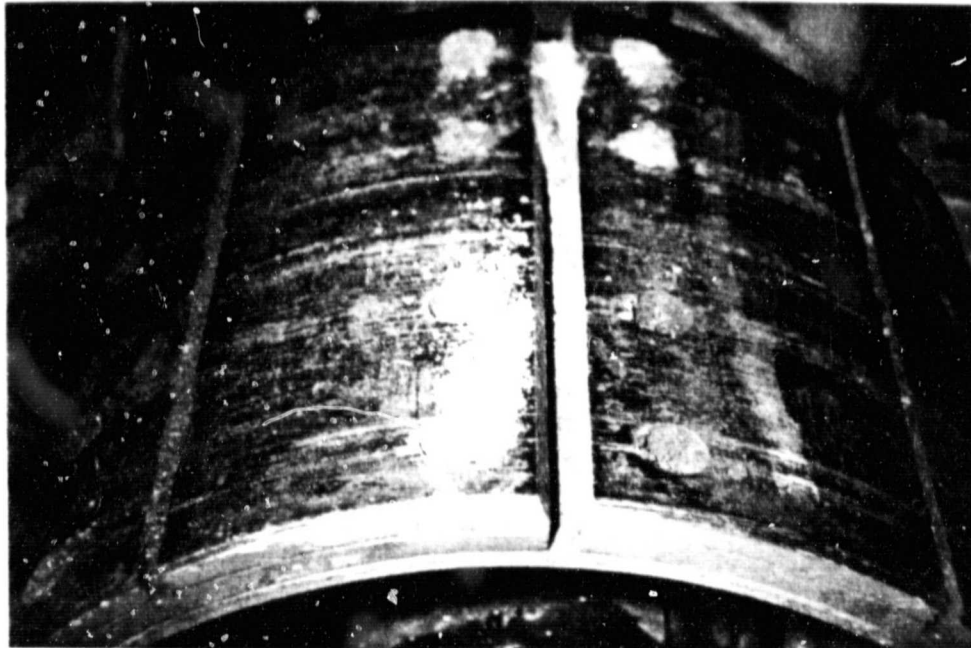
FIGURE IV-10
Glazed Brake Drums

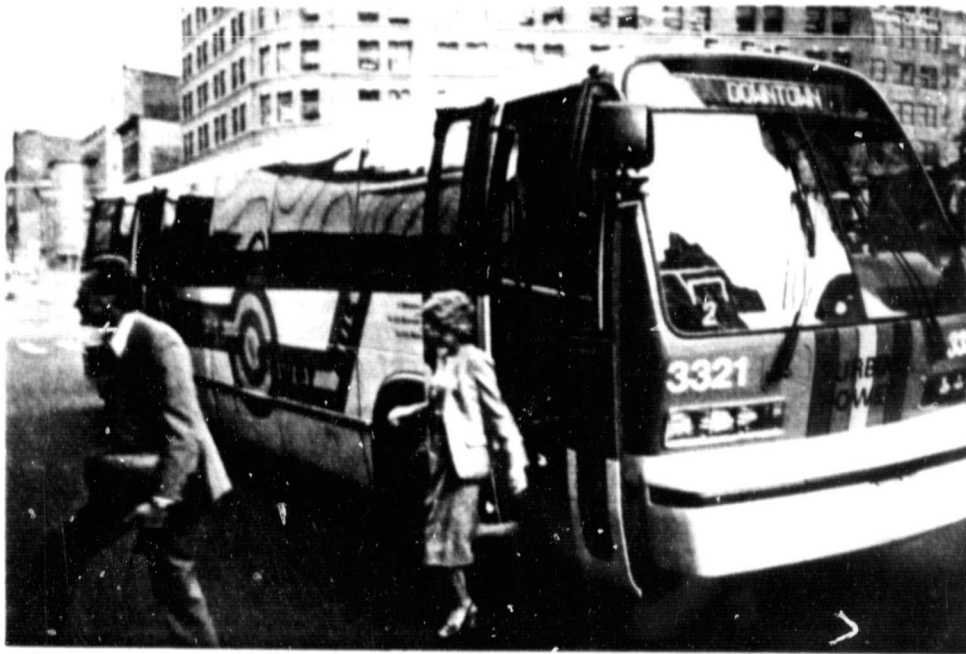
FIGURE V-1
Gas Turbine Coach #3321 in Revenue Service
(April 1981)

Gas turbine coaches #3318, #3320, and #3321 were placed in revenue service early in April of 1981, Figure V-1. Gas turbine coach #3319, the proving grounds test coach, was delayed at the test track and began public demonstration the middle of May. During April, the coaches were available to operate in revenue service 69 percent of the scheduled coach days* and were operated on a revenue route 37 percent of the coach days. The three coaches accumulated 5,038 miles of revenue operation. Downtime was evenly divided between engine- and coach-related problems but the number of separate, specific coach-related problems outnumbered the engine-related problems by over two to one. This may be attributed to several reasons. For the most part, mechanics were familiar with coach-related problems and the repairs were generally easy to accomplish. Engine problems on the other hand were usually more complicated to diagnose and to repair, especially on the prototype gas turbine engines with which they had had minimum exposure and experience.

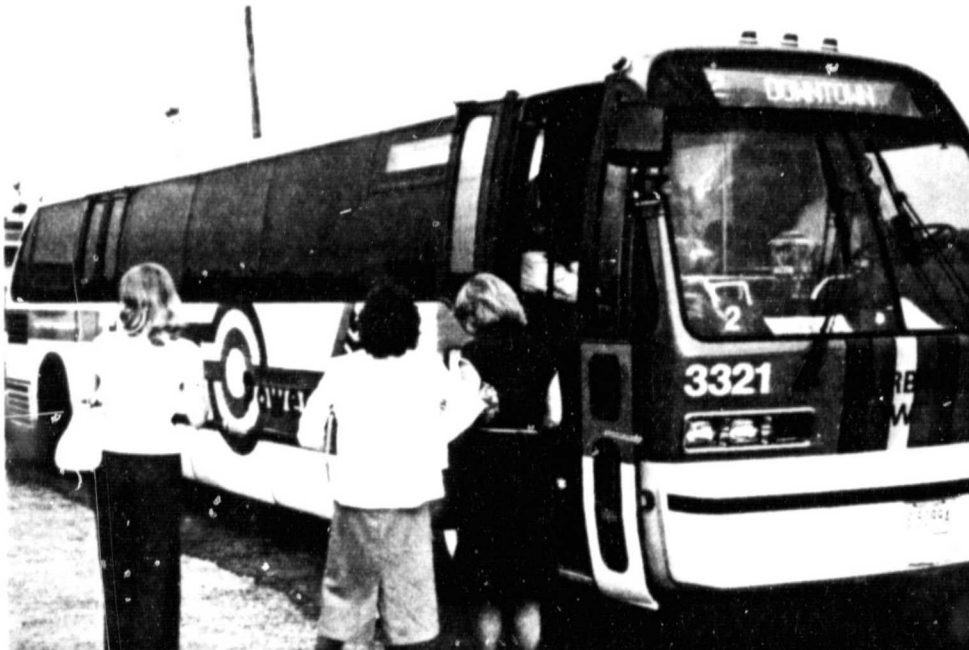
FIGURE V-2
Gas Turbine Coach #3321 in Revenue Service
(June 1981)

The four coaches continued to operate throughout June, accumulating 9,184 miles of service, Figure V-2. They were available 73 percent of the coach days and operated 72 percent of the coach days, which accounts for the higher accumulated mileage. Sixty-seven percent of the downtime was because of engine-related problems, but the ratio of coach-related to engine-related problems remained a little over two to one.
