NASA CR-167964  
PWA-5515-176

JT9D THERMAL BARRIER COATED VANES

UNITED TECHNOLOGIES CORPORATION  
Pratt & Whitney Aircraft Group  
Commercial Products Division

Contract NAS3-20630

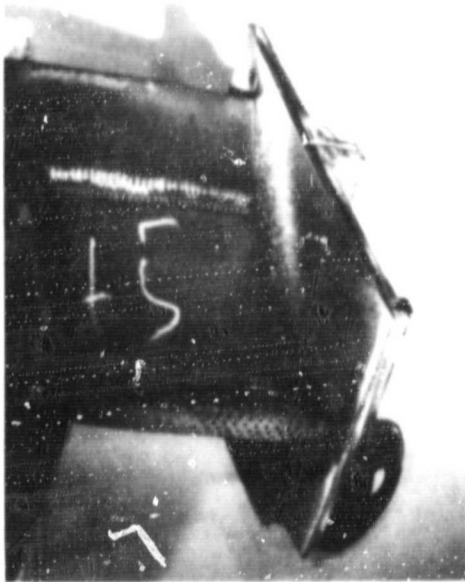
Figure 6 Post-test Condition of 6% YSZ Coating System. The favorable results shown in this photograph are typical of the 6% YSZ system. Vane position No. 46. (Numbers shown on vanes do not refer to wheel chart location on Figure 5.)

The favorable results of the 6% YSZ coating system is typified in the photograph shown in Figure 5. Representative spalled areas, which were numerous for the 20% YSZ and 21% MSZ systems, are shown in Figure 7.

The excellent durability exhibited by the 6% YSZ coating relative to the other ceramic compositions verified the observations of the first engine test. In both tests, the 6% YSZ vane coatings contained porosity and microcracking rather than segmentation cracking as the strain tolerant microstructure. Since similar microstructures were present in the less durable 20% YSZ coatings, it is not readily apparent why there was such a substantial difference in ceramic spalling resistance between the two systems. No significant difference had been observed in the laboratory burner rig tests of these two YSZ compositions (Sections 5.1.4.1 and 5.1.5.2). In contrast, the higher temperature laboratory tests (Section 5.1.5.2) did reveal a debit in the durability of the 21% MSZ relative to the YSZ compositions; this was consistent with the results of both engine tests.

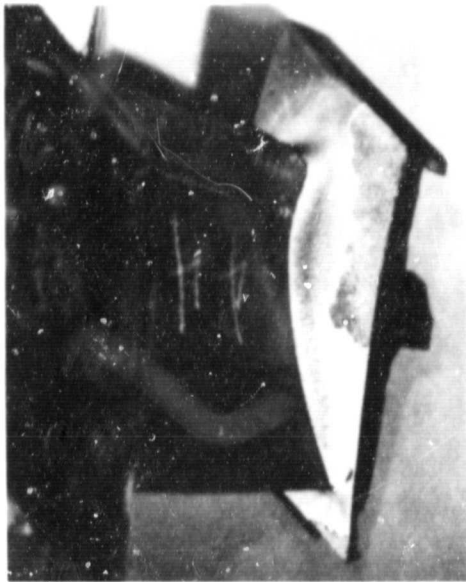
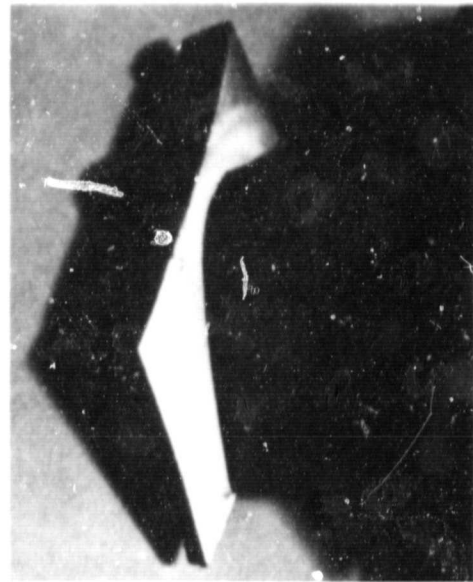
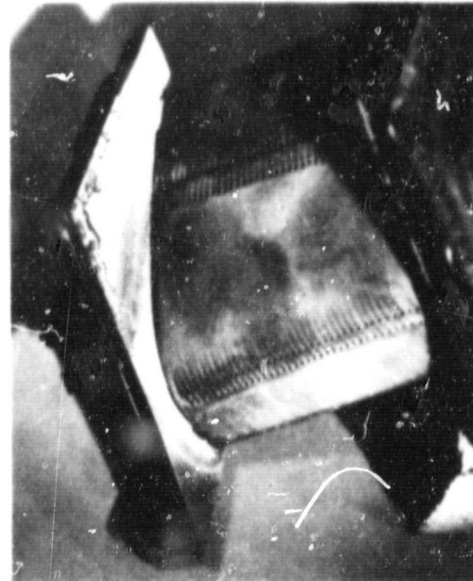
Figure 7 Post-test Condition of the 20% YSZ and 21% MSZ Coating Systems. The spallings shown in this photograph are representative of the condition of the 20% YSZ and 21% MSZ systems. Vane position No. 45. (Numbers shown on vanes do not refer to wheel chart location on Figure 5.)

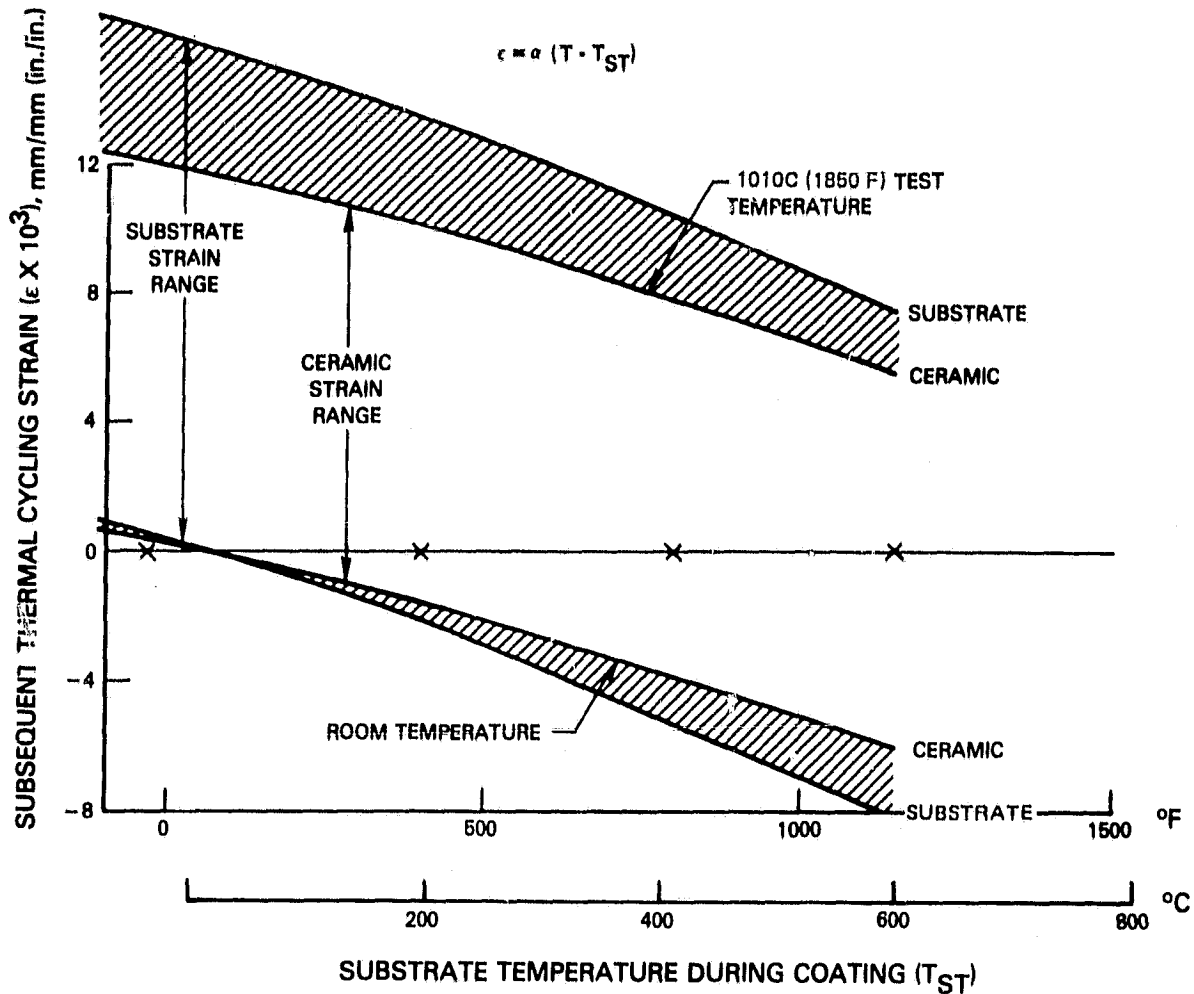
Figure 21 Variation of Interface Strain Range With Substrate Temperature During Coating.

As mentioned in section 5.1.2, control of ceramic residual stress state is desirable to avoid loading of the ceramic in compression during thermal cycling. The approach developed in this program to control ceramic residual stress was to control the temperature of the substrate during coating deposition. Figure 21 illustrates the calculated variation of in-service ceramic strains with the substrate temperature during coating deposition. Shown in this figure are the algebraic magnitudes of ceramic and substrate strains in the plane of the coating at the coating base metal interface, calculated for various values of the temperature of the substrate at the time of coating application. At high substrate temperatures, differential contraction of the metal substrate on cooling from the process temperature places both the ceramic and the layer of base metal located adjacent to the interface in compression at room temperature (lower pair of curves). During subsequent heating in service, differential expansion places both ceramic and interfacial metallic elements in tension (upper pair of curves). As mentioned above, the compressive loading experienced by the ceramic at room temperature is considered undesirable. At intermediate temperatures on the order of  $427^\circ C$  ( $800^\circ F$ ), typical of those experienced in uncontrolled plasma spray ceramic application, smaller but still significant compressive ceramic strains are experienced at room temperature. With further reduction of substrate temperature, low temperature compressive ceramic strain becomes sufficiently small that coating durability improves substantially.

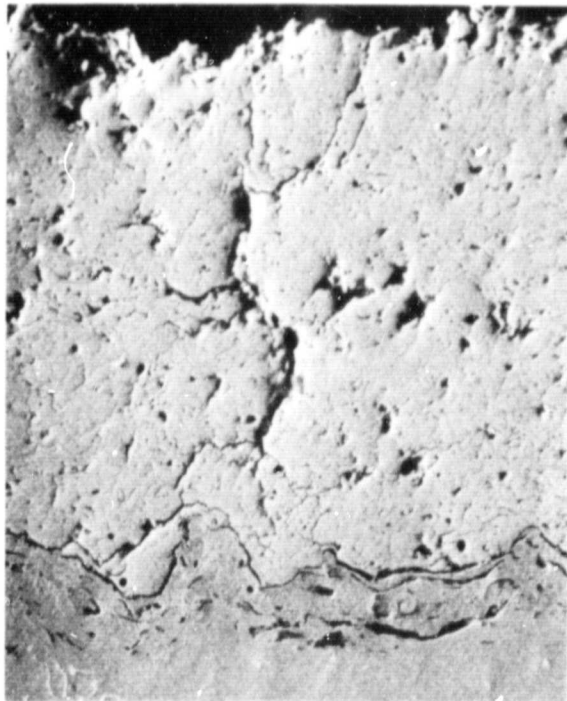
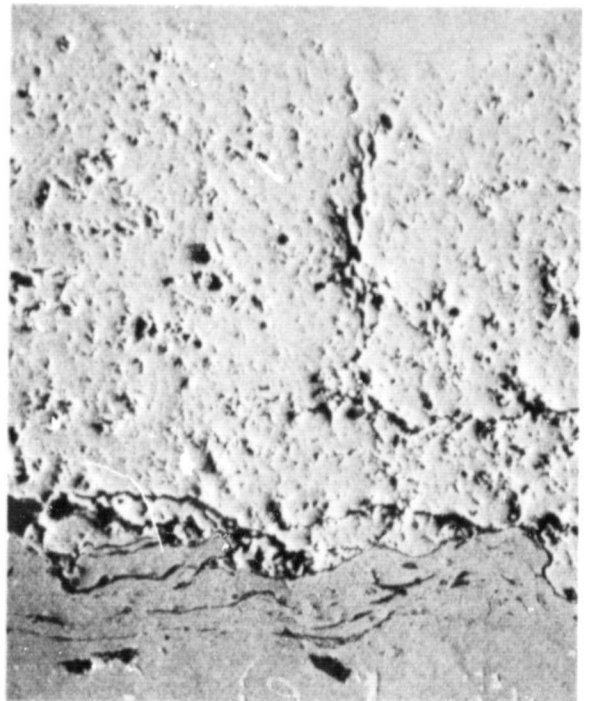
Figure 30 Light Microscope (Top) and SEM (Bottom) Photographs of Pre-Test (Left) and Post-Test (Right) Microstructures of a 12 w/o  $Y_2O_3$  Stabilized  $ZrO_2$  Coating.

The 12%  $Y_2O_3$  stabilized  $ZrO_2$  (System E) resulted in an extremely low average life to ceramic spalling (approximately 500 cycles). X-ray diffraction analyses indicated no phase transformation which would be expected to cause failure due to volume changes. Metallographic evaluation indicated a very dense microstructure with limited microcracking (Figure 30). This correlates with the fact that a fine particle size powder was used as the initial material. Although coarser particle size powders of this composition have not been investigated, it was assumed that the resulting high porosity coating would provide coating life equivalent to that which resulted from the high porosity 20% YSZ composition, since both systems theoretically contain a fully stabilized cubic crystal structure.

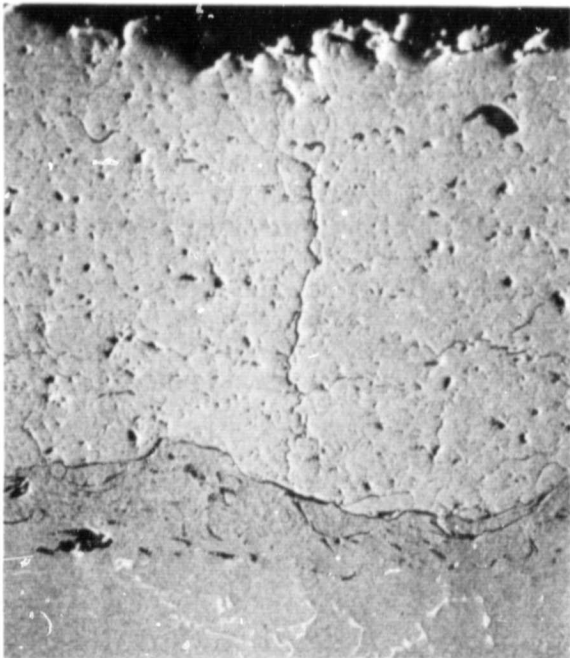
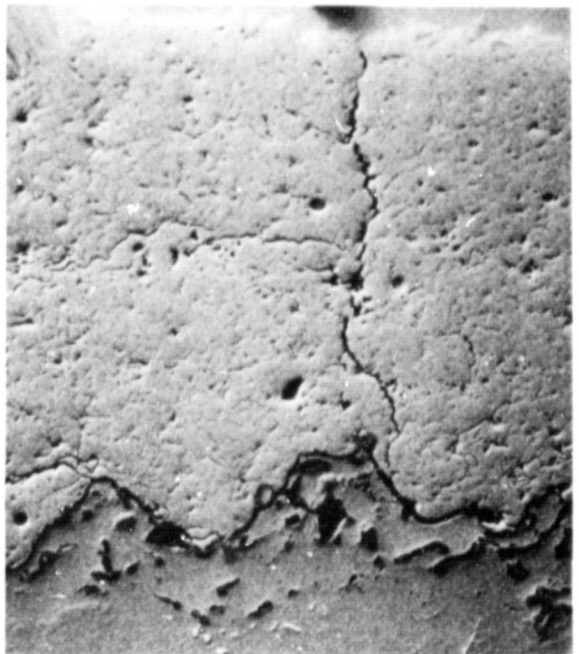
Figure 31 Light Microscope (Top) and SEM (Bottom) Photographs of Pre-Test (Left) and Post-Test (Right) Microstructures of a 6 w/o  $Y_2O_3$  Stabilized  $ZrO_2$  Coating Exhibiting Vertical Cracks which Formed a "Segmented" Structure.

Metallographic examination of the 6% YSZ coating before and after test (Figure 31) indicates a relatively dense structure with numerous vertical segmentation cracks. As discussed previously, these cracks are thought to provide strain tolerance by increasing ceramic compliance in the plane of the coating.

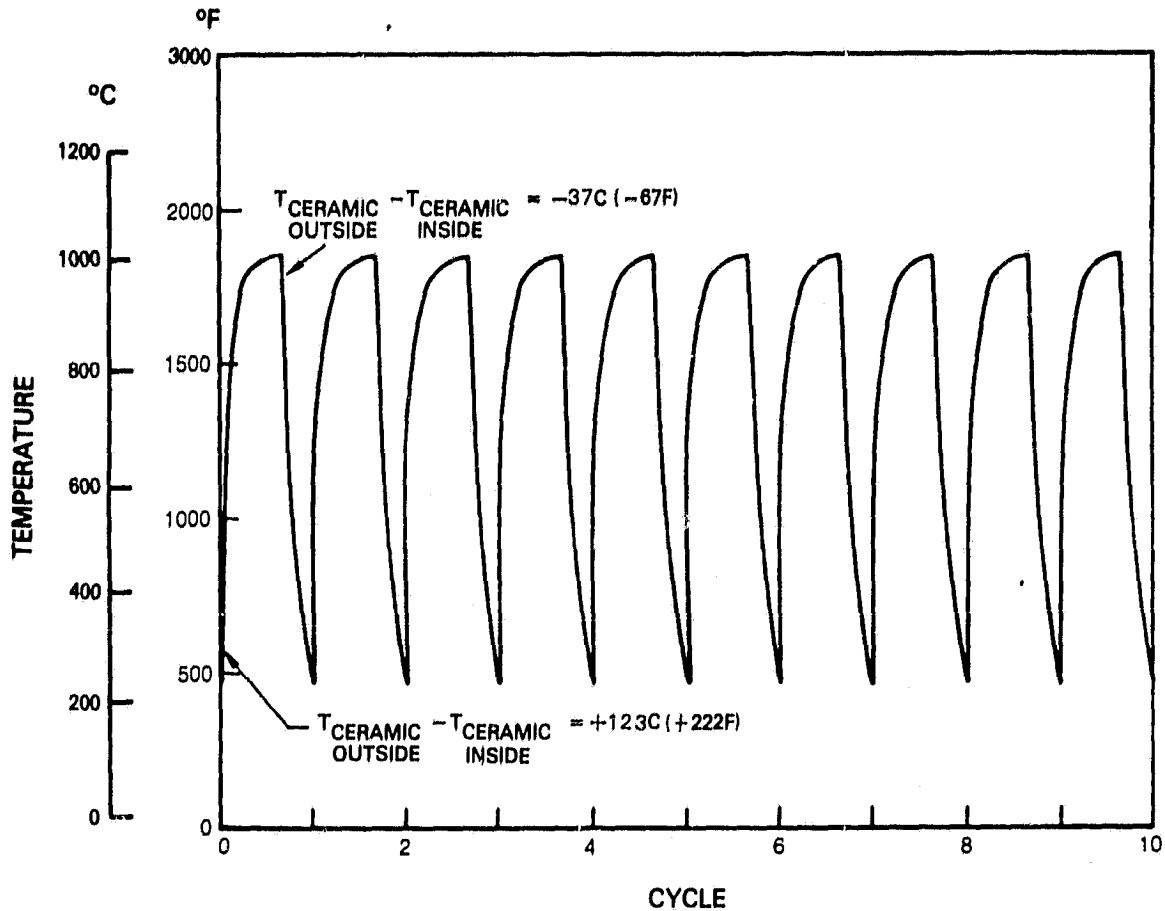
Figure 43 Cyclic Thermal History at Ceramic Outside Surface.

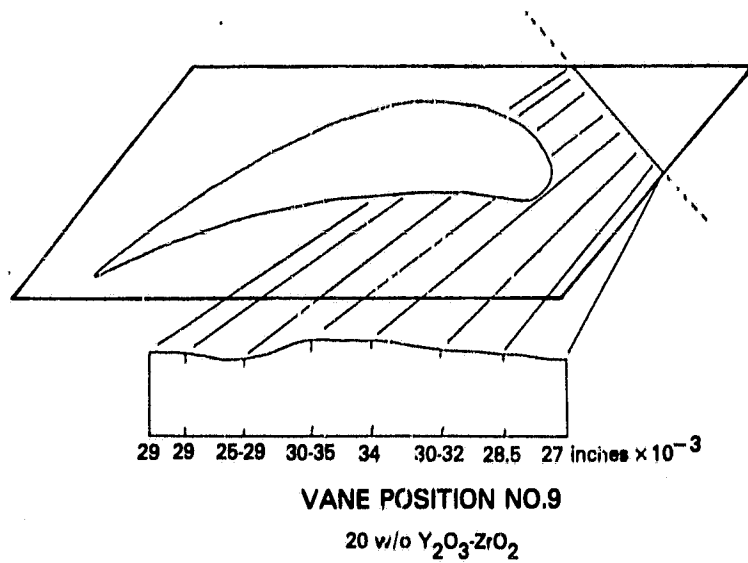
Figure 50 Typical Coating Thickness Variations Observed on ID Leading Edge of Vanes Coated With Three Candidate Ceramic Compositions.

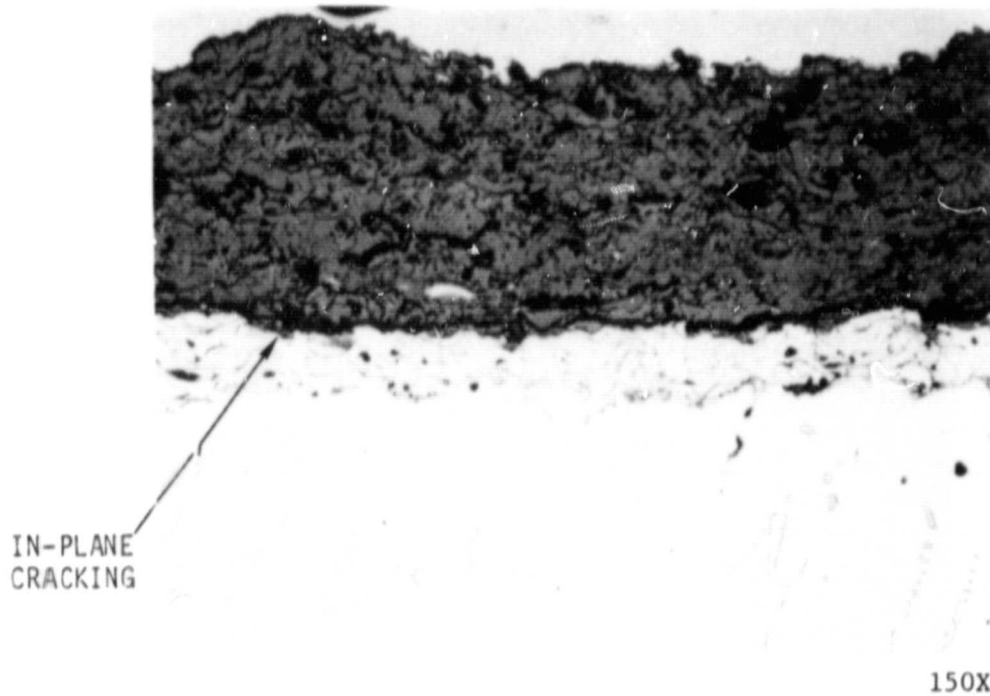
Figure 54 Typical 20 w/o  $Y_2O_3$  Stabilized  $ZrO_2$  Microstructure Observed on First Engine Test Vane. Arrow indicates in-plane cracking.

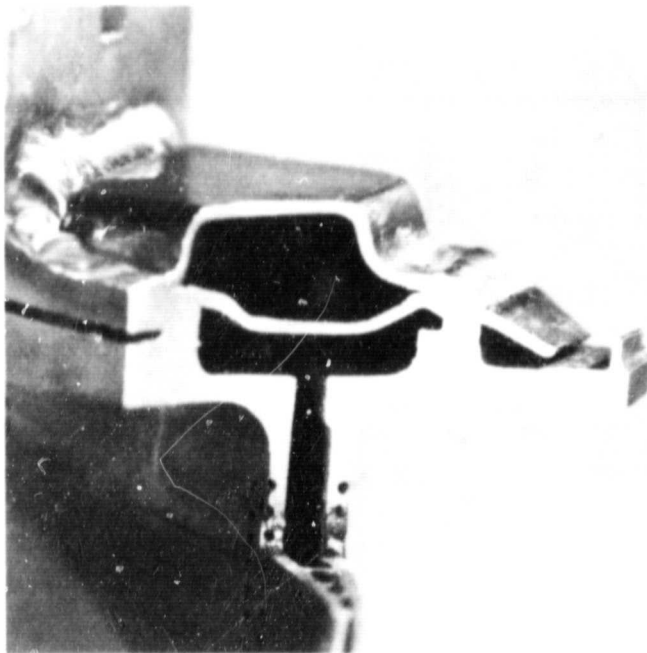
Figure 72 Cutaway View of the Design that Corrected the Impingement Air Leakage.
