HIGH-SPEED CRYOGENIC SELF-ACTING
SHAFT SEALS FOR LIQUID
ROCKET TURBOPUMPS

Rockwell International
Rocketdyne Division

June 1983

NASA-Lewis Research Center
Contract NAS3-20807
E. DiRusso, Project Manager

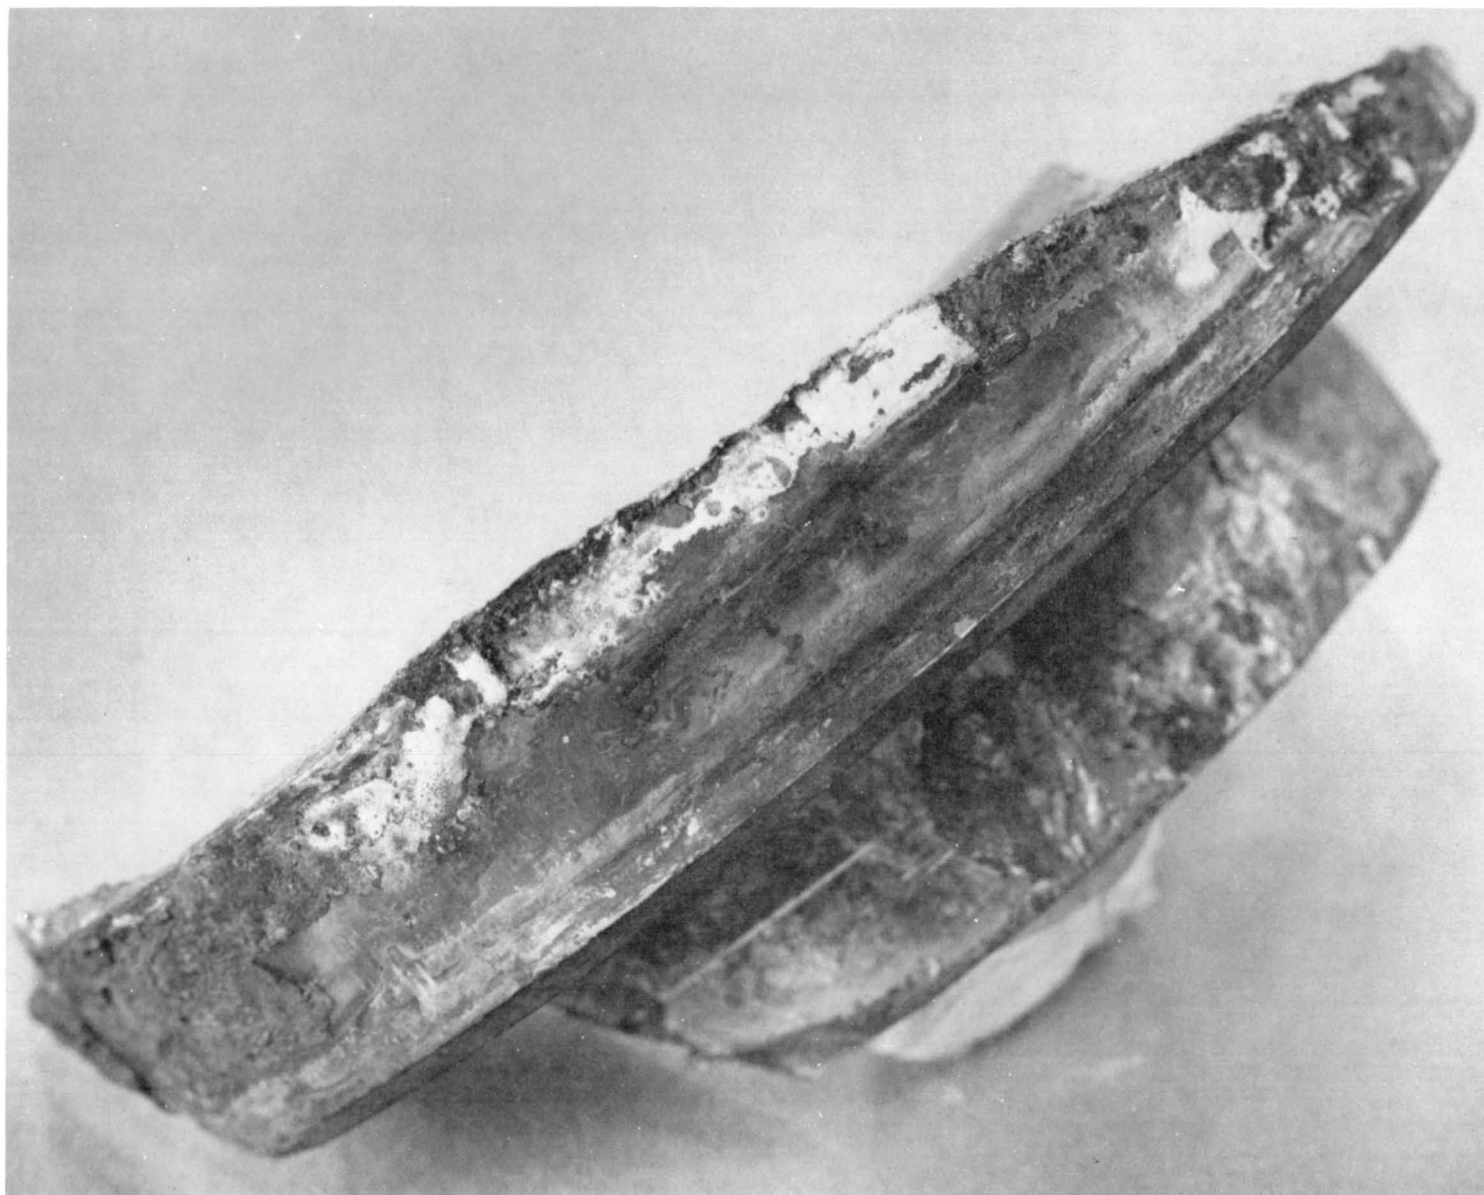
Figure 65. Posttest 222 Fire Showing Helium Seal Mate Ring

The turbine side drain housing was burned through in three places, two at the drains. The helium seal mating ring was gone except for the 90-degree section shown in Fig. 65 and 66. The rubbing surface remaining was in good condition as shown in Fig. 65. The remaining helium seal carbon segments shown in Fig. 66 indicate the rubbing surfaces were in good condition. The burning in the helium seal housing, mating ring, and drains appears to have occurred after rotation stopped.

The tester was disassembled due to the fire damage. Extensive burning occurred in the LOX and helium seal area. The outboard slave seal carbon ring was missing and the housing was mostly burned away. Figure 64 shows the outboard slave mate ring. A small chunk of the carbon nose attached to the mate ring was removed and showed the rubbing surface in good condition with no grooving.

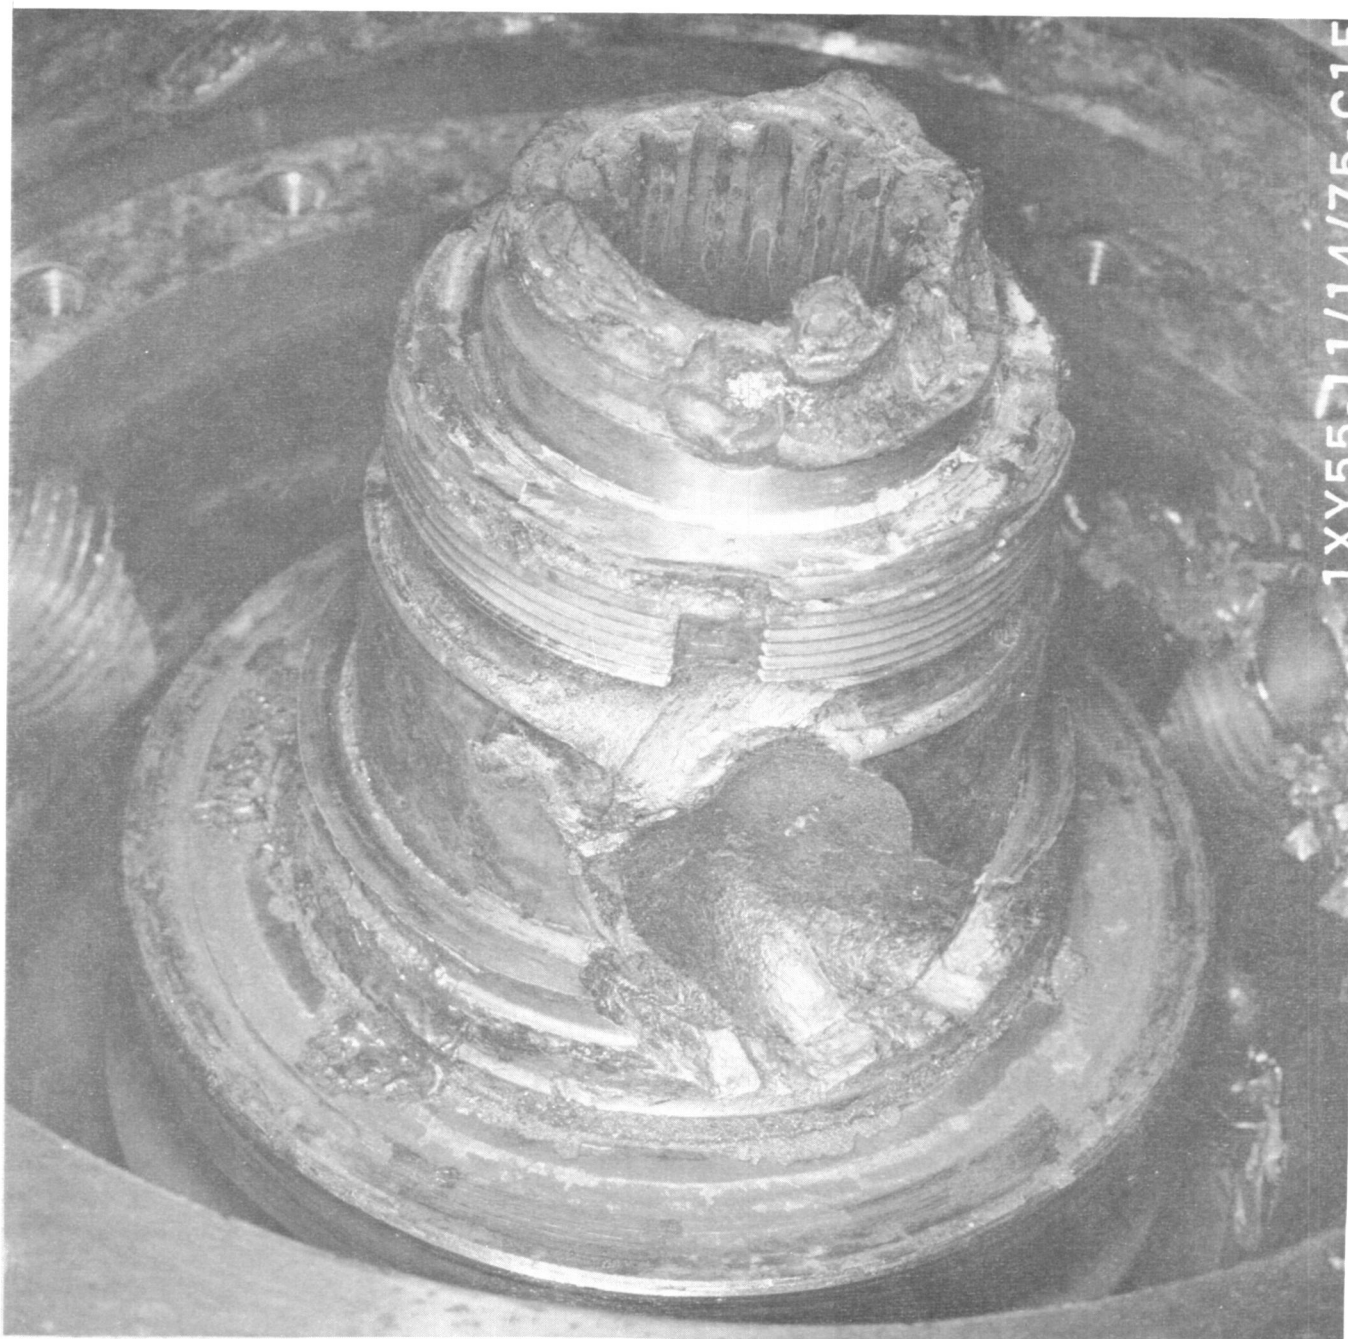
Figure 68. Posttest 222 Showing LOX Seal Mate Ring and Shaft Burning

- d. The Mod III seal was tested for 7 starts and 2724 seconds. An explosion and fire was caused by rubbing at the seal face.
