DOE/NASA 0017/3
NASA CR-165494
DDA EDR 10672

CERAMIC APPLICATIONS IN TURBINE ENGINES

Progress Report for 1 July 1980 to 31 December 1980

Detroit Diesel Allison Division
General Motors Corporation

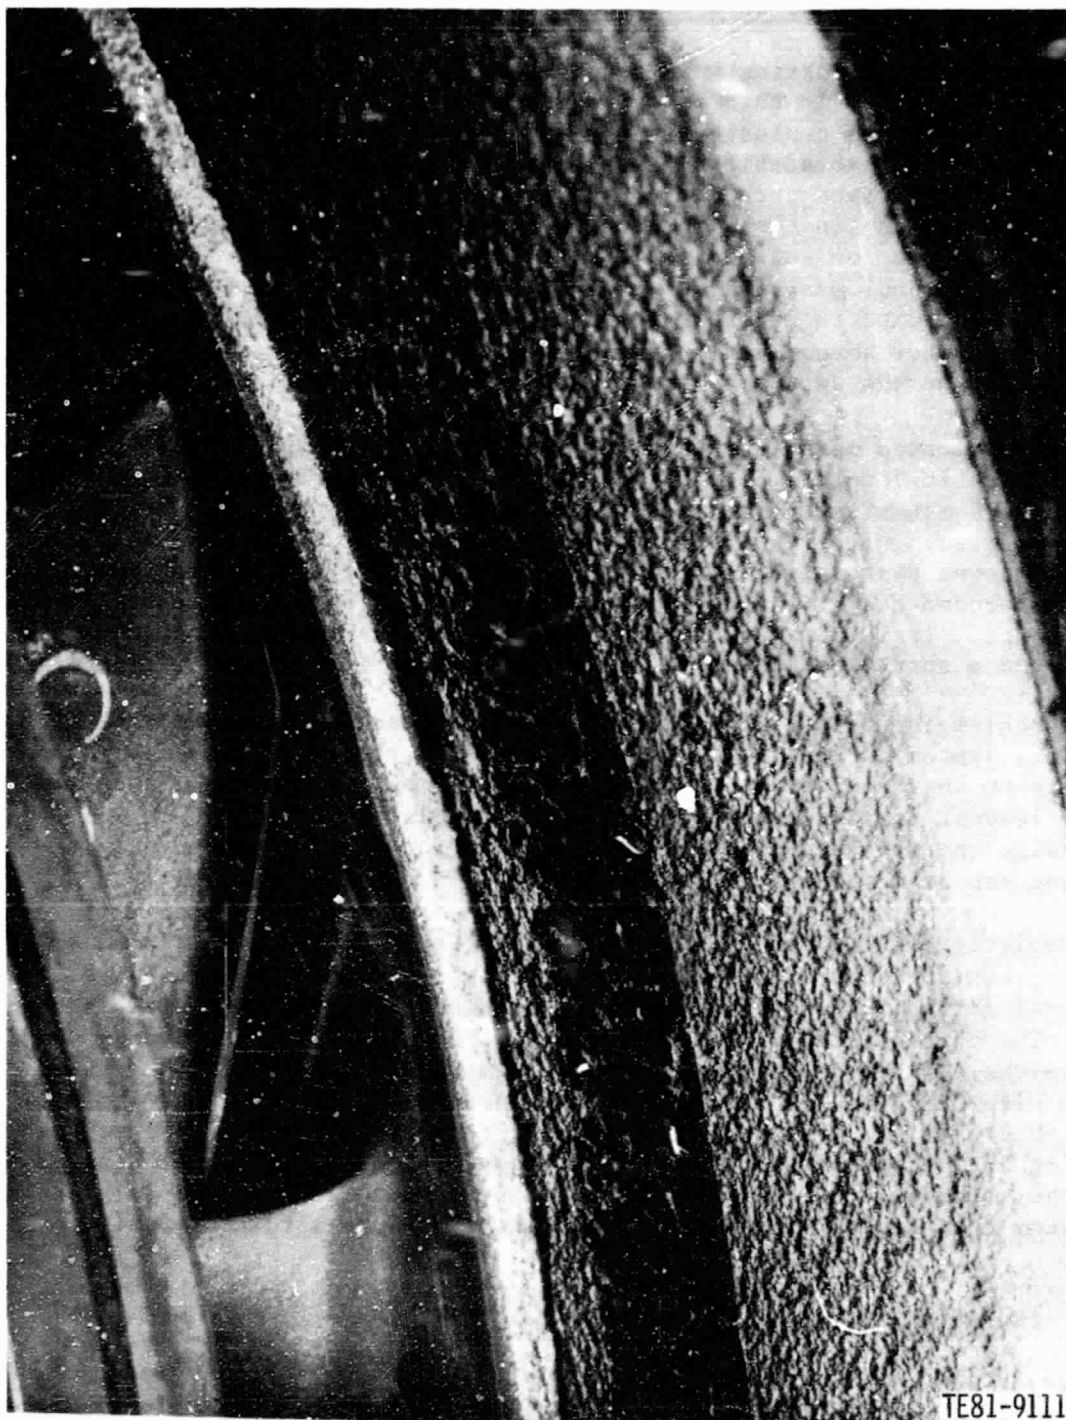
Figure 53. Turbine tip rub on zirconia/eccosphere abrasion-resistant coating. Rotor material is Mar-M246.
