ENERGY EFFICIENT ENGINE

COMPONENT DEVELOPMENT & INTEGRATION

SEMIANNUAL REPORT No. 8

October 1, 1981 - March 31, 1982

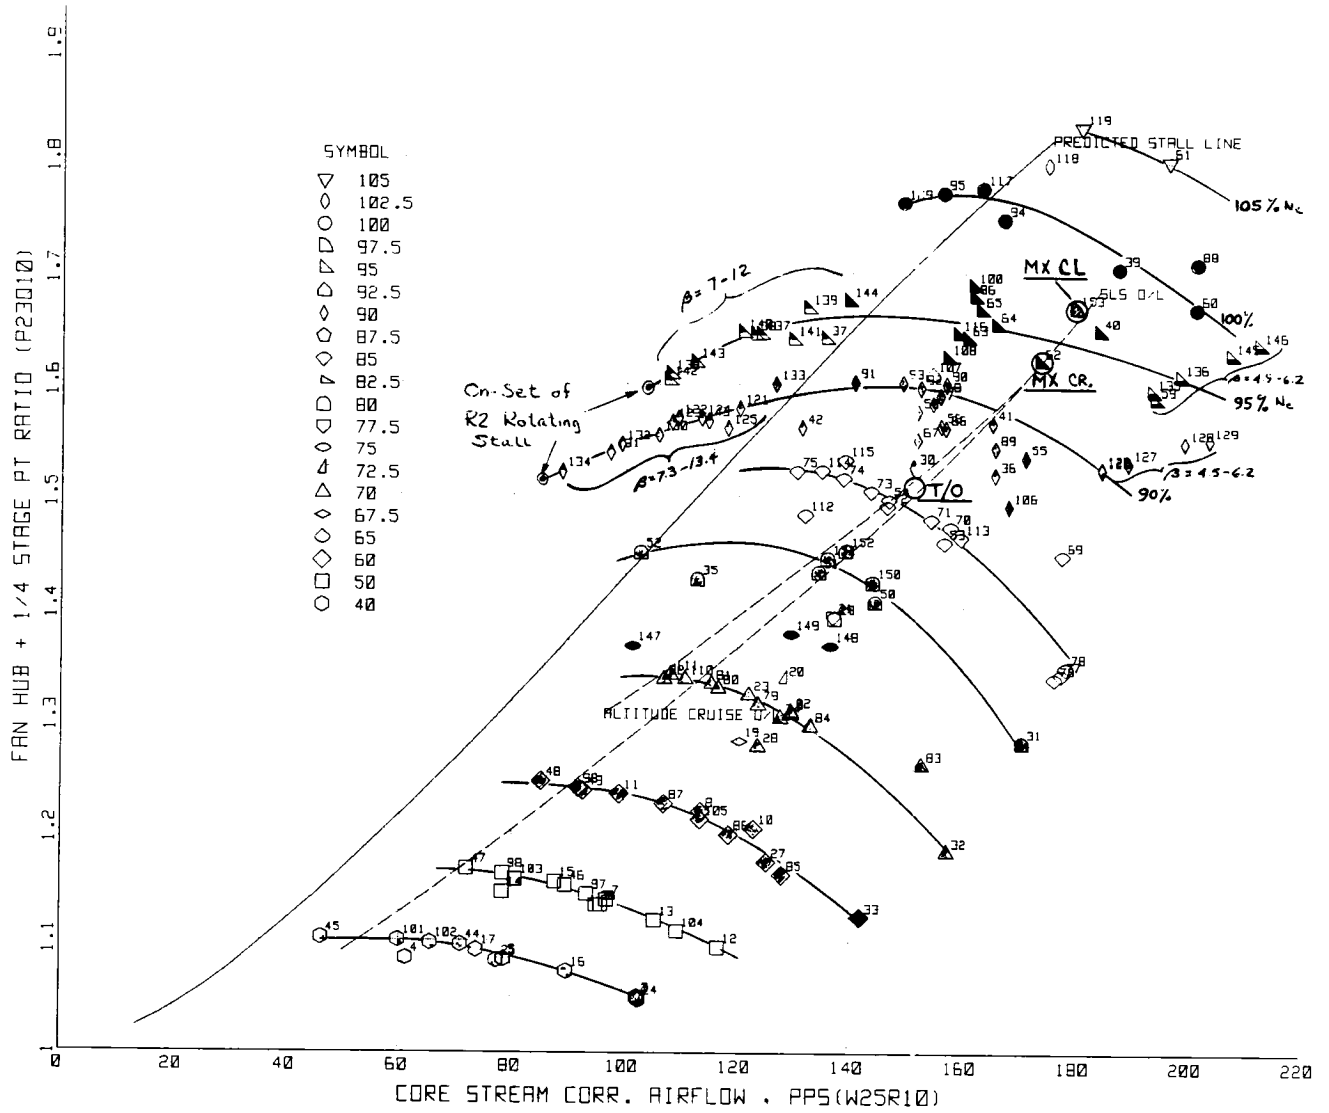
Figure 17. Fan Hub and Quarter-Stage Performance Map.

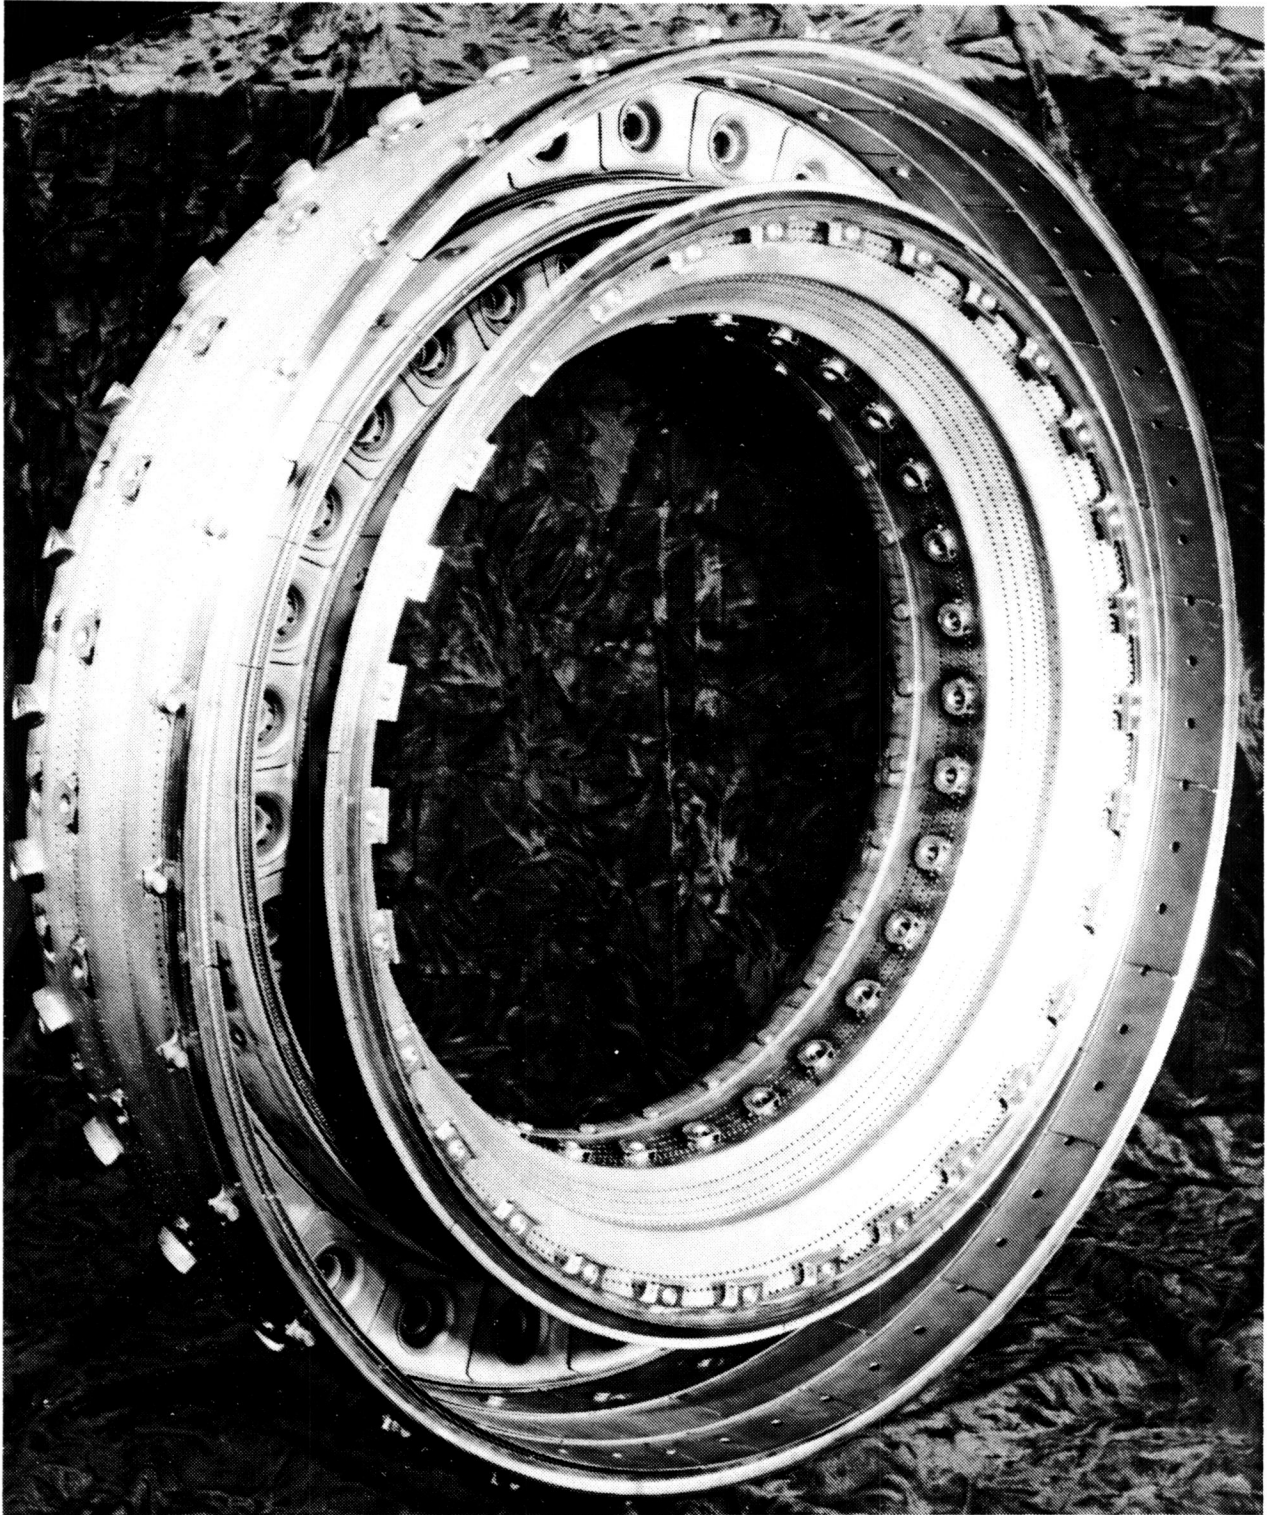
Figure 28. Engine Combustor - Aft View.

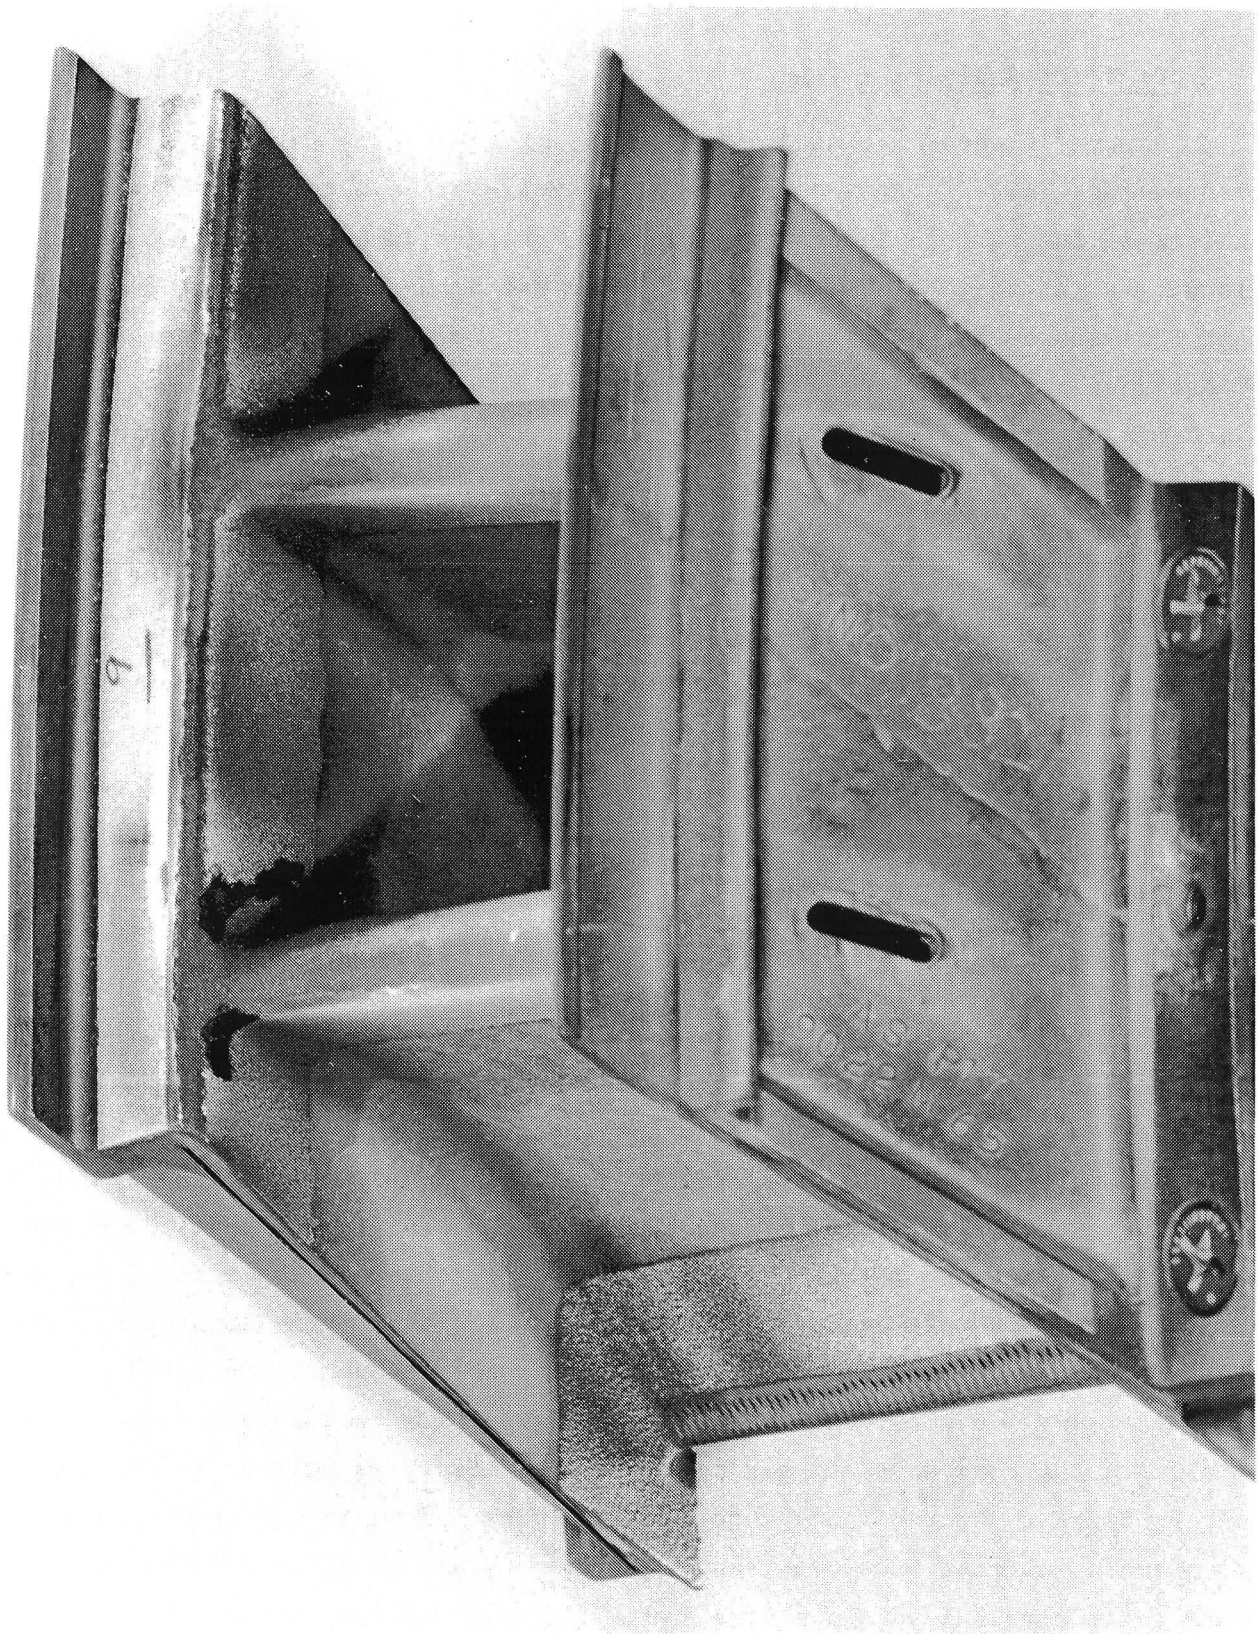
Figure 70. TBC CF6-50 Stage 2 Vane after 1000 Cycles.

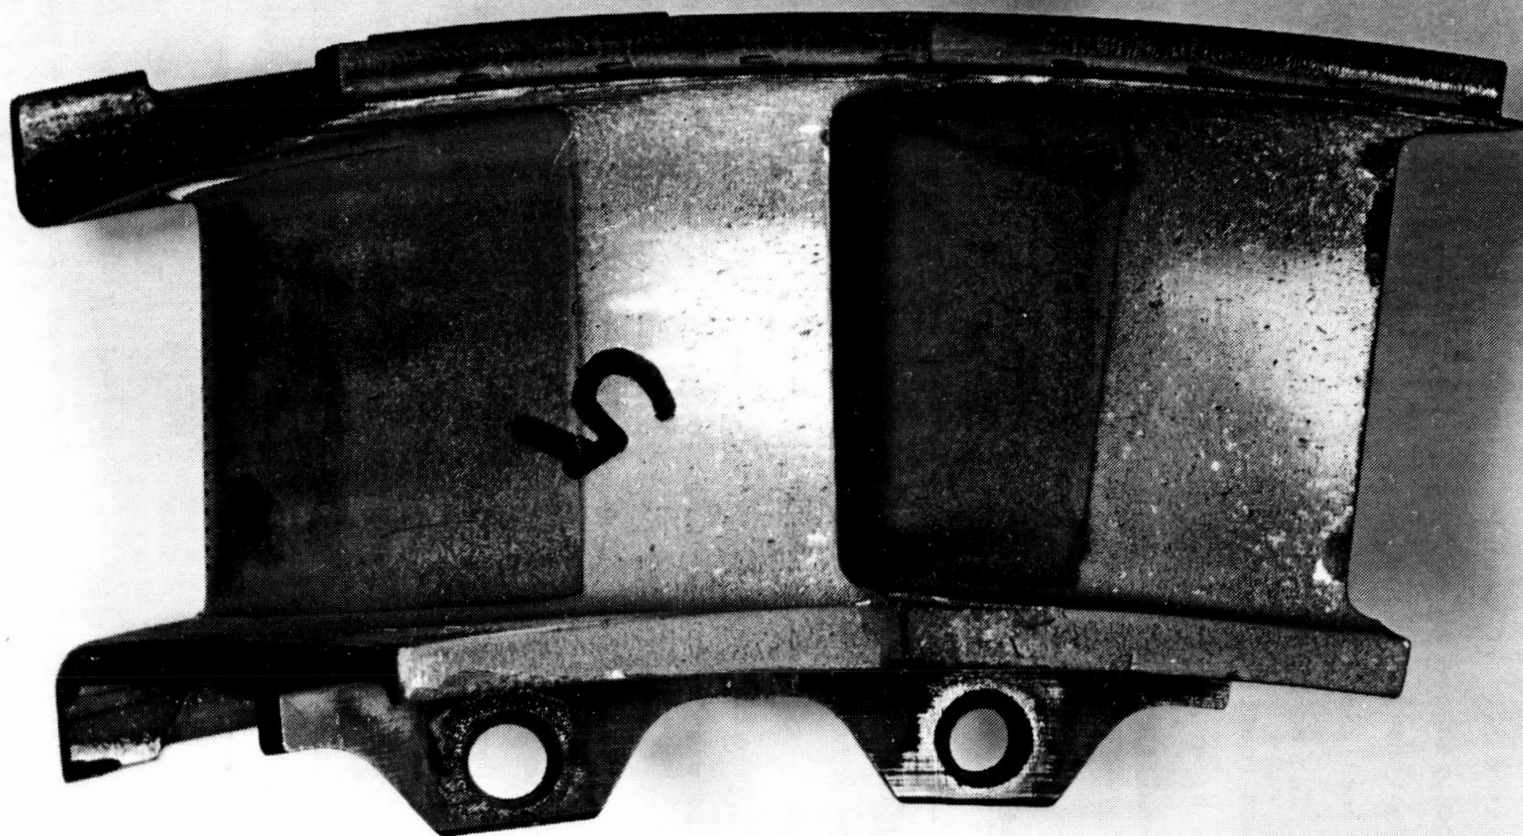
Figure 73. Condition of TBC on Suction Side of Stage 1 Vanes after 1230 Cycles.

Microstructural examination of one of the engine-tested Stage 2 vanes (paired), sectioned at 15, 50, and 95% span and in the outer and inner band regions, showed that the Codep layer had been removed successfully by grit blasting in areas where the bond coat and ceramic top coat were applied by conventional plasma spraying. Figures 71 and 72 are optical photomicrographs of a TBC airfoil at 15 and 95% span cross sections. The TBC was severely damaged at 95% span near the outer band; the ceramic layer had spalled, and local penetration and oxidation had taken place at the leading edge (0.005-in. maximum penetration of René 80 in localized region about 0.040 in. long). The TBC was in better condition at the trailing edge, but thinning of the ceramic layer was observed. The bond coat, wherever remaining on the airfoil surface, had provided adequate oxidation protection to the underlying substrate. The TBC was in much better condition at the 15% span although thinning of the ceramic layer was observed on the suction as well as the pressure side of the airfoil. The bond coat and top coat were not nearly as uniform in thickness on the Stage 2 vanes as they were on the blades. This is due to the difficulty in manually coating a complex shape such as a Stage 2 vane. The four Stage 1 vane pairs remained in the engine for additional testing, accumulating a total of 1230 "C" cycles. The coating generally was in good condition on the suction side of the airfoils, as shown in Figure 73. There were three very small,

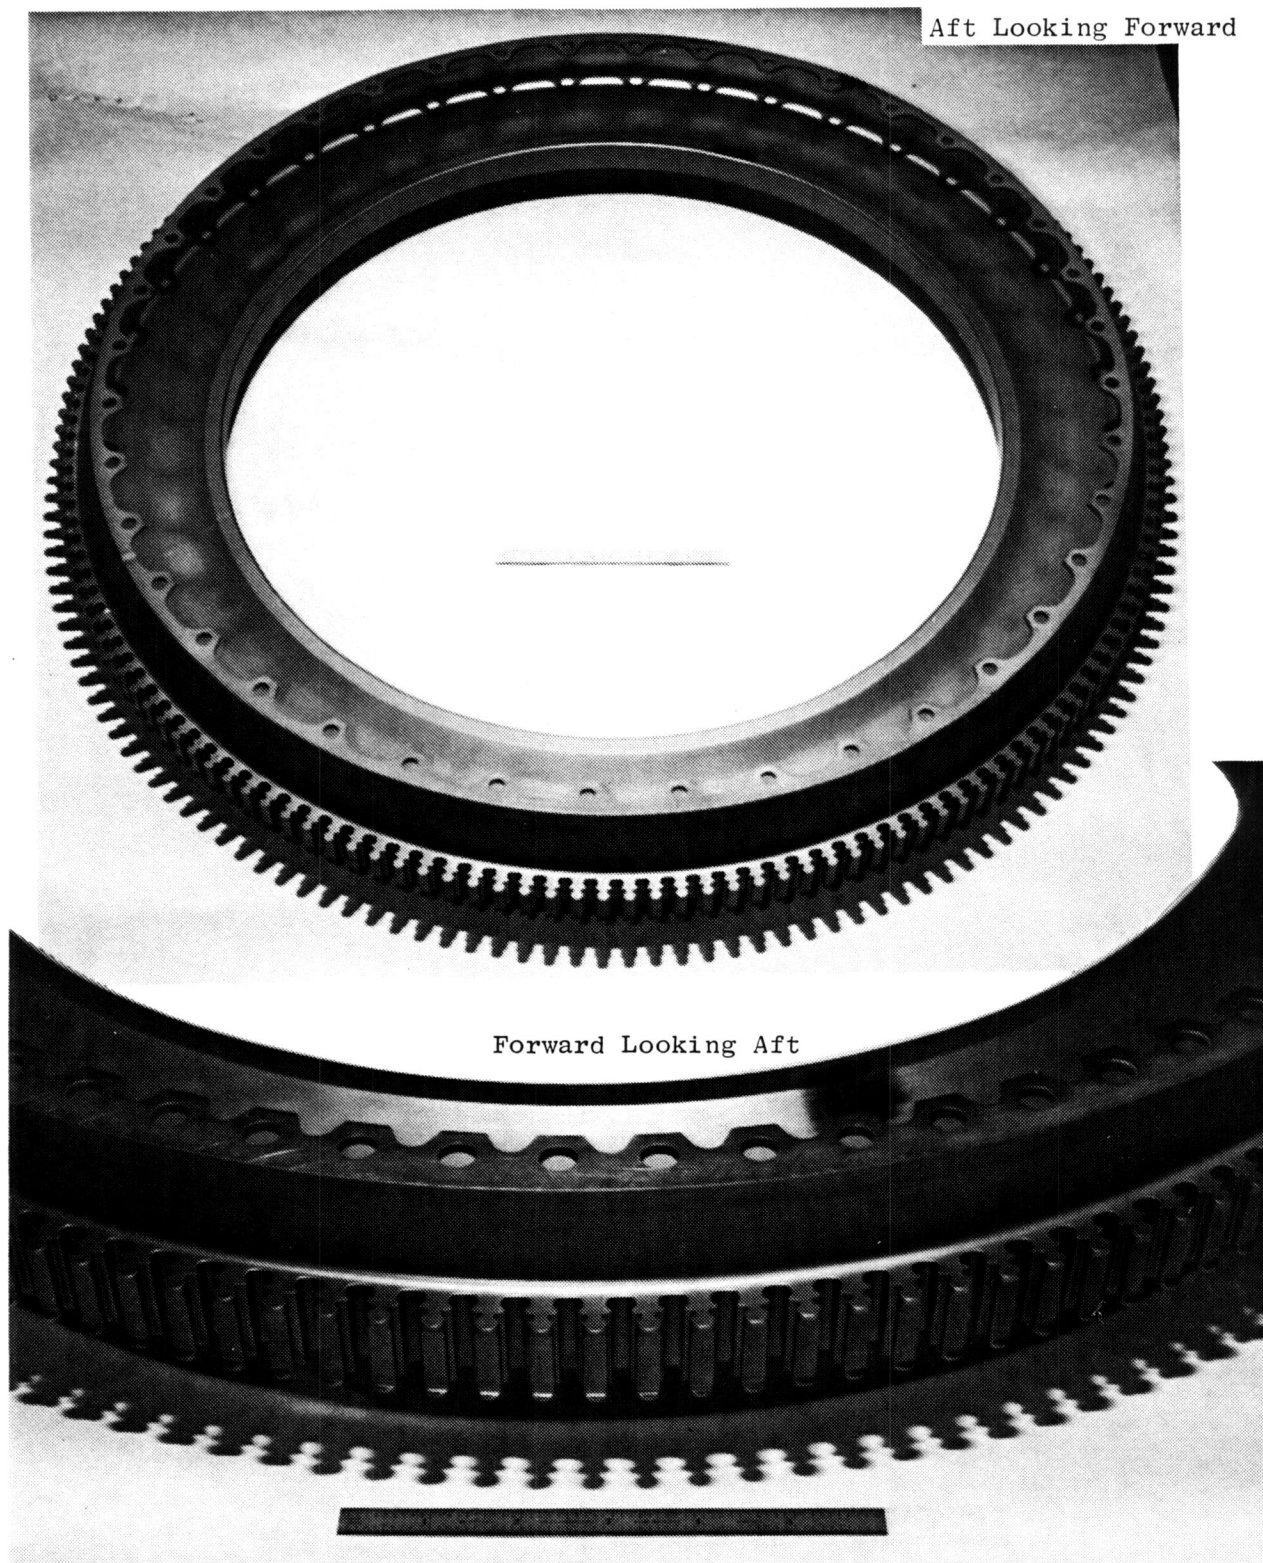
Figure 130. Stage 4 Disk.
