NASA Technical Memorandum 86925  
AIAA-85-0338

# The UH-1H Helicopter Icing Flight Test Program: An Overview

Robert J. Shaw and G. Paul Richter  
*Lewis Research Center*  
*Cleveland, Ohio*

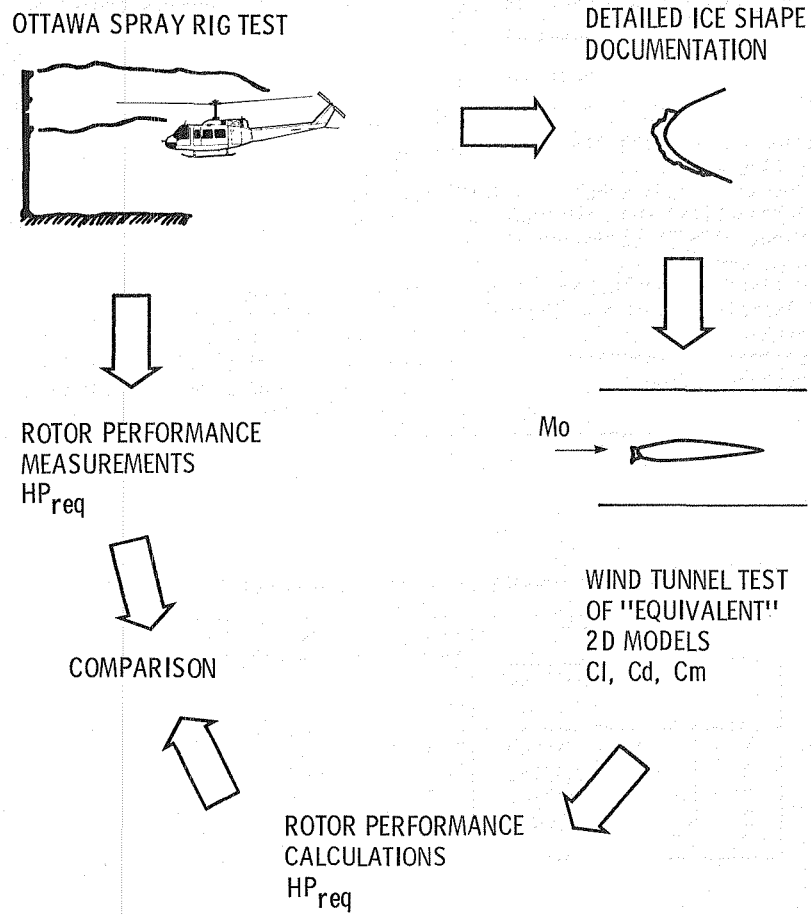
Figure 1. - Major elements of HIFT program (phase one).

The phase one efforts of the HIFT program involved helicopter icing in the hover mode. Specifically, the major elements of the program are shown in Fig. 1 along with an indication of how the elements relate to one another. The following paragraphs will discuss some important details associated with each of the elements.

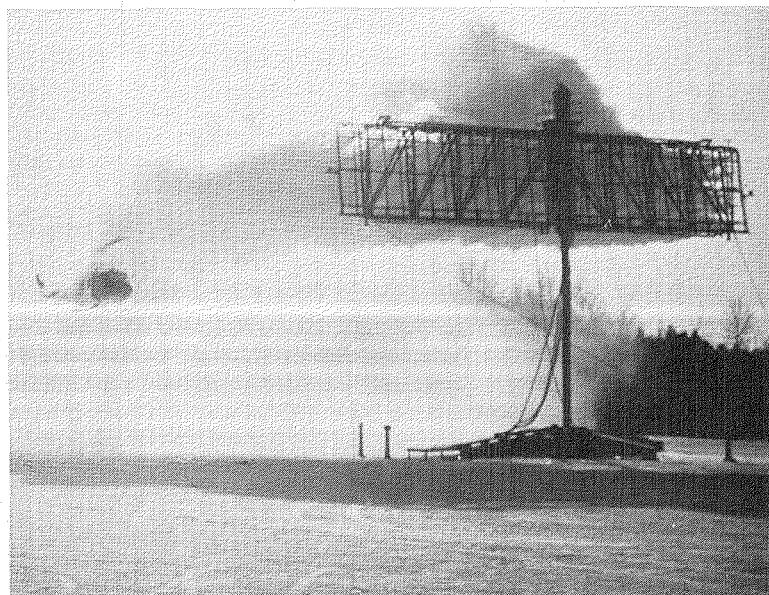
Figure 2. - UH-1H helicopter in Ottawa spray rig.

The hover icing tests were conducted in the Canadian National Research Council's Ottawa Spray Rig located adjacent to the Uplands airport. This outdoor facility, the only hover icing facility currently available for flight tests, is fully discussed in Ref. 4. The spray rig is a framework (Fig. 2) which measures 75 ft wide by 15 ft high and is attached to a 59 ft mast. A total of 156 steam atomizing nozzles are located on this framework, and they are spaced 3 ft apart on 30 vertical bars. The icing cloud is created by using pressurized steam to atomize water into a spray with the desired water droplet sizes. Icing cloud liquid water content (LWC) is primarily governed by water flow rate and wind speed while the droplet size is primarily a function of the steam pressure level. The framework can be rotated in order to align it perpendicular to the prevailing wind. The spray rig requires a wind velocity of at least 6 knots to carry the cloud over the helicopter.

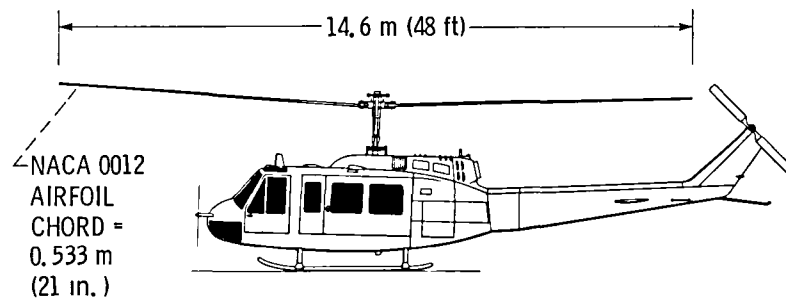
Figure 3. - Schematic of UH-1H helicopter used in the HIFT program.

The helicopter used for the HIFT Program was a Bell Helicopter Textron UH-1H "Huey" provided and operated by the U.S. Army Aviation Engineering Flight Activity (USAAEFA). The UH-1H is a thirteen-place, single engine configuration which has a single, two-bladed teetering main rotor. The maximum gross weight of the UH-1H is 9500 lb. The helicopter is powered by a Lycoming T53 engine, and the main rotor transmission is limited to 1100 shp for continuous operation. Figure 2 shows the UH-1H helicopter in the Ottawa spray rig facility while Fig. 3 shows a schematic of the UH-1H with important details noted. The required instrumentation was provided by the Army and installed by Army personnel (USAAEFA) with the exception of the main rotor blade load instrumentation which was installed by Bell Helicopter Textron personnel. A complete listing of the helicopter instrumentation is contained in Ref. 5.

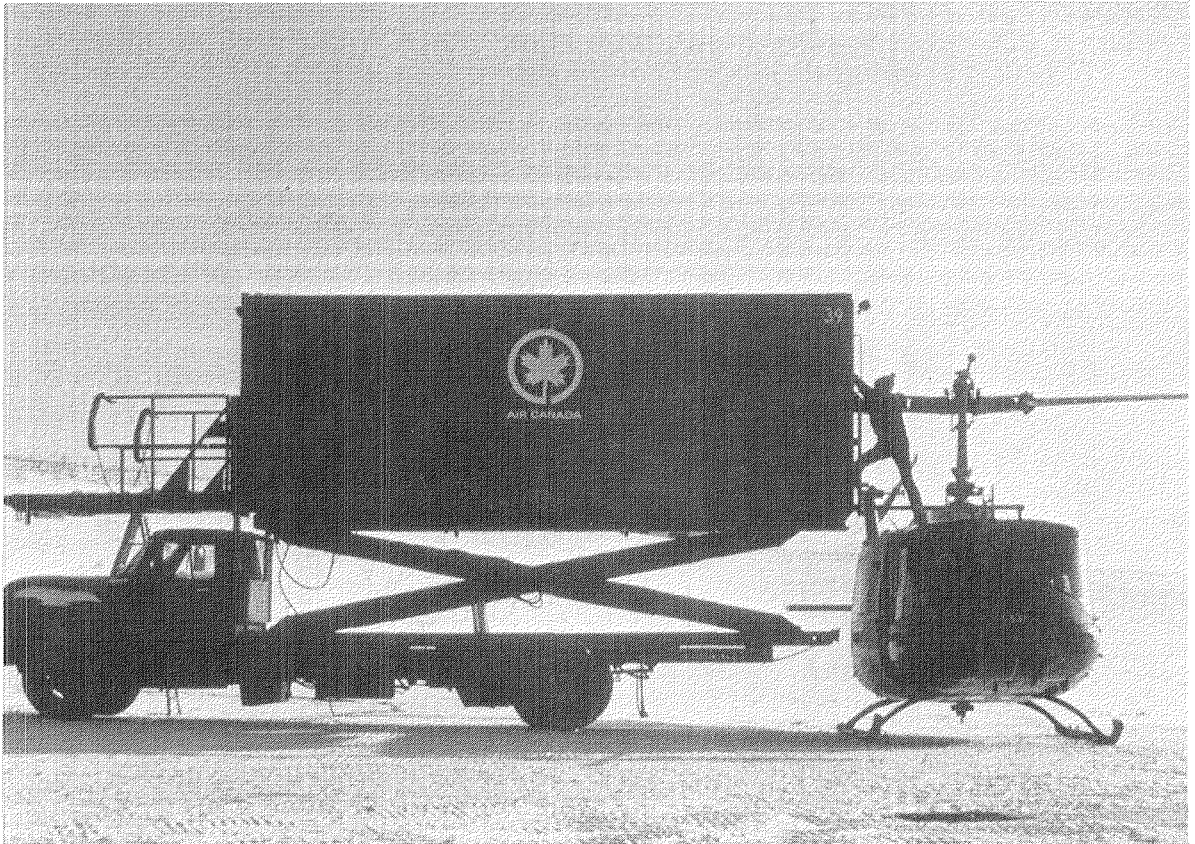
Figure 4. - Helicopter with the rotor ice accretion documentation station.

The ice accretion documentation phase was conducted in a special climate controlled work station shown in Fig. 4. The work station, a modified airline galley truck with inside dimensions of 20 by 7 by 4 ft, was backed up to the helicopter so that one of the main rotor blades could be positioned within the truck. The truck interior was then sealed from the outside by using the truck door and a tarp and the interior temperature brought up to about  $-5^{\circ}\text{C}$  using space heaters. The documentation station was kept at subfreezing temperatures to ensure that no ice melted during the time the liquid molding material required to harden.

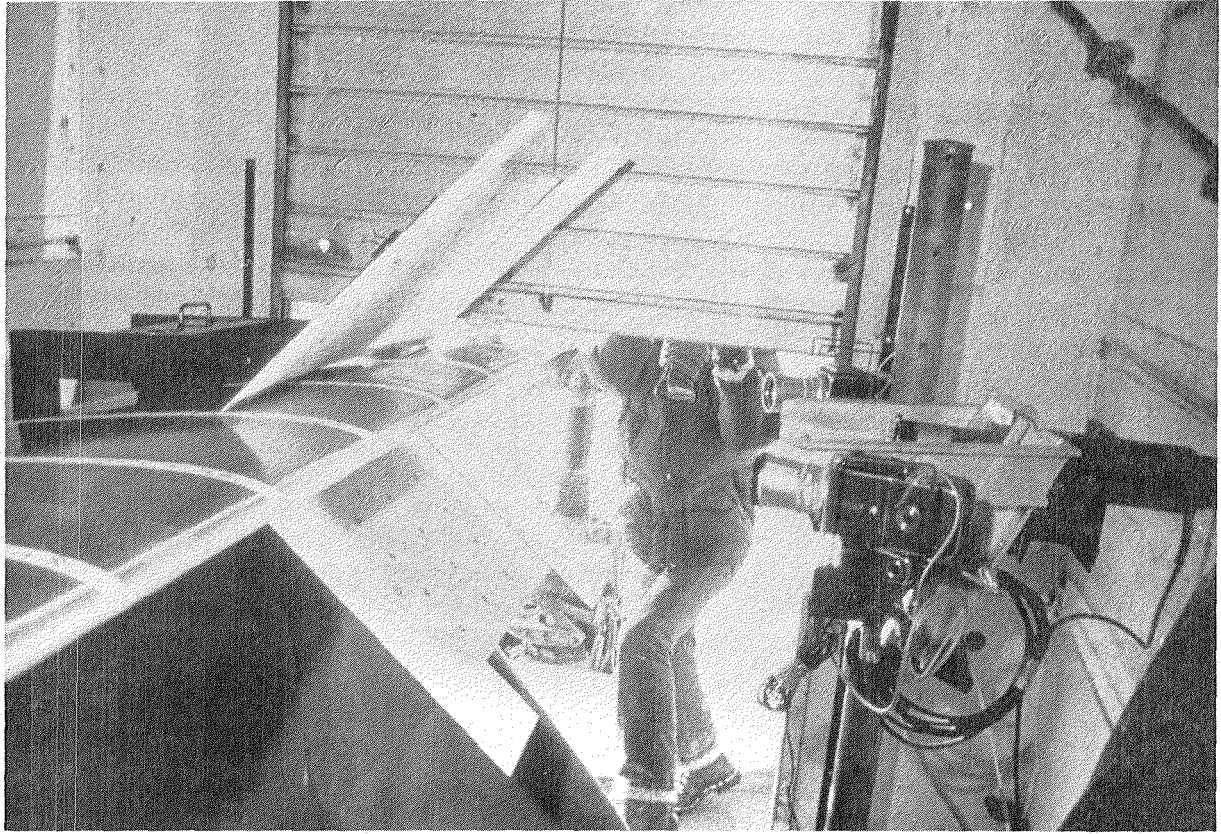
Figure 5. - Stereo photography set up.

The stereophotographic technique was developed by Arvin/Calspan Field Services, Inc. for the Arnold Engineering Development Center (AEDC) of the Air Force Systems Command. Wide angle stereo pairs of photographs of the rotor leading edge ice accretions were taken using two 70 mm Hasselblad cameras equipped with 50 mm lenses. The stereo pair photographs were taken over the span of the iced rotor blade and were centered on 1 ft-wide segments every 2 ft starting 5 ft from the hub. Figure 5 shows the overall stereophotography setup employed. Three sets of photographs were taken at each location with the two cameras located approximately, (1) 1 ft above the rotor chord plane, (2) on the chord plane, and (3) approximately 1 ft below the rotor chord plane. Post flight analysis of the stereo pair photographs in order to determine local two-dimensional ice accretion shapes was performed at AEDC using an available stereo-compiler. Reference 6 gives a more detailed discussion of the stereo photography set up and data reduction procedures employed.

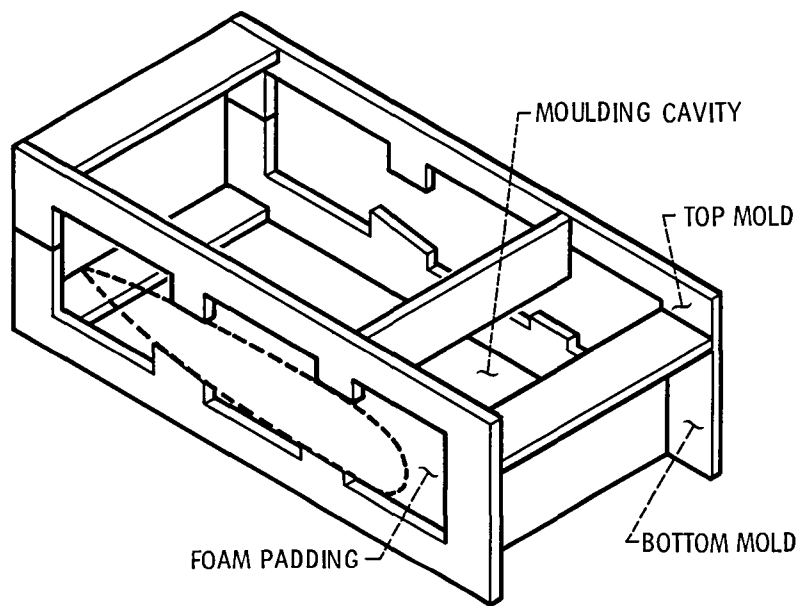
Figure 6. - Mold box details.

The silicone molding technique involved placing 1 ft wide plywood mold boxes around the iced UH-1H rotor every 2 ft along the span. The mold boxes were designed and fabricated to ensure a tight fit around the airfoil contour and to allow for molding of an ice accretion as much as 2 in ahead of the airfoil and 6 in aft of the leading edge. Figure 6 shows the details of the mold box construction. The material used to form the molds was a mixture of Dow Corning silicone rubber (RTV 3110) mixed with thinner and catalyst compounds. The choice of this mixture was based upon the results of studies conducted at NASA Lewis and information from previous research efforts available in the literature. Prior to use, the molding mixture was degassed to remove unwanted air bubbles using a vacuum pump arrangement. The degassing process took about 15 min to complete.

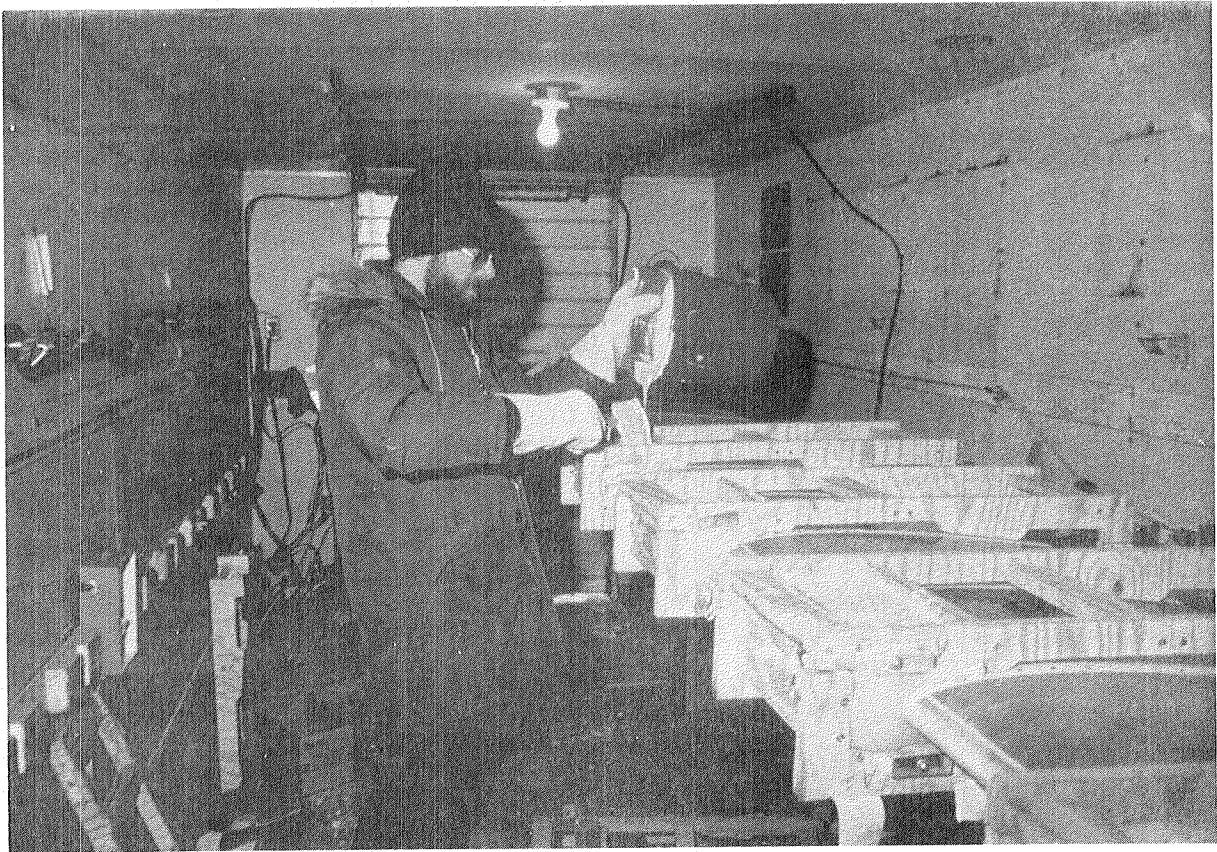
Figure 7. - UH-1H rotor blade with mold boxes attached.

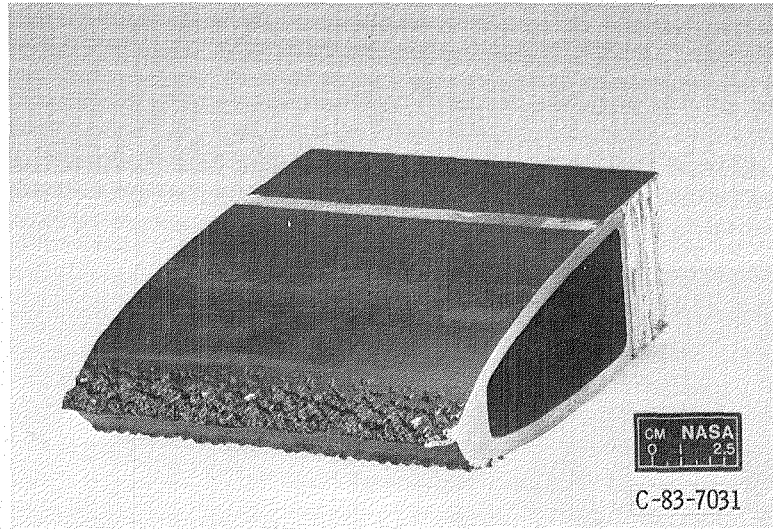
Figure 8. - Epoxy casting affixed to UH-1H rotor section.

The wind tunnel test models were fabricated using the appropriate flight E silicone molds and full scale sections of UH-1H rotor blades supplied by the U.S. Army. Replicas of the leading edge ice accretions were cast to the rotor section models using epoxy as the casting material. To cover the span of the wind tunnel test model, the mold was used to make repetitive castings starting at the midspan. The models were instrumented with surface static pressures over the first 35 percent chord to determine boundary layer growth characteristics. Figure 16 shows one of the models installed in the Fluidyne Transonic Wind Tunnel.

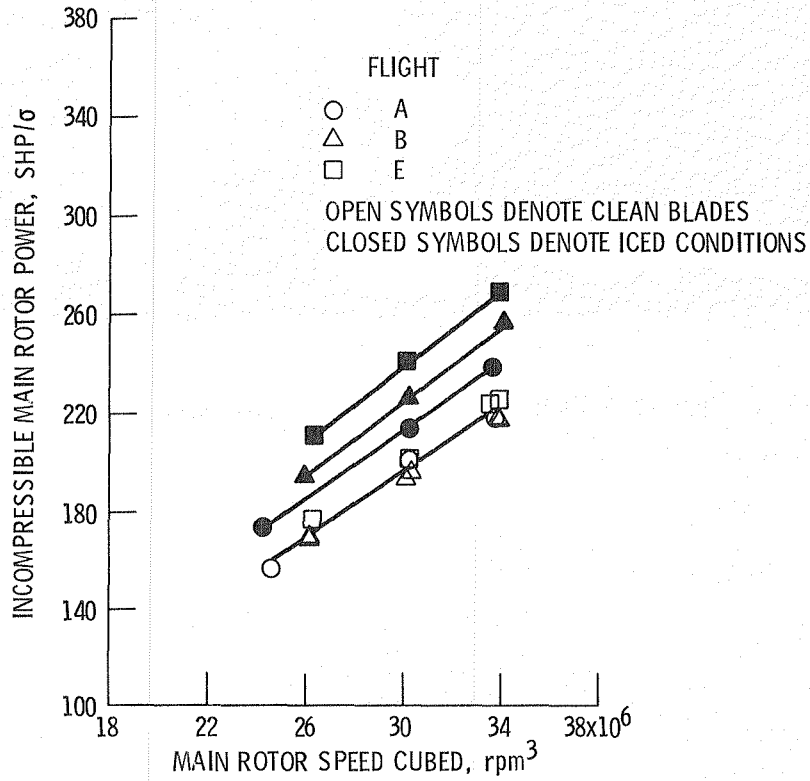
Figure 9. - Incompressible profile power curves (Ref. 5).

Profile power is an indication of the power required to pull the rotor through the air and varies linearly with the cube of the angular velocity. Figure 9 shows the profile power curves for the baseline (clean rotor) measurements and the corresponding curves for the iced rotor for flights A, B, and E. The data shown in Fig. 9 were corrected for compressibility using a standard Prandtl-Glauert correction. Average rotor profile drag coefficients  $(C_{d_0})_{avg}$  were calculated. The results summarized in Table 3 indicate flight E had the highest  $(C_{d_0})_{avg}$  value (0.0110) for the three flights. Table 3 also indicates the average increases in profile rotor horsepower ranged from 60 for flight E to 25 for flight A.

It is hard to definitely explain this apparent anomaly. However, the flight log for flight A indicates that some ice over the rotor span was shed during landing. Thus, the rotor span coverage noted on Table 4 corresponds to the extent of ice remaining after the second flat pitch runup was completed, and thus a direct comparison of performance losses for flat pitch runup and for hover for the three flights is not justified. Previous analytical studies of rotor aerodynamic performance degradation due to icing<sup>11</sup> have shown that the rotor is most sensitive to ice accretions over the outermost portion of the span, and the loss of outer span ice for flight A may explain why the horsepower increase for flat pitch runup was so low. The instrumentation appeared to be working properly for this flight as indicated by the agreement in clean rotor profile power levels measured for the three flights (Fig. 9).

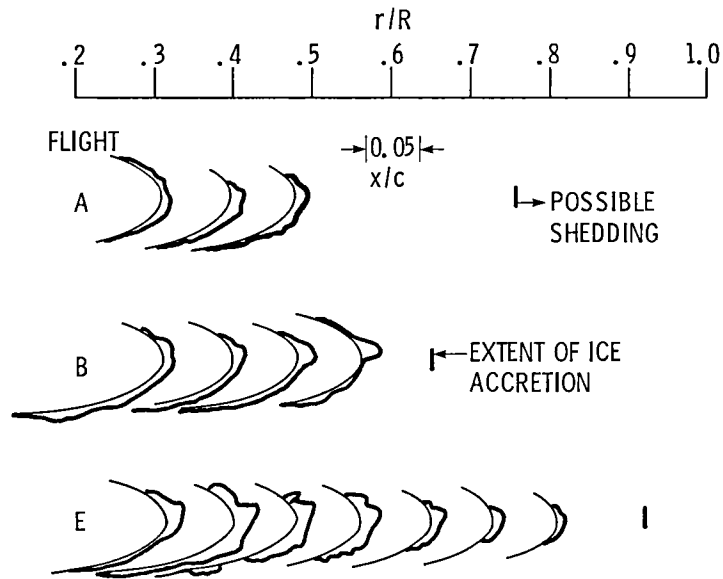
Figure 10. - Rotor ice accretion tracings for flights A, B, and E.

The available rotor ice accretion tracings for the three flights are shown in Fig. 10 for various radial locations. As the figure indicates, only three tracings were taken for flight A, those being at  $r/R = 0.31, 0.40, \text{ and } 0.49$ . However, it has already been indicated that ice coverage was noted out to  $r/R = 0.75$  but unfortunately no ice shape details were preserved for this critical outer span region. The three tracings for flight A show relatively rounded ice accretions which look something like rime ice shapes which characteristically result in smaller airfoil performance losses than do glaze ice accretions.

The tracings available from flight E show less streamlined characteristics over the inner span ( $r/R = 0.56$ ) with a transition to smaller, more rounded shapes over the outer span region. In particular, the ice tracing at  $r/R = 0.81$  is very small and rounded.

On comparison of these three sets of ice shape tracings, one might conclude that while the inner span ice accretion shapes for flight E appeared to be worse than those for flight A, the outer span ice accretion characteristics for flight A (which were not documented) might have been more disruptive to the local flow over the rotor than were those for flight E. Clearly, more outer span documentation for the two flights should have been acquired.

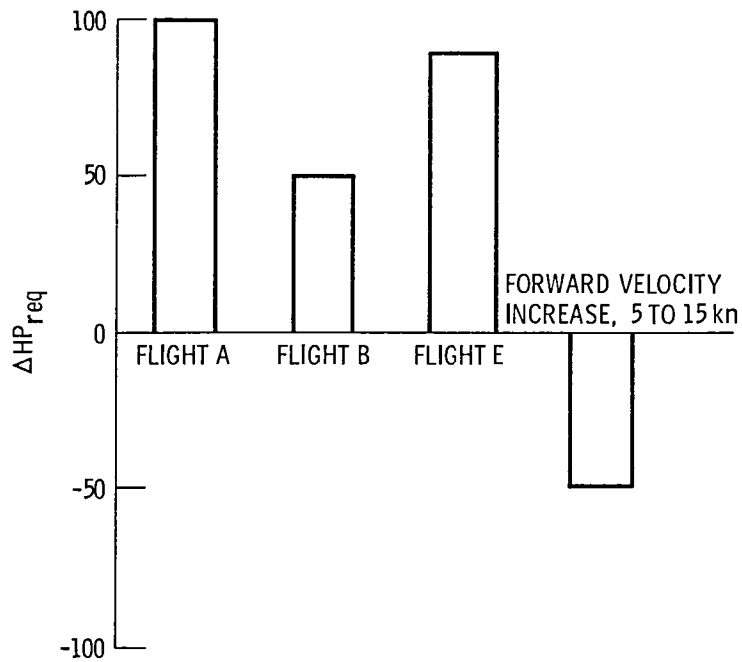
Figure 11. - Comparison of increased horsepower required due to icing with reduced horsepower required due to forward velocity increase.

Also, it should be noted that the Ottawa spray rig requires a minimum wind speed of about 6 knots to carry the icing cloud out to the rotor. Thus, the helicopter is not operating in a true hover mode either when the ice is being accreted or when the performance measurements are being made. The original test plan for the flight testing had specified that a precision low airspeed sensing system be installed in the UH-1H and be used as an airspeed indicator. However, such a system was not available and as a result, a cup anemometer located on top of the spray rig had to be used. This anemometer system would be expected to be somewhat less accurate than the low airspeed sensing system. The low forward flight velocity regime is characteristically a very sensitive one for a helicopter as the aircraft is very sensitive to gusts which can cause significant changes in power required. At such low velocities, the induced power is sensitive to wake position which can significantly vary with small changes in forward velocity. In order to assess this sensitivity, analysis was carried out at Bell Helicopter Textron using a forward flight rotor performance prediction code to determine change in power required for the UH-1H as a function of forward velocity (information received in private communication from L.F. Berkowitz of Bell Helicopter Textron). The results are shown in Fig. 11 where the horsepower required increases for flights A, B, and E are compared to the decrease in horsepower required when the forward velocity was increased from 5 to 15 knots. As the figure clearly indicates, the magnitudes of the changes in horsepower required are the same for the icing flights as that due to a change in forward velocity. This figure indicates the forward velocity must be known very accurately when measuring performance losses due to icing at very low forward flight speeds.

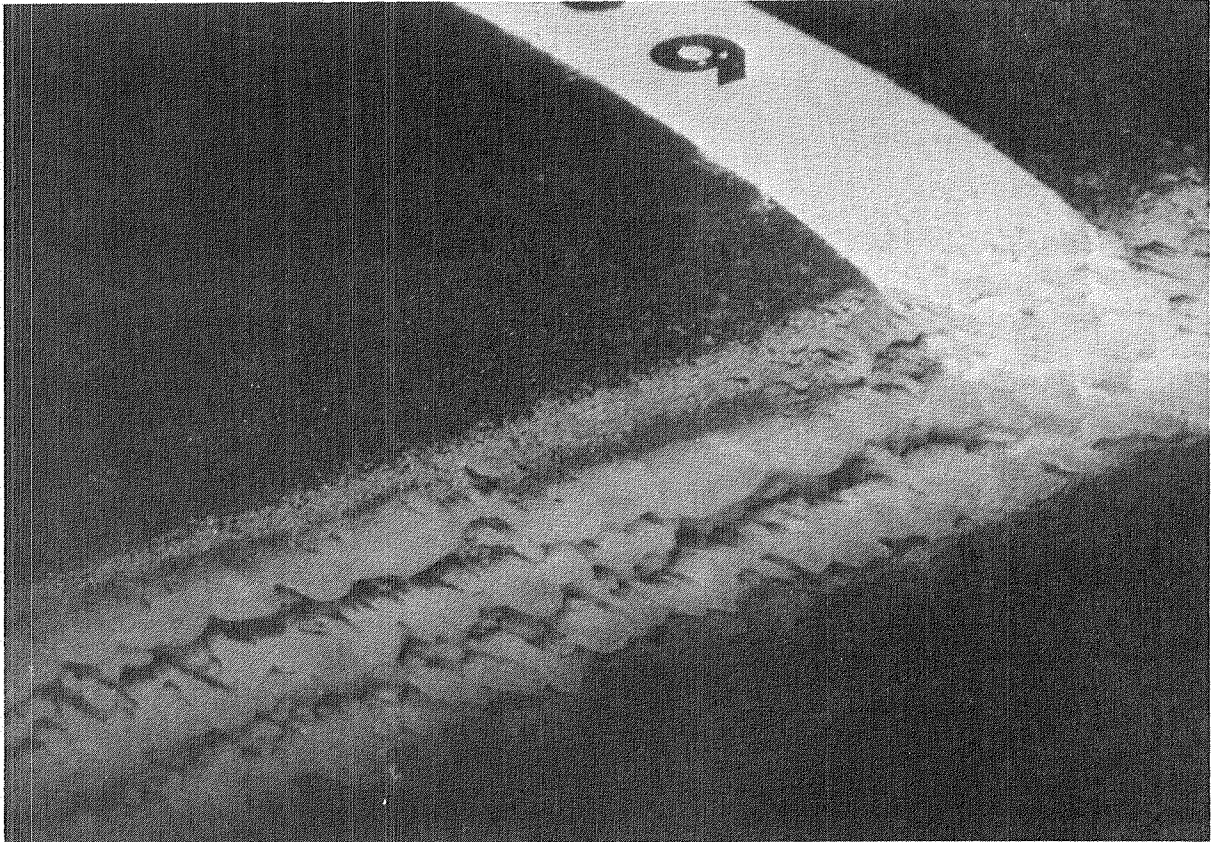
Figure 12. - Photo of typical ice formation on rotor blade showing three dimensional details (the white stripe is 1 in. wide). (ref. 7)

On site inspection of the rotor ice accretions indicated that a considerable amount of local three dimensional detail existed<sup>14</sup> as revealed in Fig. 12. The tracing technique and to a certain extent the stereo photography technique capture the two dimensional nature of the ice accretion at the

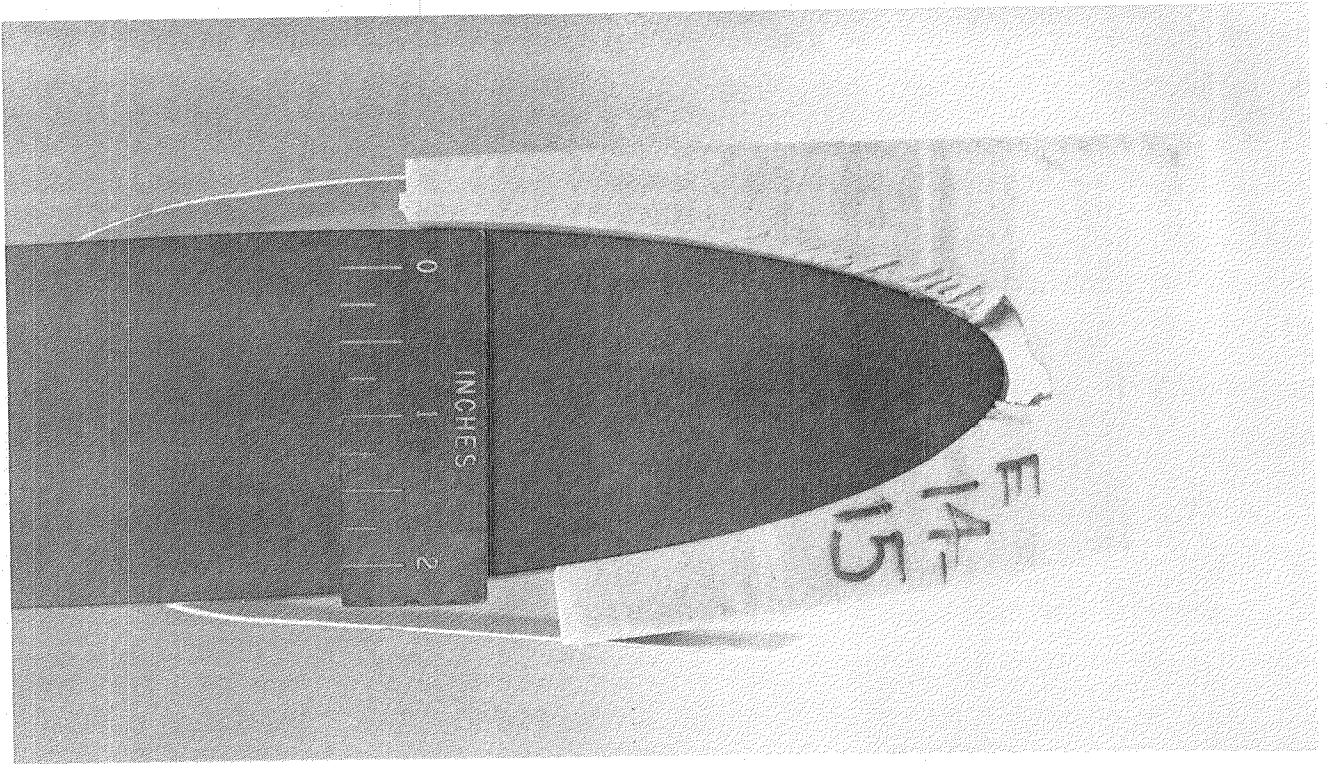
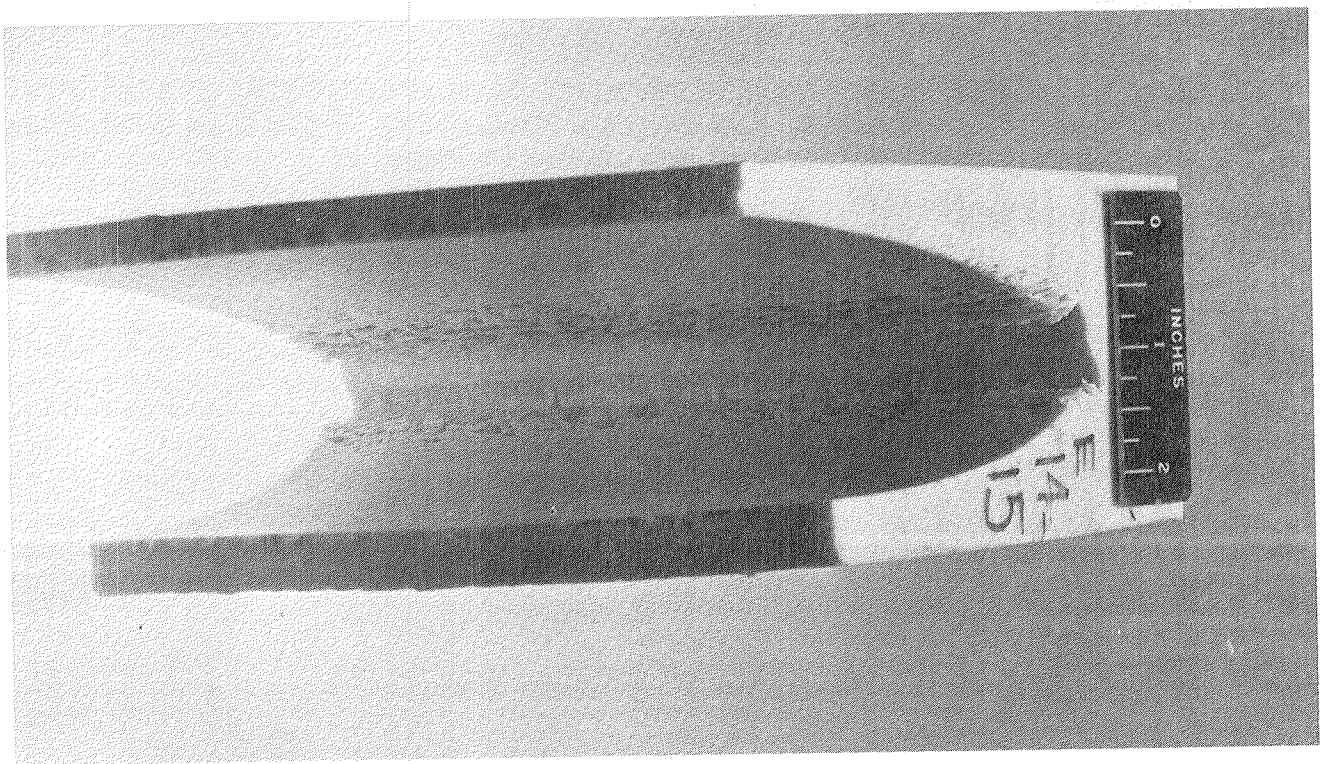
Figure 13. - Typical molds obtained of ice formations. (ref. 7)

The silicone molding technique appears to make almost exact reproductions of the ice accretion characteristics, including the most minute three dimensional details. Figure 13 shows two views of a mold obtained during the program. While the photographs do give some appreciation for the detail preserved, a personal inspection is required to truly appreciate the details. However, it should be pointed out that the silicone mold does require a significant amount of time to harden (approximately 2 to 3 hr), and thus the amount of data which can be acquired is limited.

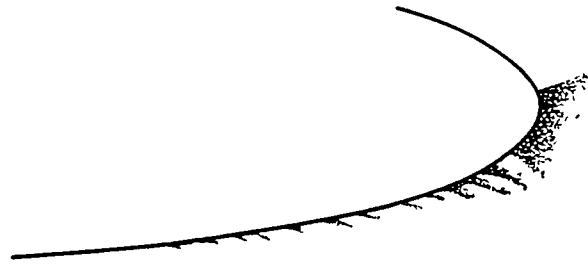
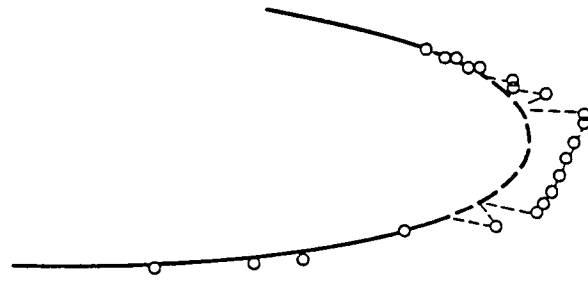
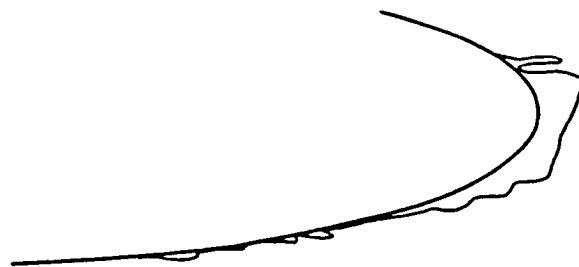
(a) Edge projection of mold.

(b) Stereoscopic photograph.

(c) Tracing.

Figure 14. - Comparison of ice shape documentation techniques. (Flight E,  $r/R \approx 0.46$ .)

Figure 14 compares the ice shape details available from the three methods. The profiles are shown for  $r/R \approx 0.46$  for flight E. To reduce the silicone mold to a two dimensional cross section, a photograph was taken of the edge of the appropriate mold. A comparison of the three tracings indicates that some differences in ice shape characteristics did exist between the three methods; however, these variations are judged to be no greater than those that would be obtained by using any one method and taking several closely spaced "slices." That is, the ice accretion exhibited some locally three dimensional details as already discussed (Fig. 12).

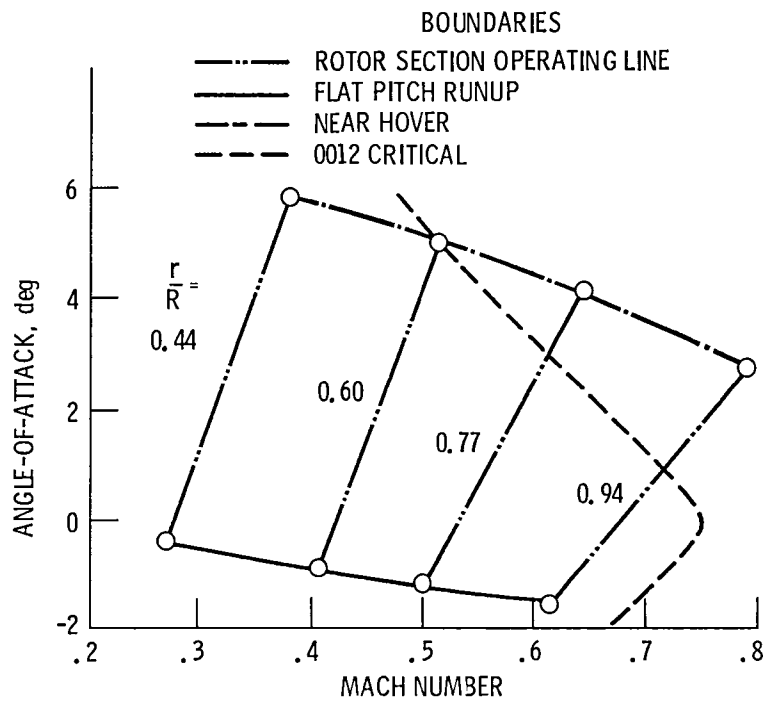
Figure 15. - Rotor section operating boundaries (Ref. 15).

Based upon rotor performance analyses conducted by Bell Helicopter Textron personnel (information received in private communication from L.F. Berkowitz of Bell Helicopter Textron) and available rotor ice accretion documentation, four stations were chosen for wind tunnel testing. The four stations chosen were at nondimensional radial locations ( $r/R$ ) of 0.44, 0.60, 0.77, and 0.94. Since ice accretion occurred to  $r/R$  of about 0.92 for flight E, only three "iced" airfoil models were tested in addition to a clean airfoil model which served as a baseline reference. The conditions chosen from wind tunnel testing were determined from the rotor analysis performed by Bell Helicopter Textron. Since the rotor ice accretion and performance data were acquired in a near hover mode (i.e., a finite forward wind speed existed), a forward flight analysis code had to be used and thus the local Mach number and angle-of-attack conditions for each radial station did vary with azimuthal position of the rotor blade. Figure 15 shows the two boundary curves for rotor section operation conditions, the lower curve corresponding to flat pitch runup conditions and the upper curve corresponding to the near hover

performance conditions. The figure also shows the critical flow boundary for the NACA 0012 airfoil, and it can be seen that supercritical conditions would be expected for the  $r/R = 0.77$  and  $0.94$  stations. Wind tunnel test points for each model were chosen to be within the two boundaries and along the appropriate operating line shown in the figure so as to adequately document any Mach number or angle-of-attack effects on section drag levels.

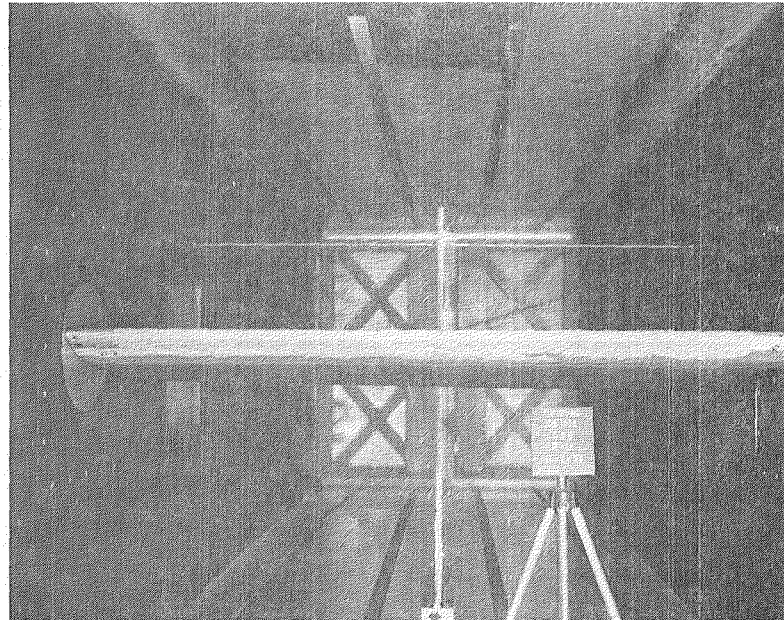
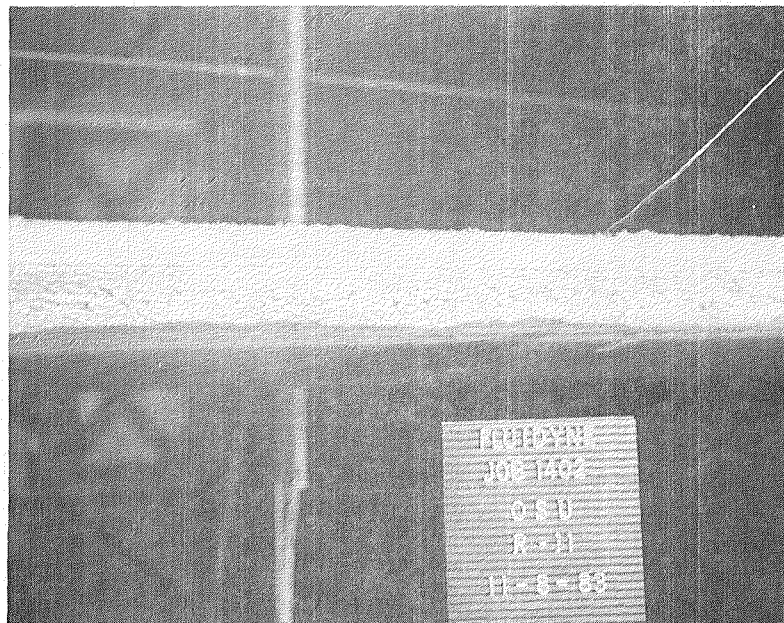
Figure 16. - UH-1H rotor section model with artificial ice accretion installed in Fluidyne wind tunnel.

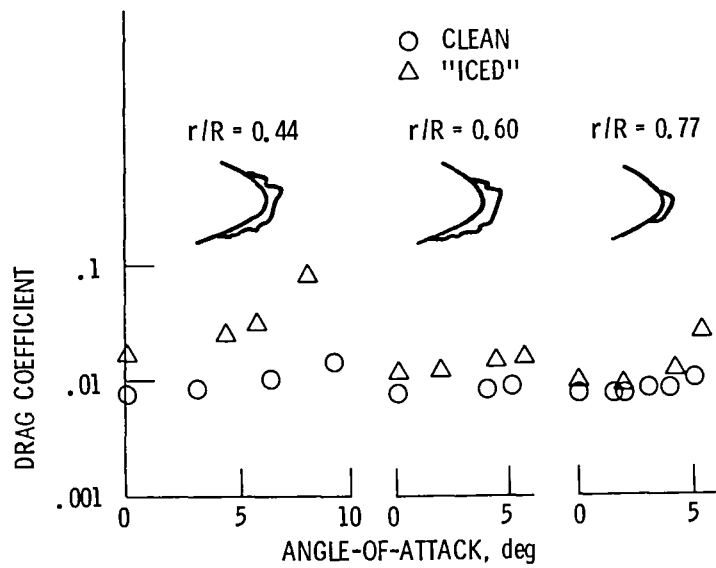
Figure 17. - Dry wind tunnel result for "iced" airfoil performance.

The section drag coefficient levels measured for the three test models corresponding to  $r/R = 0.44$ ,  $0.60$ , and  $0.77$  are shown in Fig. 17 as a function of angle-of-attack which has been corrected for tunnel downwash interference. The clean airfoil reference drag levels are also shown. It should be noted that the Mach number was varied as a function of angle-of-attack for those models corresponding to the  $r/R = 0.60$  and  $0.77$  iced airfoils so as to choose test points which were close to the respective operating lines shown in Fig. 15. The experimental Mach number variation was  $0.42$  to  $0.54$  for the  $r/R = 0.60$  accretion model and  $0.53$  to  $0.69$  for the  $r/R = 0.77$  accretion model. For the most inboard model ( $r/R = 0.44$ ), the Mach number was taken to be constant ( $0.36$ ). Also for reference, the figures show reference ice shape tracings which are the same as some of those shown in Fig. 10.

As the figure indicates, the largest drag levels were measured for the inboard ice accretion ( $r/R = 0.44$ ) with a maximum drag coefficient of  $0.080$  being recorded for a corrected angle-of-attack of  $8.12^\circ$ . The rapidly increasing drag coefficient level with increasing angle-of-attack suggests a large scale, upper surface flow separation had occurred. Figure 18 shows leading edge surface pressure coefficient variations both for the iced airfoil and the reference clean airfoil for an angle-of-attack of  $5.9^\circ$ . These profiles shown in differential form indicate a difference in the surface pressure characteristics for the iced airfoil occurred from  $x/c = 0.05$  to  $0.35$ . This reduction in level of pressure coefficient differential is indicative of a reduction in lift for the airfoil, and the nature of the iced airfoil curve (a plateau existing from  $x/c = 0.2$  to  $0.3$ ) suggests the presence of a separation-reattachment zone. The presence of a localized separation-reattachment zone has been observed for other iced airfoils in other experimental programs. While the pressure differential plot of Fig. 18 suggests only a small change in lift occurred at a  $5.9^\circ$  angle-of-attack, the rapid increase in drag at the higher angles shown in Fig. 17 for the  $r/R = 0.44$  ice accretion suggest the separation-reattachment zone grew to a much greater size. For these higher angle-of-attack conditions, the effect of the

The drag coefficient curves for the other two ice accretion shapes ( $r/R = 0.60$  and  $0.77$ ) show smaller increases relative to the clean airfoil baseline curves. This is to be expected as the corresponding ice accretion shapes are somewhat more "aerodynamic" in cross section as Fig. 17 indicates.

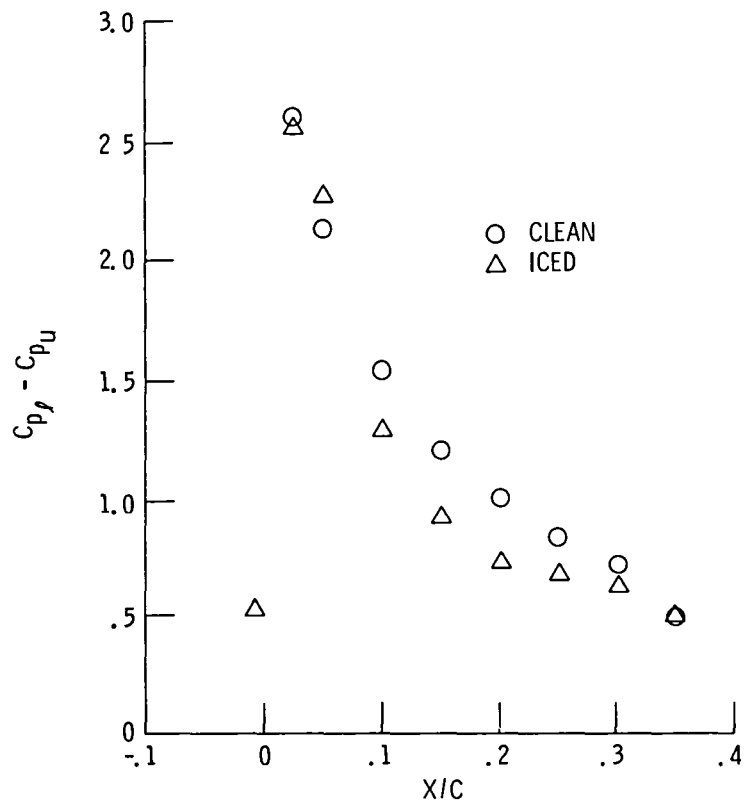
Figure 18. - Surface pressure coefficient differential curve.  $M_\infty = 0.35$ ,  $\alpha = 5.9^\circ$ ,  $r/R = 0.44$ .

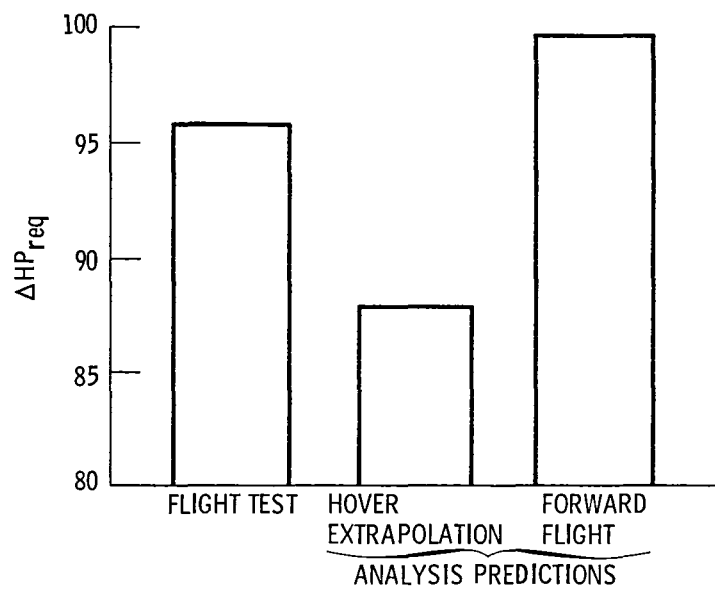
Figure 19. - UH-1H rotor performance degradation due to icing for flight E - experimental and predicted.

The results of the two analysis predictions performed by Bell Helicopter Textron personnel compared to the flight test measurement for flight E are shown in Fig. 19. The results are judged to be surprisingly good. The flight test results indicated an increase in required horsepower of  $96$  while the forward flight analysis predicted  $100$  and the hover extrapolation method predicted  $88$ . Of course, these results may be somewhat fortuitous in view of the several concerns already mentioned
